Duckworth Farmhouse
AL-V1-C-200

INVENTORY FORM FOR STATE HISTORIC SITES SURVEY

Duckworth Farmhouse

AL-VI-C-200
DUCKWORTH FARMHOUSE
STONEY RUN WESTERNPORT
USGS BARTON QUAD
1:24000
1947

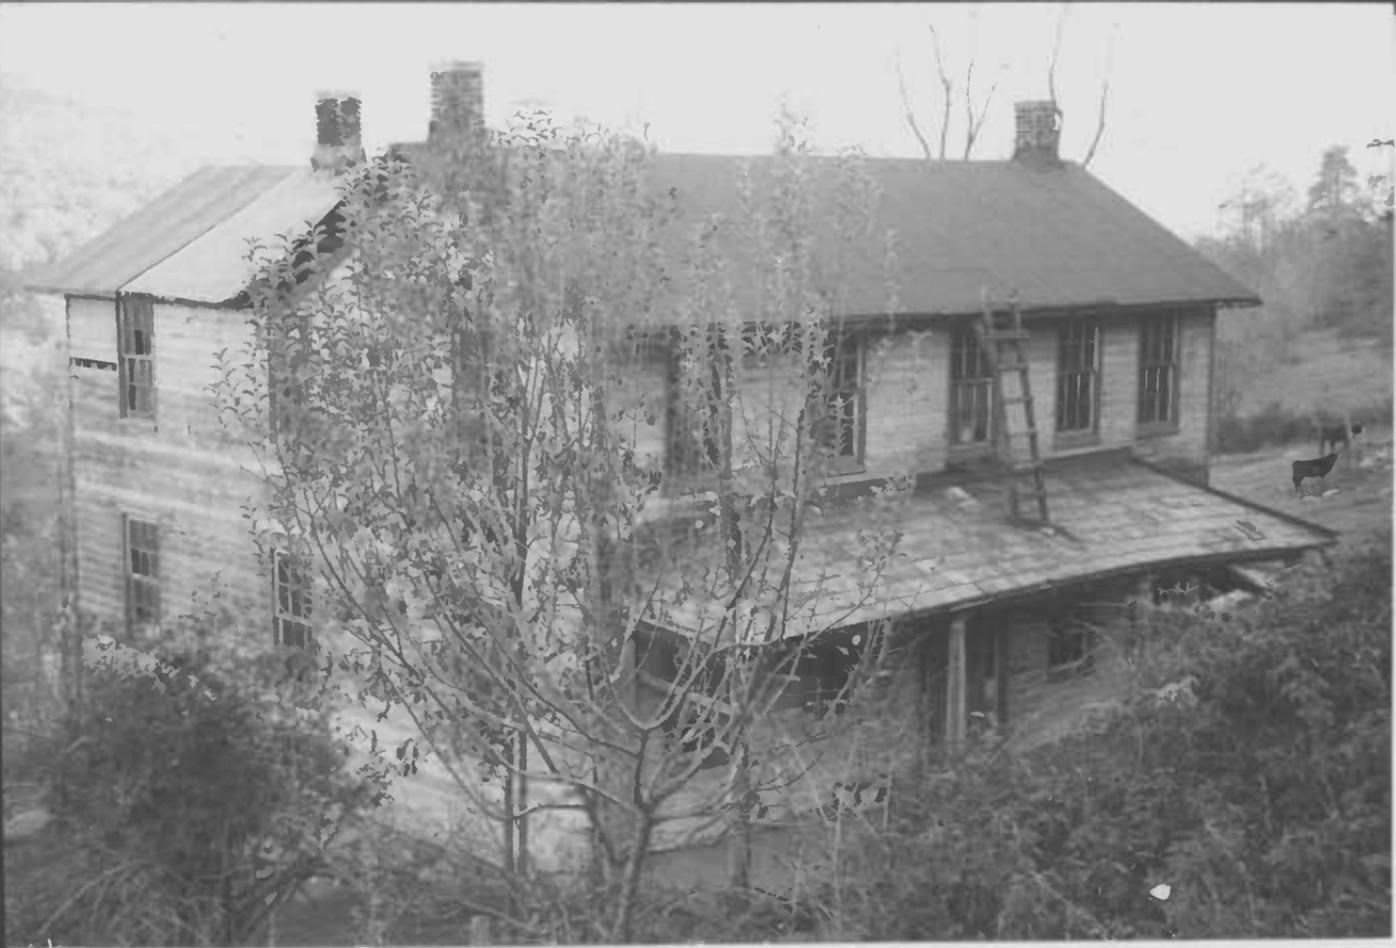
AL-VI-C-200

SOUTH

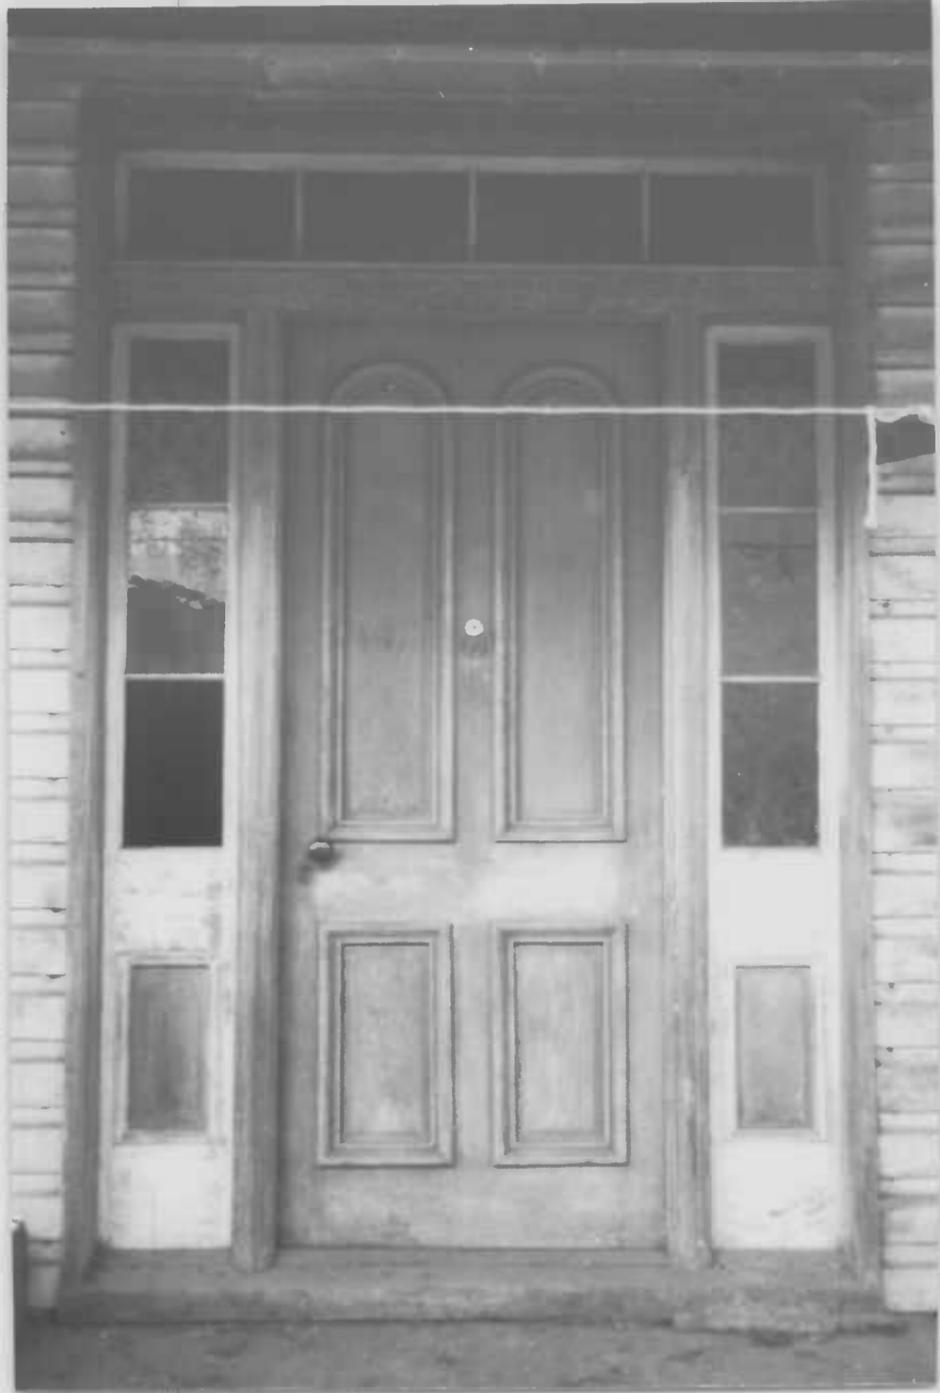
AI-VI-C-200
DUCKWORTH FARMHOUSE
STONEY RUN, WESTERNPORT
DAVID A. DORSEY

The main entrance in the center of the northwestern facade includes a four light transom, sidelights of three lights and one moulded panel each, and a wide door with two semicircular arched and two rectangular moulded panels and original hardware. Windows are wide, pegged six over six lights with wooden lugsills. A two tiered veranda runs the length of the southeastern and southwestern facades. It rests on tall wooden posts with lattice work. The shed porch roof is supported by square wooden posts with decorative brackets and a plain balustrade.

ENTRANCE, DOORS: LOCATION: center NW sidelights each of 3 lights 1 panel
HARDWARE: original() replaced() 4 light transom.
FAN LIGHT, TRANSOM, SIDE LIGHTS, PLAIN
Paneled, Vertical, Horizontal Boards 2 semicircular arched panels
2 rectangular

DETAIL - ENTRANCE
N.W. FACADE
