Located on the north bank of the Severn River, over-looking Round Bay and Annapolis, is the early 19th century brick house known as Carter's Bluff. It was owned through most of the 19th century by the Linsted family, appearing on the 1860 and 1878 county maps under the names of M. Linsted and Jno. Linsted, respectively. In about 1900, the farm was acquired by two brothers, named Riggs, from Baltimore. The house was renovated and used as a summer home. After the death of the last Riggs brother in the early 1940's, the land was bought by developers and the Linstead-on-Severn subdivision was built. Mr. and Mrs Carter purchased the house, with about two acres, at that time.

11. FORM PREPARED BY

DATE: August 1975

## Carter's Bluff (Linsted House)

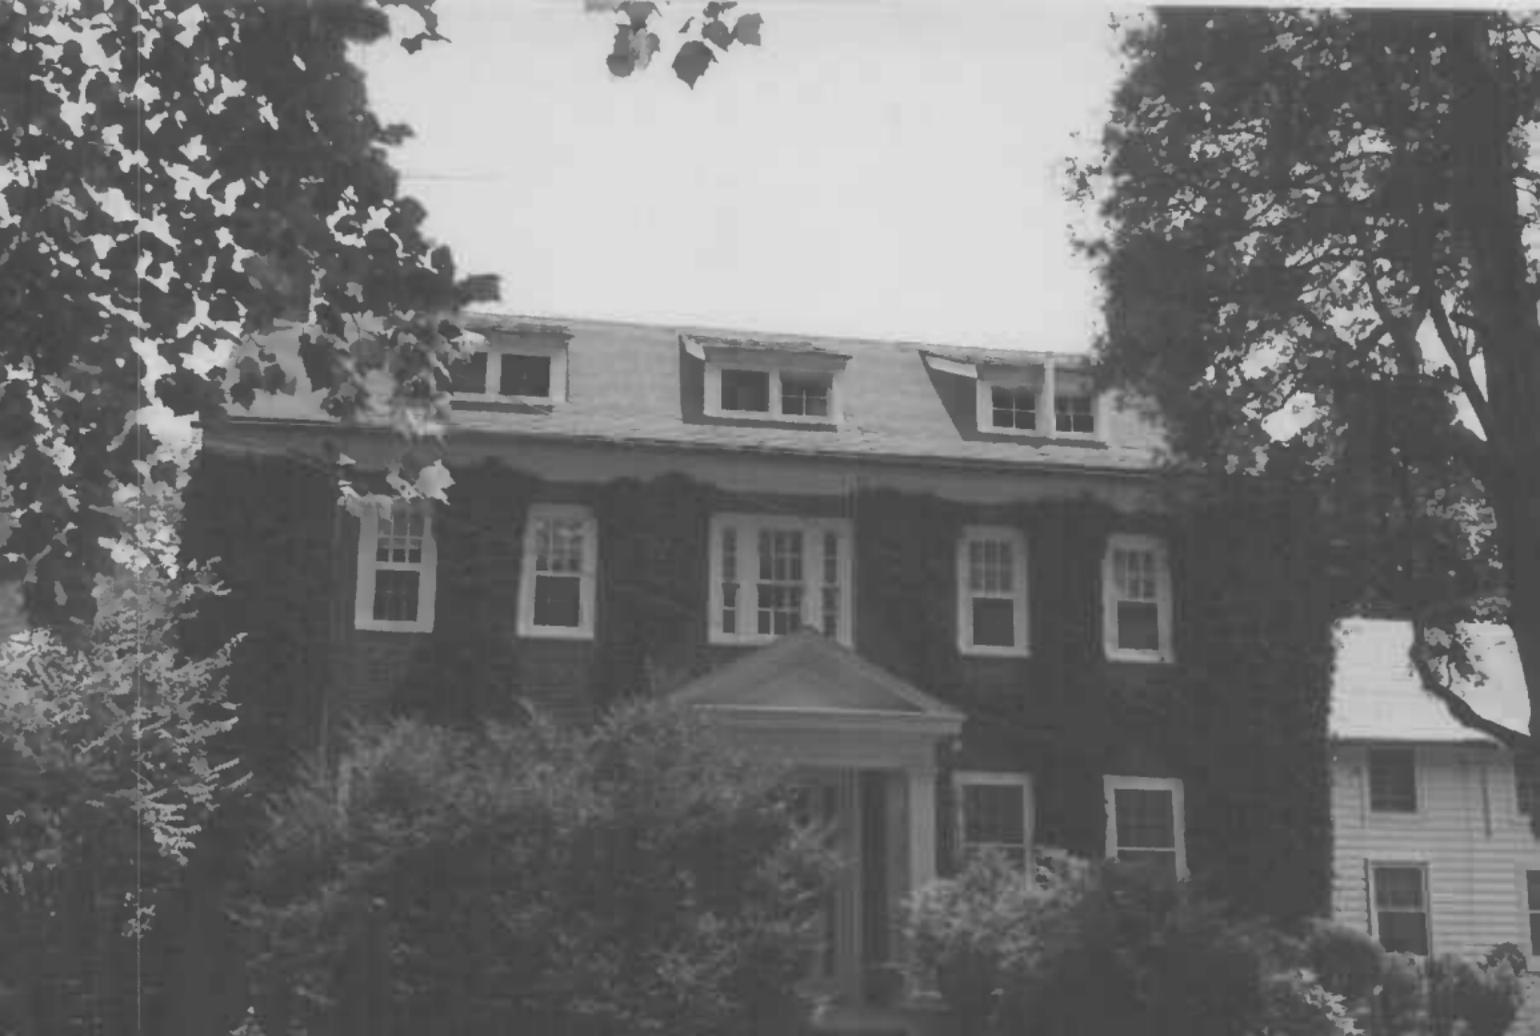
aa-16-T-a<sup>(map 16)</sup>

The interior plan consists of two rooms divided by a center hall with an exterior door at either end. The north entrance is covered by a simple wooden porch with a pediment. The south entrance leads out onto the veranda. All of the windows, except the center windows on the second floor, have 6/6 pane sashes, wider on the first floor than on the second. The center opening on the second floor of the north facade is a wide, three part window having a 6/6 pane center portion flanked by 4 pane sidelights. The corresponding window on the south facade may have been altered. It now contains a door leading out onto the foof of the veranda. All of the openings have flat brick arches.

Carter's Bluff  
(Linsted House)  
North elevation

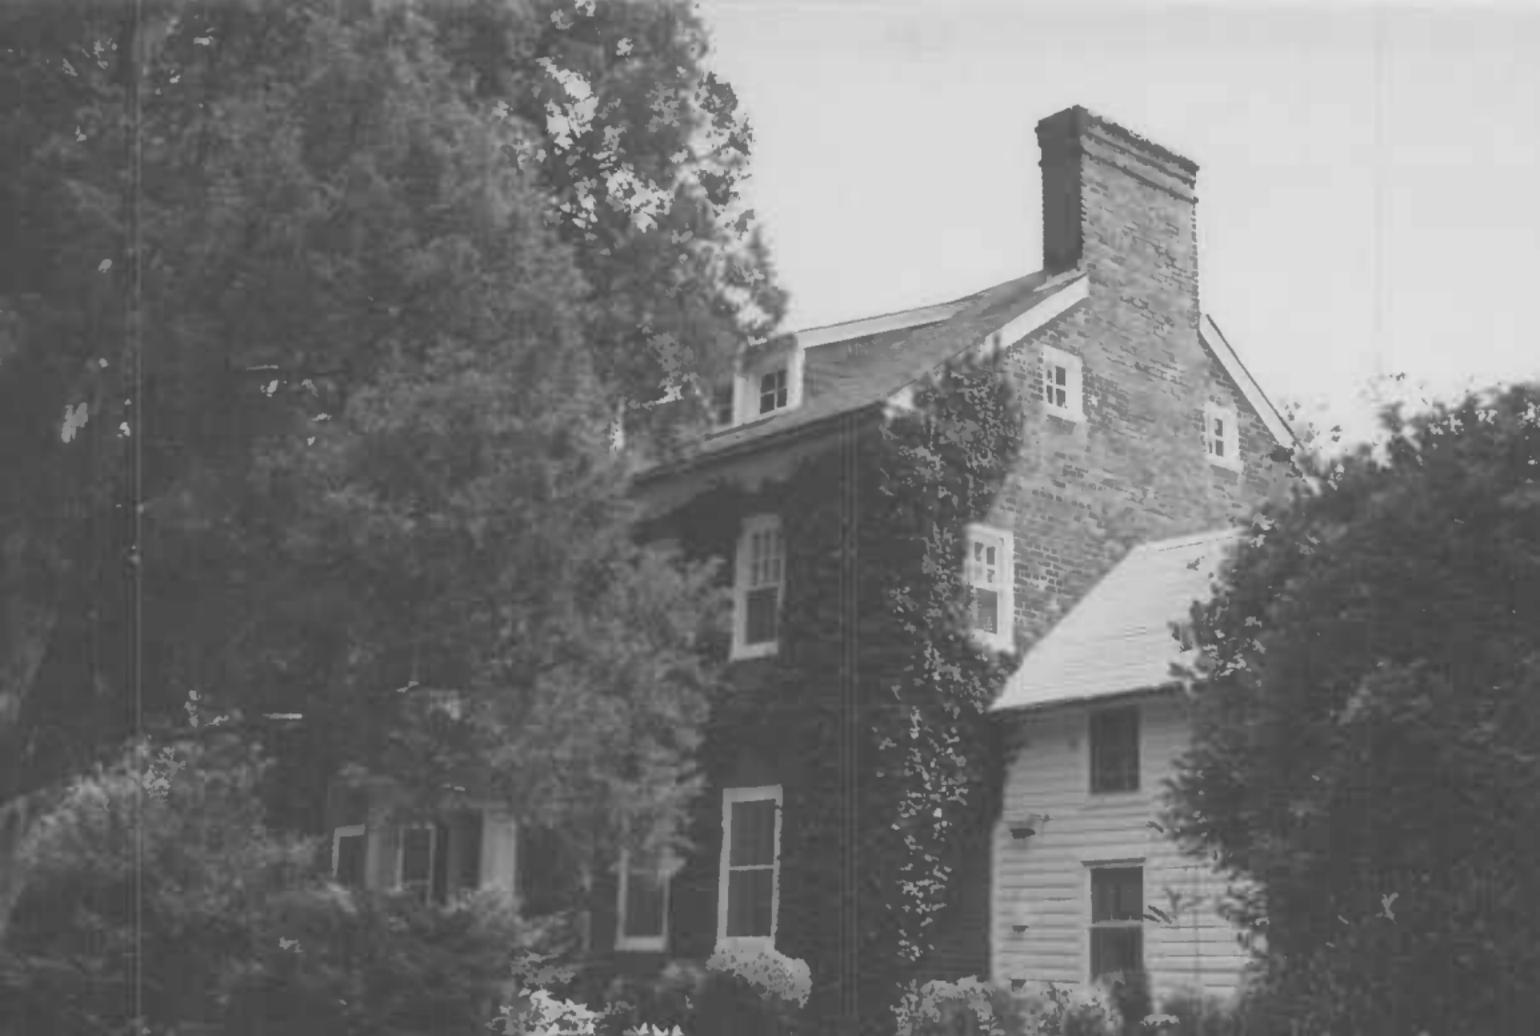
aa-16-T-a (map 16)

The small frame addition to the west end of the house contains the kitchen. The structure has been enlarged and modernized but part of it may date from the early 19th century.

Carter's Bluff  
(Linsted House)  
N.W. corner

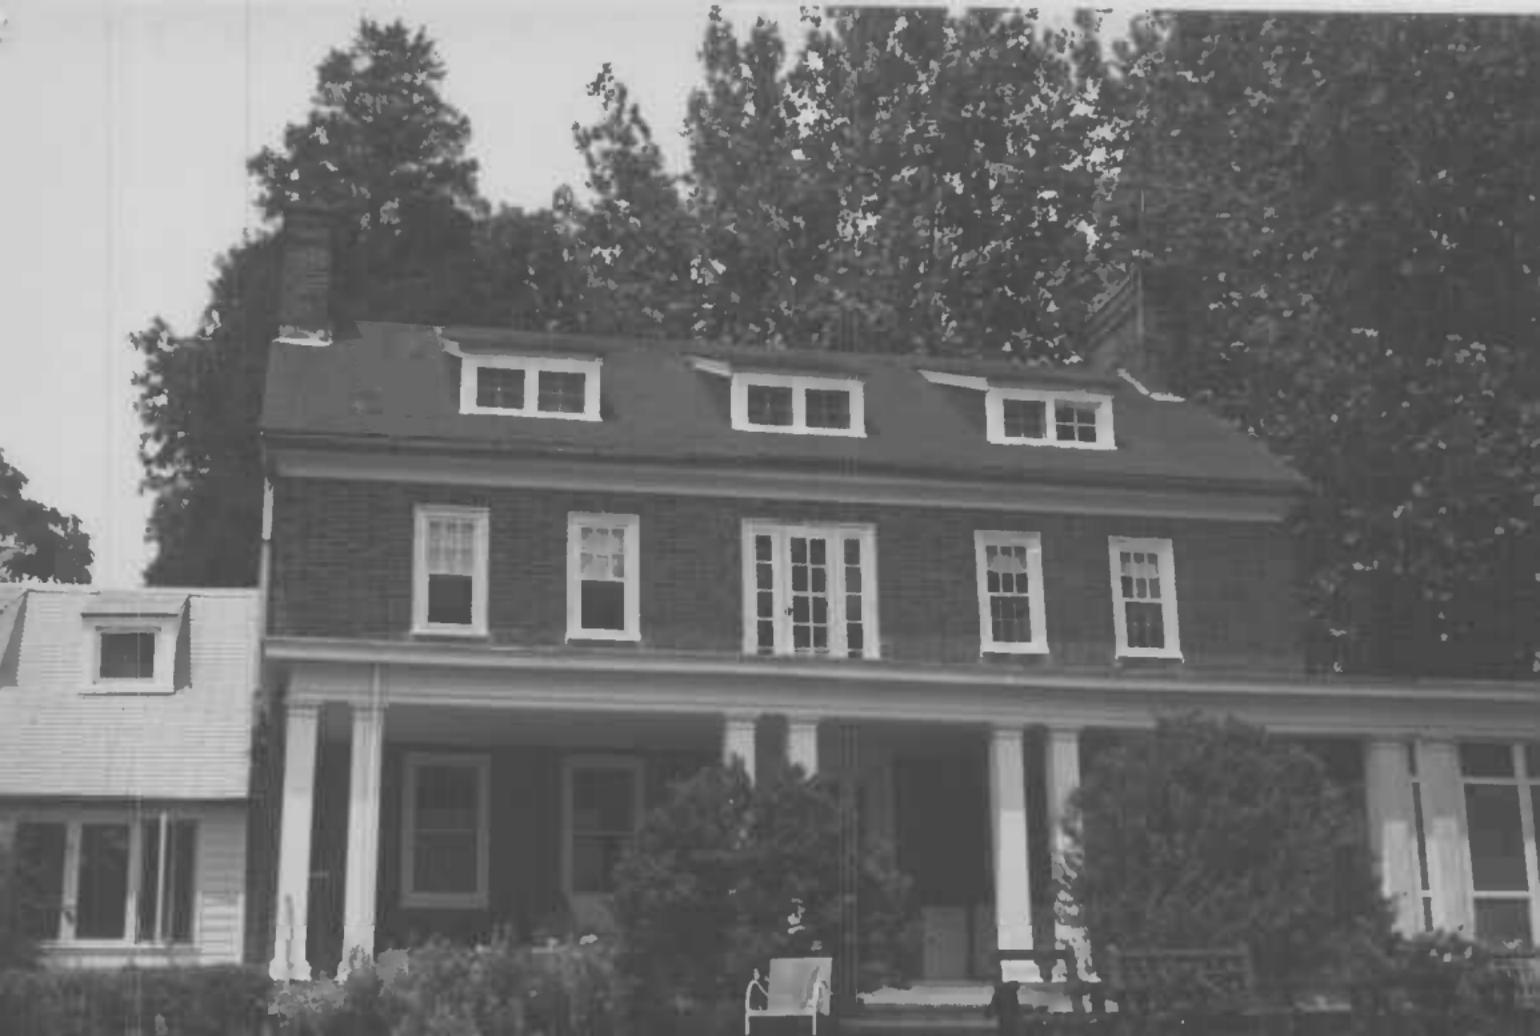
aa-16-T-a (map 16)

The south wall of the house (facing the river) is laid in Flemish bond with one header course to every three stretcher courses. The house has no basement and no water table.

Carter's Bluff  
(Linsted House)  
South elevation
