MARYLAND HISTORICAL TRUST
 21 STATE CIRCLE
 SHAW HOUSE
 ANNAPOLIS, MARYLAND 21401

HISTORIC SITES SURVEY FIELD SHEET
 Individual Structure Survey Form

SURVEY NUMBER: AA 399
NEGATIVE FILE NUMBER:
UTM REFERENCES: Zone/Easting/Northing
U.S.G.S. QUAD. MAP:
PRESENT FORMAL NAME: St. Anne's Episcopal Church
ORIGINAL FORMAL NAME: St. Anne's Episcopal Church
PRESENT USE: Church
ORIGINAL USE: Church
ARCHITECT/ENGINEER: J.R. Condit, Newark, NJ
BUILDER/CONTRACTOR:
PHYSICAL CONDITION OF STRUCTURE: Excellent (X) Good () Fair () Poor: ()
THEME:
STYLE: Lombard Romanesque
DATE BUILT: 1858 (Steeple 1865)

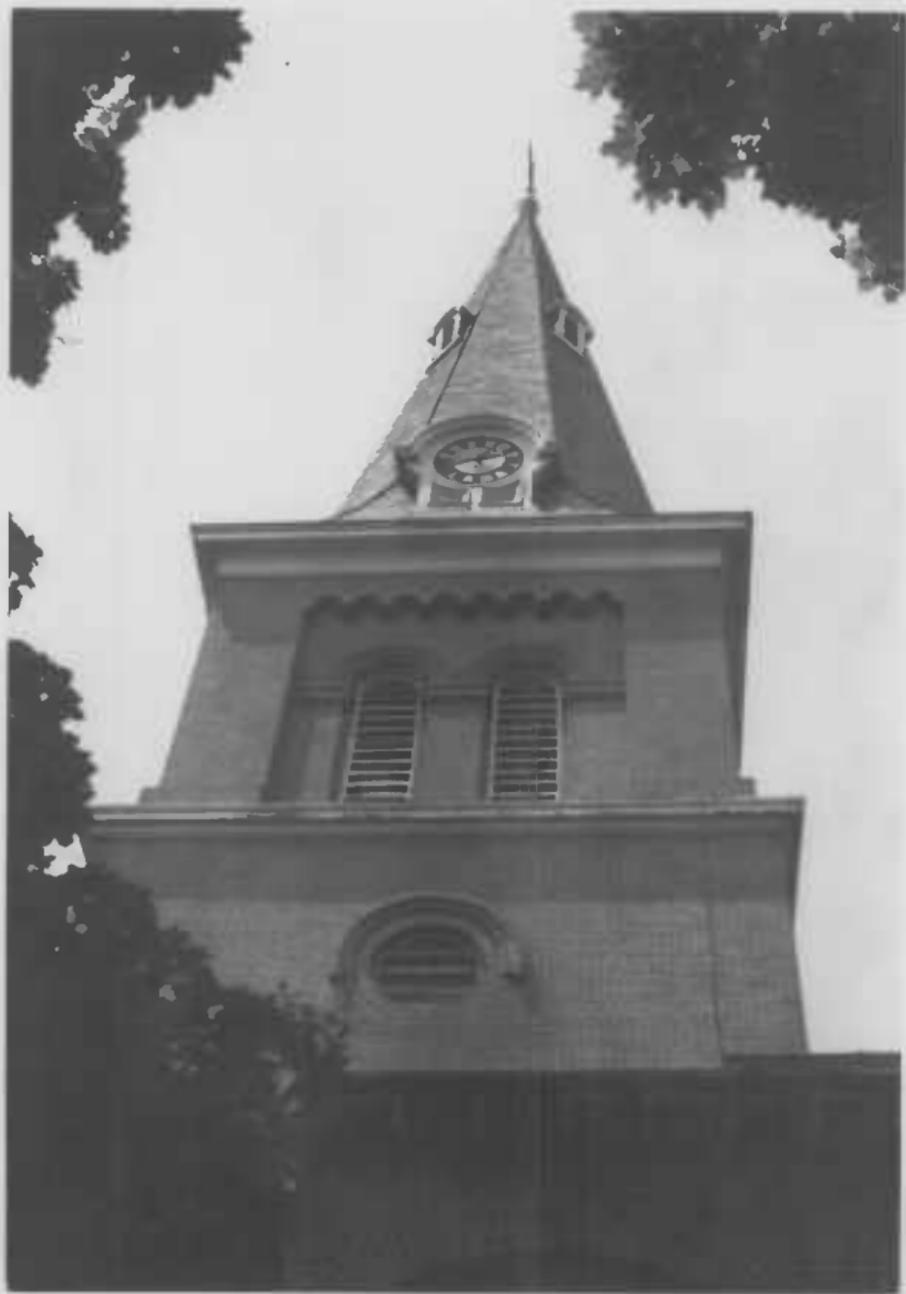
PA-399

Octagonal tower with round arched vents, flared at base of tower to connect with square section, which has four round headed clock frames. third floor of tower has paired compound arched openings with louvers, set in a blind, recessed arcaded panel, vents serving bell level; second level of tower has tall round arched window opening at front, round vents at sides and rear with corbeled openings; front lower facade has projecting porch with compound round arched opening, round fan light, paneled double door under a molded transom bar; side elevations divided into bays with round arched windows in compound arched openings, repeated above along the upper level at sides of nave and side aisles.

St Anne's Church
Spire, 1/27/07
WDM

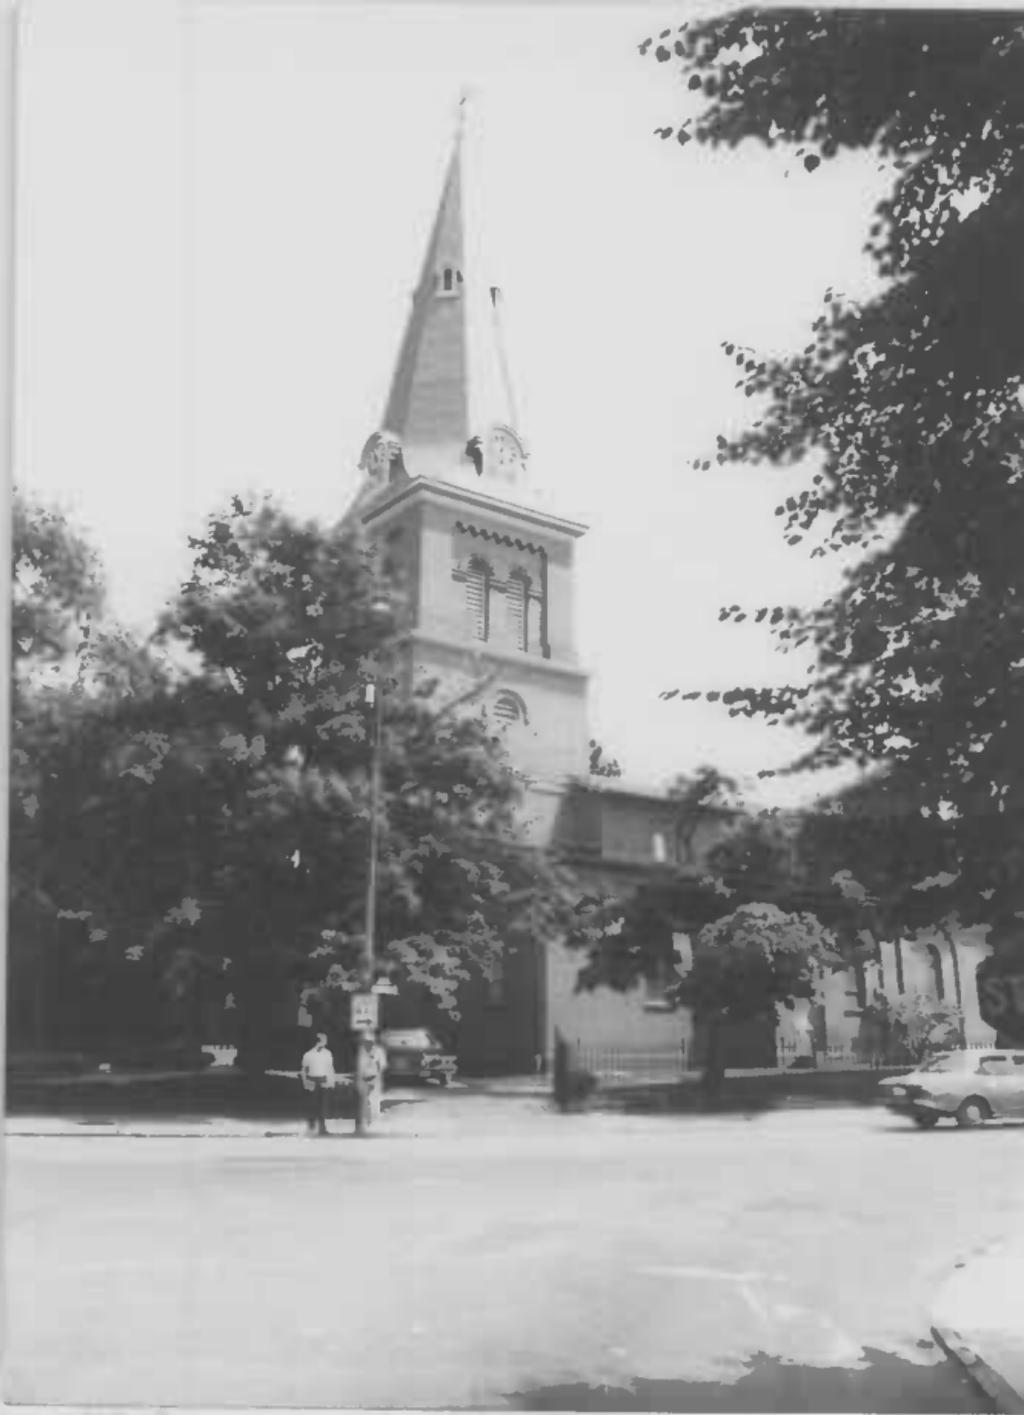
St. Anne's
Annapolis, Anne Arundel County
Russell Wright July, 1982
Maryland Historical Trust,
Annapolis, Maryland
NE Elevation/camera facing SW

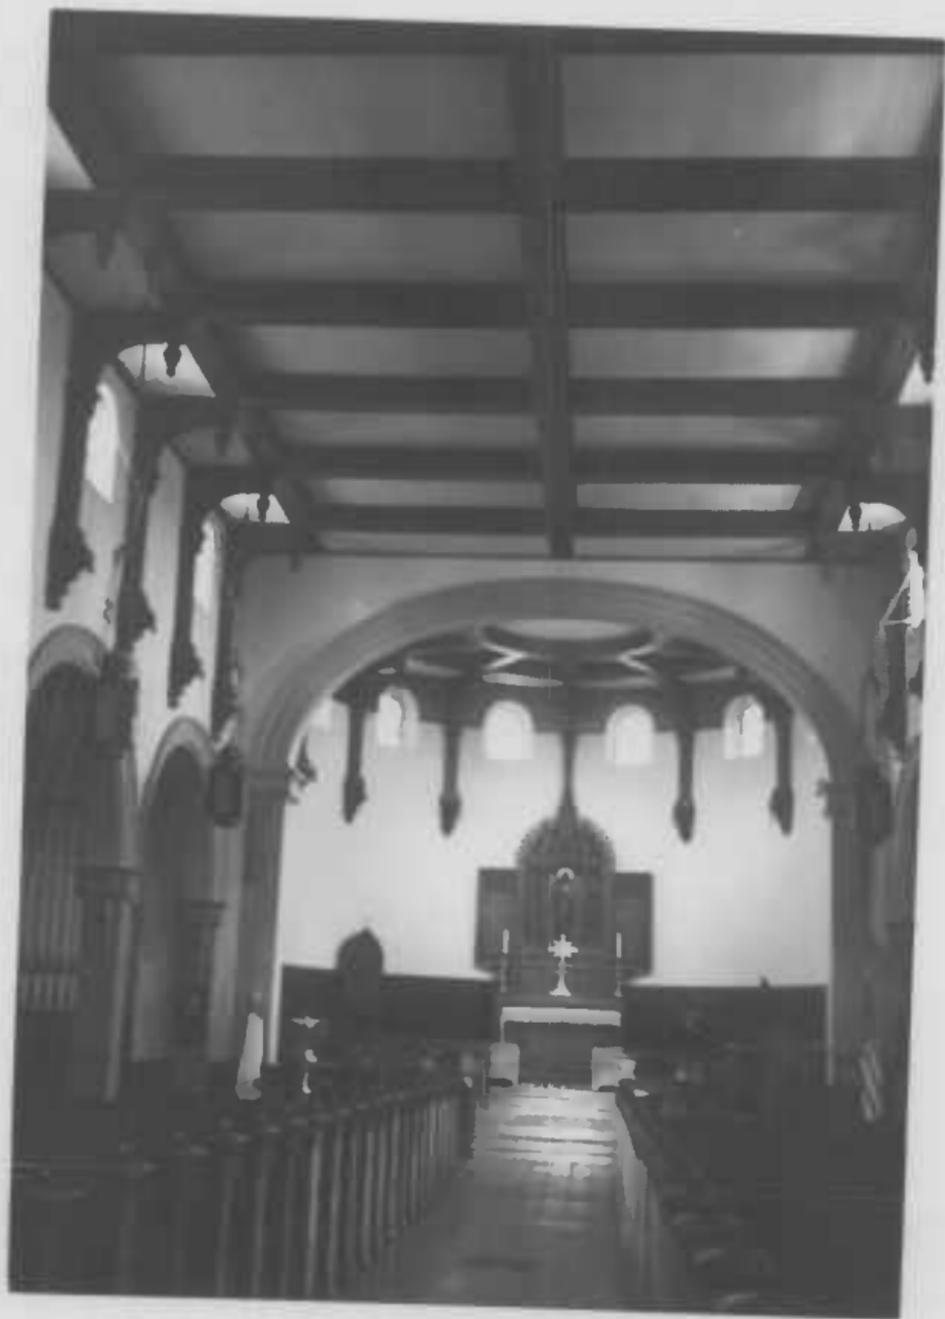
PA-399

St. James Church
interior
12/24/19. WDM
