Maryland Historical Trust State Historic Sites Inventory Form

Survey No. AA-849

historic THE MILL PROPERTY

and/or common EVANS MILL PROPERTY

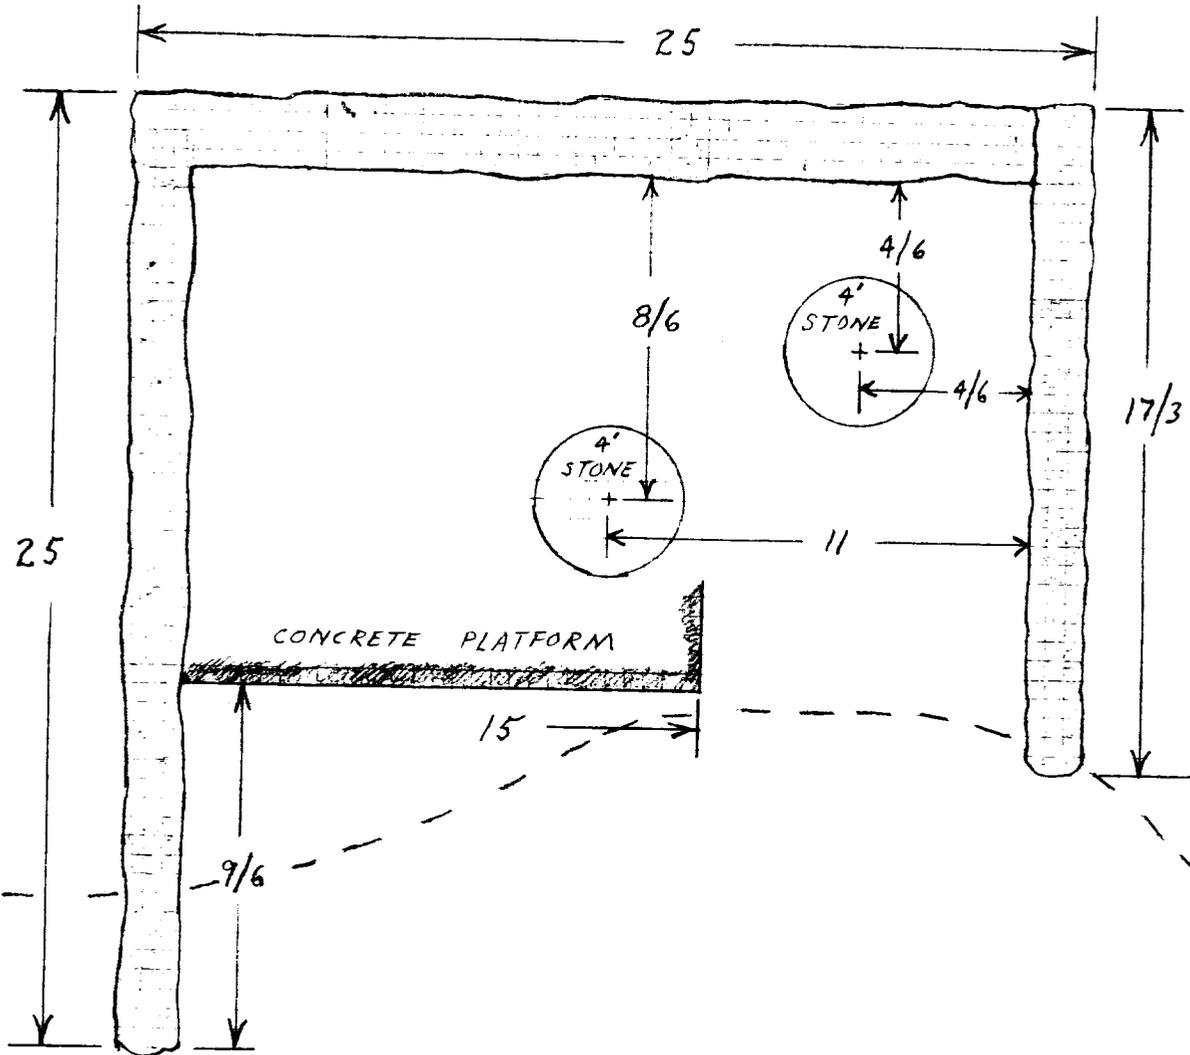
MEGGER PROPERTY
MILL
REMAINS
AA-849

All that remains of the mill site and house are features such as the wheel pit, a stone foundation of three walls, concrete flooring, two grinding wheels, bits of metal (millstone banding) and a metal belt pulley.

The remains of the stone foundation indicate a building roughly 25 feet by 17 feet. The complete northeast wall is still standing; it is constructed of sandstone and mortar. The other two walls are partially intact and are crumbling.

Ft/Ln

Remaining
stone wall

1 Ft

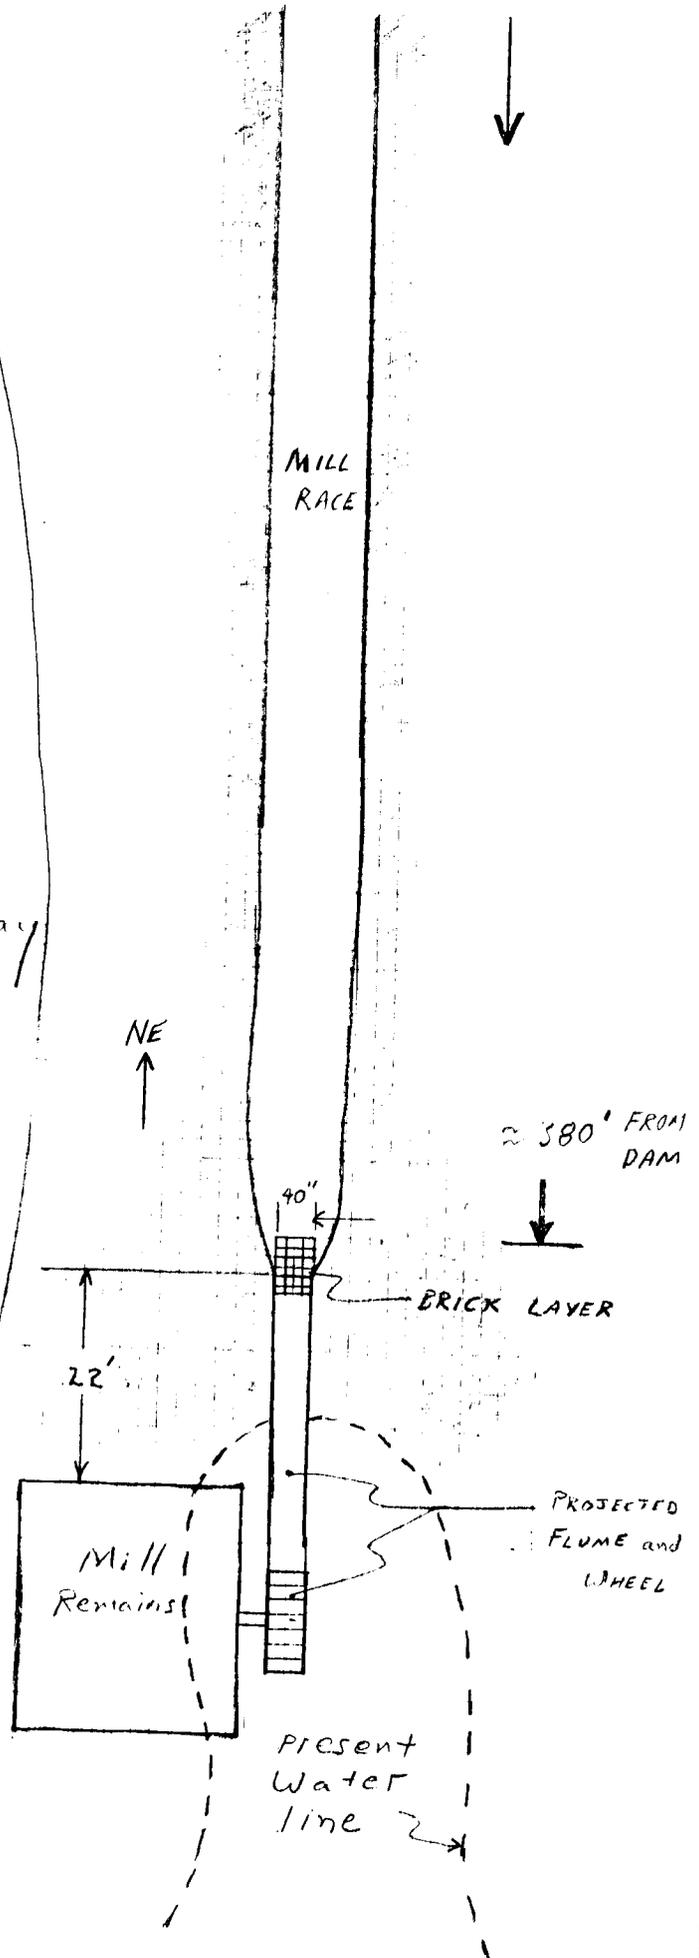
#1 AA-849

An earthen dam intersects the course of Stone Branch, which flows to the Patuxent River from south to north on the property. The dam measures 276 feet before crossing the branch and continuing another 100 feet after being intersected by the stream. The surviving height of the dam is 4 feet above grade on the upstream side and is generally 5 feet across at the top. The dam also has an additional break in it which permits a dirt road to go through it to the west.

At the point where the dam once crossed the branch the millrace begins a straight run to the southwest and the mill site. The millrace is 380 feet in length. Surface features indicate the previous existence of diversion channels and holding or accumulation ponds shortly after its beginning at the dam. There are no further outstanding features until the race terminates at the wheel pit. Bricks have been laid at the point where the millrace meets the wheel pit. These bricks were apparently used as a foundation to support the flume.

Water Line

Roadway Remains

MEGER PROPERTY

MILL

LOCATION

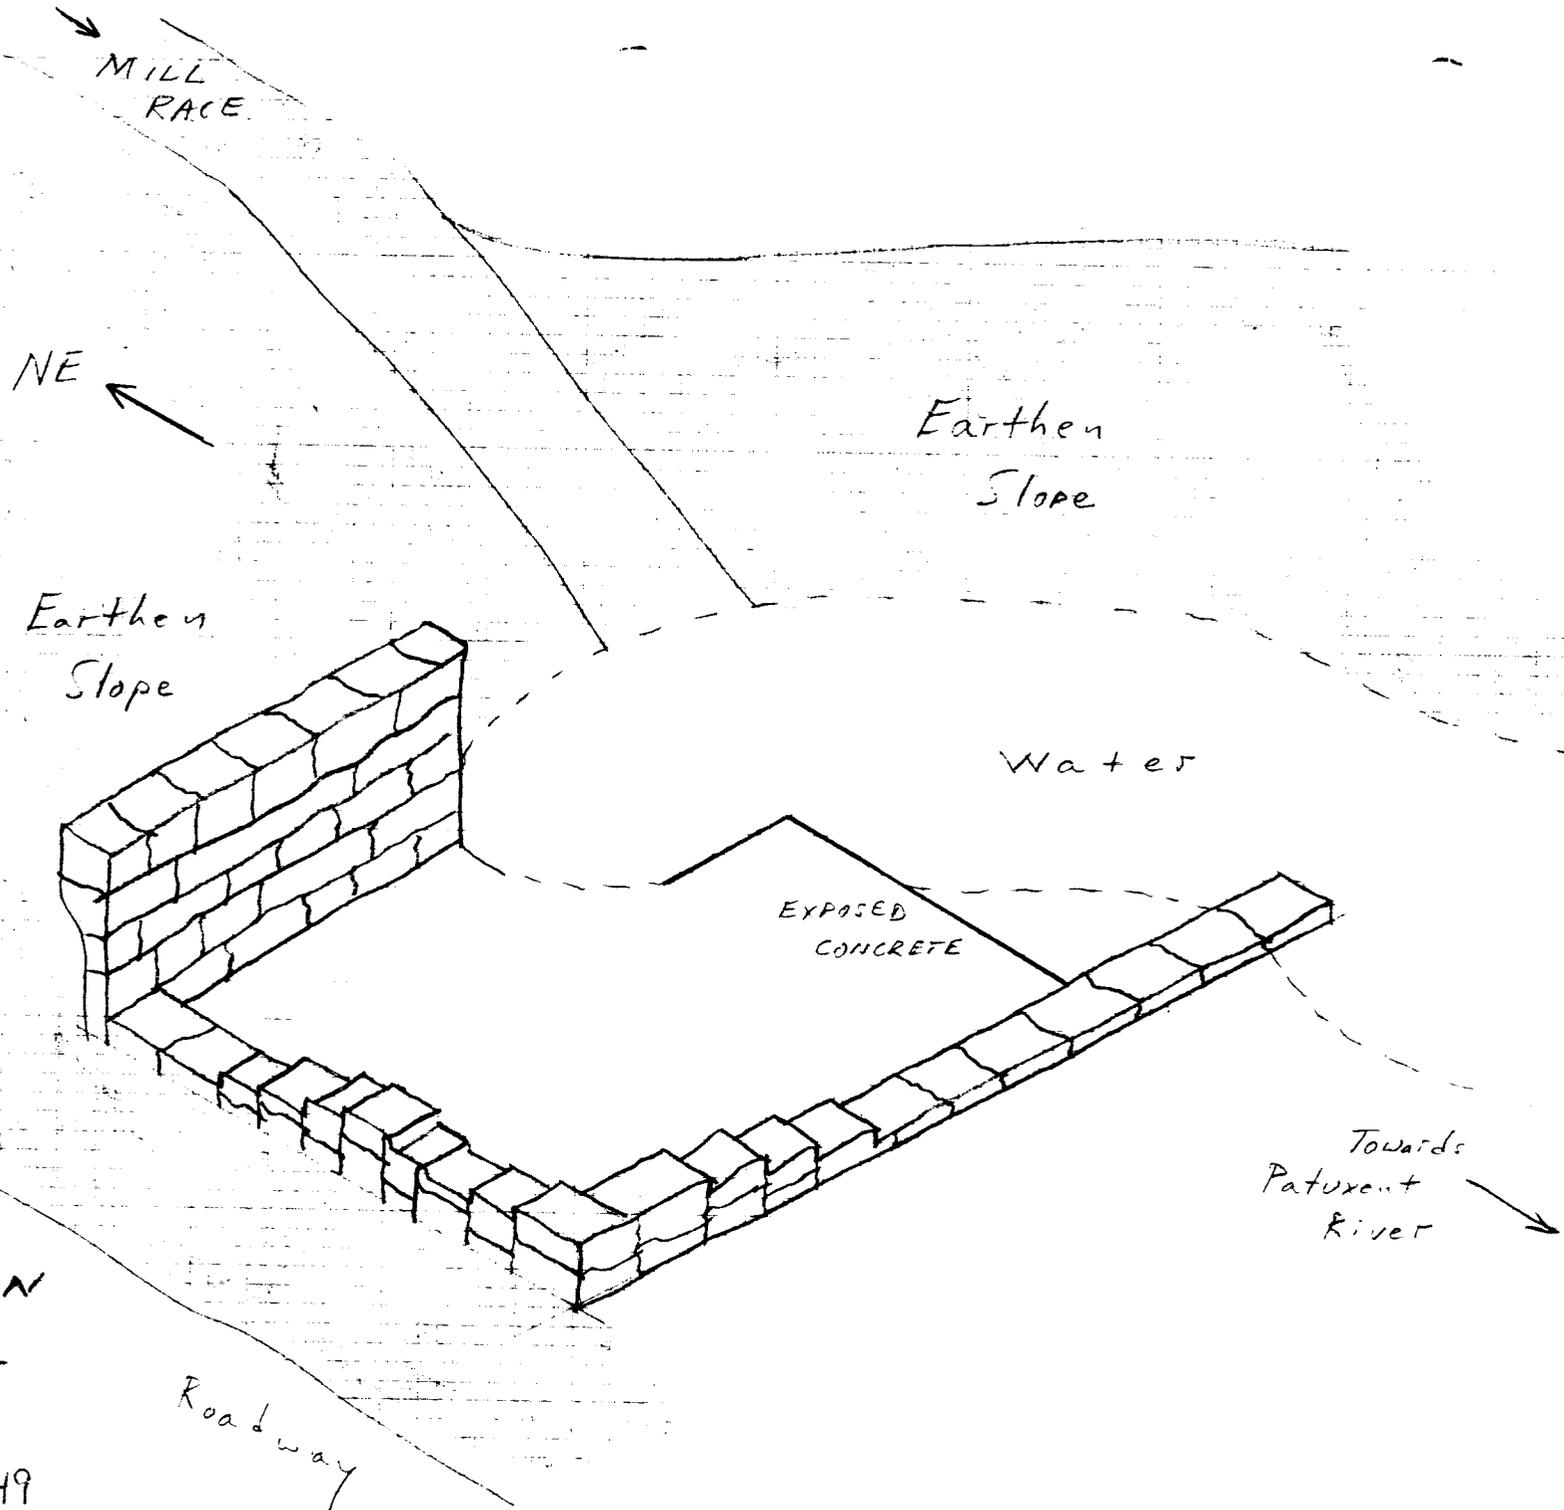
MILL
FOUNDATION
REMAINS

There are two millstones resting on the 3 inch thick concrete floor. They are of composite construction: Belgian Buhrstone chips and a binder, probably concrete, being the primary materials. Each stone is 4 feet in diameter.
