Marbury Building

Crownsville Hospital Center

**Maryland Historical Trust  
State Historic Sites Inventory Form**

Survey No. AA-970

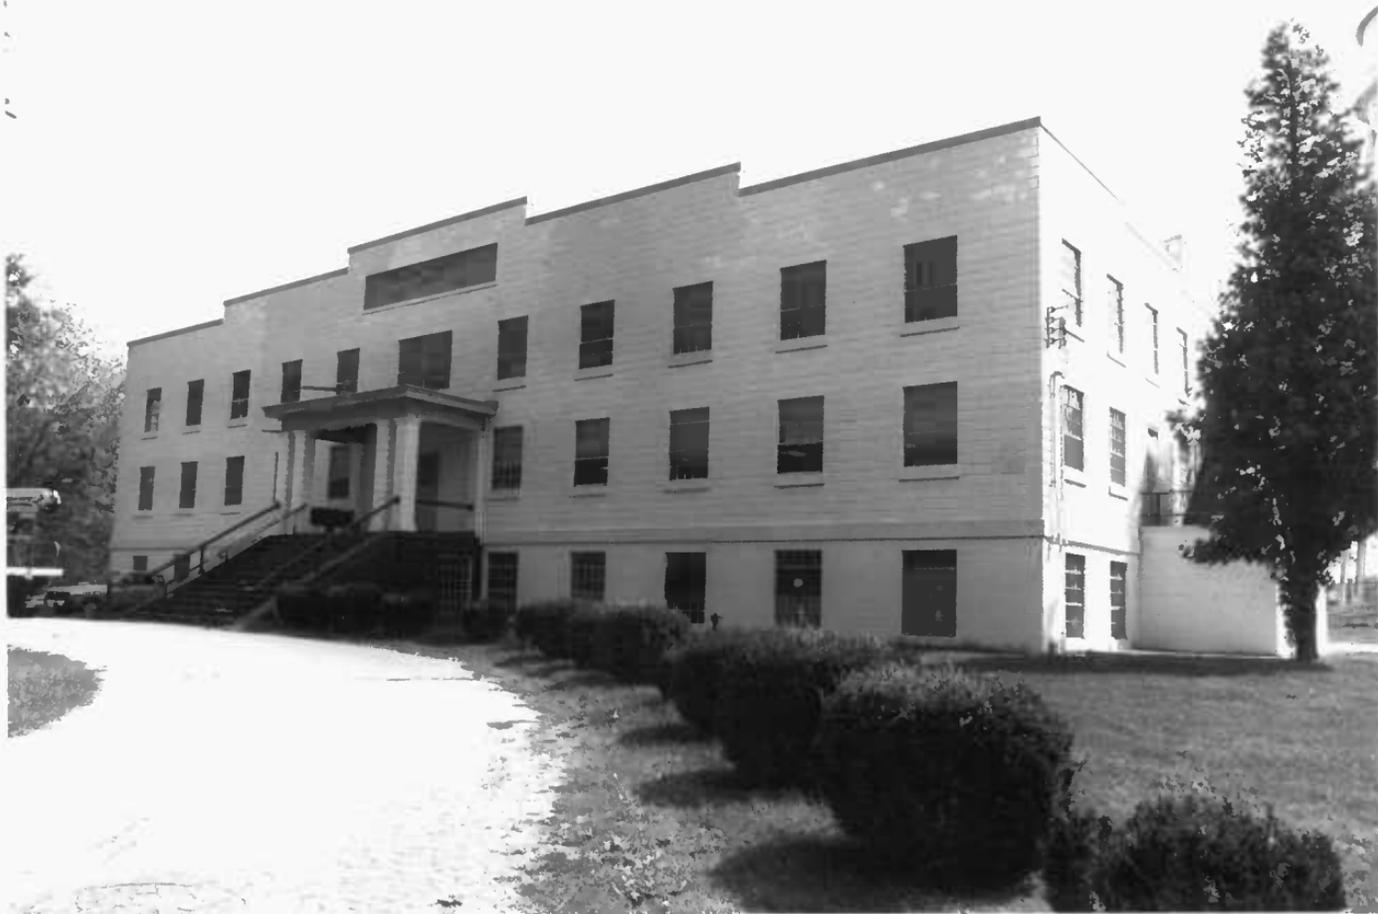
Negatives at MHT  
North

The North facade displays the dominant features of the building. The foundation is also made of concrete but its surface is smooth. The fenestration consists of the steel projecting windows with a single sash of five panes by five panes. Thick concrete sills and flush lintels provide further detail on the windows. A raised water table separates the wall from the smooth concrete of the foundation and the molded bricks of the first and second floors. The stepped parapet has been inscribed to identify the building as the William L. Marbury Building.

The North facade exhibits a flat roof portico which incorporates the central bay of the wall. Molded concrete blocks form the paired pillars which support the wooden entablature. The entablature culminates in a boxed cornice. A similar but less detailed portico appears on the east face.

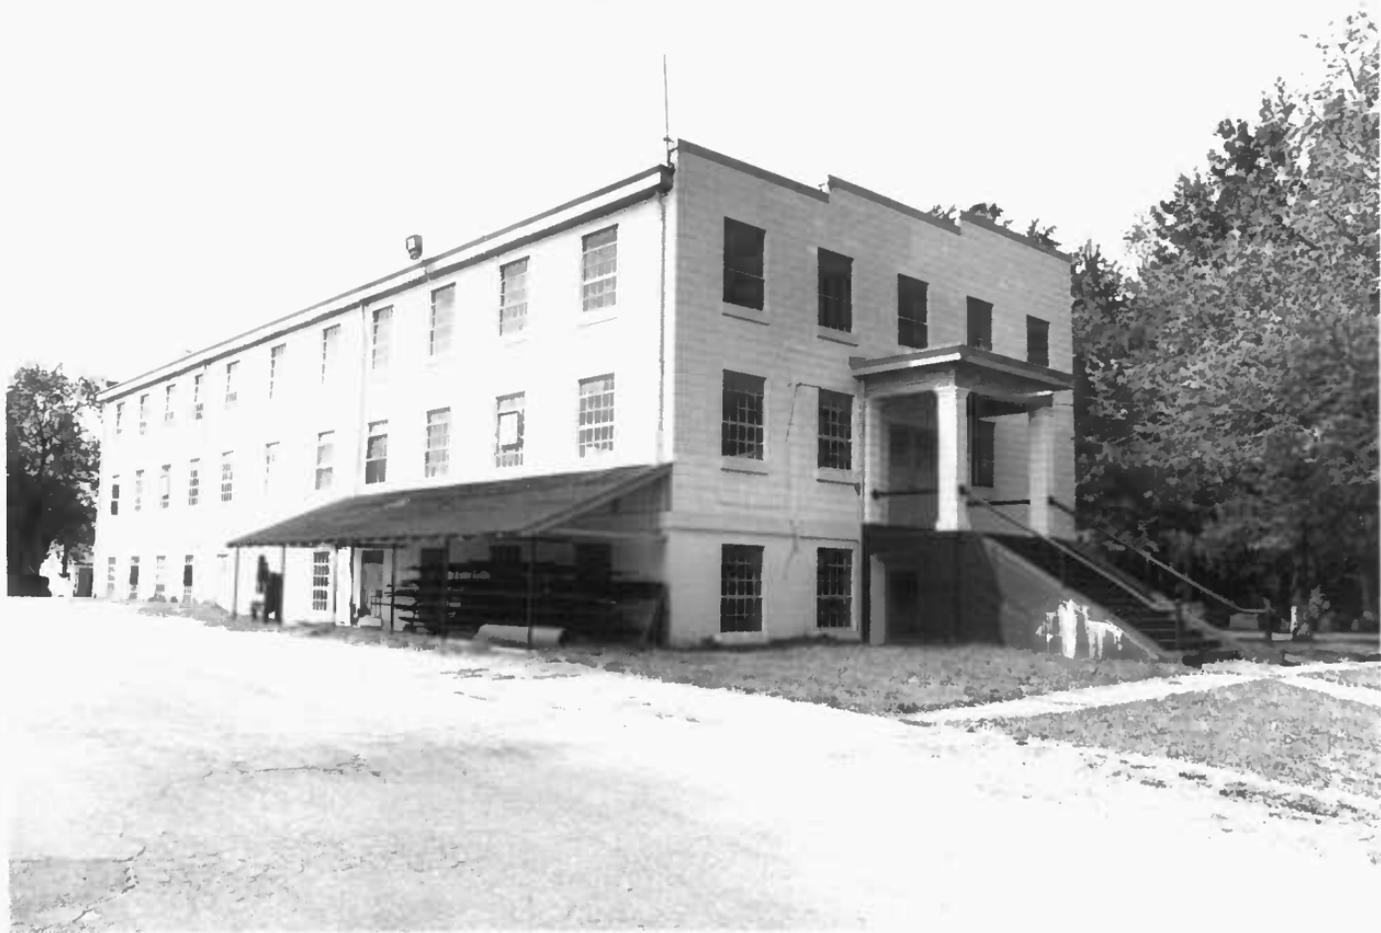
Southeast

Both the south and west walls display the standard features from the water table to the fenestration. The south wall has a wooden boxed cornice instead of stepped parapet. The main distinction on the west wall is the alterations which occurred to accommodate a fire escape. A brick interior wall chimney with a concrete capstone breaks the roof line on the west wall.
