AA-975

Winterode Building

Crownsville Hospital Center

Maryland Historical Trust State Historic Sites Inventory Form

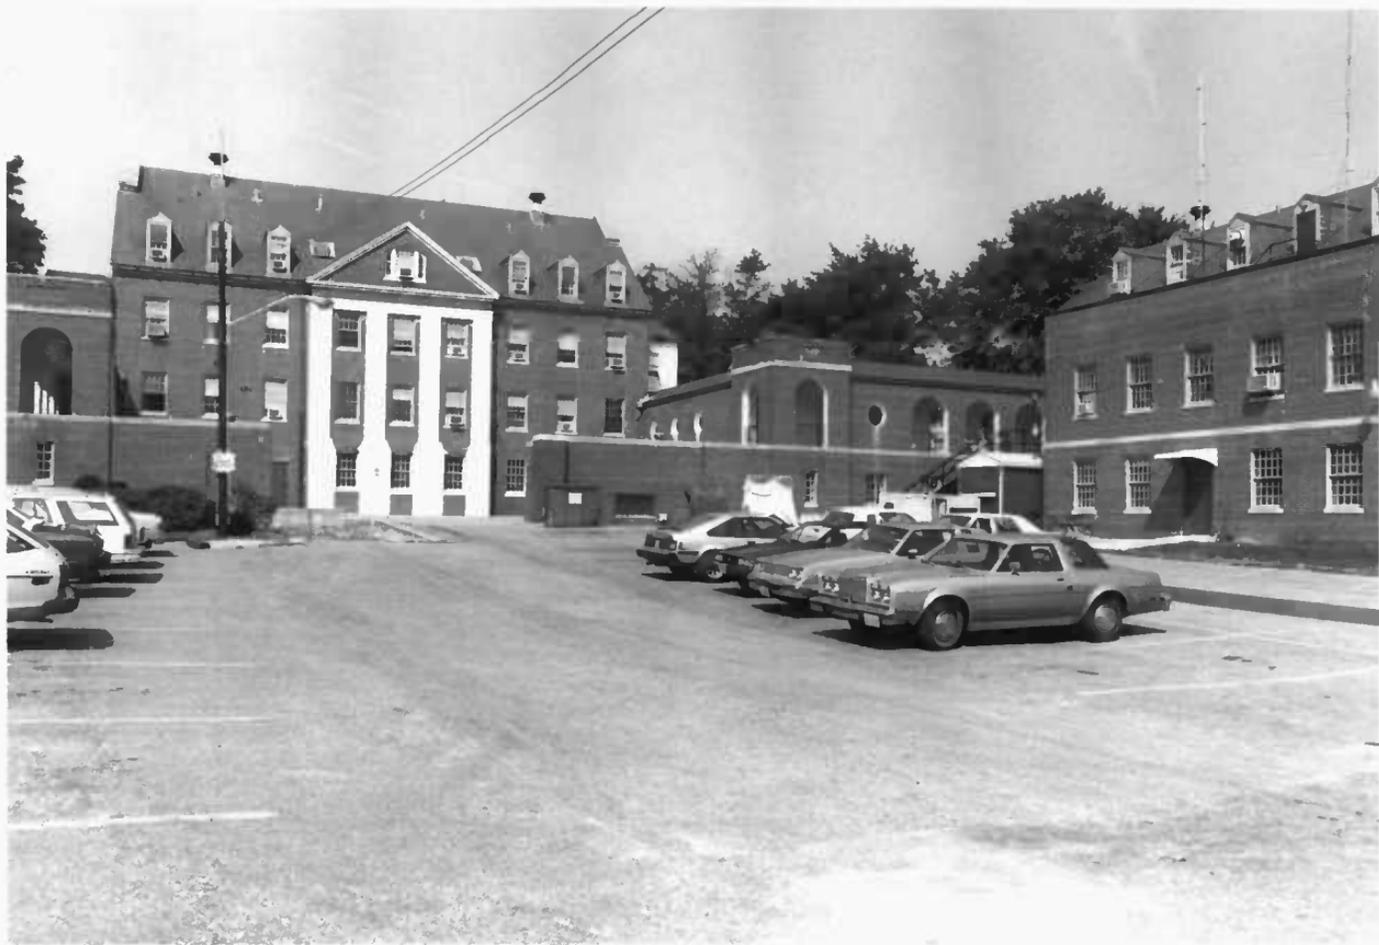
AA-975

The south wall of the Winterode Building displays a central gable which forms a pavilion incorporating the three middle bays. Brick pilasters punctuate the pavilion. A tripartite window with a segmental arch rests below the cornice. A molded brick water table runs across the facade.

South Face of Main Building

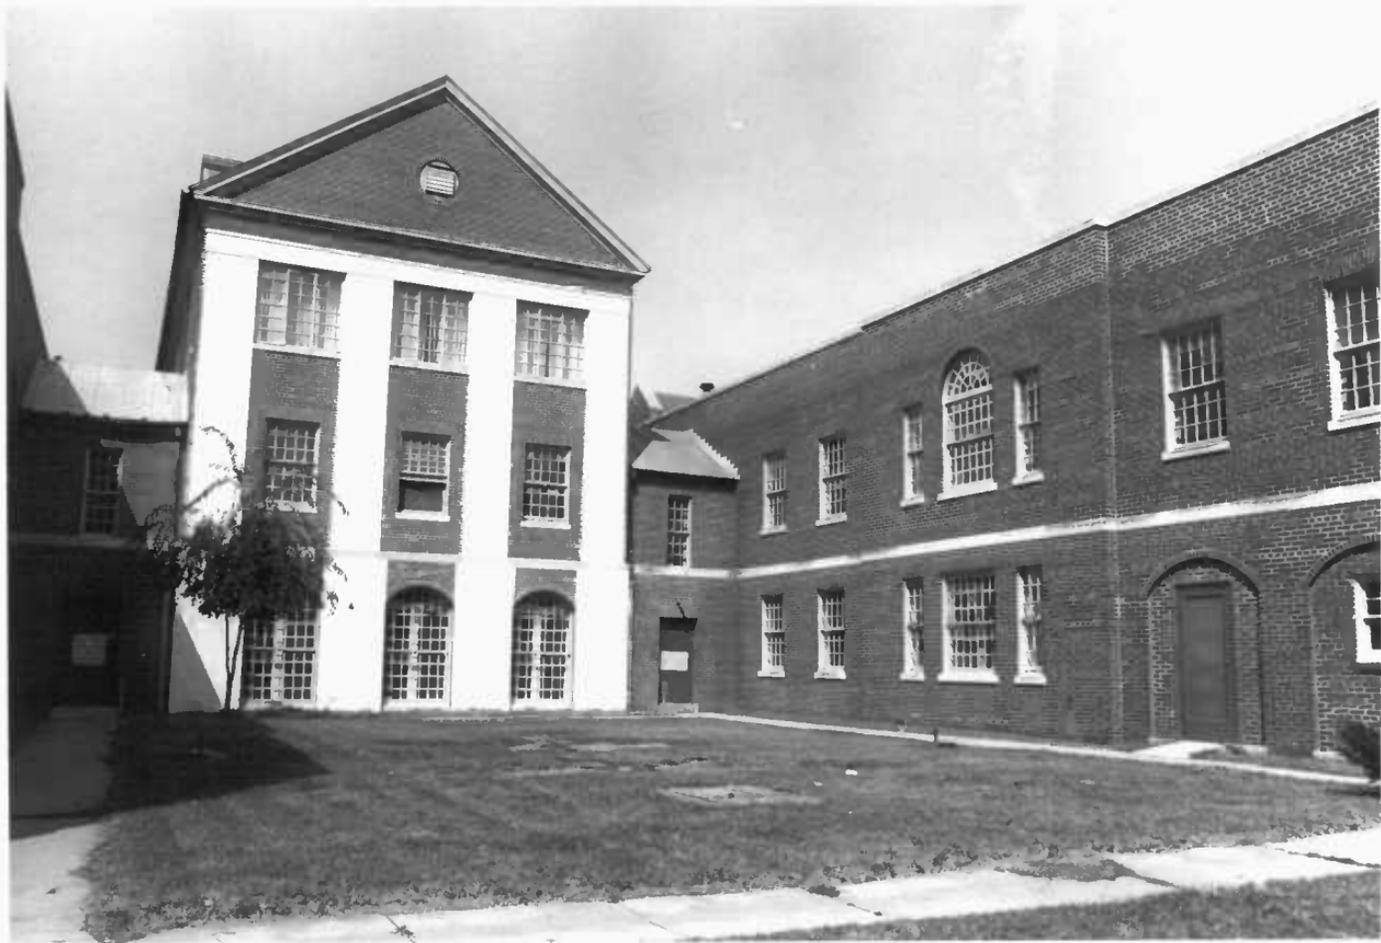
AA-975

The flanking buildings are very similar in appearance and composition. They measure three bays wide and nine bays deep, which is perpendicular to the Winterode Building. The facades display the same fenestration and other architectural elements which embellish the Winterode Building. Each flanking building has wings which run parallel to the original building. The attachments

SOUTH FACE OF WESTERN BUILDING

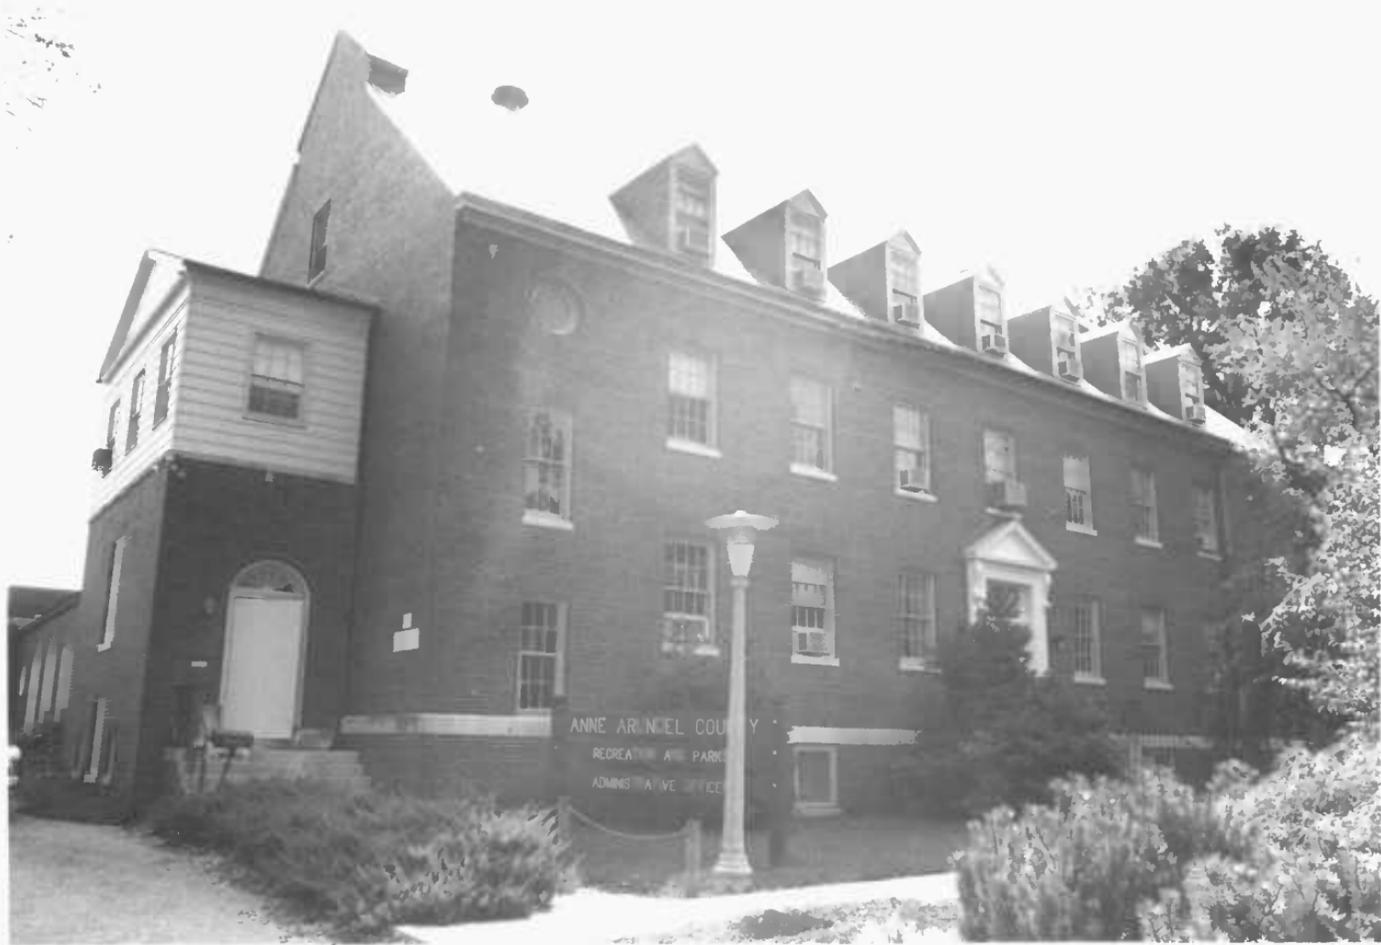
AA-975

The north facade is dominant and displays most of the features which appear throughout the exterior. The ground level openings feature casement windows with concrete sills. The concrete water table acts as the lintels for the openings. The first and second floor windows exhibit a 8/8 sash, concrete sills, and brick jack arch lintels. Two oculus windows appear on the outside bays just below the boxed wooden cornice. Pedimented dormers line the gable roof. The triangular pediment dormer has a plain cornice and a 6/6 sash. The entrance is decorated by a triangular pediment as well. Swan neck brackets support the grooved soffit and boxed cornice of the pediment. The original door has been retained.

North Facade of Main Building

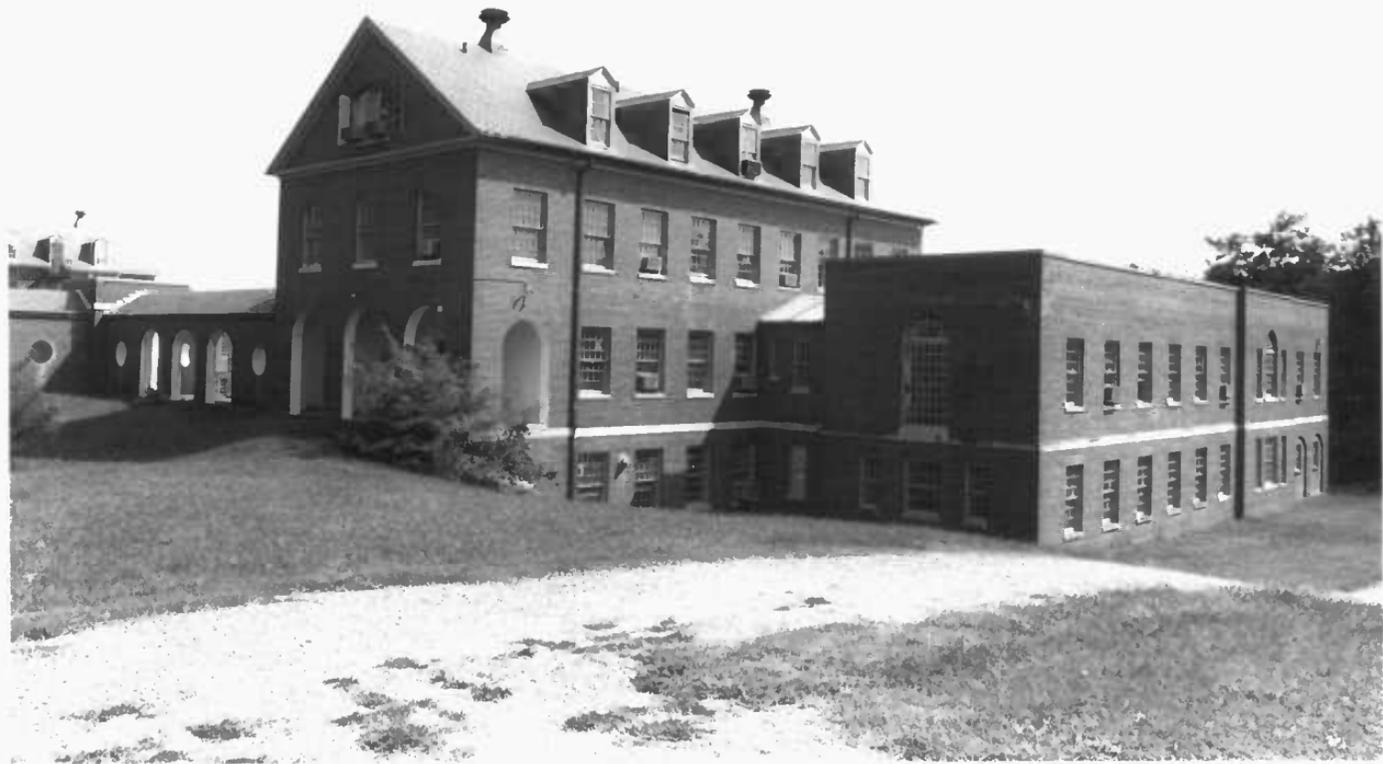
AA-975

NORTH AND WEST FACE OF
WESTERN BUILDING
