MARYLAND HISTORICAL TRUST WORKSHEET

NOMINATION FORM for the NATIONAL REGISTER OF HISTORIC PLACES, NATIONAL PARKS SERVICE

1. NAME				
COMMON: Mantua Mill House				
AND/OR HISTORIC:				
2. LOCATION				
STREET AND NUMBER: Southwest side of Mantua Mill Road				
CITY OR TOWN: Glyndon				
STATE: Maryland		COUNTY: Baltimore

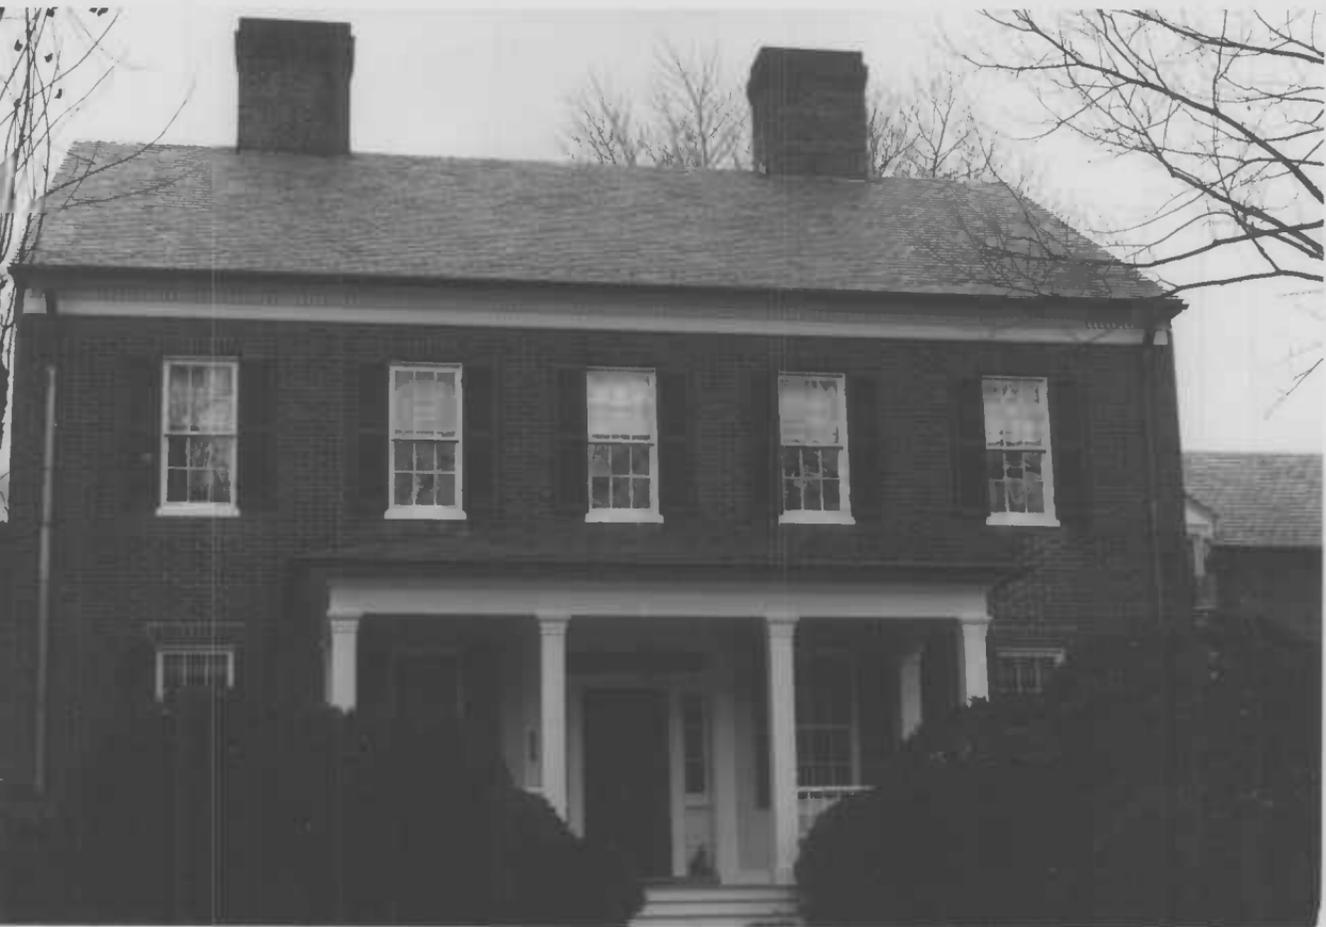
B7

Mantrel Mill House

nam no 73 E facade

Bricks of the north front are laid in common bond, without headers; headers occur every sixth course in other facades. Masonry above the windows is supported by unbonded jack arches. The principal entrance is through the center bay of the north front, with a secondary entrance directly through the house in the south facade. The 6/6 windows have paneled shutters in the first storey, louvred blinds in the second. Two windows light the attic through each gable end, and a small circular window lights the space above the attic. The early photographs show that windows and doors are basically unaltered.

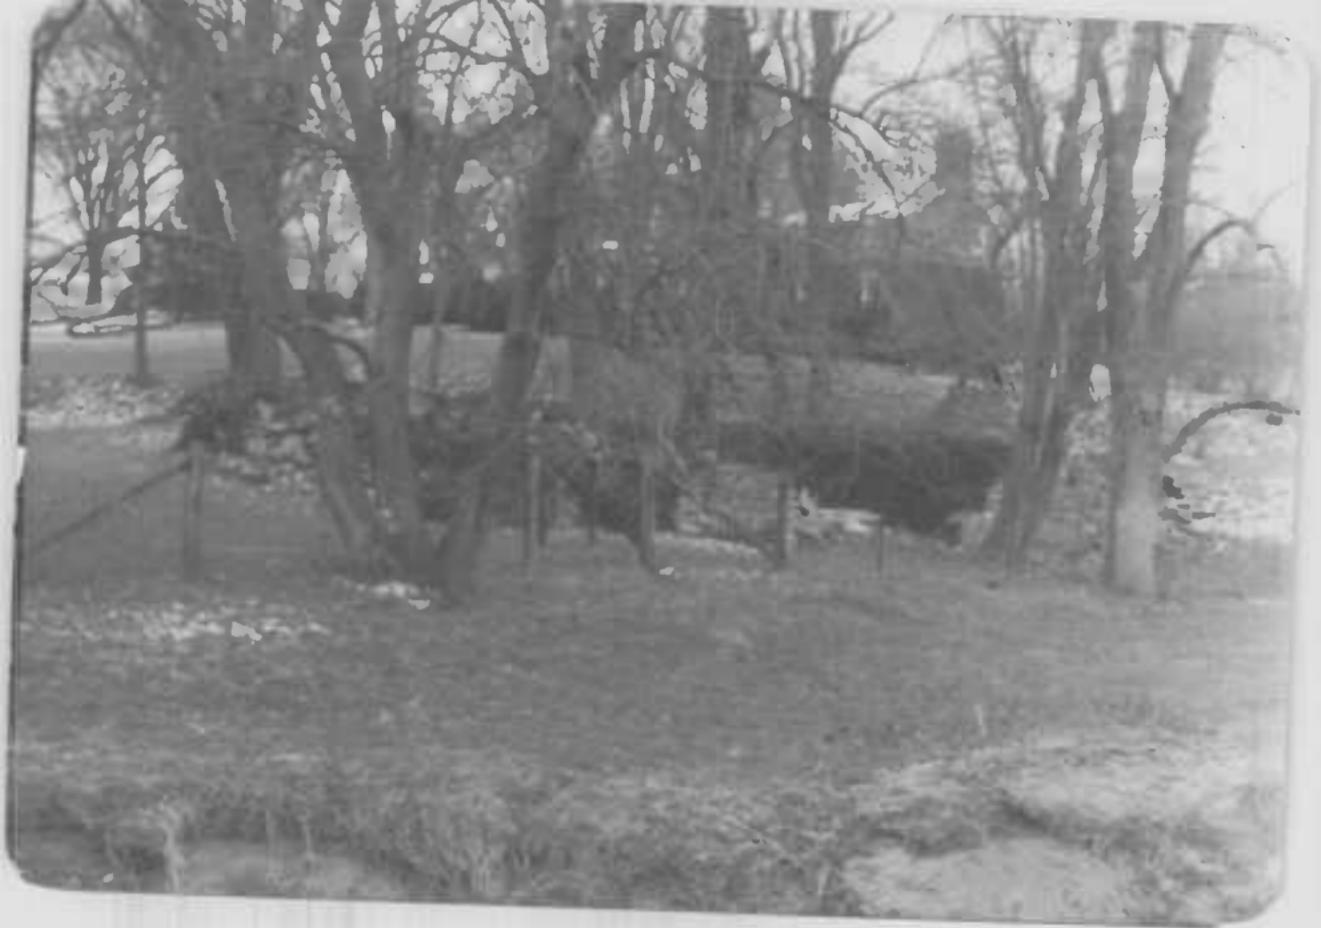
8A

Mantua Mill. Ruins

from N

The millrace may still be seen west of the house, leading to the stone foundations of the mill, northwest of the house.
