701 BALTIMORE AVE.

INVENTORY FORM FOR STATE HISTORIC SITES SURVEY

Church of the Immaculate Conception CCD Center

701 Baltimore Avenue

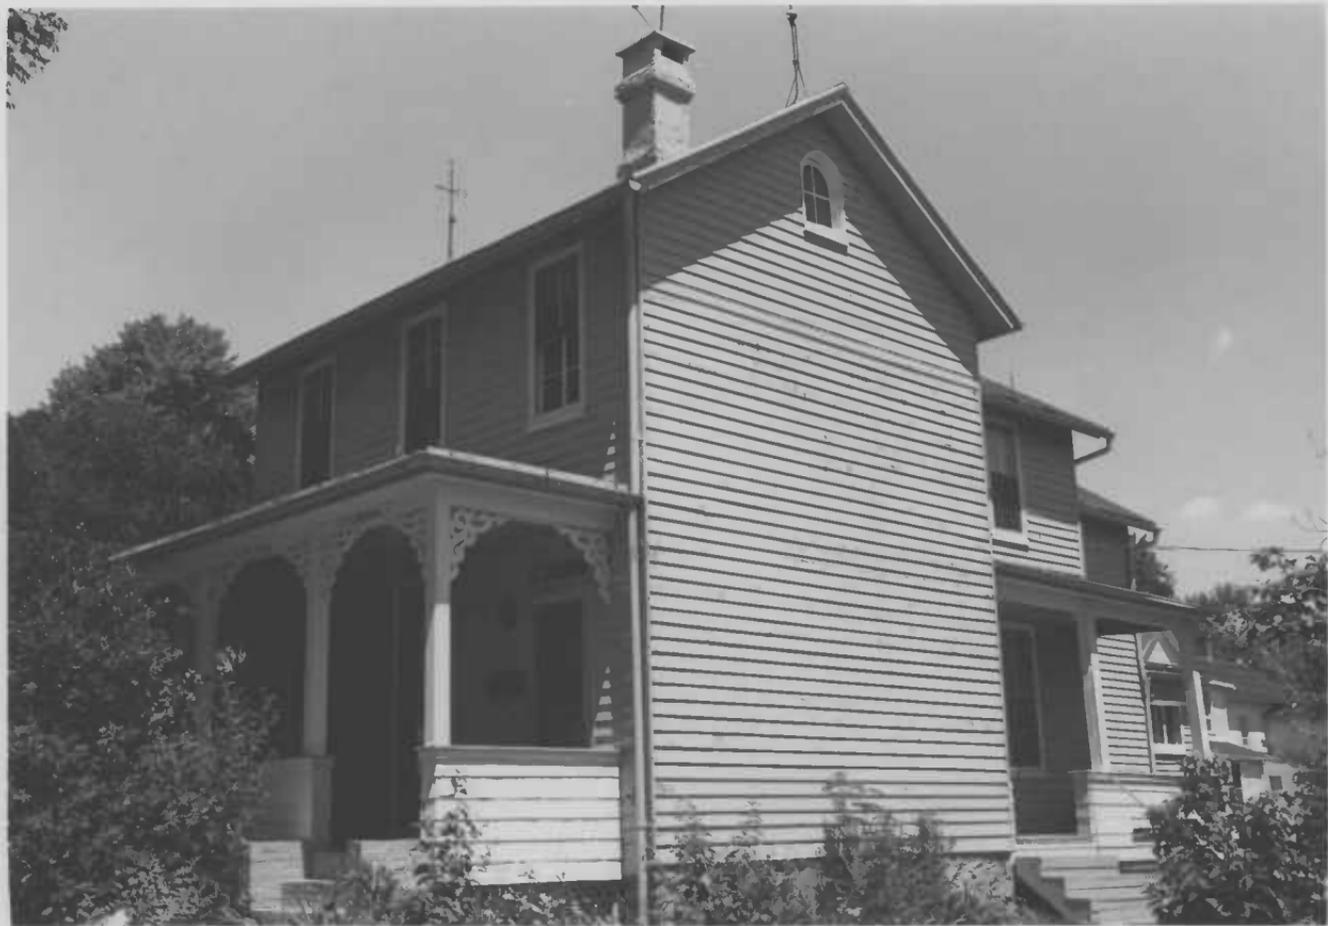
701 BALTIMORE AVE
S. W. CORNER

Located at 701 Baltimore Avenue is a two-story frame house with a gable-end roof . It consists of a main block, withn a corbelled chiminey located just south of center, and three telescoping projections to the east. The main block is three bays wide and one bay deep with the projection being two bays, one bay and one bay wide to the east.

The main or west facade is characterized by a porch running the full length of the first floor facade. The porch roof is supported by four square columns with chamfered edges and featuring a railing partially enclosed with shingles. The roof of both the structure and the porch are covered with asphalt shingles. The facade features a regular fenestration of three 4/4 sash windows an the second floor and two 4/4 sash windows on the first floor. Also noted are over-sized brackets at the roof between the porch and column. An entrance-way is surrounded by a doorframe with transom above.

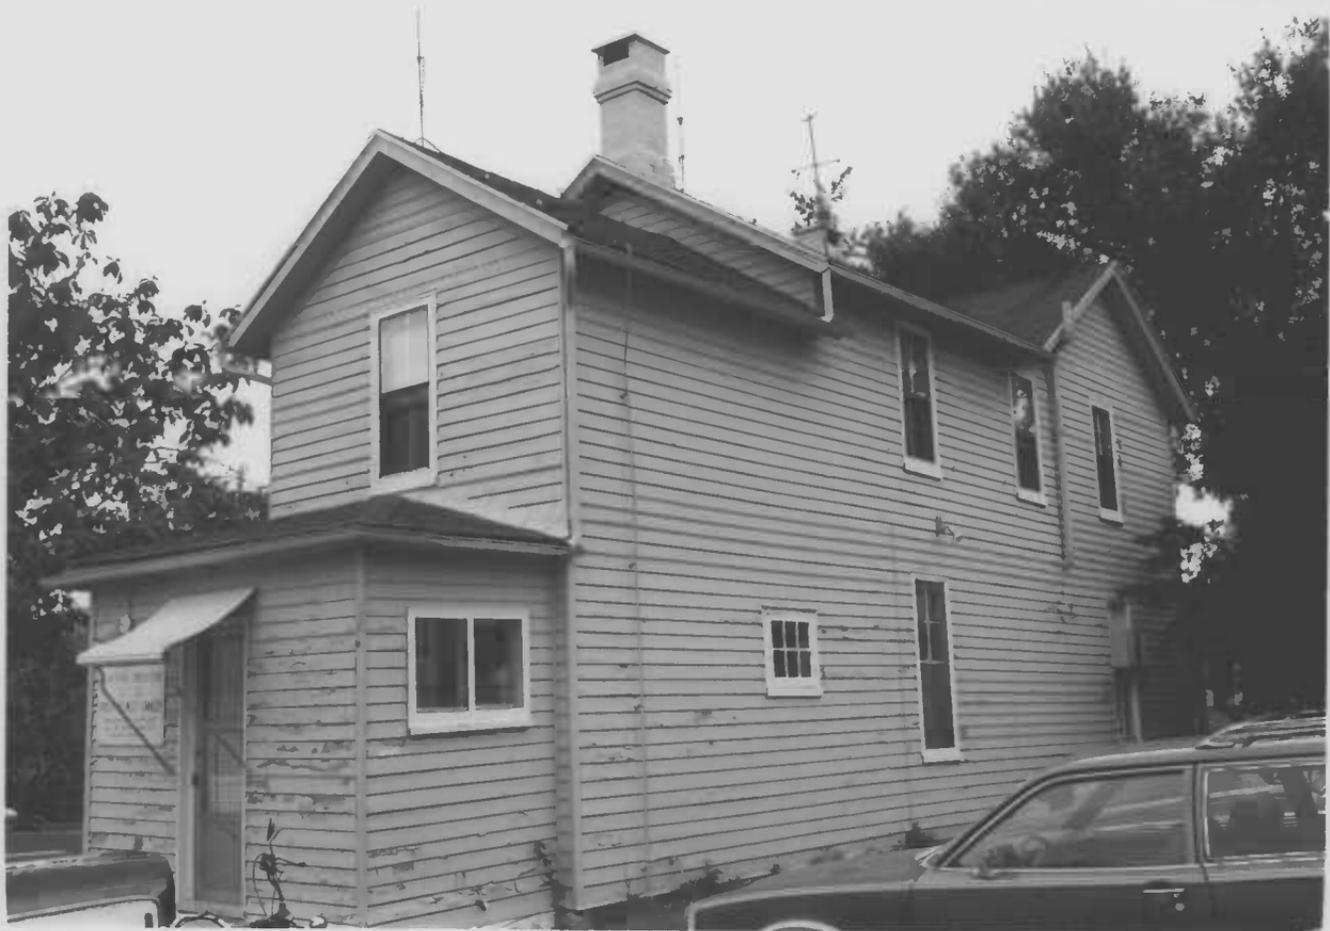
701 BALTIMORE AVE.
N.E.

The east facade features the gable-end of the eastern-most extension with a centrally located 4/4 sash window. This facade displays a full view of the southern-most bay of the main block and points up the basic L-shape of the structure. Also featured on this facade is what appears to be a one-story addition or enclosed porch with hip roof and centrally located entranceway.

The north facade is characterized by irregular fenestration and window size with 4/4, 3/3 and 1/1 sash. Also visible on this facade are the graduated rooflines of the telescoping extension. The gable-end of the main block visible on this facade, features centrally located 4/4 sash windows in the first and second story. The western-most extension features two 4/4 lite sash windows located on the second story and one in the eastern-most bay of the first story. The eastern-most portion of the telescoping extension is characterized by a slightly lower roofline and a single 6 lite casement window located in the western-most end of the first story. Also visible on this facade is what appears to be an enclosed stoop or porch. This one-story addition is one bay wide and features one centrally located 2 lite casement window.
