### MARYLAND HISTORICAL TRUST NR-ELIGIBILITY REVIEW FORM

Property Name: Moore's Orchard Inventory Number: BA-2142

# Maryland Historical Trust Maryland Inventory of Historic Properties Form

**1. Name of Property** Moore's Orchard

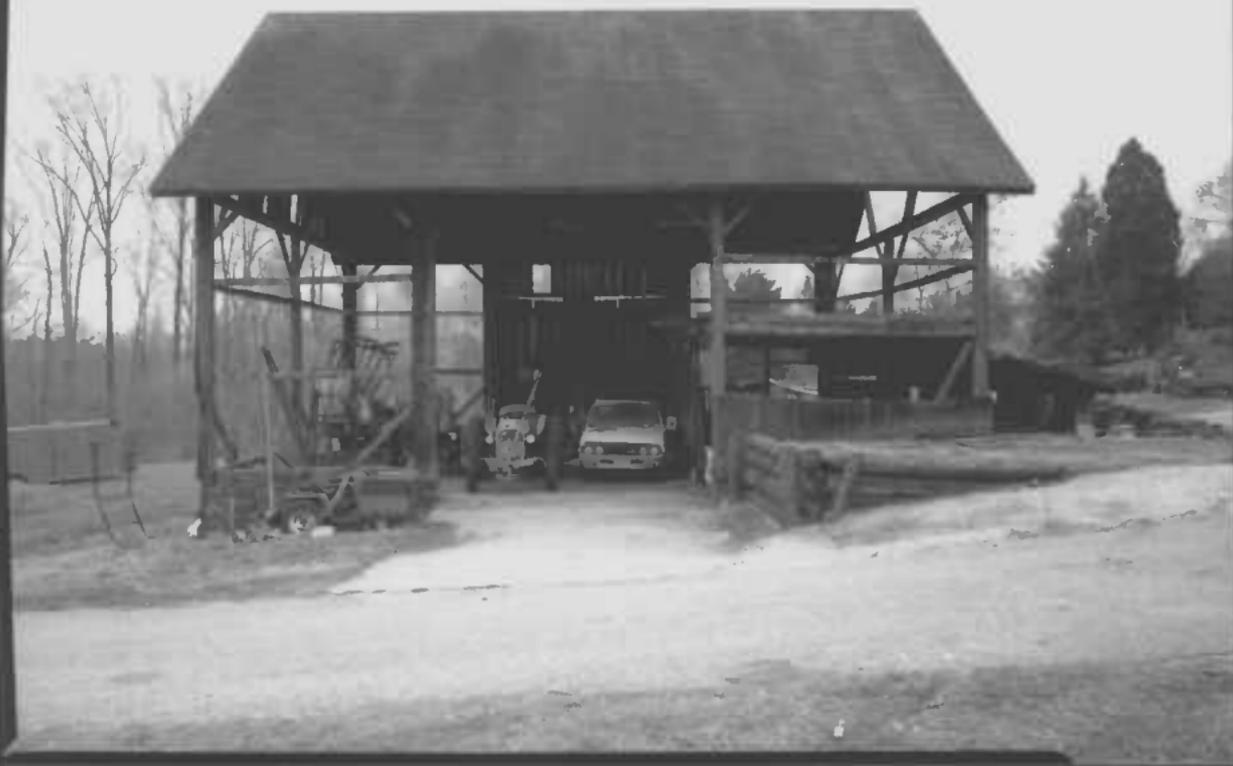
BA-2142-1

Moore's Orchard Barn, North Elevation.

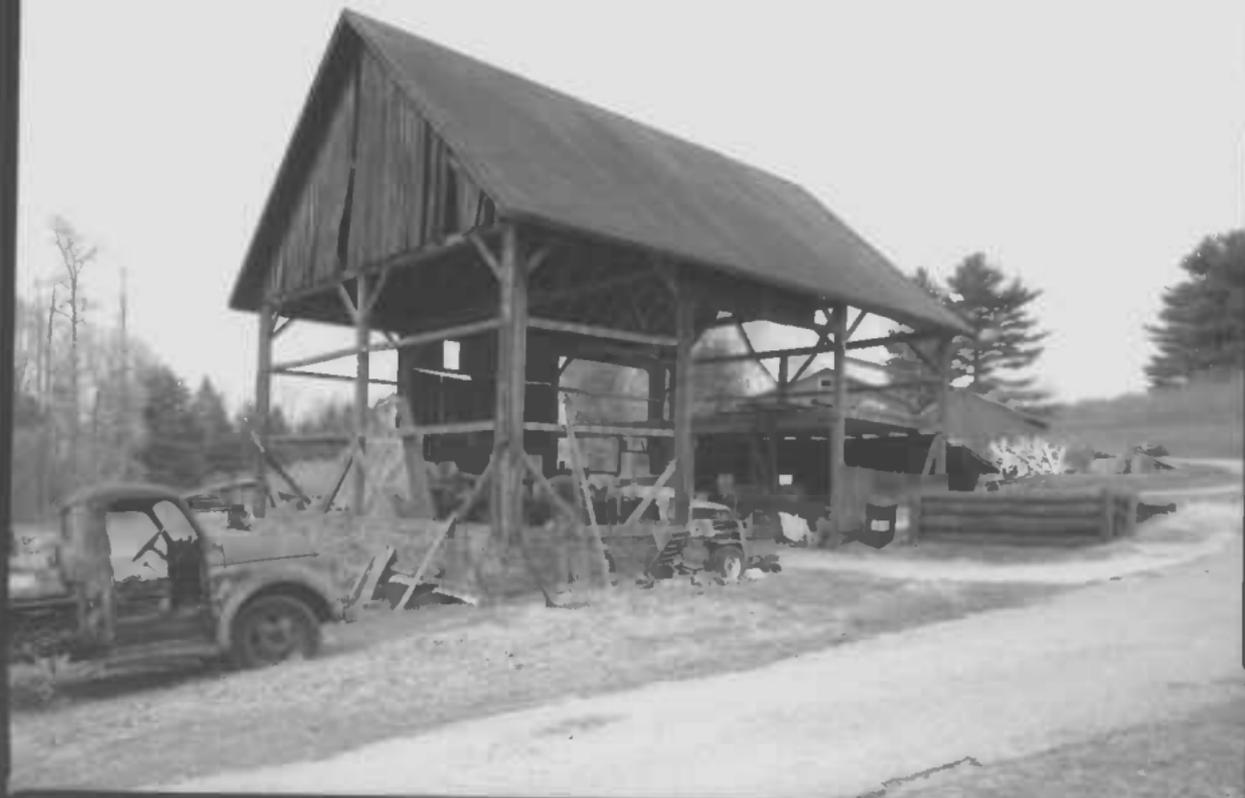
BA-2147-2

Moore's Orchard East Perspective View of North and East Elevations

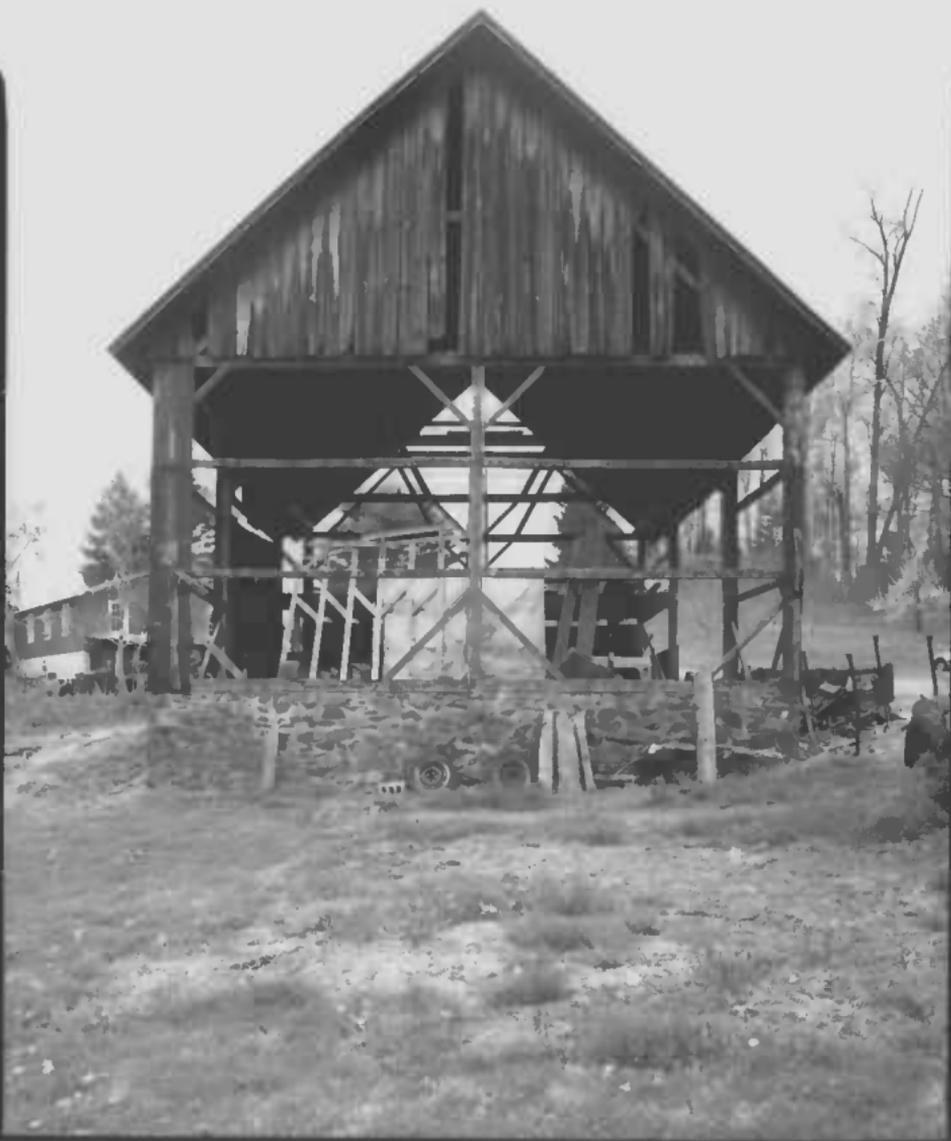
BA-242-3

Moore's Orchard Barn (East Elevation)

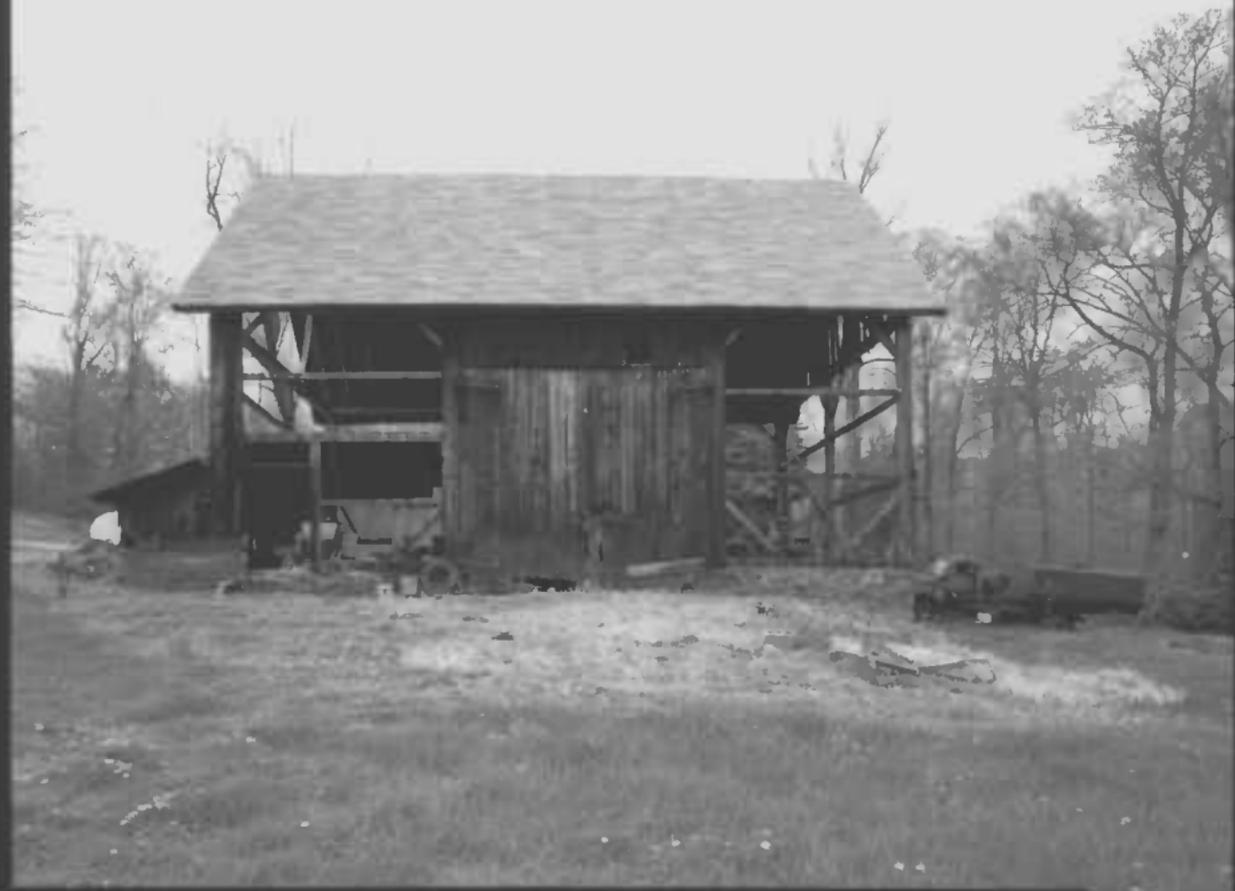
BA-2142-4

Moore's Orchard Barn South Elevation

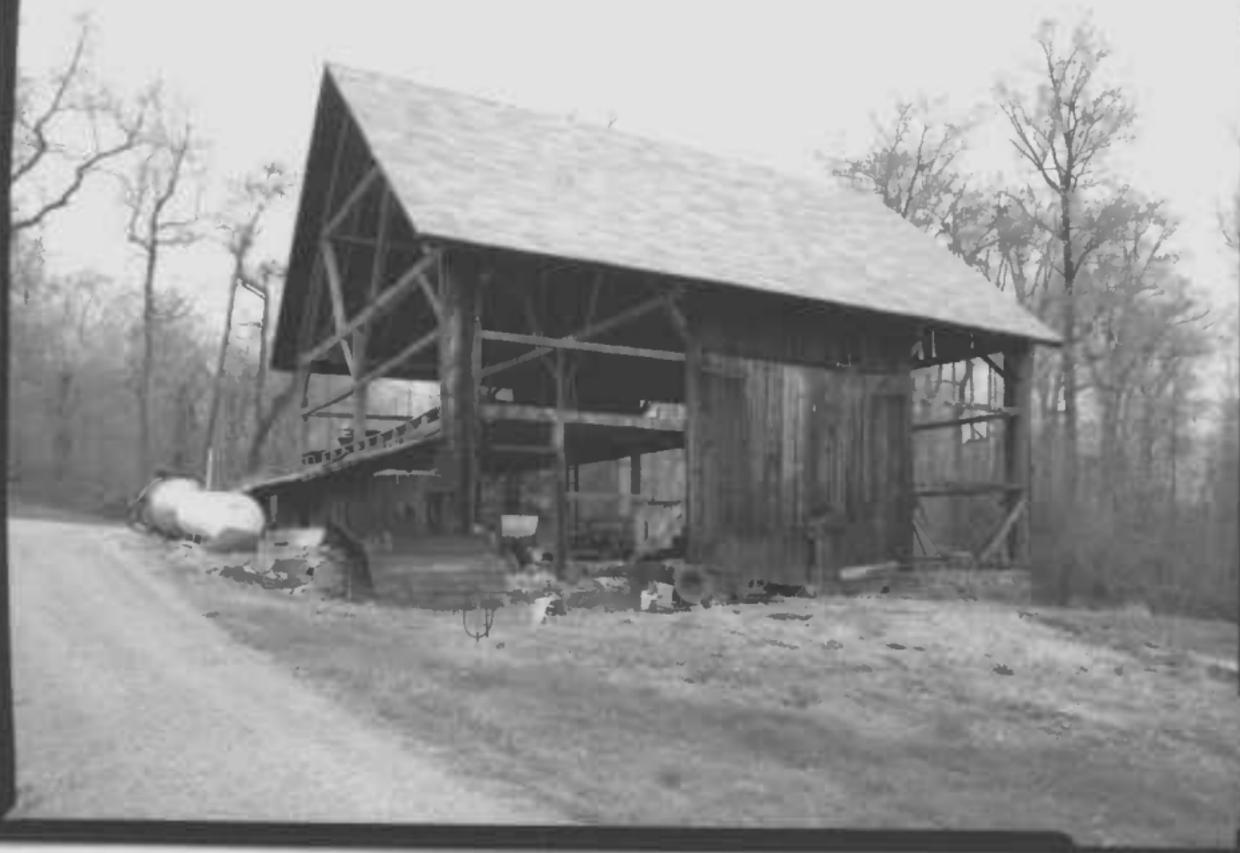
BA-2142-5

Moore's Orchard Park Perspective View of Seams and Soil Elevations

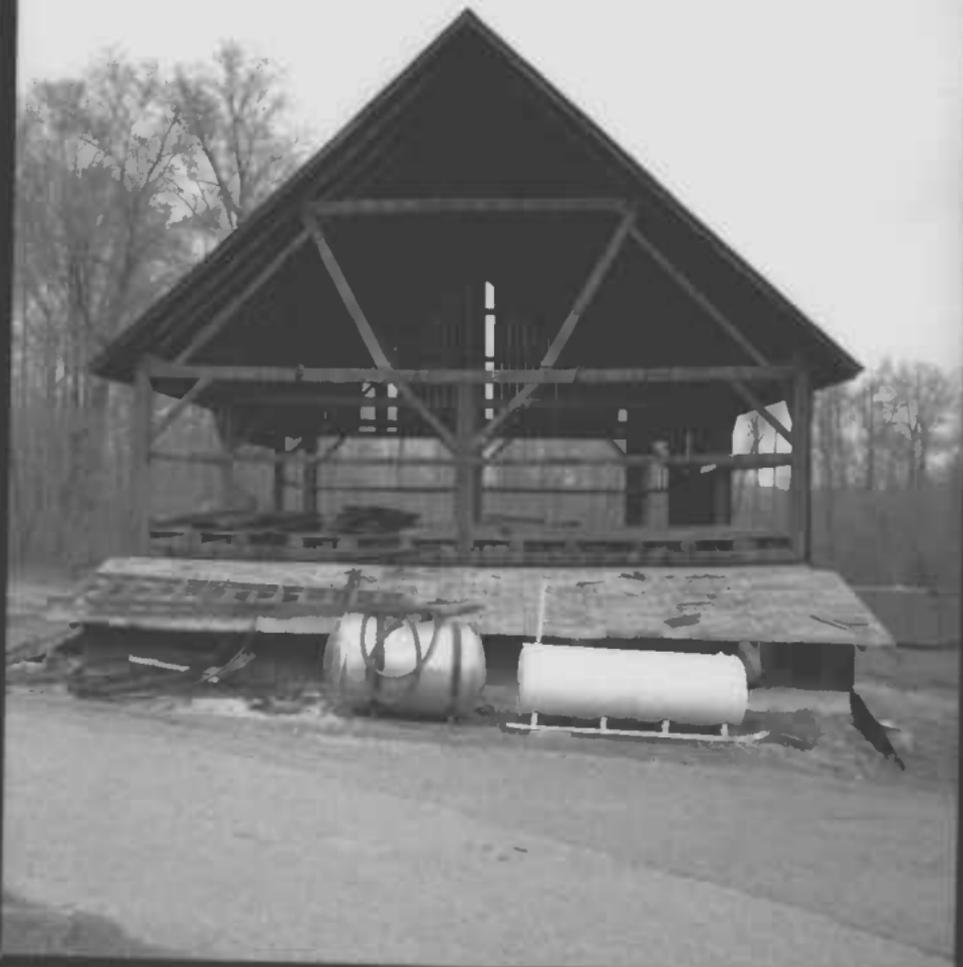
EA-2142-6

Moore's Orchard Barn West Elevation

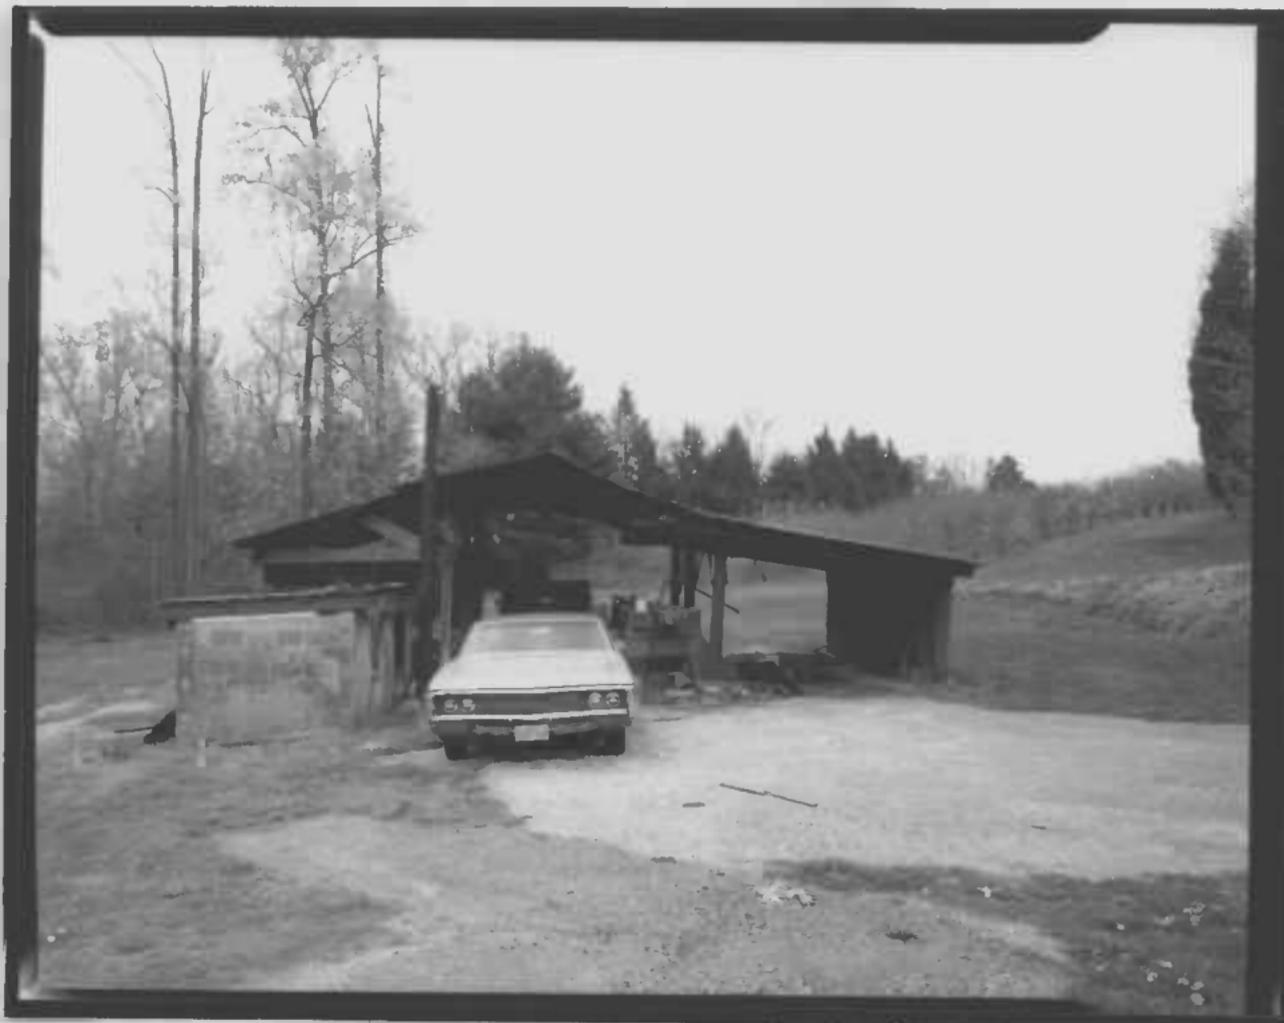
BA-2142-8

Moore's Orchard Shed North Elevation

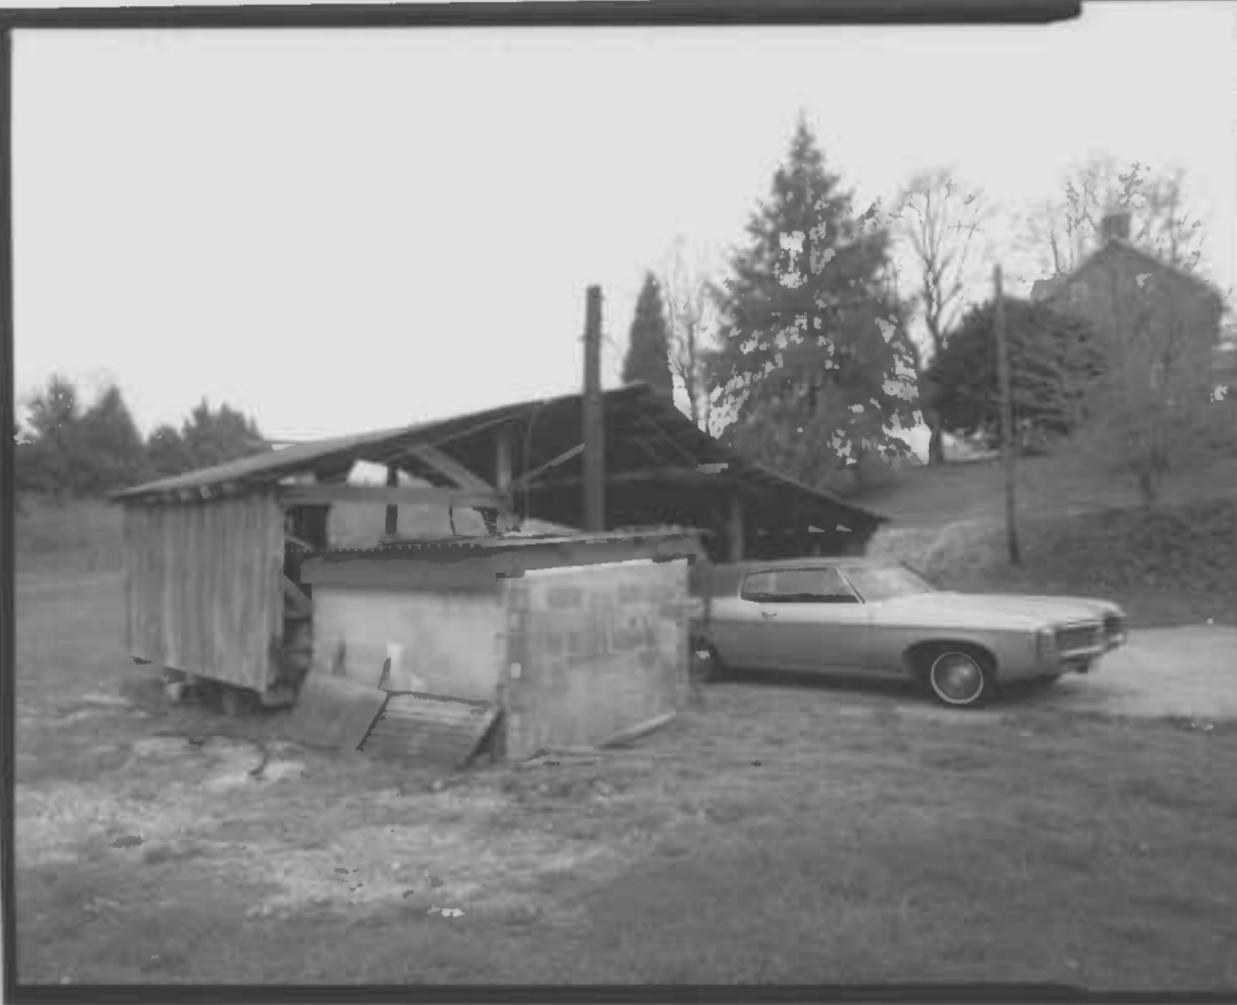
BA-2142-9

Moores Orchard Shed. Perspective View -> North -> East Elevations

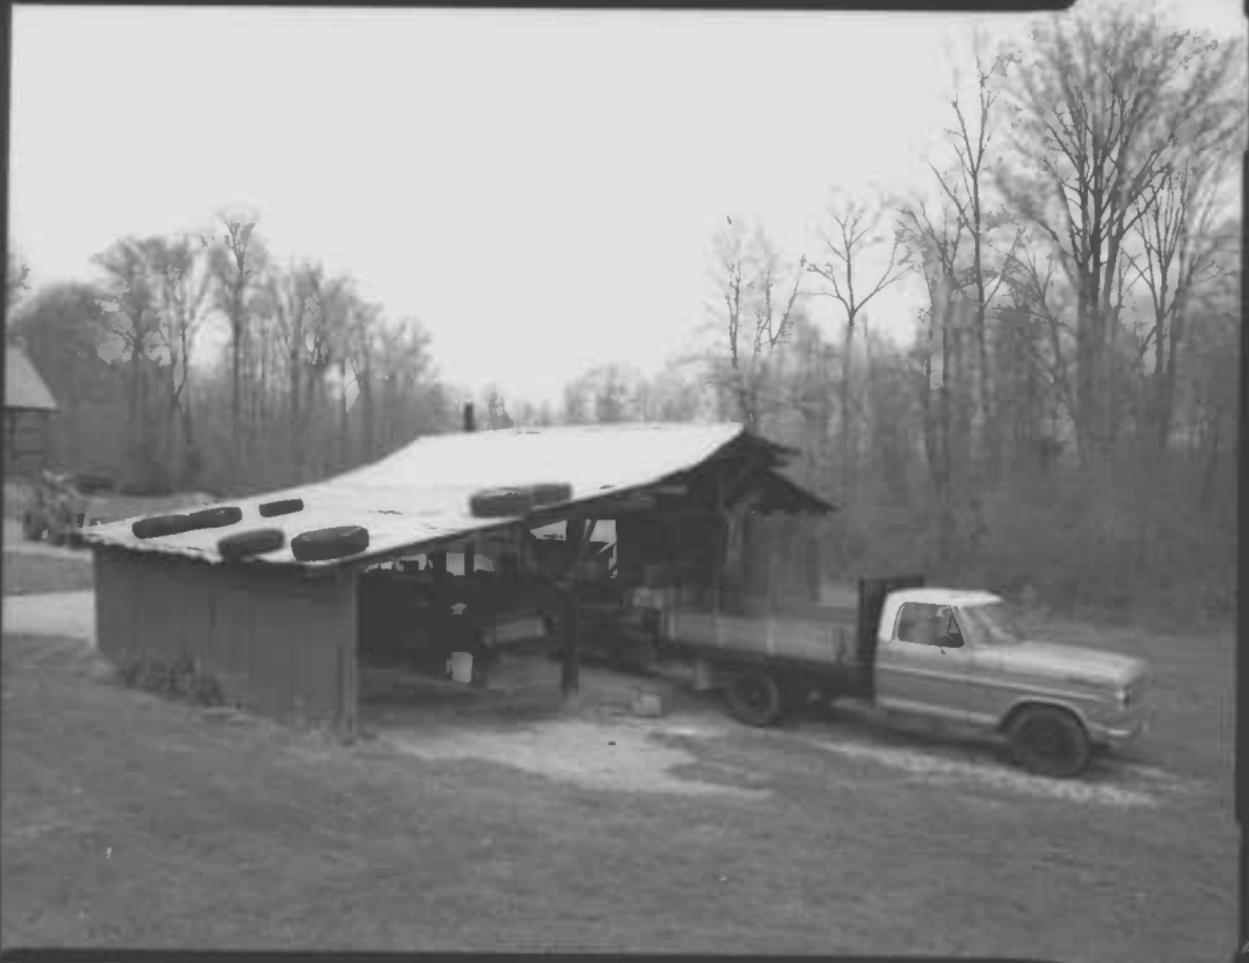
BA-2142-10

Moore's Orchard Still Perspective Views of South and West Elevations

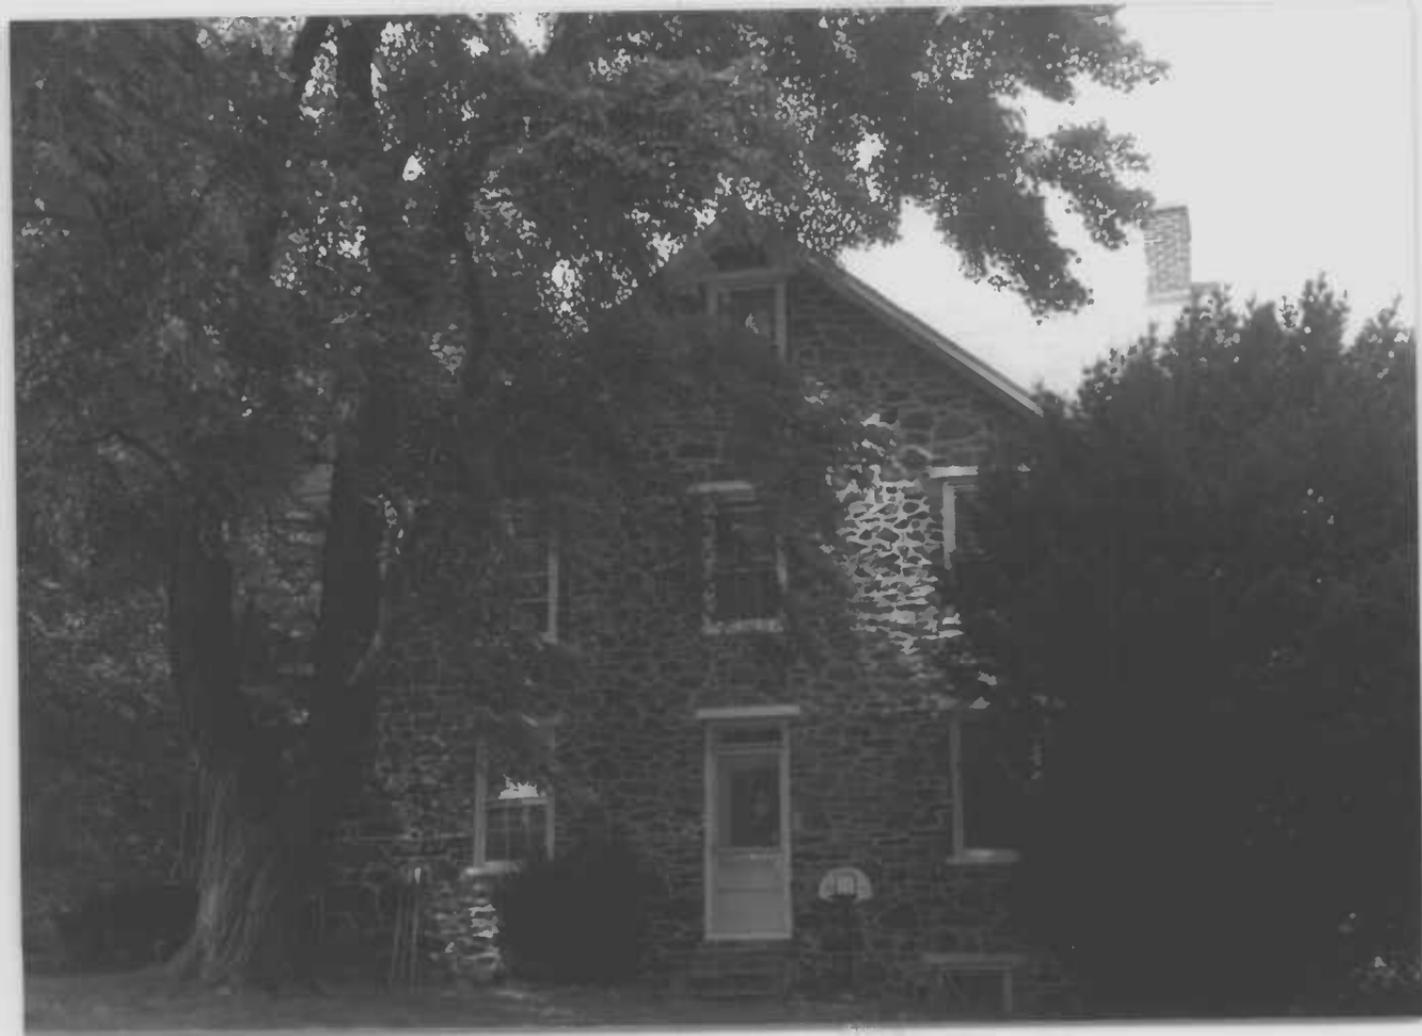
#1 of 15

1852 Stone Dwelling. East Elevation

The front of the building faces east and exhibits a front-facing gable and a three bay facade. Six wooden, double-hung, six over six windows with wooden lintels, one in the front gable, three on the second floor, and two on the first floor, surround a centrally located small entry porch with stone steps. The front entry also exhibits a wooden lintel while the door exhibits a window in the upper portion and two panels in the lower portion. A metal screen door has been added to this opening. Two double-hung basement windows flank this entryway.

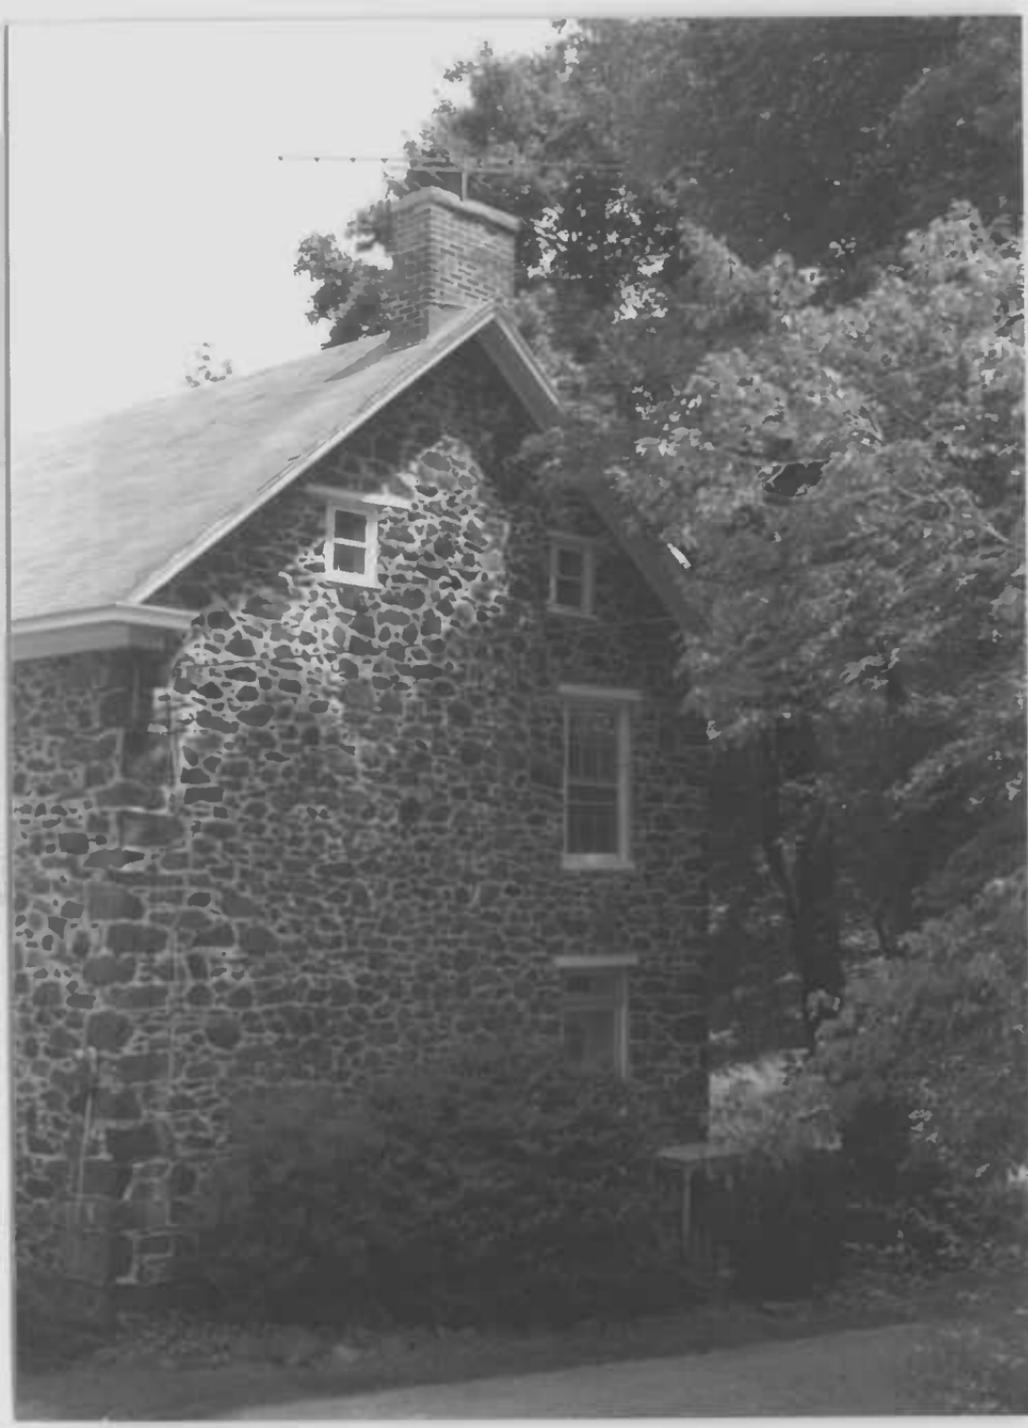
#2 of 15

1852 Stone Dwelling. South Elevation

The southern gable facade exhibits a single full-sized, wooden, double-hung, six over six window on the second floor on the eastern end of the facade and a first floor doorway beneath. In addition, two smaller, double-hung, two over two, windows are present at the attic level, one on either side of the mortared brick chimney, which is centrally located but, with the exception of the portion above the roof, is not visible on the exterior.

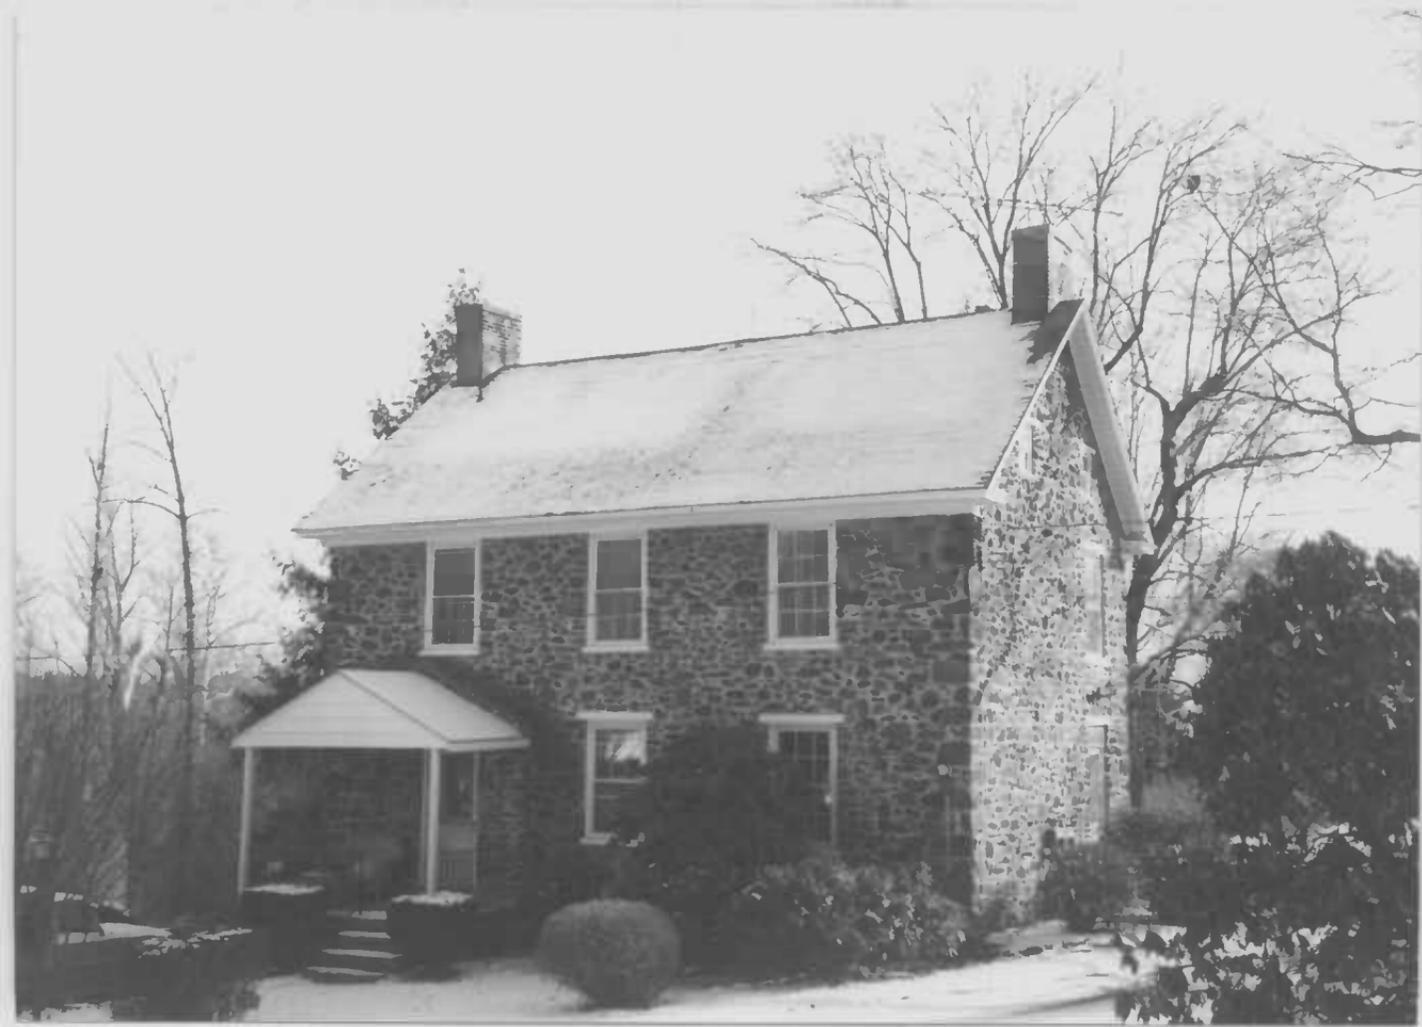
# 3 of 15

1852 Stone Dwelling, West Elevation

The rear of the building also exhibits a three bay facade. There are five wooden, double-hung, six over six windows but the doorway on this facade is located on the northern end of the structure. It is reached by means of a small gable-roofed, wood-columned porch with concrete steps, painted wooden decking, and metal railings. The porch appears to be a late 20<sup>th</sup> century addition.

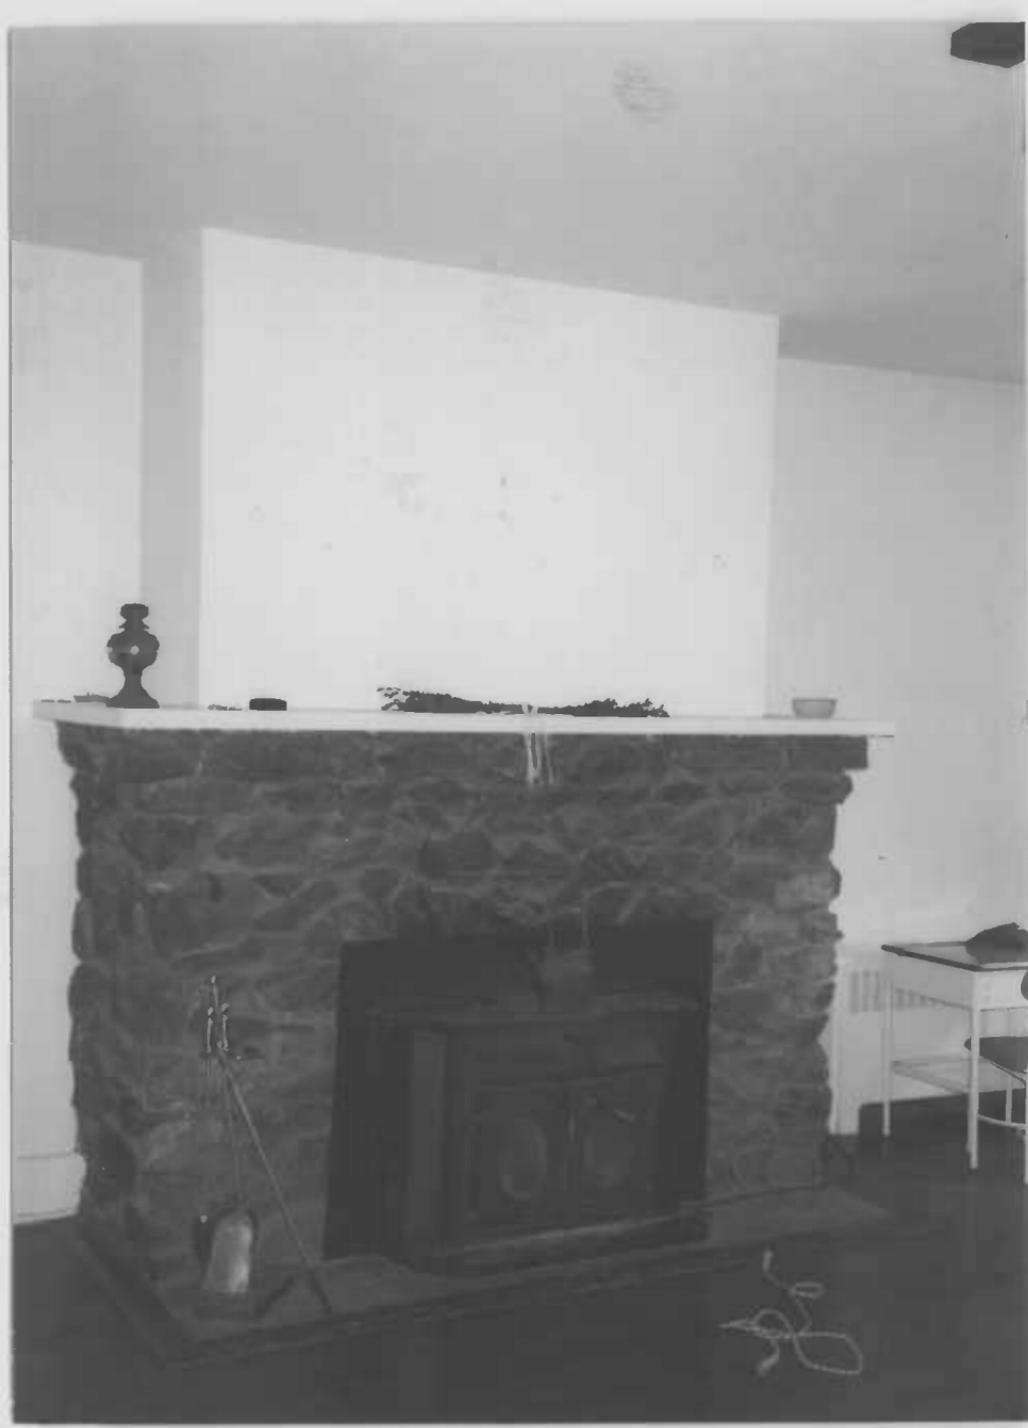
# 4 of 15

1852 Stone Dwelling. Fire place in  
South Parlor, view SW.

A second room runs along the southern side of the house with a centrally located fireplace on the southern wall similar to the one in the other room. Again, the wall and ceiling appear to be plaster and lath while the floor is carpeted.

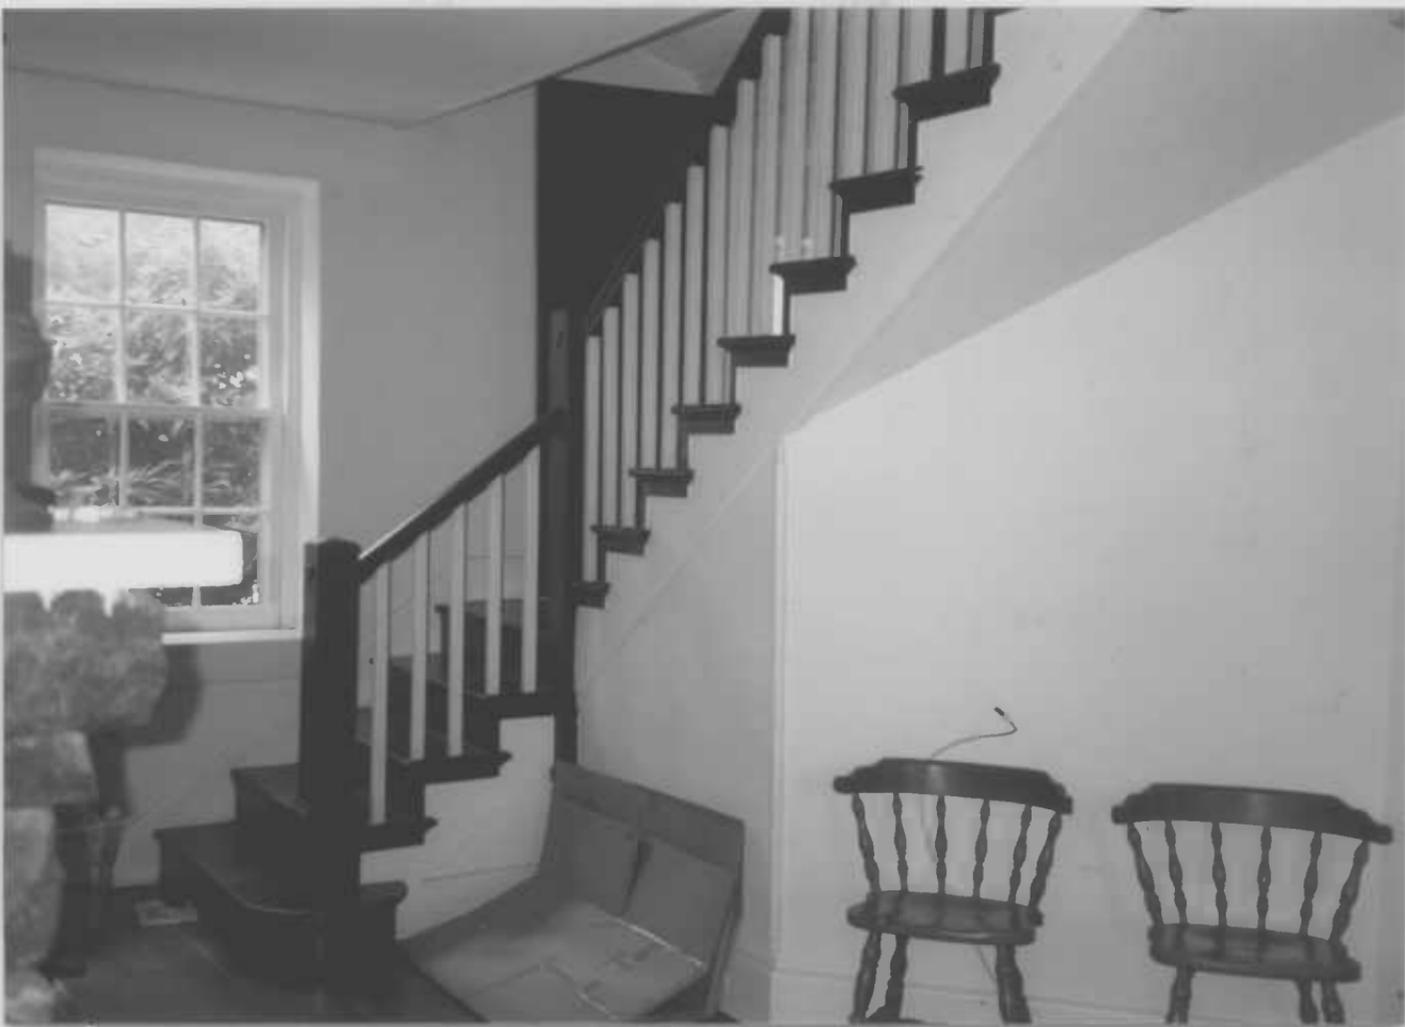
# 5 of 15

1852 Stone Dwelling. Stairway.

S. Parlor. View West.

The stairs are hardwood with stained and finished treads and painted risers. The banister is also stained while the railings are painted. As previously noted shorts sets of stairs lead to a landing from either the kitchen or living room. At the top of the stairs is a hallway. In the central portion of the front of the second floor is a bathroom with cast iron/enamelled appliances and lavender and white tiles. To the south is a room similar to the living room. This room exhibits a fireplace which appears to have been slightly enclosed, narrowing the opening to about half the downstairs fireplaces. The mantle is wooden. Flooring is 3-inch wide hardwood.

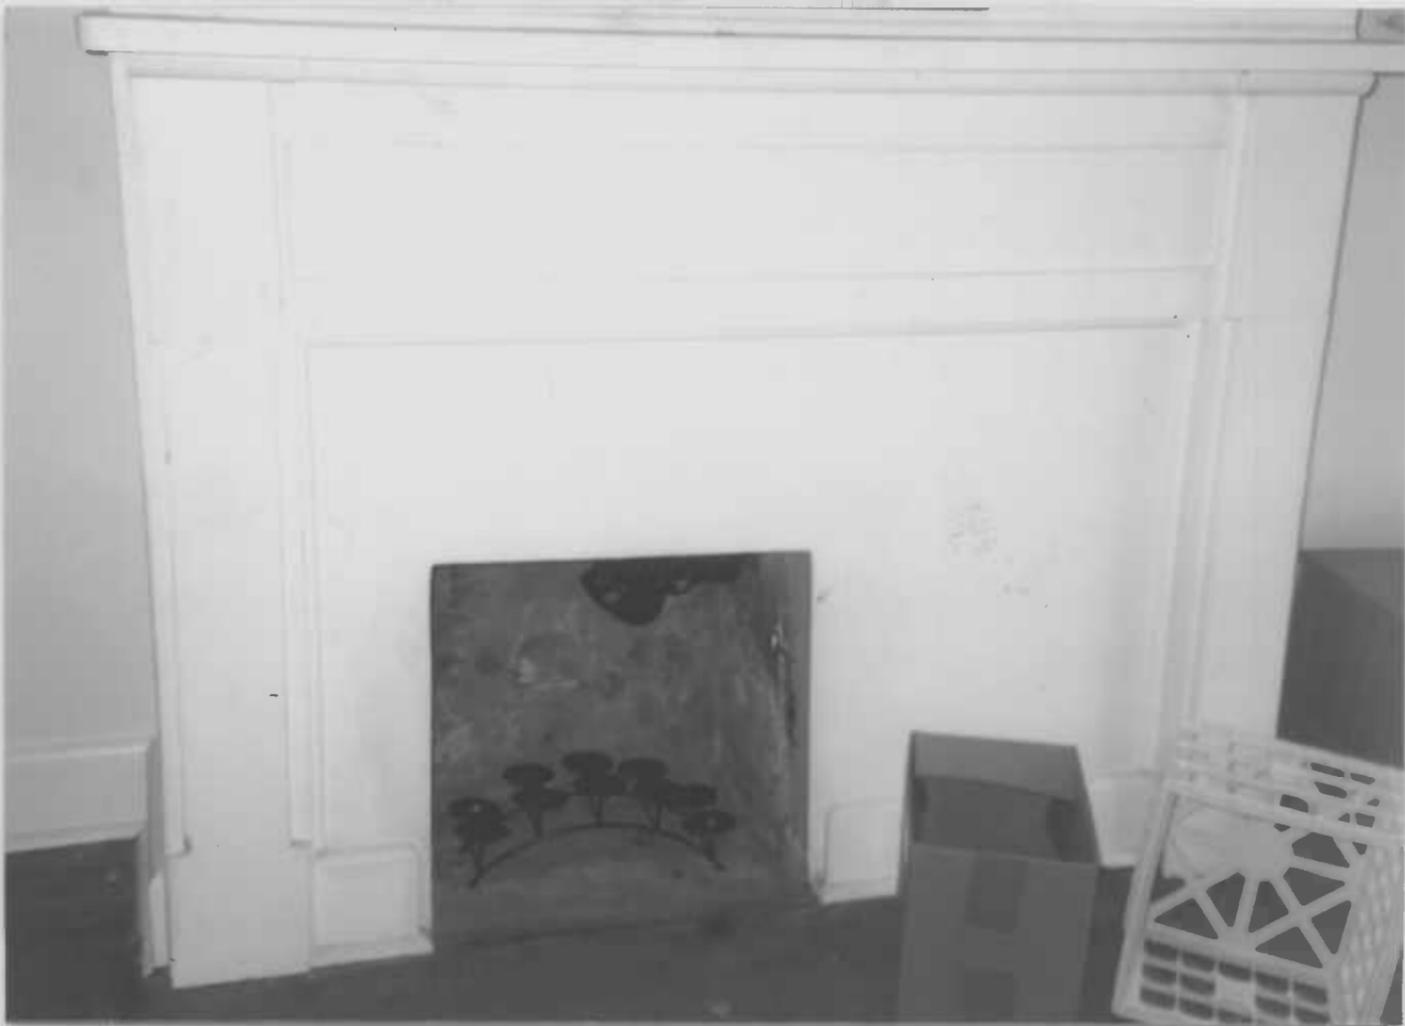
#6 of 15

1852 Stone Dwelling. Fireplace.

South Bedroom. 2ND Floor. View  
South.

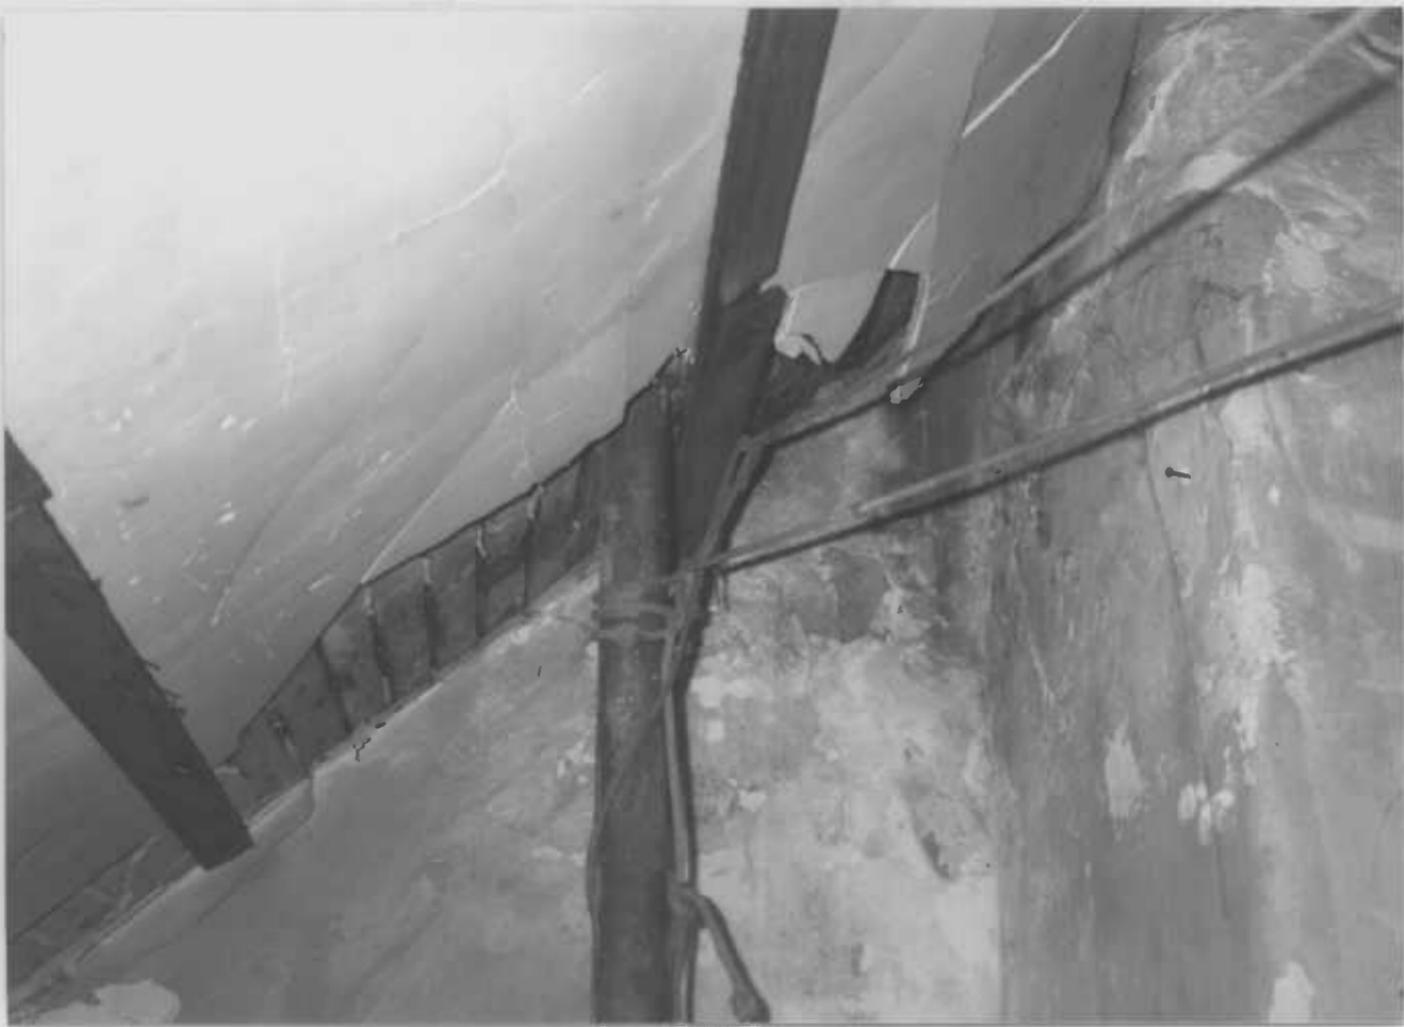
→ 7 of 15

1852 Stone Dwelling. Attic. NE  
Corner

The hall on the second floor leads from the top of the stairs to the west between the stairs and the two smaller bedrooms. Here a door leads to the attic. The attic itself is divided into four separate rooms, one in the front facing gable, and all relatively small with slanting ceilings due to the roof line. The plaster and lath finishing present throughout the rest of the house is evident here as well primarily due to its failure along the northern and eastern sides of the building. There appears to be a structural problem with the roof in this area and leakage is causing peeling and cracking of the plaster. Some areas have been patched with corrugated cardboard. The flooring of the attic is 3-inch wide hardwood.

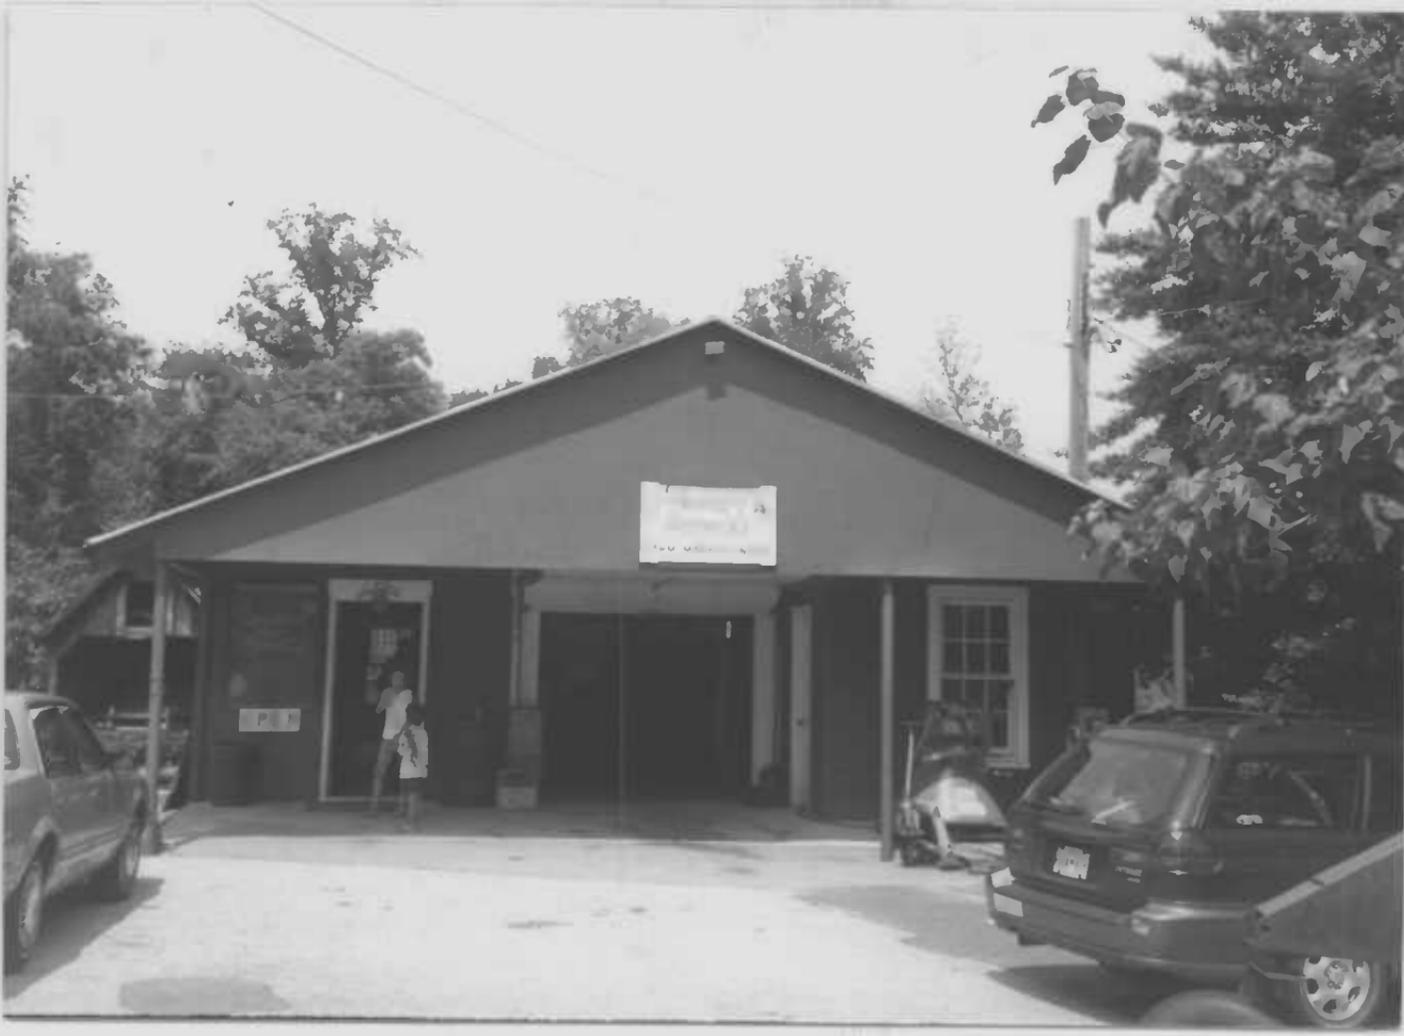
# 8 of 15

Farm Store, South Elevation.

The house is reached from Joppa Road by a relatively long, paved drive which leads to the rear of the house, two garages, and a farm store. The farm store is located north and west of the dwelling and measures 30 by 70 feet. The foundation is concrete block and forms a full basement with drive-in entry from the north. The structure is a one-story frame structure, painted red, with a gabled, metal roof. The north and south facade are three bays with wooden double-hung, six over six windows. The southern facade, which is the entrance to the selling floor, is on the same level as the first floor of the dwelling and has a garage-type opening facing south flanked by a doorway to the left. A small, enclosed room is located east of the doorway but under the existing roof. This room has a double-hung, six over six window facing south. The northern facade is two bays with wooden, double-hung, six over six window. A small square window is located in the attic, under the gable. The interior of the store is entirely unfinished. Unfinished shelving and tables line the walls to display fruit and other stock.
