### MARYLAND HISTORICAL TRUST NR-ELIGIBILITY REVIEW FORM

Property Name: Moore's Orchard Inventory Number: BA-2142

# Maryland Historical Trust Maryland Inventory of Historic Properties Form

**1. Name of Property** Moore's Orchard

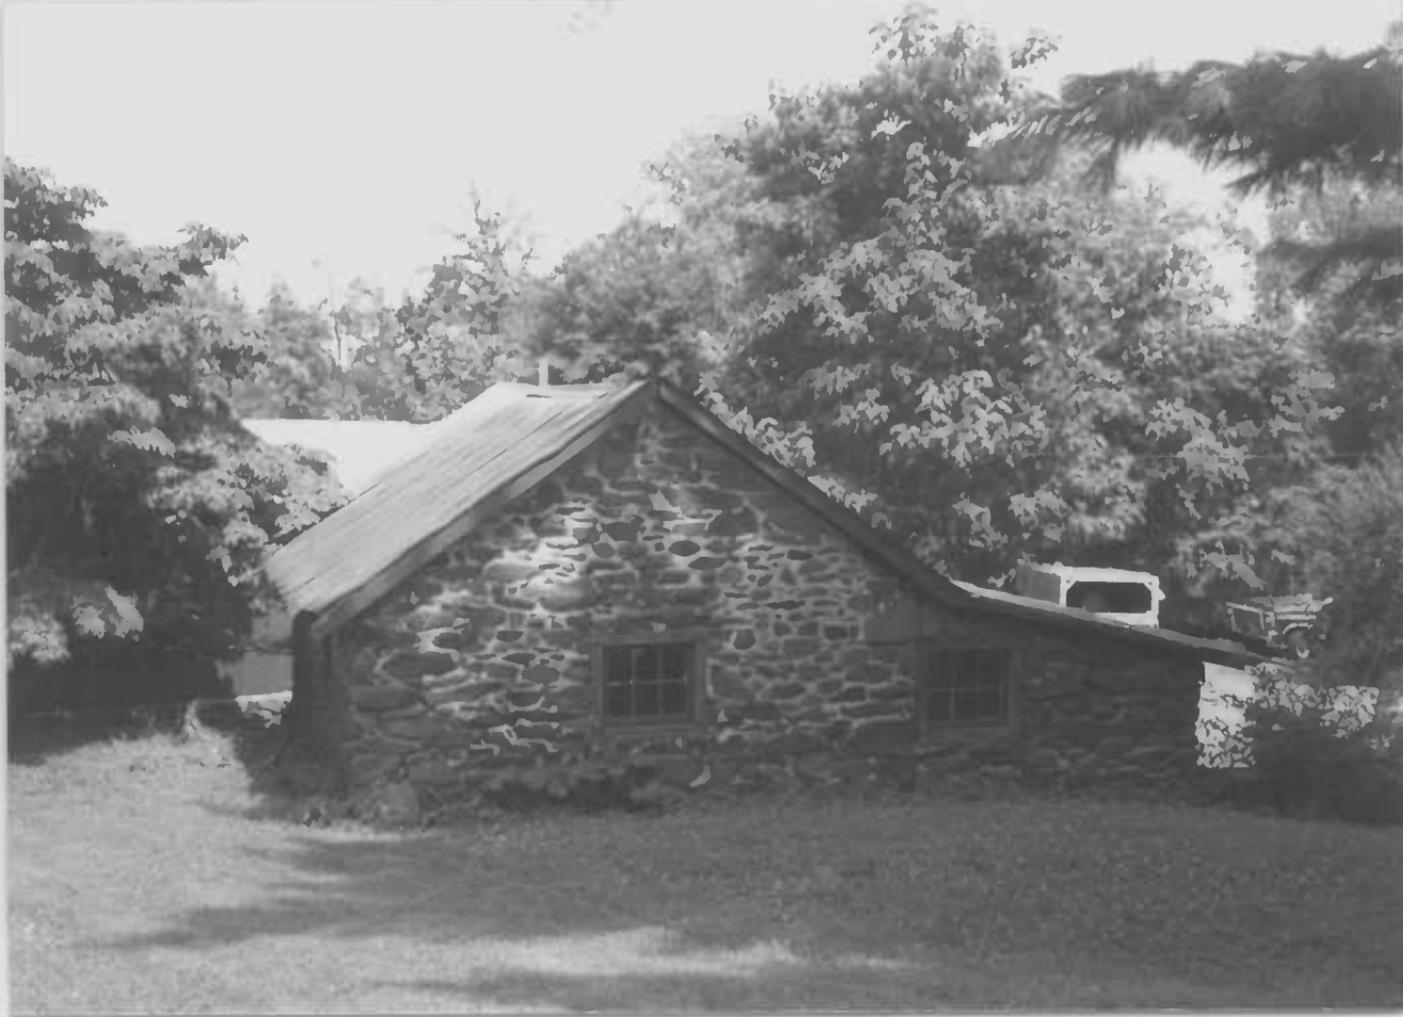
#9 of 15

1st Garage. South Elevation

Just west of the store is a garage/farm shed. This is a banked one-story frame structure, painted red, with a gabled metal roof, and a mortared sandstone foundation. The building measures 25 by 30 feet. The eastern, or front facade consists of hinged, double doors which produce an opening large enough for a tractor or car. There are no windows or ornamentation of any type. The floor is concrete. There is shelving on three sides. The owner stated that the structure was built during the early 20<sup>th</sup> century.

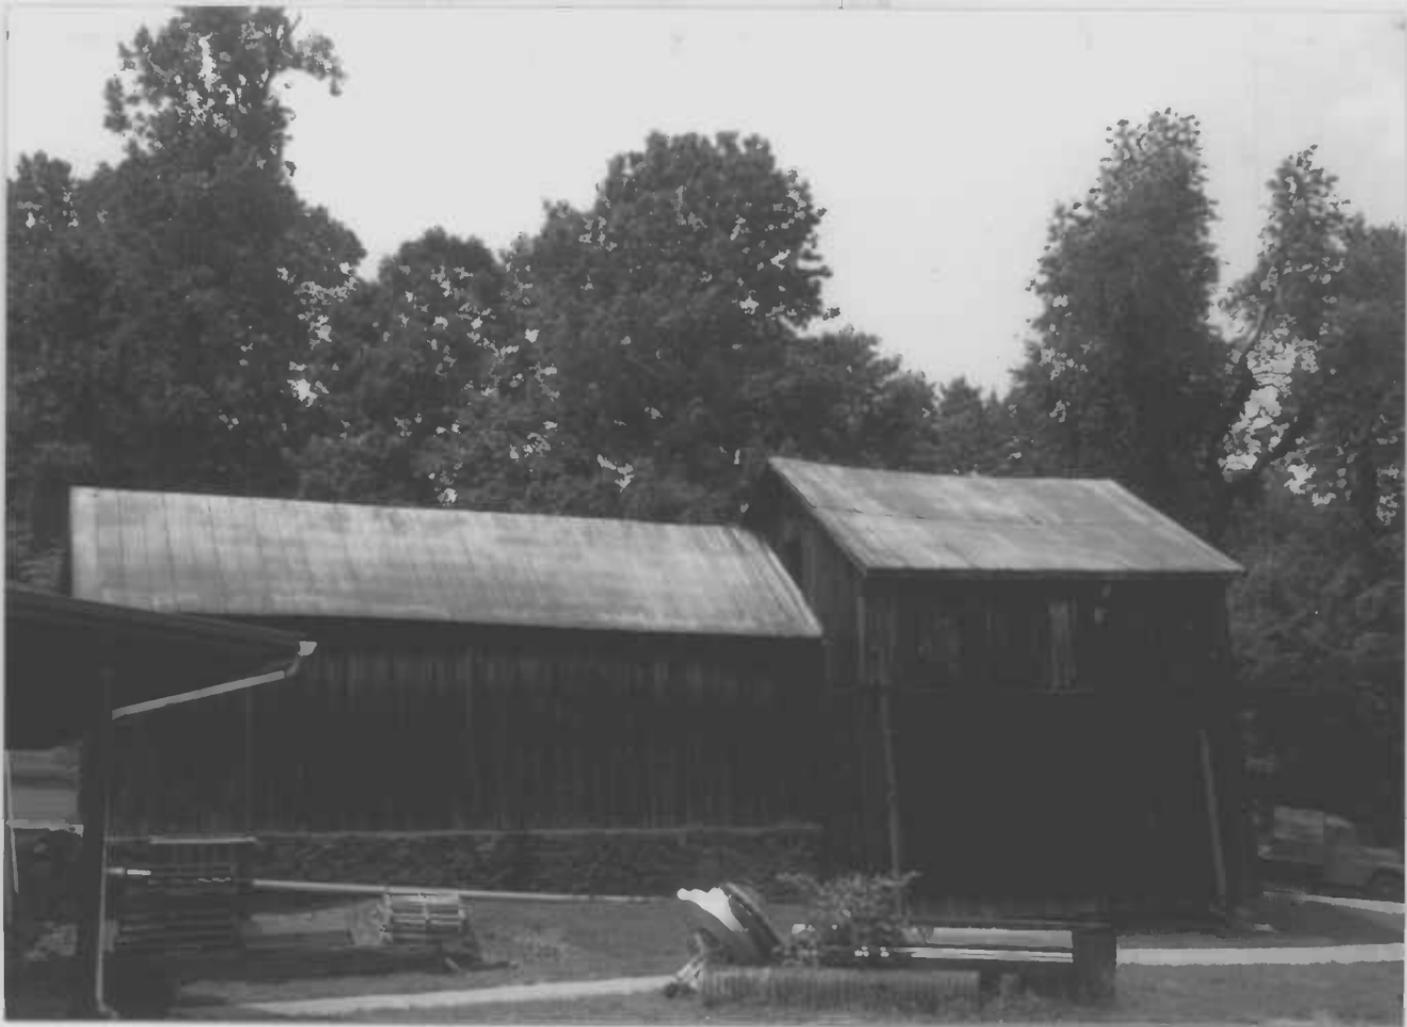
# 11 of 15

Attached Barns . View East.

The farm lane continues to the north between the store and the larger of the two garages. To the east side of the road, directly to the rear of the farm store is a large farm shed which is timber-framed and vertical board-sided. The structure appears to be two buildings joined together. The roofs are gabled metal. The southernmost of the two joined structures measures 10 by 40 feet and is a single story. It rests on a mortared, sandstone foundation. There is a garage door-sized opening in the southern facade with a window sized opening in the gable above it. No door was present. The northernmost of the two structures measures 25 by 25 feet and is a story and a half. It appears to rest on a poured concrete footing on its western side and sandstone footers on the eastern side. A garage door-sized opening is located on the northwest side of the shed. Adjacent to this large doorway is a standard-sized doorway. No doors were present. A window-sized opening was present under the gable.

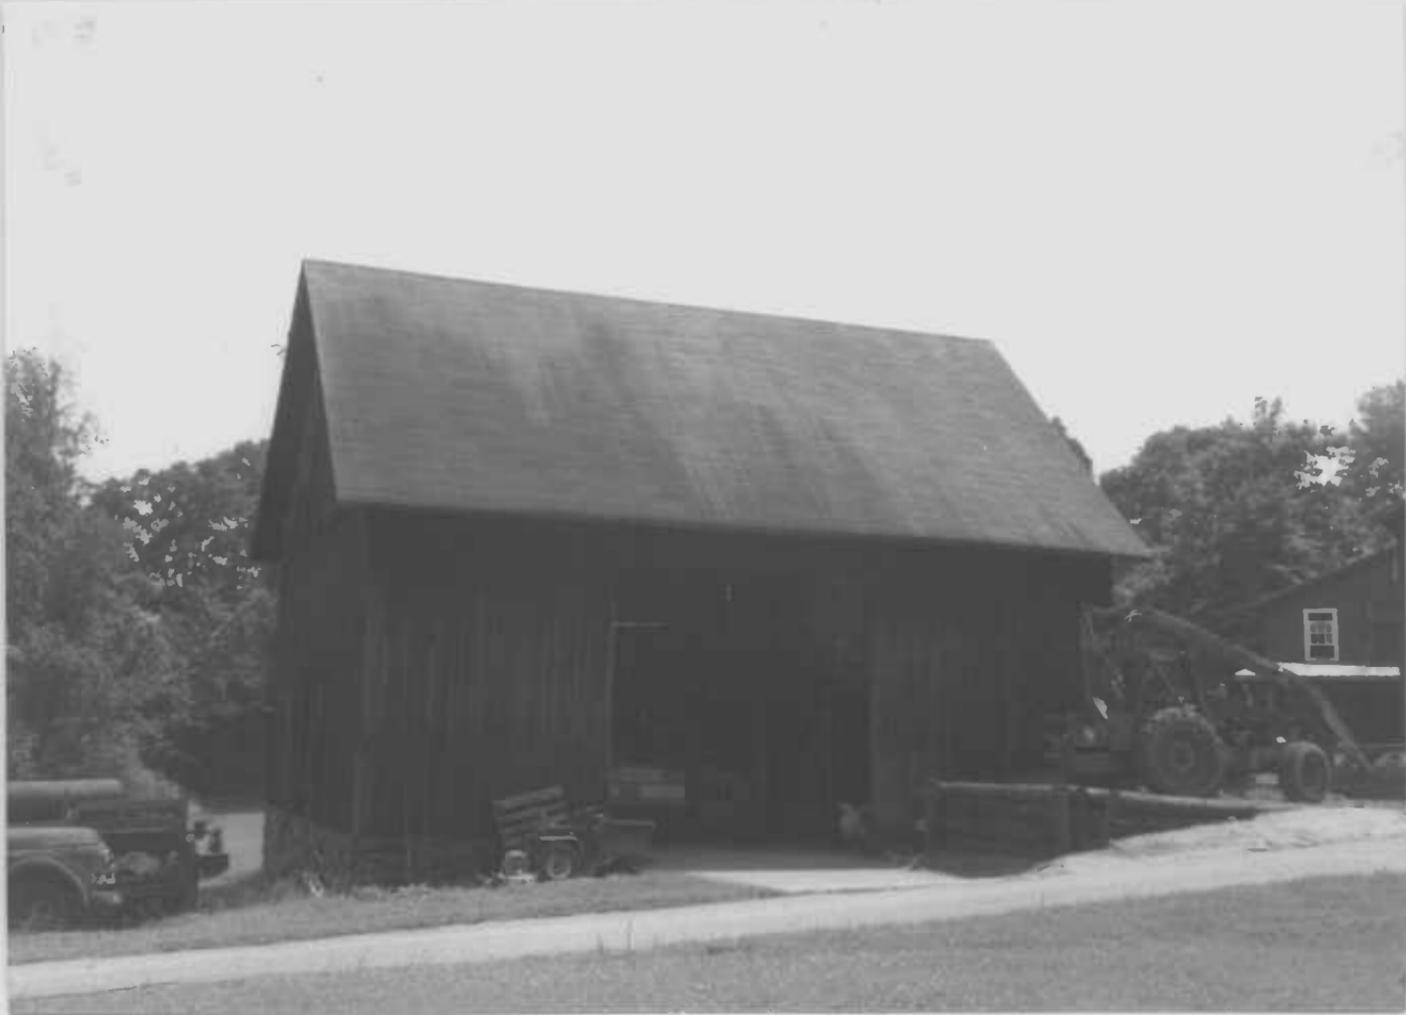
# 12 of 15

Peach Barn. West Elevation

A second barn is located north of the double shed building. This barn is of similar construction – timber-framed with vertical board siding, a gabled metal roof, and mortared sandstone foundation. It measures 30 by 45 feet and is a single story. A garage door-sized opening is present in the center of the western facade. This barn is in use as a peach packing shed. There is a narrow, asphalt-shingled, pent-eved addition which stretches along the entire southern side of this barn. This appears to be for additional storage.

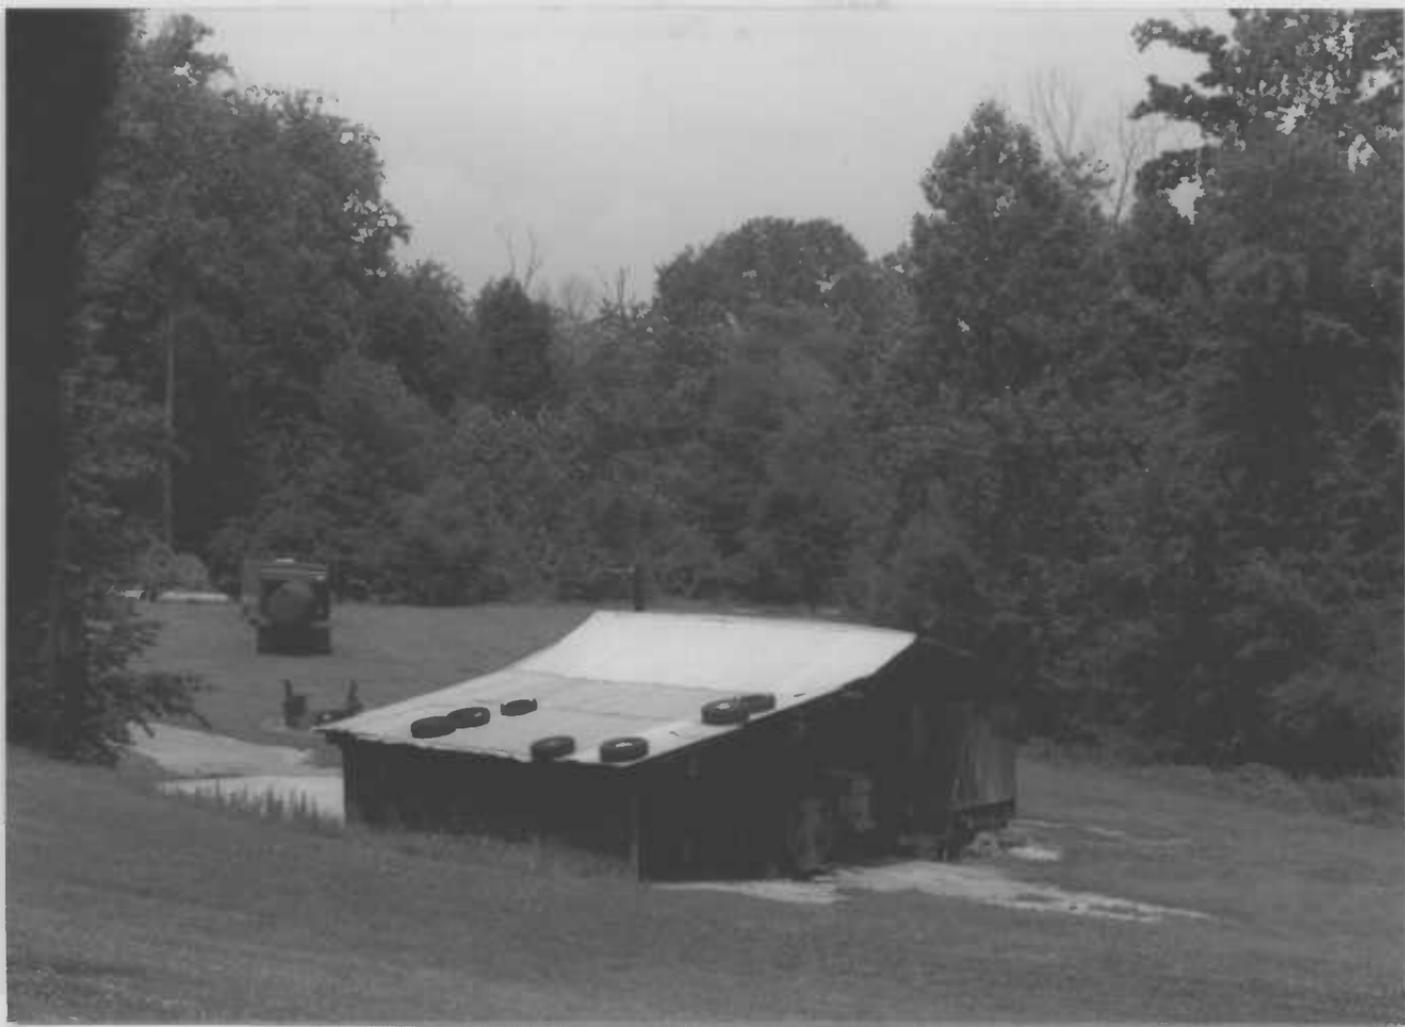
# 13 of 15

Shed. View SE

The final farm-related structure is an open-ended, metal-roofed shed with vertical board sides located to the south of the house on a lower terrace. This shed measures 20 by 40 feet and consists of three bays, likely for storing large farm equipment. A small concrete block structure on unknown purpose is located just outside the northwest corner of the shed.

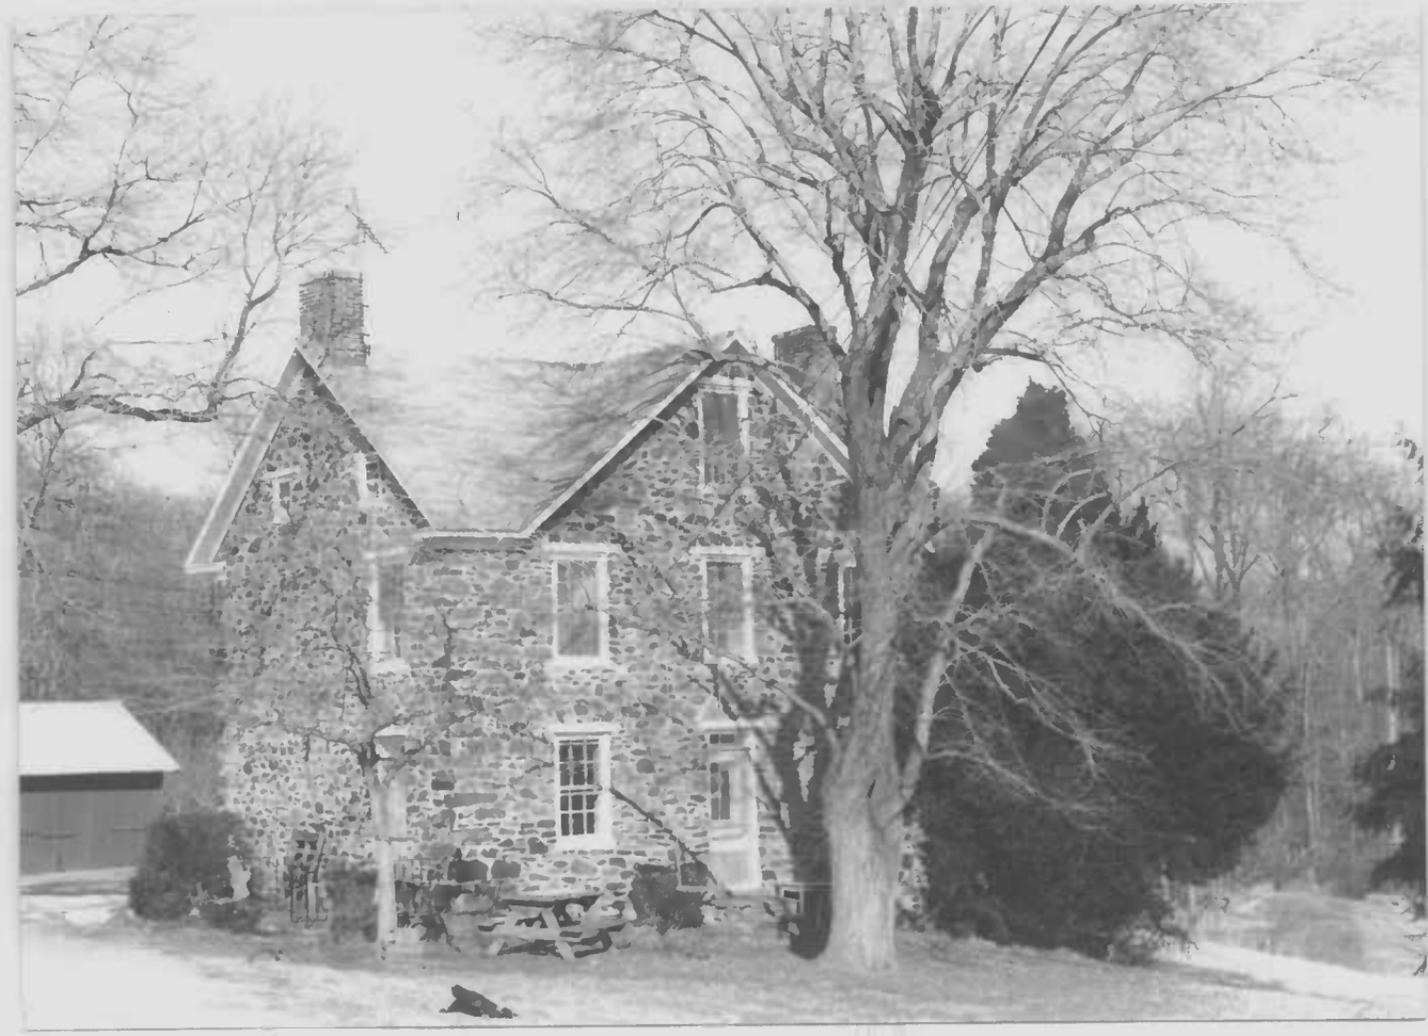
# 15 of 15

1852 Stone Dwelling. East Elevation

The front of the building faces east and exhibits a front-facing gable and a three bay facade. Six wooden, double-hung, six over six windows with wooden lintels, one in the front gable, three on the second floor, and two on the first floor, surround a centrally located small entry porch with stone steps. The front entry also exhibits a wooden lintel while the door exhibits a window in the upper portion and two panels in the lower portion. A metal screen door has been added to this opening. Two double-hung basement windows flank this entryway.
