INVENTORY FORM FOR STATE HISTORIC SITES SURVEY

33 Willow Avenue

BA 2161

PHOTOGRAPHS: 33 Willow Avenue

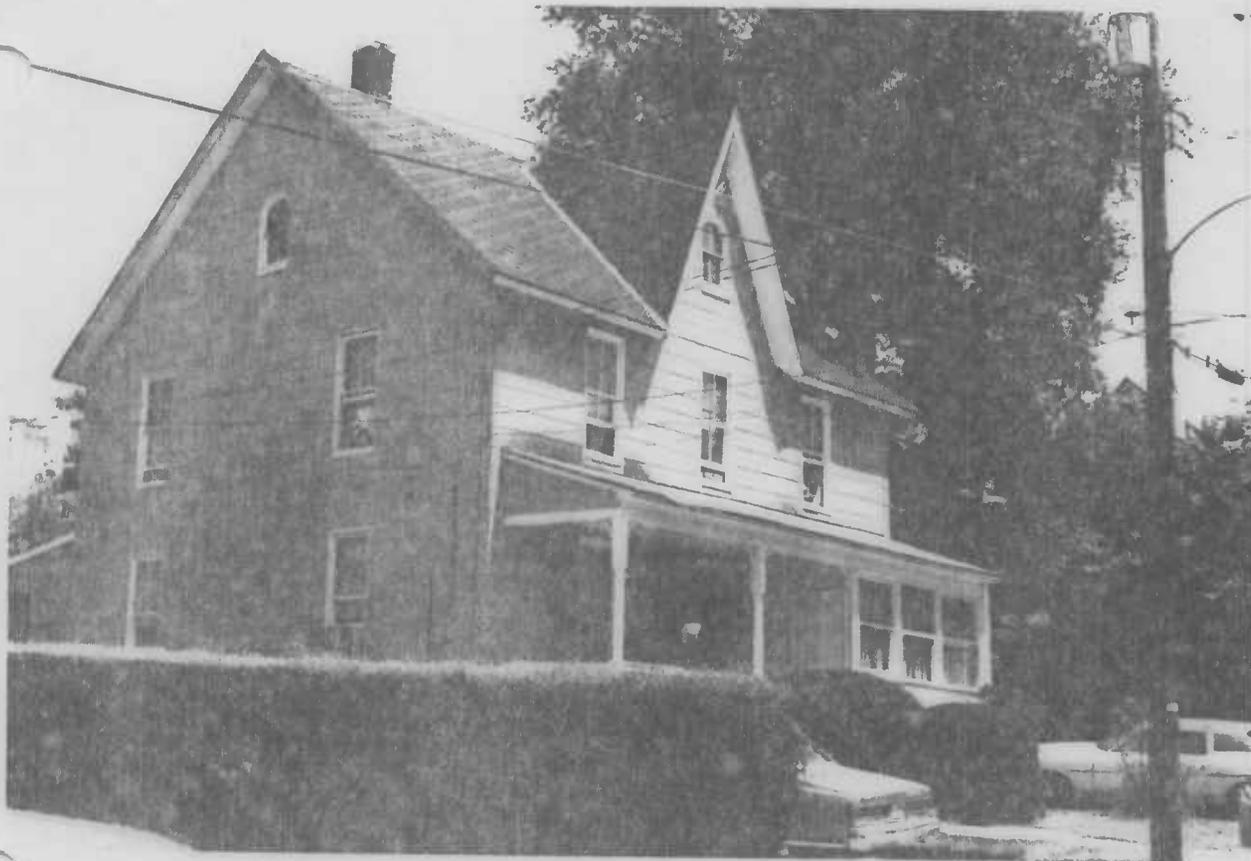
ABOVE: South-west Corner

The west facade displays two 2/2 sash windows with plain white trim on the first floor and two on the second floor. An arched 2/2 sash window is located in the attic. Also from this facade you see the west end of a single story shed roof addition made to the rear of the main house. It displays two 6/6 sash windows located directly next to one another.

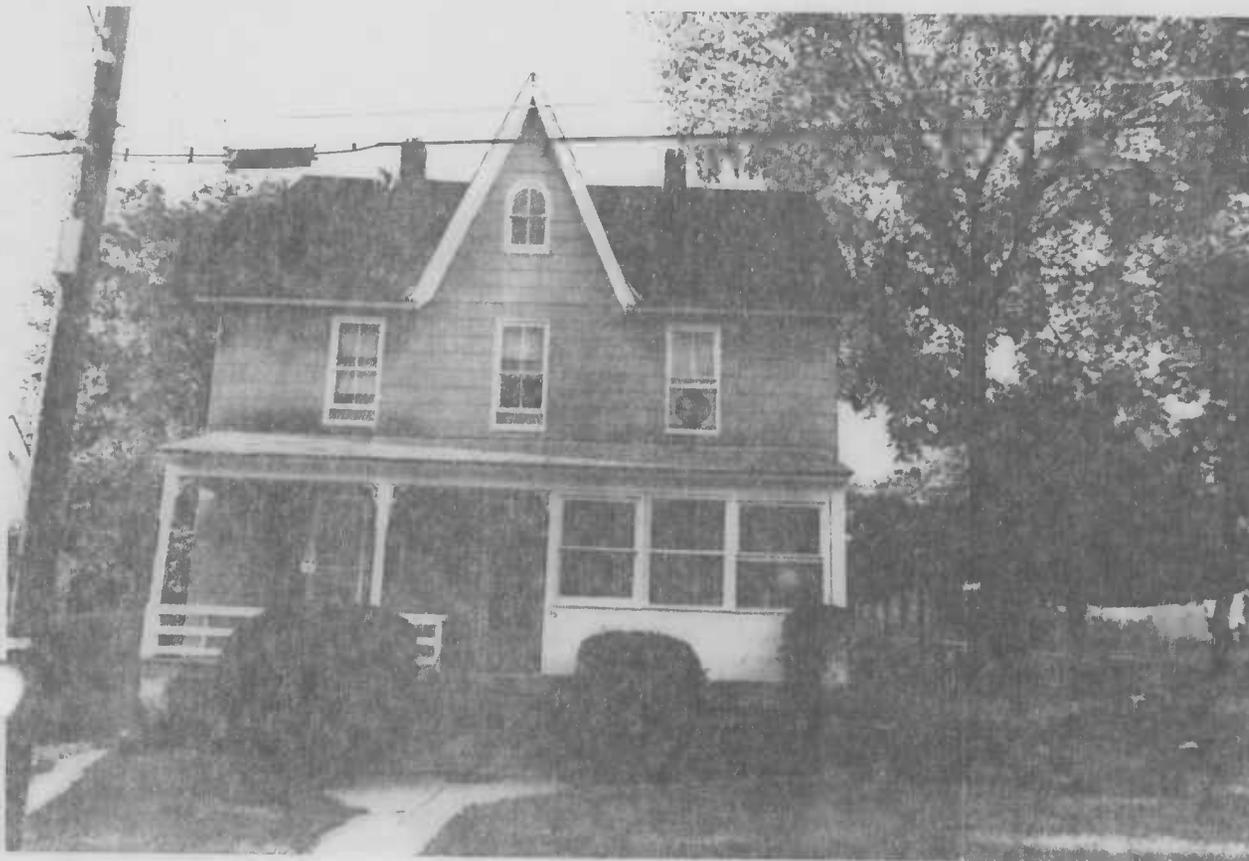
BELOW: South (Main) Facade

The house rests on a slight incline and faces south on Willow Avenue. The main block is three bays wide and two bays deep. It is presently covered with (asphalt) shingles and rests on a stone foundation. A huge cross gable roof caps the building. Two interior brick chimneys exit the roof on either side of the cross gable. The front porch which originally spanned the entire south facade has been partially enclosed on the eastern half.

Six concrete steps lead to the porch which rests upon brick porch piers and is surrounded by a lattice-like porch base. Heavy turned post support the porch roof. A slat railing encloses the porch and scroll brackets add ornamentation.

Fenestration on the south facade consists of one 2/2 floor length window on the left side of the door and three 1/1 sash windows on the enclosed porch to the right of the door. The door is a wood paneled door with glass transom above. A second door leading to the enclosed porch is entered from the south facade as well. This second door is a wood paneled door similar to ones used in the interior of houses. Fenestration on the second floor of the south facade consists of three 2/2 sash windows. A 2/2 sash arched window appears on the attic floor in the center of the cross gable.
