Survey No. CAR-246

These two houses are remnants of the Old Choptank Hotel which was located on Market Street across from the courthouse. The hotel was divided and moved c. 1902 and the Law Building (CAR-201) was erected on the Market Street site; two parts of the hotel were moved to Franklin Street and converted to residences.

Old Choptank Hotel

113 and 115 Franklin Street

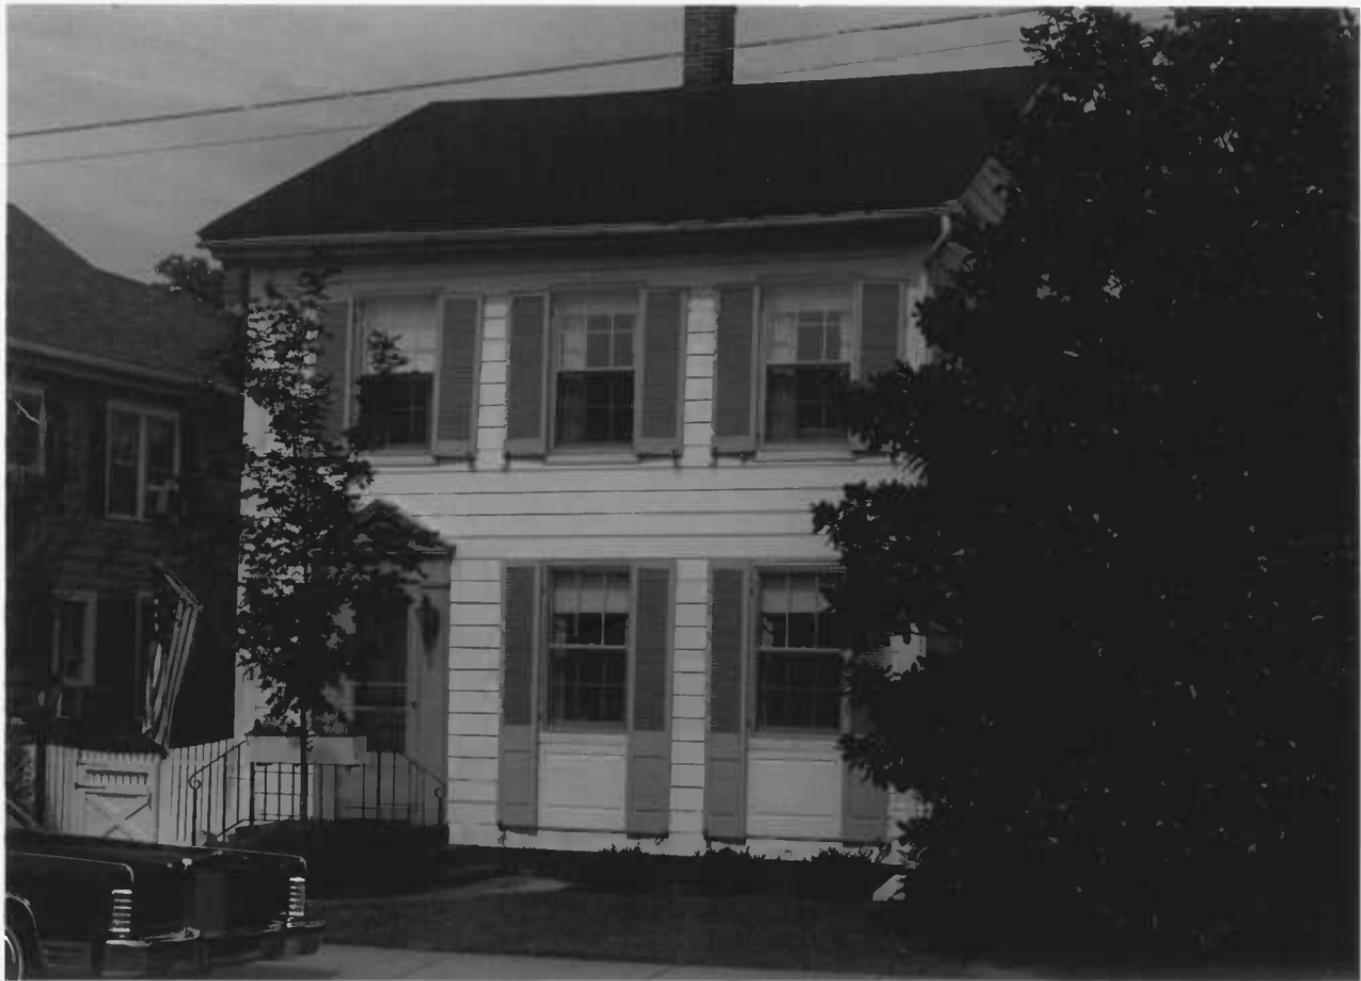
CAR-246

These two houses were once part of a larger building which was later divided up and moved to the present locations. The house at 113 Franklin Street is a two story frame house with a three-bay facade. Most of the windows have 2/2 sash with the exception of a bay window on the east elevation. Decorative features of the house include corner pilasters, cornice returns, louvered shutters and an entrance with fluted pilasters and pediment. The house has been altered by the addition of aluminum siding.

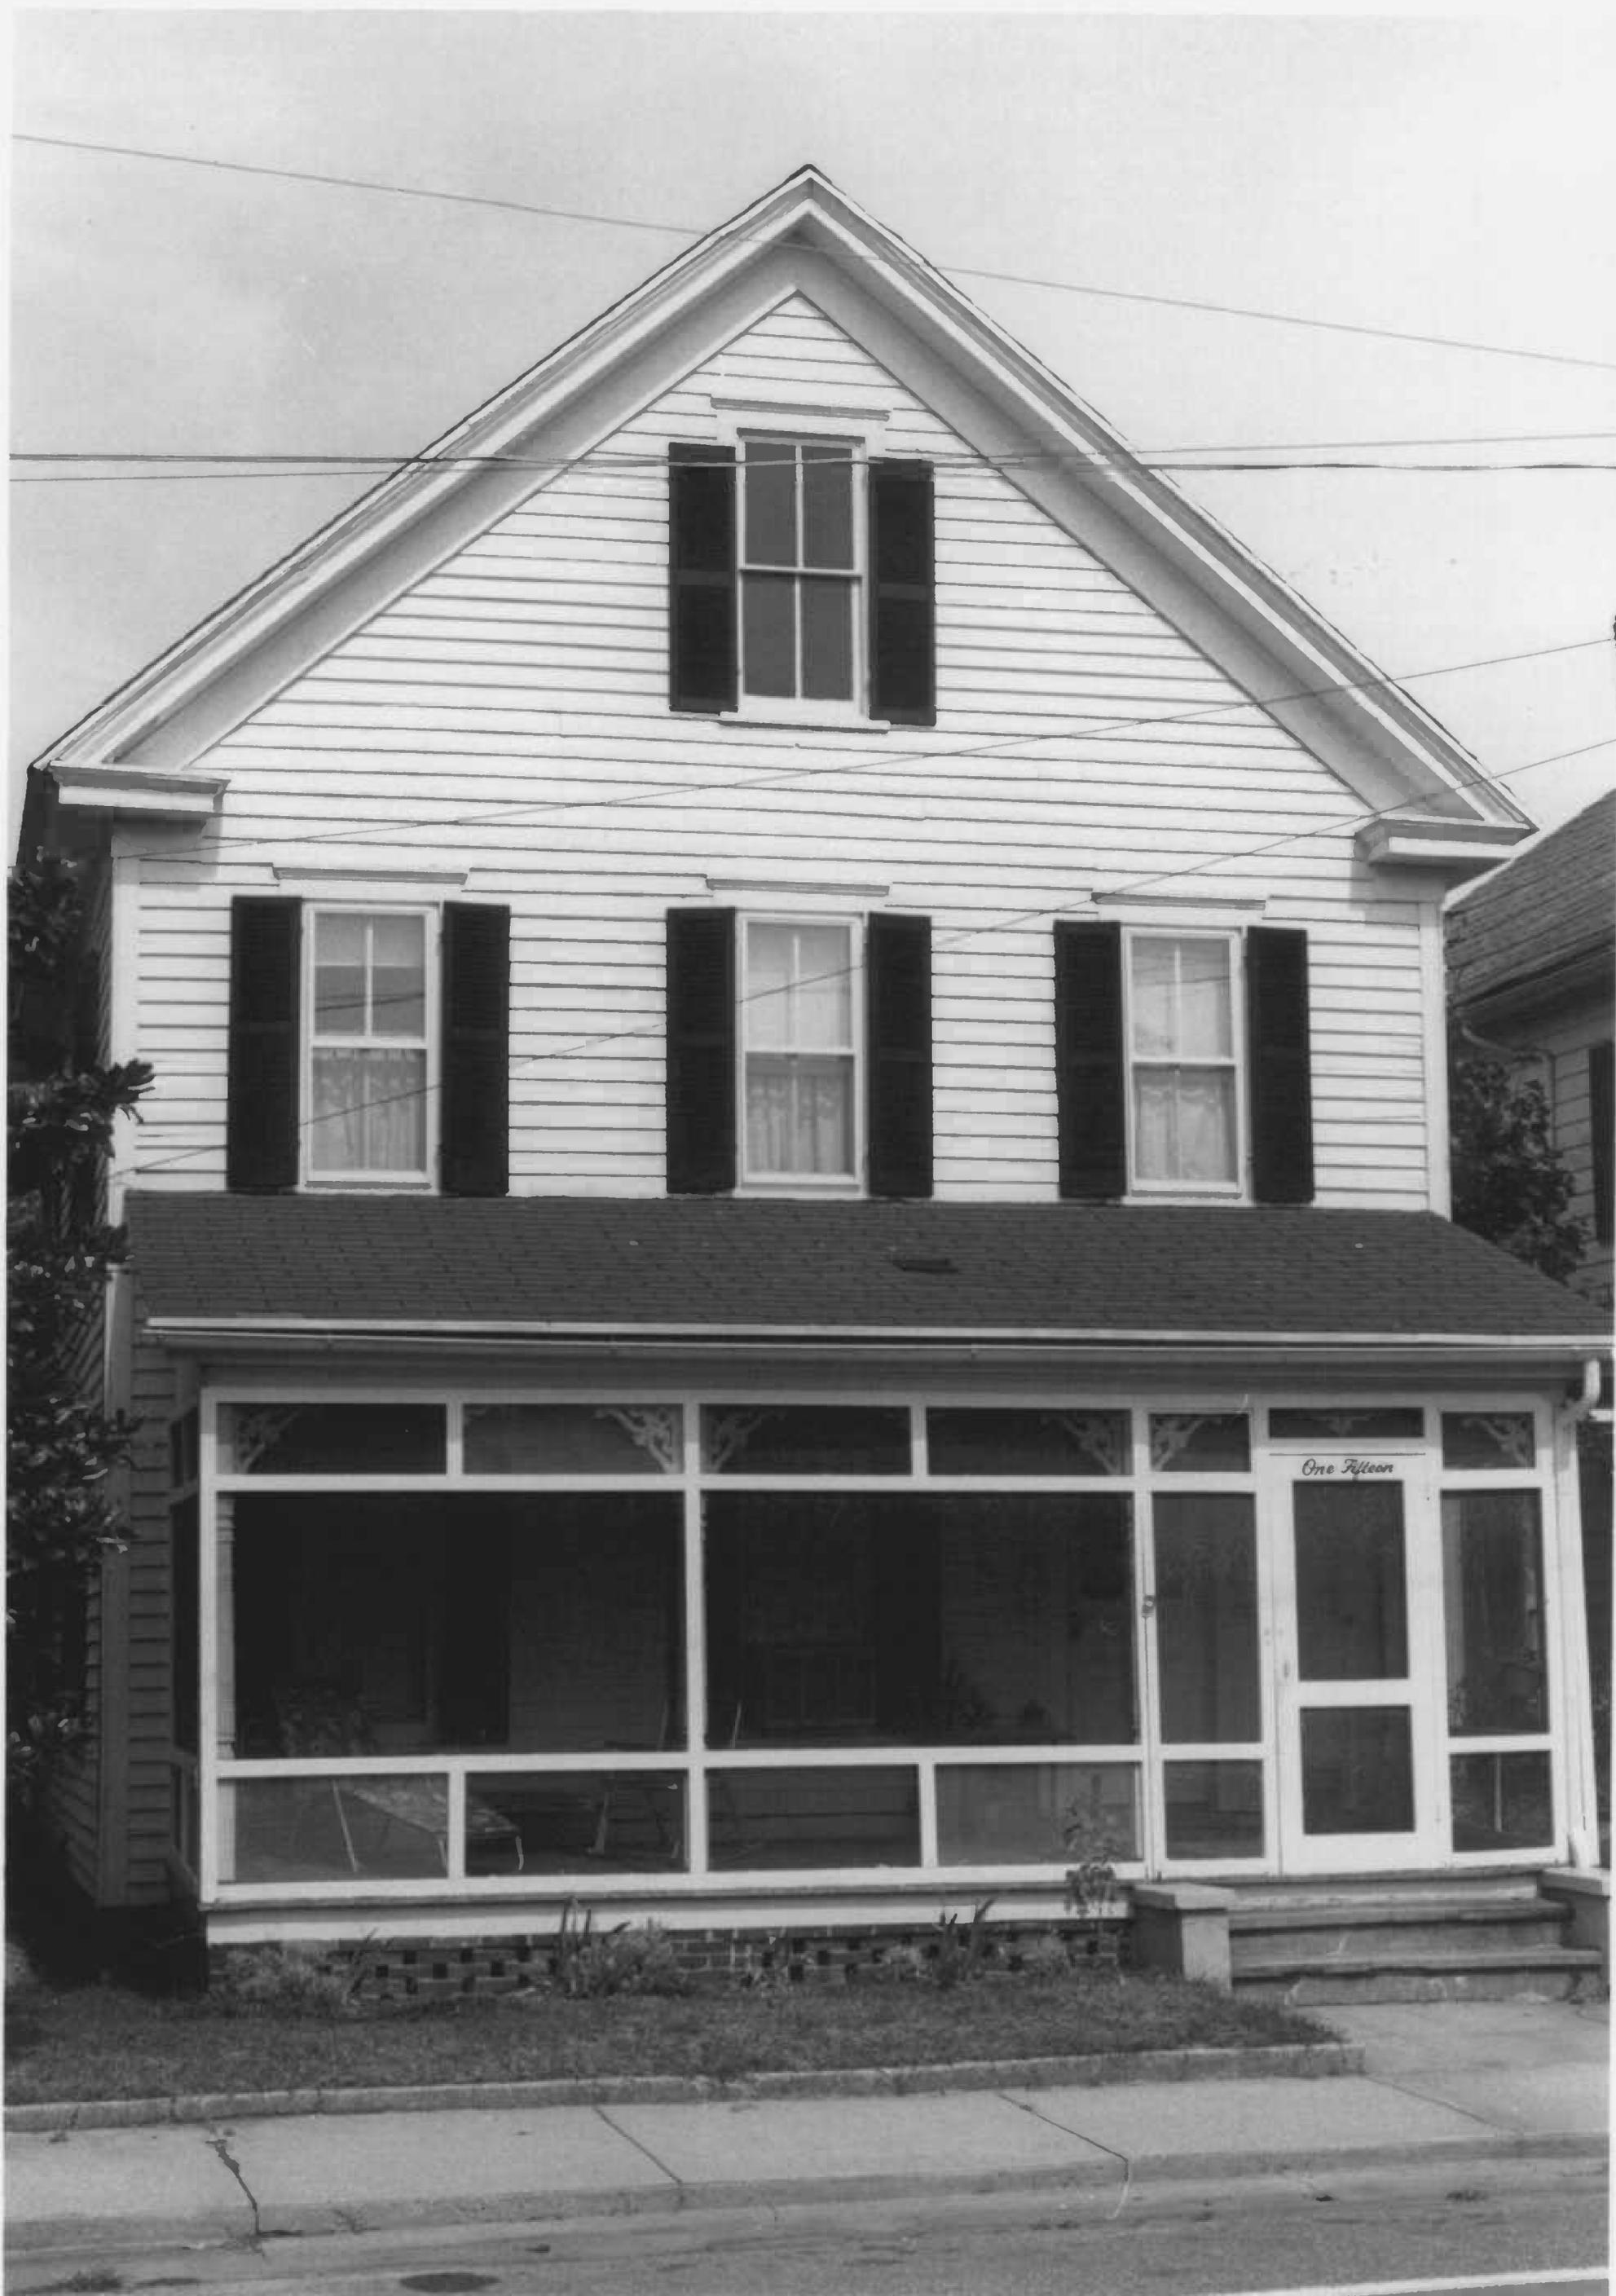
One Fifteen

115 Franklin Street is a three bay frame house with steeply pitched gable-front roof, 2/2 sash windows with original shutters and a front porch with turned posts and jig saw wood trim.
