INVENTORY FORM FOR STATE HISTORIC SITES SURVEY

Morris Farm House

West side of Cherry Lane

Tuckahoe State Park VICINITY OF

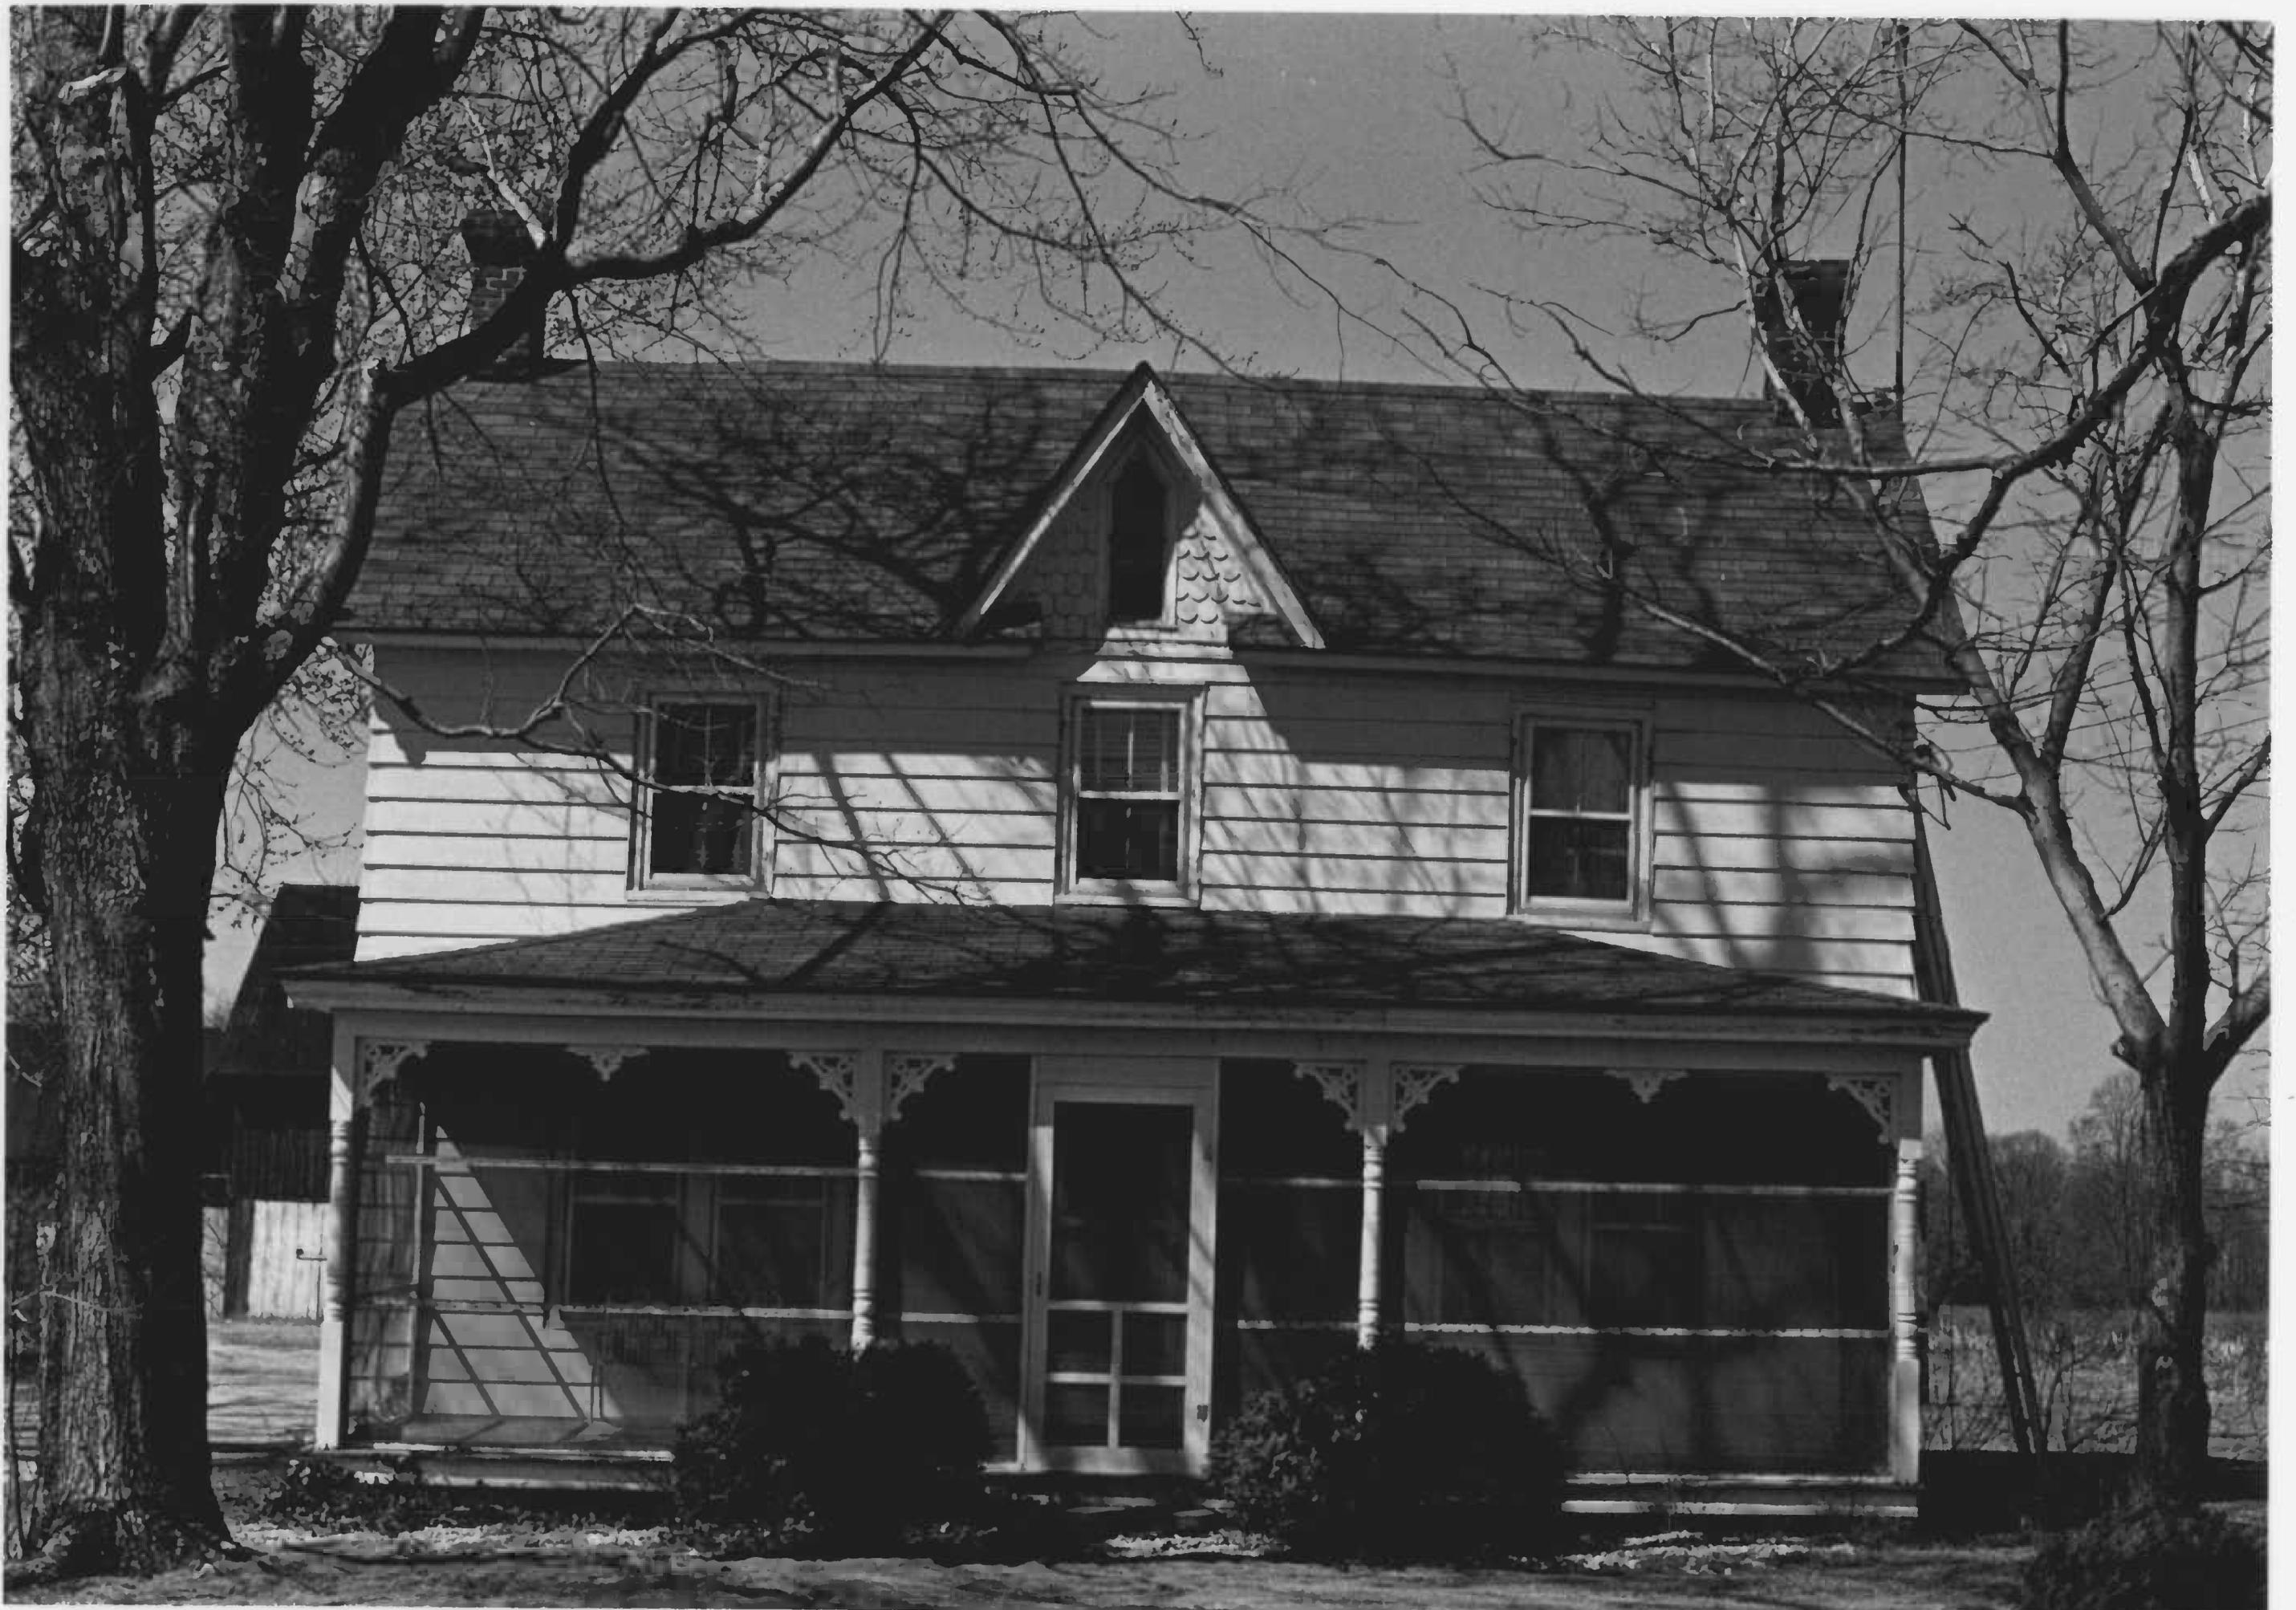
CAR-255  
DNR 81-85

The east facade of the main block is distinguished by a one-storey screened porch with turned supports, brackets and pediments. A central doorway is flanked by double windows. 3/1 sash windows with 2/2 sash mark the three corresponding openings on the second storey. A lancet 2/2 sashed window surrounded by fishscale shingles punctuates the centrally pitched gable. The asbestos shingled roof is further defined by corbel capped brick interior chimneys at both gable ends.

MORRIS FARMHOUSE  
WEST SIDE OF CHERRY LANE  
RIDGELY, MARYLAND

TUCKAHOE STATE PARK  
EAST ELEVATION

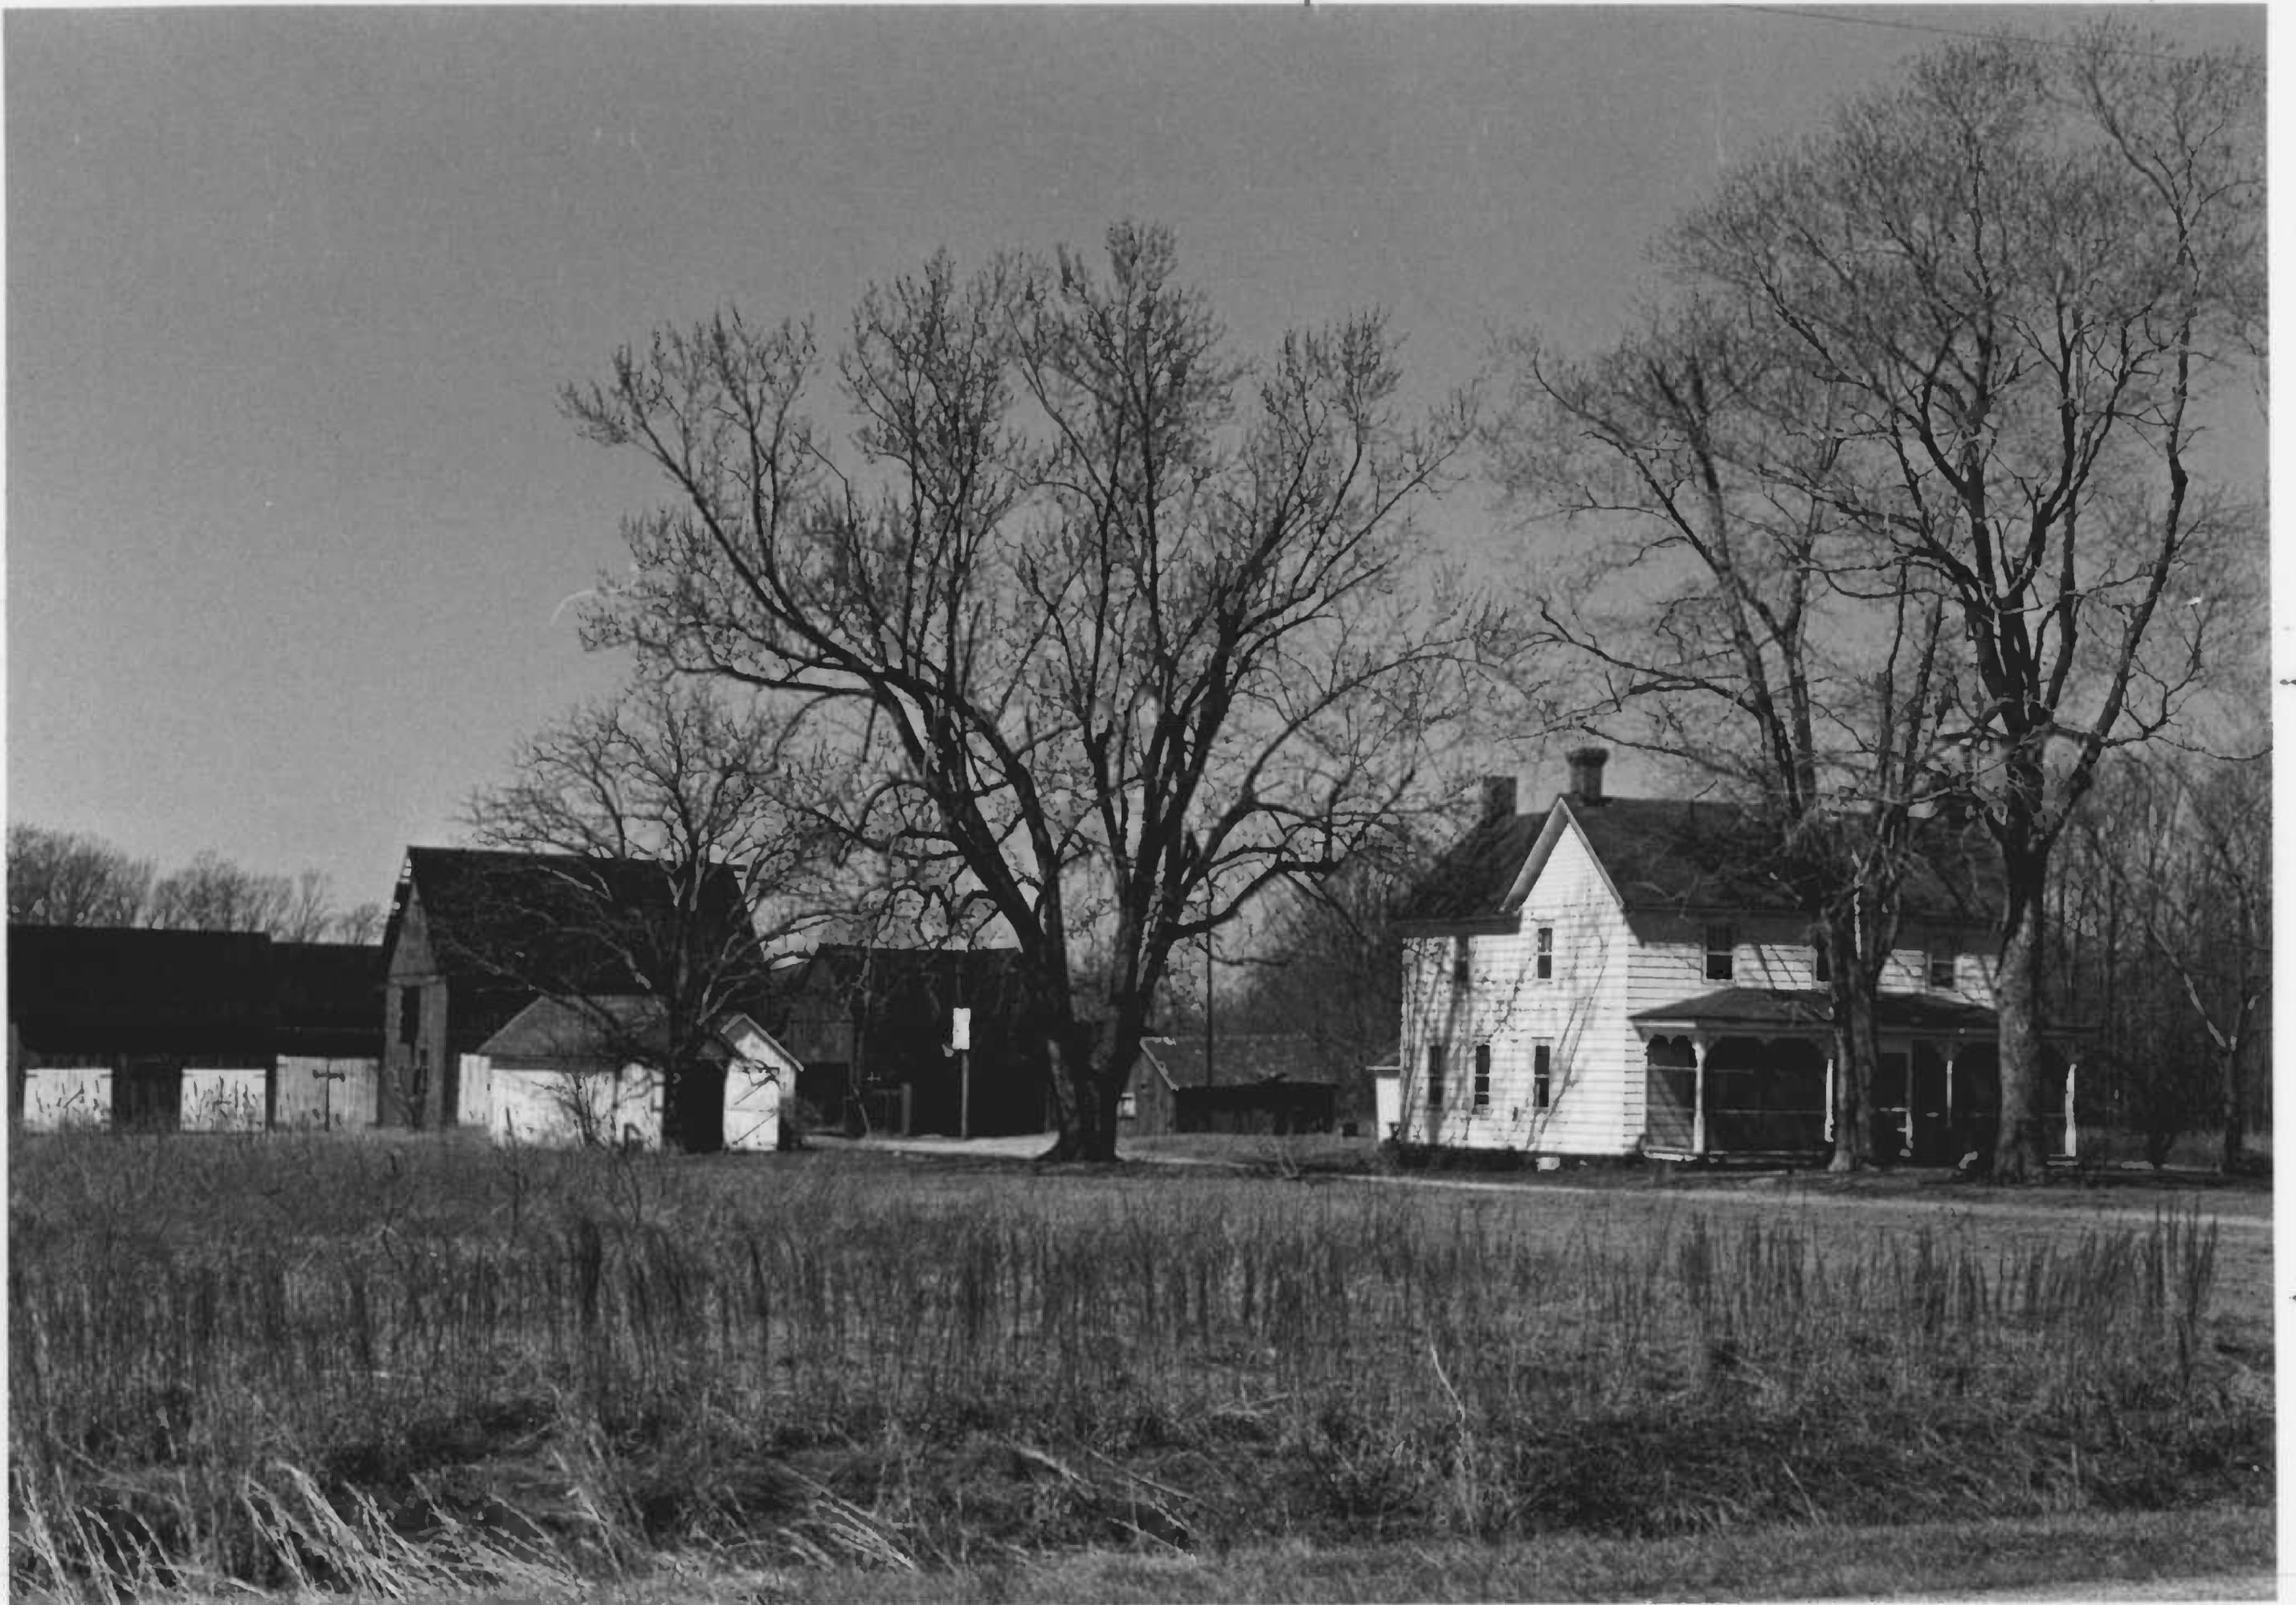
DNR 81-85

The two storey, two bay el projects from the two southernmost bays. The south facade is defined by two 2/1 sashed windows on the first storey and a centrally located 2/1 sashed window on the second storey. A shed roofed addition extends across the first storey of the north facade. A doorway in the east bay and a 2/1 sashed window in the west bay characterize this addition. A 2/1 sashed window is centrally located on the second storey of the north facade. Another entrance is found on the west facade. Above it is a 2/1 sashed window. An interior brick chimney rises from this gable end.

MORRIS FARMHOUSE  
WEST SIDE OF CHERRY LANE  
RIDGELY, MARYLAND

S.E. ELEVATION
