MARYLAND HISTORICAL TRUST

INVENTORY FORM FOR STATE HISTORIC SITES SURVEY

Grubb Property

Eckman House

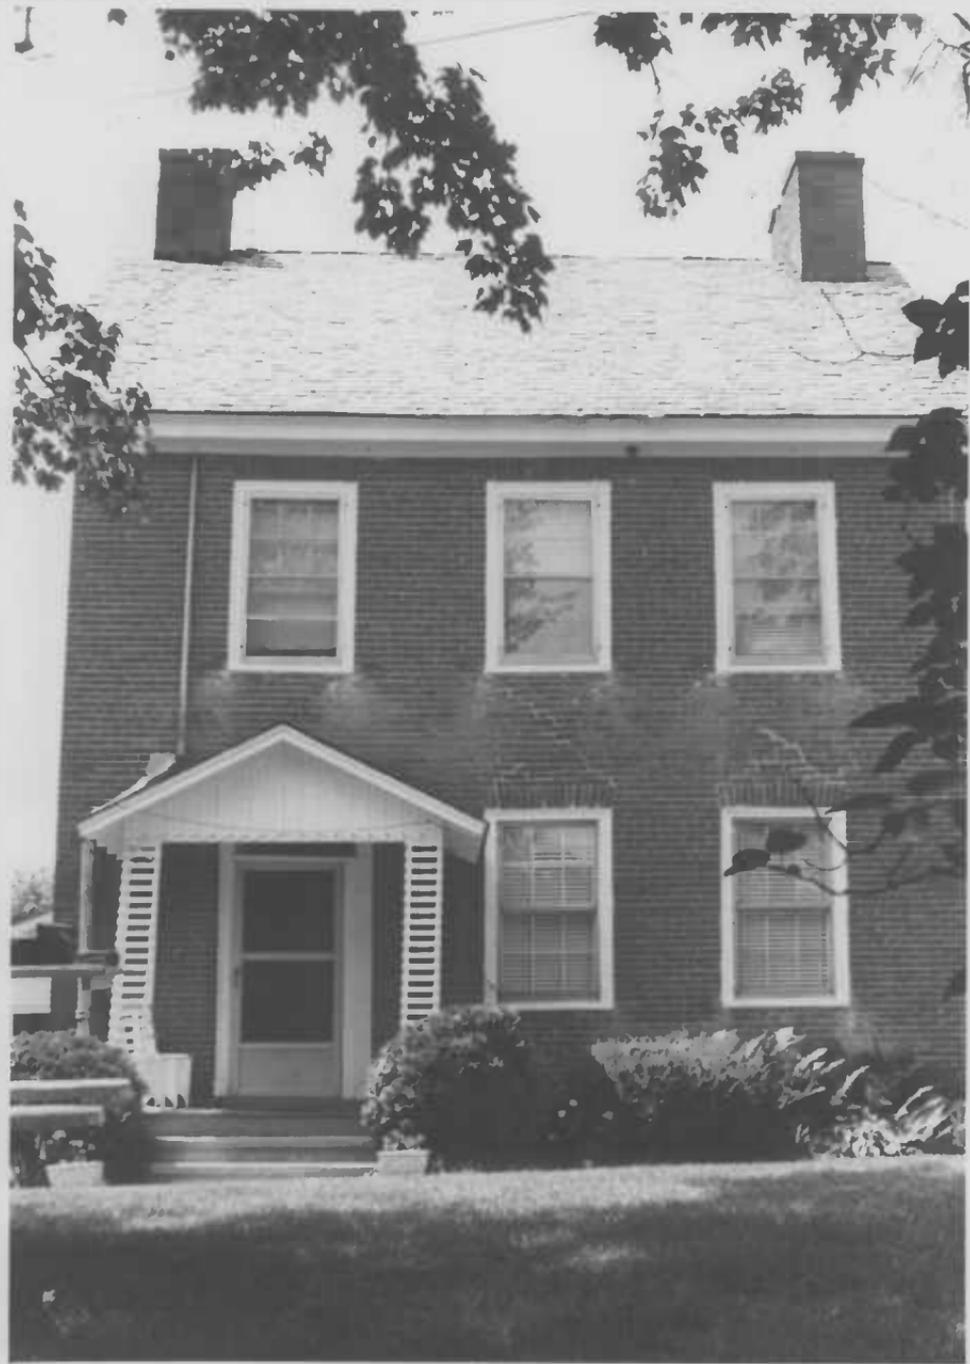
EAST ELEVATION

The east facade is 3 bays across with the entrance in the southern bay. The main facade is laid in common bond with 5 rows of stretchers for every row of headers. Jack arches are over the first and second story 6/6 sash windows. The window and door surrounds are molded. Shutters have not lasted but the pintels do remain. The early front door is present and consists of 6 panels with an inset molding. The door reveals are also paneled. A boxed cornice with bed molding extends across at eave level. A late 19th century single bay gabled porch protects the entrance. The gable end is decorated with saw-tooth vertical boards. The eaves ~~are~~ extended and left open.

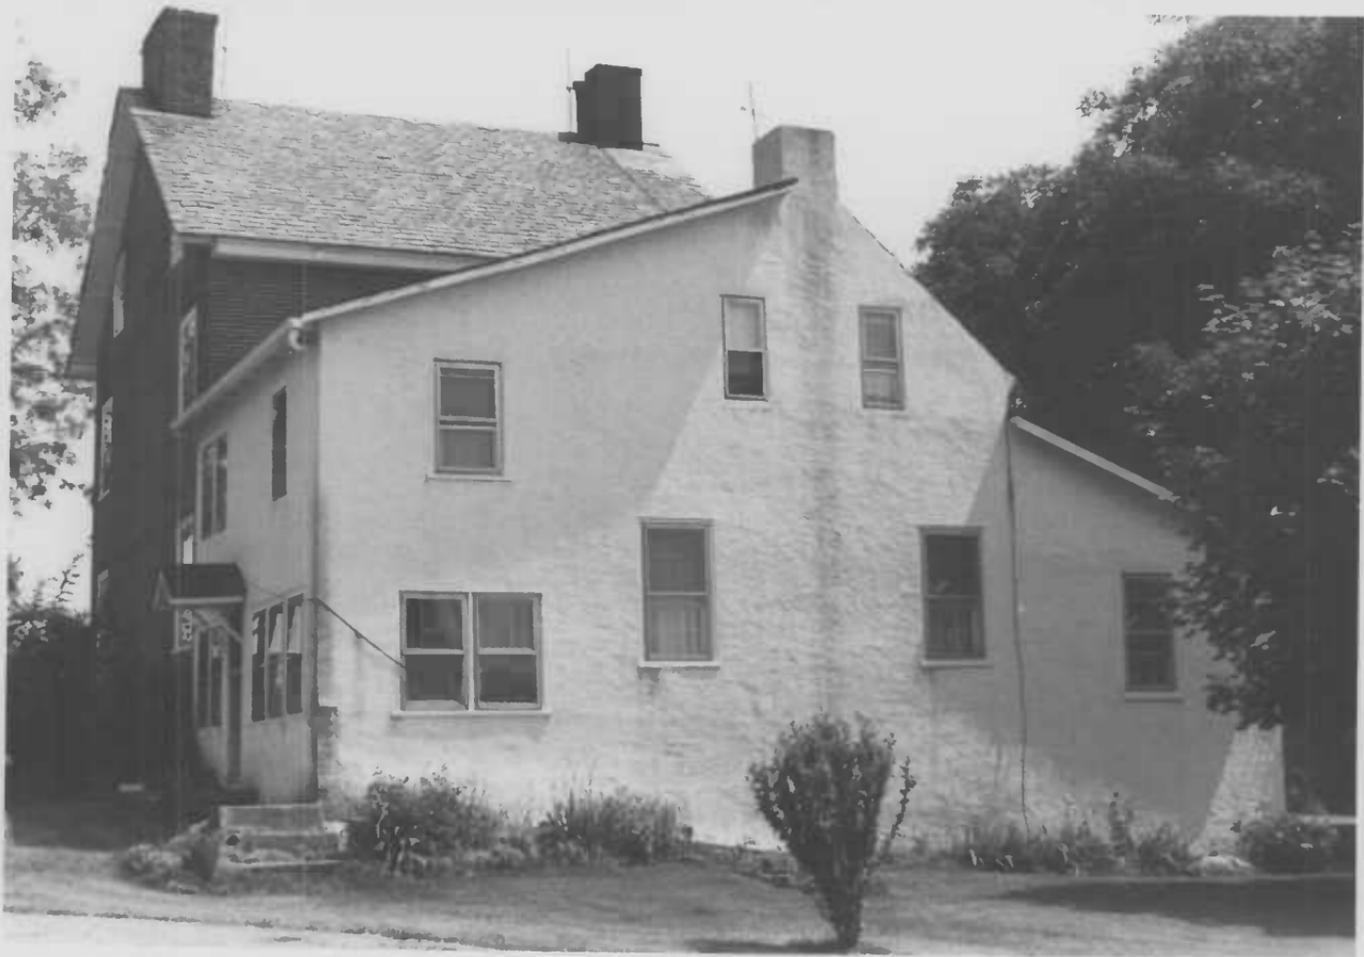
WEST ELEVATION

The rear section is stuccoed brick with a brick cornice along the south side. The north side is totally covered with the 2 story addition. A small stack is found in the gable end of the addition. The window sash are 6/6 on the first floor. There are two 4/4 second story sash that flank the stack.

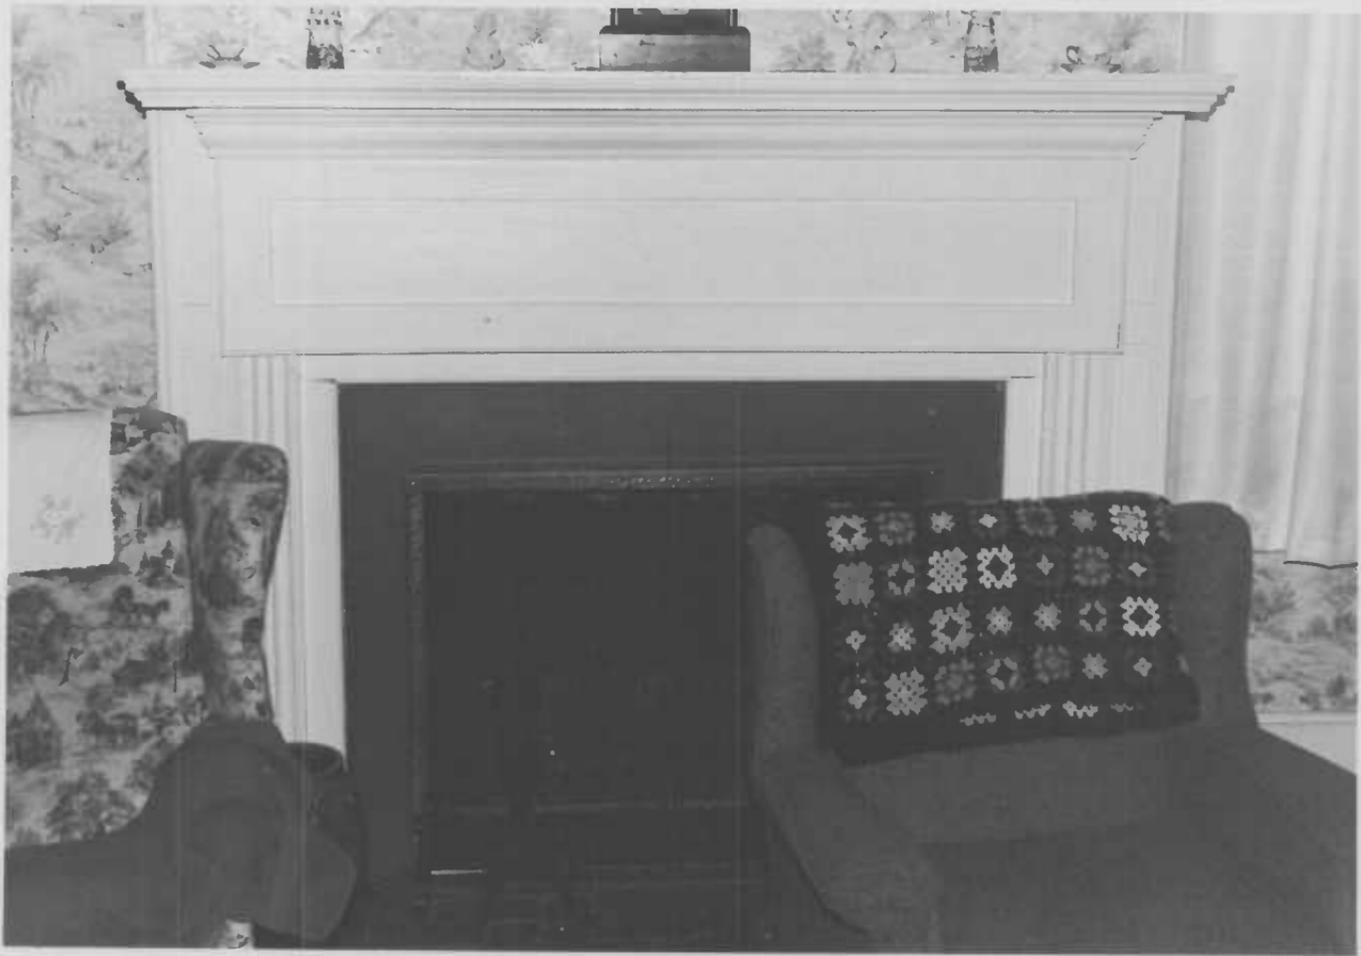
NORTH PARLOR MANTEL

sharply before reaching each supporting post. The door surrounds are widely fluted with bulls-eye corner blocks. Six panel doors with inset moldings and box locks also remain. The north-east parlor retains its 19th century mantel. Similar fluting to the door surrounds was used as a surround for the mantel. These fluted columns support a long rectangular paneled frieze. An elaborate molding serves as an cornice which supports the molded mantel shelf. A second mantel is located in the northwest room but is much more plain.

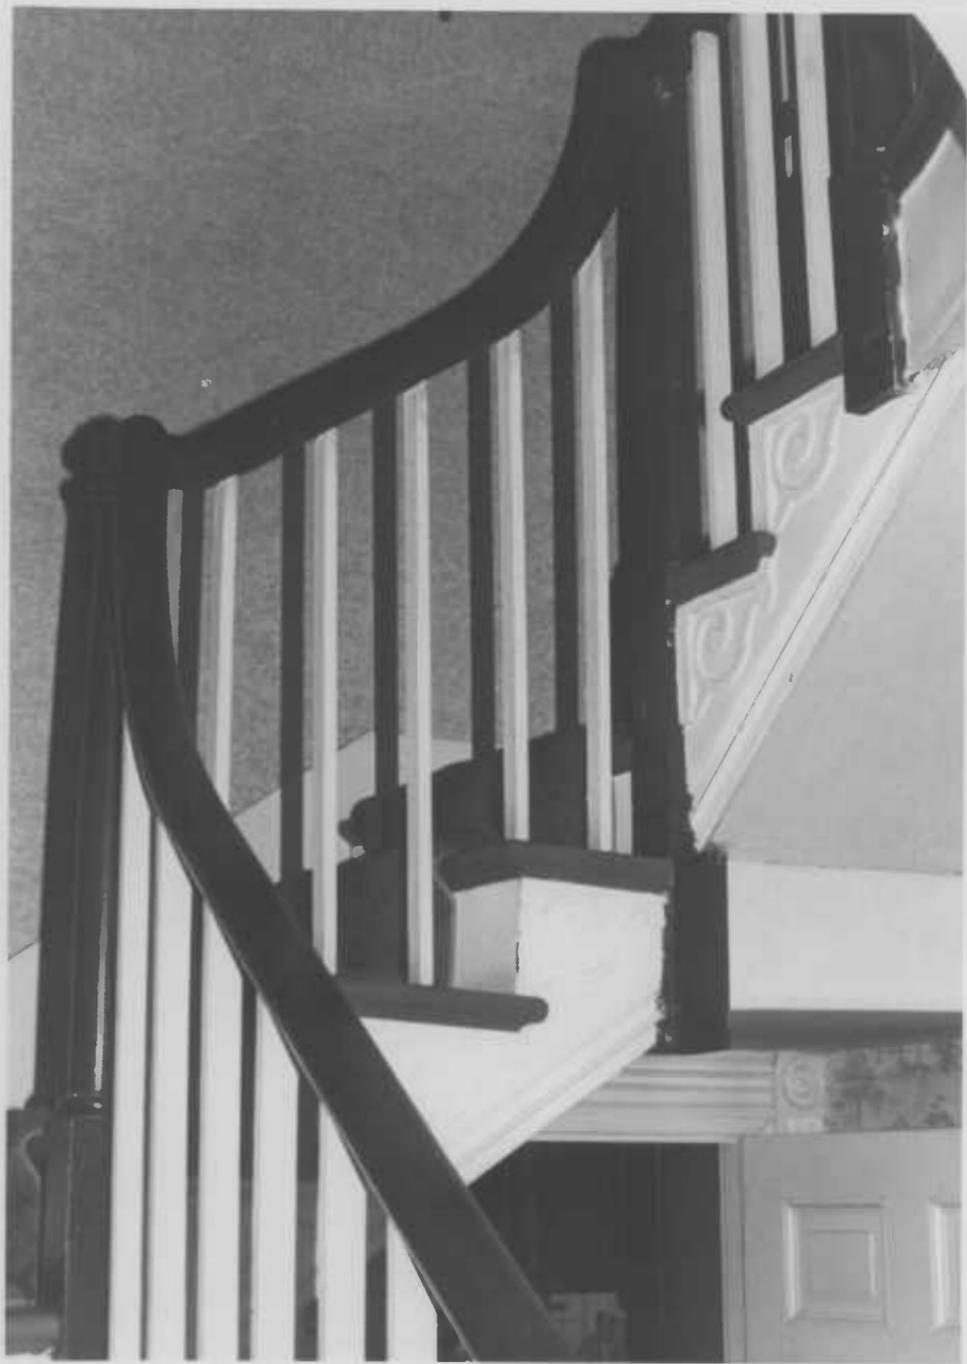
STAIR

The early 19th century interior of the main block is basically intact. The main stair has its early 19th balustrade with slightly swollen newel post and oval handrail. There are two rectangular balusters on each tread and the stringer is decorated with an elaborate scroll. The handrail terminates just beyond the post with a carved element in the shape of a cupped hand. The handrail is typical of the period and rises
