Inventory Number: CE-527
Tyson House
Cecil County, MD
C. Mazurek
June 1998
Section 7.1

TYSON HOUSE, FAIR HILL N.R.M.A.

INVENTORY FORM FOR STATE HISTORIC SITES SURVEY

HISTORIC
TYSON HOUSE RUINS
AND/OR COMMON

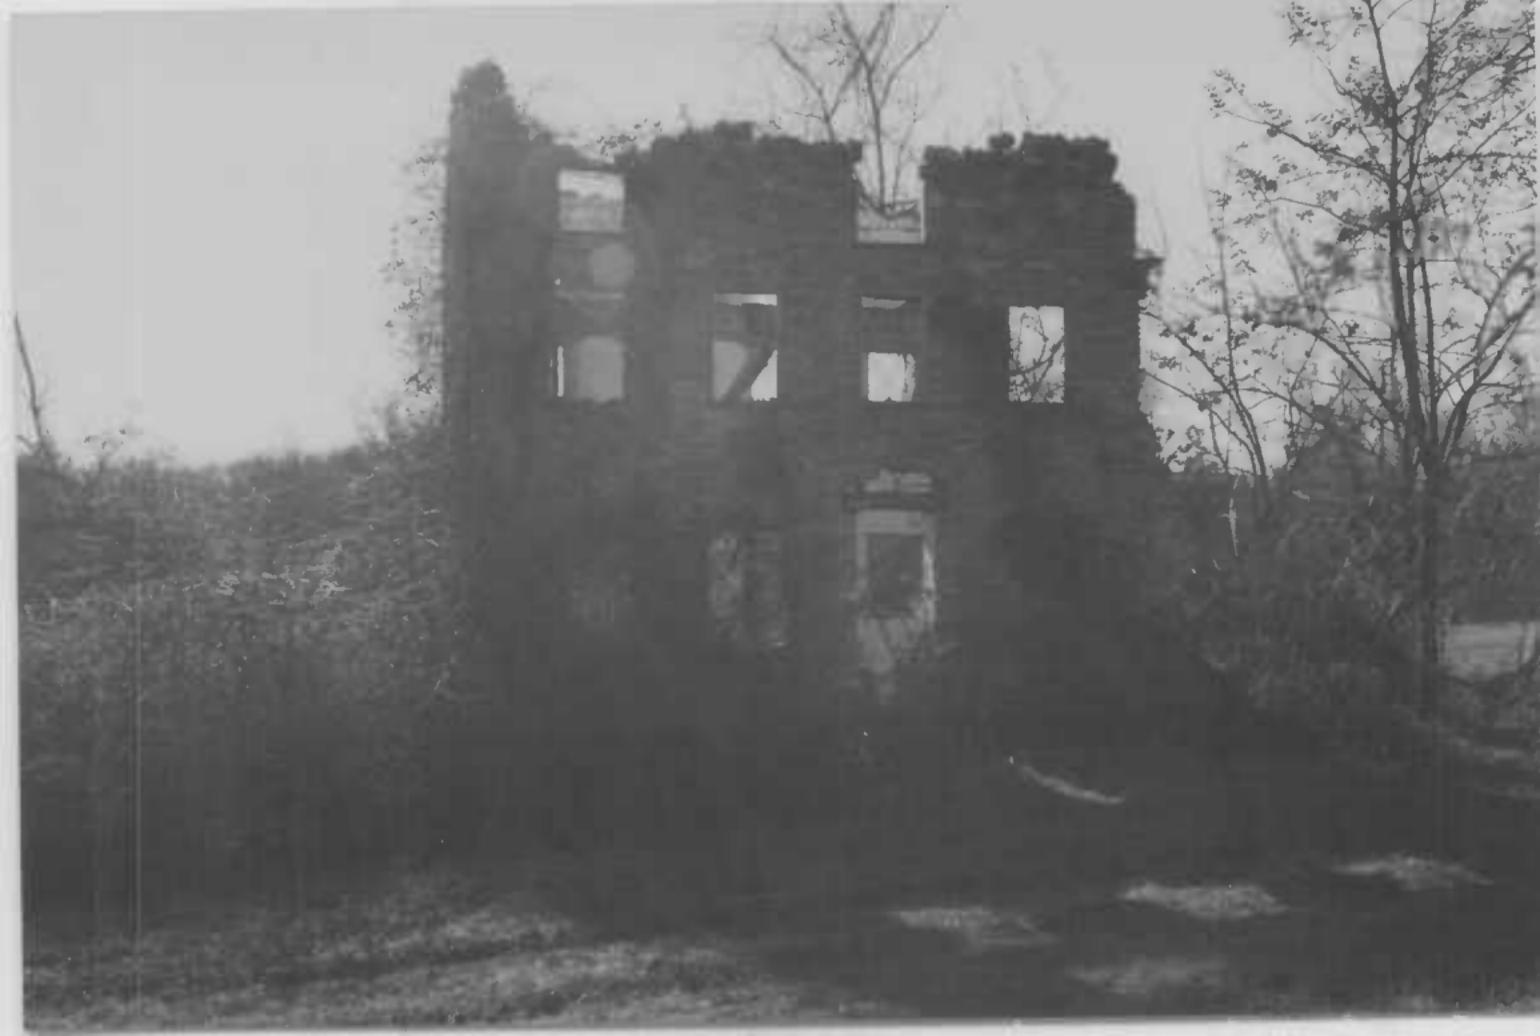
WEST ELEVATION

This structure has been unoccupied for many years, and has deteriorated beyond livability. The loss of the roof has further compounded the problem of deterioration. It is a simple plan that may have been divided into two units, is two and one-half stories tall, and is four bays wide. According to the last historic sites survey in 1979 the roof, now gone, was gabled with a central chimney. The entire structure is constructed of uncut fieldstone, with no courses, that appears to have had a stucco finish applied to it at one time. All of the window sashes and doors have deteriorated or have been vandalized. The interior wood framing has fallen into the basement, but it is still possible to see that the walls were covered with a plaster coating. The entire west facade is missing. For the most part the Tyson House is just the shell of the original structure.

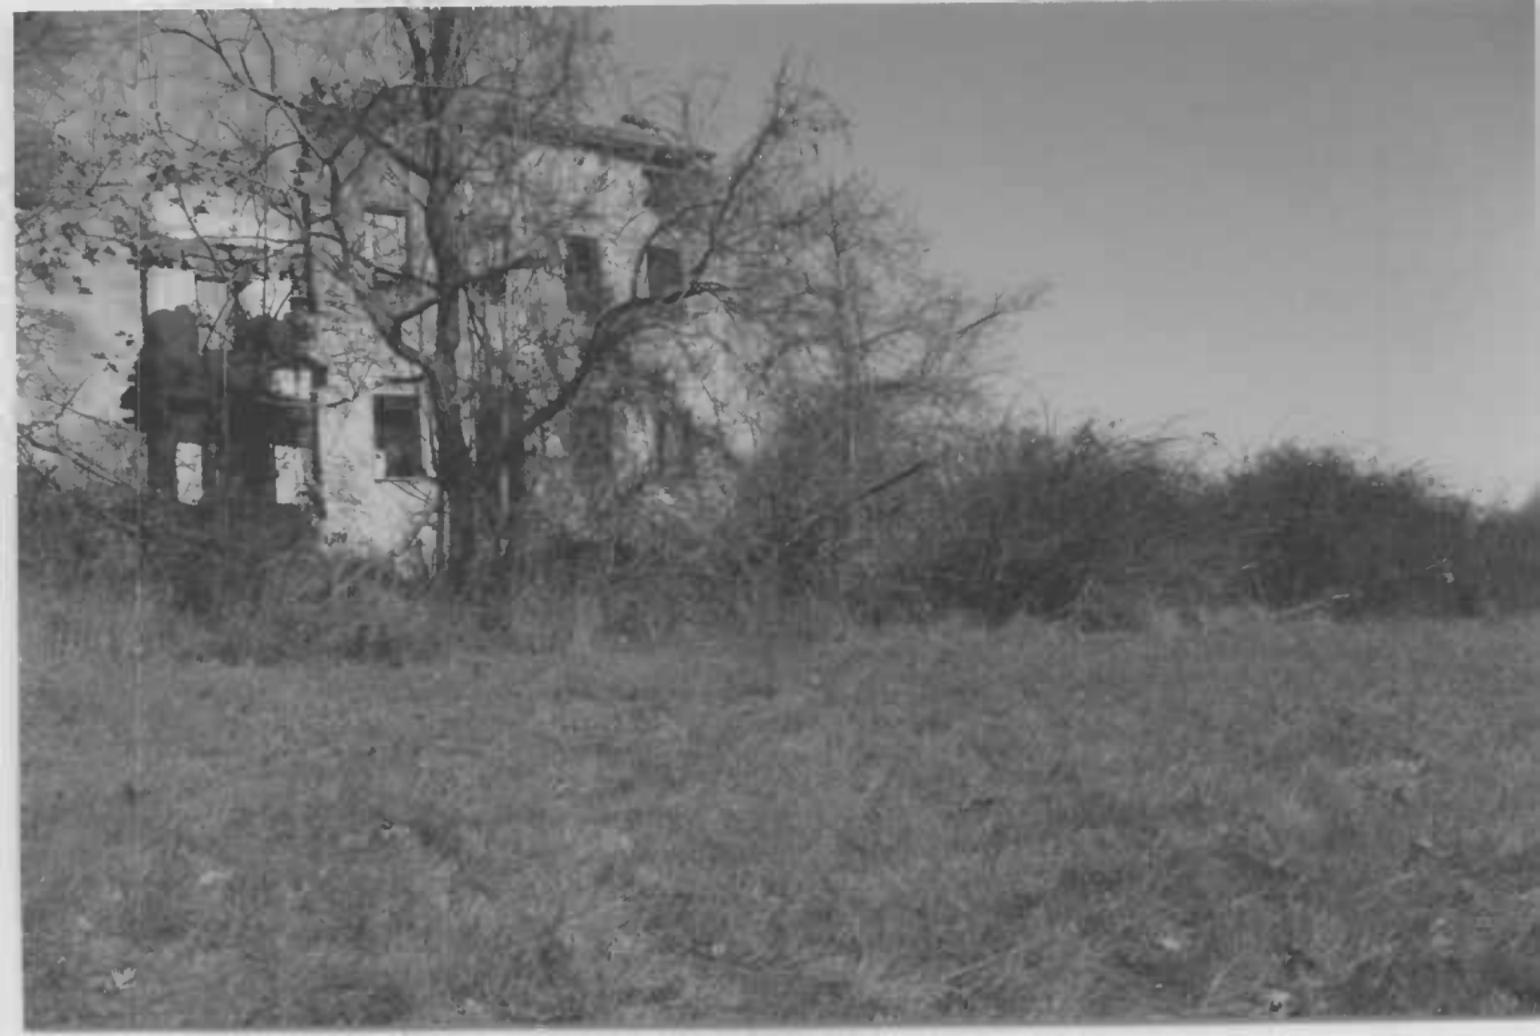
S.E. ELEVATION

The Tyson House Ruins consist of the east gable end of the house and the four-bays of the north and south facade. The west gable end and the westernmost bay of the north and south facade have entirely collapsed. The structure was constructed of field-stone covered in stucco. It is two and three-quarters story tall and originally was a five-bay by two-bay structure. The main facade faced north and had a central entrance. The outer bays of the first story and five-bays of the second story contain six-over-six sash windows. The three-quarter story had three windows

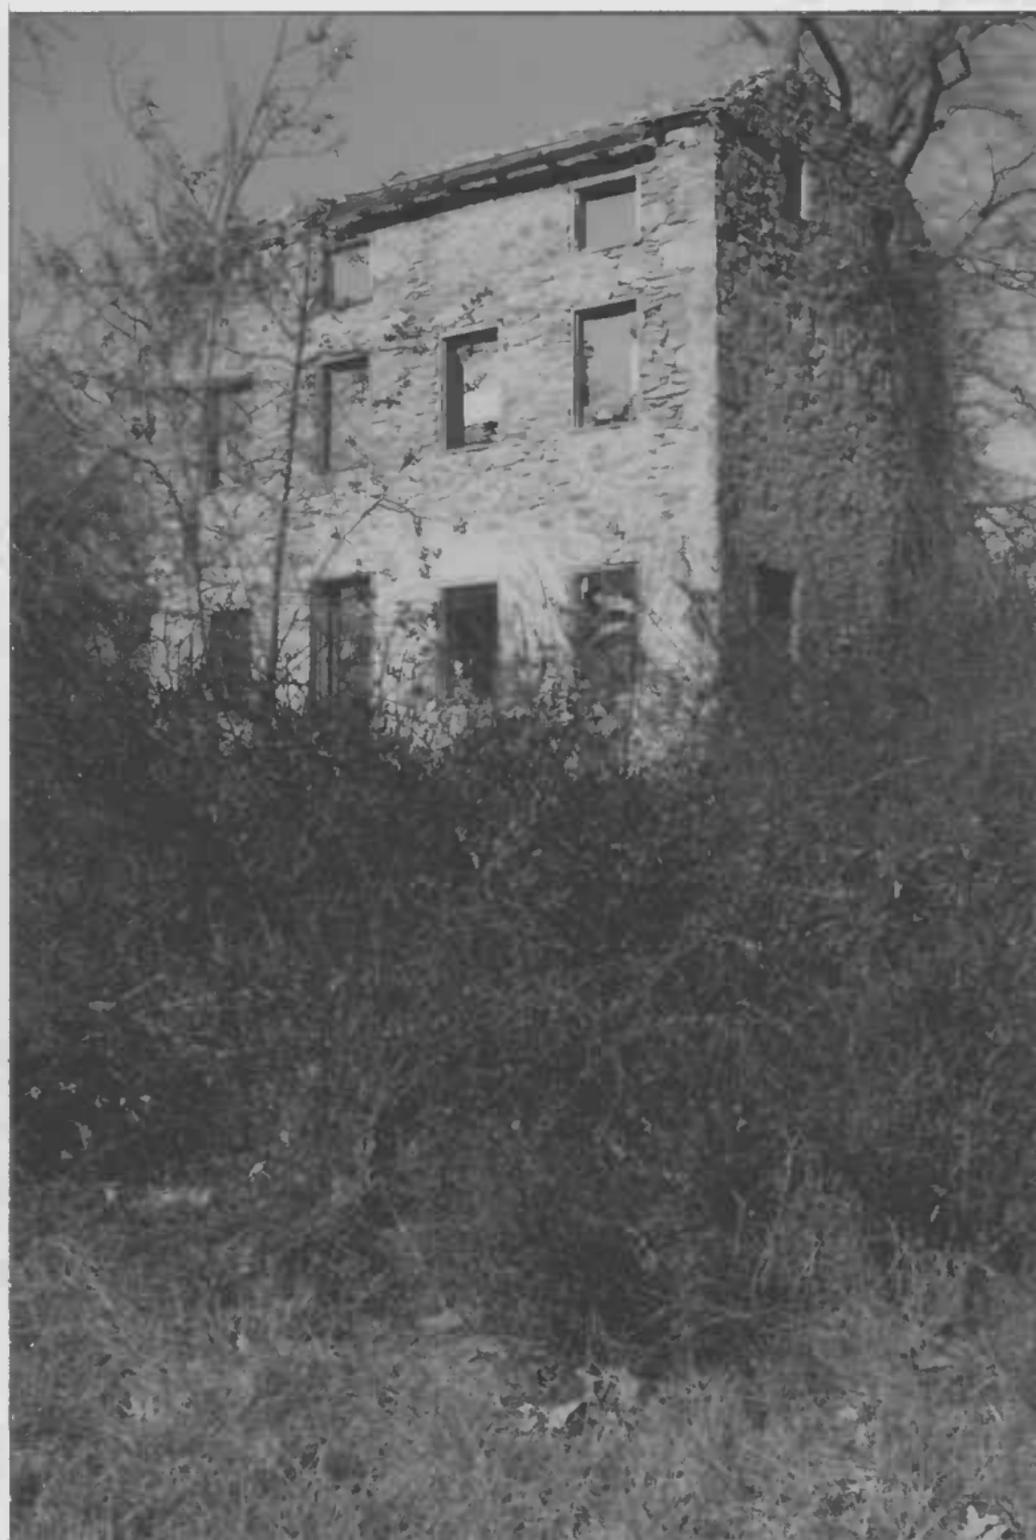
N.E. ELEVATION

symmetrically arranged in the center bay in the outer bays of the structure. The gable roof contained a boxed and *dentil* cornice. ^{The roof} It was most recently covered in sheet metal. The east gable end has two windows on the first story and two small windows in the gable. There was an interior-end chimney on this wall. It is not possible from the ruins to determine the fenestration on the west wall. The south facade was fenestrated in a manner similar to the north facade but also contains two foundation level three-pane windows.
