# Maryland Historical Trust

## State Historic Sites Inventory Form

CE-1006

and/or common Old Hammy Methodist Church

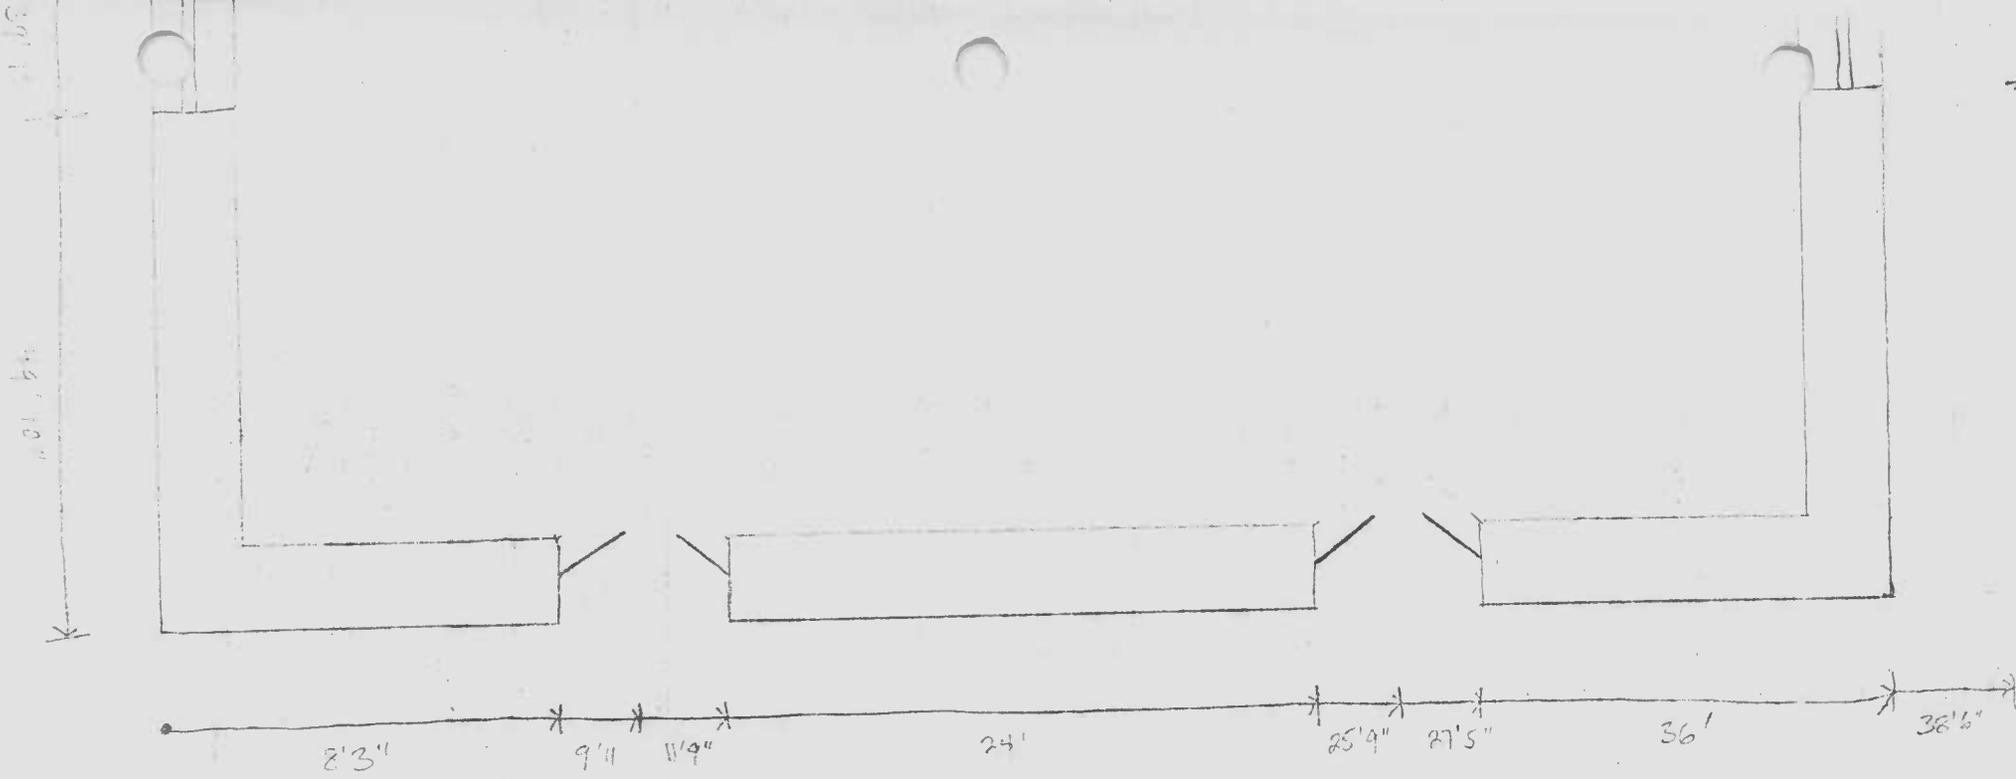
FIRST FLOOR PLAN

HARMONY CHAPEL

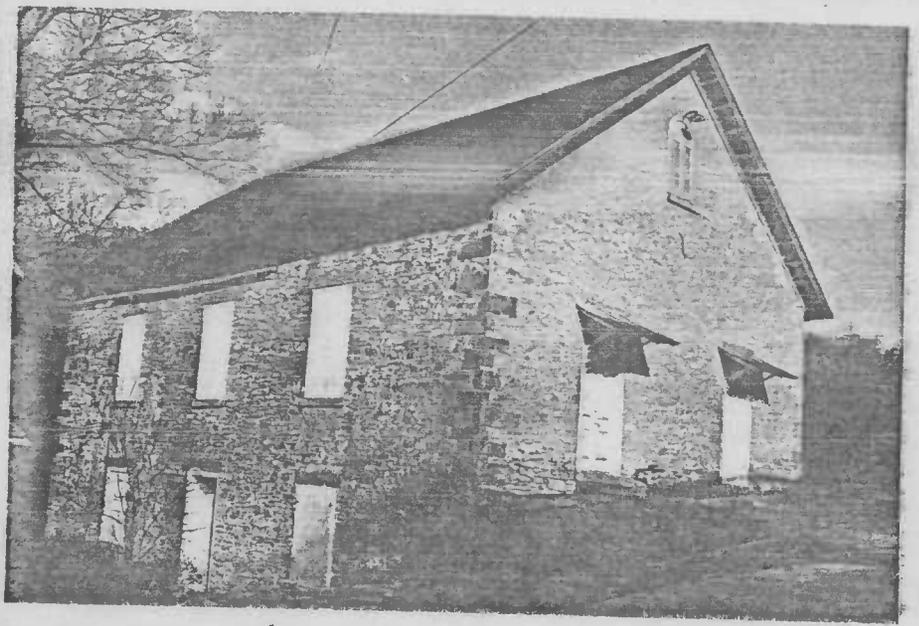
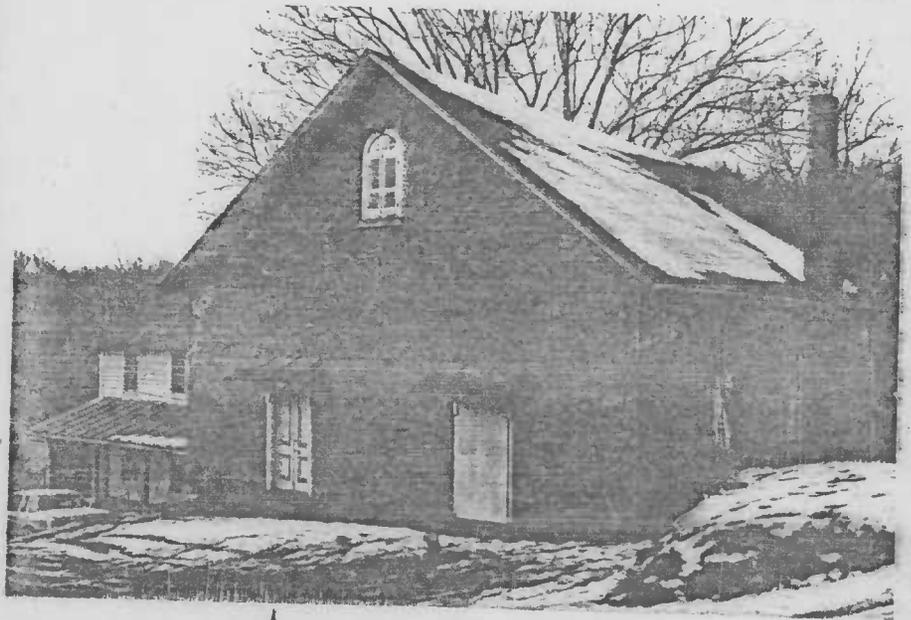
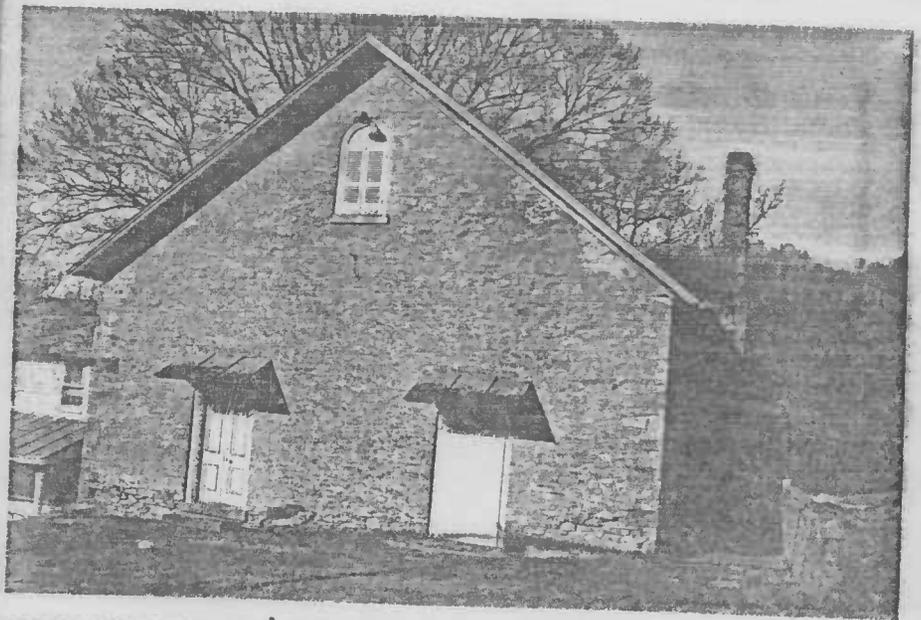
The two-bay entrance (south) facade of the church contains two equal sized four-panel doors, both approached by a couple of steps and both subsequently sheltered by a little canopy consisting of a sloping tin roof diagonally braced with 2"x4"'s on either side. Above the doorways, which are spaced across the facade about the same distance from the corners of the building as they are from each other, in the pediment area is an arch headed window opening which contains a louvered wooden panel painted white with the inscription. As with the other fenestration in the building, this opening possesses a granite sill. The eaves are deep, but there is no articulated cornice with returns.

The west facade, facing the adjacent minister's dwelling (not owned by DNR), is articulated by a side entrance door flanked by two windows on the first story and three windows directly above these on the second story. These openings are uniformly characterized by flush granite lintels and slightly projecting granite sills. All windows have been boarded up, on the second story level completely obscuring the original sash but on the first floor level the boards are double hinged to the simple timber surrounds and potentially operable. The door on this facade is a double door, each of two molded panels surmounted by a molded transom bar and plain wooden transom (no lights). To accommodate the 1½'-2' thickness of the stone walls, the jambs are deep and the door recessed, but the simple surround itself is virtually undifferentiated, about 4" wide and painted white as is the other wood trim on the building. The stucco is, at various points, flaking off the building particularly at the southwest corner beside a short flight of steps.

CE 1006 Hammy Chapel  
top - South & West Facades  
center - South & East Facades  
bottom - South Facade

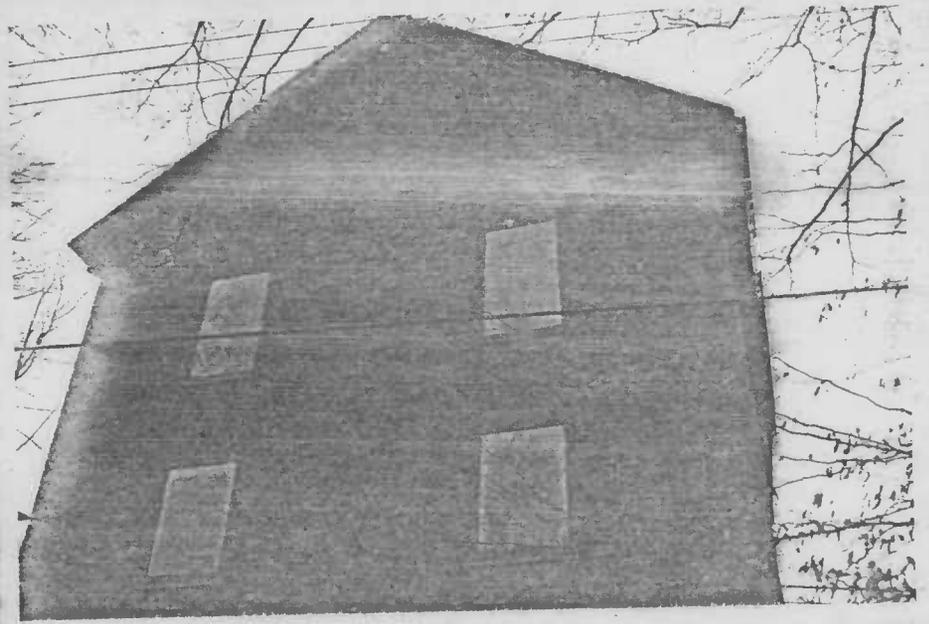
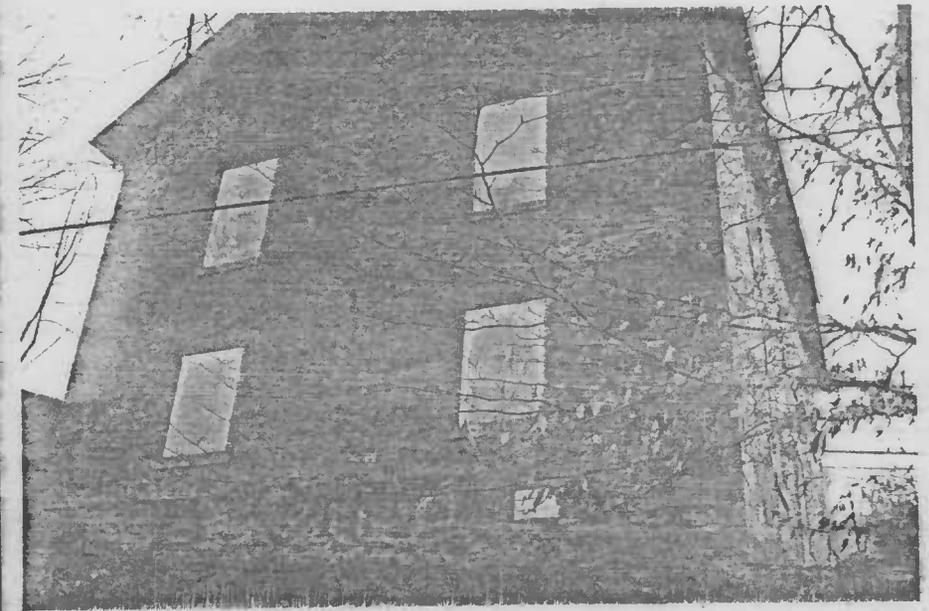
The north gable end which overlooks a precipitous hillside drop contains a pair of windows on both first and second stories evenly disposed on the facade and treated like its counterparts. Several inches below this fenestration is a well-defined water table created out of an increased thickness of stone wall and worked with a chamfered top edge.

top - North Facade

center - North Facade

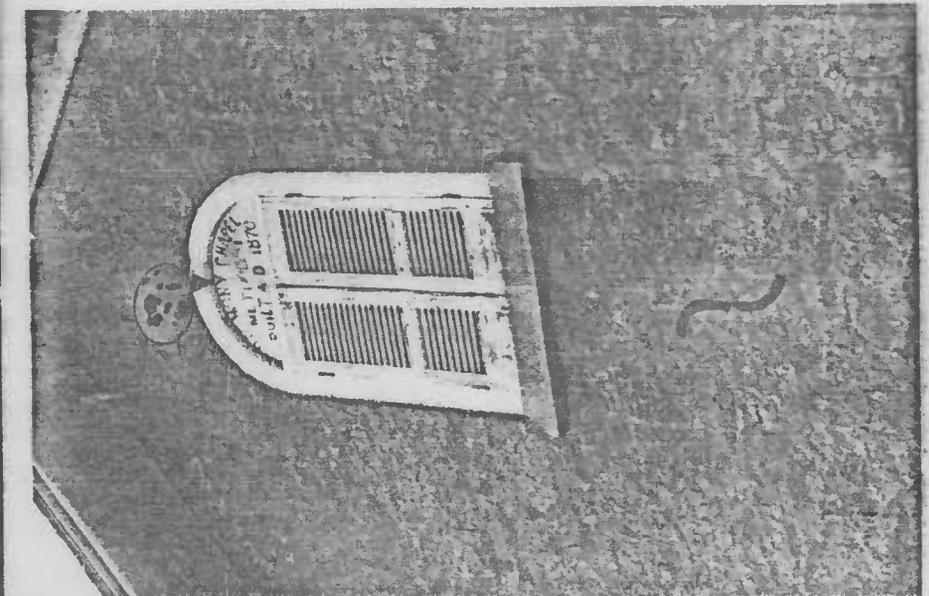
The Old Harmony Methodist Church located in Rowlandsville, is a small parish church built in 1870, according to an inscription which reads "Harmony Chapel, Methodist, AD 1870") in its gable end window above its entrance. Its walls are constructed of rubble fieldstone, quoined in granite at the four corners, and covered with pale ocre stucco on all four sides of the building. The roof has been replaced and resheathed in asphalt shingles and a chimney (containing a stove flue from the basement story) has been re-executed in concrete.

bottom - South Gable - Dated Window

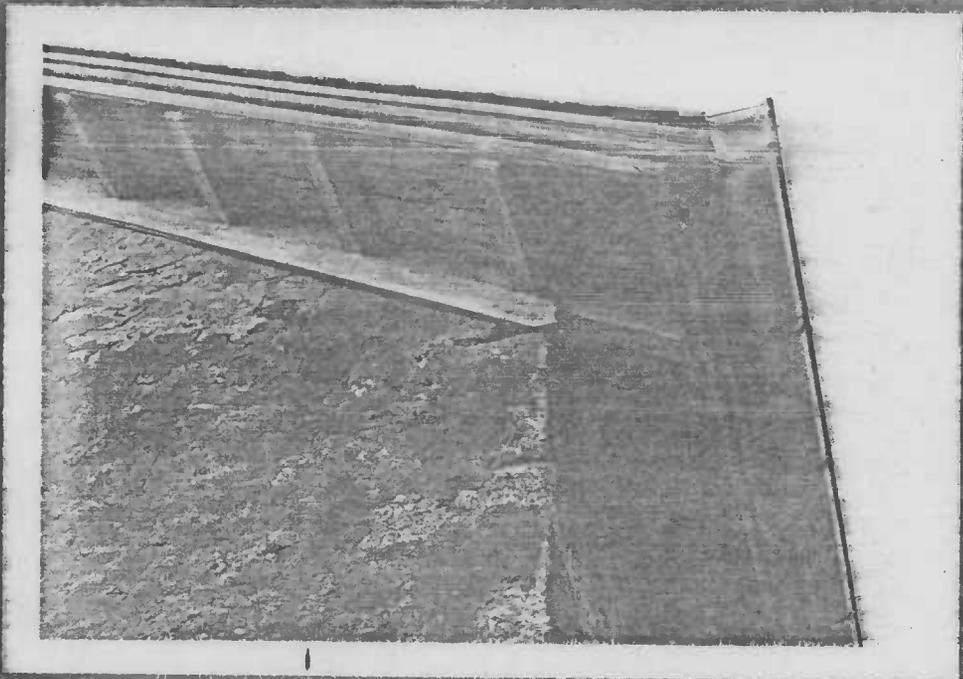
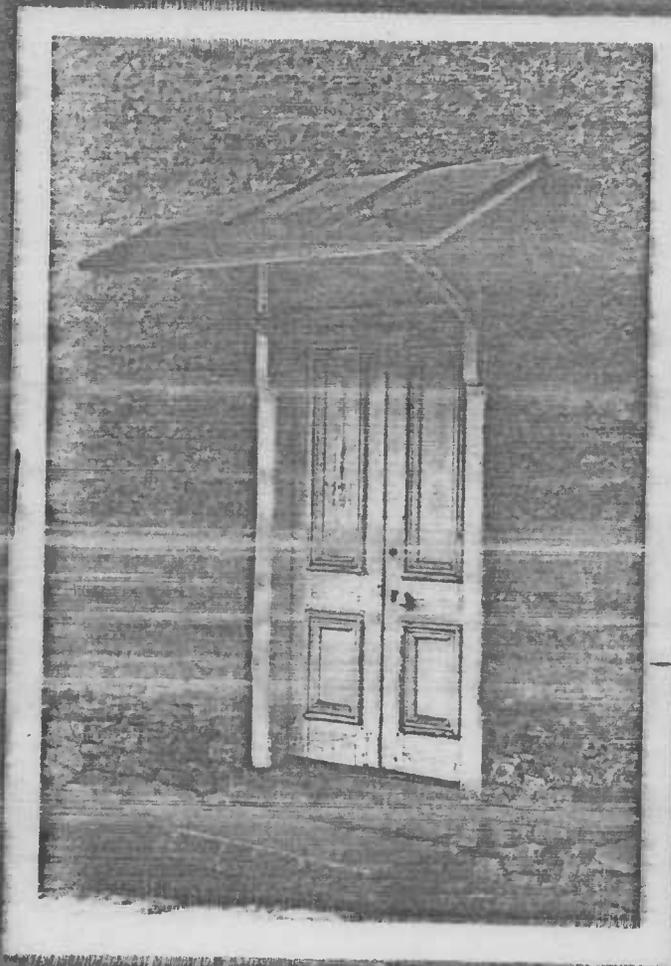
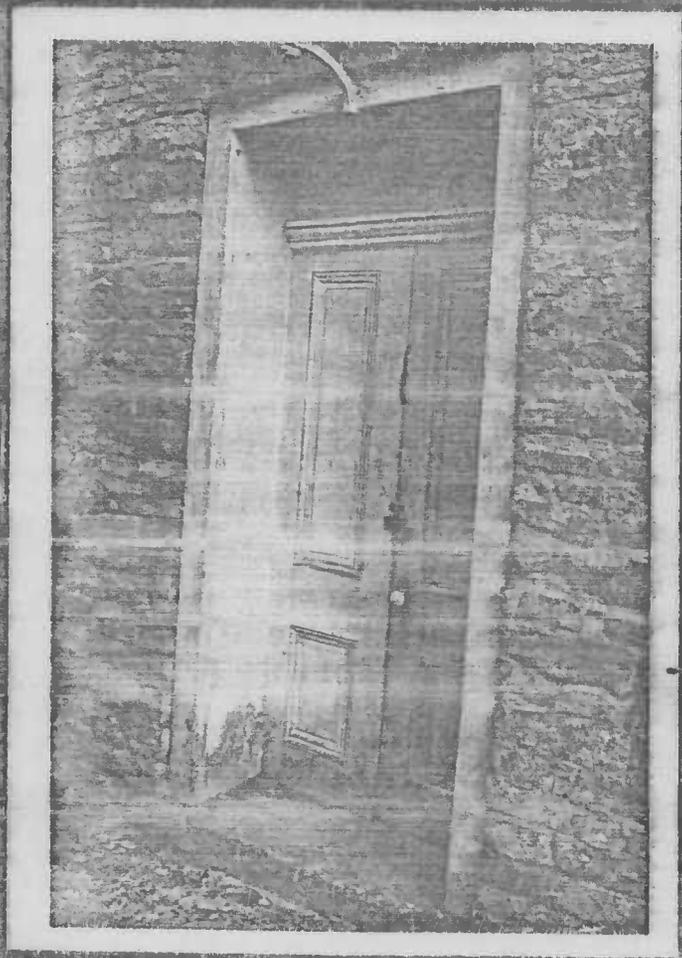
CE 1006 Hammy Chapel  
top - Southeast Corner, Cornice  
bot. left - South Facade, west Double Door  
bot. right - West Facade, Double Door

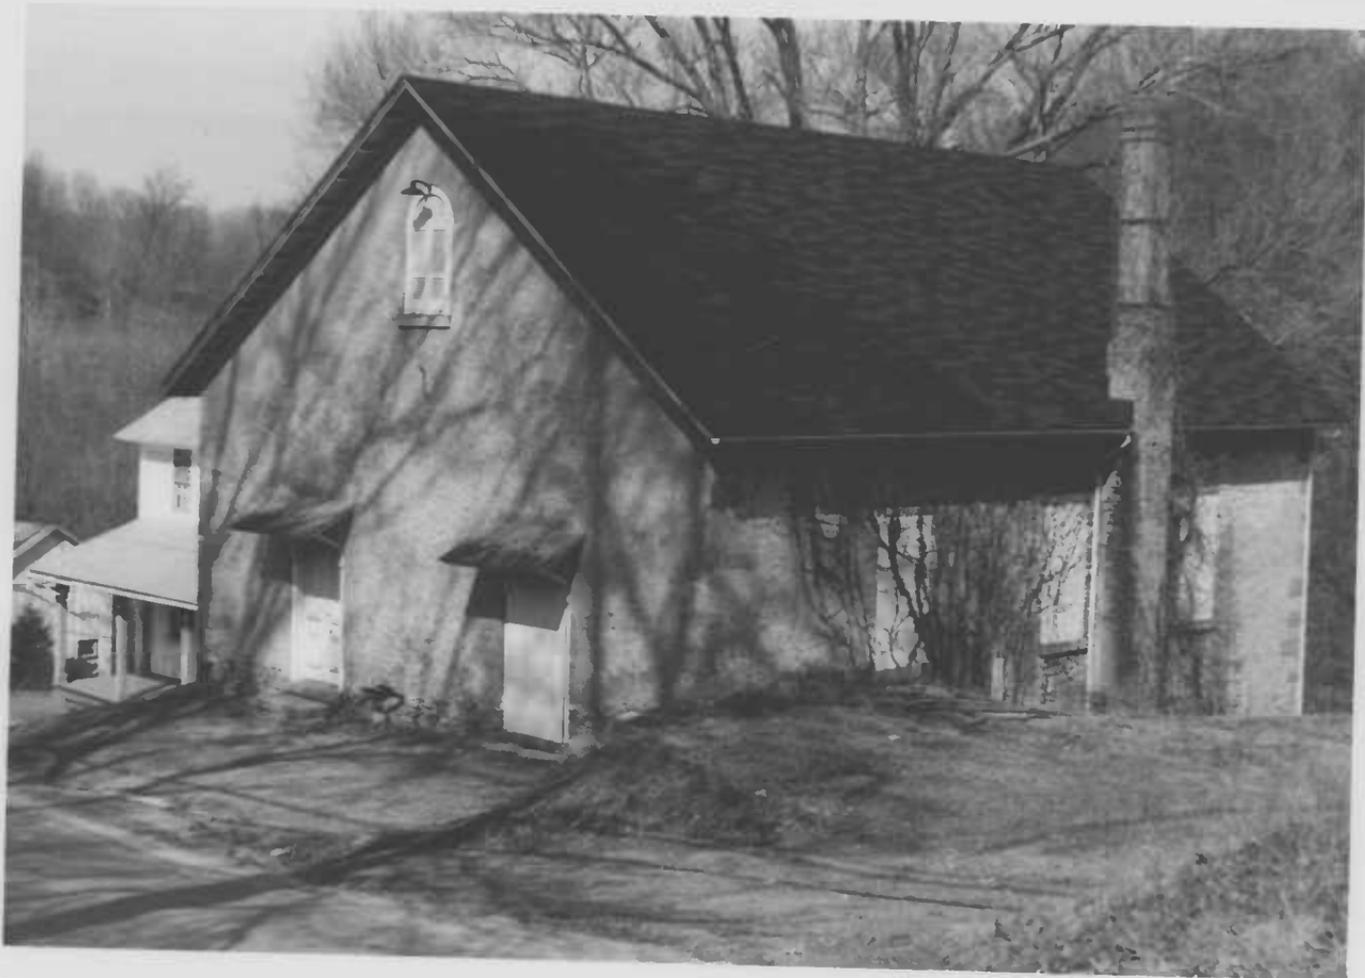
(Old Harmony Methodist CE-1006  
Rowlandsville Church  
Southeast Elevation

This same slope is responsible for creating entry at second story level on the south facade and for about one third of the east facade being obscured by the hillside it is built into. Visible are the three second story windows, identically detailed to those on the opposite side, below which are the northeast corner window and the middle window, half covered. The exterior concrete chimney rises from the basement level between the two windows to a height several feet above the roof.
