MARYLAND HISTORICAL TRUST

INVENTORY FORM FOR STATE HISTORIC SITES SURVEY

"Steel Mount"

Rowland Road 1 mile east of Liberty Grove Road

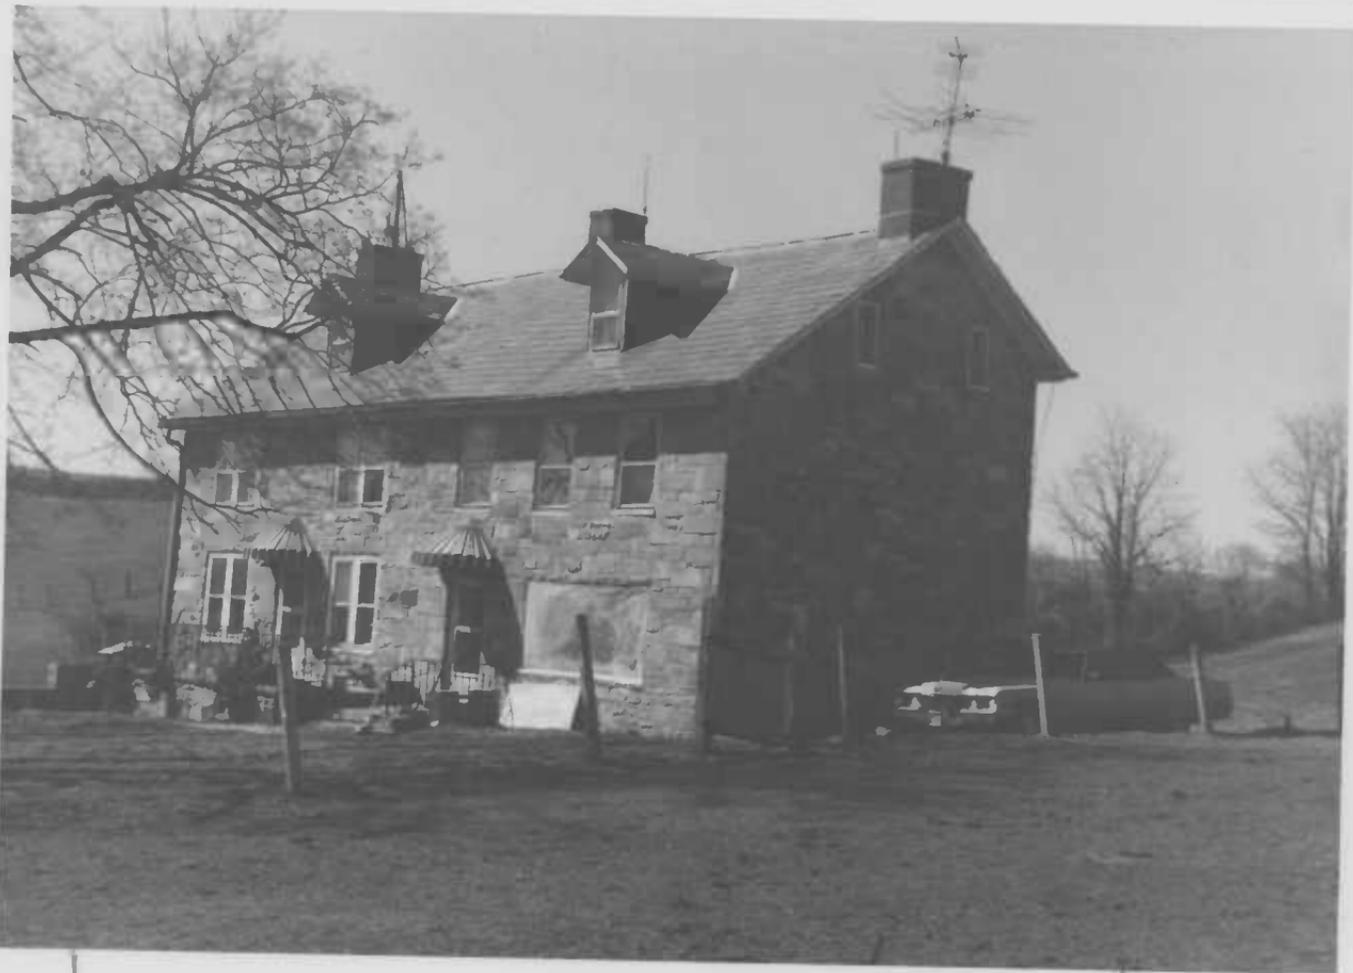
SOUTHEAST ELEV.

The east side is presently six bays across with the earlier mid to late 18th century section to the west. Each section is three bays across. The 18th century house has a central entrance. The flanking windows have been enlarged to a double single pane sash window. The door has been replaced but the four flush paneled reveals remain. A stone keystone arch also remains over the entrance. The second floor windows have been treated in this manner. A boxed cornice does retain its bedmolding which extends across the entire front of the house.

The 1820 side hall/parlor addition has a western bay entrance and an adjacent picture window. The original windows were obviously removed when the larger opening was cut in. Three single pane sash light the second floor. Two single pane sash gabled somer pierce the south sloped and are centered with respect to the entire house. A definite seam is found between the two structures are provides proof of the separate building stages.

The east end wall is primarily stone with two attic windows that flank the chimney. The chimney stack is laid with brick above the roofline. The ends of the roof are extended beyond the wall surface. The depth of the addition is only three quarters of the main block depth so there is a partial north slope to the roof. (see Henry Glassie p. )

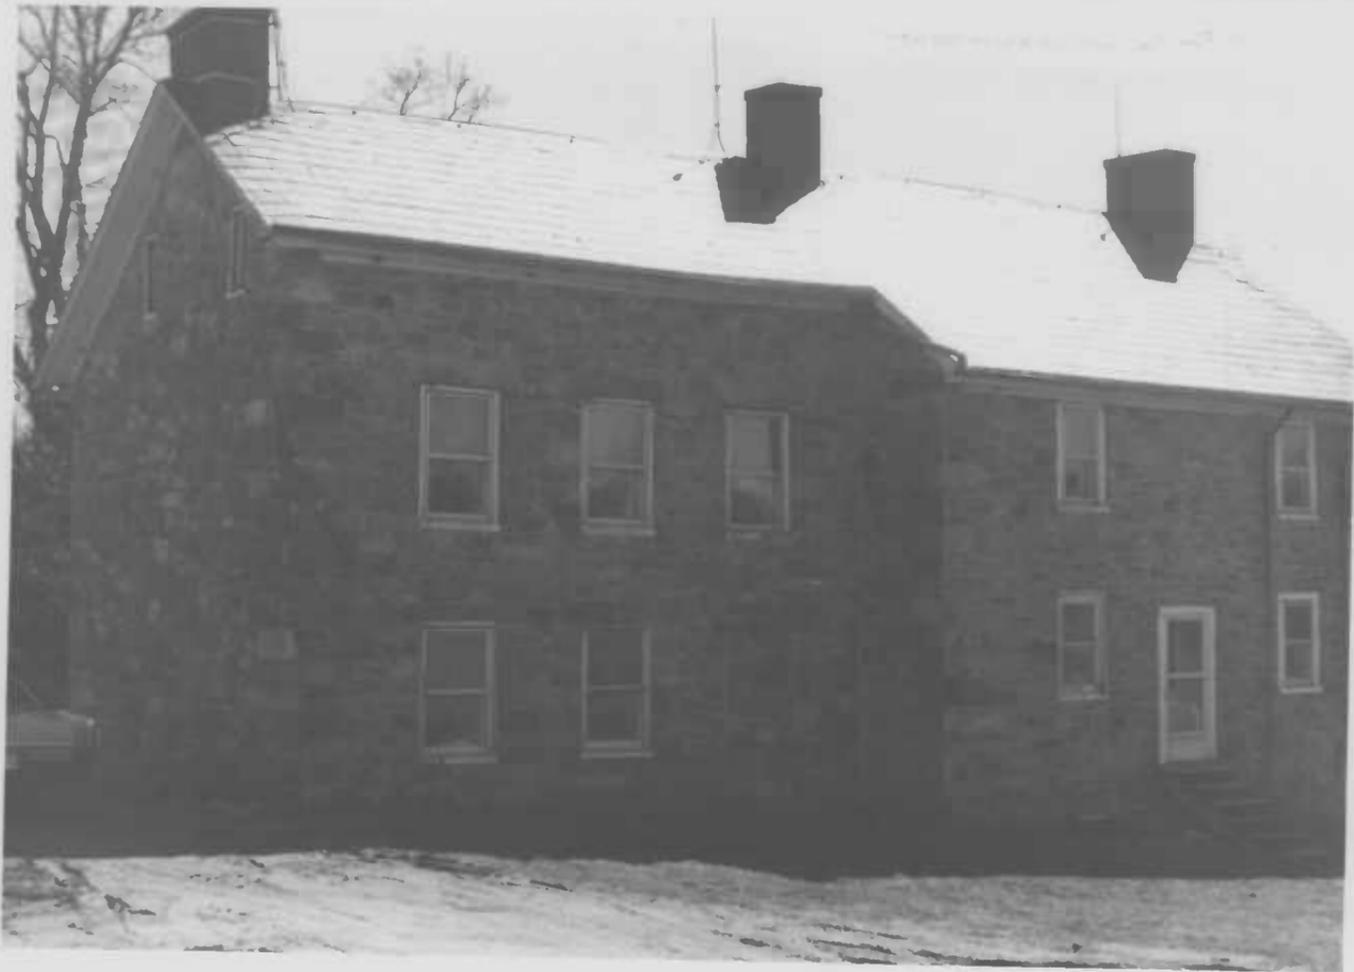
NORTH ELEVATION

The north side of the addition had three openings on each floor but the western most first floor window has been walled in. The sash have also been replaced on this side with single panes. The boxed cornice is the same as the front of the house but not continuous since it is broken by the differences in room depth. A remnant of the beaded bargeboard is visible on the main block east end wall.

The north side of the 18th century house is similar to the front with a central opening that is flanked by single pane sash windows. The entrance retains its two panel (raised) reveals.

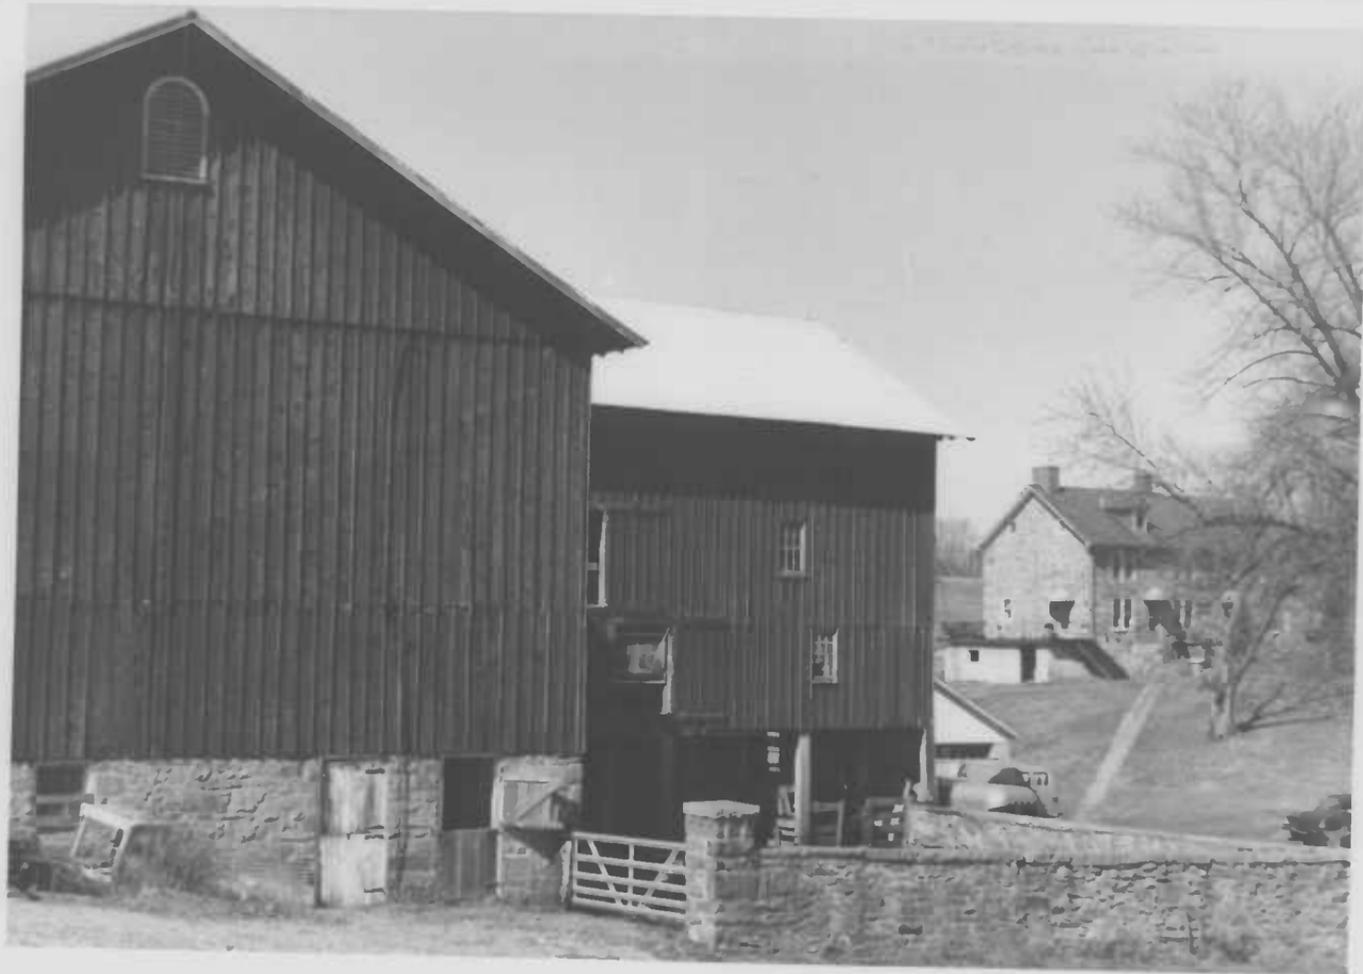
SOUTH ELEVATION OF BARN/HSE  
NR PORT DEPOSIT

The only farm structure that remains from the 19th century is a large timber frame mid 19th century barn with board and batten siding. It rests on a granite and fieldstone foundation.
