Name: New Cut Rd over Mill Pond Stream

Maryland Inventory of Historic Properties  
Historic Bridge Inventory  
Maryland State Highway Administration  
Maryland Historical Trust

SHA No. CE 077 Bridge Name New Cut Road over Mill Pond Stream

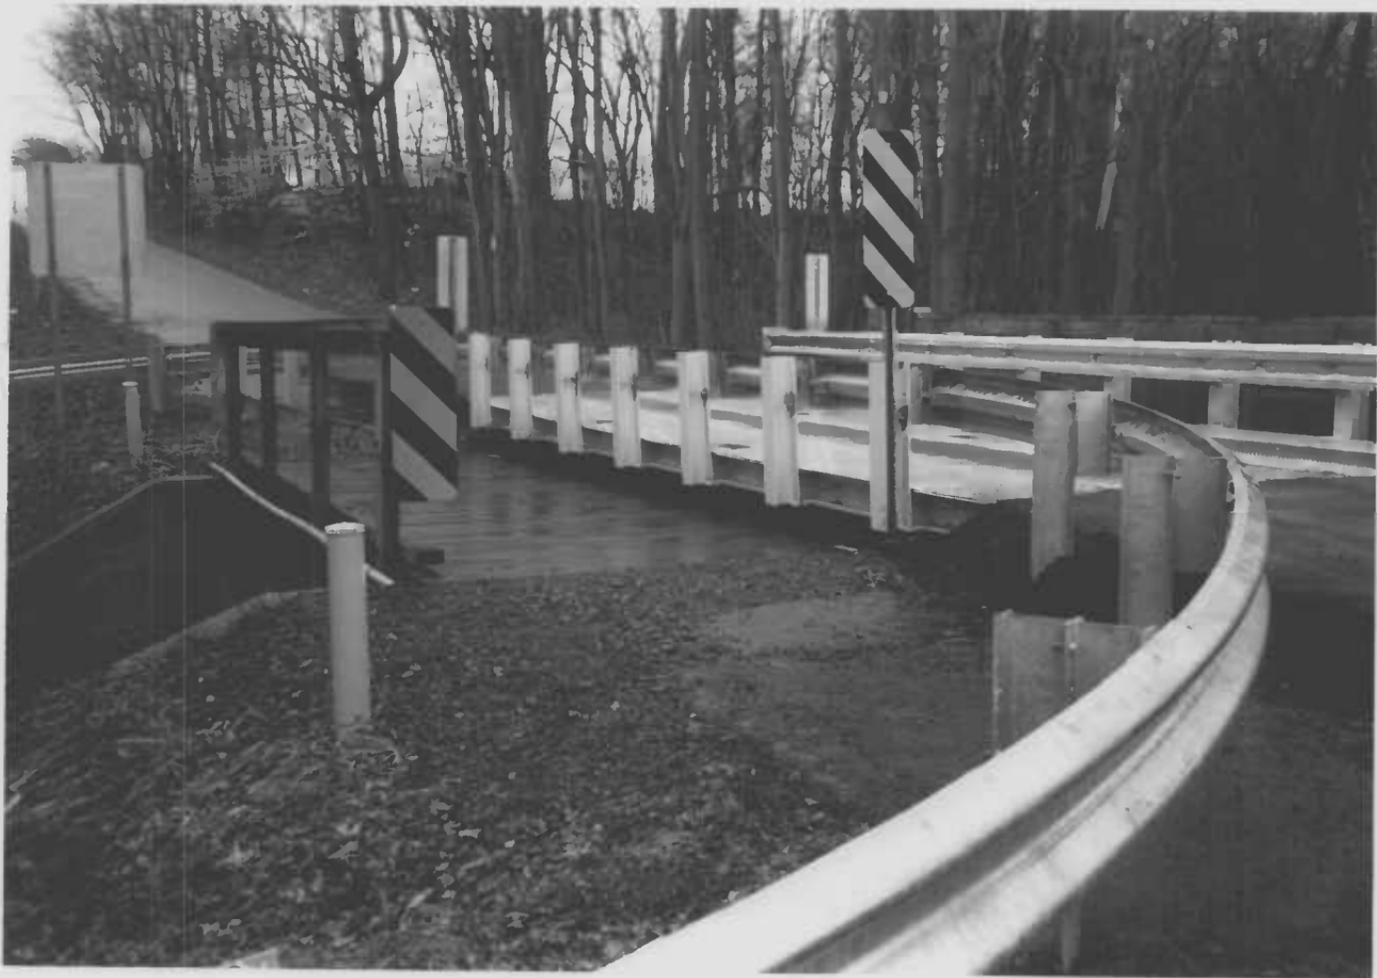
- 1 CE-1486
- 2 New Cut Rd. (Lovers Ln) over Mill Pond Stream
- 3 Cecil Co, MD
- 4 3/98
- 5 Marris German, WMA
- 6 MD SHPO
- 7 Northeast corner looking south
- 8 1 of 6

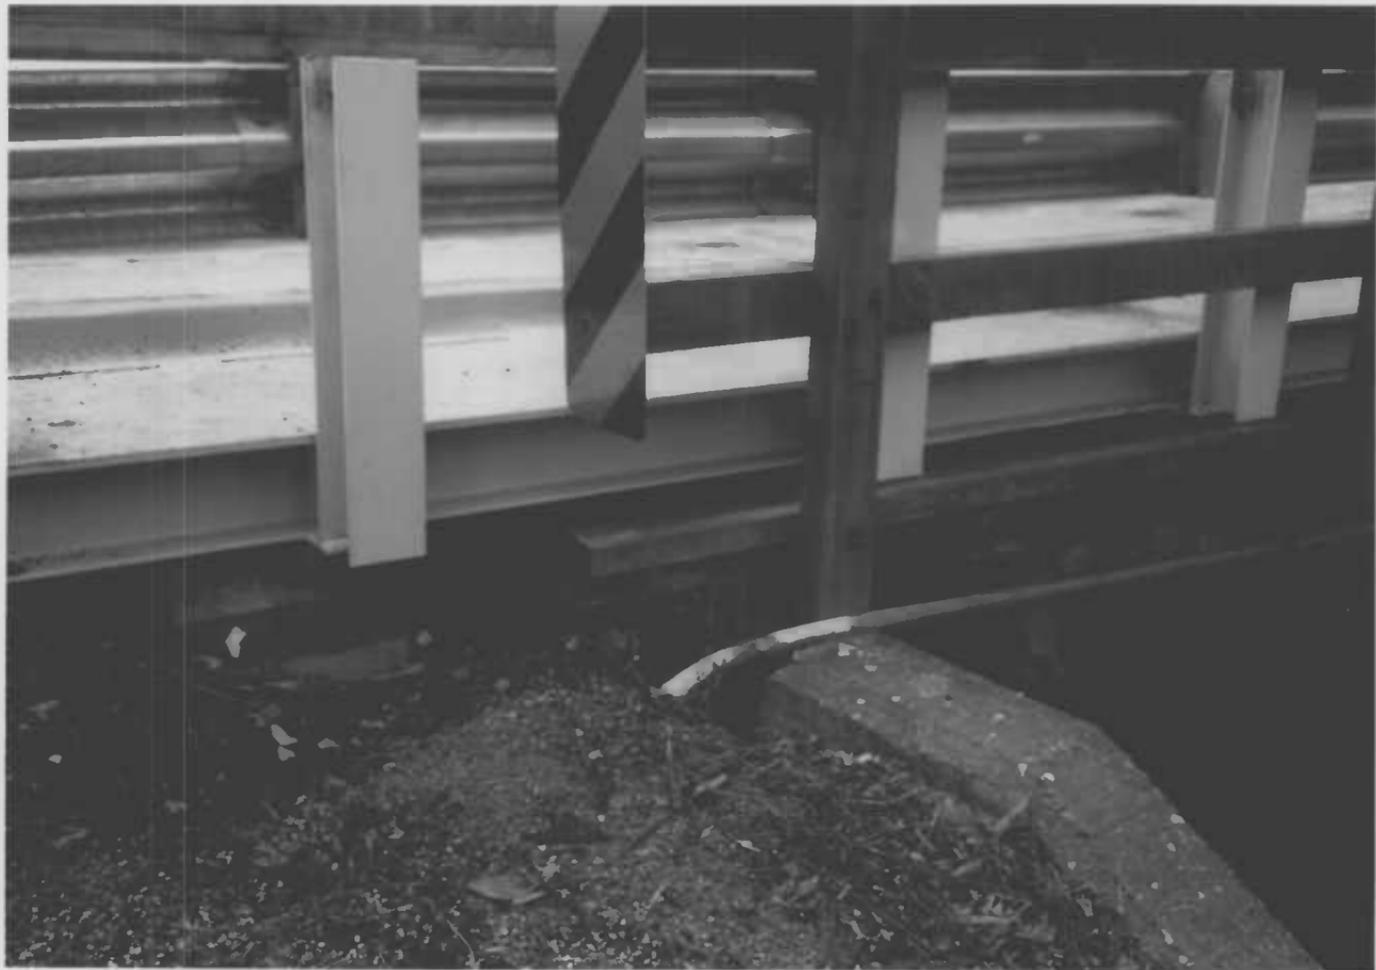
8. 2 of 6

7. Northwest Corner steel structure spanning existing timber

A steel structure has been constructed to span the original timber bridge and is aligned by steel guardrails.

There have been replacements of individual members of the railing and deck planks. These replacements cannot be dated. The repointing of the stone abutments is not dated in the inspection files either. Between 1995 and present, a steel structure was constructed which spans the timber structure and metal guardrails were added to the bridge.

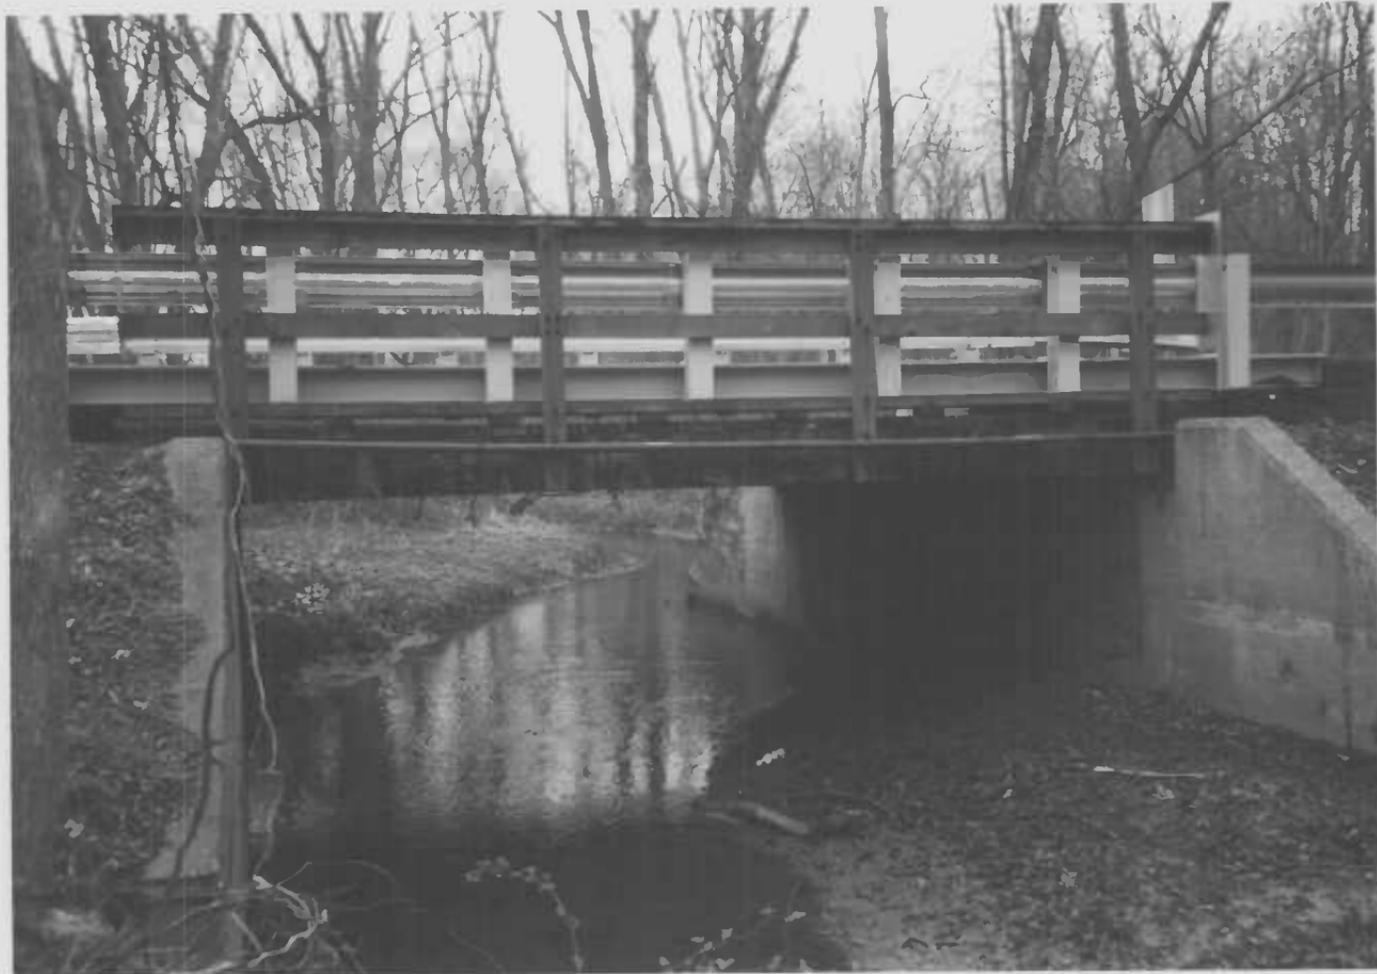
8. 3 of 6

7. Elevation looking upstream

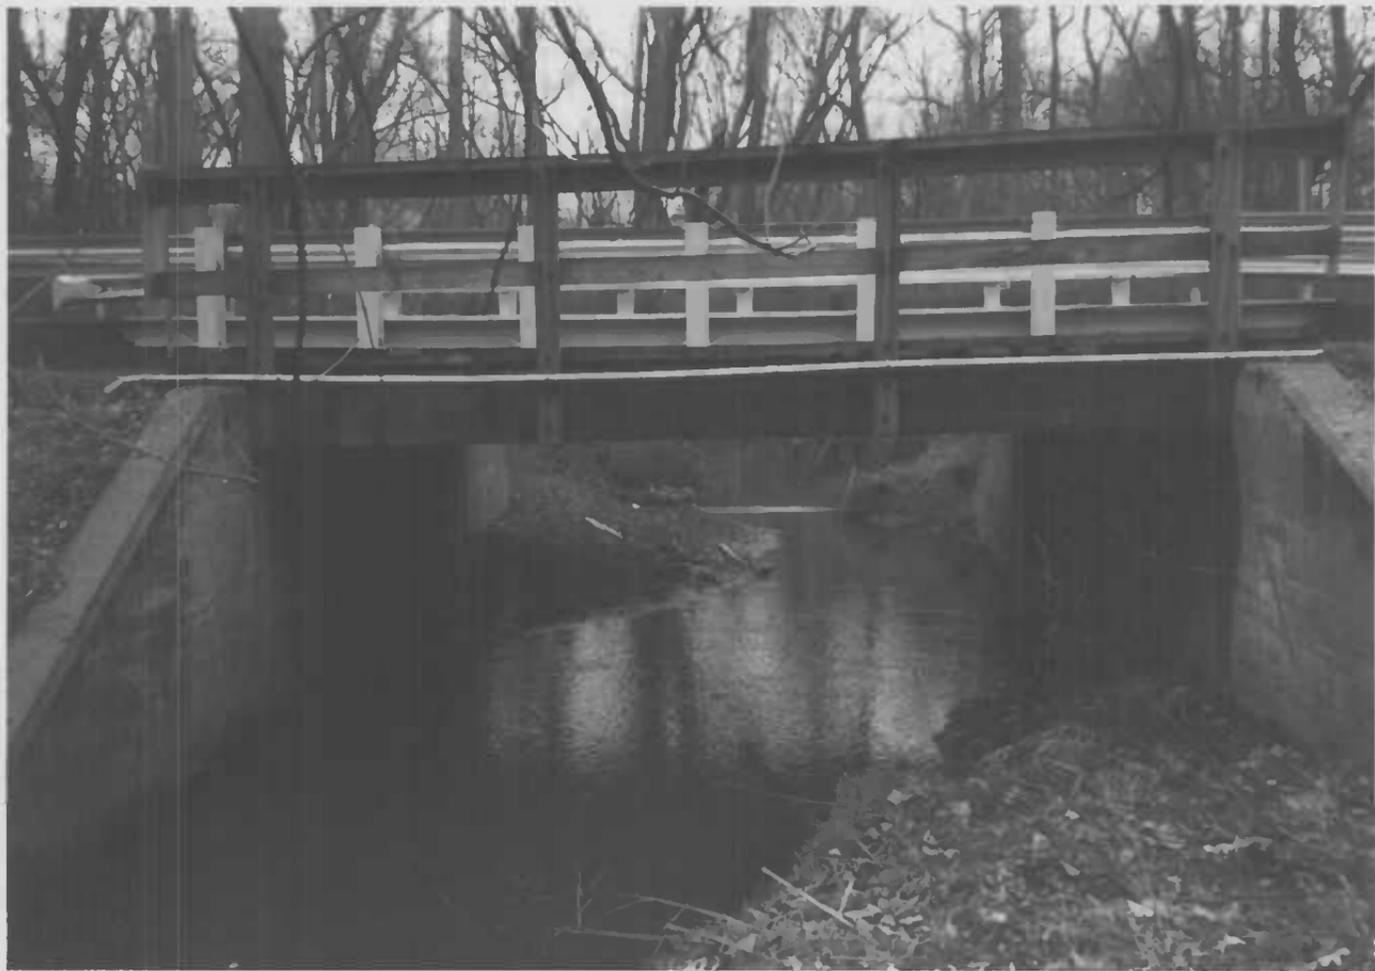
- 1 CE-1486
- 2 New Cut Rd (Lovers Ln) over Mill Pond Stream
- 3 Cecil Co, MD
- 4 3/98
- 5 Marris German, MD
- 6 MD SHPO
- 7 Elevation looking downstream
- 8 4 of 6

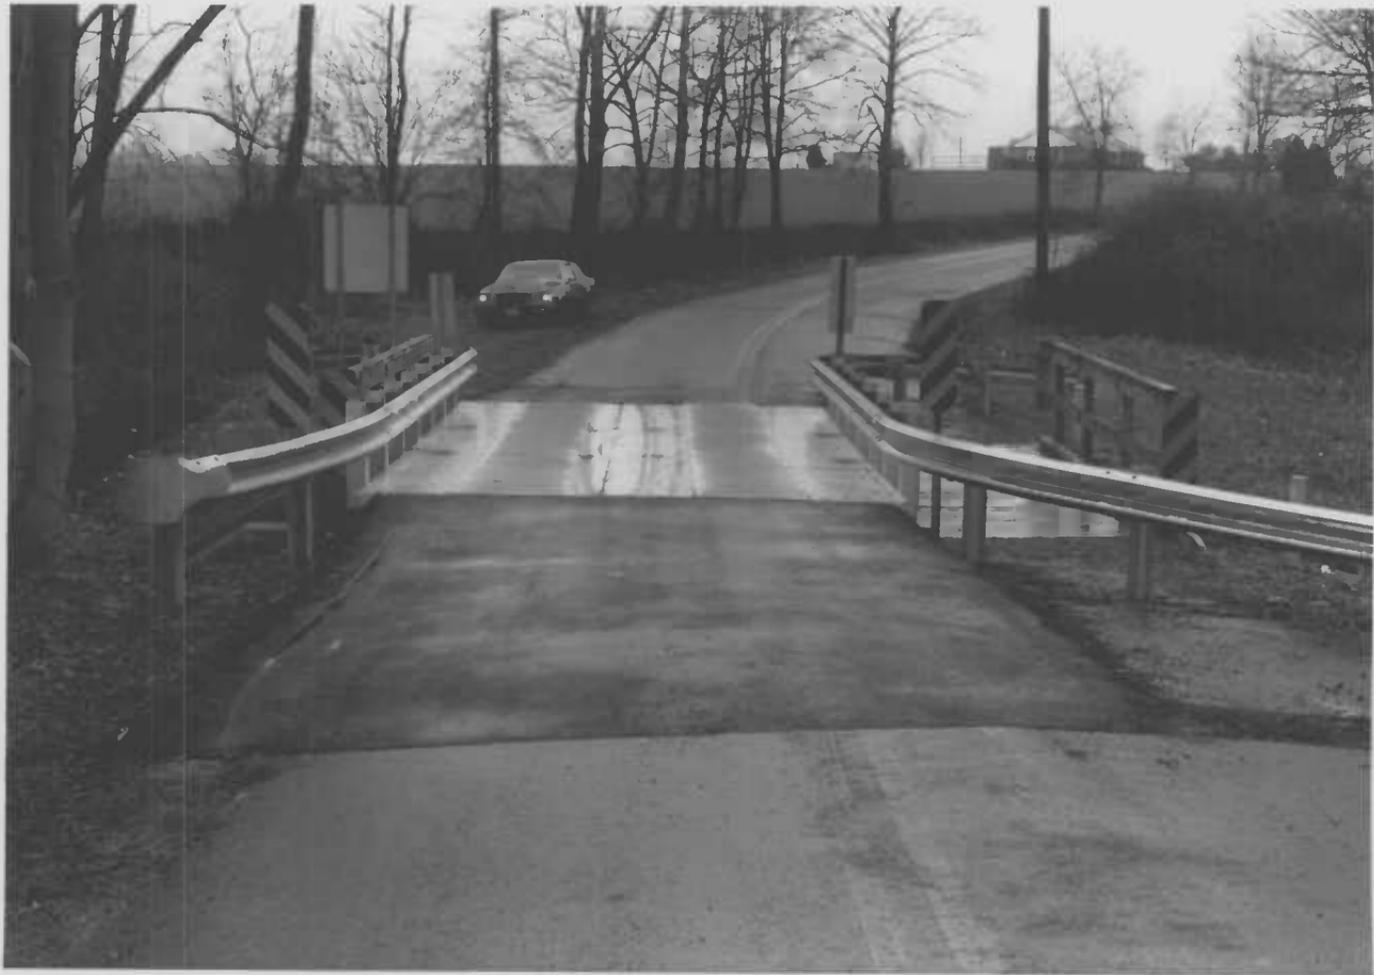
- 1 CE-1486
- 2 New Cut Rd (Lovers Ln) over Mill Pond Stream
- 3 Cecil Co., MD
- 4 3/98
- 5 Marris German WMA
- 6 MD STPO
- 7 Looking North
- 8 5 of 6

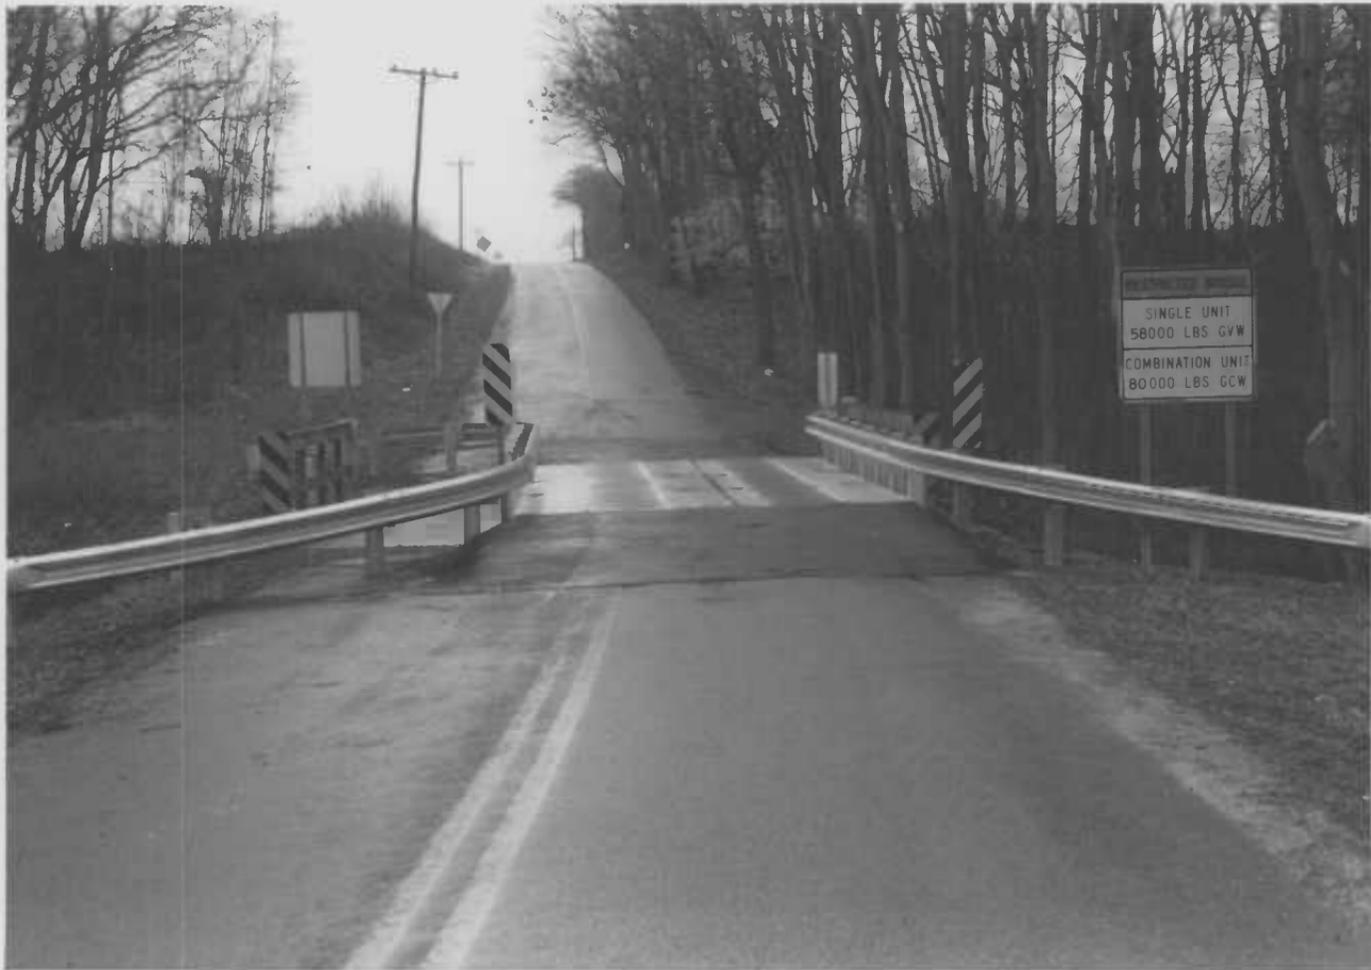
RESTRICTED BRIDGE

SINGLE UNIT
58000 LBS GVW
COMBINATION UNIT
80000 LBS GCW

- 1 CE-1486
- 2 New Cut Rd (Covers Ln) over Mill Pond Stream
- 3 Cecil Co., MD
- 4 3/98
- 5 Morris German (NMA)
- 6 MD SHPO
- 7 Looking South
- 8 6 of 6
