CH - 310
ROSS-HANCOCK HOUSE (ruin)
Grayton vicinity
Private

INVENTORY FORM FOR STATE HISTORIC SITES SURVEY

HISTORIC ROSS-HANCOCK HOUSE (RUIN)
AND/OR COMMON

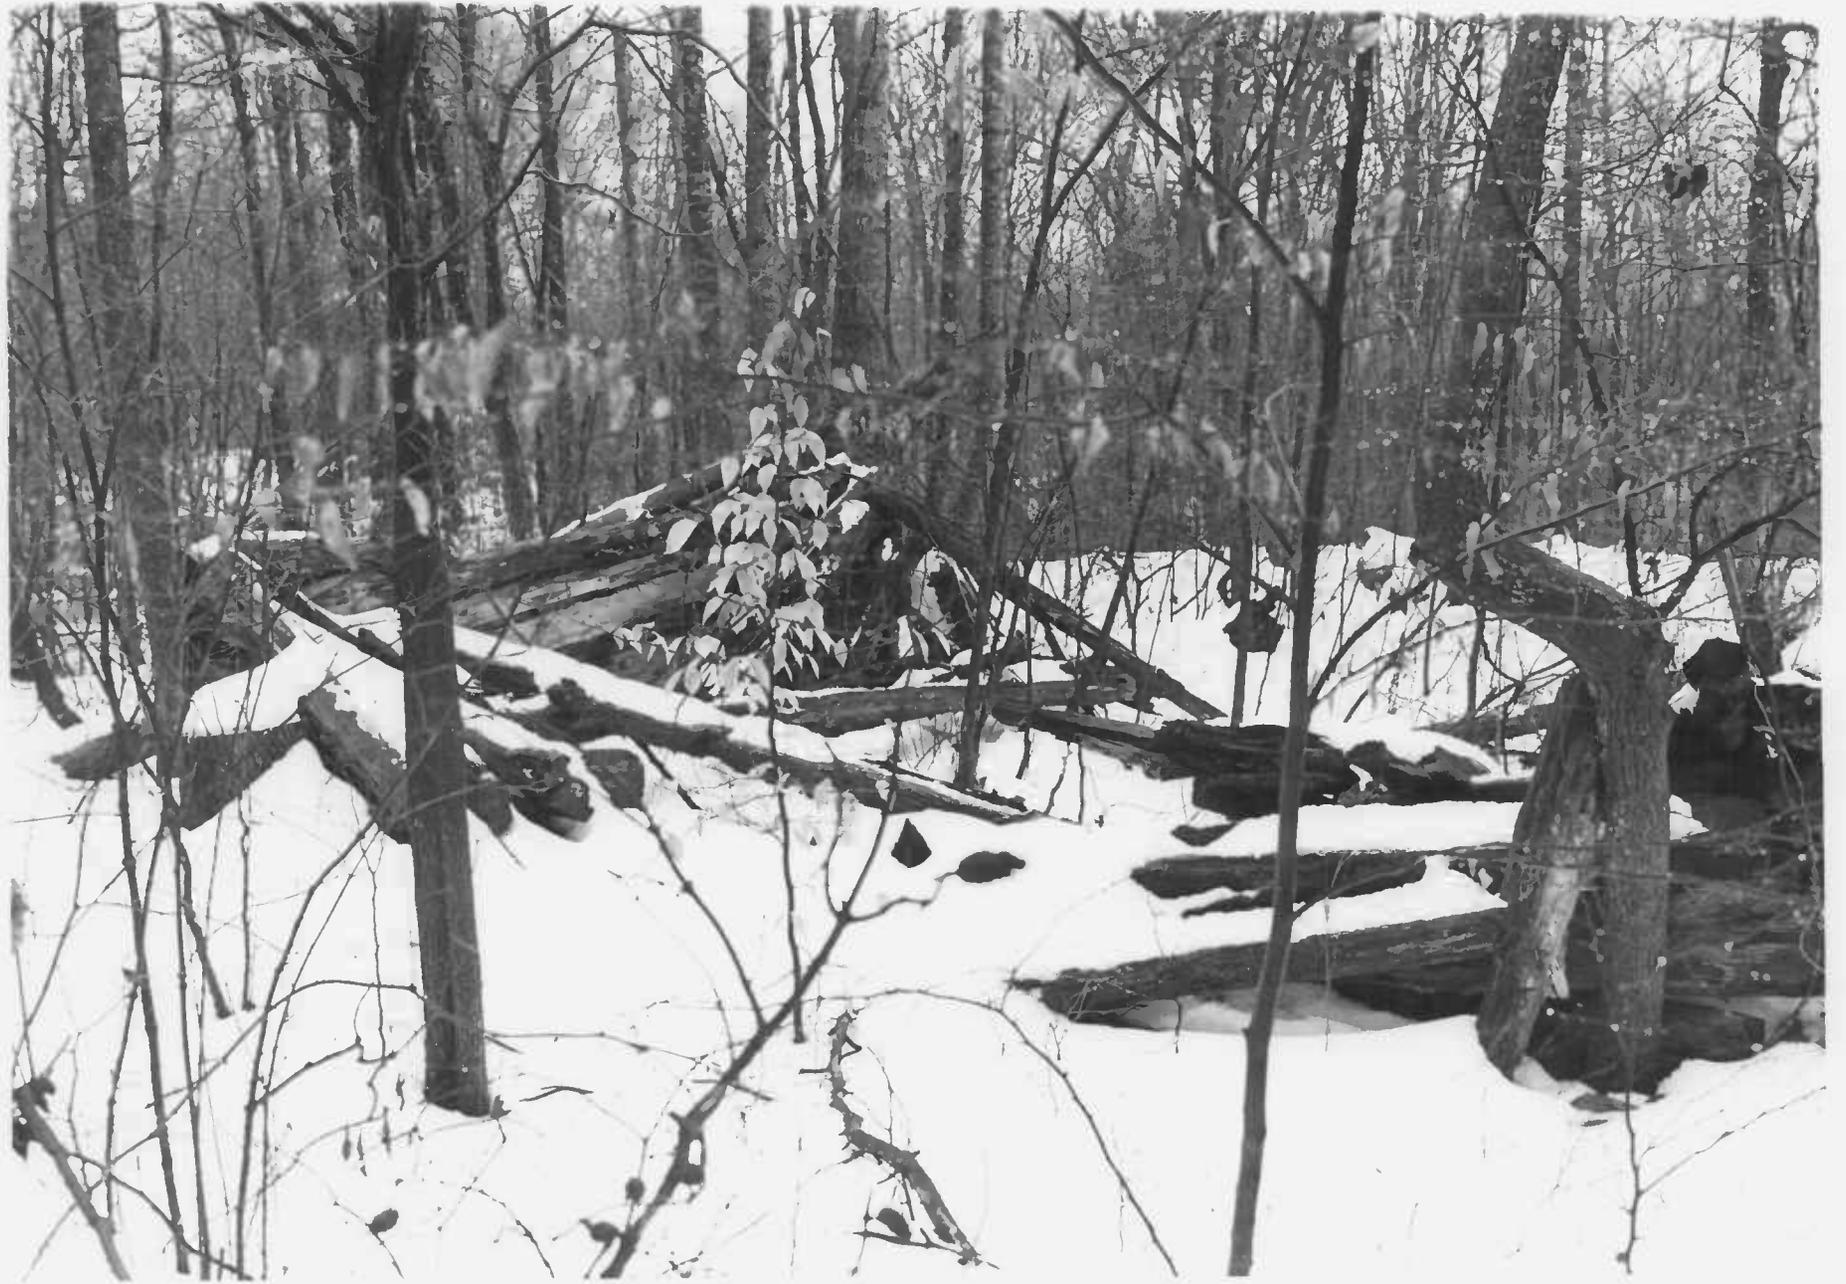
Ross - Hancock House
Nanjemoy, Md.
South Side

Due to the completely ruinous condition of this house, much of the information about its original design and construction could not be seen and was provided by William Digges, the black oral informant in Charles County who took me to the site and who came here often as a child to play with the Hancock family who lived here. According to him, this small log house consisted of two rooms: one up and one down. The house faced south. Into its facade opened one door located in the center. There was only one window in the entire house, located in the eastern gable end. Outside of the opposite gable end ascended a log chimney originally, which was later replaced by a brick chimney, according to Digges. The log walls were unsheathed on the exterior, heavily chinked with mud, and the sills laid directly on the ground. The corners were half dove-tailed, a type of notching that is not unusual in this area, though V notching is more common. To hold and brace the walls more securely, the logs were fastened to one another by pegs running vertically through the center of the logs. In St. Mary's County log posts are often found pegged to the log walls for the same purpose.

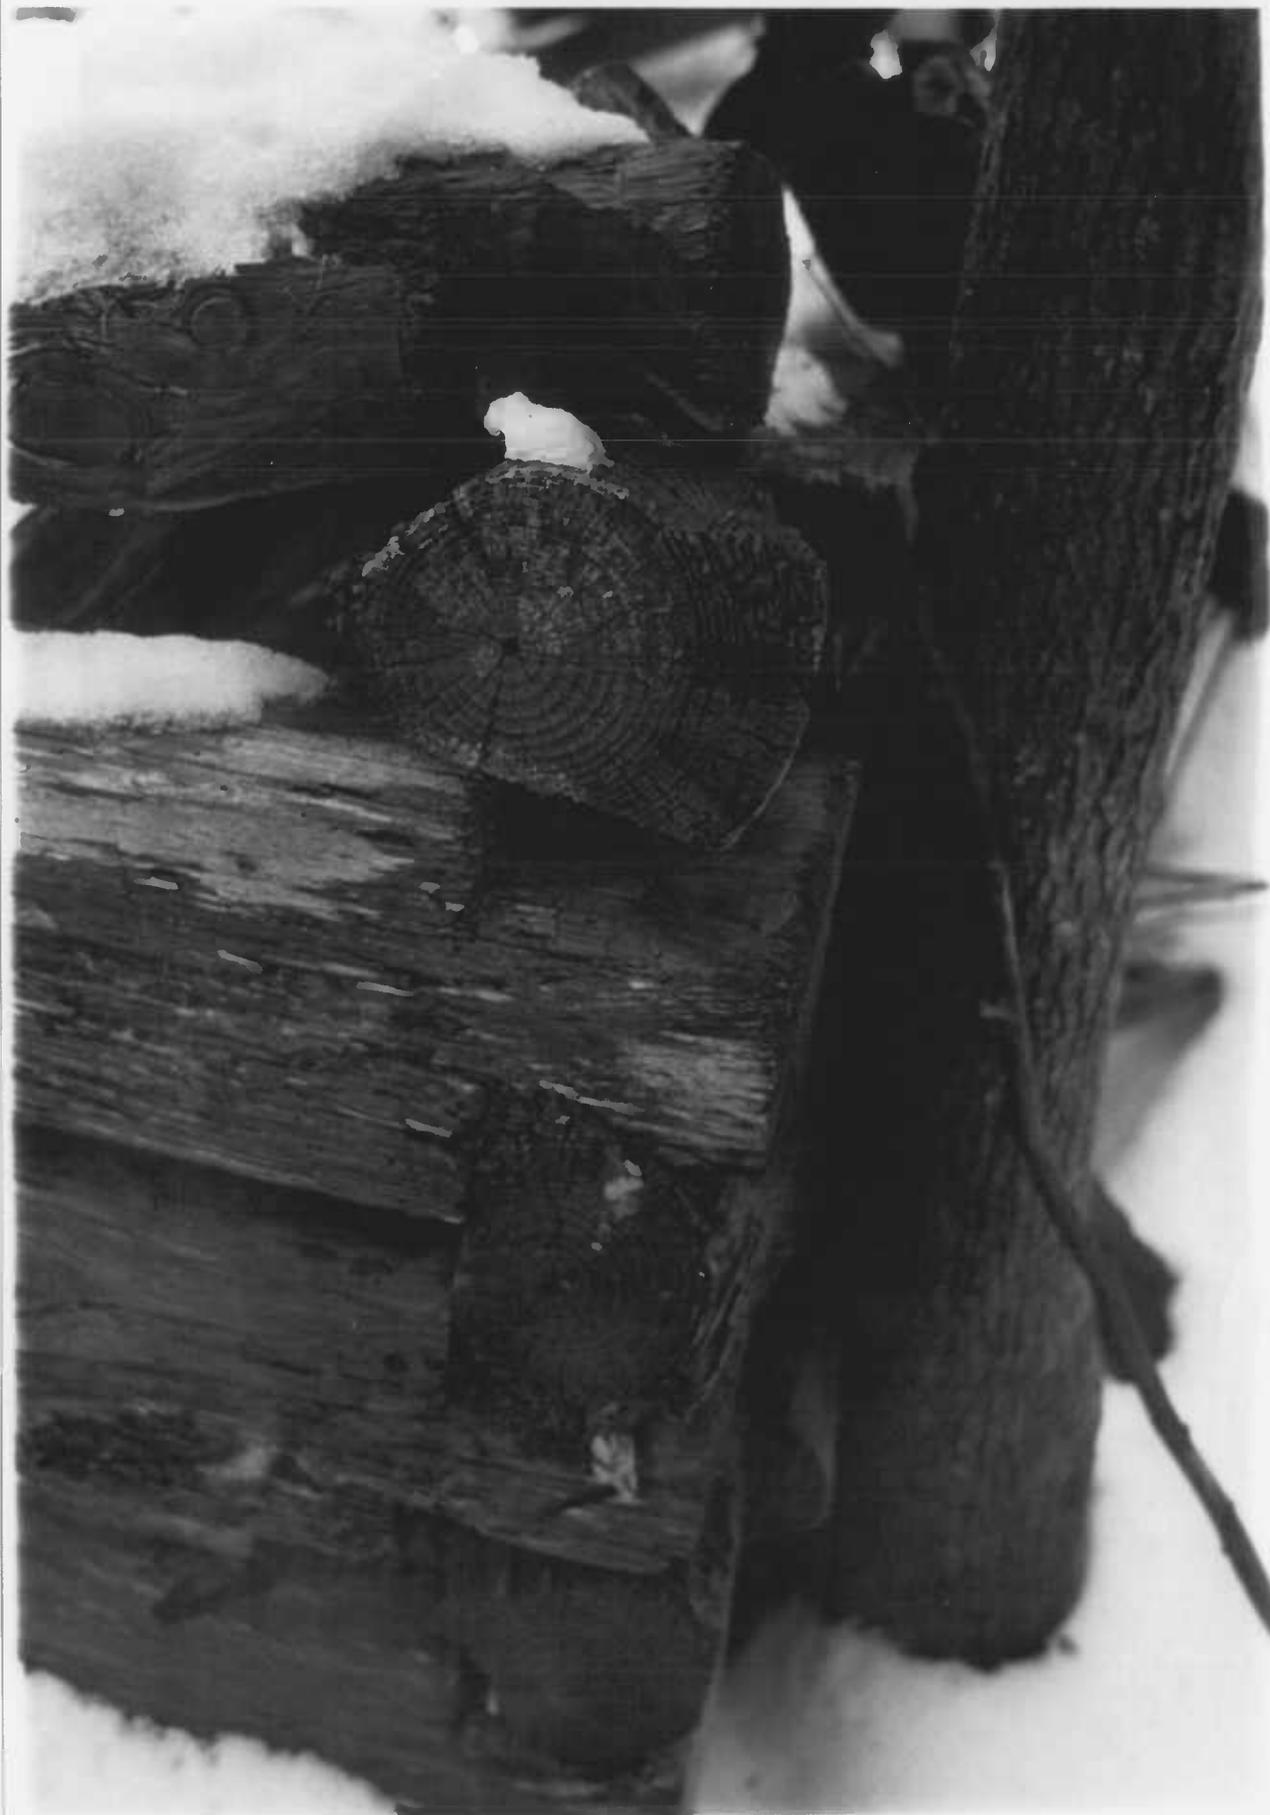
ROSS-HANCOCK HOUSE
NANJEMOY, MD.

NORTHEAST CORNER
