CARR-115  
John Hiner Farm  
Taneytown (vicinity)

c. 1808-1835

# Maryland Historical Trust State Historic Sites Inventory Form

historic John Hiner Farm

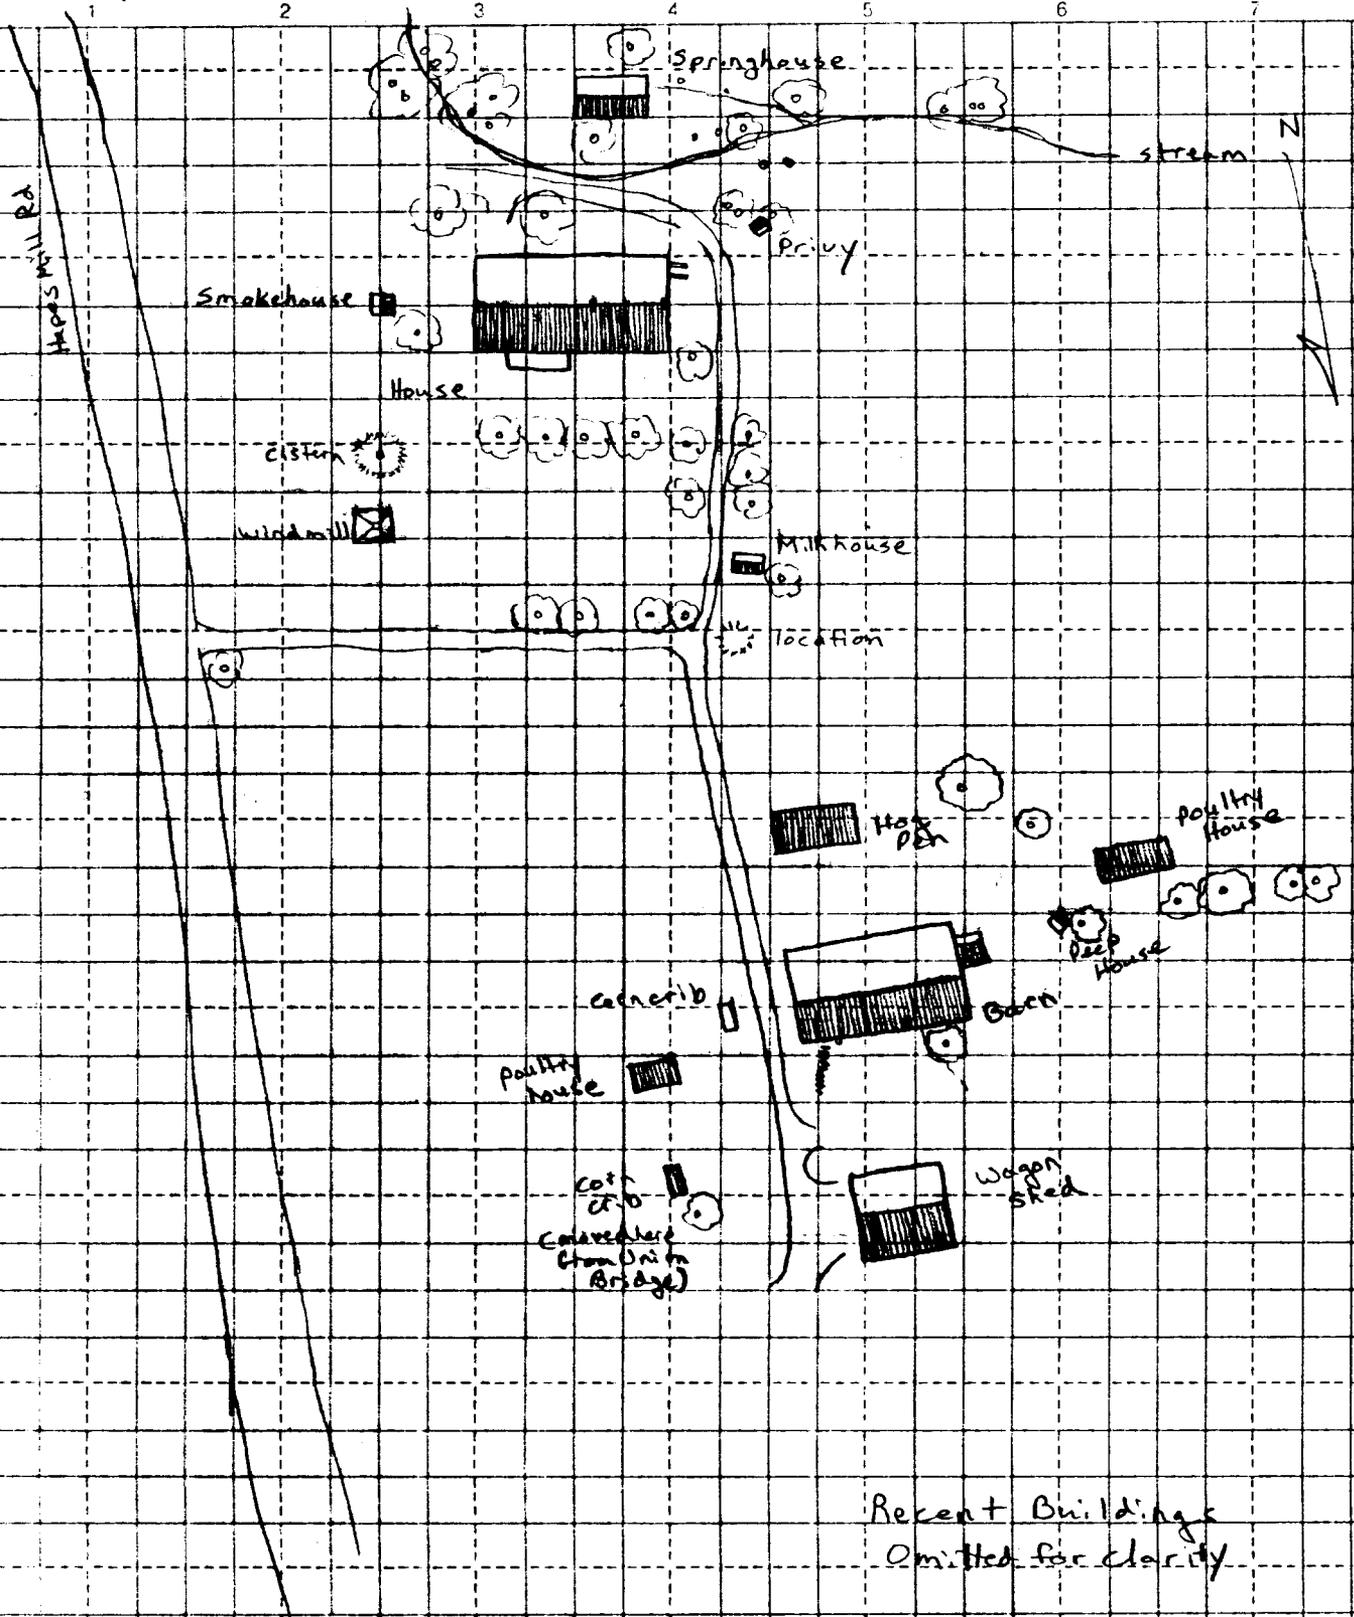
1250 Hapes Mill Rd  
Site Plan

Recent Buildings  
Omitted for clarity

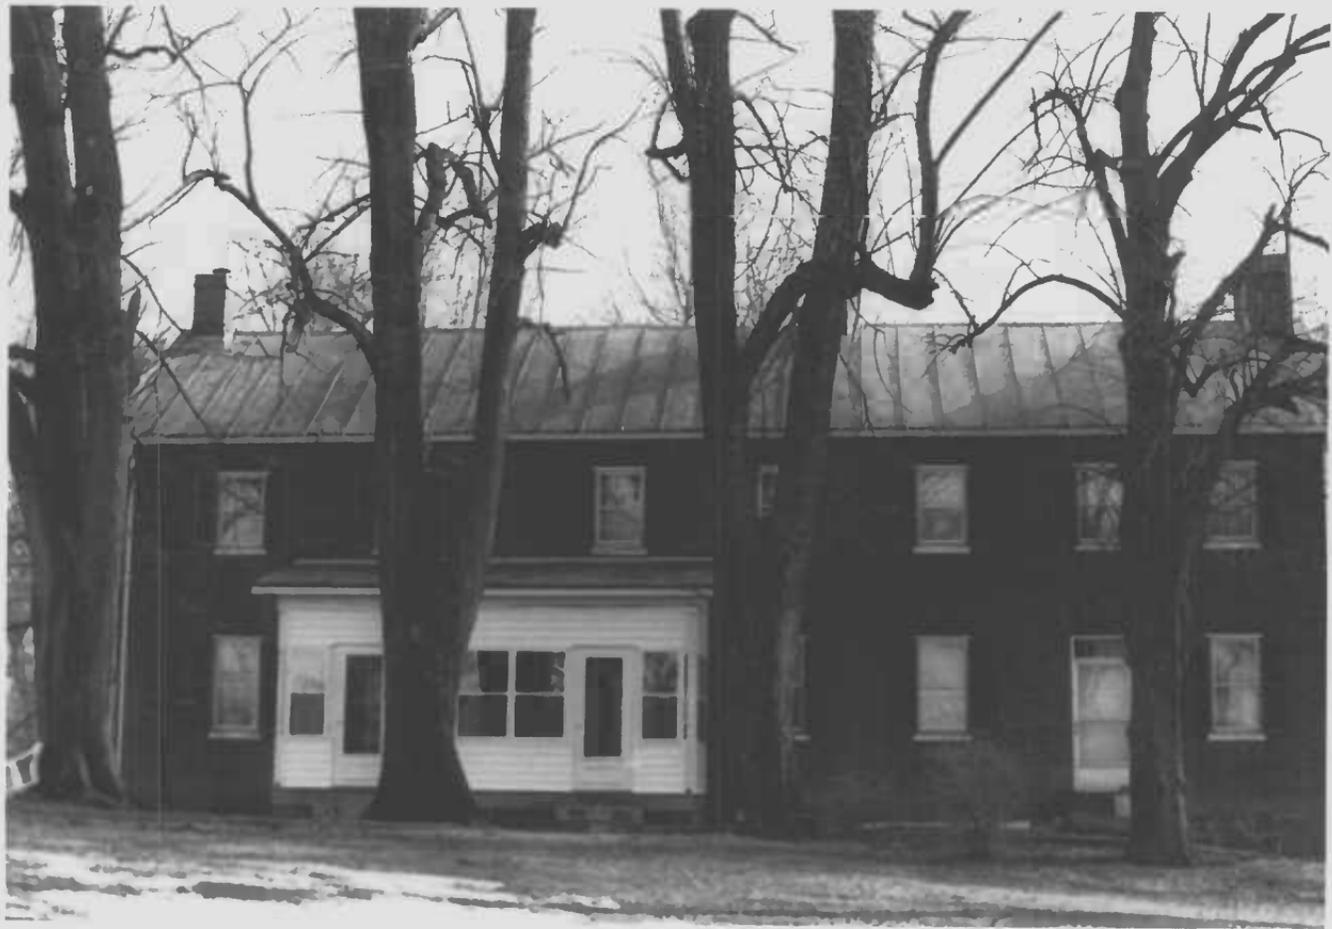
1/11

house - north elevation

The north elevation, on the first story, has in the east bay a 1/1 sash with a wood sill, splayed brick jack arch, a mortised-and-tenoned-and-pegged frame with a beaded interior edge, and blinds. Proceeding westward there is a six-panel door, two of which are now glazed, with sunk fielded panels that have ogee panel moulds. It has a stone sill, a beaded-interior-edge frame with pegged mortise-and-tenon joints, a plain headrail, a four-light transom, and a splayed brick jack arch. West of this is an eight-panel door with sunk fielded panels, two of which have been replaced by glazing, and ogee panel moulds. There is a wood sill, a mitered frame with a beaded interior edge, a Greek-profile ogee on the headrail, a four-light casement transom, and a splayed brick jack arch. Further west are two 1/1 sash with the same details as the east bay. West of this is an eight-panel door with sunk fielded panels and ogee moulds. The frame is mitered and has a beaded interior edge. The headrail has a Greek-profile ogee, with a four-light transom above. In the west bay is another typical 1/1 sash. There is a new, two-bay, one-story porch with turned posts, that has recently been enclosed, in the two bays with doors between the east and center bays. The second story has seven 6/6 sash, with the same details as those on the first story. The cornice has one course of corbelled brick, with two corbelled dogtooth courses above.

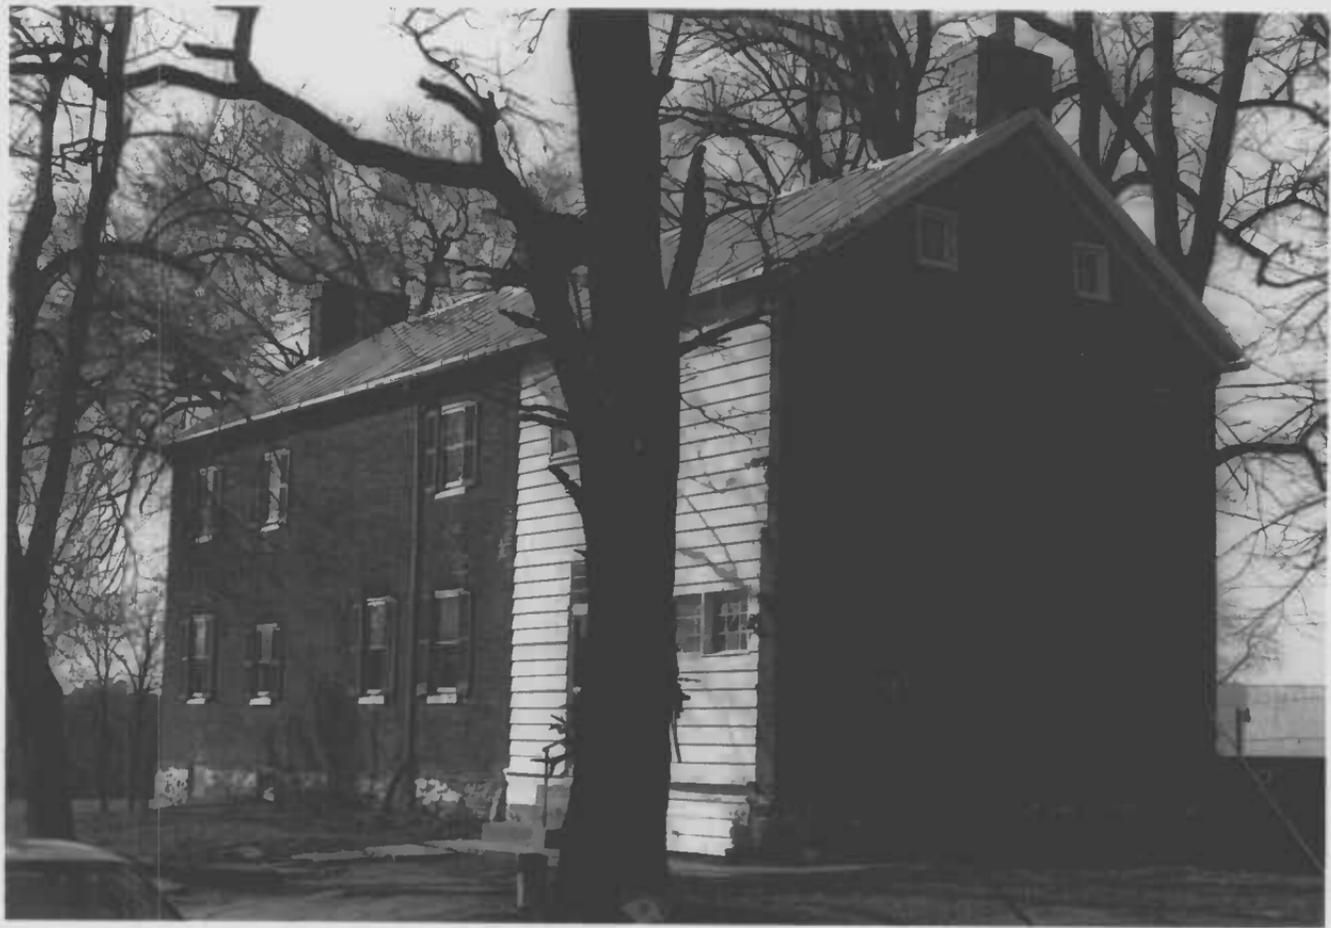
2/11

House - south & east elevations

The south elevation has a diamond-in-section wood vent in a pegged mortise-and-tenon frame in each of the two west bays of the foundation. The first story has, from west to east, a typical 1/1, a shorter, but otherwise typical 1/1, no opening, two typical 1/1, and a two-bay enclosed porch under the roof of the house. The eastern wall is brick three wythes thick. The original recessed brick wall has a one-light over two-panel door to the west, with sunk, fielded panels that have ogee moulds. The pegged mortise-and-tenon frame has a beaded interior edge. To the east is a 6/1 sash in a pegged mortise-and-tenon frame, with a wood sill and a splayed brick jack arch. The chamfered porch posts survive behind the later infill, but the hand rails and balusters have been removed. The second story has, from west to east, two typical 6/6, two bays with no openings, a typical 6/6, and a two-bay enclosed porch with a brick wall at the end of two

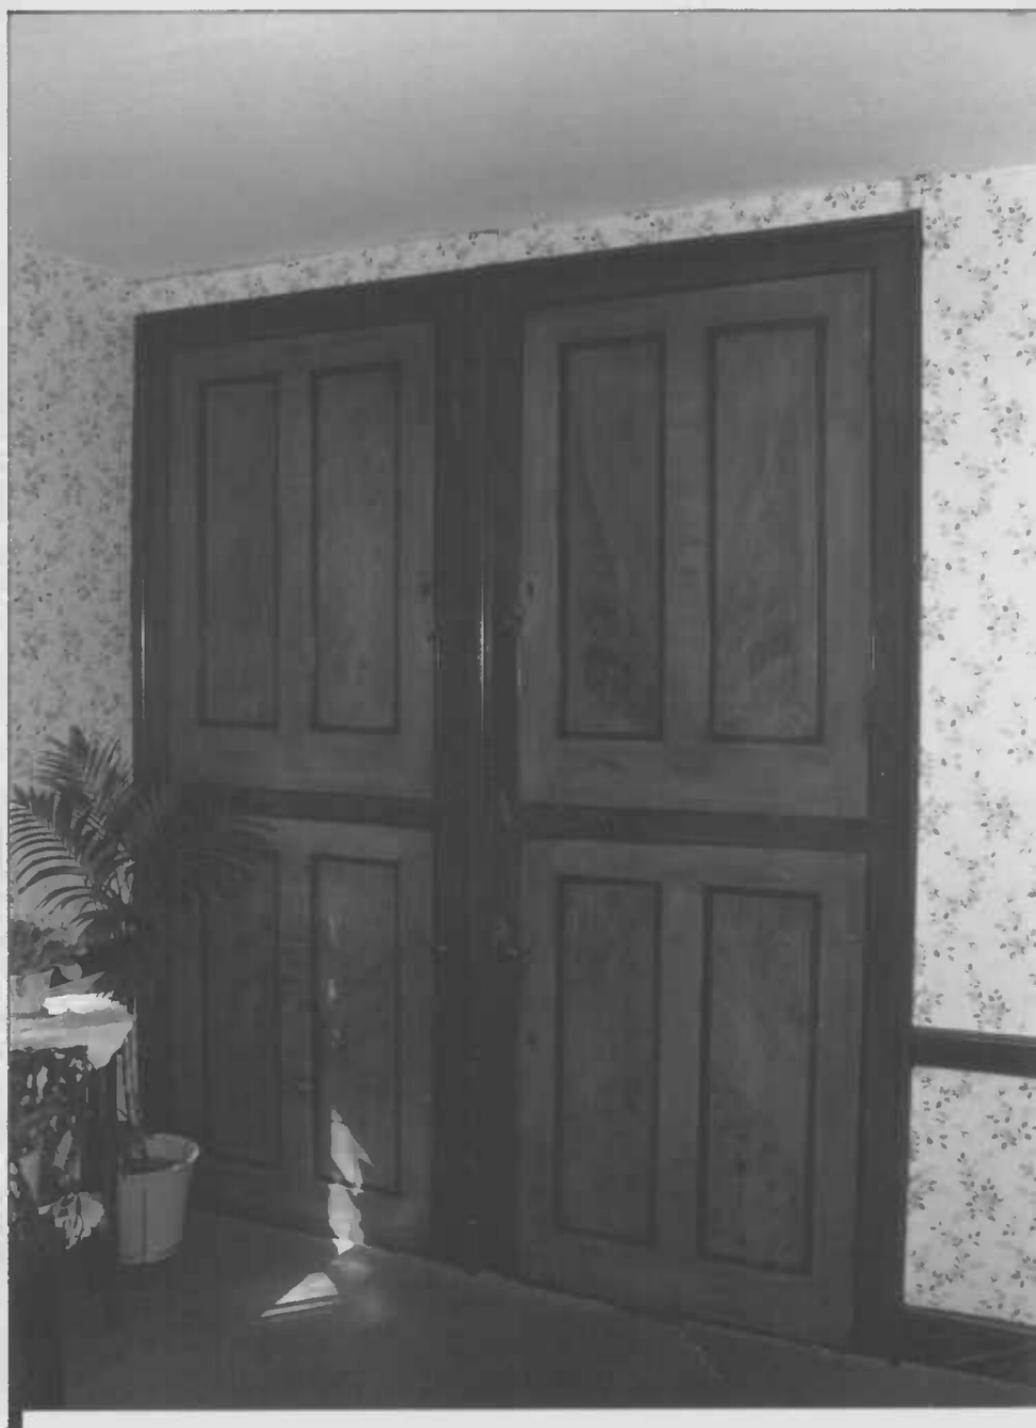
4/11

Neg. Loc.: Maryland Historical Trust  
west chamber closet

The second story floor plan mirrors the first. The west chamber has a fireplace on the west wall that is closed off with a new fireboard. The wood mantel has a bead on the inner and outer edges, and an ovolo in the center of both sides and the top of the architrave. The frieze is plain. The bed mould has a large bead at the top and a Greek ogee and small bead at the bottom. The mantel has a combed finish. There is a bead on top of the marbleized baseboard. The chairrail has a bead on the bottom edge, and a combed finish. South of the fireplace is a built-in closet. The architrave has a beaded interior edge and an ovolo backband. It is grained to imitate mahogany. The closet is

divided in half both horizontally and vertically, and has four two-panel doors. The panels are flat and sunk, with no moulds. They are grained tan, with a mahogany color that creates a faux "margin", and a narrow, light colored "inlay" between the "margin" and the tan "field". They are hung on cast-iron butt hinges. The window jambs are wood boards with an ovolo run on the inner corner to act as a surround. There is a peg rail in the southeast corner and on the north wall. The door on the east has six flat, sunk panels with no moulds, and is grained like the closet doors. A cast-iron box lock replaces a keyhole plate latch.

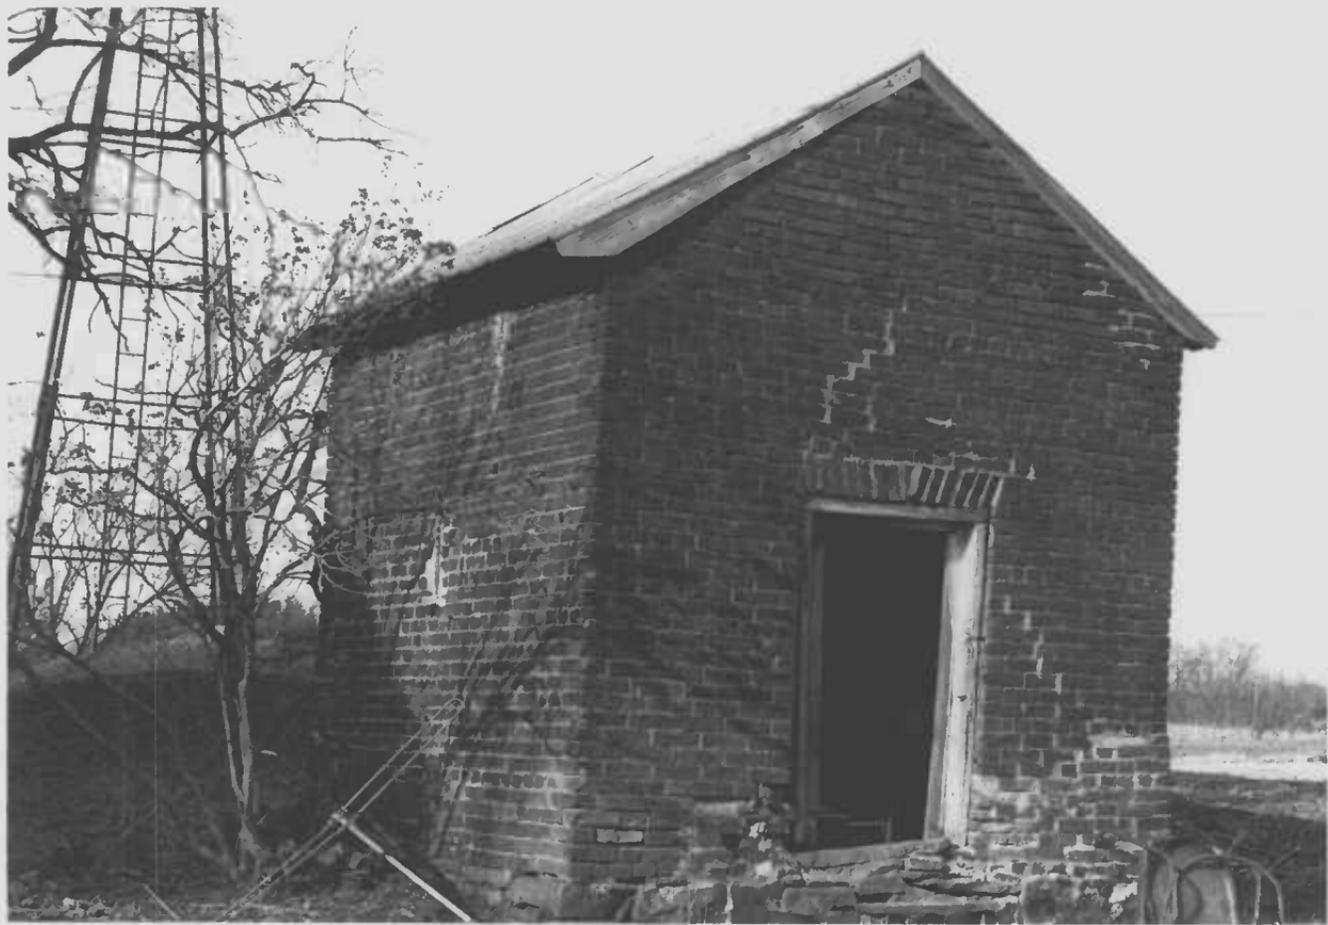
5/11

Smokehouse - west & south elevations

About 25 feet east of the house is a smokehouse built of 4-1 common bond brick on a rubble stone foundation. It has a gable roof of inverted-V-seam metal and a north-south ridge. The south elevation has a doorway with a stone sill and a pegged mortise-and-tenon frame. The east and west elevations each have a splayed slit vent. The eaves on the north and south have rake boards and the rafter ends on the east and west are tapered and cut. The plates are notched to hold the rafters. The interior has a dirt floor and plastered walls. The splayed vents have interior wood lintels. There are three east-west joists that appear to be sawn and are set in pockets in the wall, resting on top of thin boards. They support loose sticks that run north-south that probably held the meat. There are also two girts that appear to be sawn and rest on top of the side walls, inside the front and back (south and north) walls. These girts are connected somehow to the plates. The rafters also appear to be sawn; the ridge joint was not visible.

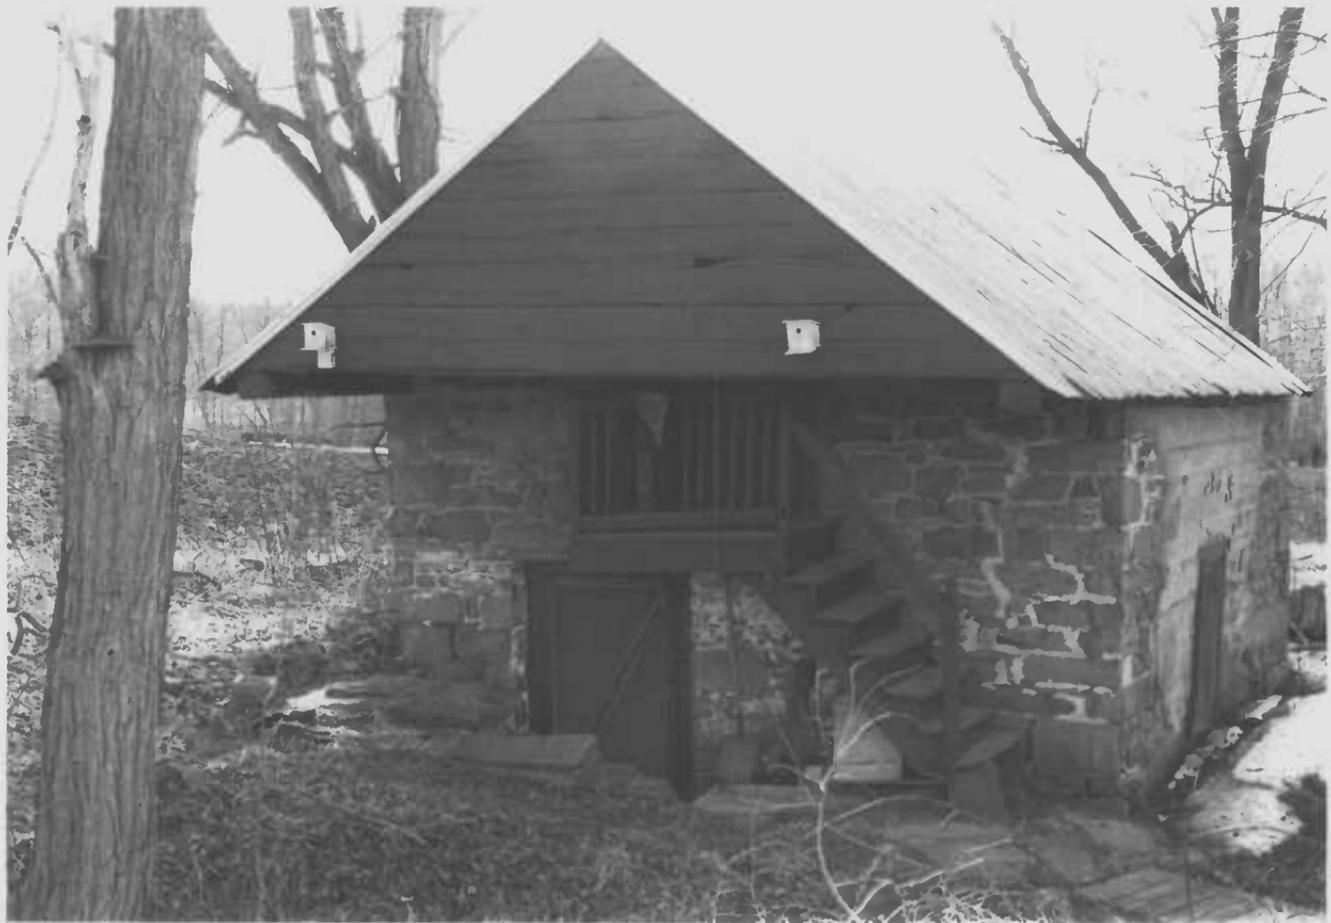
6/11

Neg. Loc.: Maryland Historical Trust  
Springhouse - east & north elevations

About 40 feet south of the house is a rubble stone springhouse. There are traces of whitewash on the stone. It has a corrugated metal gable roof with an east-west ridge, and the roof is cantilevered on the east about 5 feet. The soffit under the cantilevered portion is open to the rafters. The east elevation, on the south, has three stone steps down to a beaded-edge vertical-board door on cast-iron butt hinges. The frame may be mortised and tenoned, but is not pegged. It has a beaded interior edge and a cavetto backband. There are wood steps along the east wall to the upper story. The hand rail and newels are mortised and tenoned and pegged. The rails have a beaded bottom edge and the vertical balusters are rectangular in plan. The door and frame of the upper story are identical to that of the lower story. Carved on this door is "T.Ly 75". The east wall of the building, above the stone, has vertical boards, while the east gable end has horizontal flush board siding, and each board has a beaded bottom edge. The north elevation has a 6/6 sash in the lower story with a wood lintel, a sill that is now below grade, and a frame like the doors on the east. Much of the north wall is now poured concrete. According to family tradition, this building used to be taller, but the roof blew off and the walls were lowered some when it was rebuilt. The south elevation has two slit vents on the lower story. The west elevation has a slit vent on the lower story, to the south.

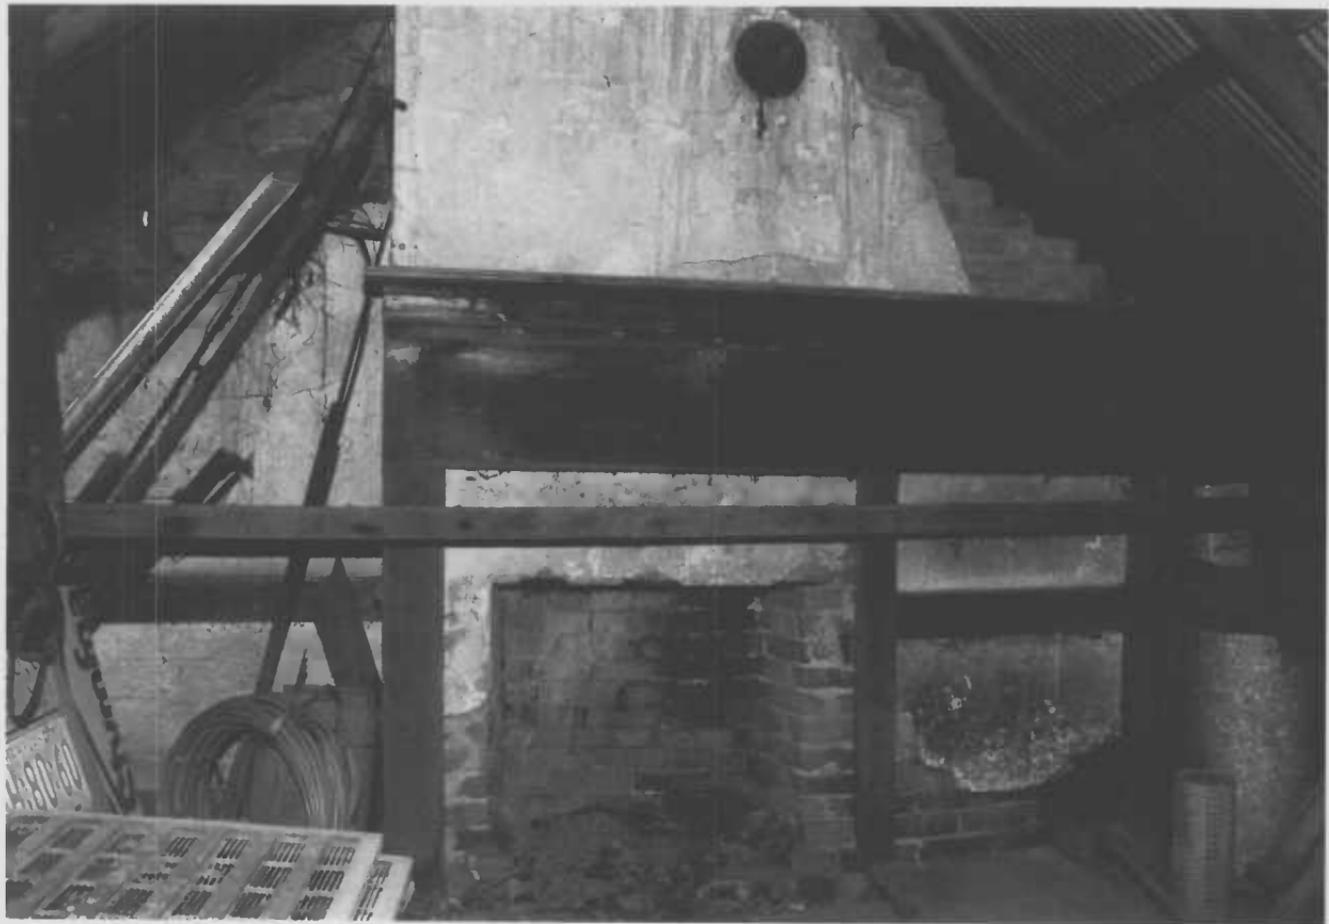
7/11

Springhouse - upper story mantel

The lower story of the springhouse has a concrete floor with a trough on the south side. There is a large stone fireplace with straight jambs on the west wall, set to the north. The fireplace has a wood mantel tree, and was originally plastered. The north window jamb has a beaded interior edge. The upper story joists are exposed and run north-south. They are mill-sawn, are 2½ by 7 inches, and are spaced 24 to 25½ inches on centers. They rest on a 1-inch thick board set in the stone wall. The walls were originally plastered. The upper story has a random-width floor that runs east-west. There is a small brick fireplace with splayed jambs on the west wall. The firebox and surround were originally plastered. There is a wood mantel that extends across the entire fireplace wall, including the flue from the lower story. The architrave has a beaded interior edge. The bed mould has a large astragal at the top, a cavetto below it, then another cavetto with a bead at the bottom. The edge of the mantel shelf has a

cavetto at the bottom. A stove was later piped into the chimney, and the chimney no longer passes through the roof. This room has a chair rail with a beaded bottom edge and a rounded edge to the shelf. The concrete north wall has written into it "1923 C. S. [Clayton Scott] Koons and J. A. [John Addison] Koons April 26 Frank Bohn Frank Bohn Grant Bohn." The plates are hewn and are 7 inches by 8½ inches high. The mill-sawn rafters are exposed, and appear to have always been so. They are 2¼ to 2½ inches wide, and are tapered in depth from 2½ to 3 inches at the ridge to 4½ inches deep at the feet. They are half-lapped and pegged at the ridge and appear to be sawn off and toe-nailed to the plate. At the southeast corner of the springhouse is a rubble stone retaining wall with a covered area for the spring.

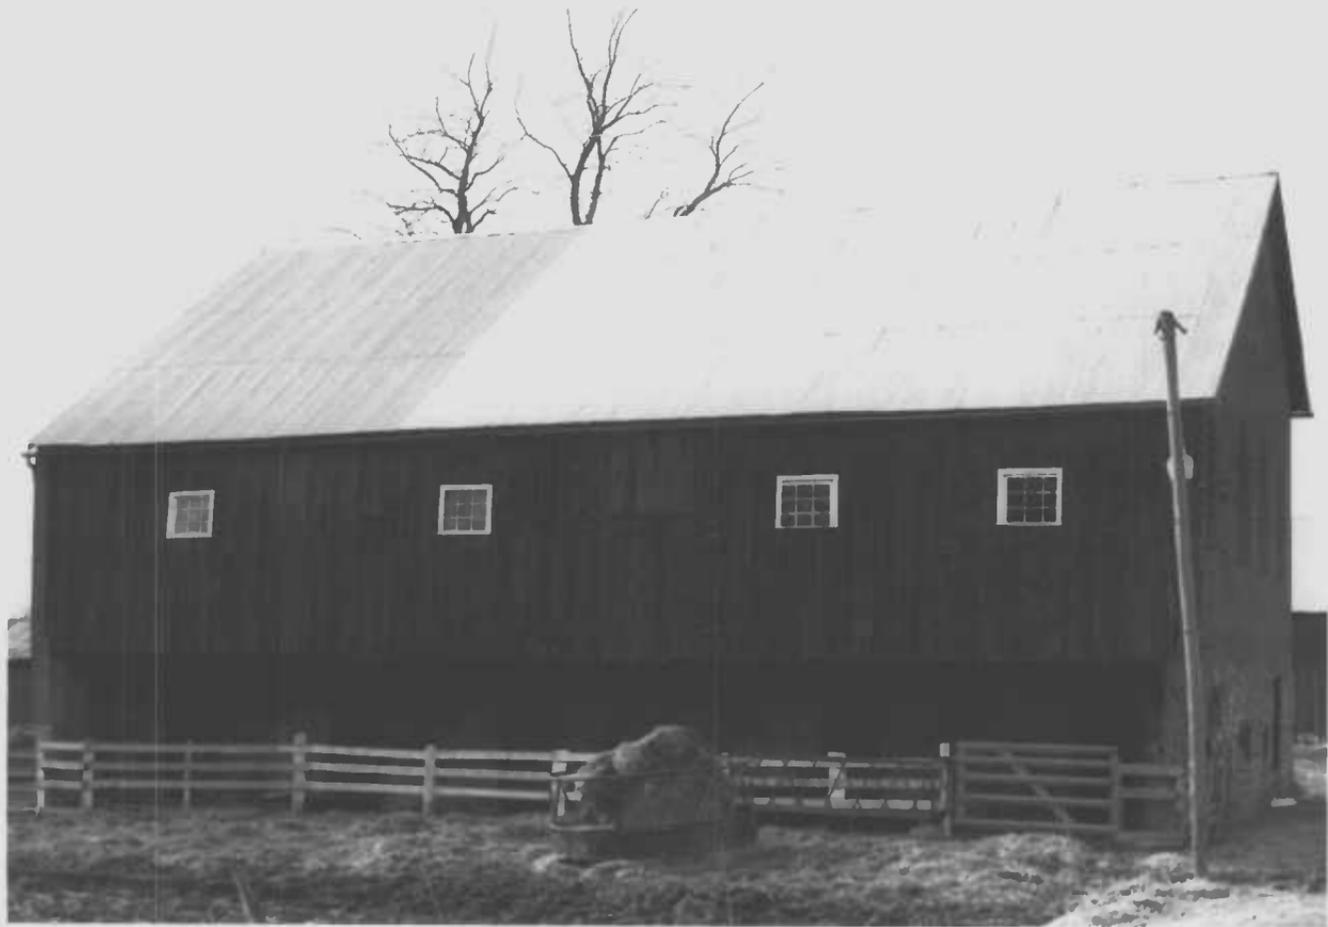
8/11

barn - southeast & northeast elevations

About 200 feet north of the house is a brick bank barn with a southeast facing forebay. The barn sits on basically flat ground, with a ramp built up to it on the northwest. The southeast elevation, on the lower story, has 5, 6, and 7 to 1 common bond. From southwest to northeast there is a beaded-edge, vertical-board dutch door on strap hinges with rounded ends. Above the door were slats that are now missing. Next is a wood vent with vertical louvers that are diamond in plan. It has a pegged mortise-and-tenon frame and a splayed brick jack arch. Then is a matching door, with slats, a matching vent, two similar doors that are later, but are not dutch doors, a matching vent, a matching door, a matching vent with a later door covering it, and a matching door, but with beaded-edge-and-center vertical boards. The head rail and slats are missing from the latter. The upper story has vertical-board siding. There is, from southwest to northeast, a six-light sash, a door on strap hinges, a six-light sash, double doors on strap hinges, and two six-light sash. The gable roof has a northeast-southwest ridge and is covered by corrugated metal. The slope to the southeast is longer than the slope to the northwest.

The northeast elevation has 4, 5, and 6 to 1 common bond. The lower story has a semi-circular arched opening under the forebay, with a pintle and latch for a door that used to hang here. A brick in the pier by this doorway is marked "Daniel [?Boone?] 1834." North of this is a double wood vent with diamond-in-section wood louvers in a pegged mortise-and-tenon frame, then a single vent with identical details. To the far north is a random-width, beaded-edge vertical-board door in a mortise-and-tenon-and-peg frame, with a stone sill and a splayed brick jack arch. It has interior strap hinges with round ends with points. The upper story has four brick lancet vents, with another brick lancet vent in the gable end. There are also diamond-plate tie rods.

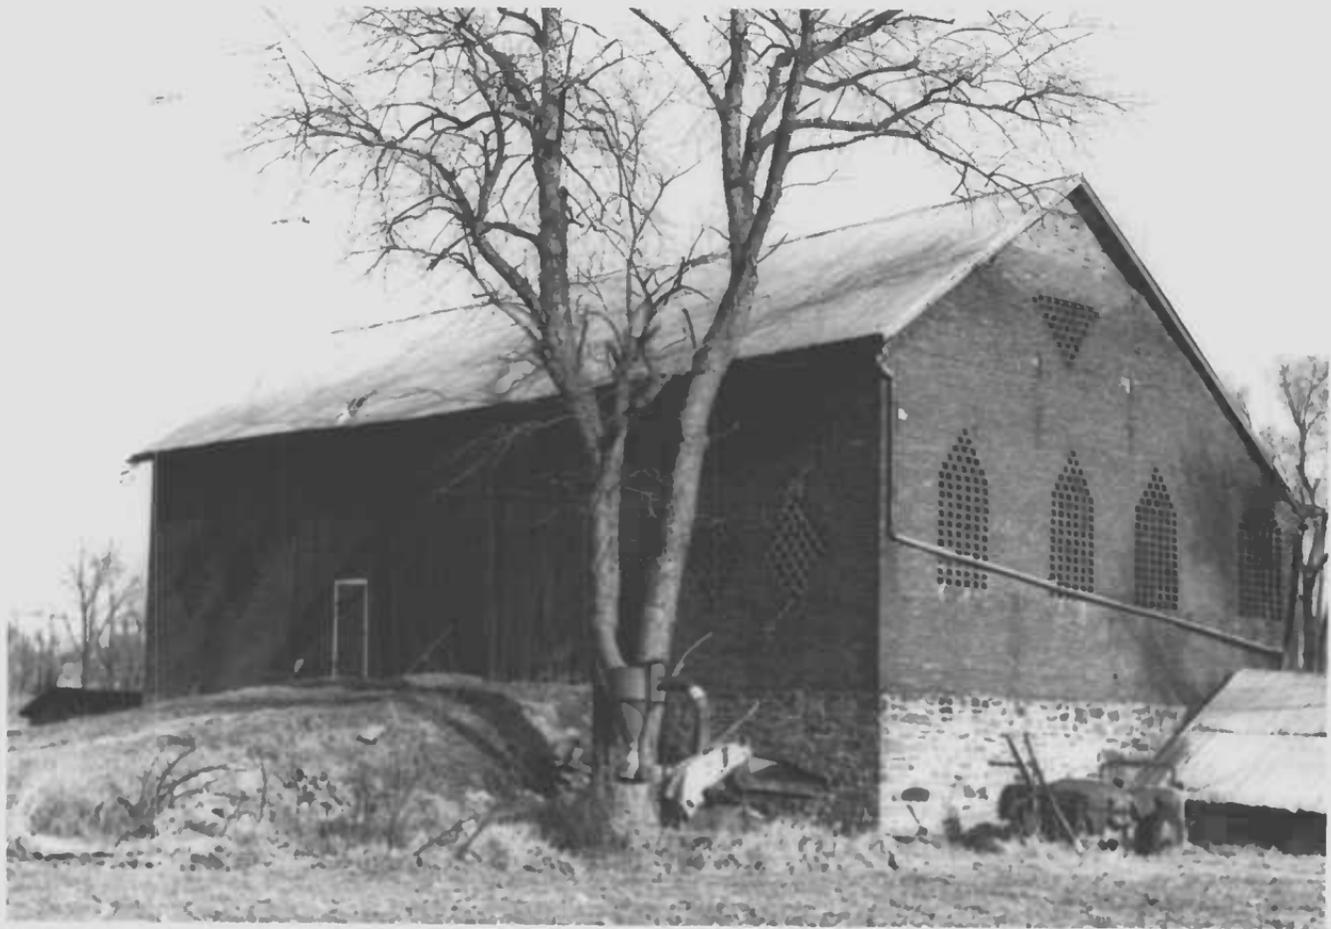
9/11

barn - northwest & southwest elevations

The northwest elevation has 5-1 common bond. There is a wood vent in the lower story on each side of the ramp. The upper story has two brick diamond-shaped vents on each side, with a pair of vertical-board wagon doors on strap hinges to the northeast and a single, like door to the southwest. The southwest elevation has two closed off wood vents in the lower story, with a segmentally-arched doorway under the forebay. The upper story has four brick lancet vents and the gable end has the bottom half of a brick diamond vent. The top half of the brick vent has been rebuilt, and tie

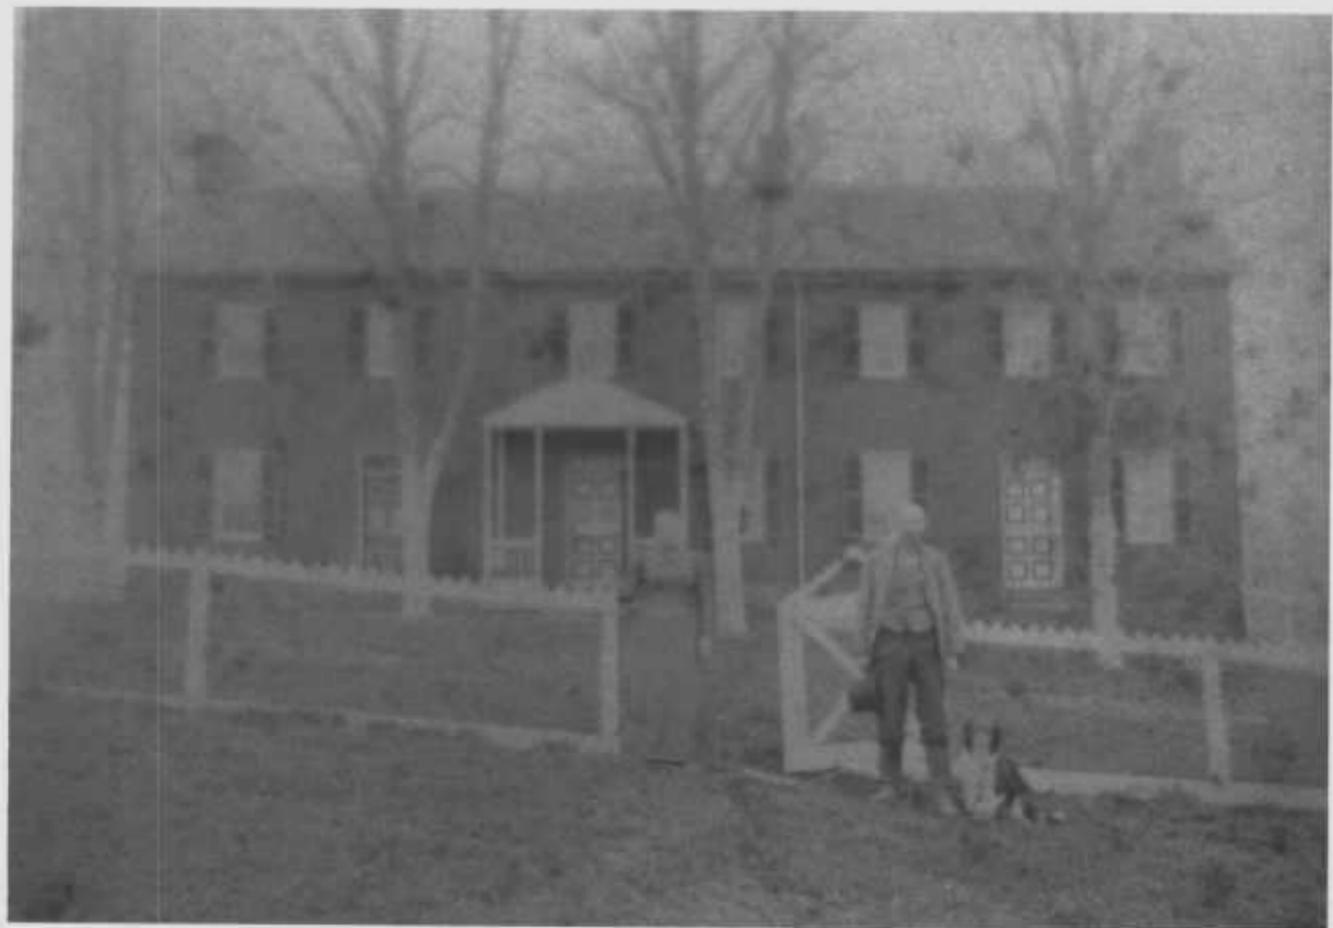
10/11

Neg. loc: Maryland Historical Trust  
c. 1896 photo of house - north elevation

Since the land could not be divided, under the Act of Direct Descents the land was vested in the oldest son, Henry. In 1808 Henry sold 229 acres to his brother, John, for \$1,800. John sold off some of the acreage. By 1825 he held 196 acres and ten years later it was down to 190. John was also most likely responsible for construction of the existing house and barn. A brick house is noted in the 1837 account. The house Hiner built is very unique in Carroll County. It would appear that the builder created it by combining two familiar house plans, the four-bay Pennsylvania farm house plan and the three-bay, center entrance plan. Both house plan types are common, but, when combined, one of them is usually used as an ell on the rear of the other, not placed side-by-side. The mouldings used in the house are typically found in buildings built before 1830. There have been few changes to the house since its construction. The marbleizing and graining on the woodwork probably dates from the 1850's or 1860's, as do the later locks, and the combed finishes probably were added in the early twentieth century. A c. 1896 photo of the house shows the original one-bay, gable roof porch which was removed in the early 1940's and replaced with the existing porch structure. It also shows the use of contrasting paint colors on the doors. The kitchen door has dark rails, stiles, and fields, while the panel margins are light. The other two doors use the opposite scheme, thus setting them off functionally from the work space of the kitchen. Also of interest in the photograph is the fence, which apparently had wire between the posts and the top and bottom rails. The top rail had a saw tooth motif on top of it. The four trees which still exist on the north side of the house, in a straight line, were already of considerable size and must have been at least twenty years old when the photograph was taken.
