National Register of Historic Places
Inventory—Nomination Form

historic Rockland Farm (preferred); Arter House

street & number 201 Rockland Road N/A not for publication

Continuation sheet Rockland Farm Item number 7 Page 1
Carroll County, Maryland

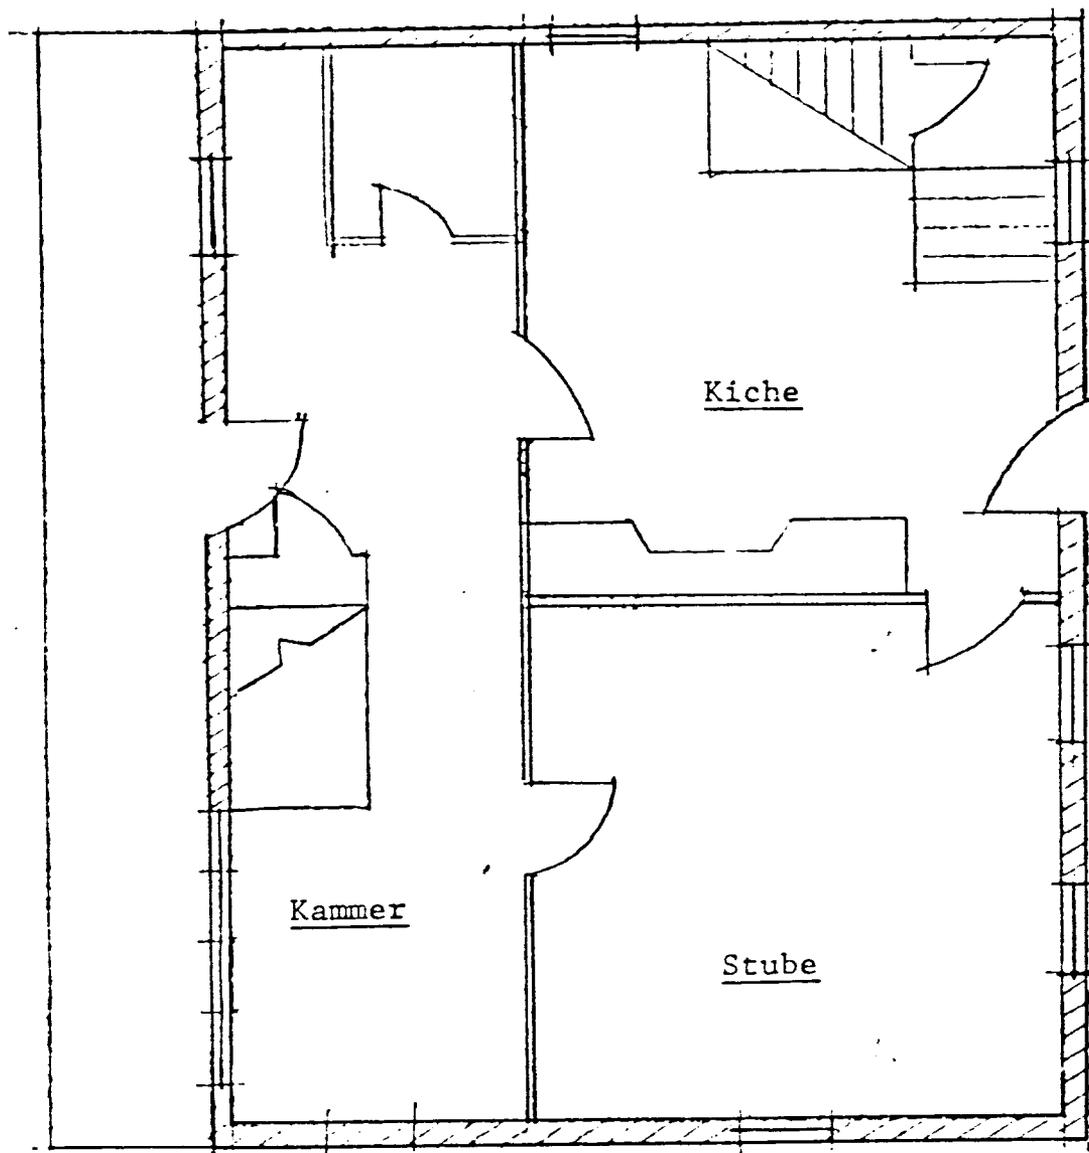
Sketch Floor Plan
July 1986

The Kiche, or original kitchen, on the interior is the northernmost room and originally ran from the front to the back of the house. The evidence for the partition wall being a later alteration includes the fact that the chairrail on the partition does not match the other walls of the room. Also, the partition wall on the south side of the house (between the Stube and Kammer) is brick while the one on the north side (in the Kiche) is constructed of frame with lath and plaster. This room contains the corner stairway to the second story. The stairway has a double flight in the northeast corner of the Kiche, with the upper section boxed in. The mantel on the large fireplace has a plain shelf with serpentine molding. The room has a molded chairrail and the door frames have quarter-round molding. The interior doors have six-panels, and retain their original Pennsylvania German hardware with wrought strap hinges and wooden box locks.

The Stube, or parlor, is the southeast room and contains molded chairrail, molded window frames with crossettes, and six-panel doors with original hardware. In a traditional Pennsylvania German layout, this room would have been heated by a cast-iron stove with the flue feeding into the main chimney.

The second story of the farmhouse has five rooms. The stairs lead into the northeast room which is a large open room with a corner stairway to the attic. It has a beaded board partition wall on the west side that contains two doorways. The door into the northwest room is a six-panel door with wrought strap hinges and arrow plates. A narrow six-panel door leads into the middle room on the west side which originally was a small foyer for the back stairs but has been converted to a bathroom.

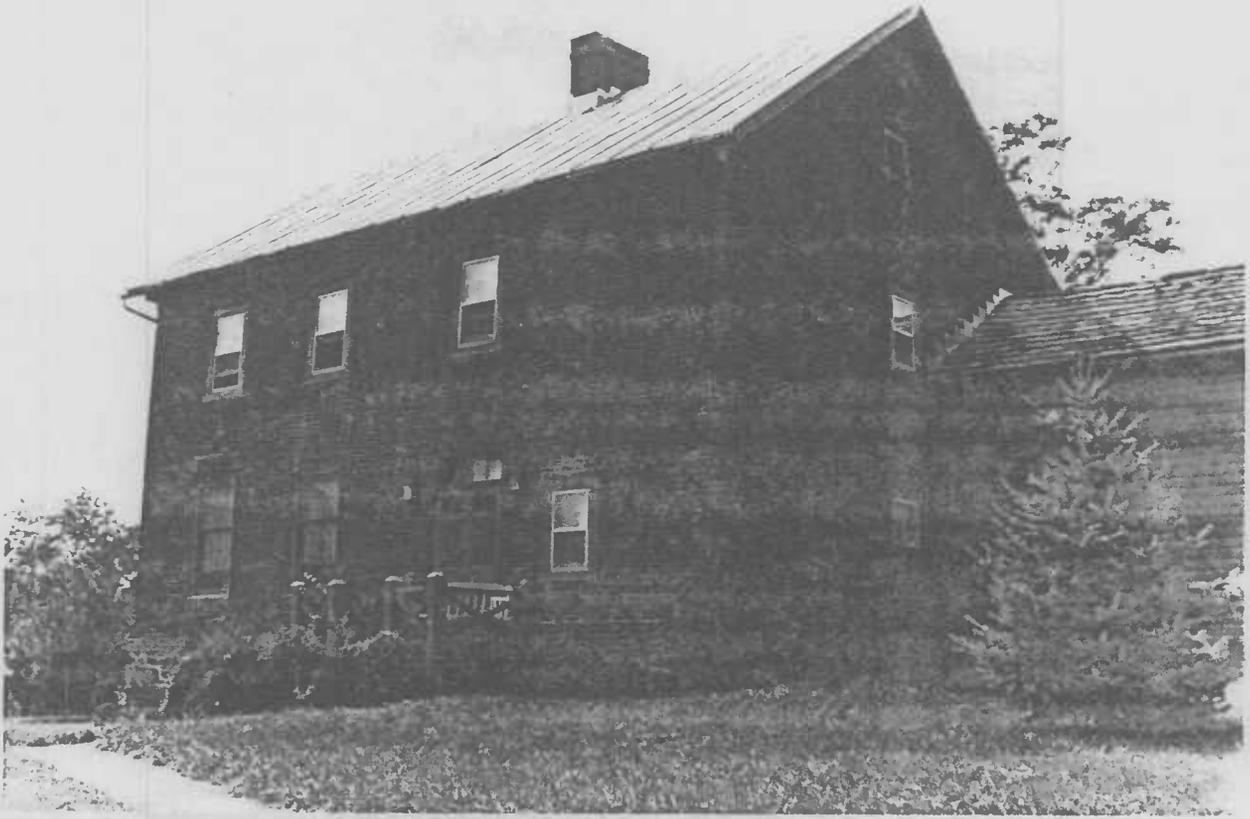
1/24

view from northeast

This farmhouse is a two-story, three-bay by two-bay brick structure on a stone foundation. It is built into a slope so that the main facade has both a ground level basement entrance on the southern side and an entrance on the northern side of the first story. The brickwork on this facade is Flemish bond, while the other elevations are laid in common bond. A molded watertable runs along the main and south facades. The house has a gable roof covered in standing seam sheet metal and a boxed cornice. The chimney is centrally located along the ridge of the roofline.

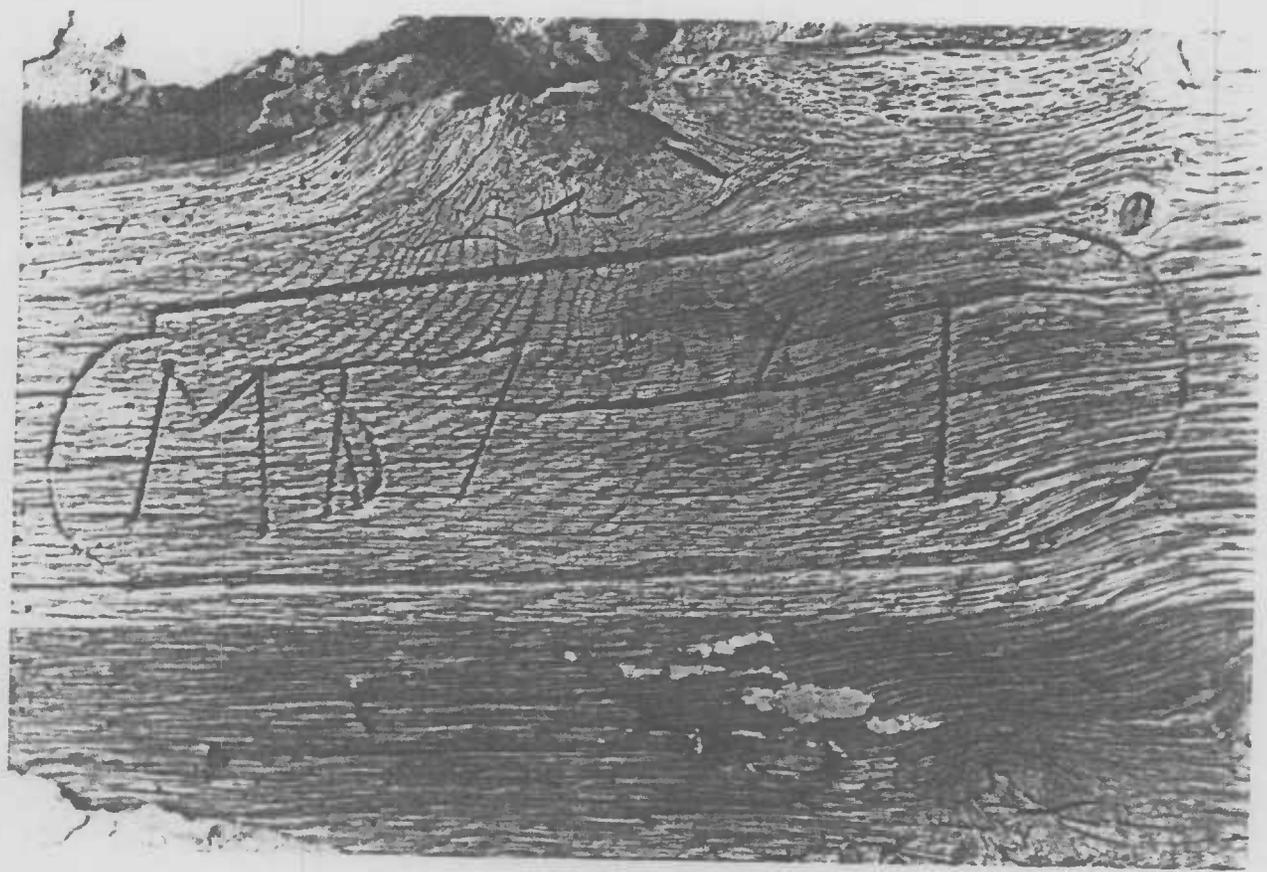
Rockland Farm CARR-342
Carroll County, Maryland
Photo by Joe Getty, August 1985
Negative at Maryland Historical Trust
detail, dated lintel over bulkhead entrance
4/24

Michael Arter owned this farm, now known as Rockland Farm, until his death in 1808, so he is almost certainly the builder of the farmhouse. In the basement entrance of the farmhouse is a log lintel with the inscription "M 1795 E" which would stand for Michael Erter and the date 1795. This lintel appears awkward in its installation in the brickwork, and may not be original to the house - perhaps it is relocated from a log barn or other log structure that once stood on the property. Whether it is original or not, however, it helps to confirm the fact that this is a house of Michael Arter's.

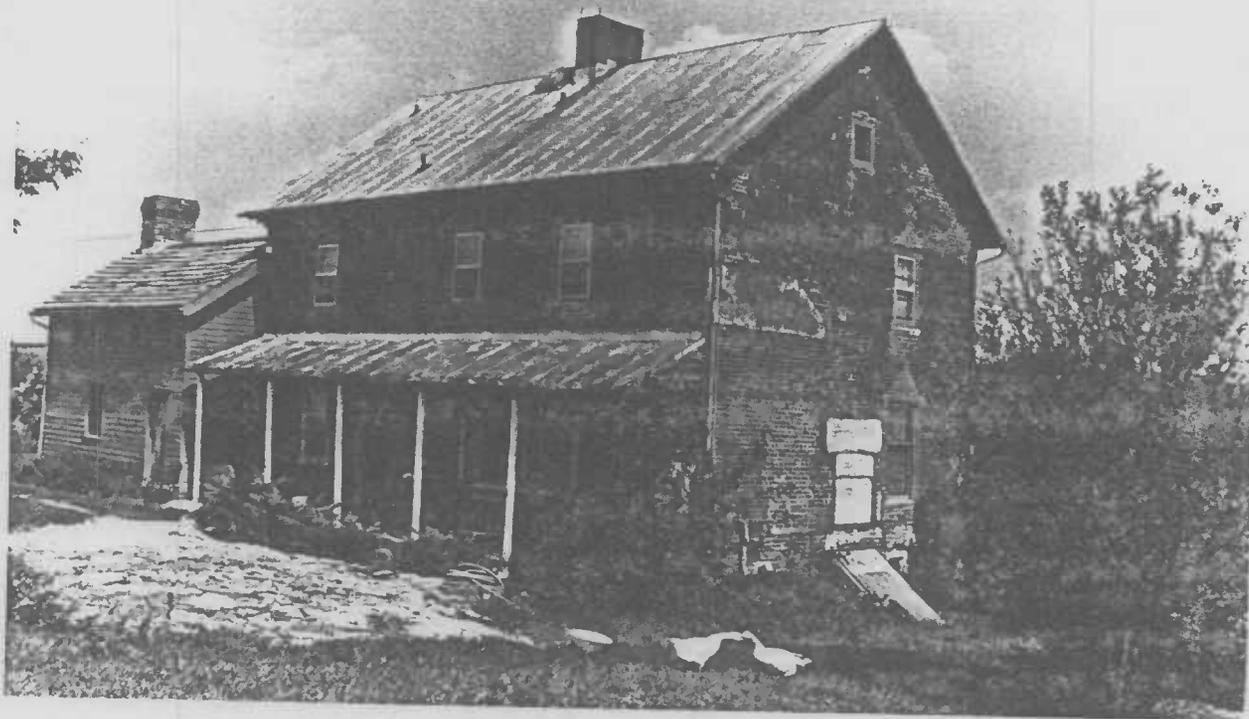
5/24

Rockland Farm CARR-342
Carroll County, Maryland
Photo by Joe Getty, August 1985
Negative at Maryland Historical Trust
view from southwest

The south gable end of the brick house has windows located towards the east side. There is a basement window with arched brick lintel, an eight-over-twelve sash window on the first story, a six-over-six window on the second story and four-pane casement window centrally located on the gable. A bulkhead entrance centrally located at the basement is a 20th century alteration. This facade also contains evidence, including paint marking,

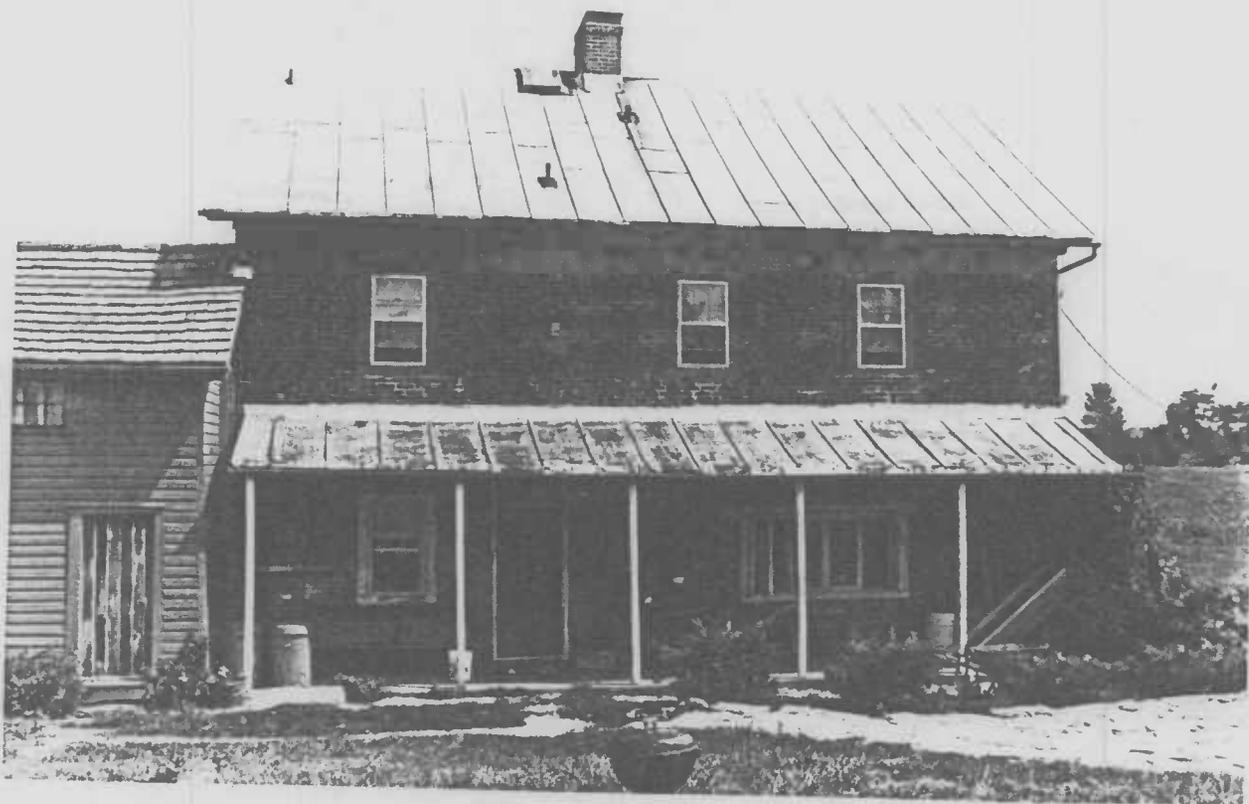
6/24

Rockland Farm CARR-342
Carroll County, Maryland
Photo by Joe Getty, August 1985
Negative at Maryland Historical Trust
west elevation

The west facade is three bays wide with an asymmetrical arrangement. The entrance is located off-center in the second bay from the north (so that it is in line with the entrance on the main facade). The northernmost bay, and the three bays on the second story contain six-over-six sash windows with wide pegged frames. An unusual feature is the wide, horizontal window in the southernmost bay of the first story. While the panes in this window have been replaced, the framing appears to be early. However, this conflicts with the traditional use of this room as a bedroom, and probably the window is an early-to-mid 19th century alteration. The full-length, one-story porch on this facade also dates from that period.

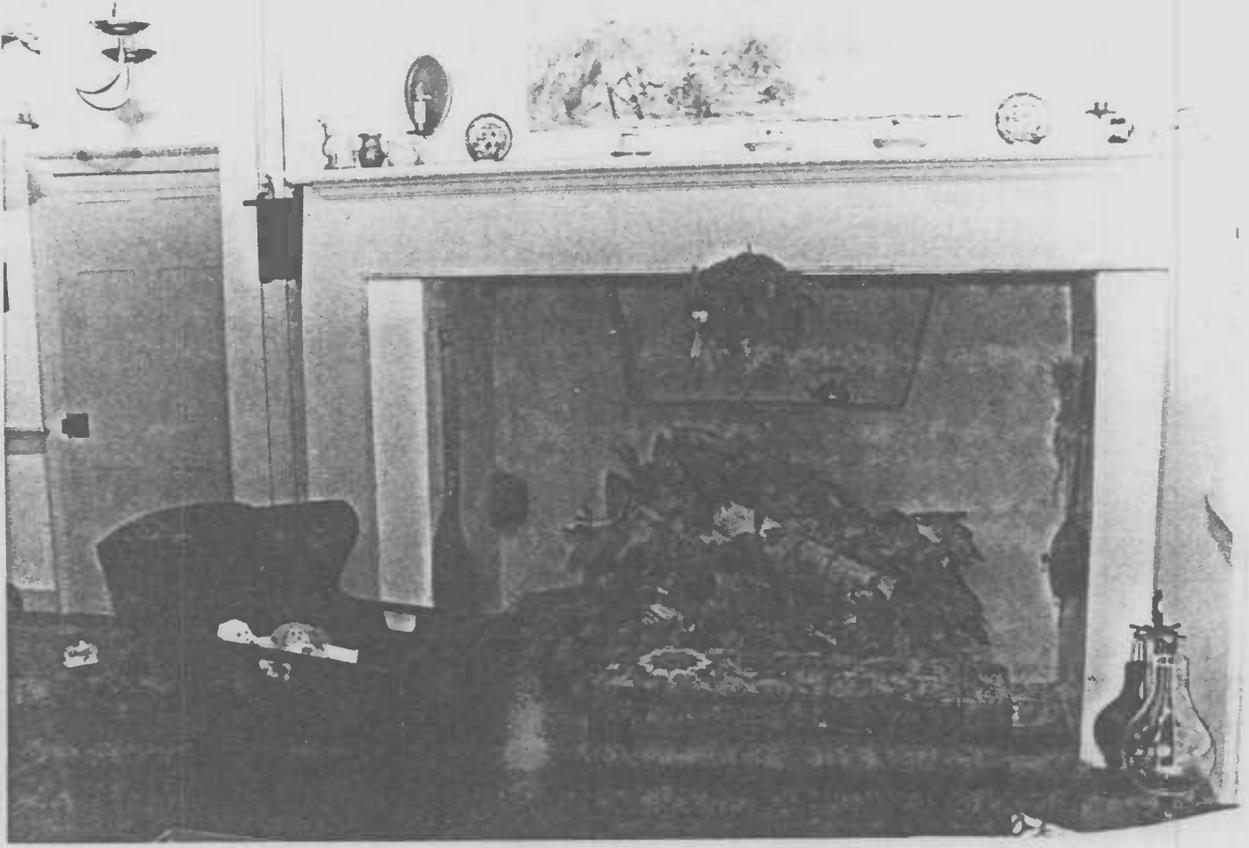
9/24

Rockland Farm CARR-342
Carroll County, Maryland
Photo by Joe Getty, August 1985
Negative at Maryland Historical Trust
Niche, fireplace detail

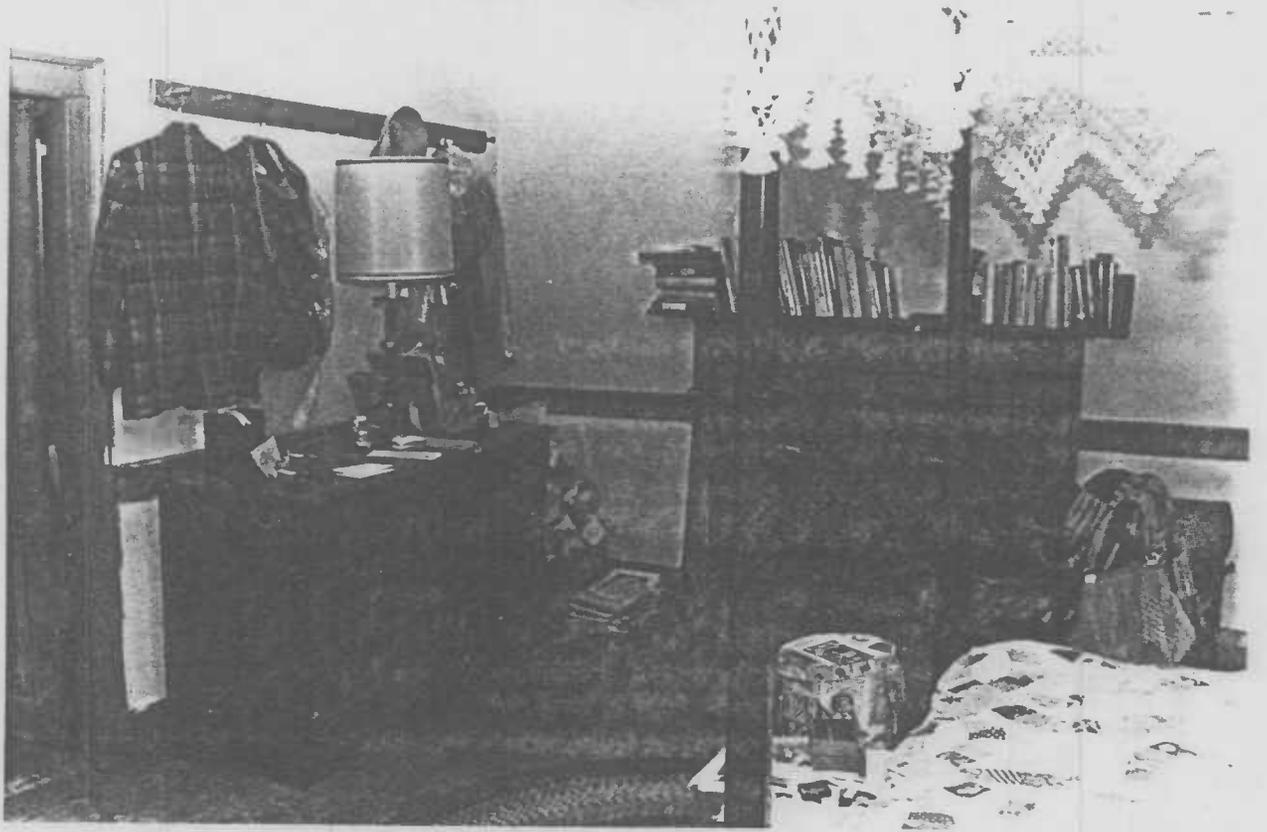
13/24

southeast room, 2nd floor

The southeast room is a bedroom with refined woodwork. In the Pennsylvania German cultural tradition, this was the guest room and usually had the best woodwork in the house and was almost always located on the second floor over the parlor. The guest room was used not only for accommodating visiting family and friends, but also for storage of the best material possessions of the family, such as furnishings and Sunday clothes. At Rockland Farm, the guest room has a molded chairrail, plain fireplace mantel, door frames with quarter-round molding, and peg rails. The six-panel interior doors have strap hinges and the door to the northeast room retains a Dutch elbow lock.

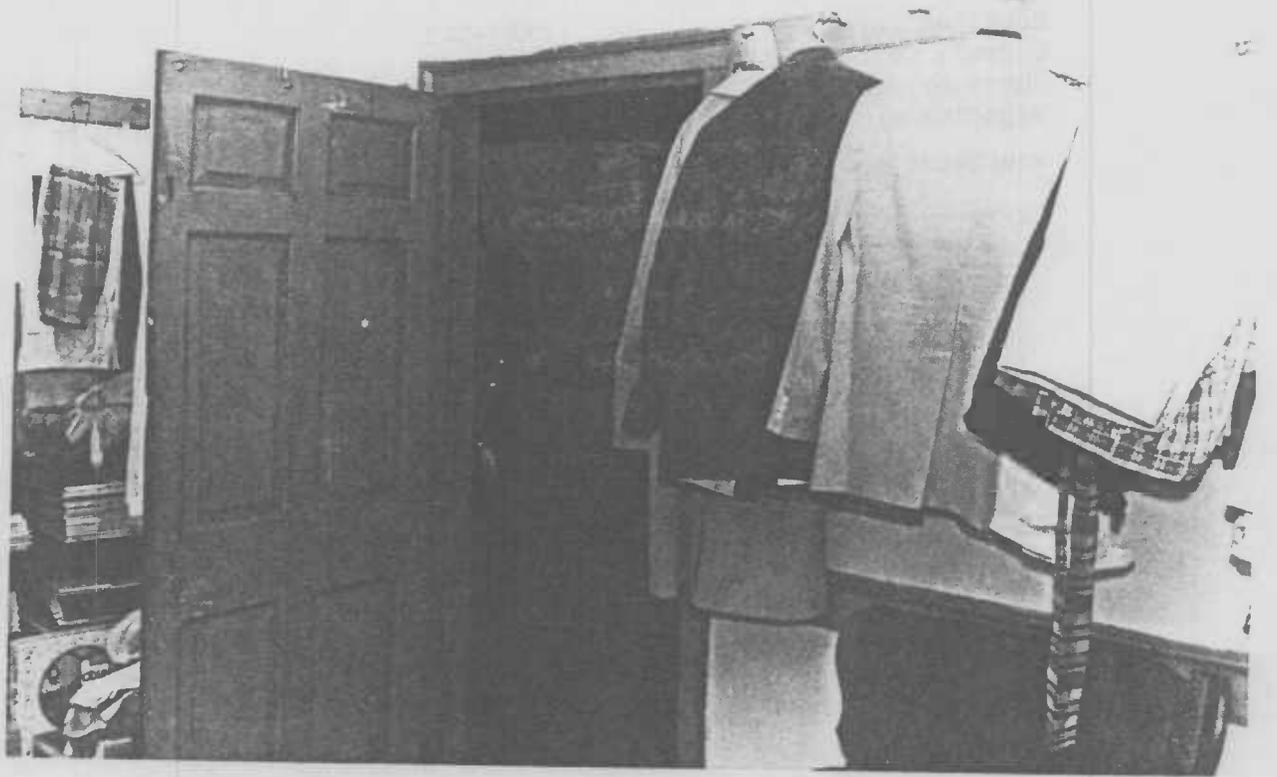
14/24

southwest room, 2nd floor

The southwest room is a small narrow room above the first story Kammer. It would have been a Kammer, but may have contained several blanket chests for storage instead of beds for sleeping. The room has a chairrail and peg rail running around its sides.

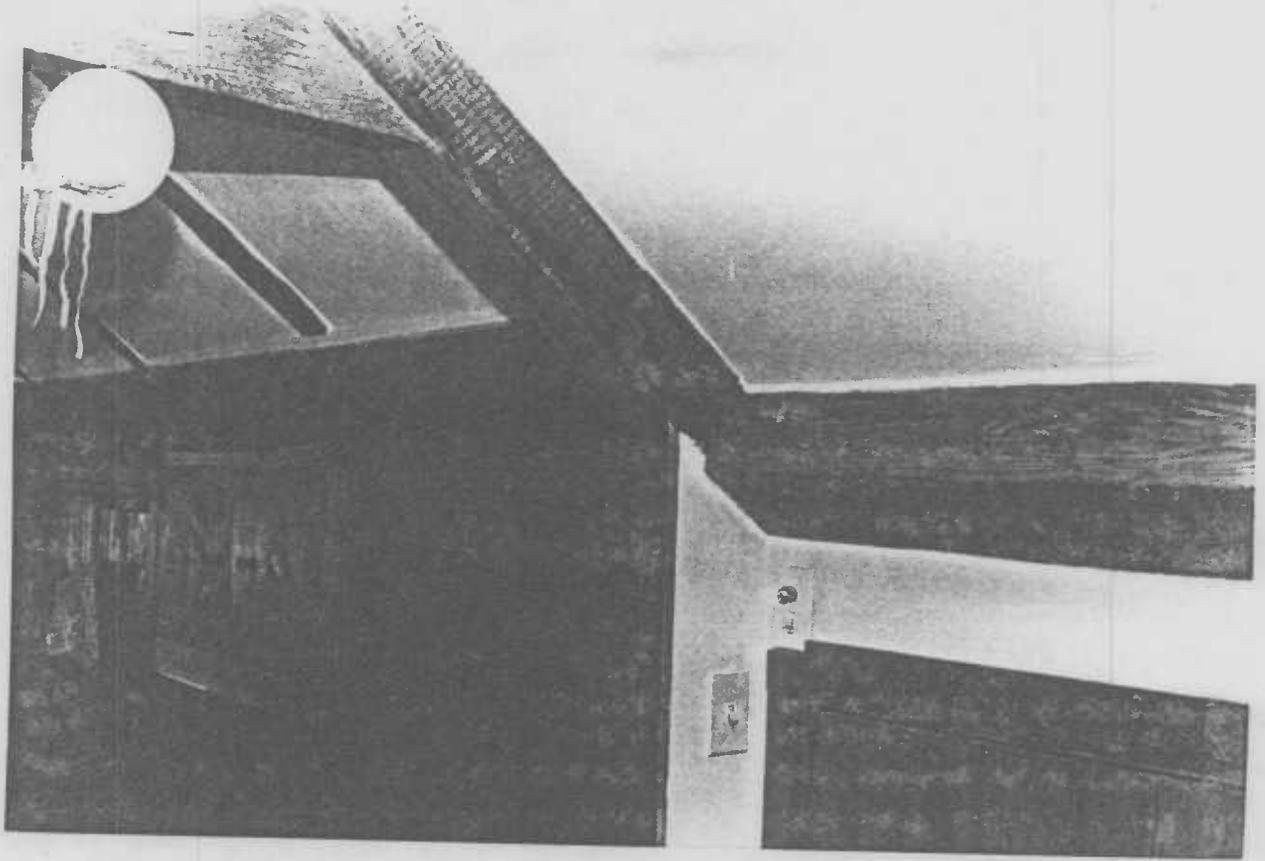
17/24

Rockland Farm CARR-342
Carroll County, Maryland
Photo by Joe Getty, August 1985
Negative at Maryland Historical Trust
exposed roof framing in attic

The attic was an open room that has been remodeled as two bed rooms. The roof framing system is visible in the attic and consists of a principal purlin system supporting common rafters.

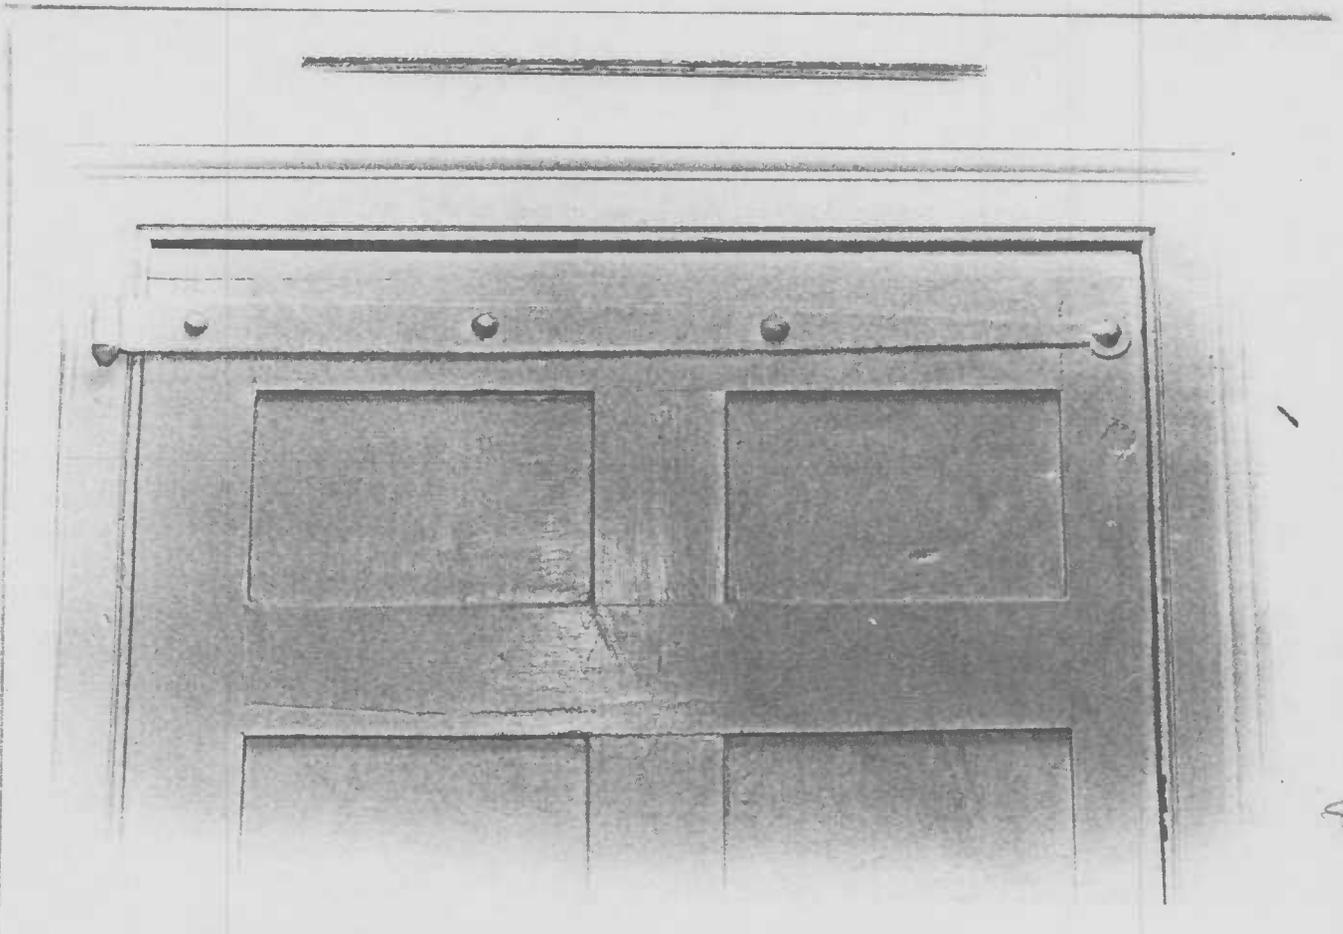
18/24

Rockland Farm CARR-342
Carroll County, Maryland
Photo by Joe Getty, August 1985
Negative at Maryland Historical Trust
detail of strap hinge and surround, west
entrance door

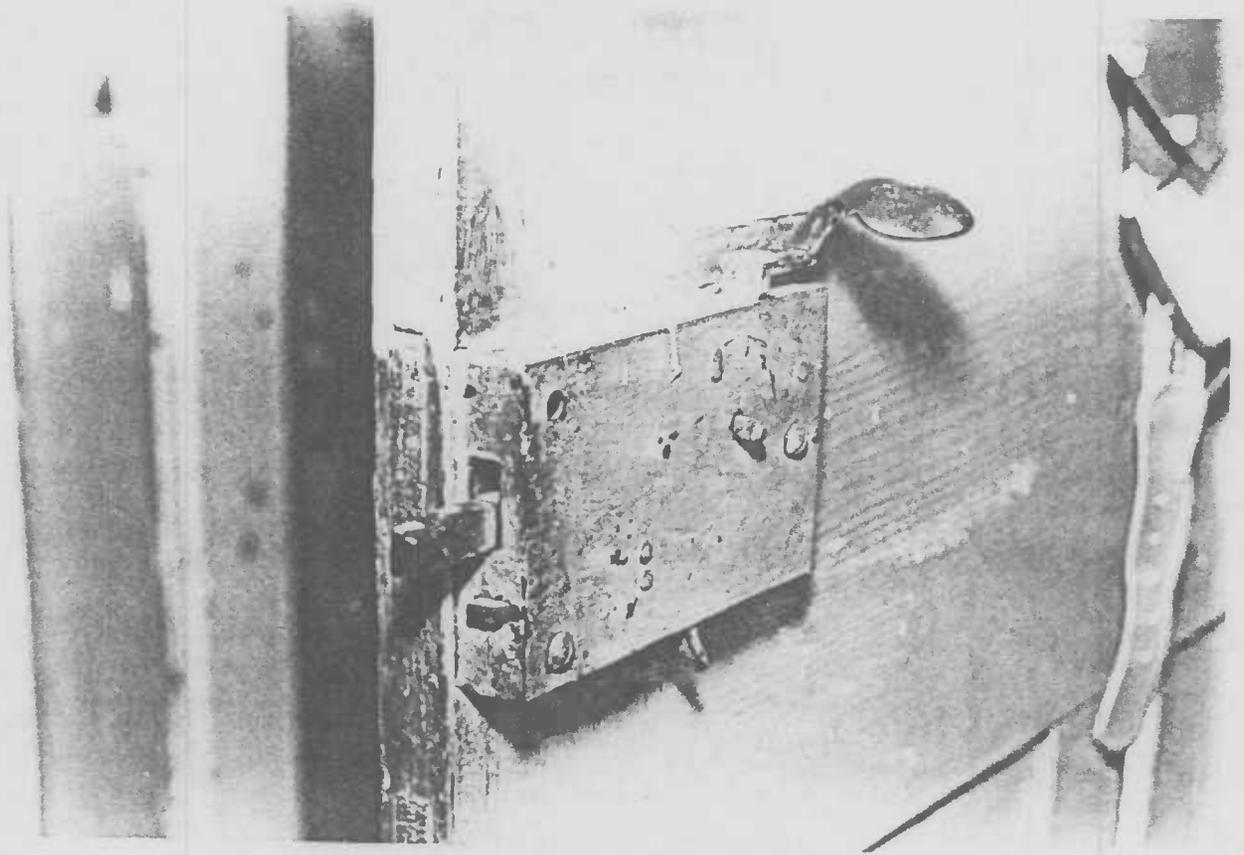
Rockland Farm
Carroll County, Maryland
Photo by Joe Getty, August 1985
Negative at Maryland Historical Trust
detail, Dutch elbow lock, southeast room
2nd floor
19/24

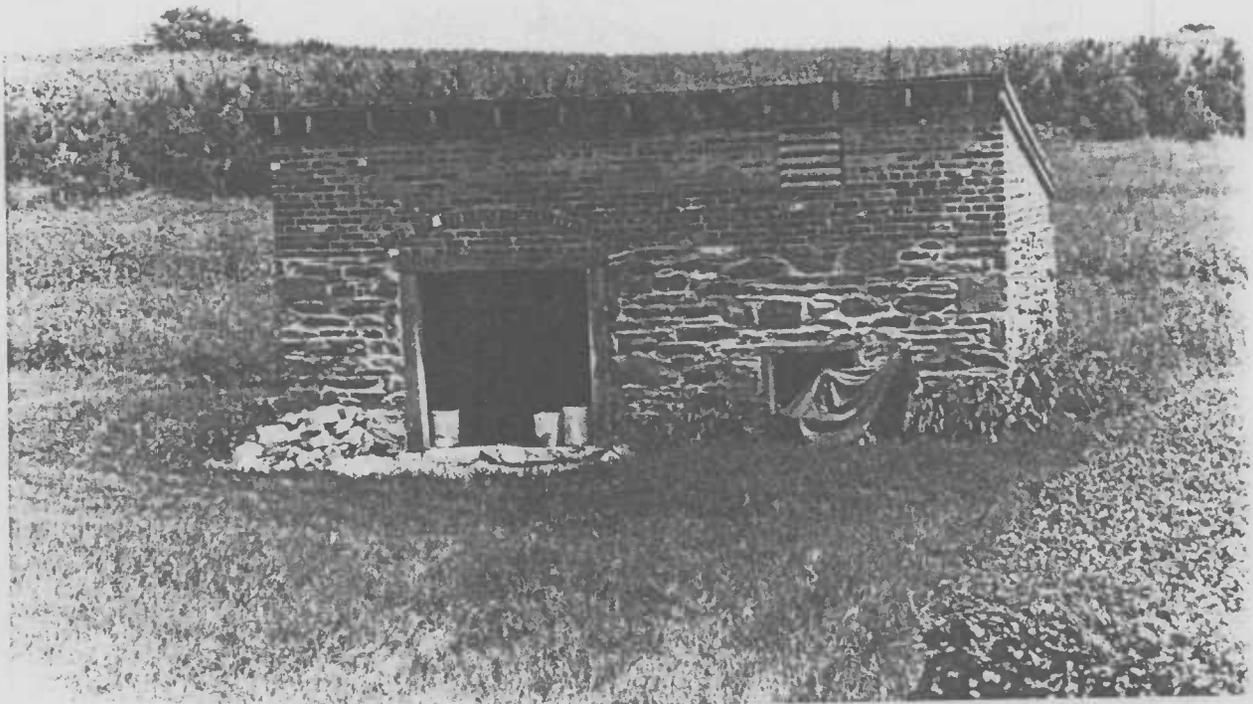
22/24

springhouse foundation, view from west

The property had numerous farm and domestic outbuildings that have been lost over time. East of the farmhouse is the site of the original springhouse. The stone foundation of the springhouse is all that remains of the original structure. A modern brick structure with a shed roof has been built on top of the of the foundation to protect the spring.

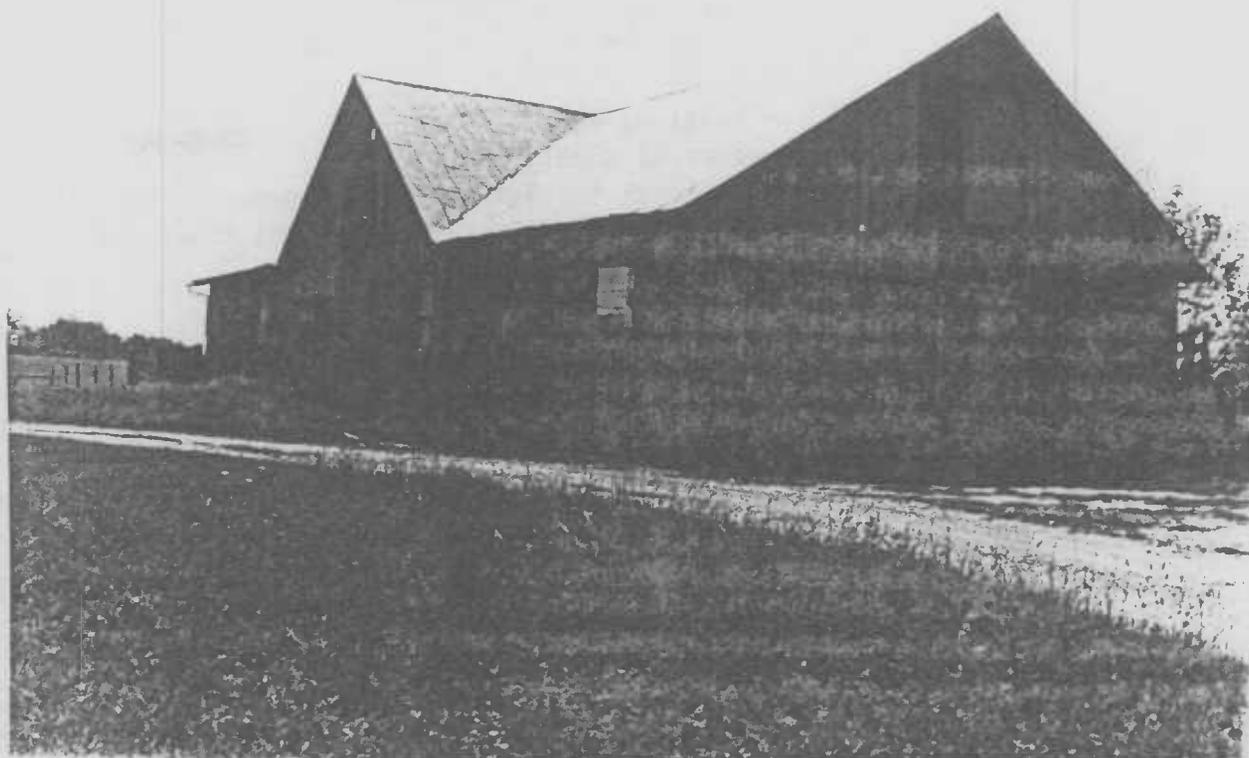
23/24

Rockland Farm
Carroll County, Maryland
Photo by Joe Getty, August 1985
Negative at Maryland Historical Trust
barn, view from northeast

Two other historical outbuildings remain on the property, both from the late nineteenth century. One is a frame barn with a rectangular-shaped plan and a gable roof with a cross-gable. Built in 1888, it departs from the bank barn tradition popular in this area, with its one and one-half story height, board-and-batten exterior, and Victorian style pointed arch window trim. The August 11, 1888 edition of the Democratic Advocate provides the following information about the barn: "Charles B. Roberts is building a barn 40' by 84' on his Rockland Stock Farm. Raising took place on Wednesday afternoon. Charles C. Crumbaker of Linwood is the builder." The other structure, which is contemporaneous to the barn, is a corn crib in deteriorated condition. The structure is frame, covered with German siding, and has a gable roof. The corn crib's design provides a through-passage for a wagon with cribs on both sides.

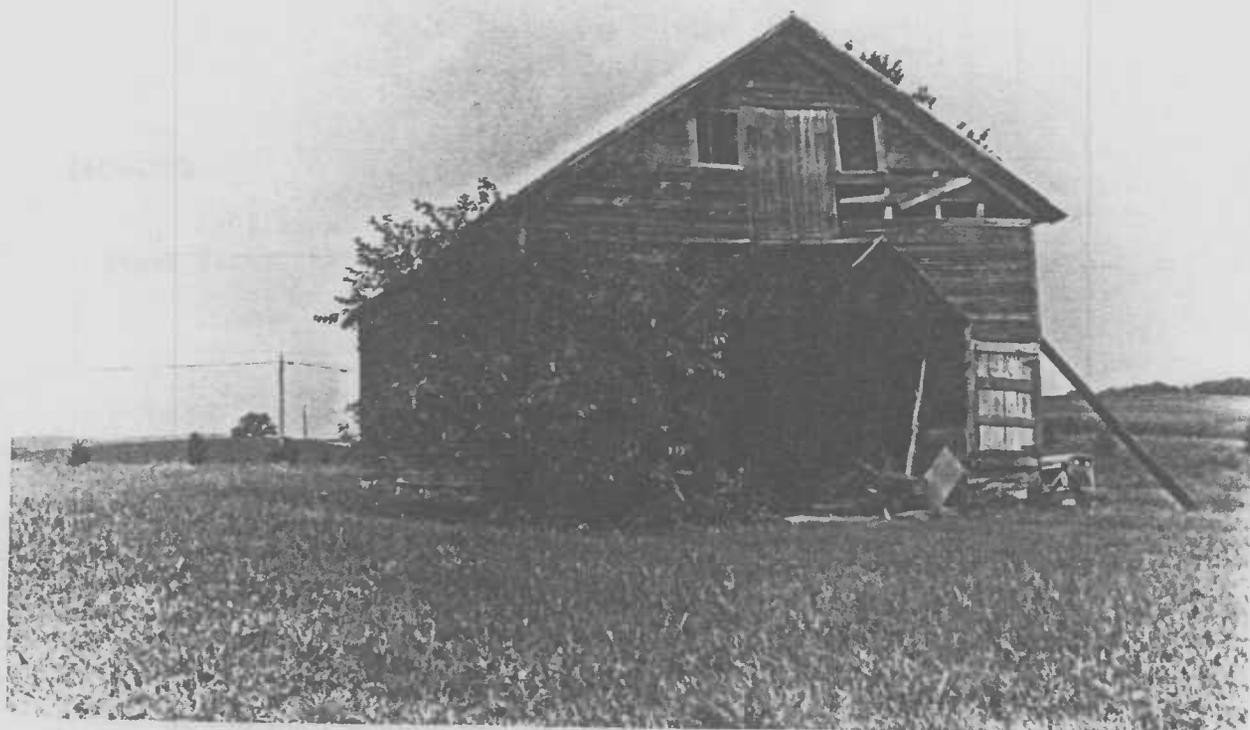
corn crib, view from southwest
24/24
