CARR - 404

# Maryland Historical Trust State Historic Sites Inventory Form

**1. Name** (indicate preferred name) Hazard Clark Farmhouse

street & number 41 WTR Lane  not for publication

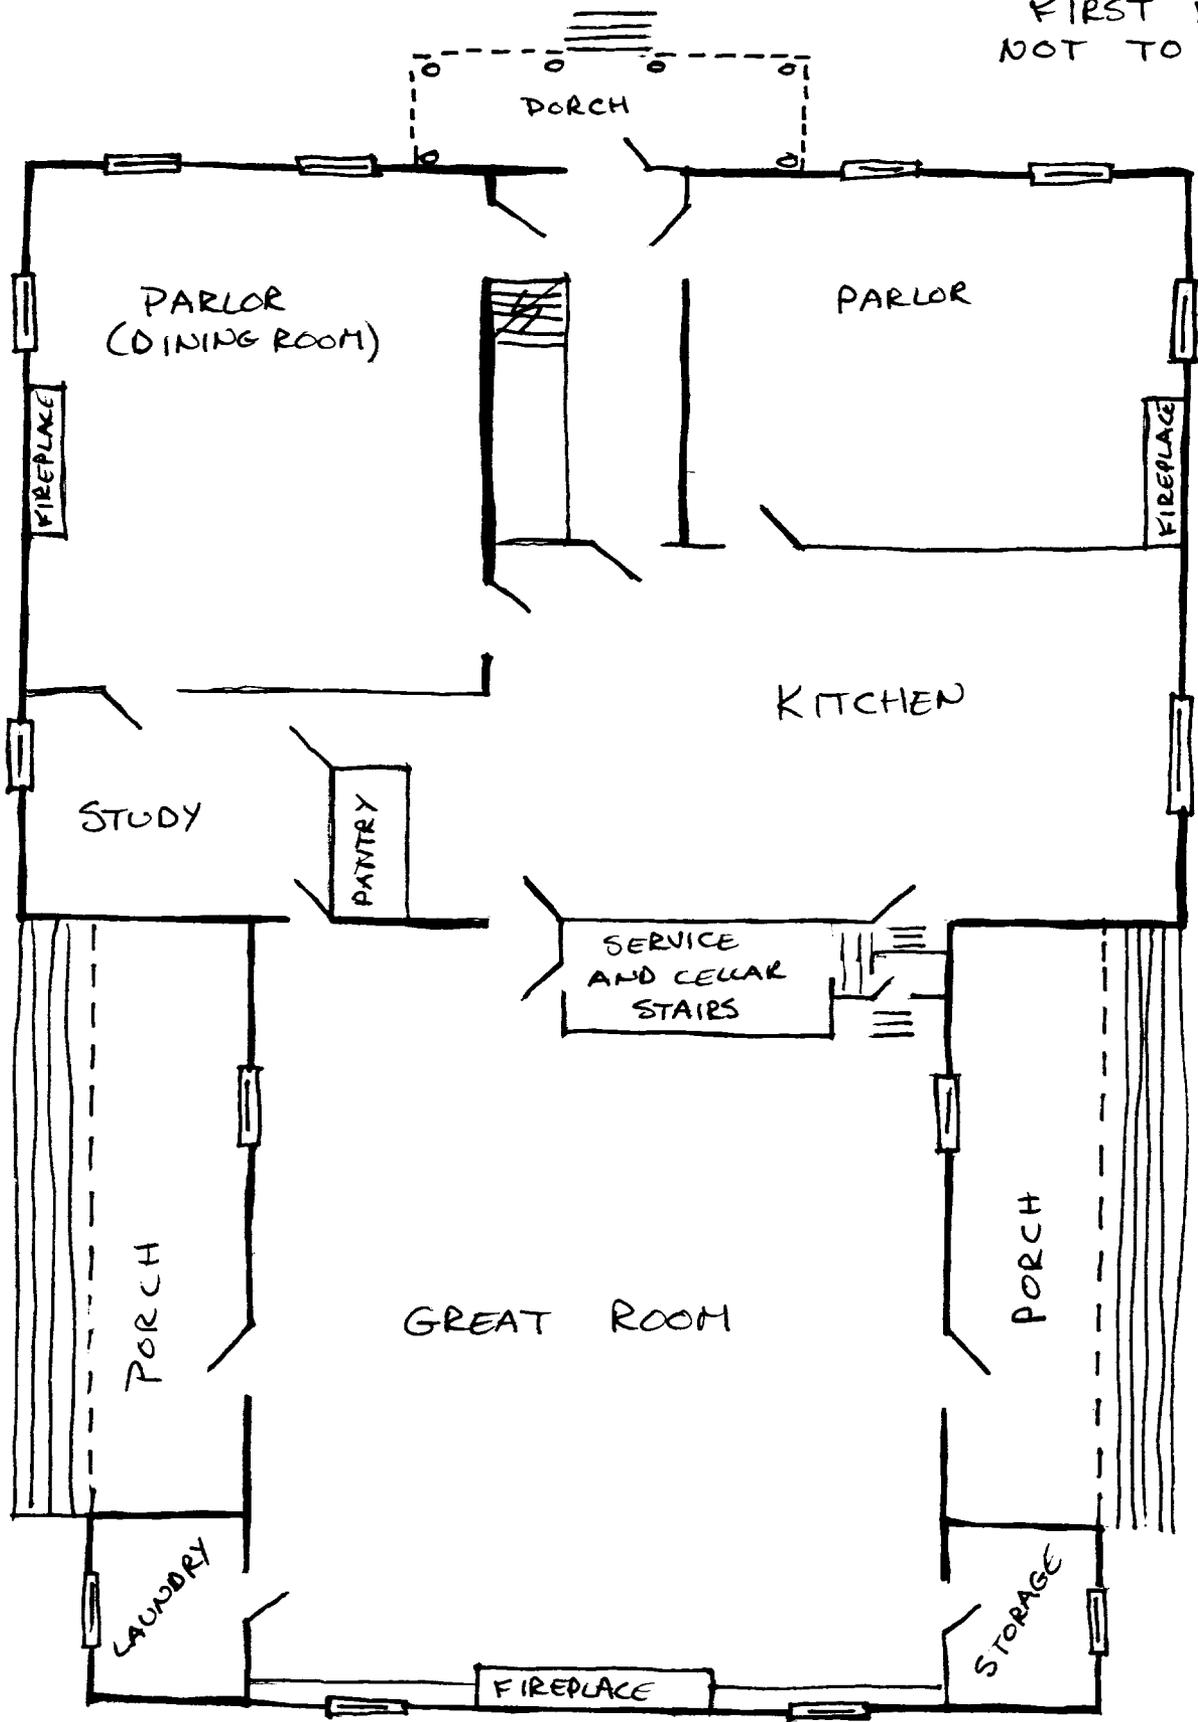
FIRST FLOOR  
NOT TO SCALE

Originally, the interior of the main block of the house probably consisted of a narrow central hall, flanked by large parlors with smaller rooms behind, which remains mostly intact only on the north (right) side. Two doors lead to the parlors just at the entrance and the hall now ends at a modern door located at the rear of the open-string staircase, which rises on the right. The interior doors for the most

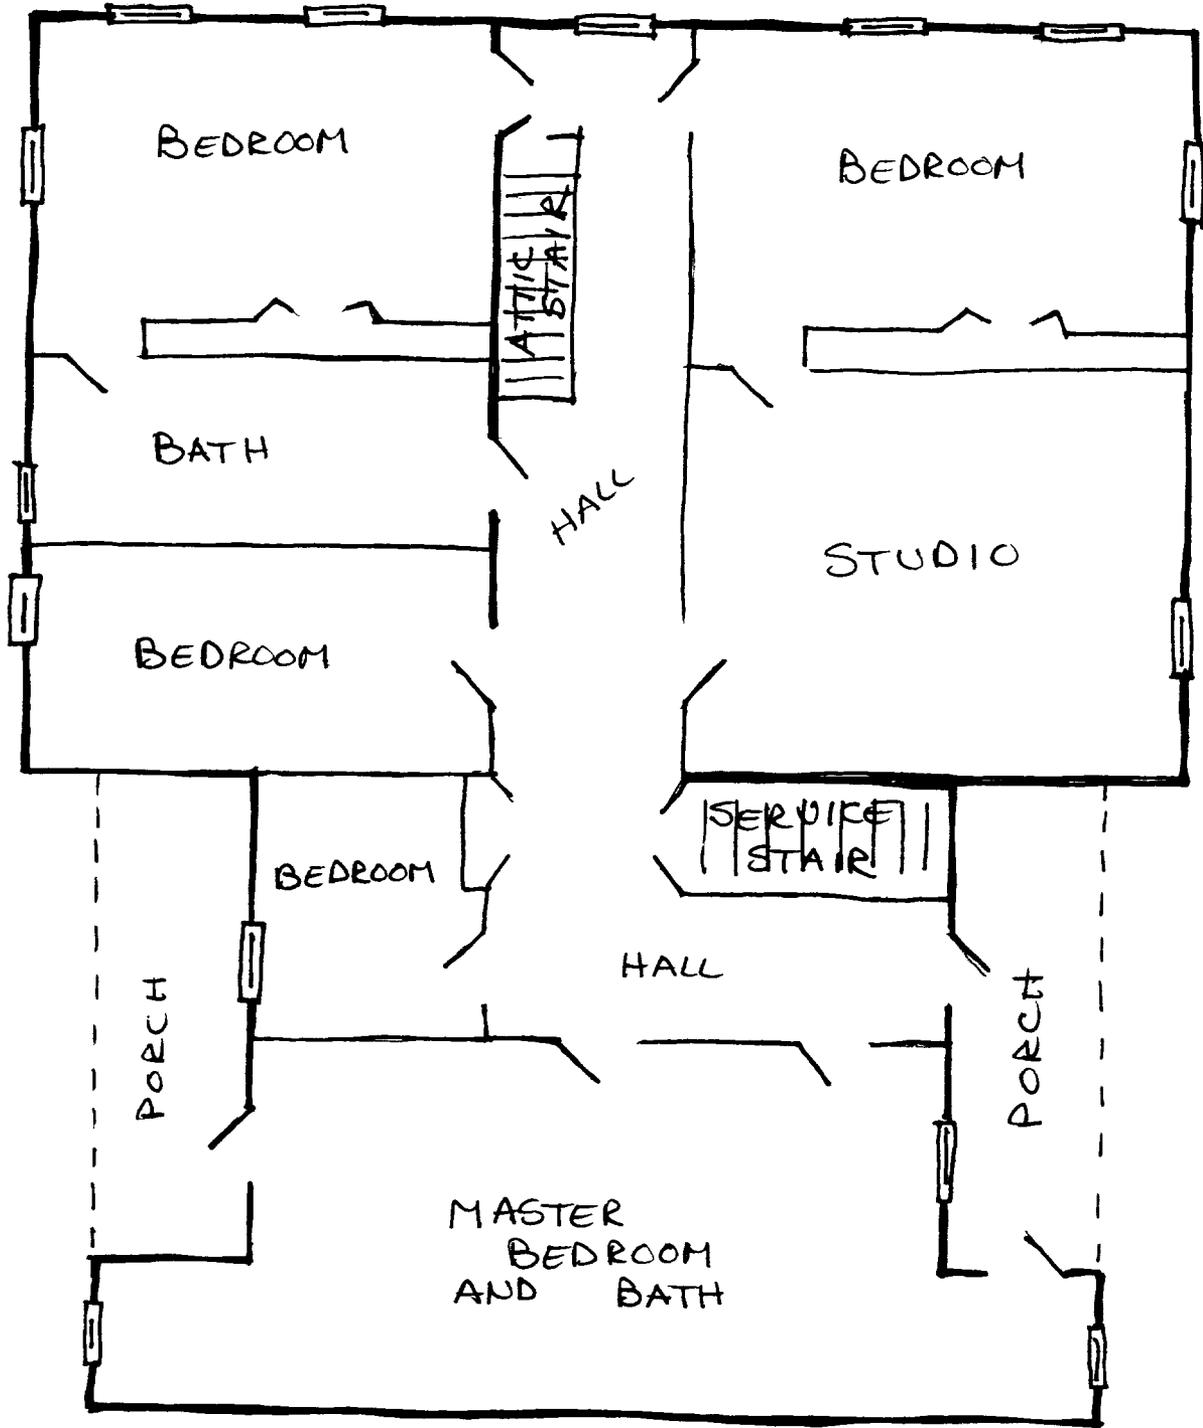
CARR 404  
HAZARD CLARK FARM  
SECOND FLOOR  
NOT TO SCALE

The original plan of the second floor, main block, was like that on the first floor: two large rooms on either side of the central hall, with a smaller room behind, with the hall running back to the rear wing. The west walls of the front rooms have been moved forward to accommodate a modern bathroom on the north side (where the small, modern window was added) and also a modern closet along this wall in both north and south front rooms.

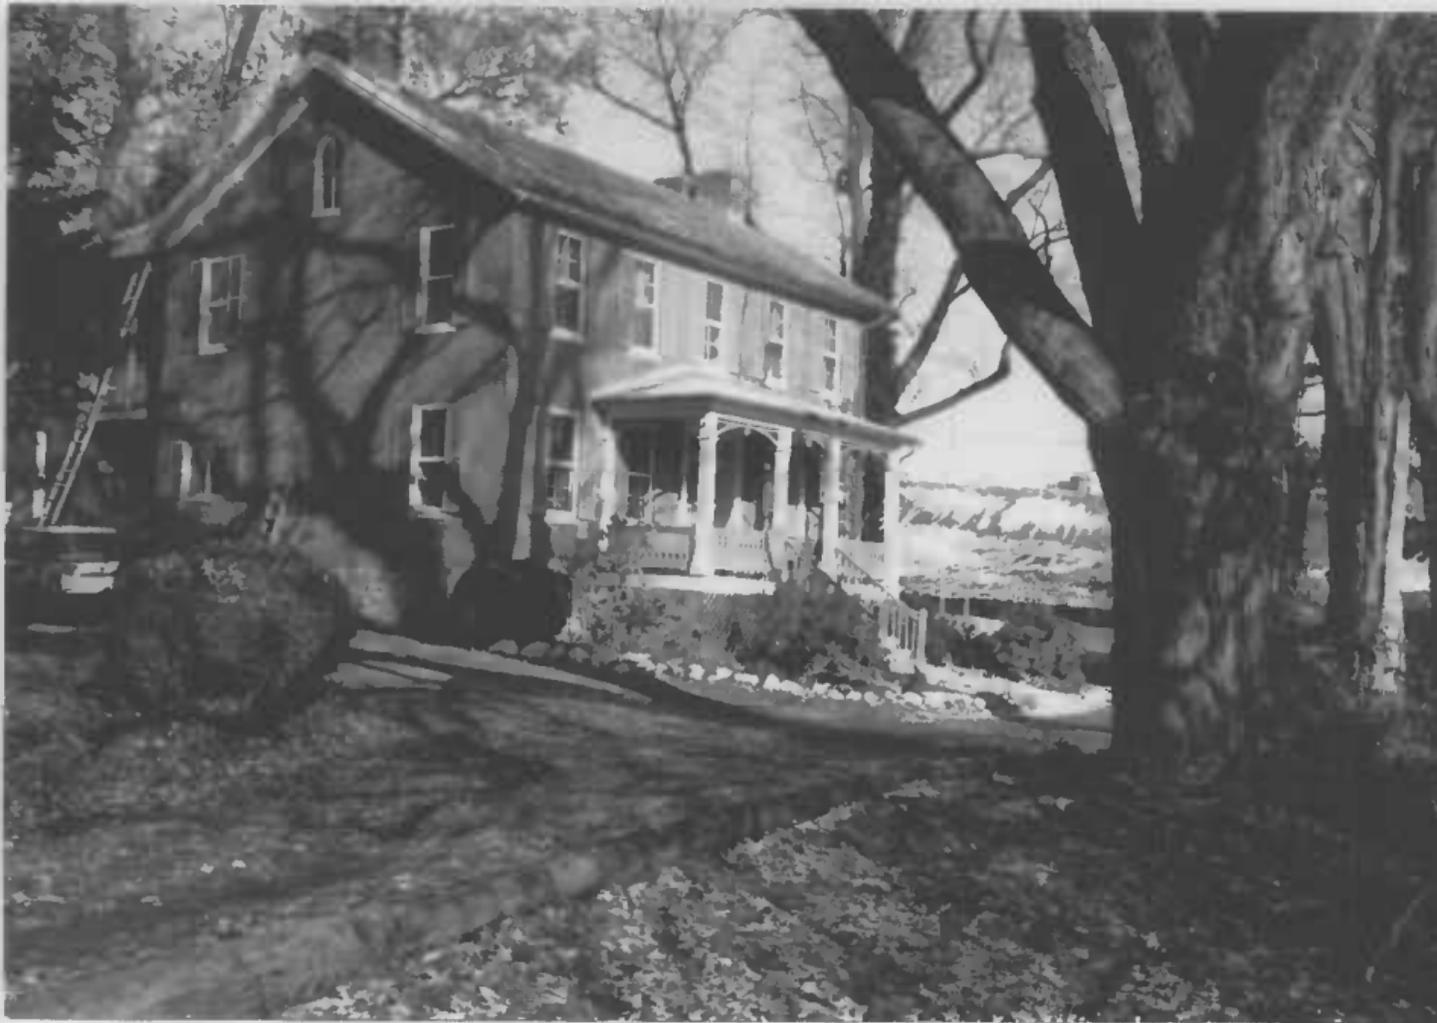
Hazard Clark Farmhouse . CARR-404  
41 W TTR Lane  
East and south elevations

The front (east) facade consists of five bays, dominated by a large three-bayed wooden porch sheltering the central front door. Slender square tapering columns support the porch's hipped roof. Machine sawn balustrades stretch between the columns and simple corner arches meet in the center of the porch bays at a turned acorn finial. A set of wide wood steps with square balusters rises to the porch. The deep-set, single front door is framed by a rectangular three-light transom and sidelights. Soffit and jambs are delicately beaded. The door has four recessed panels and a wide granite sill. The windows of this front facade, as well as most throughout the house are 4/4 double hung sashes. They appear original to the house. They are capped with flat vertical brick lintels. Trim is plain and narrow, with wood sills. The wooden shutters frame both sides and most appear original. The raised cellar area has a 6/3 double

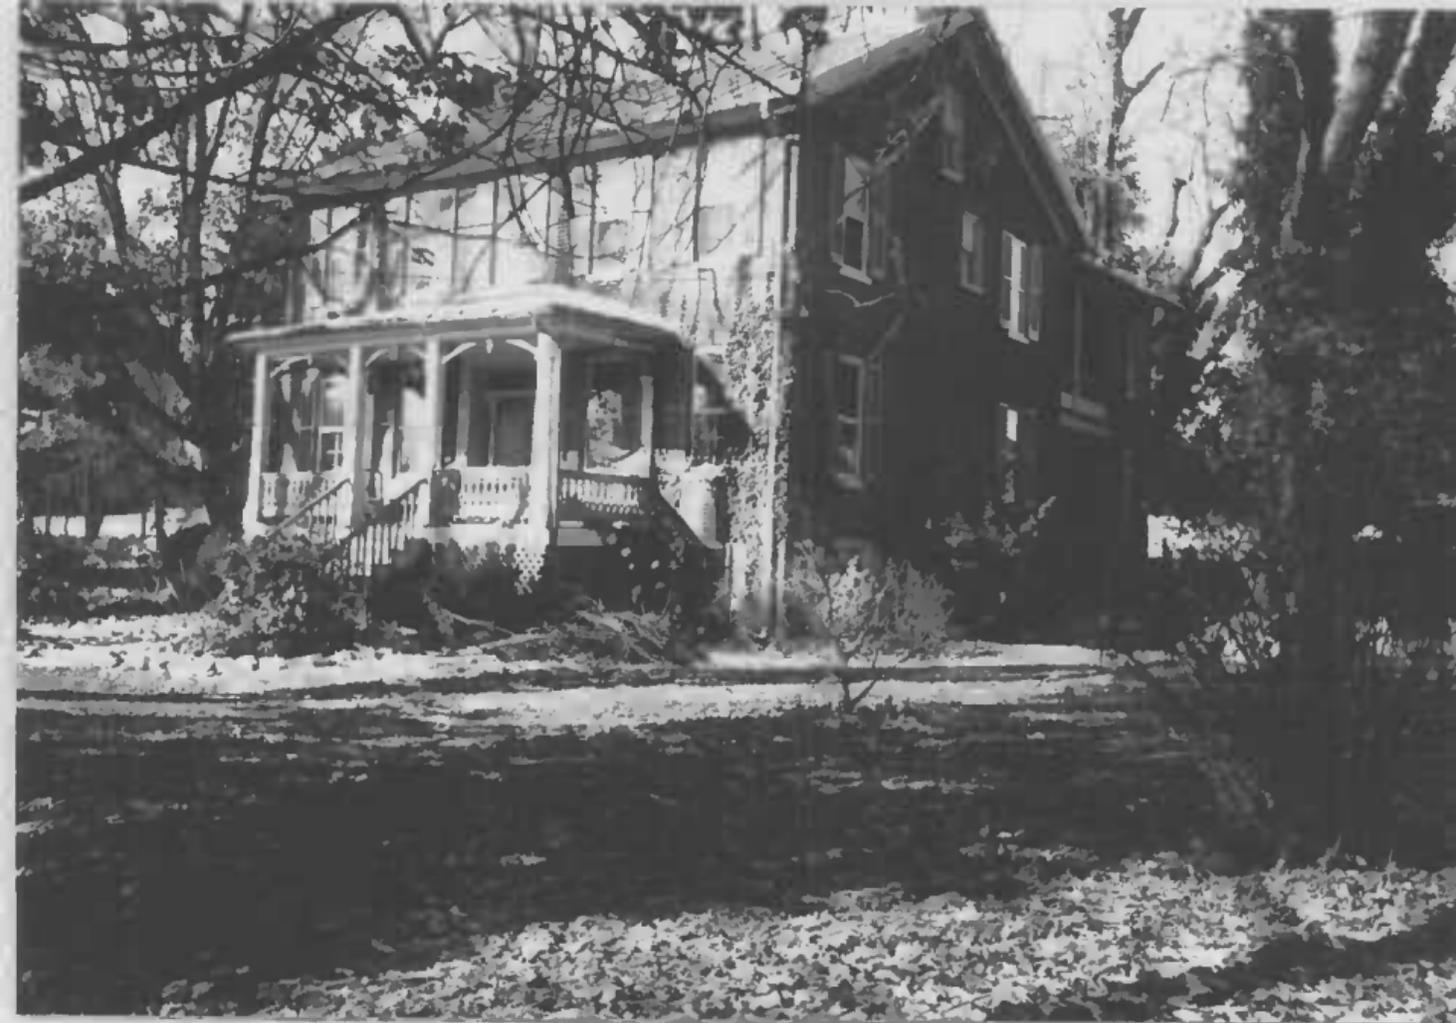
Front (east) and north  
elevations

The north gable end of the main block consists of two bays with windows on the first floor, two bays with an added modern window on the second, and a round arched window with no shutters in the gable peak. The cellar level has a short but wide six paneled door at the east end, reached by three stone steps down and a window on the right like those on this level at the front.

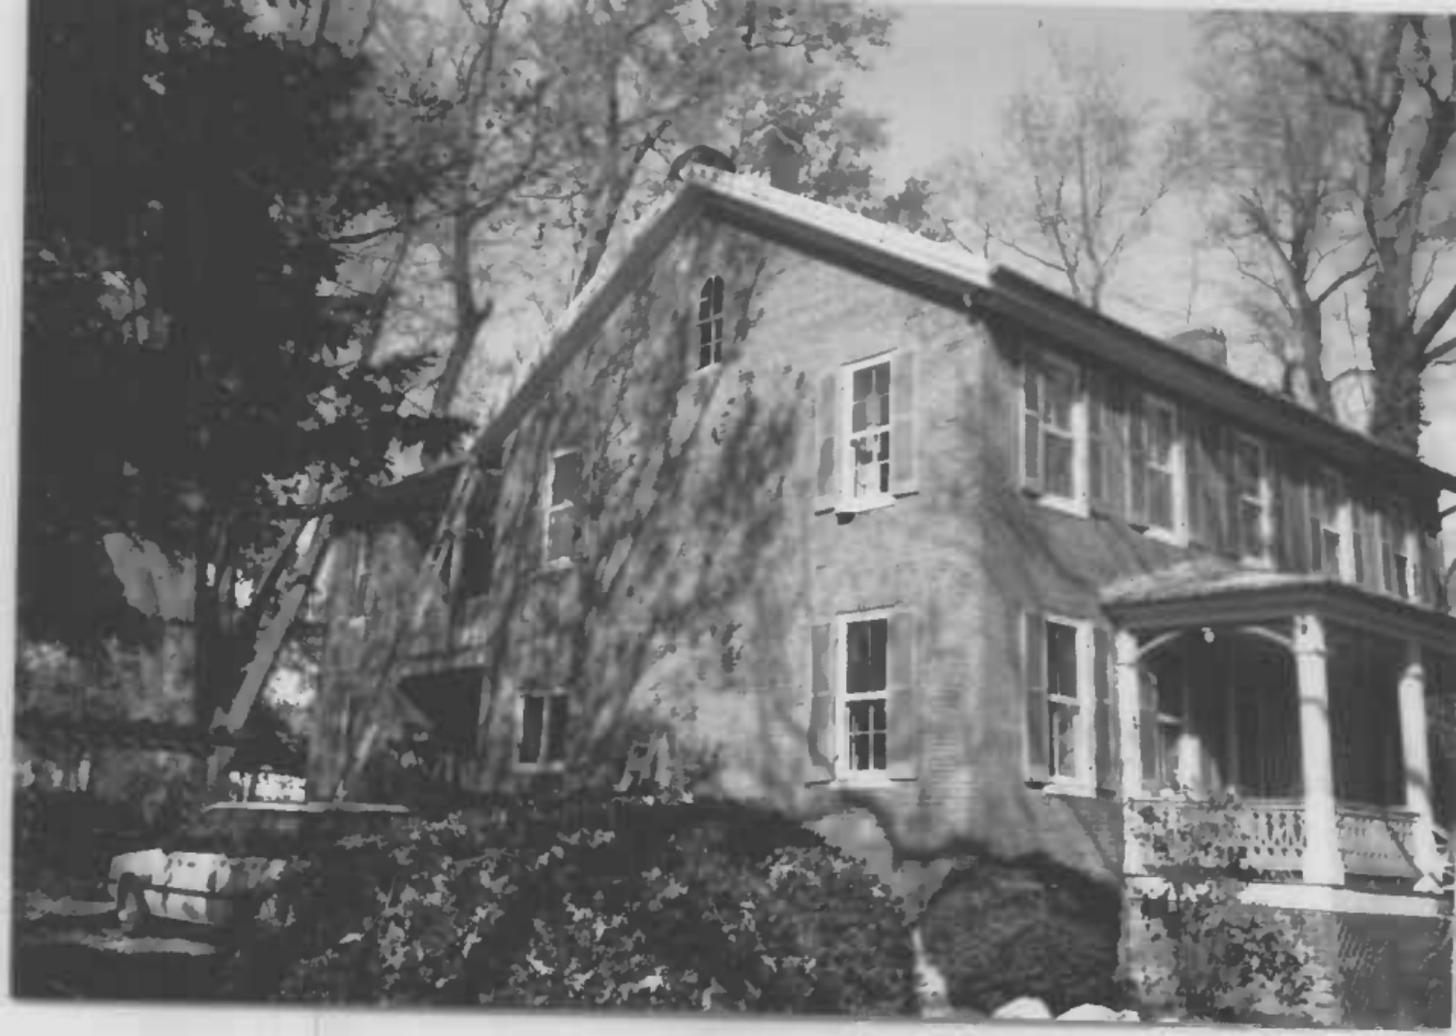
South elevation

The south gable end of the main block also has two bays on the first and second stories. The rear original window on the first floor has been replaced by a modern large casement window. The gable peak on this side also contains a round arched window. The cellar level has no windows, but a small square grate is at the right and a deeply recessed opening (blocked by wood) is at the left.

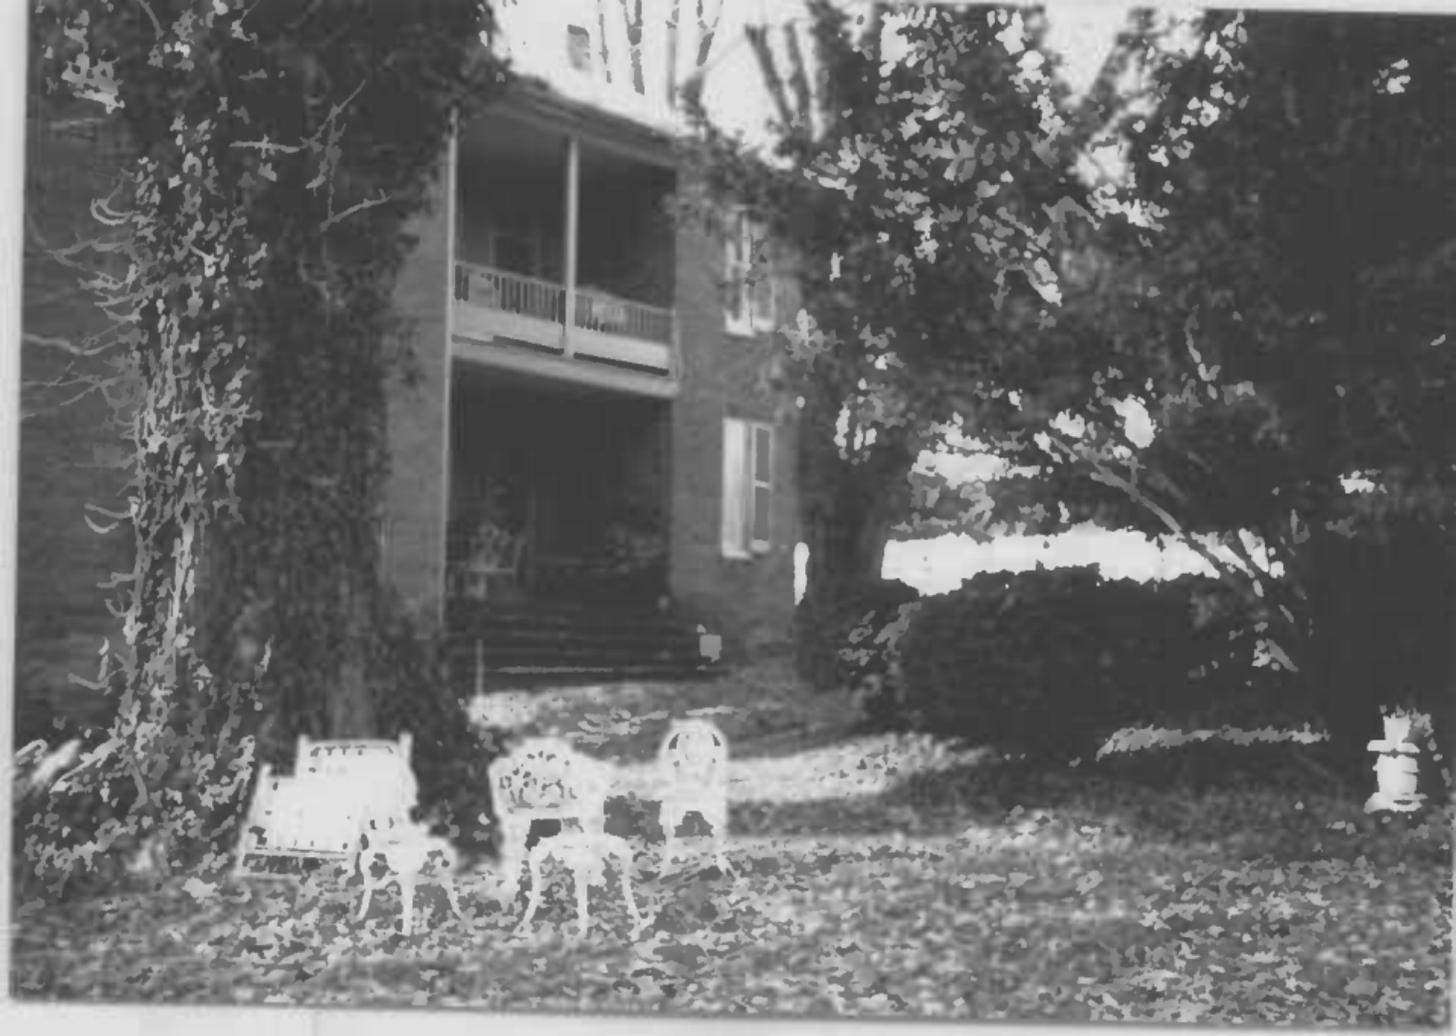
Rear wing, west elevation

The rear (west) gable end of the rear wing has two bays on the first story, consisting of a twelve-paned casement window. The second story and attic level have no openings.

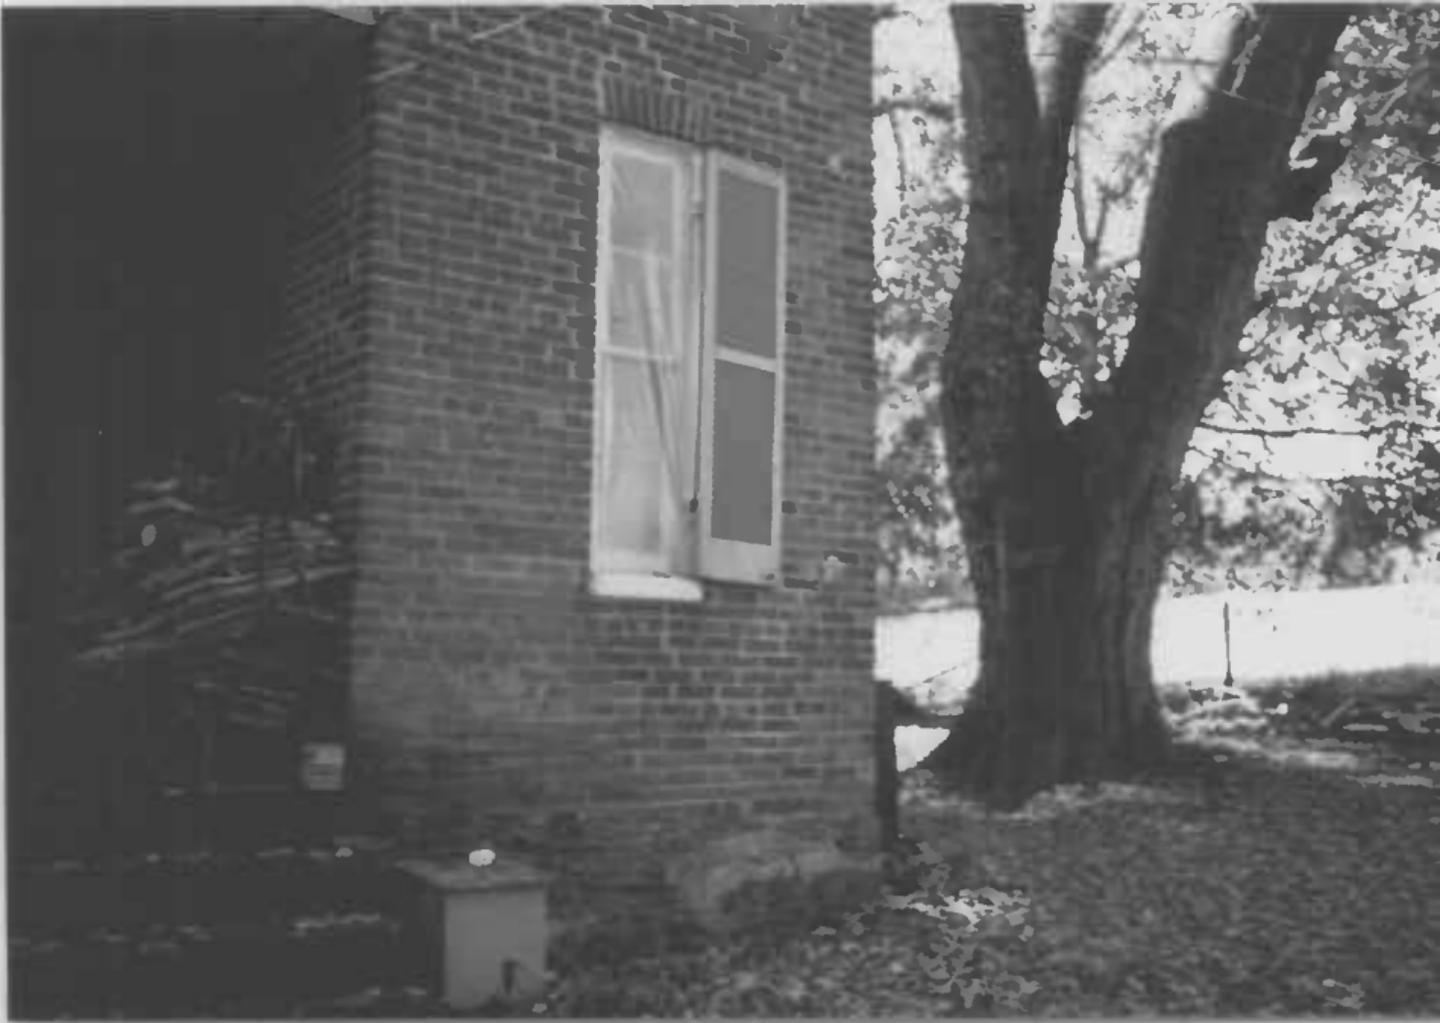
West elevation, rear wing  
Repaired foundation  
Hazard Clark Farmhouse

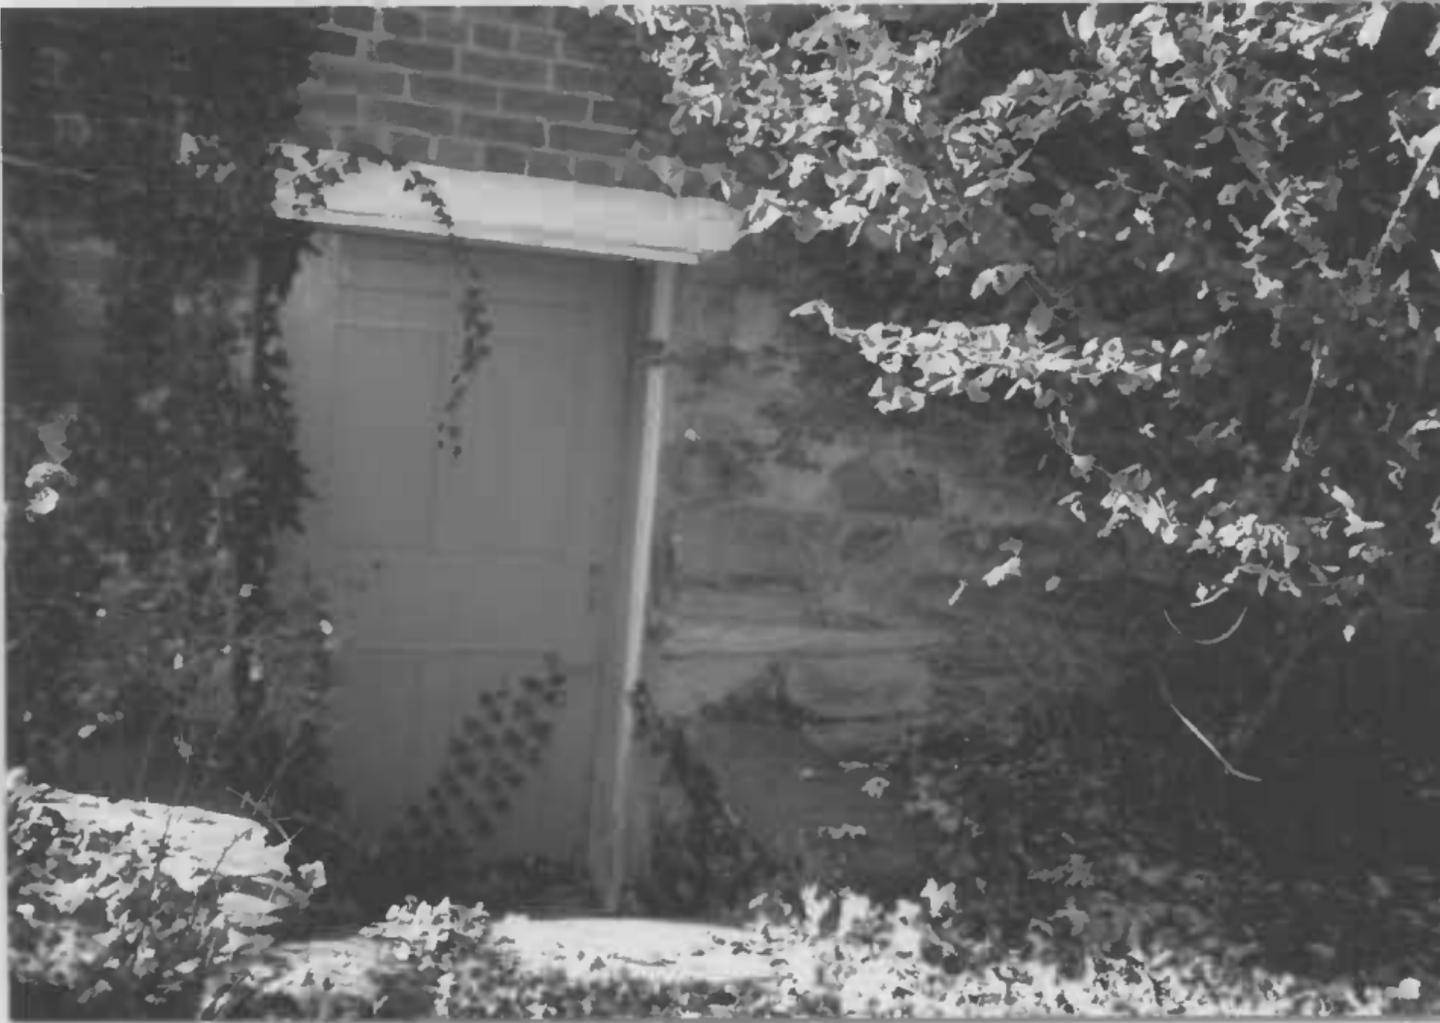
Cellar kitchen door  
West elevation  
Hazard Clark Farmhouse

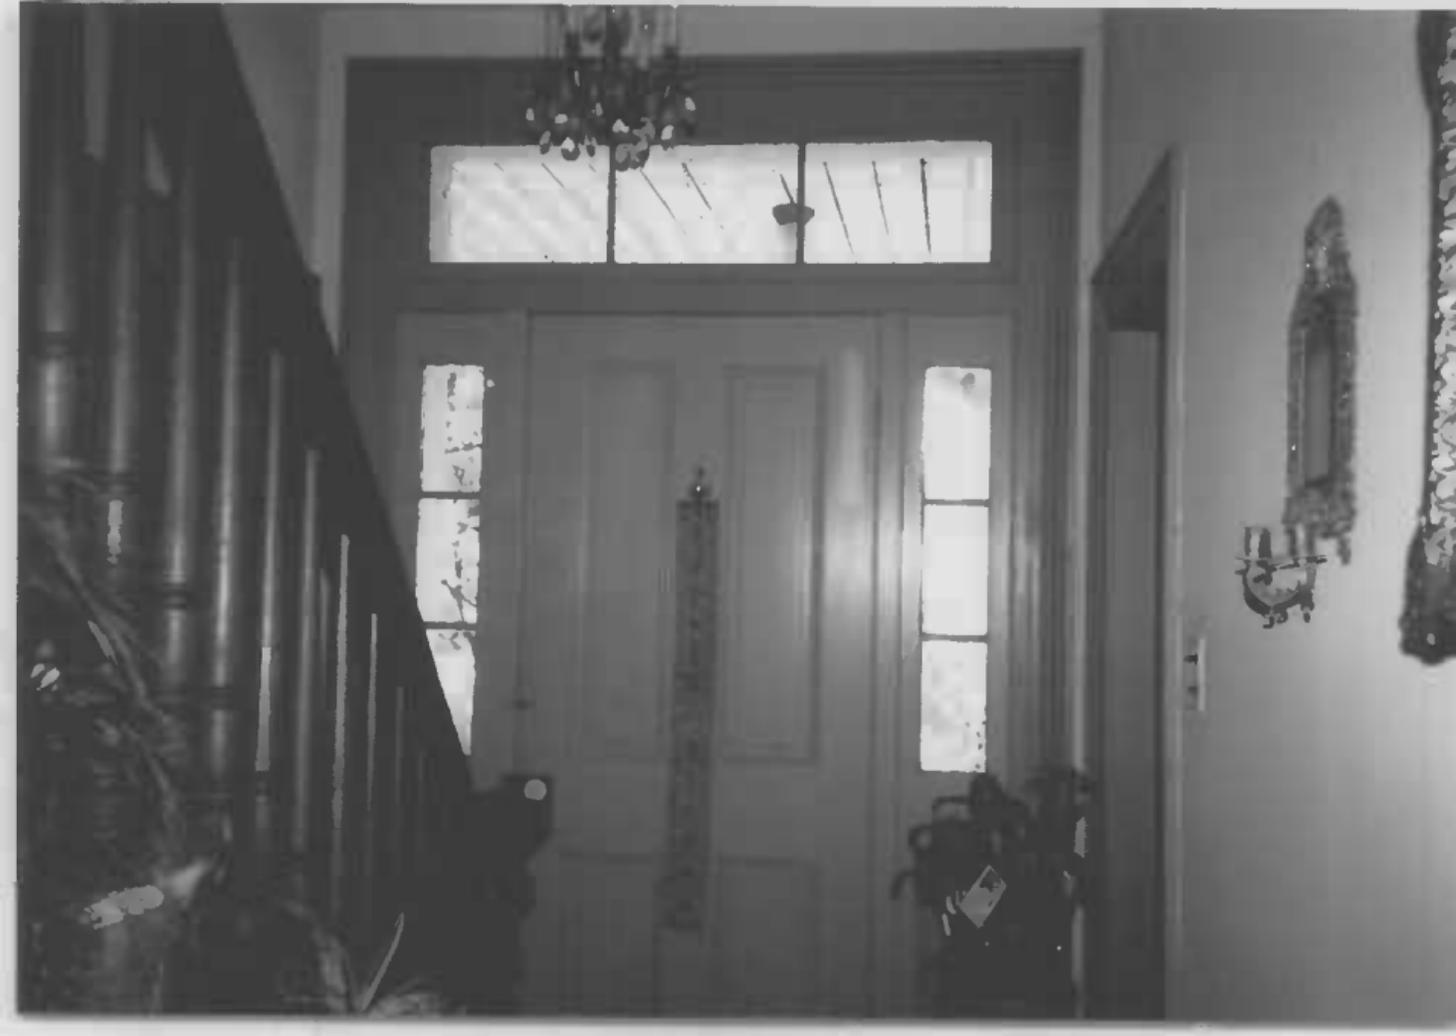
Interior, front door  
Hazard Clark Farmhouse

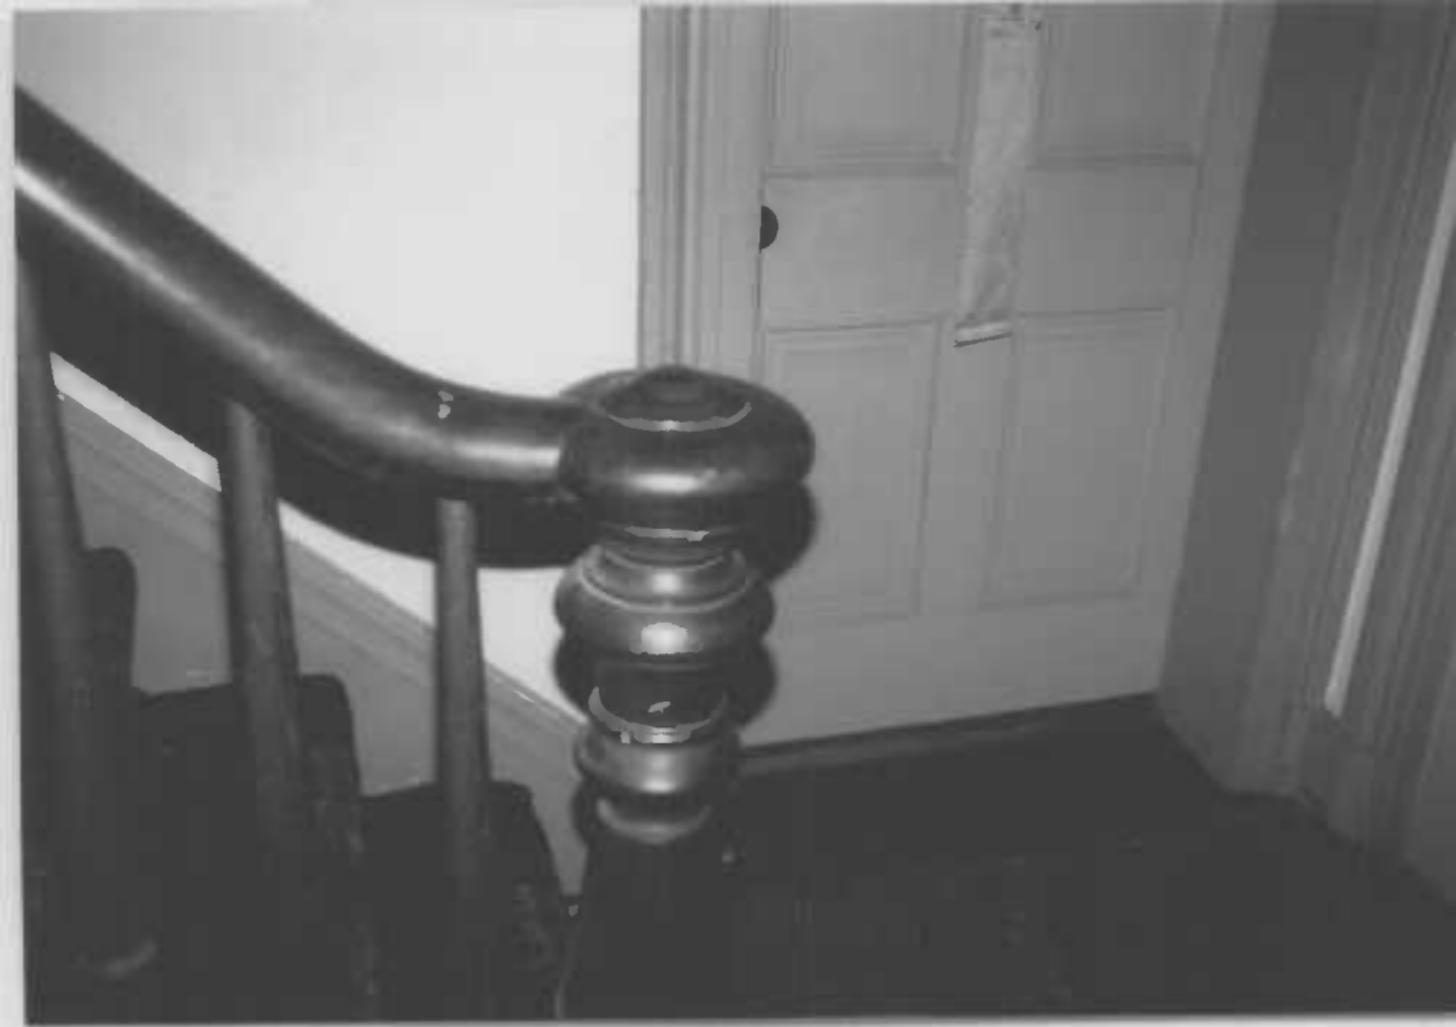
Newel post, dining room door

The newel post of the stairway is bulbous but gracefully turned. The balusters are spool turned at the bottom and taper gracefully up to the rounded handrail. The entire balustrade is of cherry and continues in the same style and treatment to the second floor, where the railing encloses the staircase. A separate enclosed staircase rises directly above the first to the attic.

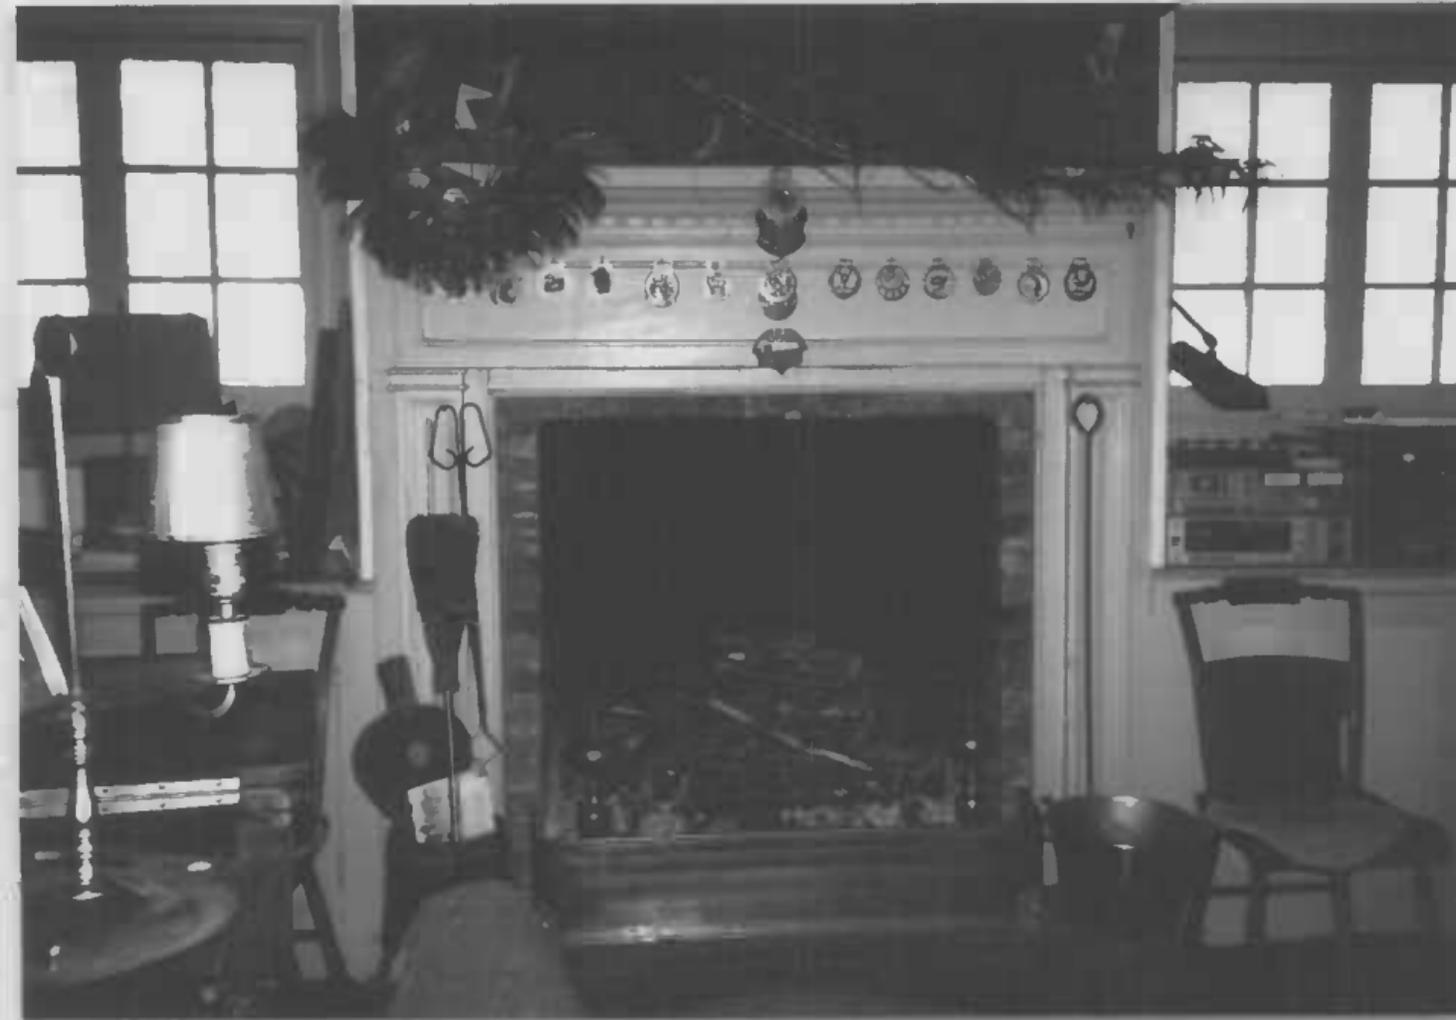
Fireplace in rear wing, ground  
floor, west wall  
Hazard Clark Farmhouse

The major part of the rear wing on the first floor consists of one great room, dominated by a large raised brick hearth. The fireplace has raised moldings on the architrave and dentil moldings under a wide mantle shelf. The over mantle is of brick, in a running bond pattern. The casement windows, whose openings at least are original, flank the fireplace and are above built-in cabinets (not original). The wings on either side of the room formed by the recessed porches have been enclosed to serve as glass storage on the south and a modern laundry room on the north. Cut nail heads are evident.

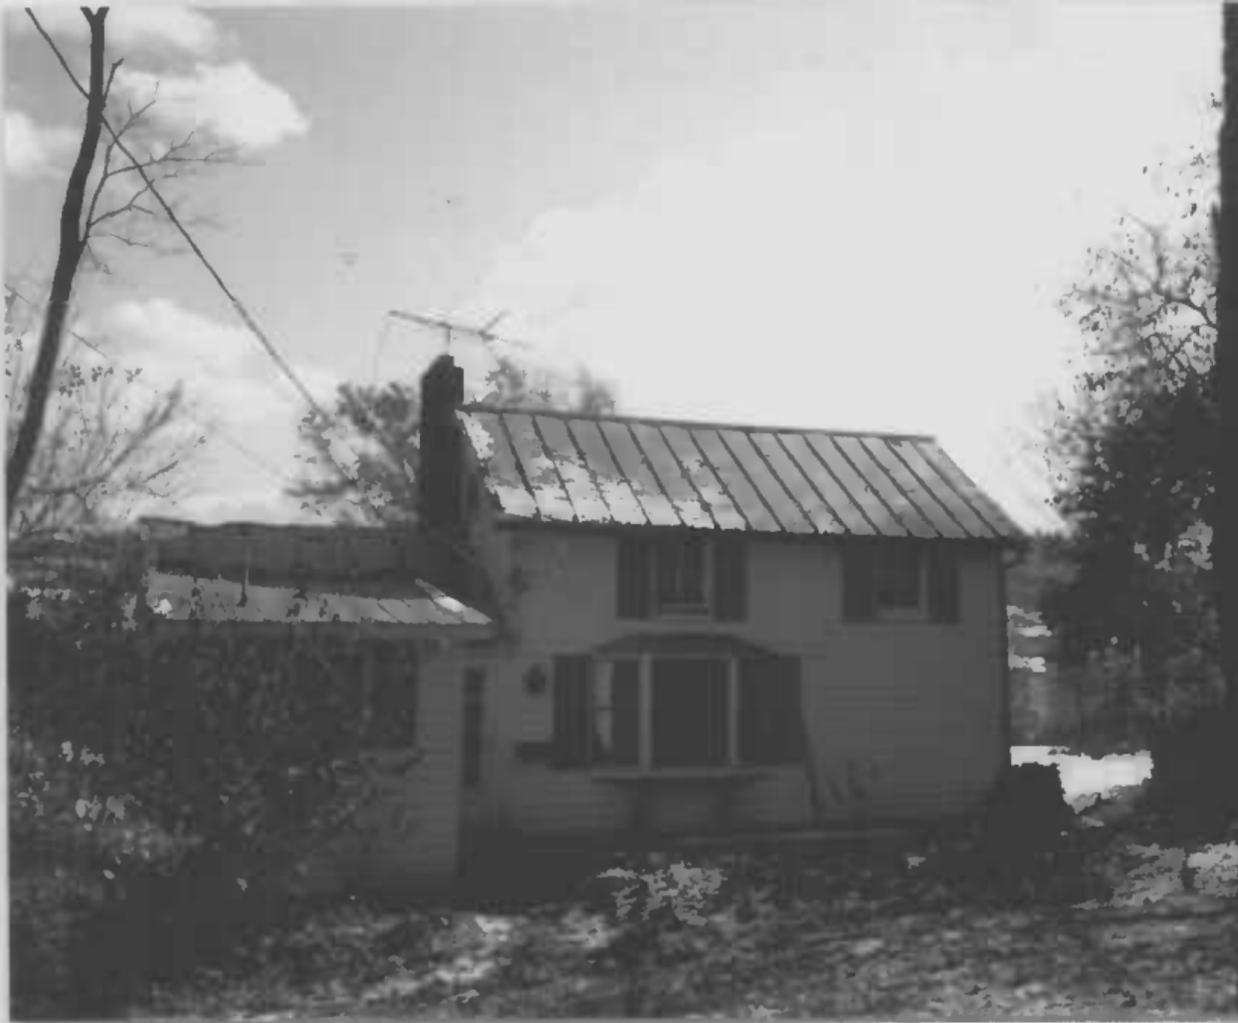
Tenant house, originally springhouse  
and dairy

Among the other buildings on the property, both the large frame bank barn and smaller house barn structure stand on random stone foundations that appear older than their upper construction. The springhouse/dairy has been so altered as to lose its original identity, although it still contains the trough in the cellar floor to cool the milk and cheese. No longer on this property, but part of the original site is a lime kiln, which has been rebuilt.

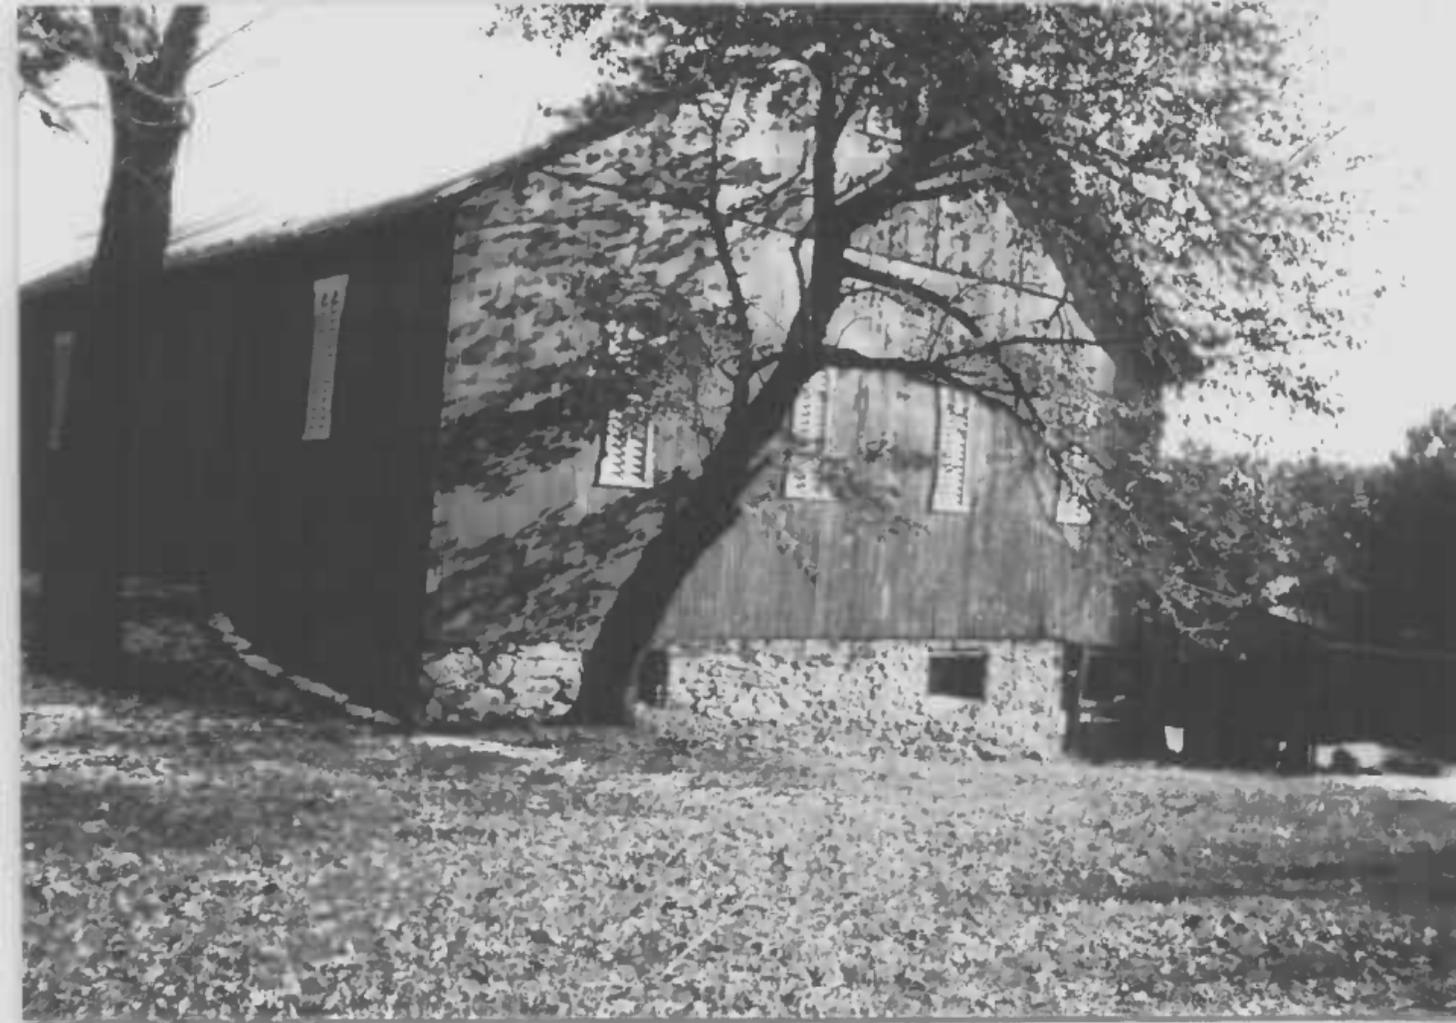
Bank barn, Hazard Clark Farm

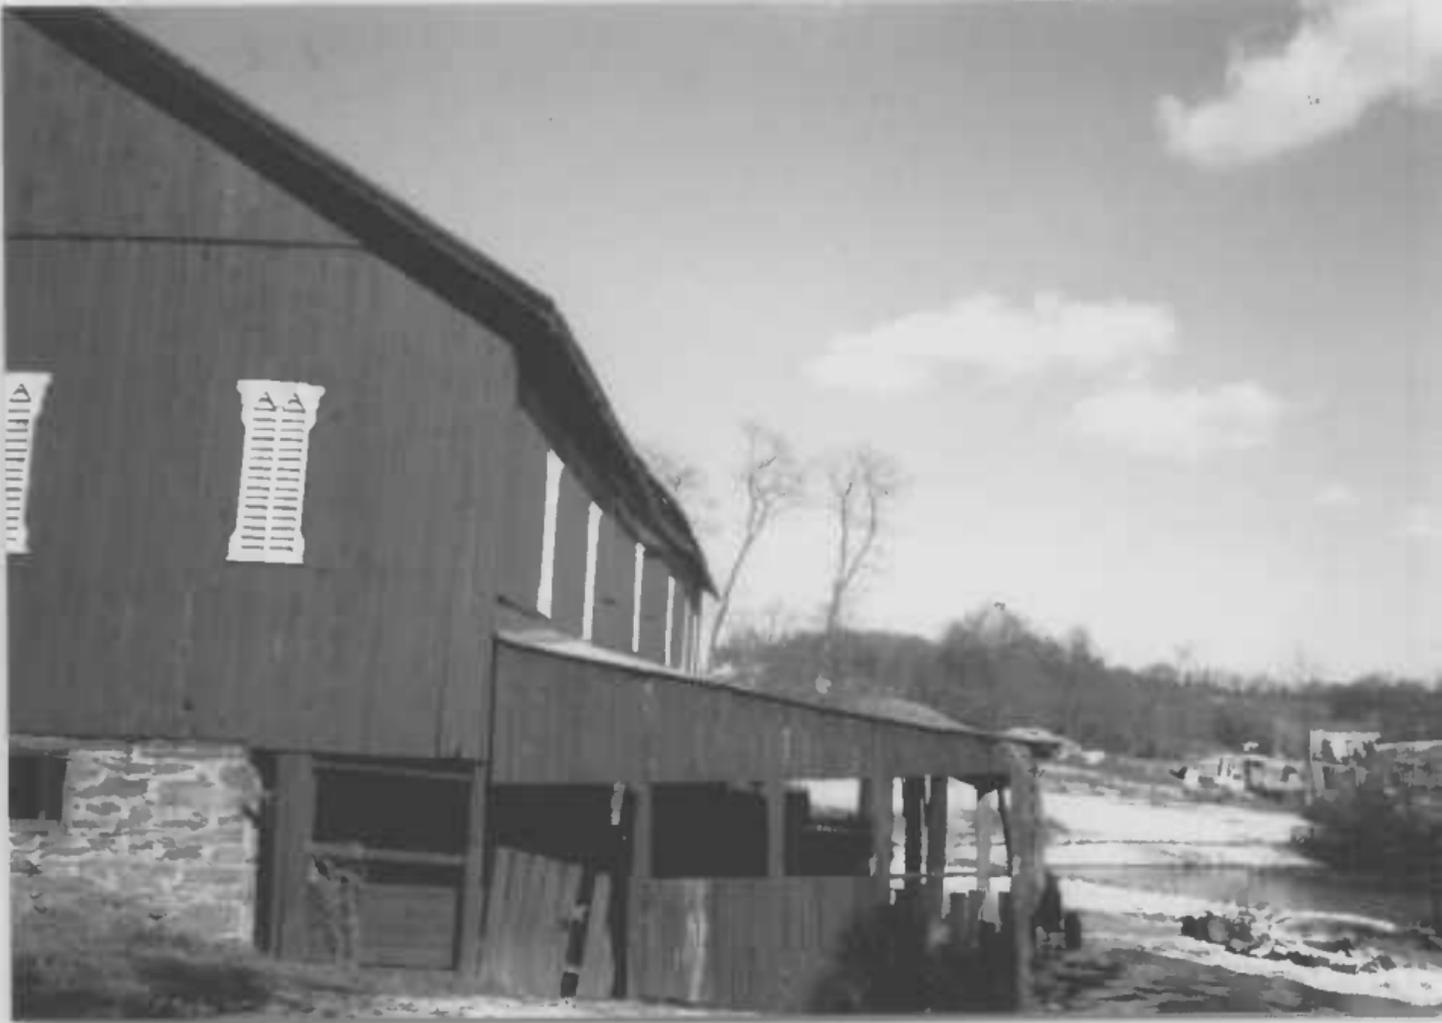
Bank barn, rear view  
Hazard Clark Farm
