CARR - 404

# Maryland Historical Trust State Historic Sites Inventory Form

**1. Name** (indicate preferred name) Hazard Clark Farmhouse

street & number 41 WTR Lane  not for publication

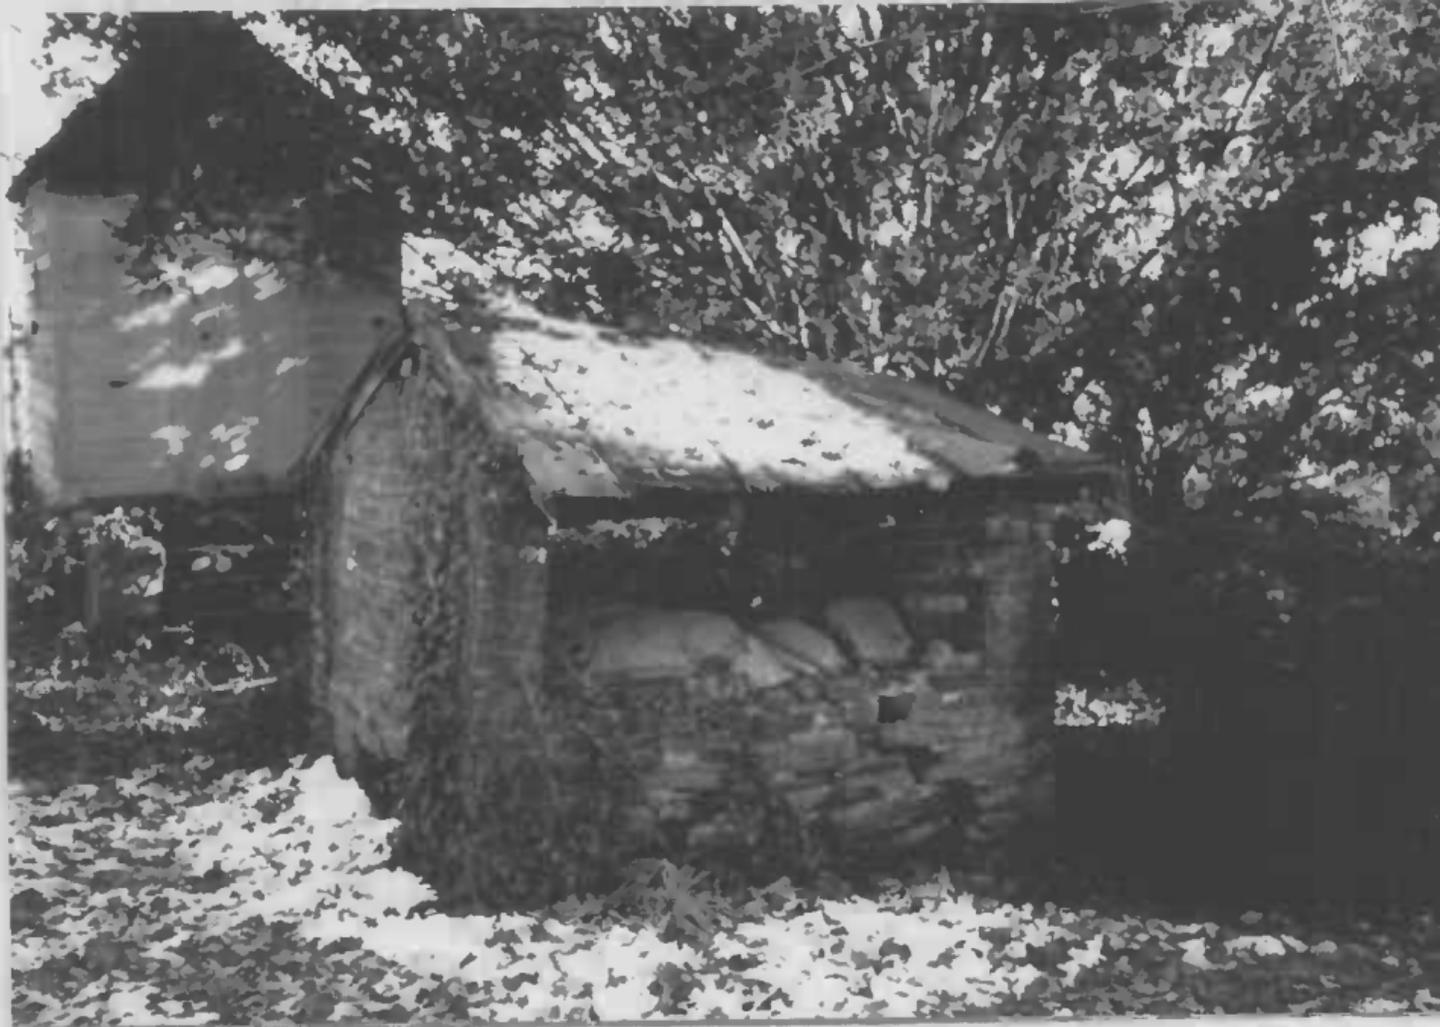
Foreground, Beehive oven CARR-404  
Background, former smokehouse  
Hazard Clark Farm

In the northwest sideyard are two interesting structures, believed to have been built when the house was first constructed. One is a roofed beehive oven, now in disrepair. Its roof is of standing seam metal set upon square wood columns with exposed eaves. Near this is a tall square frame structure originally a smokehouse. It now has a modern shingled roof with no chimney. Four wooden steps lead up to its flat wood door which has mismatched, modern hinges.

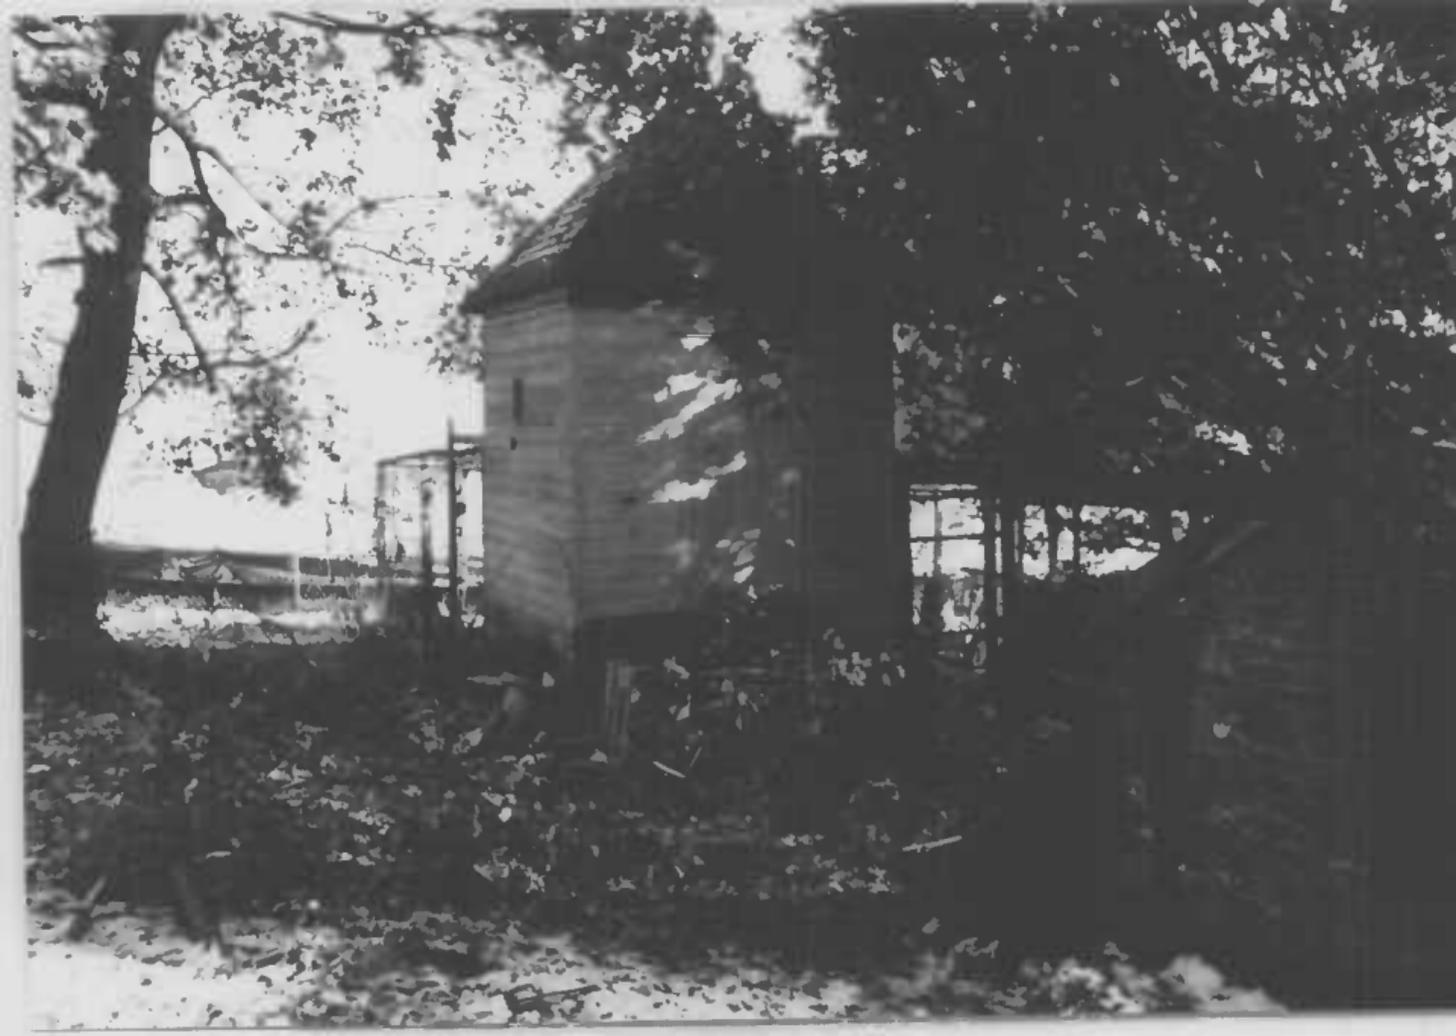
Smokahouse  
Hazard Clark Farm

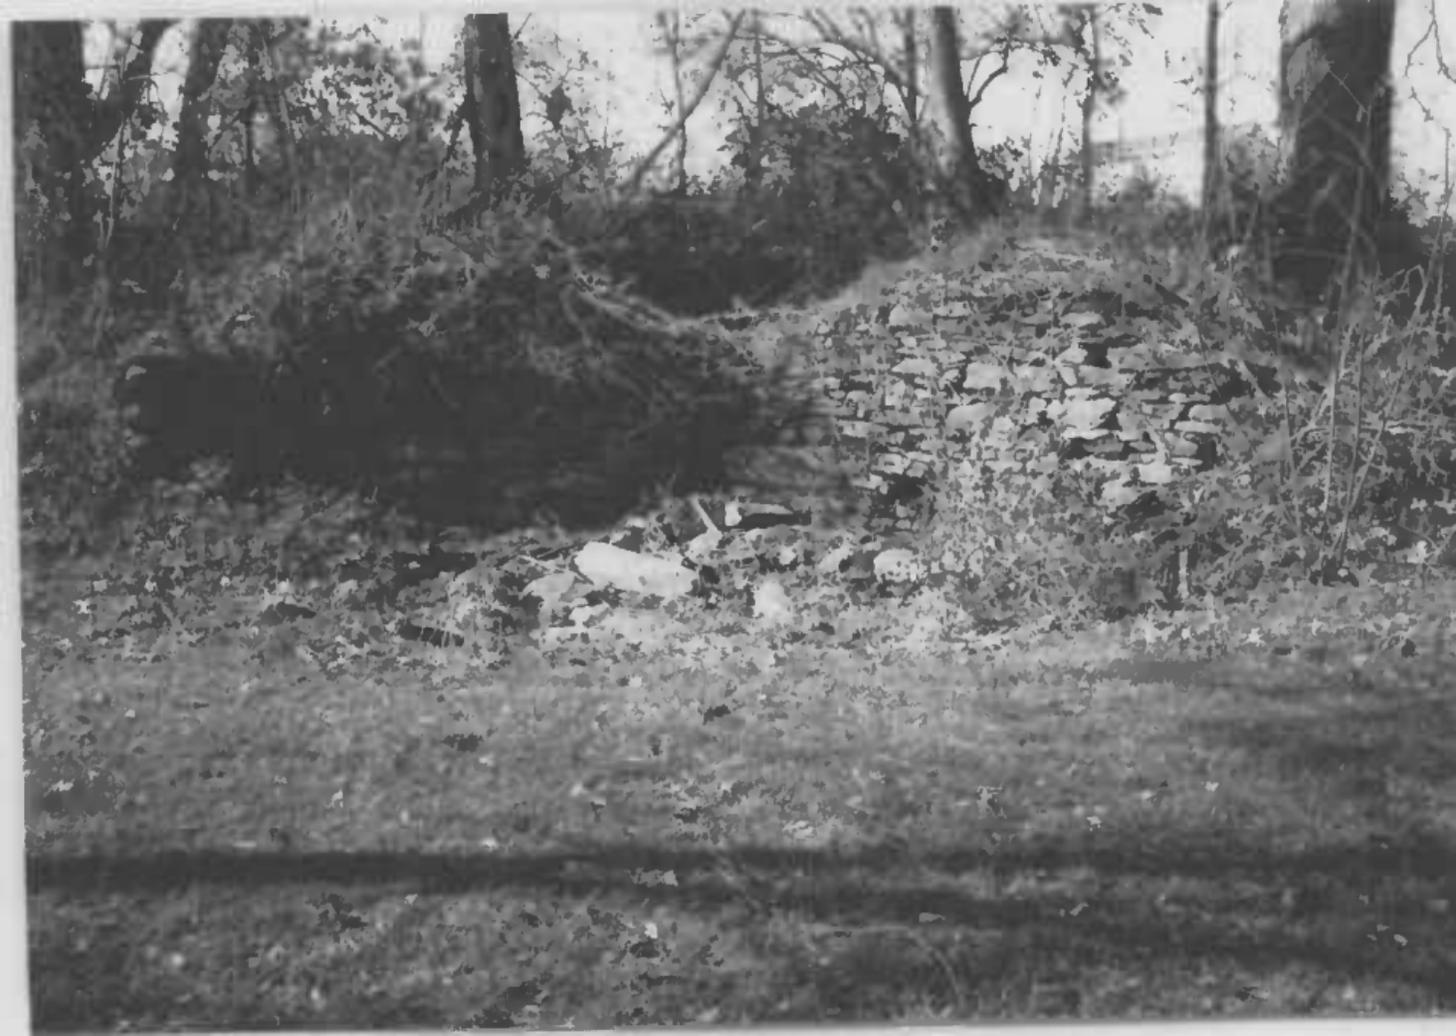
Lime kiln

Originally on farm property

Located in Furnace Hills, Quarry Ct.

Among the other buildings on the property, both the large frame bank barn and smaller house barn structure stand on random stone foundations that appear older than their upper construction. The springhouse/dairy has been so altered as to lose its original identity, although it still contains the trough in the cellar floor to cool the milk and cheese. No longer on this property, but part of the original site is a lime kiln, which has been rebuilt.

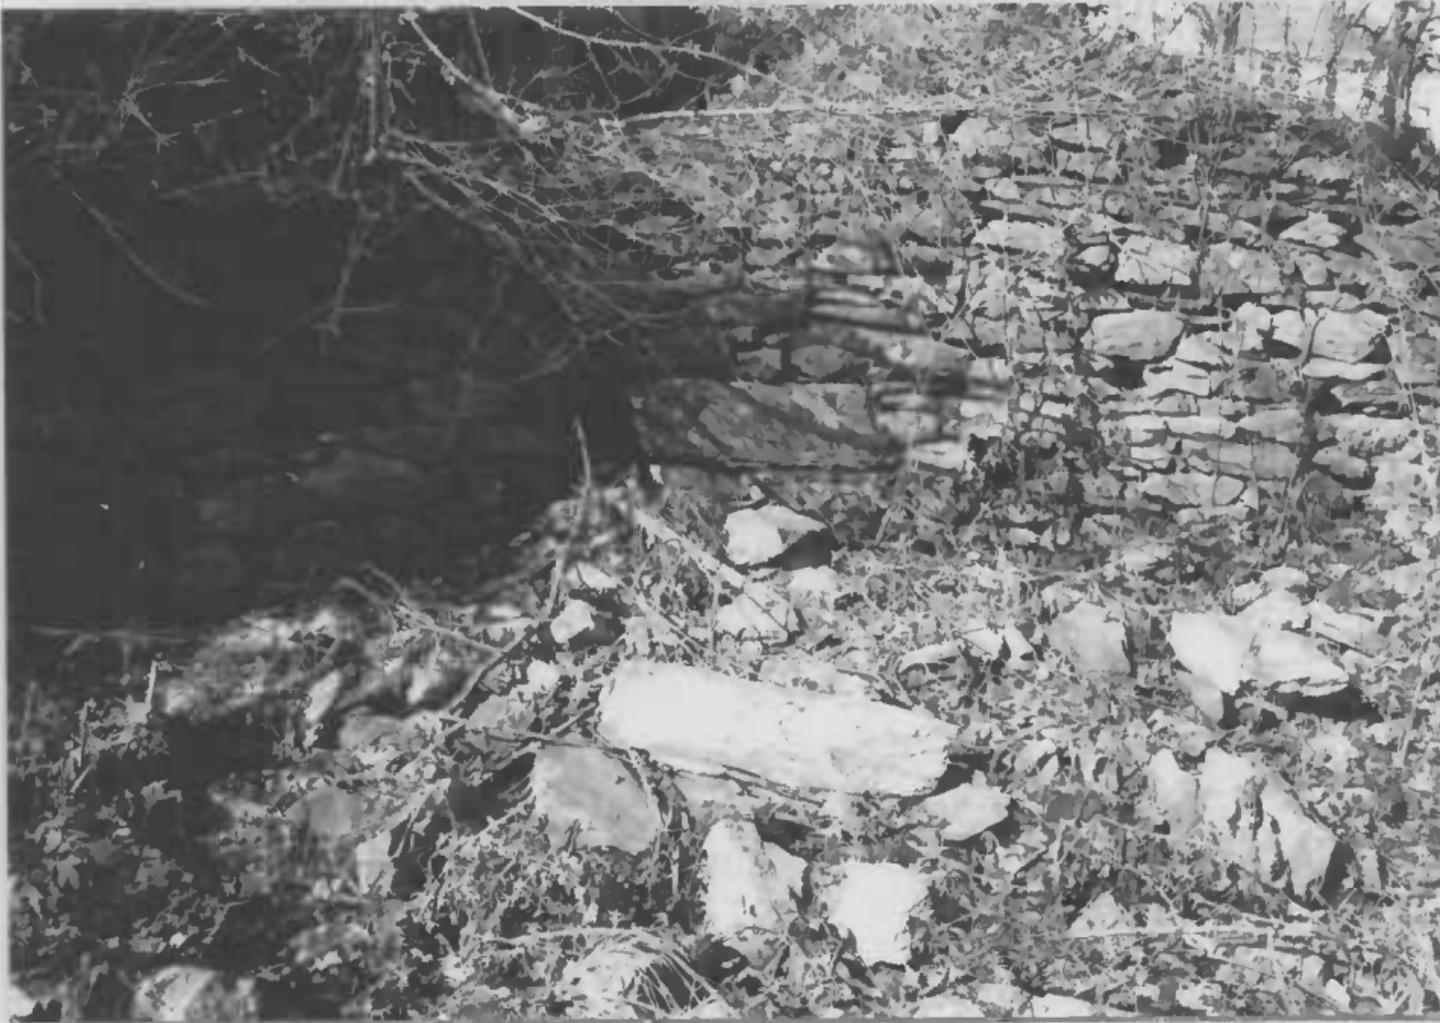
Limest. kiln, Furnace Hills, Quarry Ct

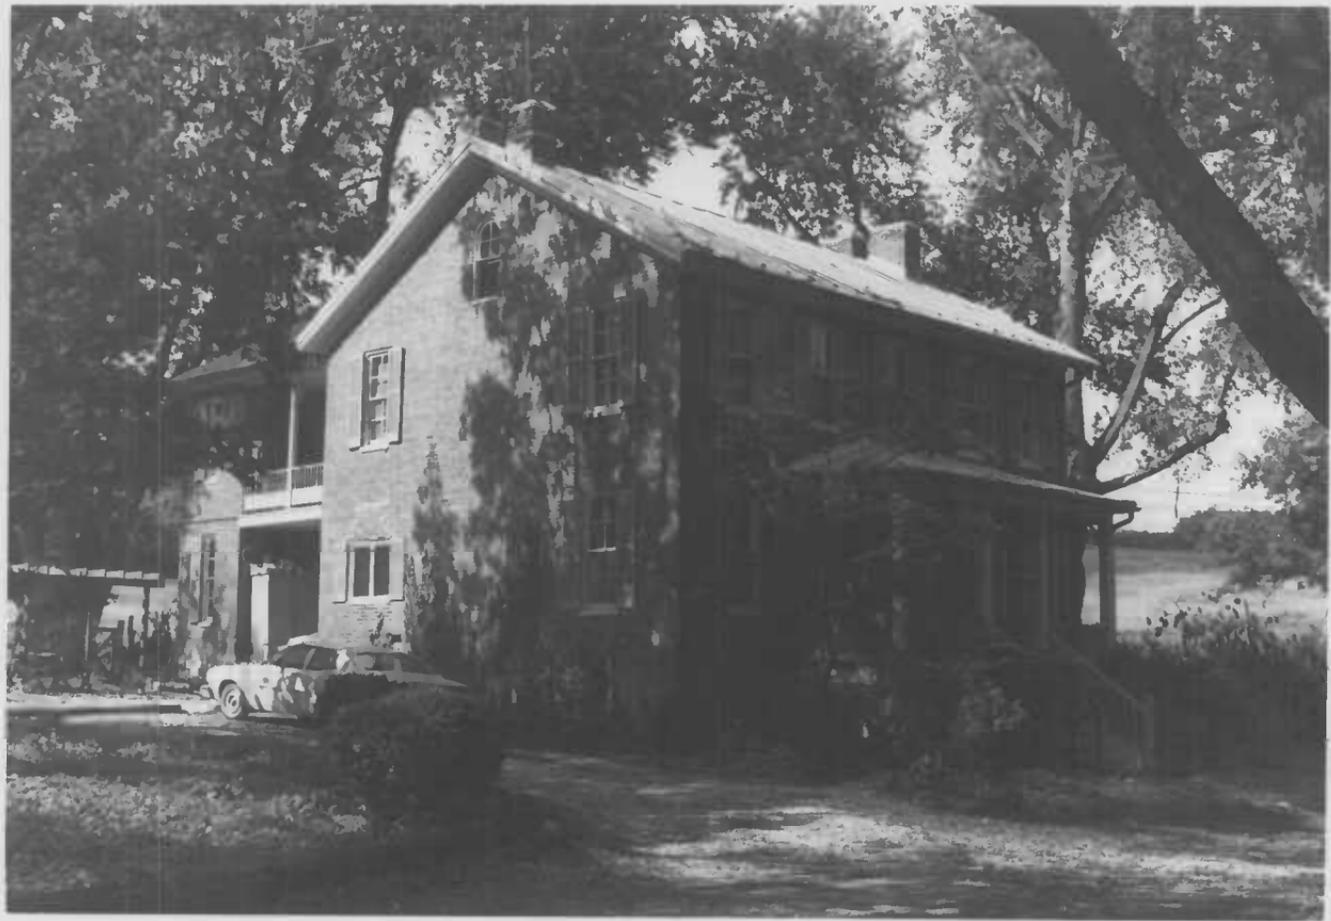
1. CARR-404                      41 WTRR LANE
2. Carroll County, Maryland
3. Joe Getty
4. August 1983
5. Md. Historical Trust, Annapolis, Md.
6. South & east elevations (camera  
facing northwest)
7. 1/2
