**Addendum to
Maryland Historic Trust
State Historic Sites Survey Inventory Form
CARR-621**

- 1. Name - Historic Name - Jesse Sherman House**
Common Name - Inge House

- 2. Location - 3060 Lineboro Road - east of MD 30, north side of Lineboro Road**

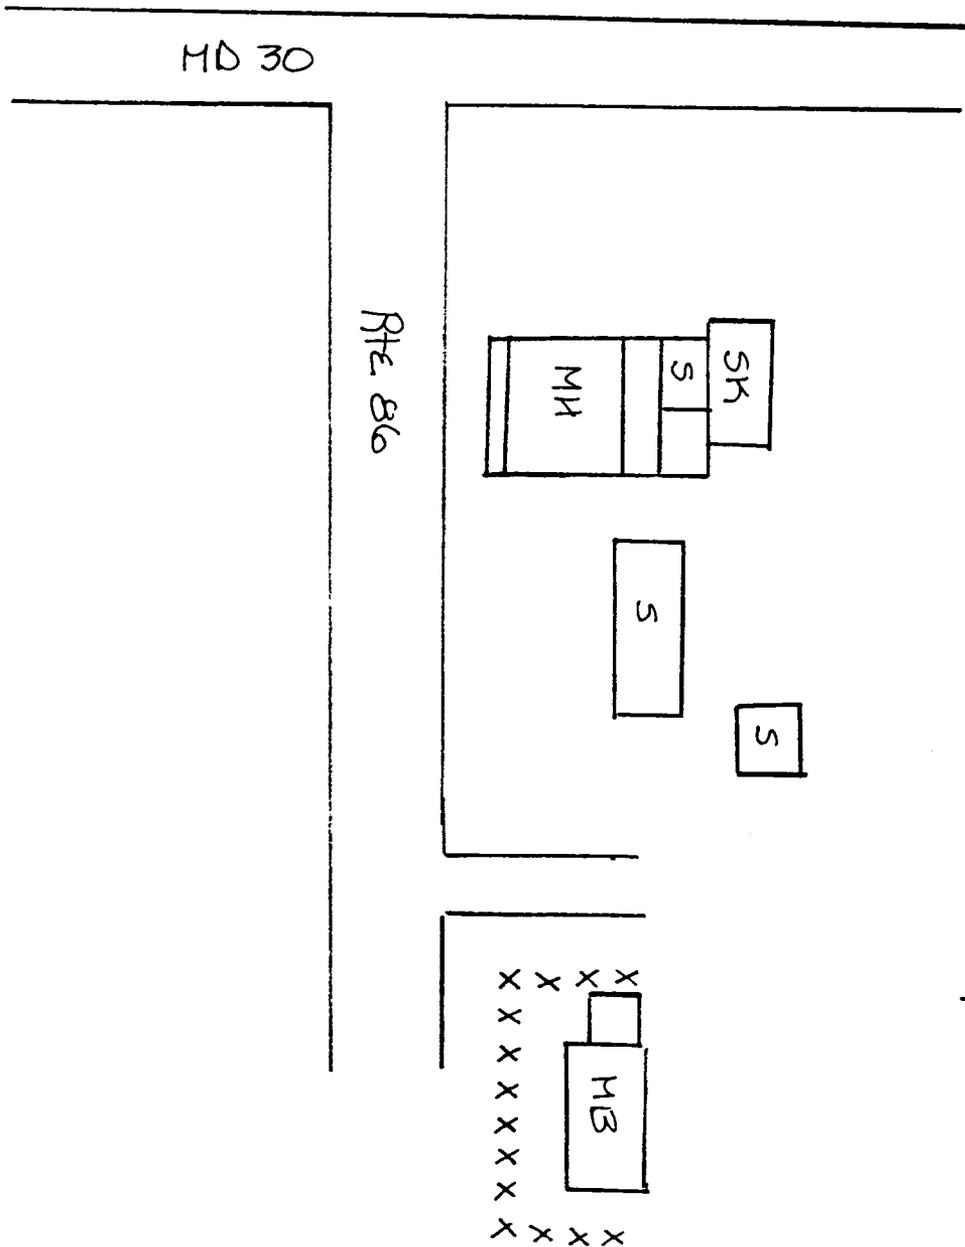
LINEAR MIDWESTERN
CARR-621

In addition to the summer kitchen, there are two other outbuildings on the property; a mid-nineteenth century frame outhouse and a concrete block, one story shed, 3-by-3 bays with a metal, hipped roof [circa 1930-1940]. The positions of the farmhouse, barn and outbuilding form a Linear Mid-Atlantic farm complex layout with the roof ridge lines parallel to Lineboro Road.

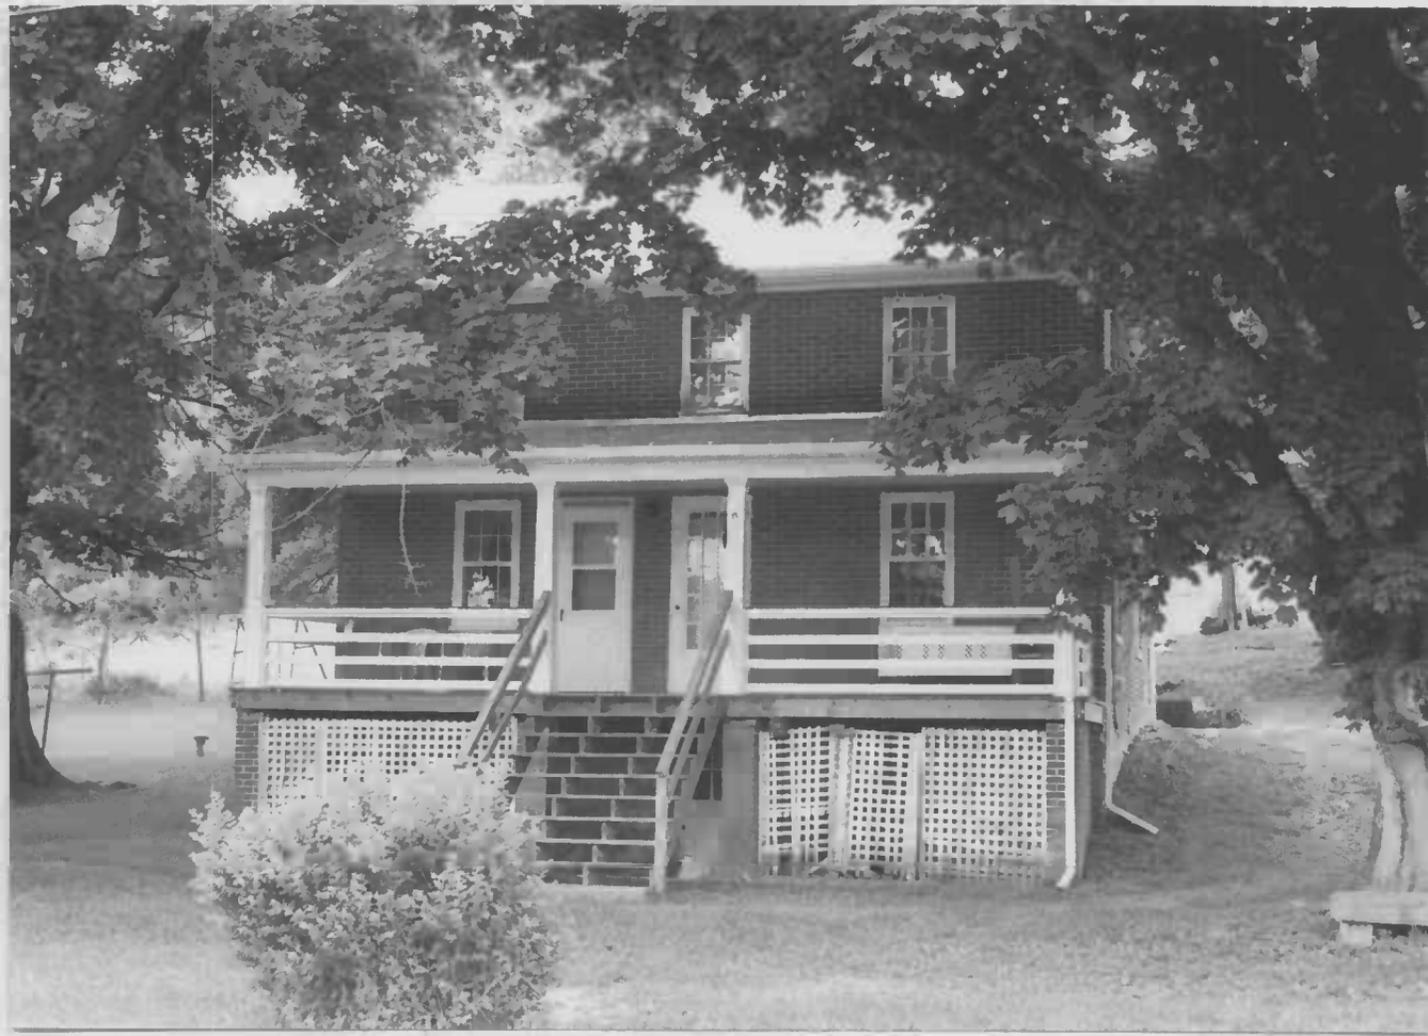
1. CARR - 621

6. Jesse Sherman House - main

South Elevation

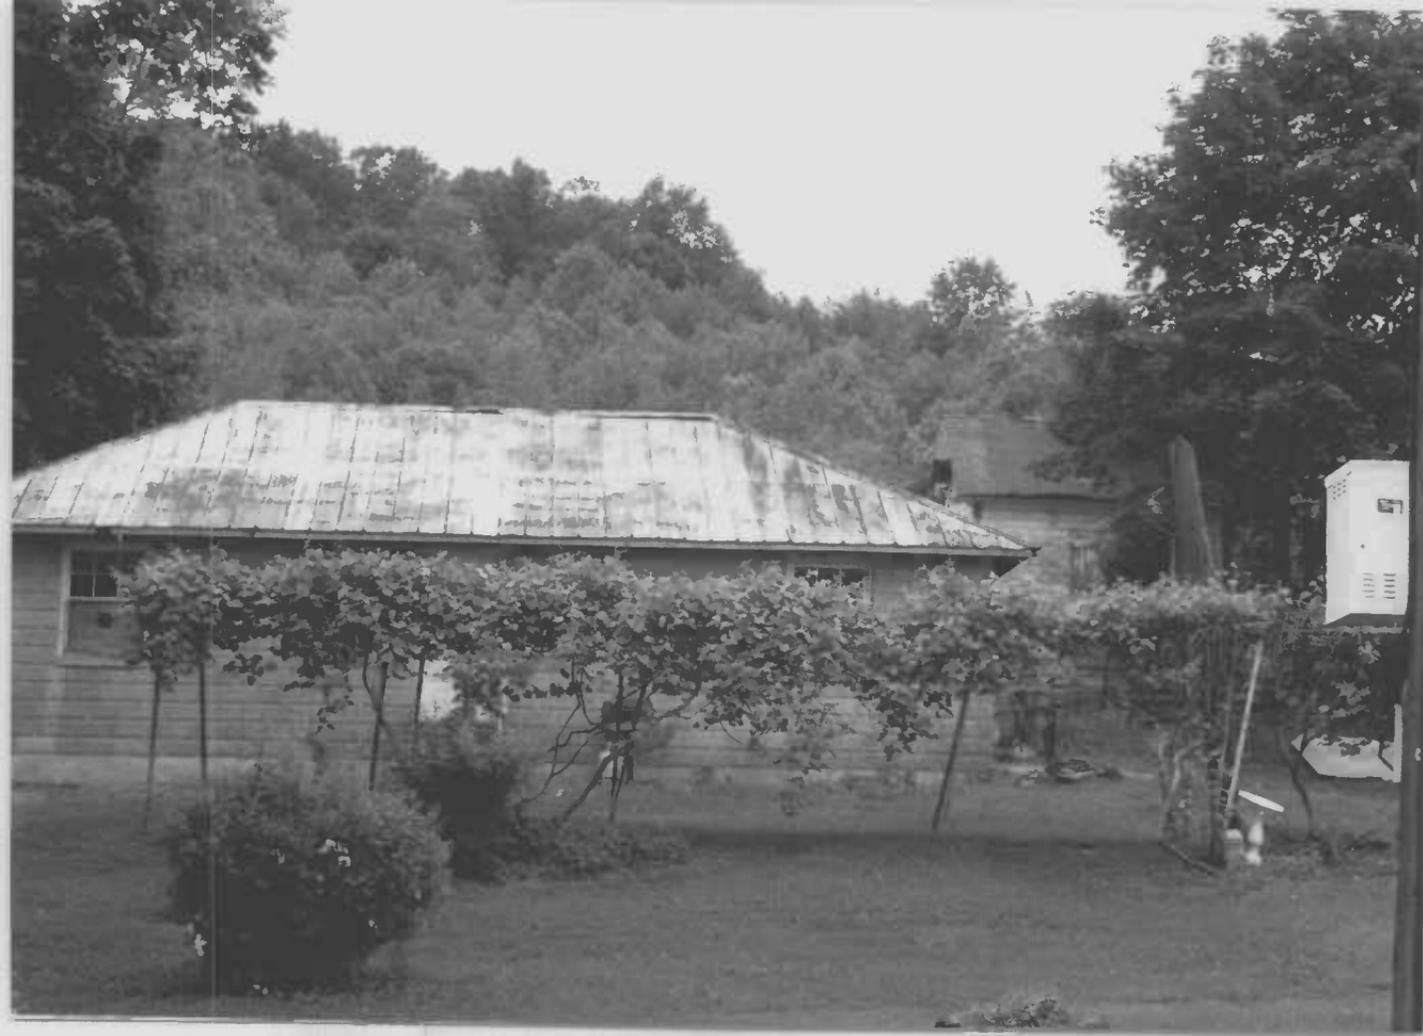
1. CARR: 621

shed out house - west elevation

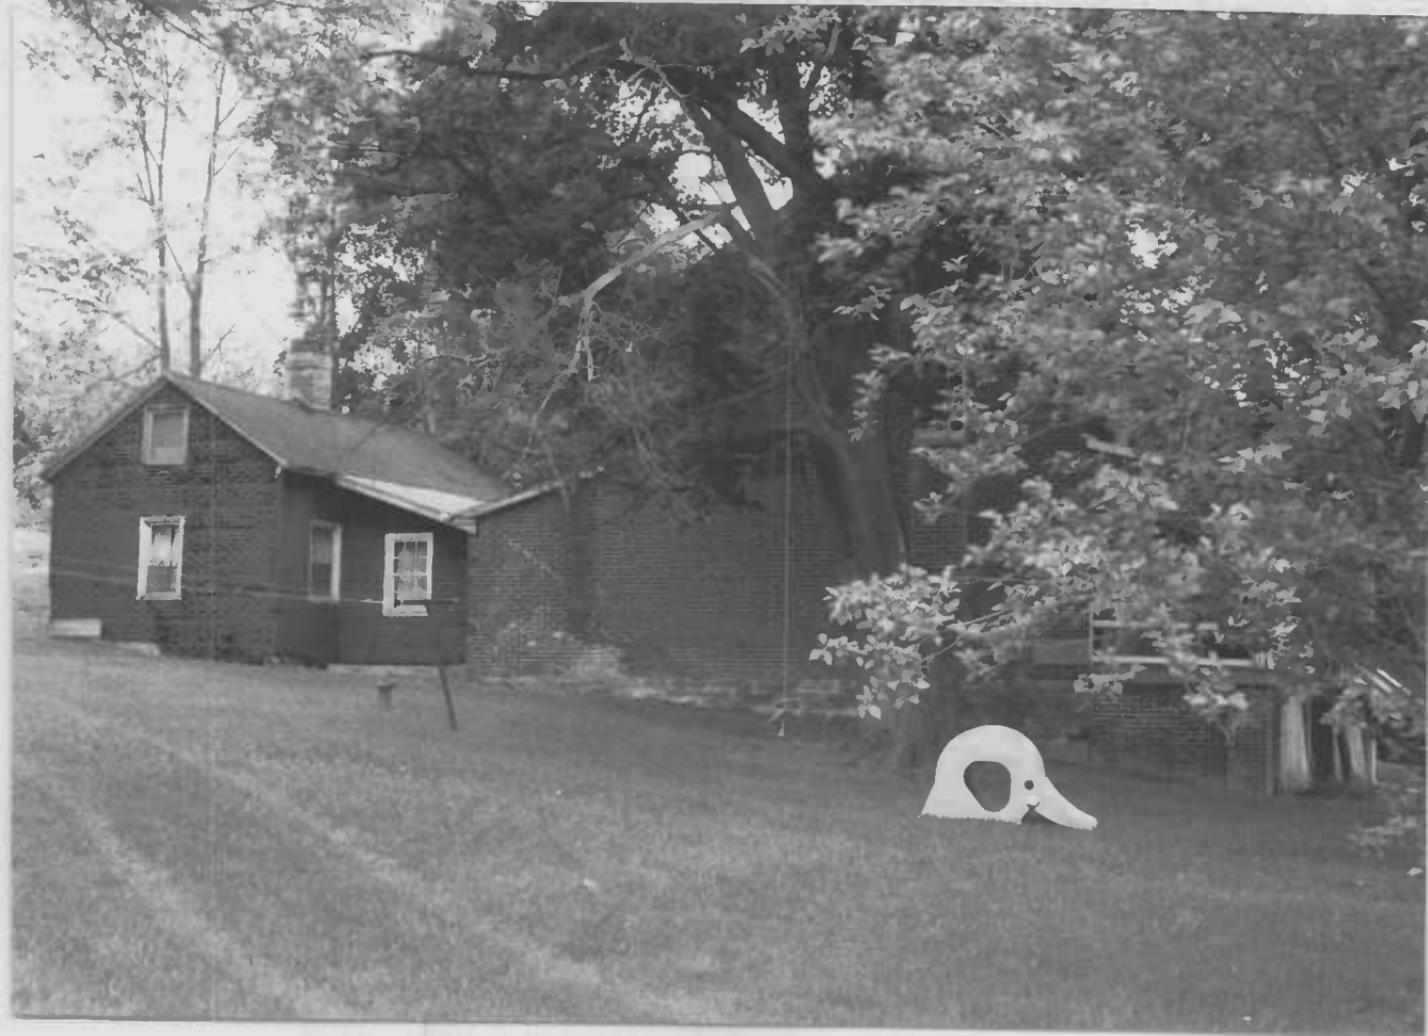
1. CARR: 621

The north elevation has a one story shed roof, brick addition and three 6/6, wood double-hung windows on the second story. A small brick addition connects the shed with a one-and-a-half story brick summer kitchen, circa 1820-1830. The summer kitchen is 3-by-2 bays with 1/1, wood double-hung windows, an asphalt shingle, gable roof and a central brick chimney with a wood, recessed panel door on the east elevation.

6. Jesse Sherman - summer kitchen

West Elevation

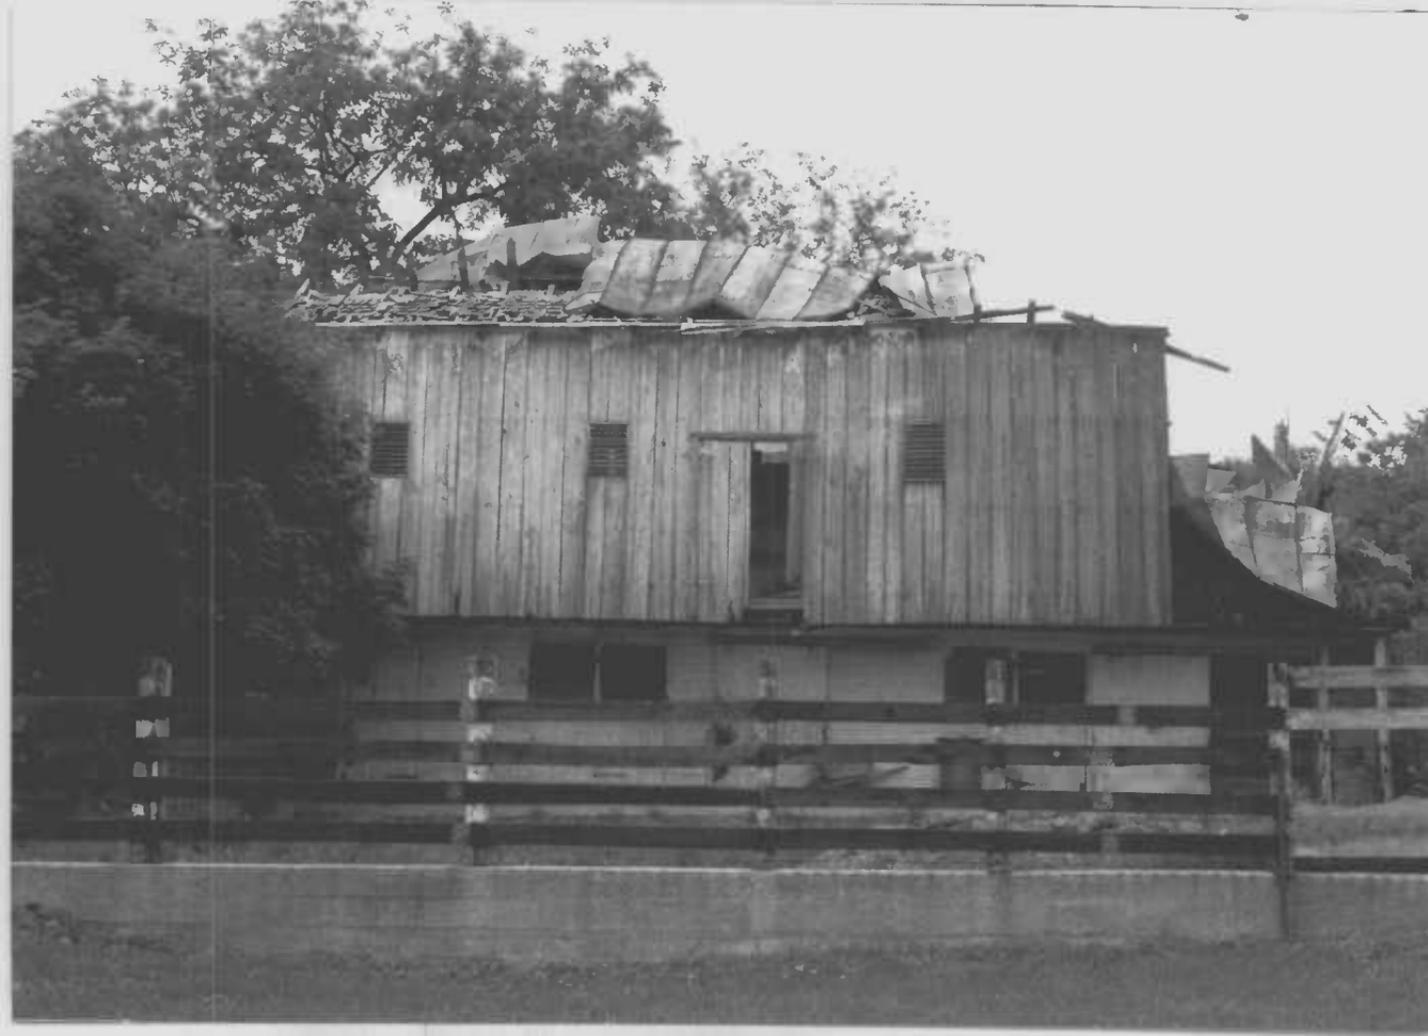
The barn is an early to mid-nineteenth century structure in a state of advanced deterioration. The two-and-a-half story structure is 5 bays by 3 bays, frame with fieldstone foundation and a metal over cedar shingle roof which has collapsed. Four wood ventilator windows are located on the south elevation above the stall area, a hay drop door is located on the upper level, south elevation. A wagon shed has been built onto the west end of the barn with a deteriorated generator room attached to the wagon barn. The barn is built into a low bank with its forebay oriented towards the south.

1. CARR: 621
2. Carroll County
3. Madeline Scheerer
4. June 1996
5. Maryland SHPO
6. Jesse Sherman
3060 Lineboro / Dug Hill
Barn - South Elevation
7. 4/5

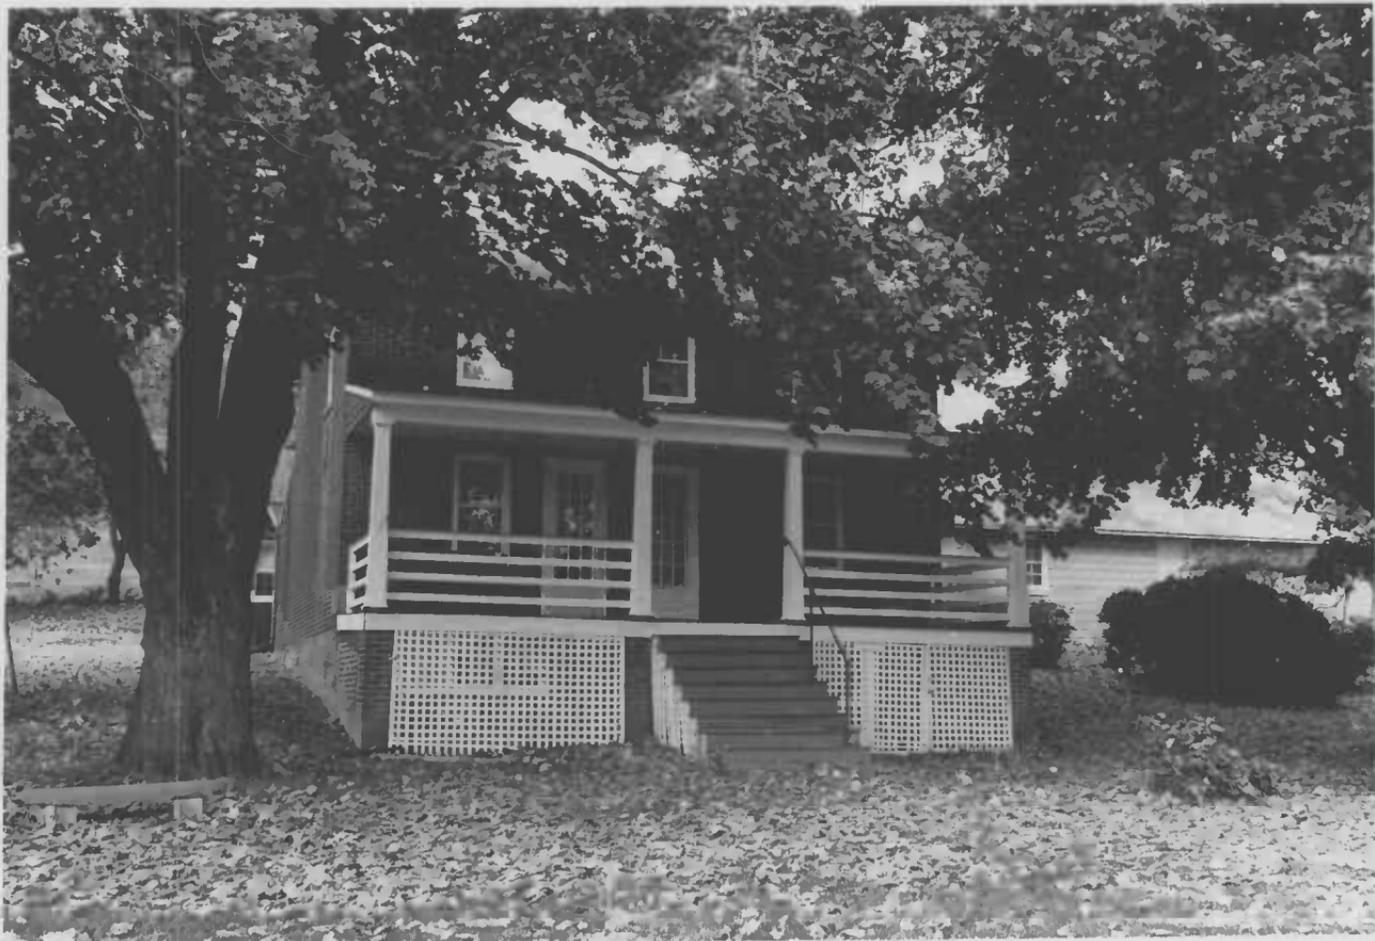
Carr-621

The principal (south) facade contains three 6/6 windows on its second story. On the first floor there are two similar windows and two doorways. The two windows are located under the two end windows above, and one doorway is located under the central window. The second doorway is located in the bay between the central doorway and the western end window, and was probably added later to the original three bay facade.

Along this facade is a one story shed roofed porch with four square posts and horizontal railings. This porch has a brick base with white latticework and a wooden stairway. The west gable end has no windows in its first floor, and one window in the second floor, with two smaller ones above. To the rear is a one story shed roof brick addition.

P. Weissman 1979
view from south
