CARR - 687

UNIONTOWN ROAD HOUSE

Westminster vicinity

FIELD SHEET--HISTORIC RESOURCES SURVEY

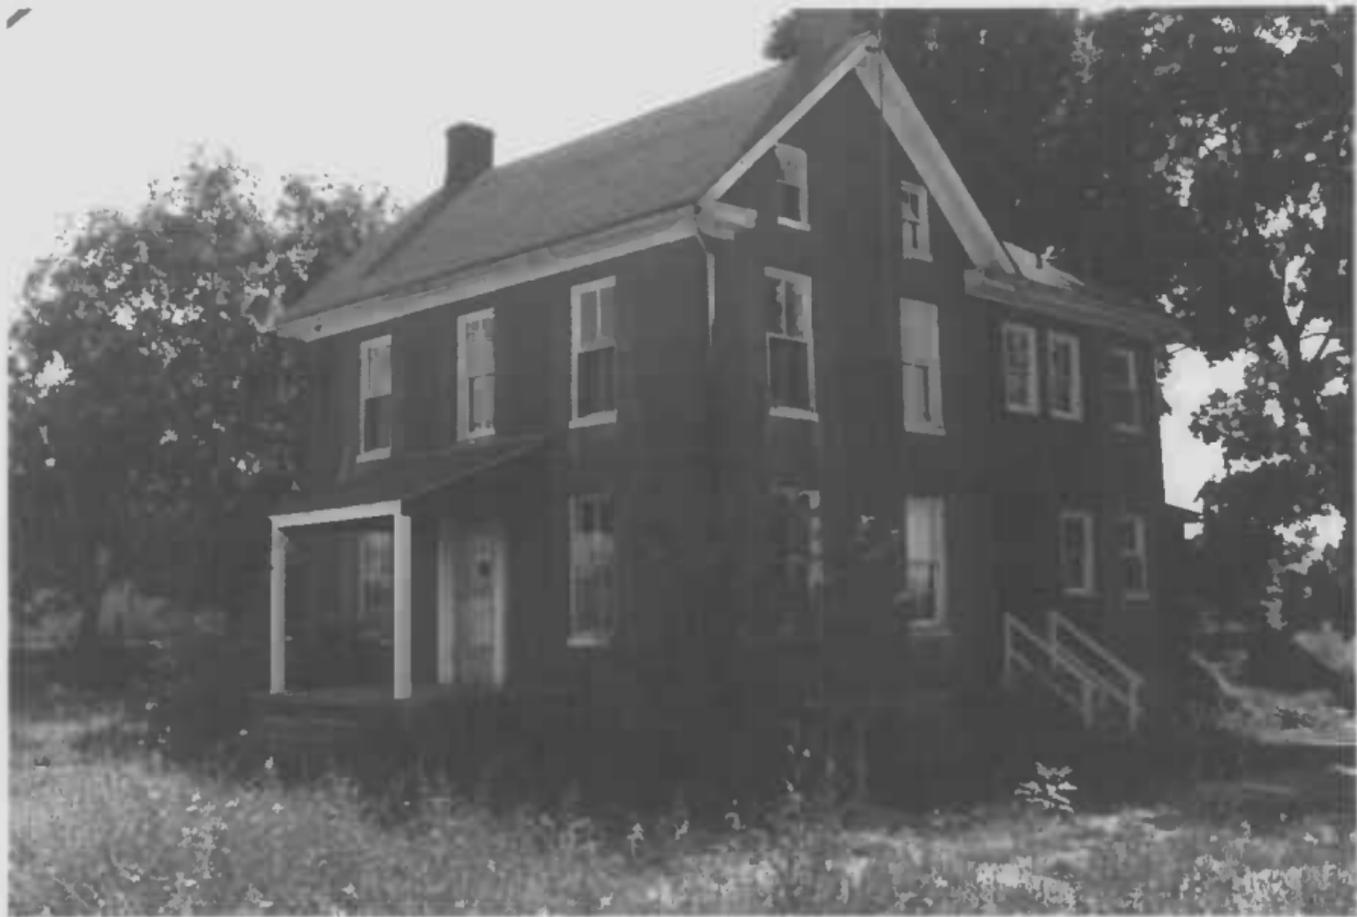
CARR-687

north elevation

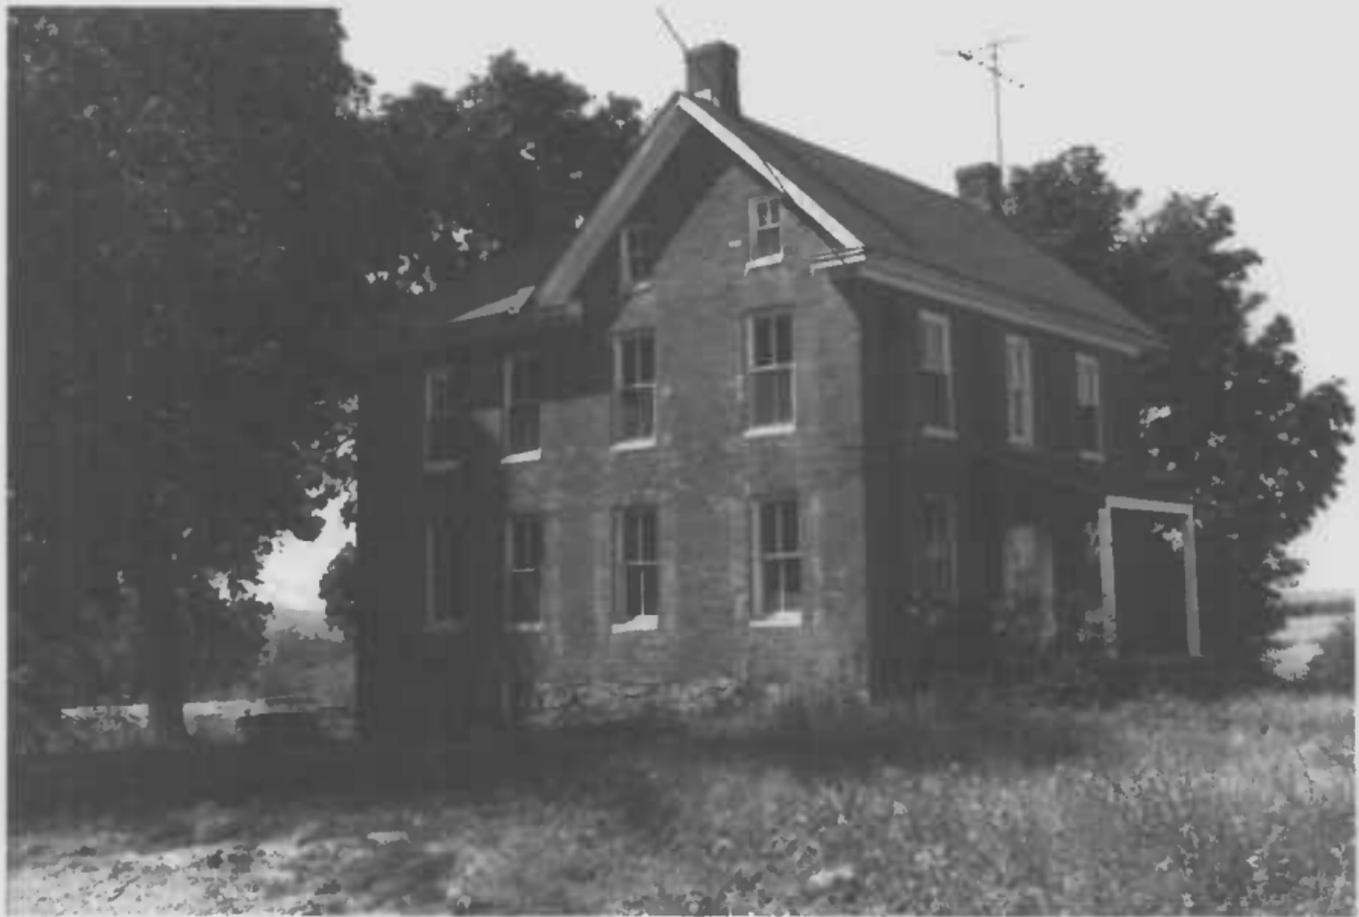
CARR-687

1. Brick House
2. Uniontown Rd. Carroll Co Md.
3. Joe Getty
4. 8183
5. Md. Hist. Trust, Annapolis Md
6. south and east elevations
7. 1/1
