CARR-693  
Jacob Mearing Farm  
Westminster

# Maryland Historical Trust State Historic Sites Inventory Form

JACOB MEARING FARM  
413 - 415 UNIONTOWN ROAD

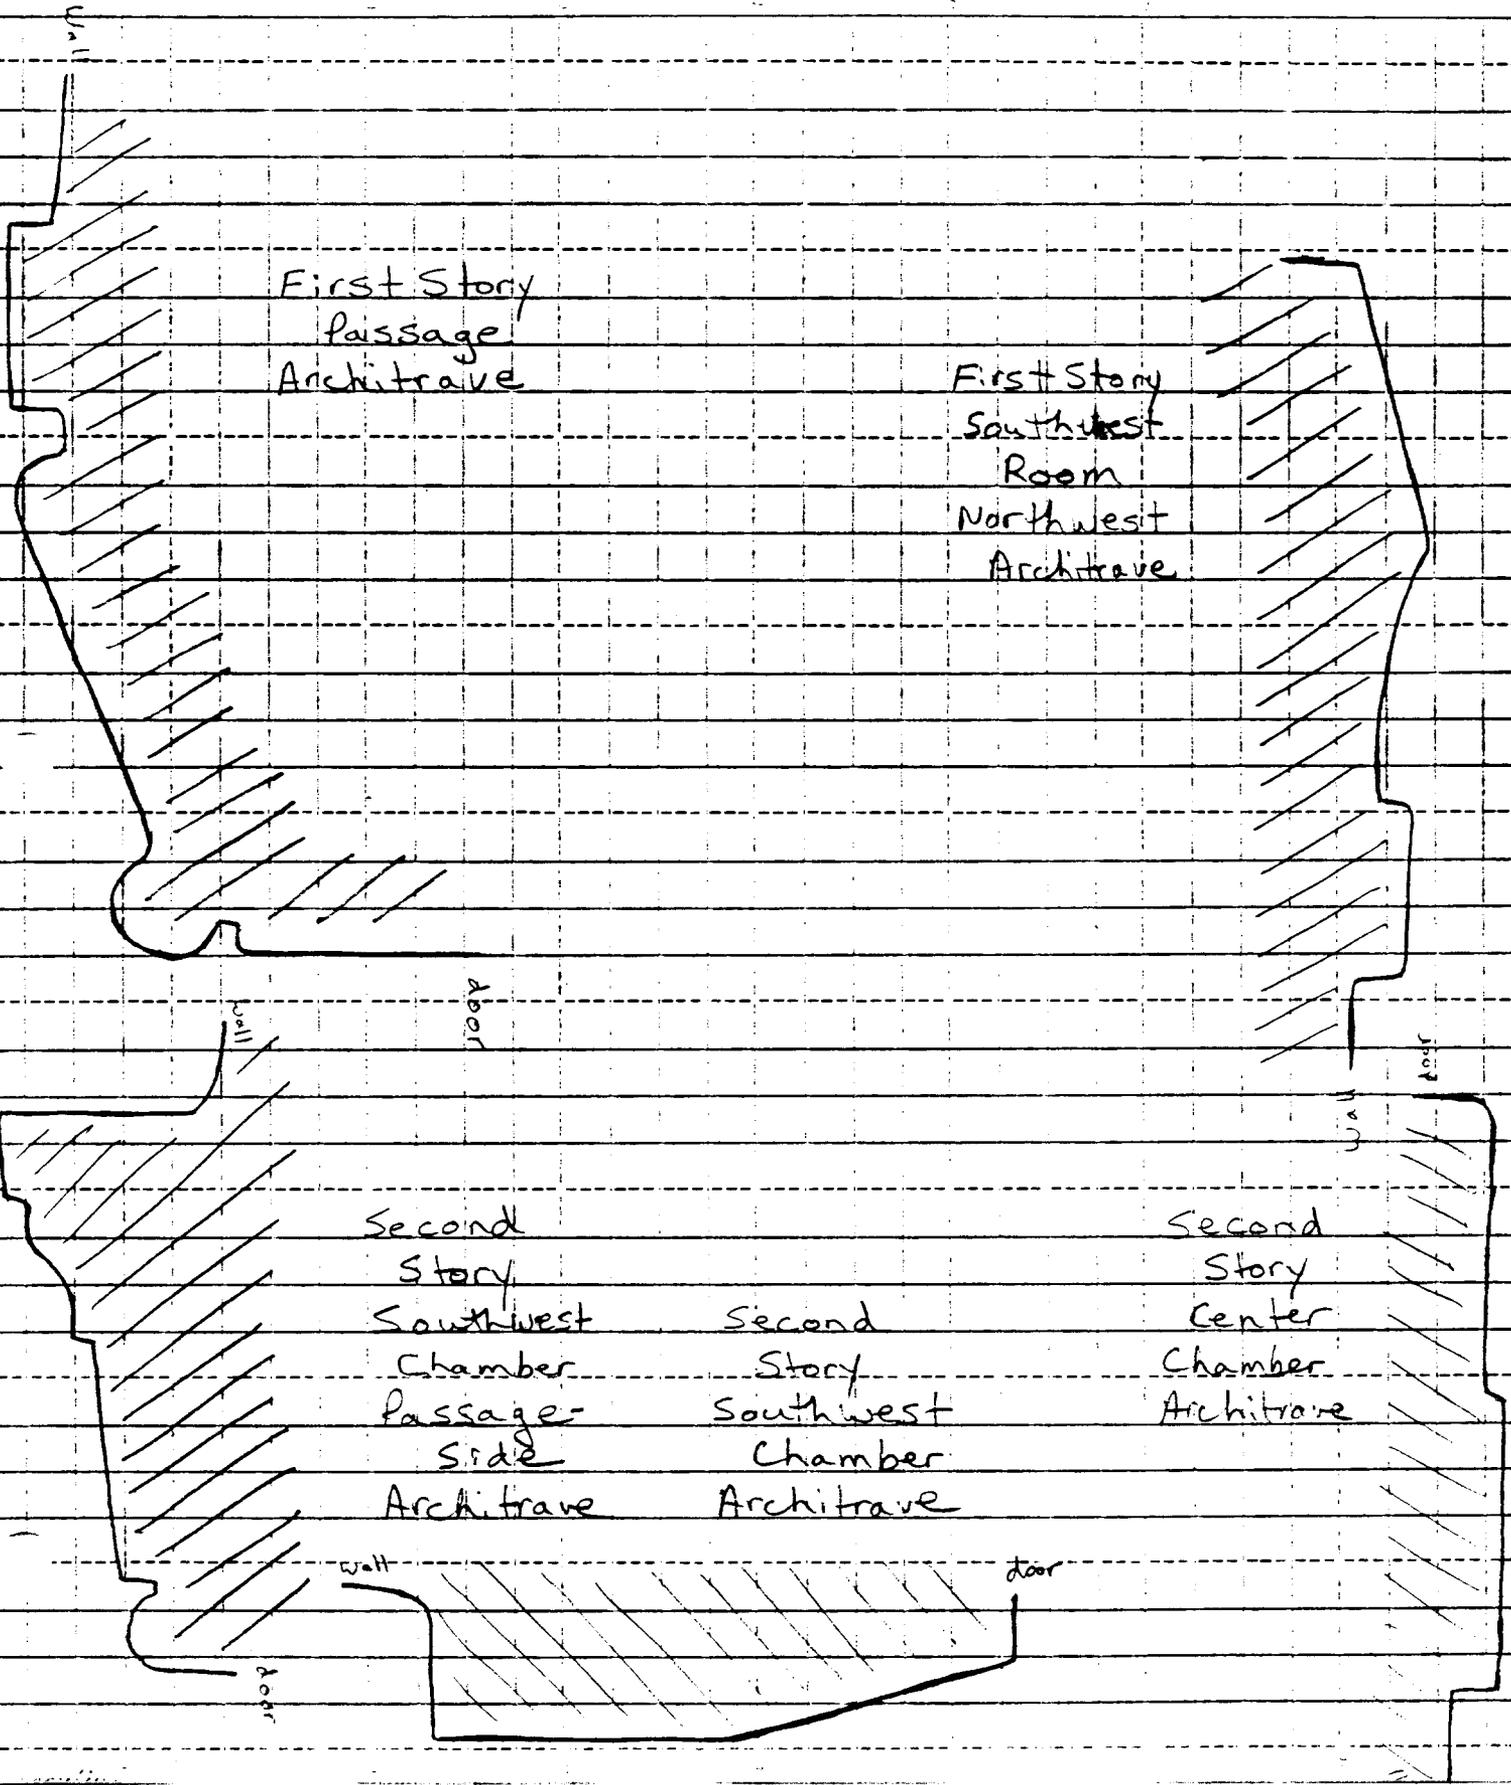
413-415 Uniontown Rd  
Moulding Profiles

First Story  
Passage  
Architrave

First Story  
Southwest  
Room  
Northwest  
Architrave

Second  
Story  
Southwest  
Chamber  
Passage-  
Side  
Architrave

Second  
Story  
Southwest  
Chamber  
Architrave

Second  
Story  
Center  
Chamber  
Architrave

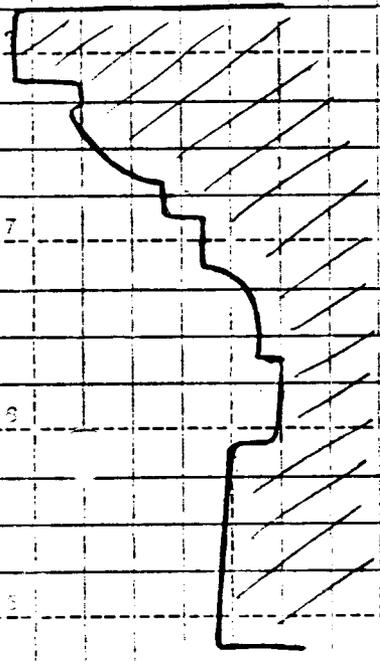
413-415 Uniontown Rd  
Moulding Profiles

Transom  
Bar

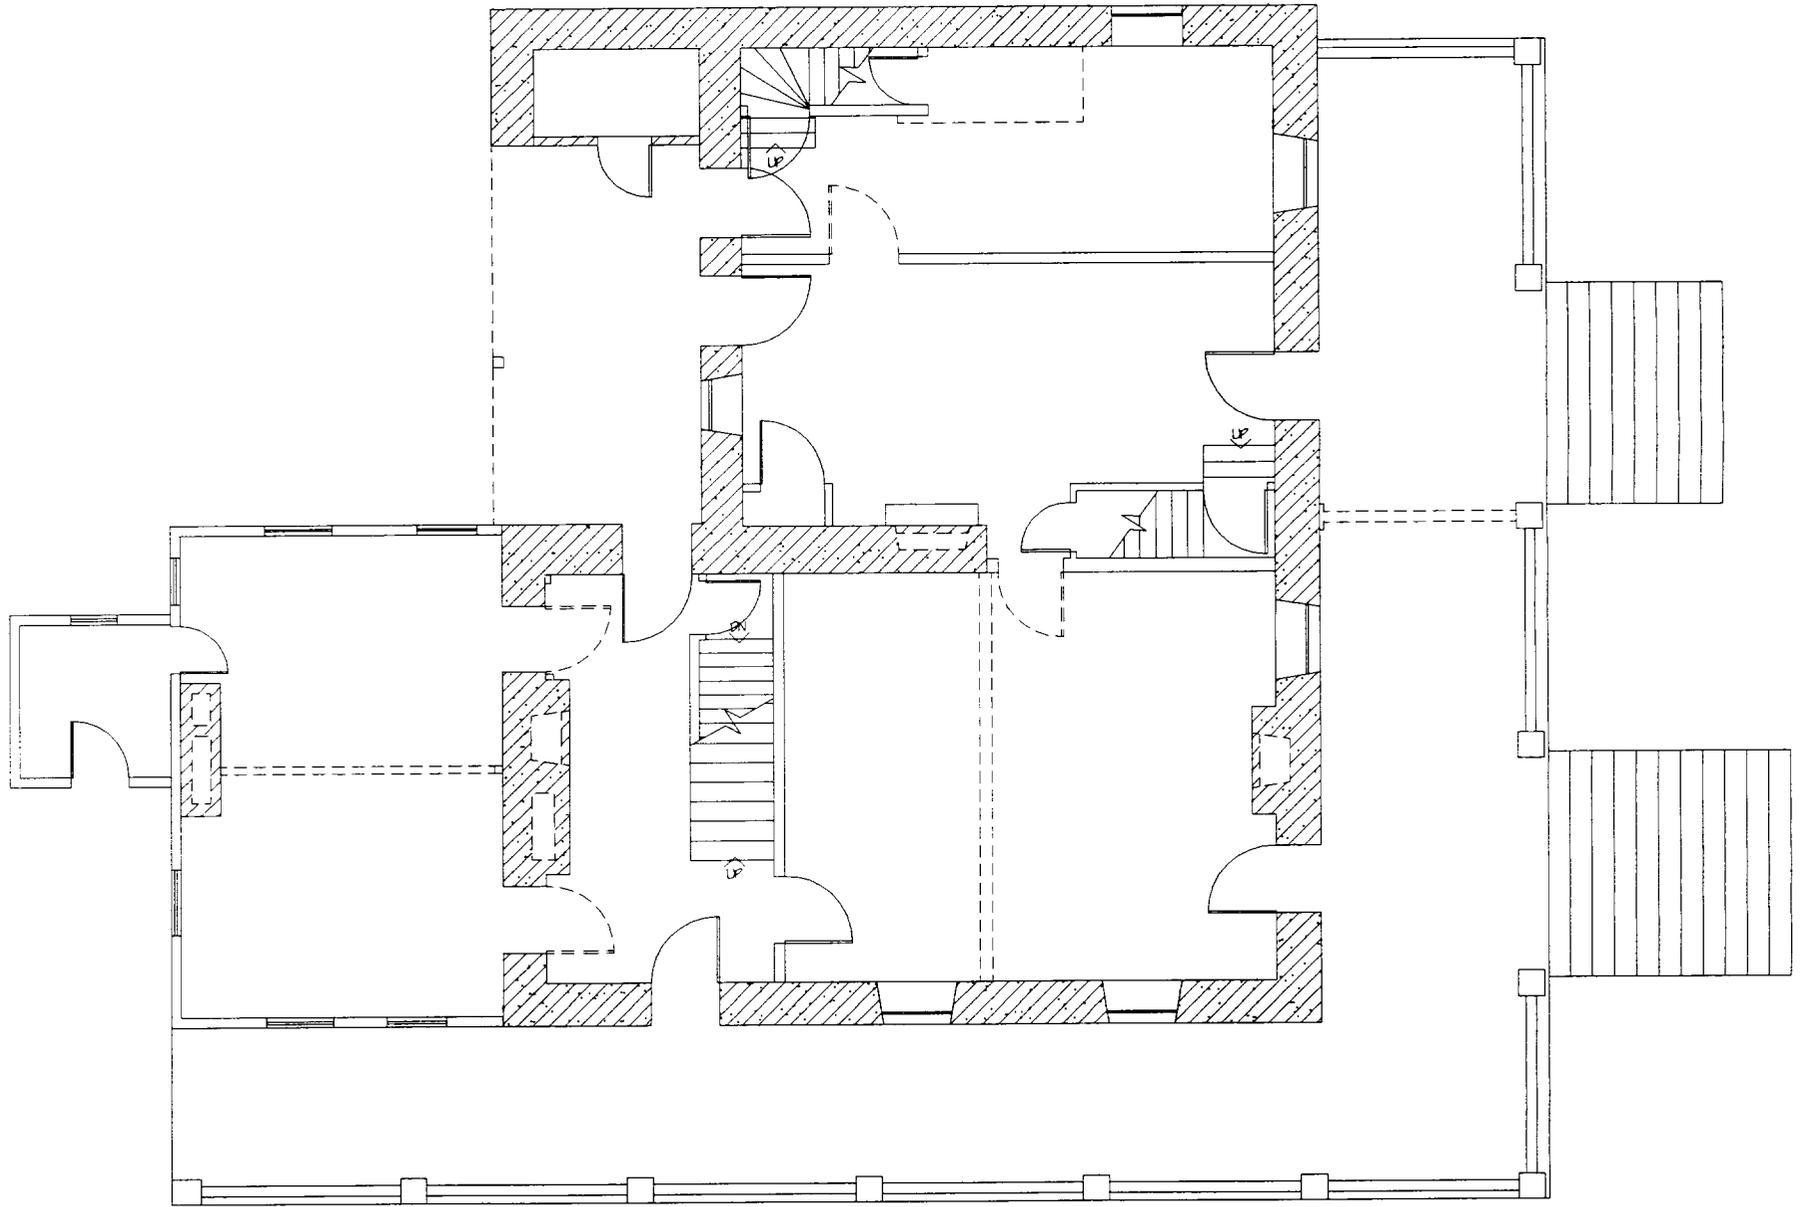
FIRST FLOOR PLAN

The first story was originally a side-passage, single-pile plan with two rooms in the ell, but the addition has created a center-passage plan building. The southwest wall of the passage has a very wide projecting flue. On either side of the flue is a door to the southwest addition with paneled soffits and jambs. There is a dog leg stair along the northeast wall that has an open stringer, turned balusters, and a large turned newel. There is a vertical-board door under the stairway leading to the cellar stairs.

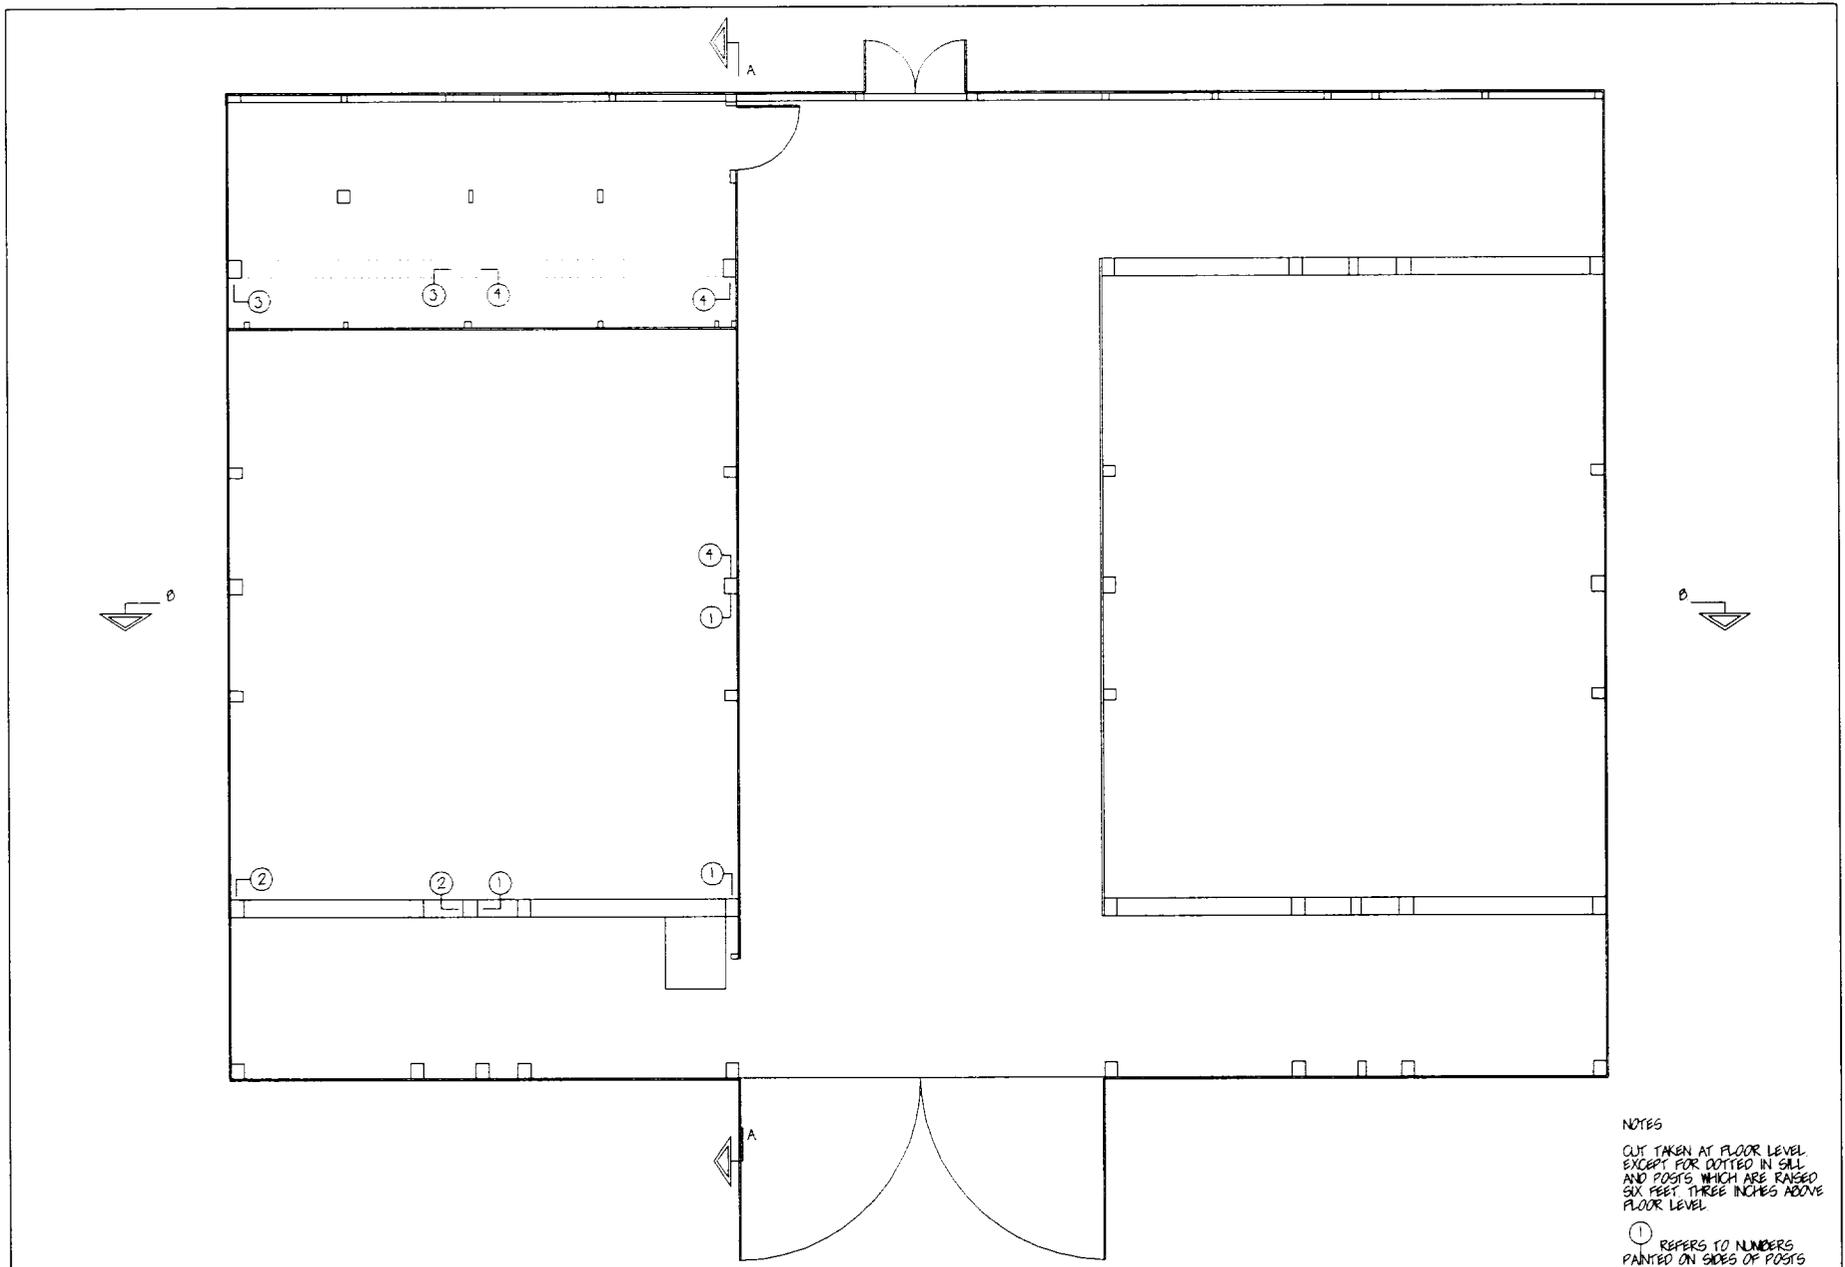
BARN - UPPER  
STORY PLAN  
AUGUST 1997

The upper story has a center threshing floor with one hay mow on each side and a granary in the east corner. The barn has four hewn, heavy timber bents with a purlin post truss supporting the roof. Each bent has five posts. There is a center post and two diagonal braces in each hay mow beneath the purlins. On the interior of the wagon door is painted "W.T.P.191[9?]".

NOTES  
 CUT TAKEN AT FLOOR LEVEL  
 EXCEPT FOR DOTTED IN GILL  
 AND POSTS WHICH ARE RAISED  
 SIX FEET THREE INCHES ABOVE  
 FLOOR LEVEL  
 ① REFERS TO NUMBERS  
 PAINTED ON SIDES OF POSTS

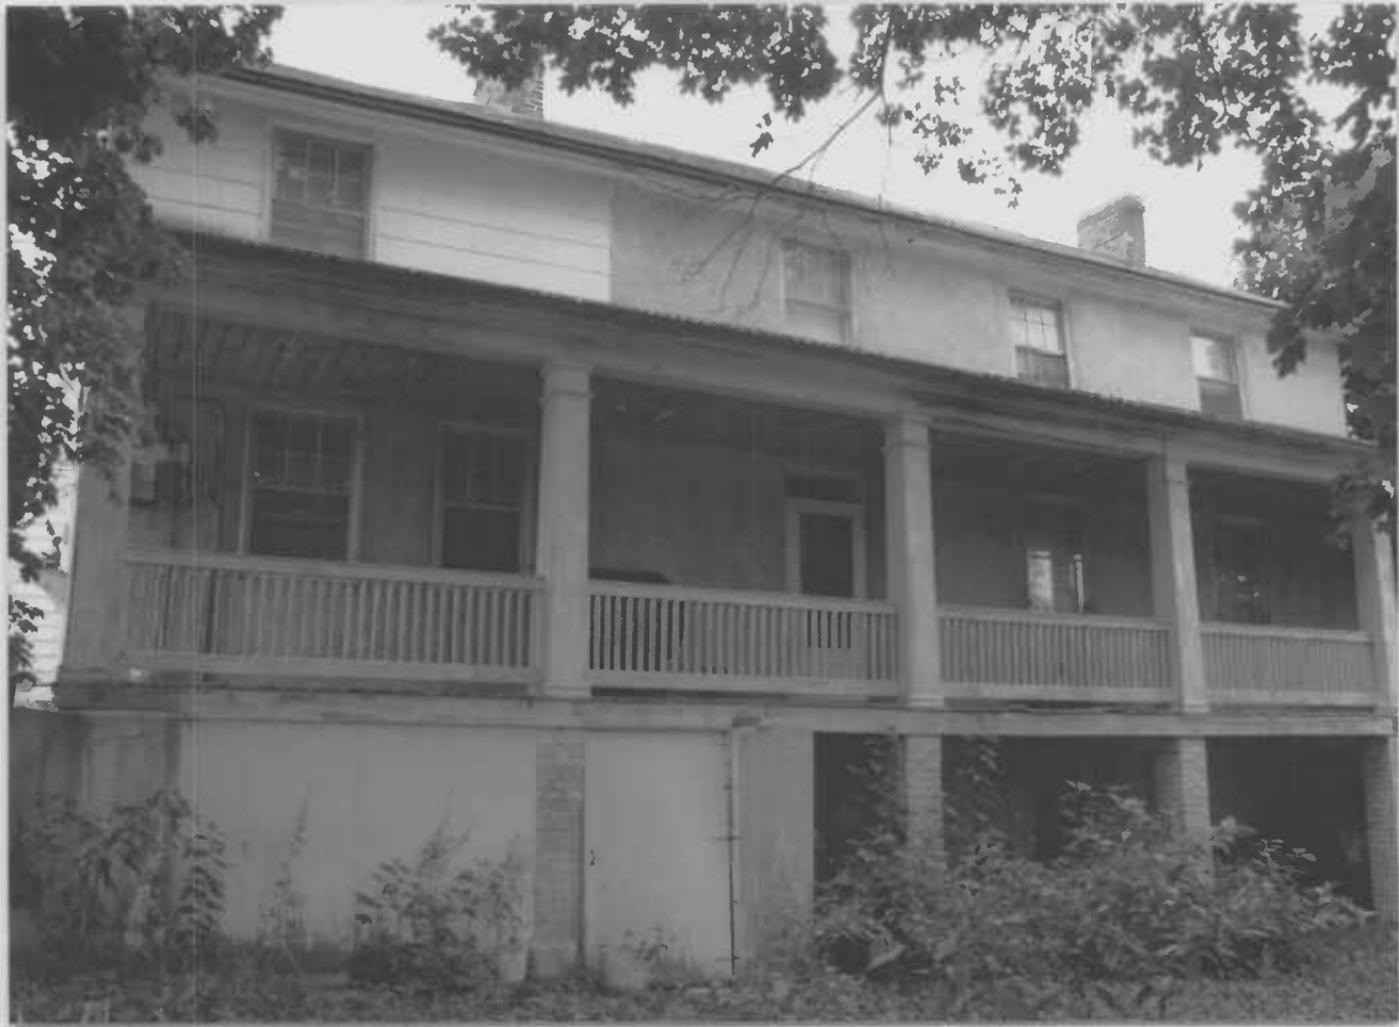
1/7

The southeast elevation foundation has a 6/6 sash, a vertical-board door, a 6/6 sash, a new door, and another 6/6 sash, moving from south to east. The first story has a centered door, with paneled soffit and jambs and a transom. The transom is now closed off on the outside, but has nine lights. There are two 6/6 sash on either side. There is a one-story, six-bay porch that wraps around on the northeast side. It has seven square battered posts and square-in-plan balusters. The second story has four 6/6 sash with no opening in the south-center bay.

Neg. loc.: Maryland Historical Trust  
house - SE elev.

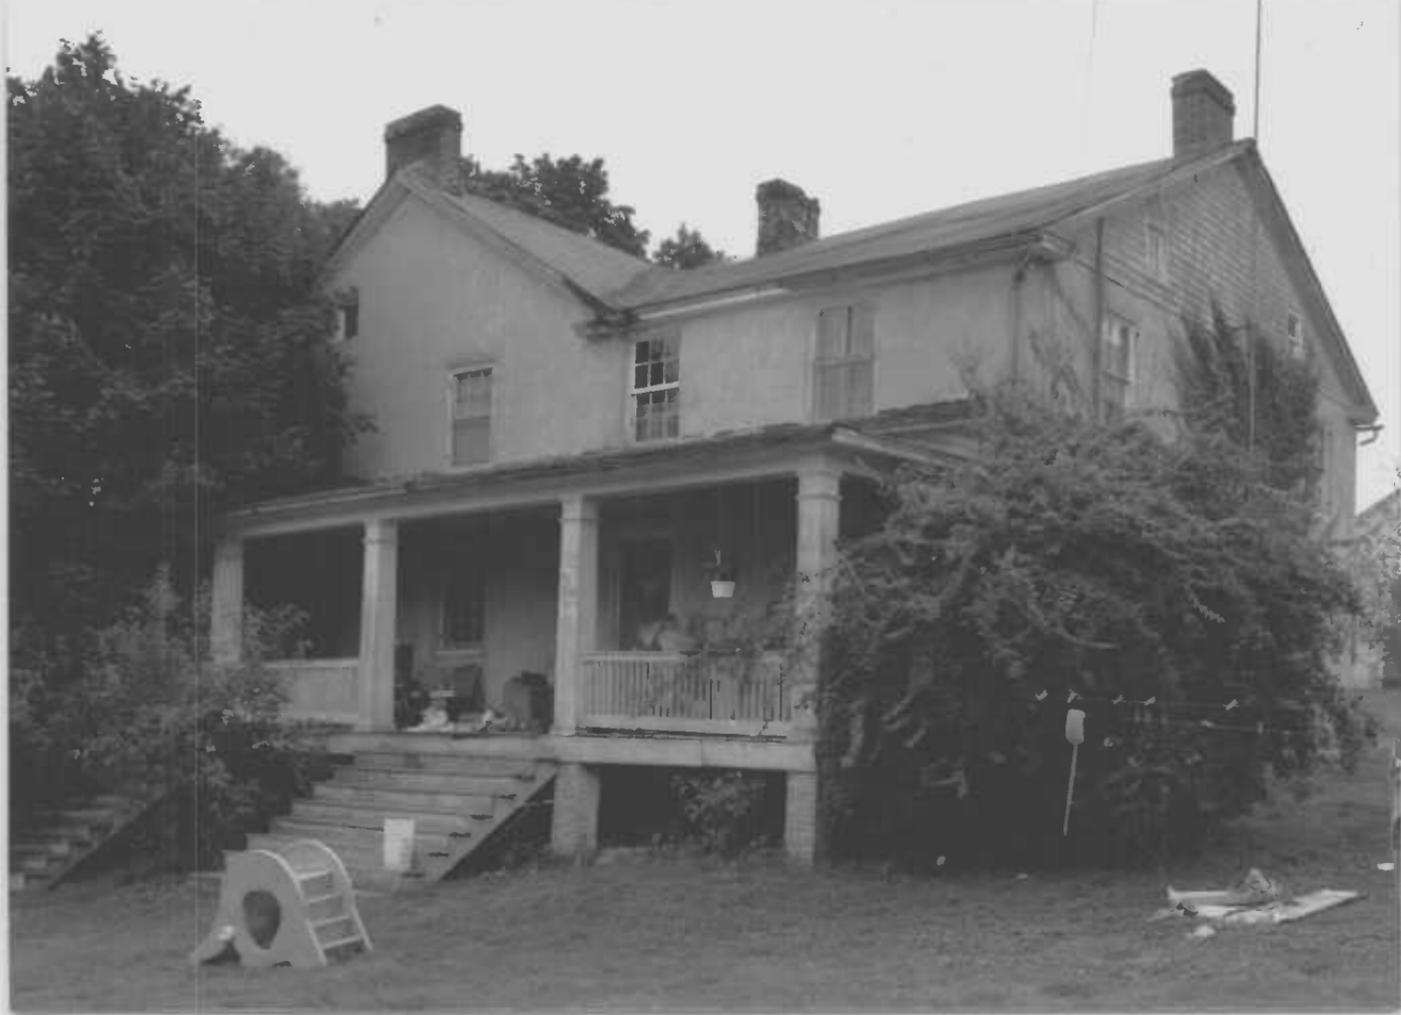
2/7

The northeast elevation has a 6/6 sash, with three-panel shutters in the east bay of the foundation, and two, small four-light sash with wood louvers. There are two sets of wood stairs that come off the porch on the northeast elevation. The porch extends all the way to the north end of the ell. The first story has a door with one light over two panels, and a two-light transom, then a typical 6/6 sash. The ell also has a door identical to the east bay, and a typical 6/6 sash. The second story has four typical 6/6 sash. The gable end of the main block has a four-light sash set east of the chimney.

The northwest elevation is two bays. The foundation has a four-light sash in the north bay. The first story has a typical 6/6 sash in the north bay, and the second story has two typical 6/6 sash. The gable end has wood shingles, while the first and second stories are stuccoed stone. The gable end has two four-light sash. The ell has a wood box cornice with returns and an interior brick chimney centered on the gable end.

Neg. Loc.: Maryland Historical Trust  
house - NW & NE elevs.

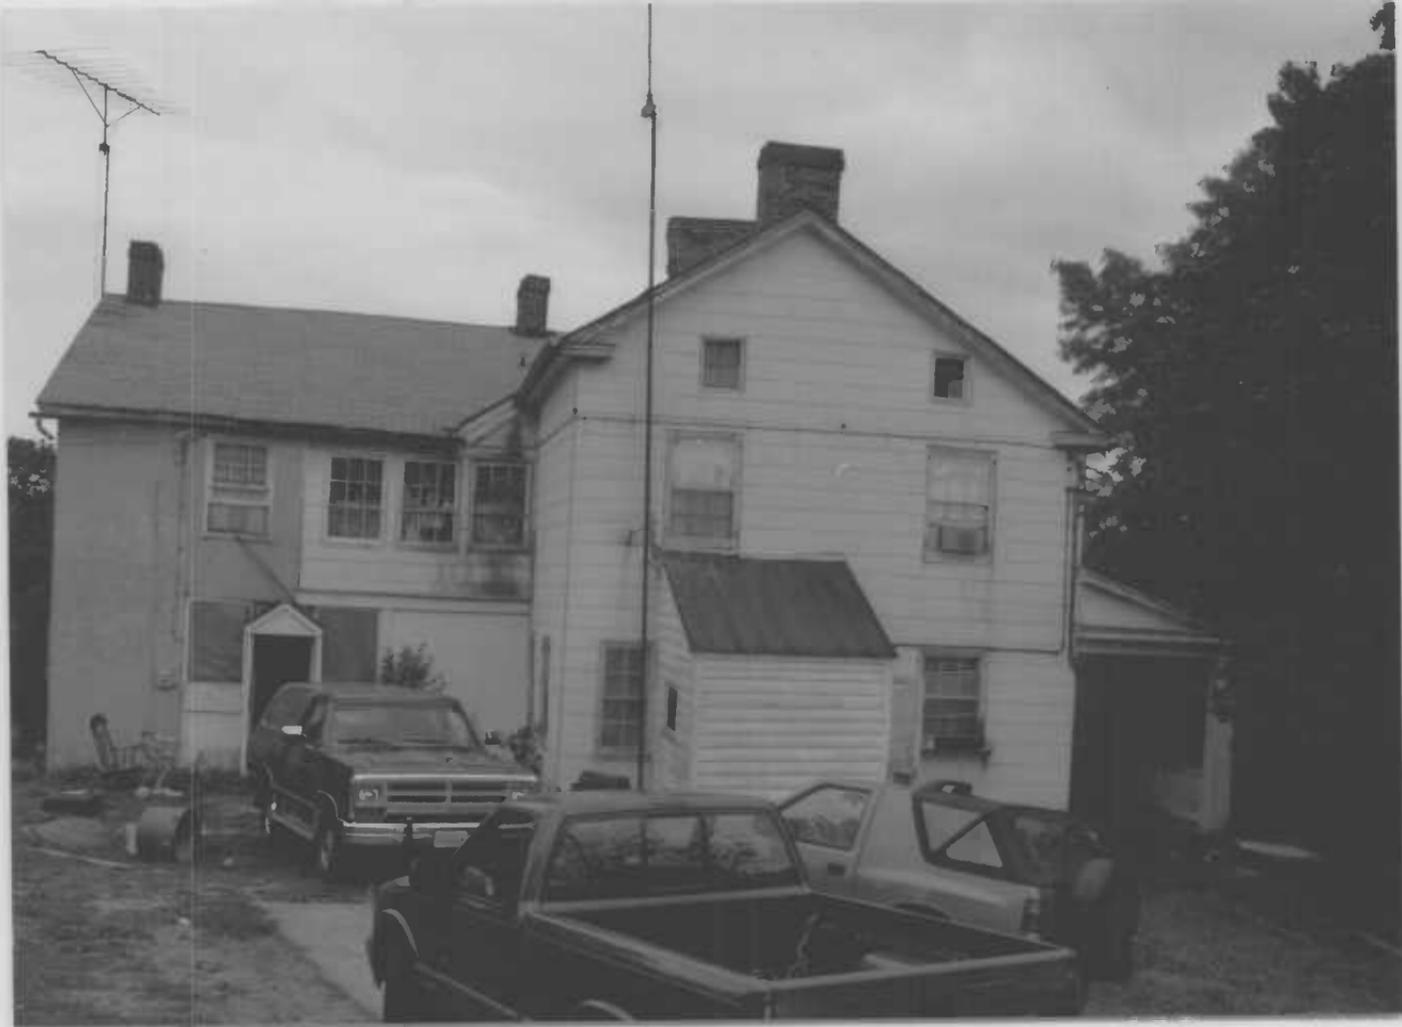
3/7

On the southwest elevation, the first story has a one-bay pantry that is rough-cast and has no openings. To the south of this is a three-bay recessed porch. This wall has two doors with one light over two panels and a four-light transom. There is also a 6/6 sash in

Neg. loc. Maryland Historical Trust  
house - SW elev.

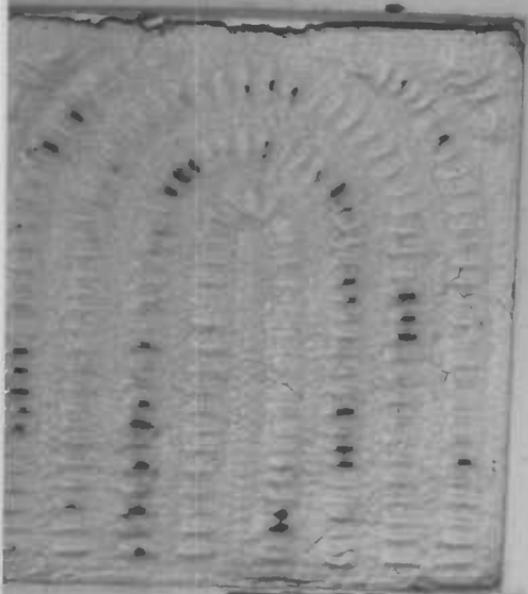
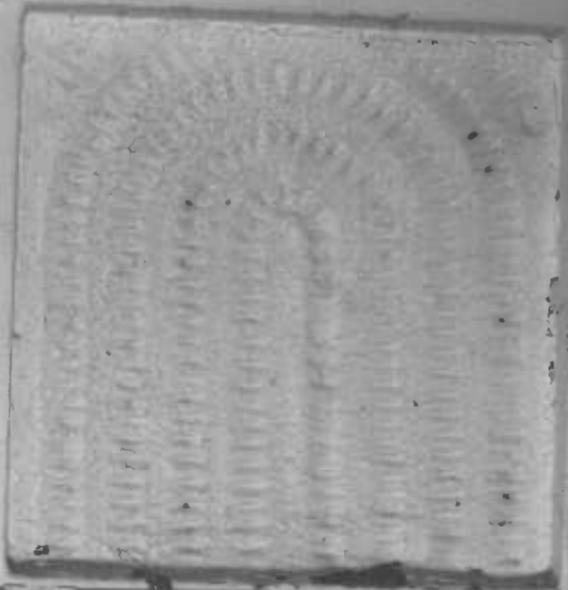
4/7

Neg. loc.: Maryland Historical Trust  
pantry door - metal panel

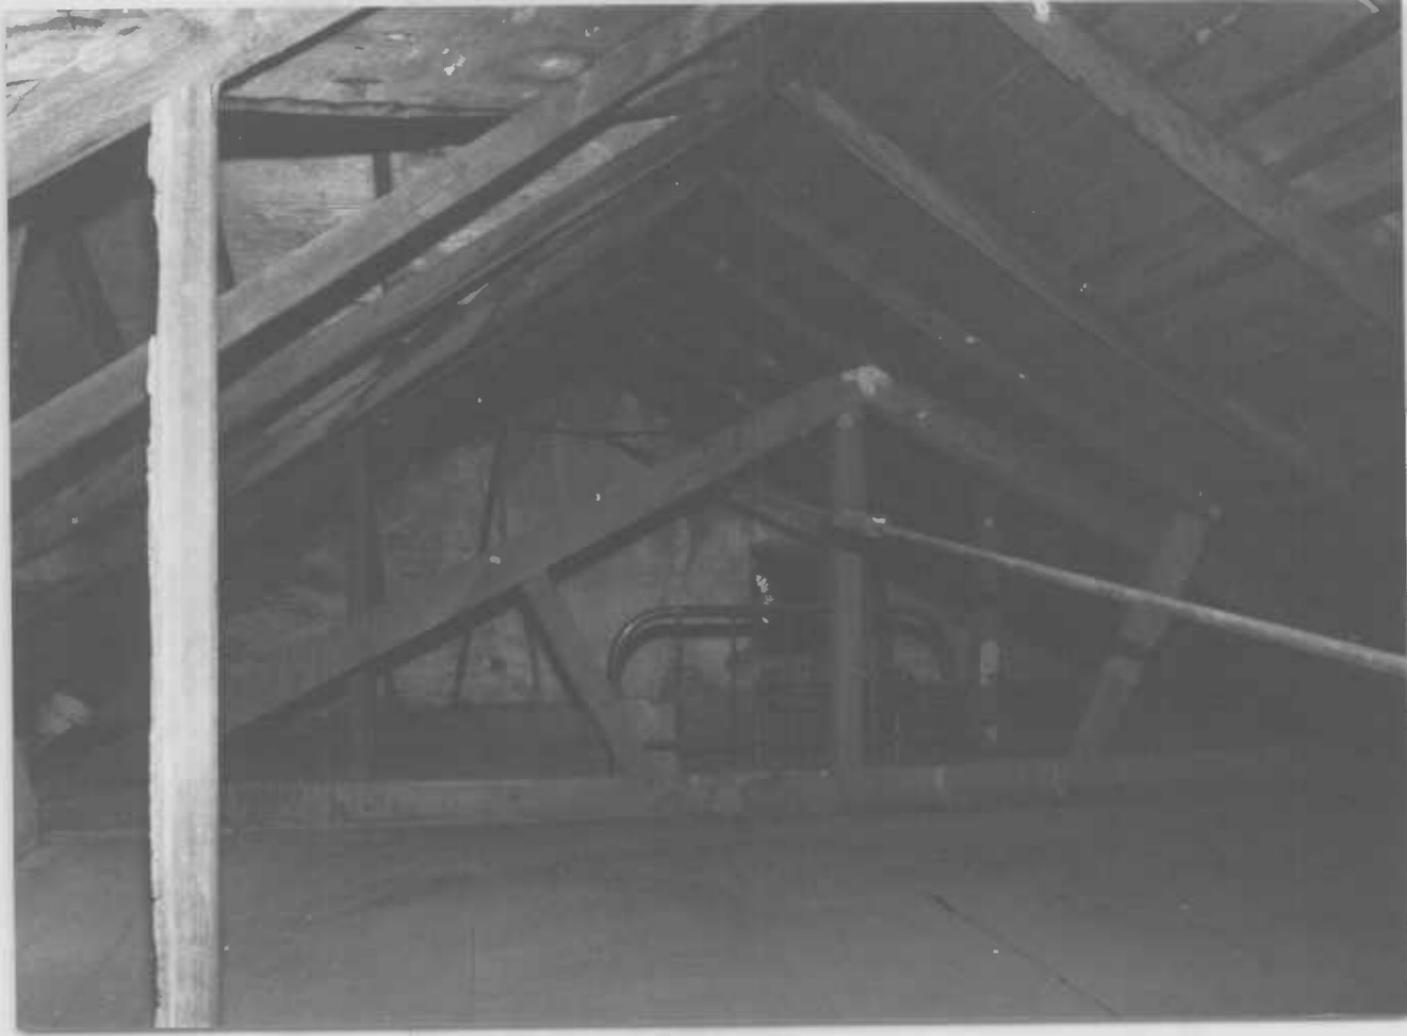
5/7

The attic rafters are mill sawn, with a center tenon and peg at the ridge in both the main block and the ell. The rafter feet have a birdsmouth cut. They lap over a small false plate and are nailed to it with three cut nails. The center of the original main block has a circular-sawn wood truss bolted together. It rests on the floor. There is also a tie rod that wraps around the northeast chimney and runs northeast to southwest. The southwest end passes through the southwest chimney. The attic in the addition has tapered rafters that are half-lapped and pegged at the ridge. The southeast side has a small false plate on the floor, while the northwest side has a frame wall raised about two feet above floor level. The rafters have a birdsmouth cut that laps over a true plate. The corner posts and plate are hewn and are mortised and tenoned and pegged together. The southwest elevation of the

Neg. loc.: Maryland Historical Trust  
attic truss

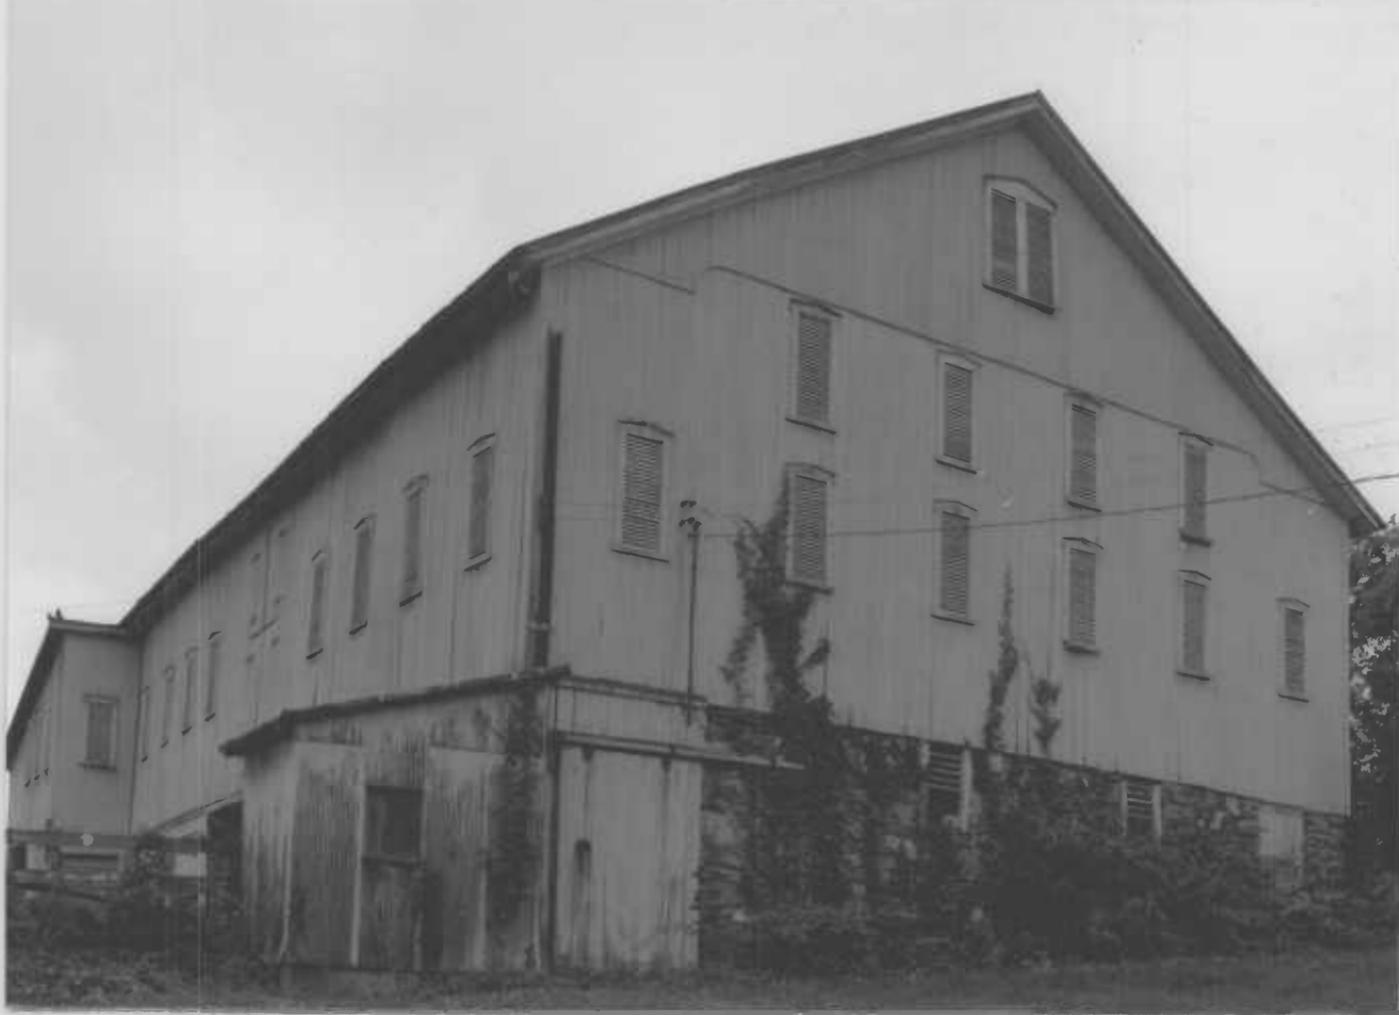
6/7

There is a bank barn about 125 feet southwest of the house. It is in line with the house and has a southeast-facing forebay with a ramp on the northwest side. It has a rubble stone lower story on three sides. The southeast forebay wall has been removed and replaced with CMU piers and doors on rollers. The upper story and all of the doors are beaded-edge-and-center vertical boards. The barn has a gable roof of corrugated metal with a northeast to southwest ridge. There is a shed roof addition on the southwest that slopes to the southwest. The southeast elevation of the upper story has four pedimented wood vents on either side of double doors above double doors. The northeast elevation on the lower story has a door on rollers under the forebay, and two diamond-in-section wood louver vents with a vertical Dutch door to the north. The upper story has six vents with four vents above and a double vent in the peak. On the northwest elevation, the north bay of the lower story has a 6/6 sash. The upper story has a center pair of wagon doors with four louvers on each side of it. There is a small corrugated metal shed roof addition at the east corner.

Neg. Loc.: Maryland Historical Trust  
barn - SE & NE elevs.

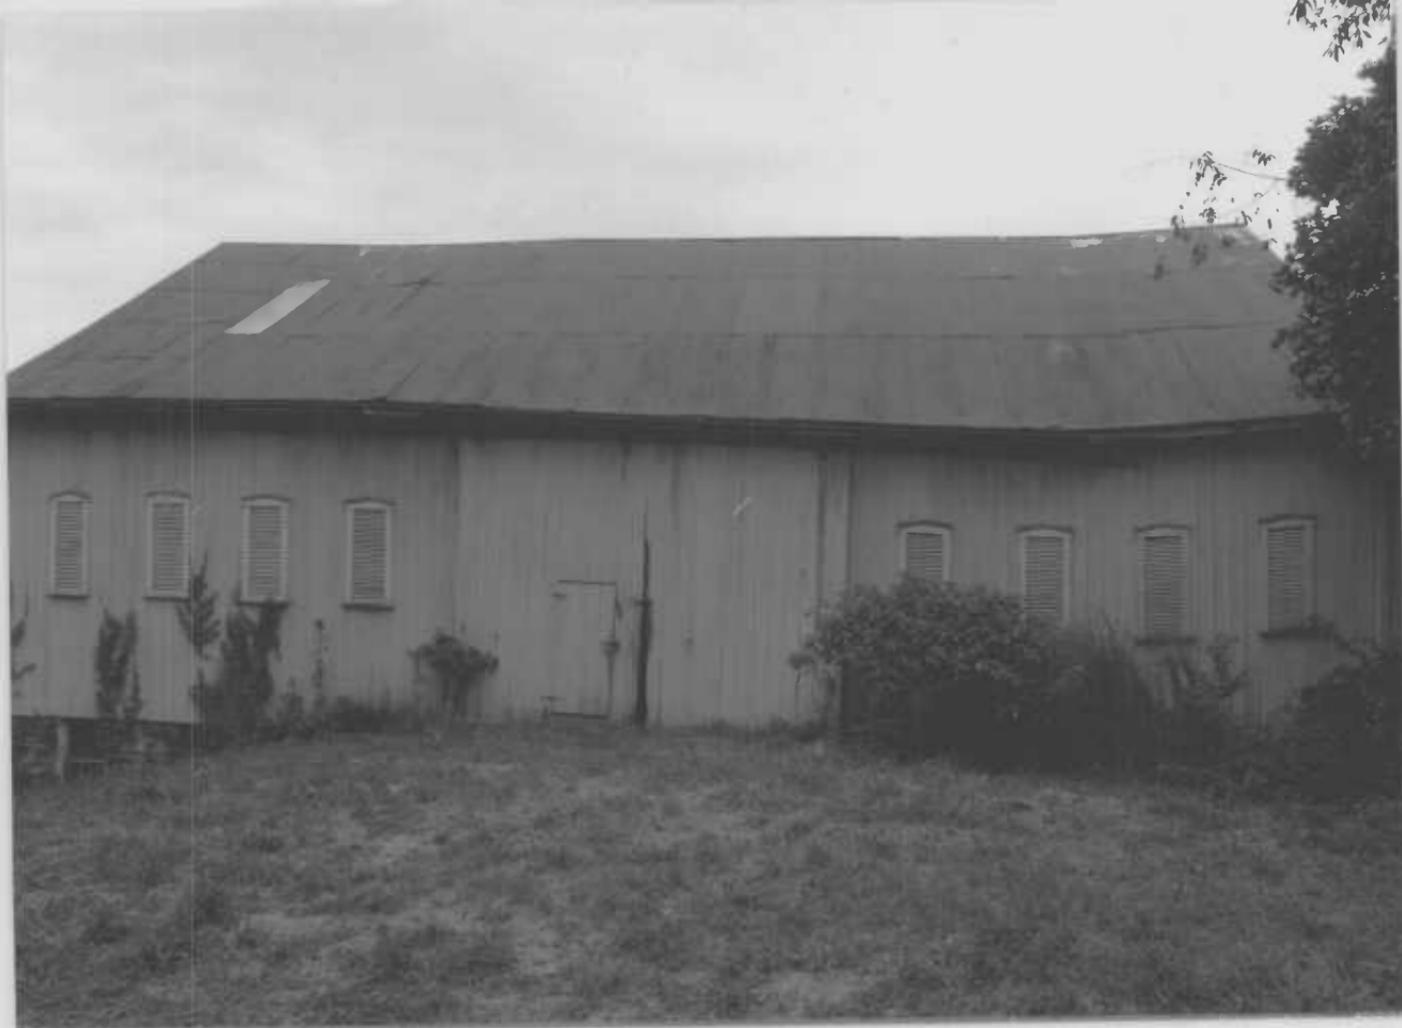
7/7

barn-NW elev.

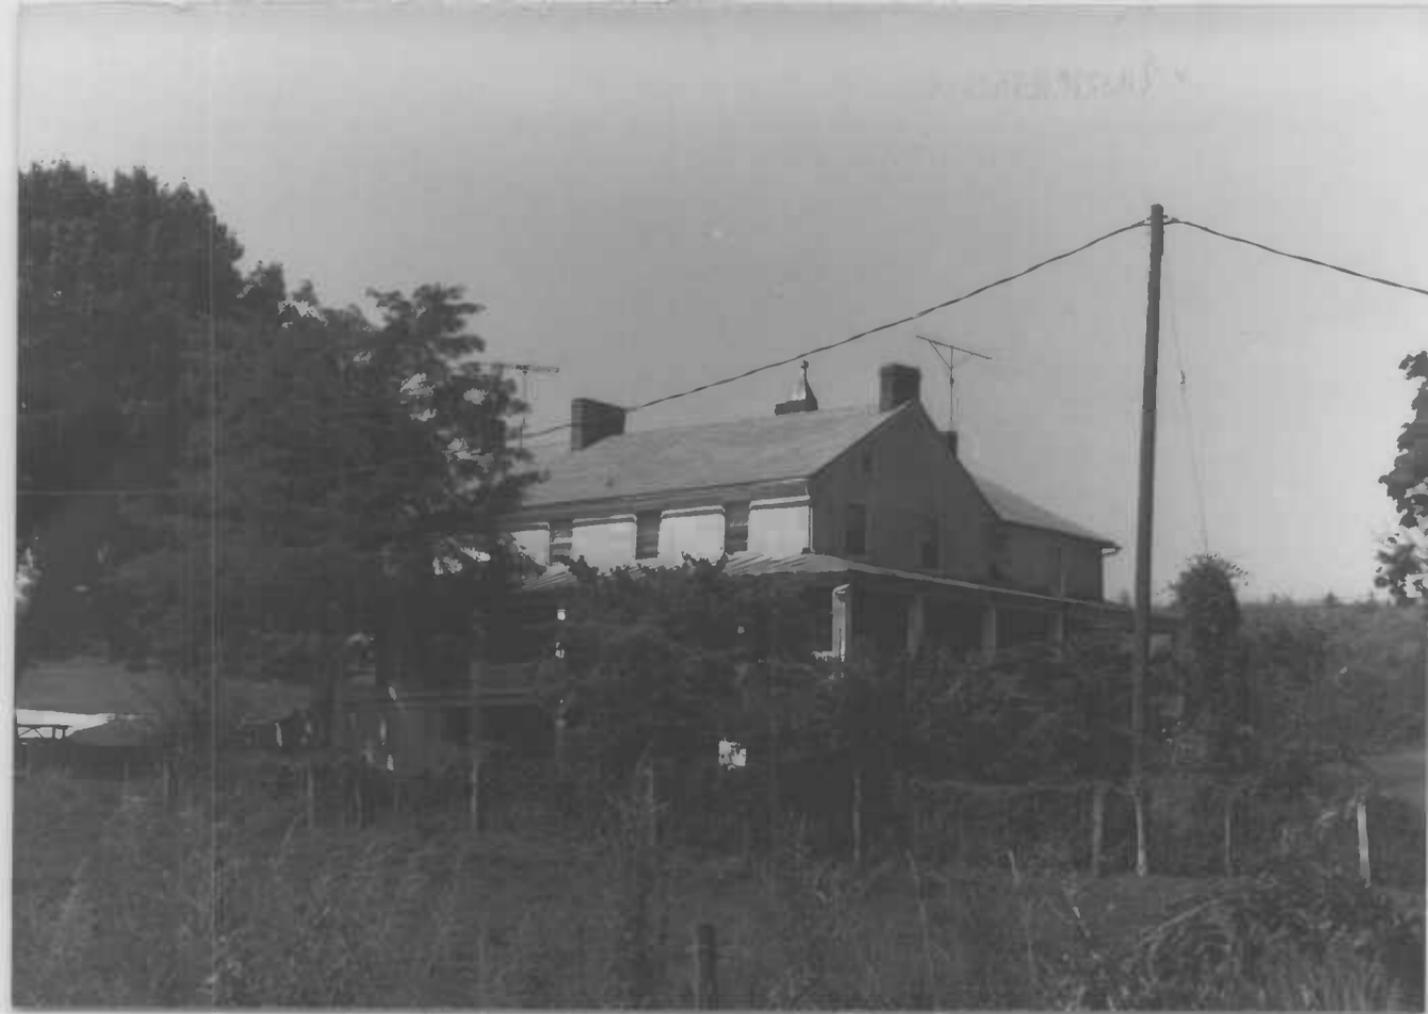
1. CARR-693 415 UNIONTOWN ROAD
2. Carroll County, Maryland
3. Joe Getty
4. August 1983
5. Md. Historical Trust, Annapolis, Md.
6. North and east elevations  
(camera facing southwest)
7. 1/1
