National Register of Historic Places  
Inventory—Nomination Form

historic Arter, Solomon, House (preferred)

and or common Arter-Davidson House

Arter, Solomon, House  
Carroll County, Maryland

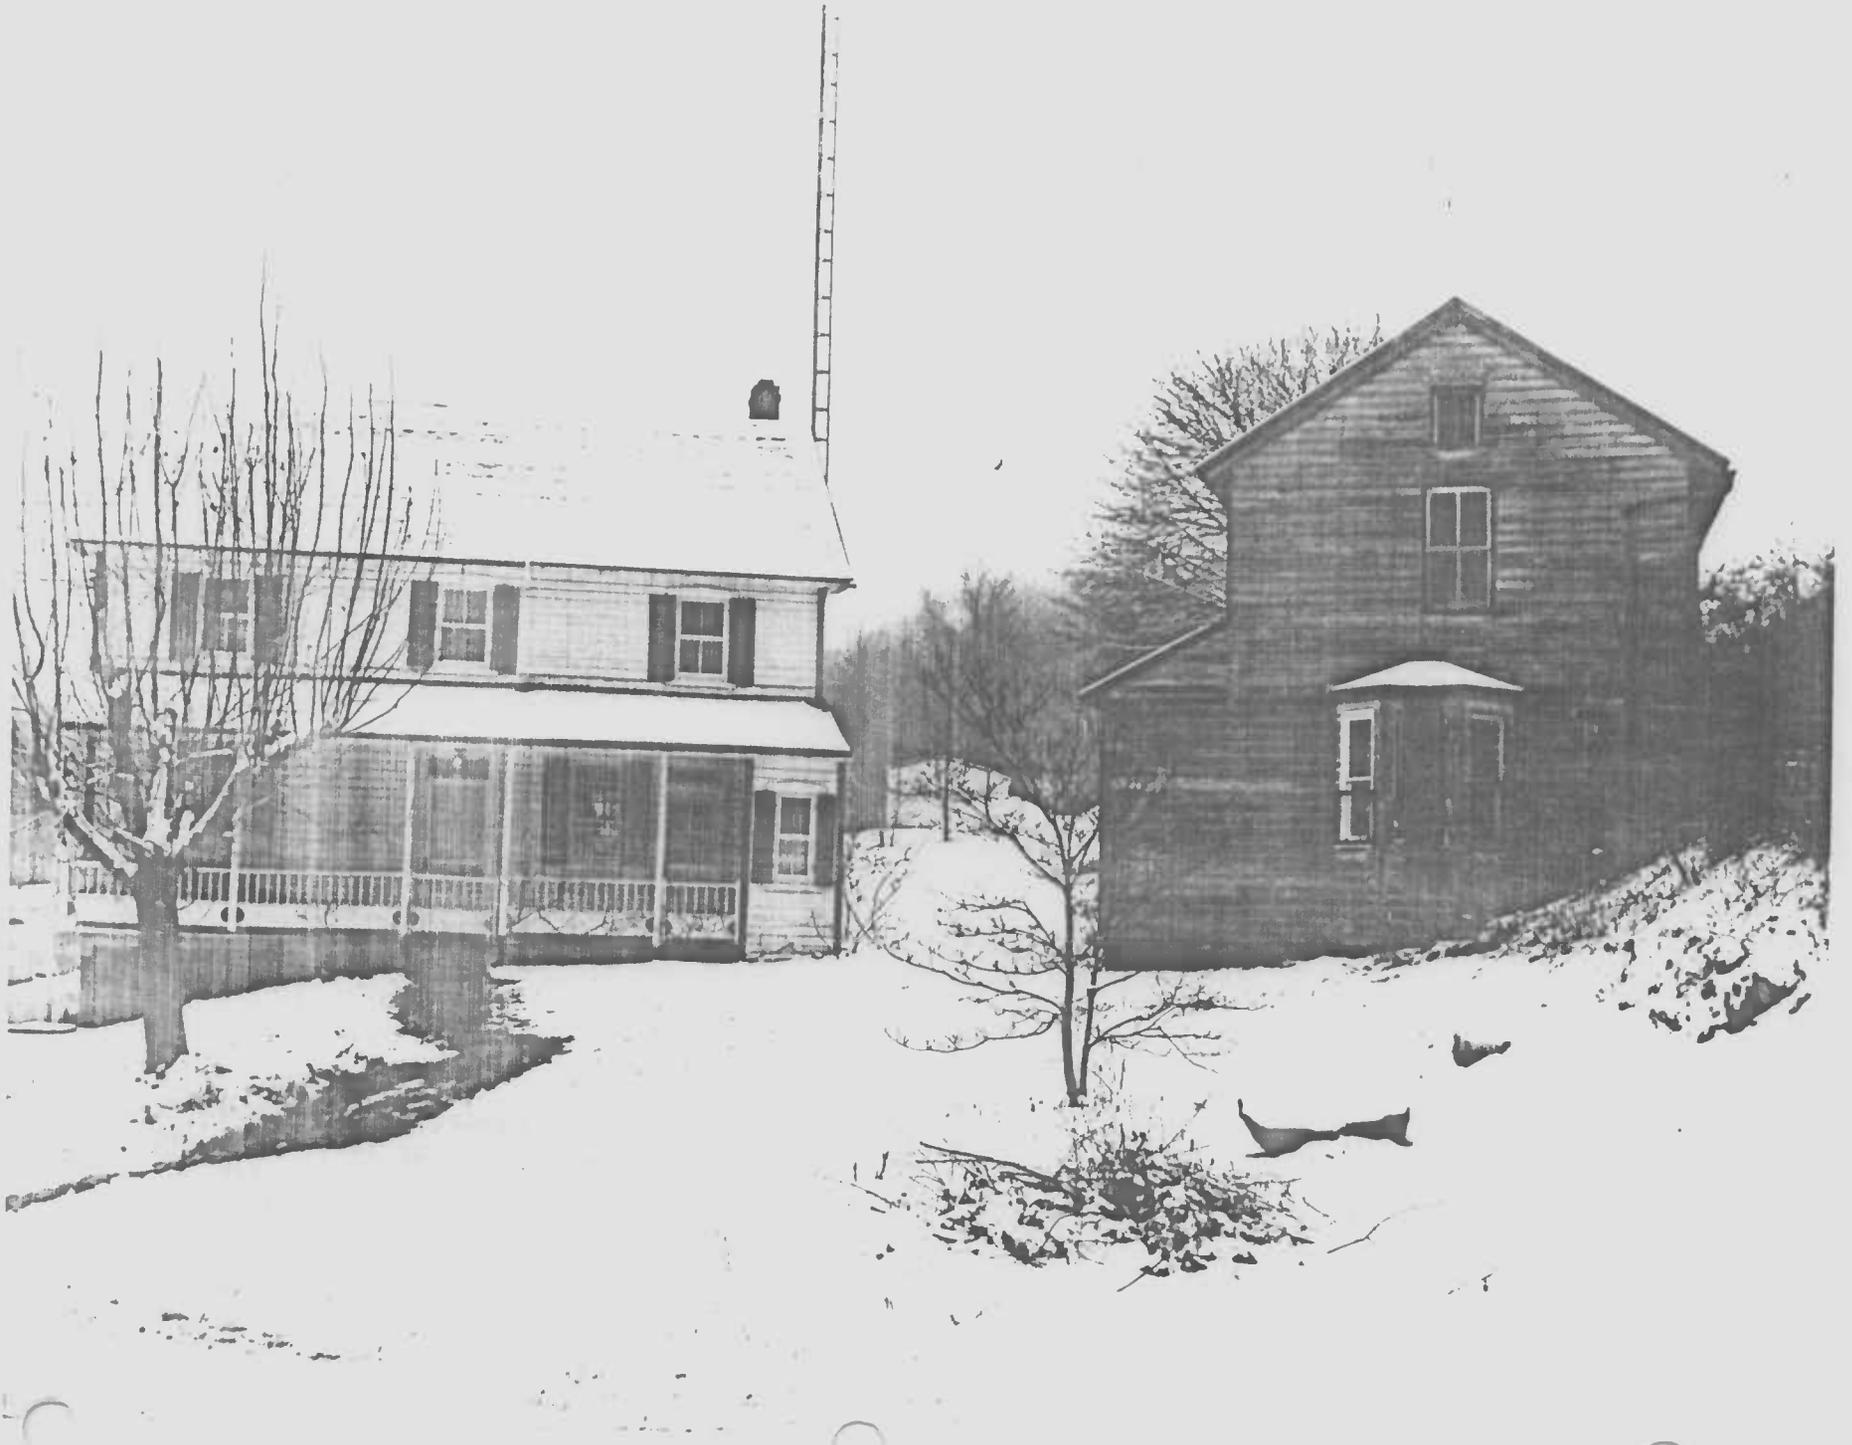
1. CARR-824 Arter-Davidson House
2. Carroll County, Maryland
3. Joe Getty
4. January 1985
5. Md. Historical Trust, Annapolis, MD
6. South elevation (camera facing north)
7. 1/19

The main (south) facade is three bays wide with a central entrance. All but one of the windows on the first story throughout the house are nine-over-six, and most of the second story windows retain original six-over-six (some of the second story windows were replaced with 2/2 sash in the late 19th century). The windows on the second story of the main facade and on each story around the house have a flat pointed-arch cornice. All of the windows have louvered shutters. The central entrance has a four-pane transom, a six-paneled door, and its original box lock. The box lock is constructed so that the exterior handle can be unscrewed as a means of locking the front door. The full-length, one-story front porch with shed roof was constructed in the late 19th century. It was supported by tapered posts and has a square bannister railing. The easternmost bay of the first story was apparently altered at the same time. These alterations include shifting one story window to an asymmetrical position, the insertion of a second doorway that leads directly to the southeast room, and the addition of a narrow pantry that projects out under the front porch roof.

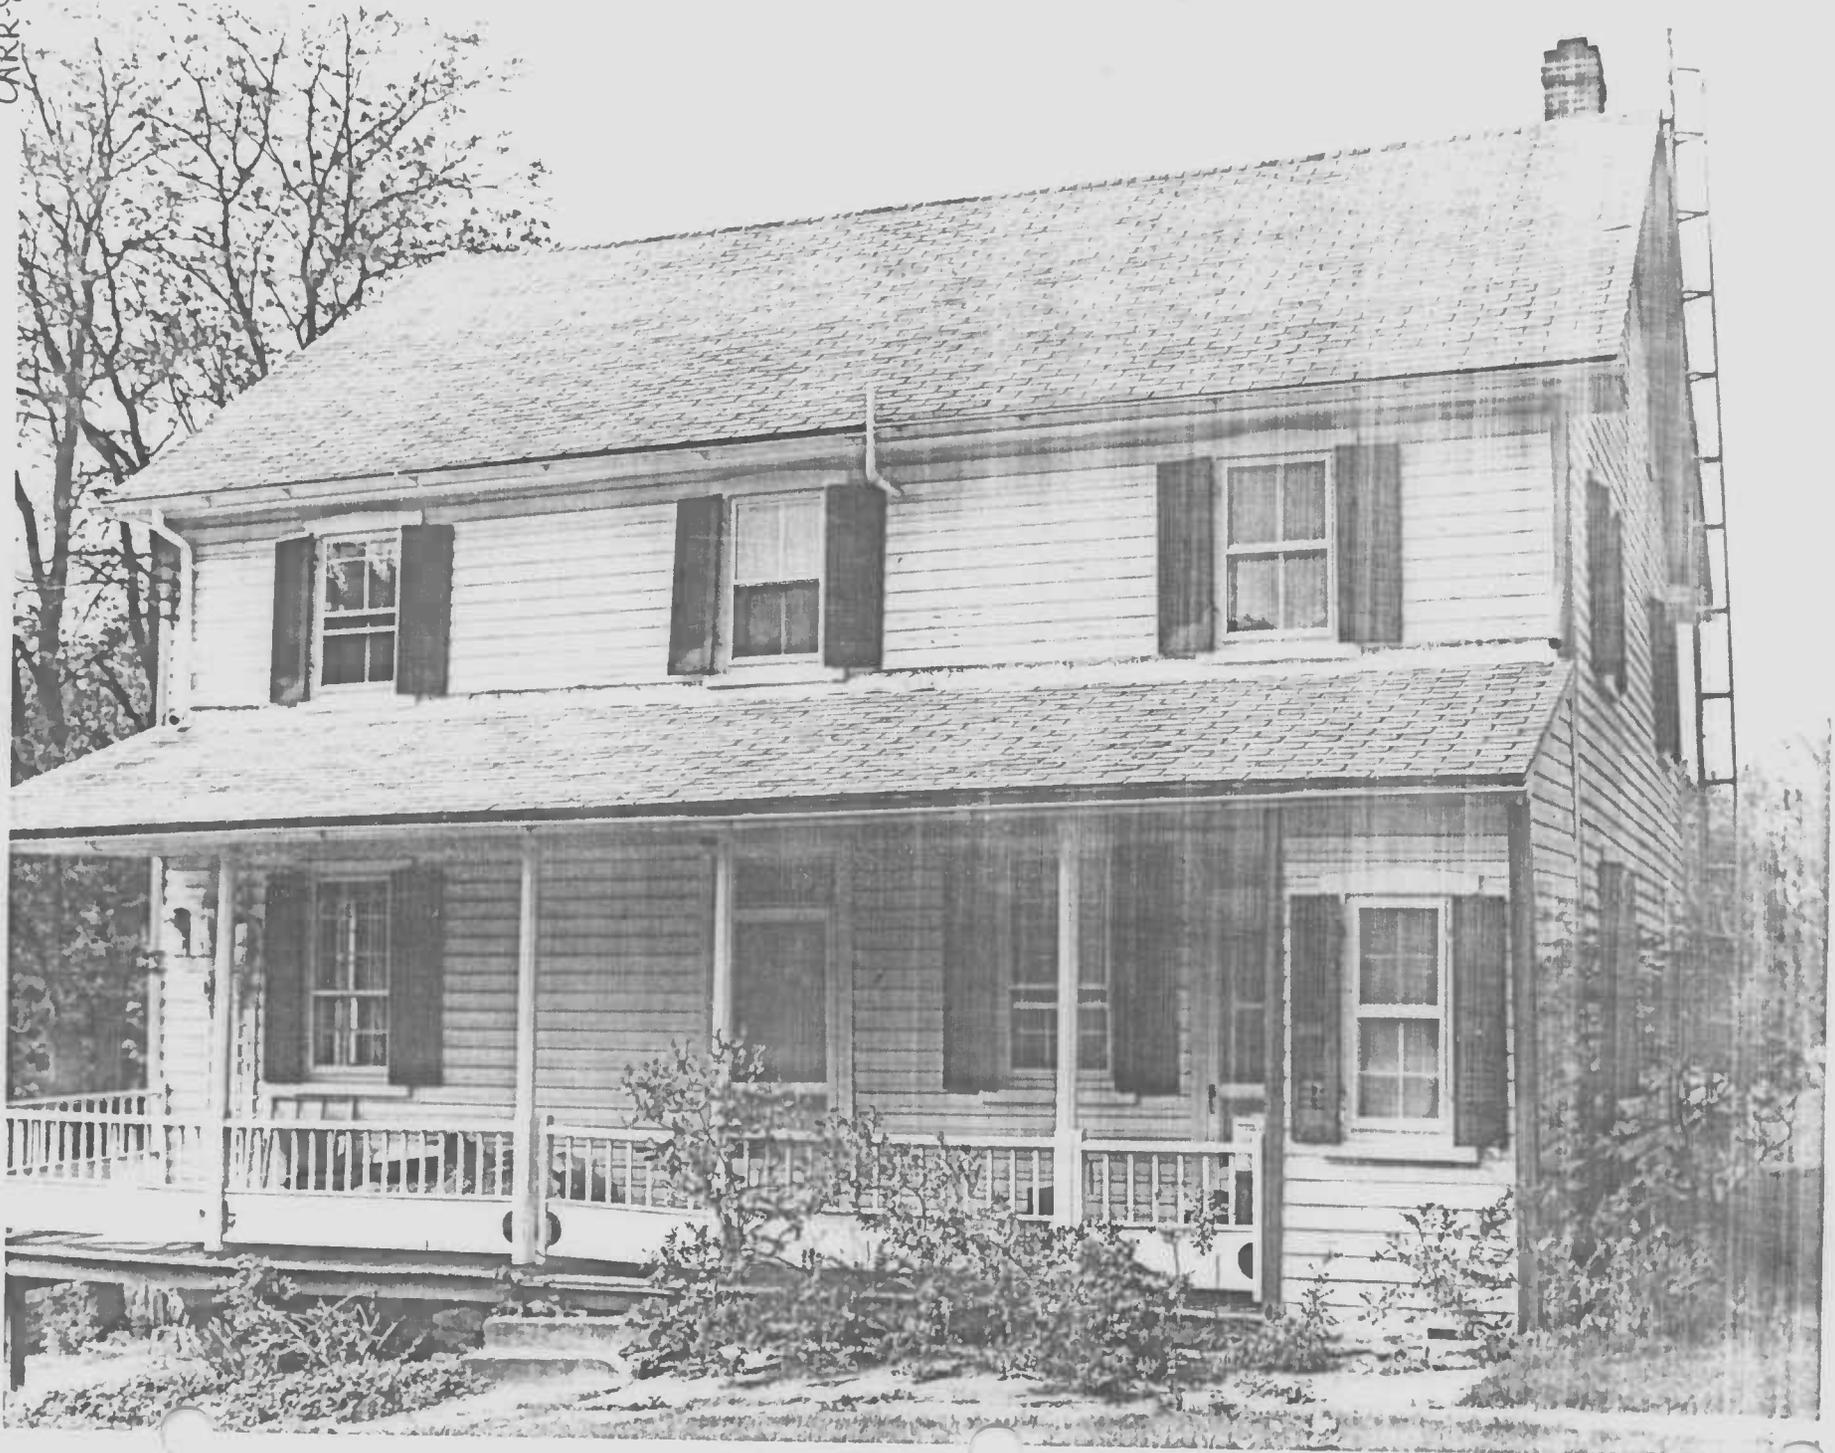
1. CARR-824 Arter-Davidson House
2. Carroll County, Maryland
3. Joe Getty
4. May, 1985
5. Md. Historical Trust, Annapolis, MD
6. South elevation (camera facing north)
7. 2/19

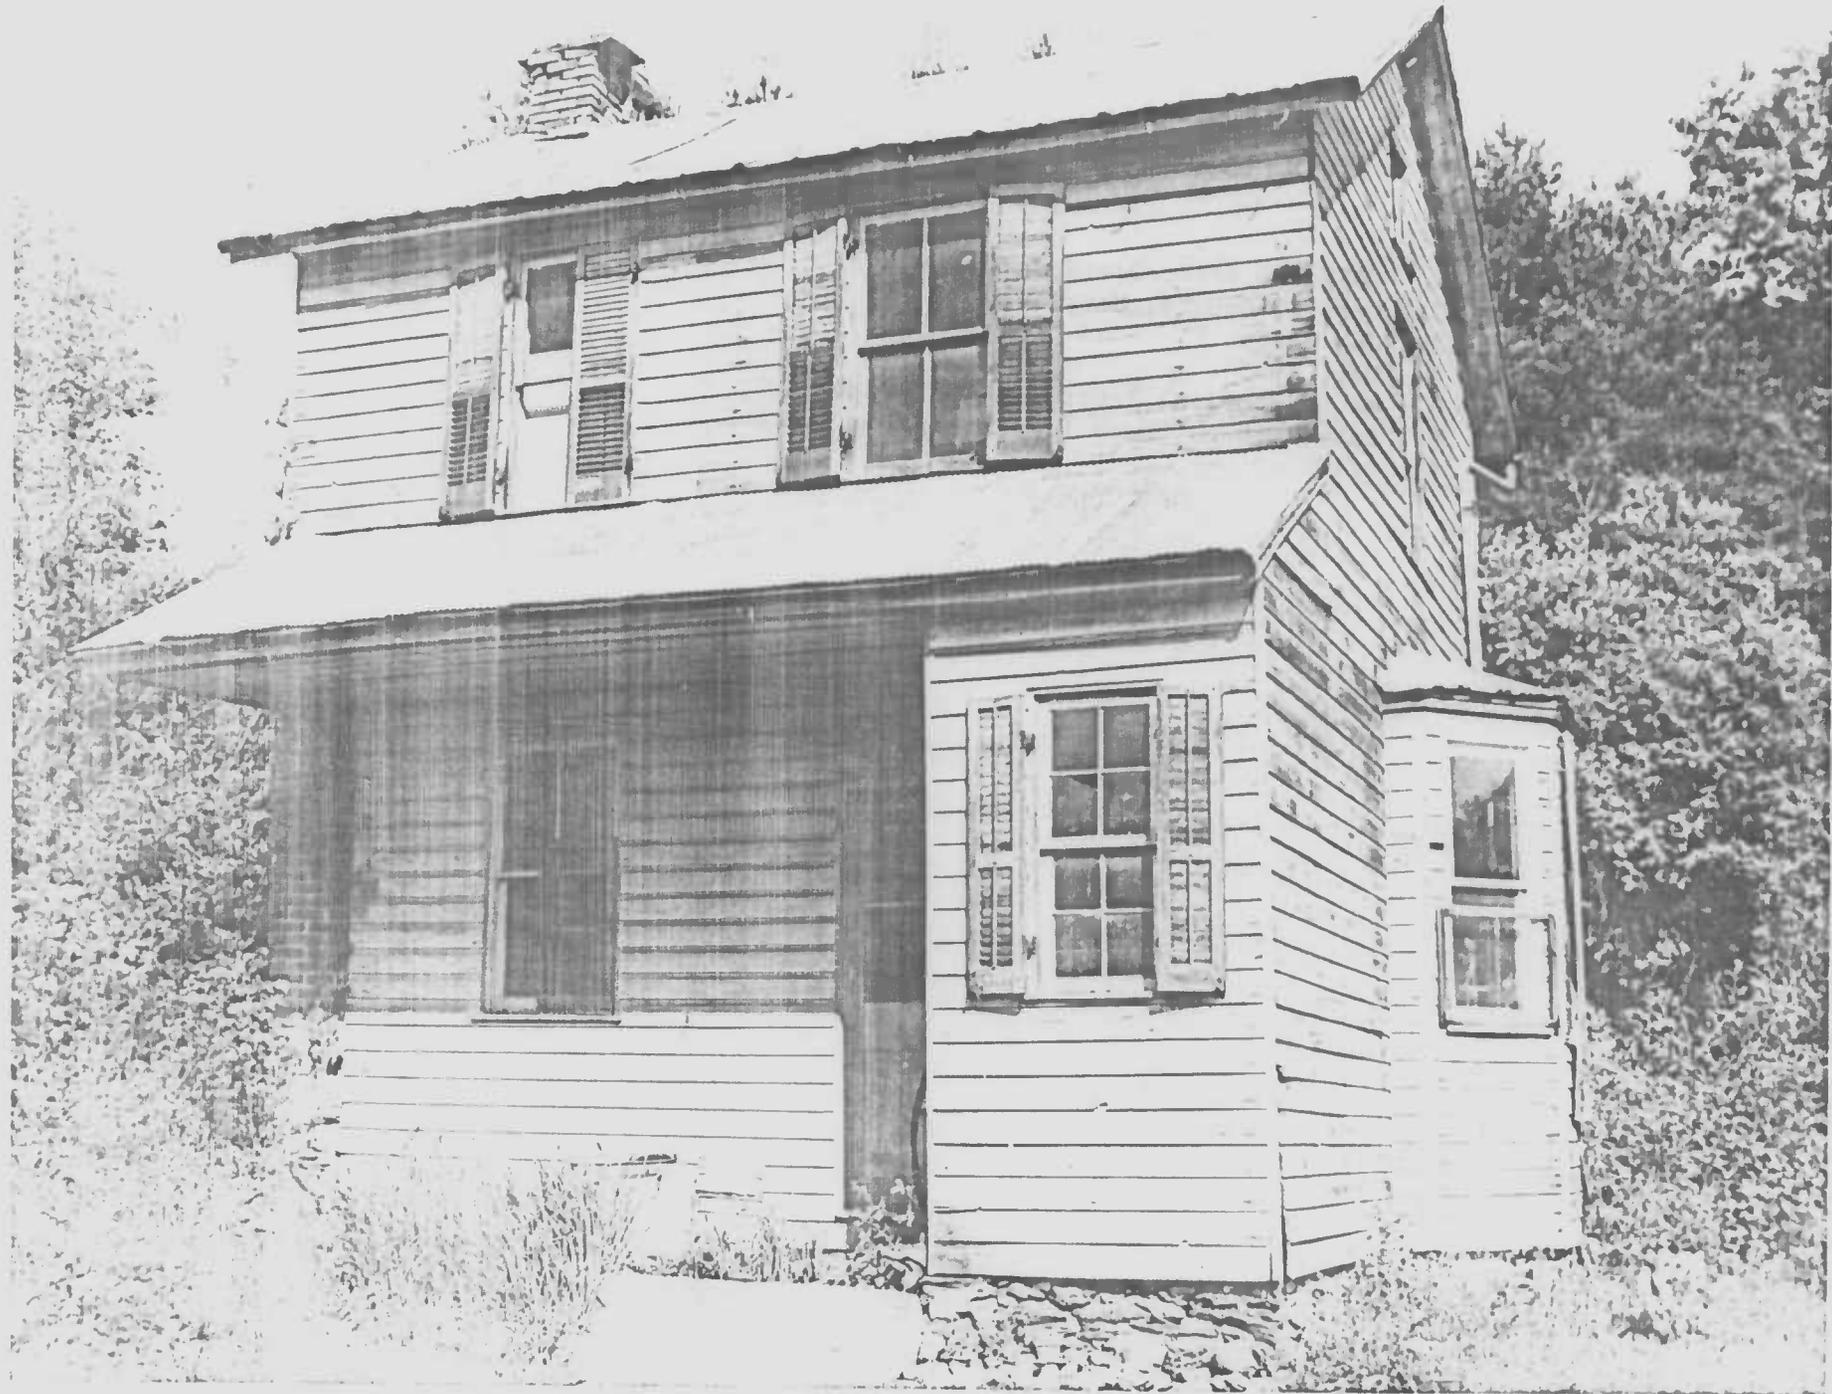
1. CARR-824 Arter-Davidson House
2. Carroll County, Maryland
3. Joe Getty
4. May, 1985
5. Md. Historical Trust, Annapolis, MD
6. Late 19th c. house (camera facing east)
7. 3/19

Also on the east side of the road is a small frame house constructed in 1883 as a retirement house for Solomon Arter, Jr., who was by then planning to turn over the operation of the farm to his son, Enan. This house is interesting in the way it incorporates Victorian design features while reflecting the conservative nature of this region. The house is constructed into a sharp slope with the main facade facing west. The slope is located on the east side so that the entire first story of the east side is covered by the ground. The north gable end is constructed of brick and contains an interior-end brick fireplace. The west, south and east facades are constructed of frame covered in German siding. This structure is built on a stone foundation. It is two-stories, two-bays by one-bay in size with a gable roof. The main facade has a full-length, one-story porch with a shed roof and a projecting pantry, similar to the one added to the main house, at its southwest corner. The interior of the structure consists of a one-room plan with a corner stair beside the fireplace. On the south facade is a one-story, three-sided, projecting bay window.

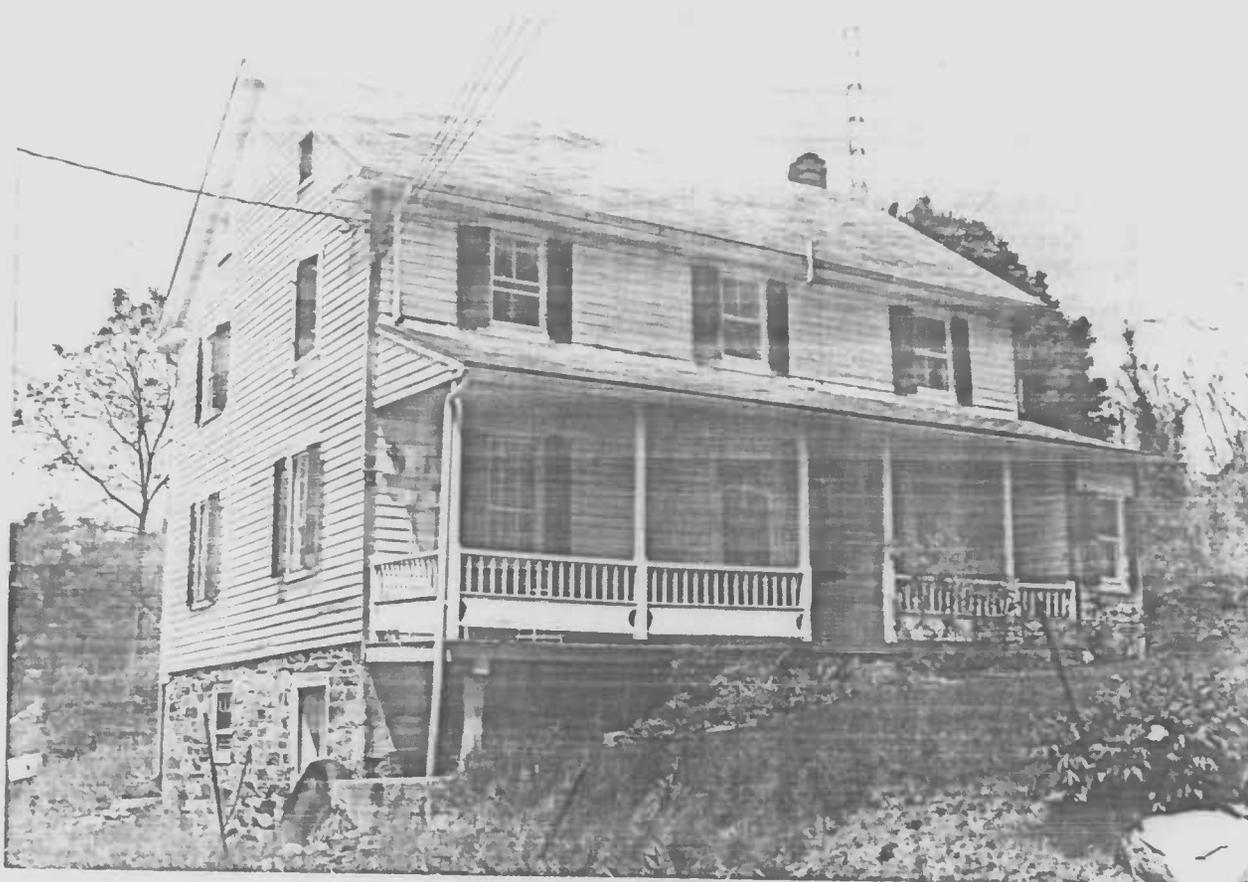
1. CARR-824 Arter-Davidson House
2. Carroll County, Maryland
3. Joe Getty
4. May, 1985
5. Md. Historical Trust, Annapolis, MD
6. South and West Elev. (camera facing n.e.)
7. 4/19

The basement is exposed at ground level on the west elevation. The basement is constructed of rough-coursed fieldstone with a bevelled joint. The southernmost bay contains a wide entrance and the northernmost bay contains a six-over-three sash window. Small four-pane windows are also located on the north and south elevations of the western portion of the foundation level. Also, the sloping ground is cut out underneath the porch on the south elevation to provide a sheltered working area. The west elevation has two nine-over-six windows on the first story, two six-over-six windows on the second story, and two square four-pane windows in the gable. The east gable end has an identical pattern of fenestration.

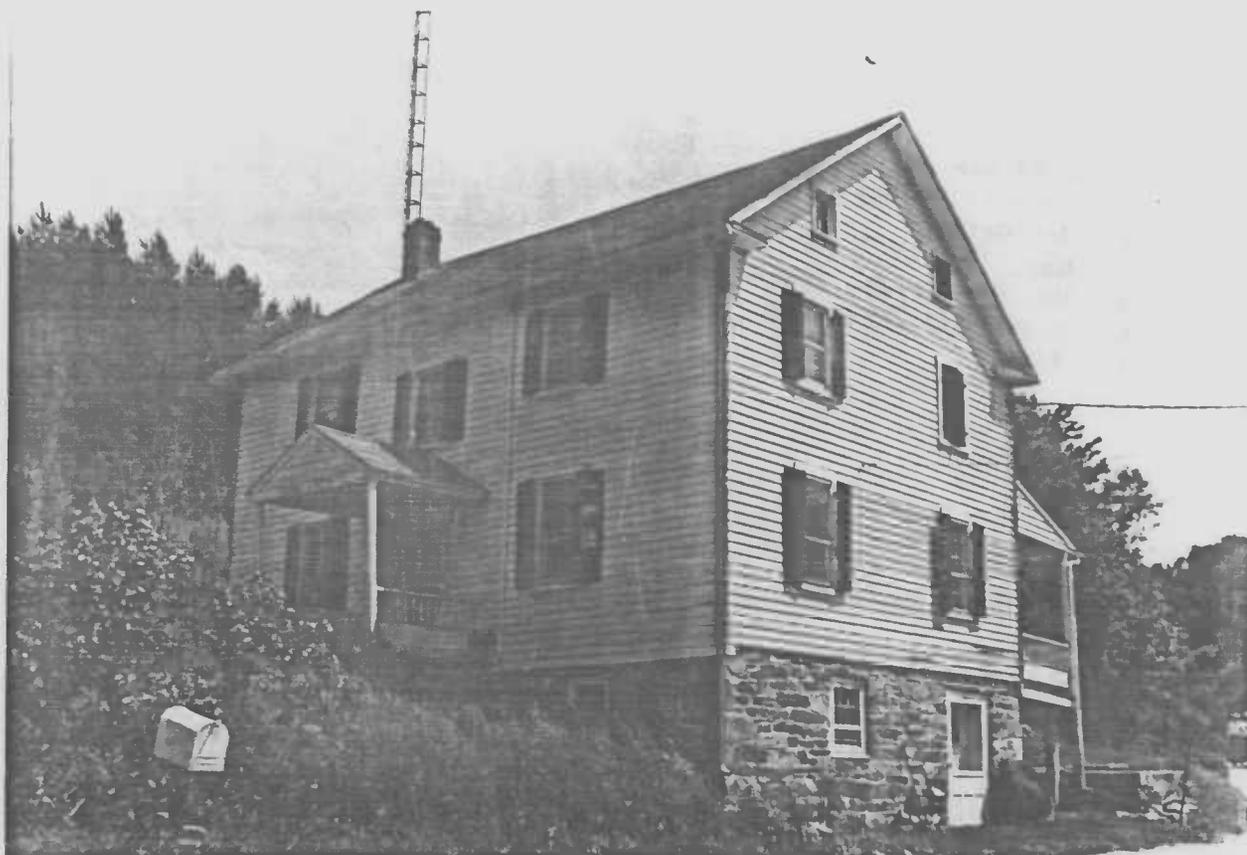
1. CARR-824 Arter-Davidson House
2. Carroll County, Maryland
3. Joe Getty
4. May, 1985
5. Md. Historical Trust, Annapolis, MD
6. North and West elev. (camera facing s.e.)
7. 5/19

The north elevation has a central entrance with a one-bay, one-story entrance porch with a gable roof. The westernmost window on the first story retains its nine-over-six sash while the easternmost window contains two-over-two sash. The central window on the second story is offset at a lower level to light the staircase. All three second story windows contain six-over-six sash.

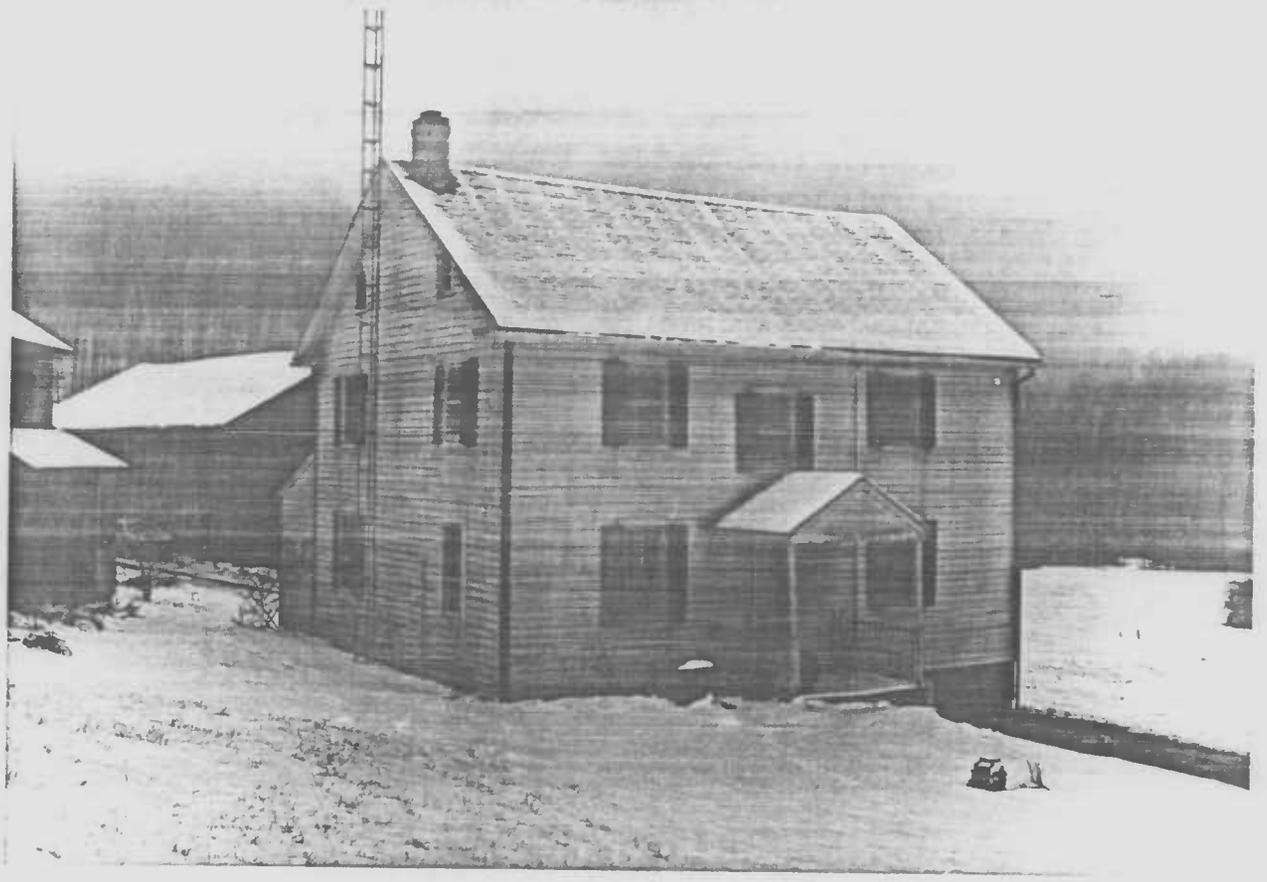
1. CARR-824 Arter-Davidson House
2. Carroll County, Maryland
3. Joe Getty
4. January, 1985
5. Md. Historical Trust, Annapolis, MD
6. North and east elev. (camera facing S.W.)
7. 6/19

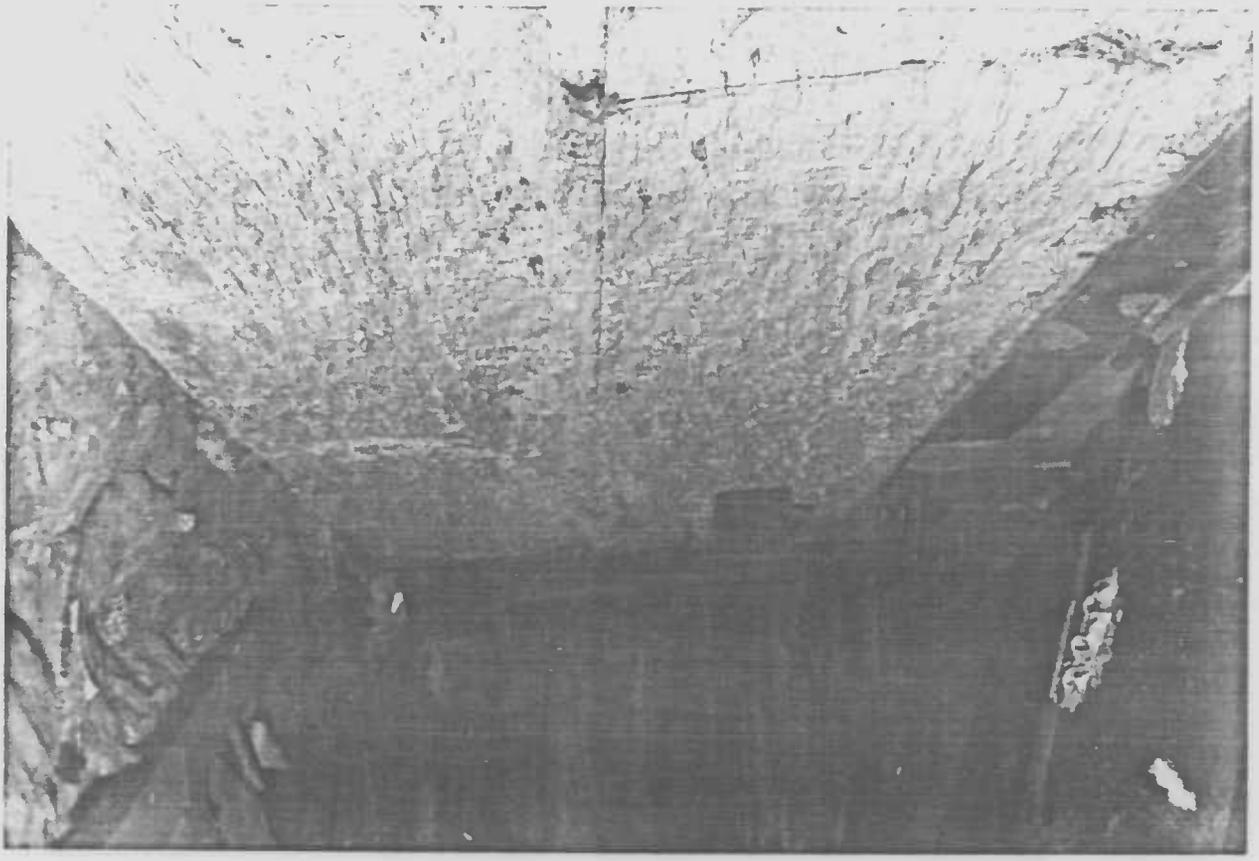
1. CARR-824 Arter-Davidson House
2. Carroll County, Maryland
3. Joe Getty
4. May, 1985
5. Md. Historical Trust, Annapolis, MD
6. Original siding under south elev. porch  
roof
7. 7/19

The c. 1810 Solomon Arter house is a two-story, three-bay by two-bay structure of log construction. It rests on a field stone foundation that is built into a partially-excavated slope with the western part of the foundation exposed at ground level. The logs are presently covered with German siding, but were originally covered with mill-sawn weatherboard. The German siding is part of a late 19th century remodeling that also included the construction of a full-length, one-story porch on the main facade. The portion of the main facade covered by the porch roof contains the original wood siding of the main facade still in place, which can be viewed by removing boards in the porch ceiling. This area reveals the original siding (14-16 inches wide) and also shows that a one-by gable roofed porch existed over the main entrance at one time. The house has a gable roof with a boxed cornice that returns at the corners. Originally, brick interior chimney stacks rose at the peak of the roof at each gable end.

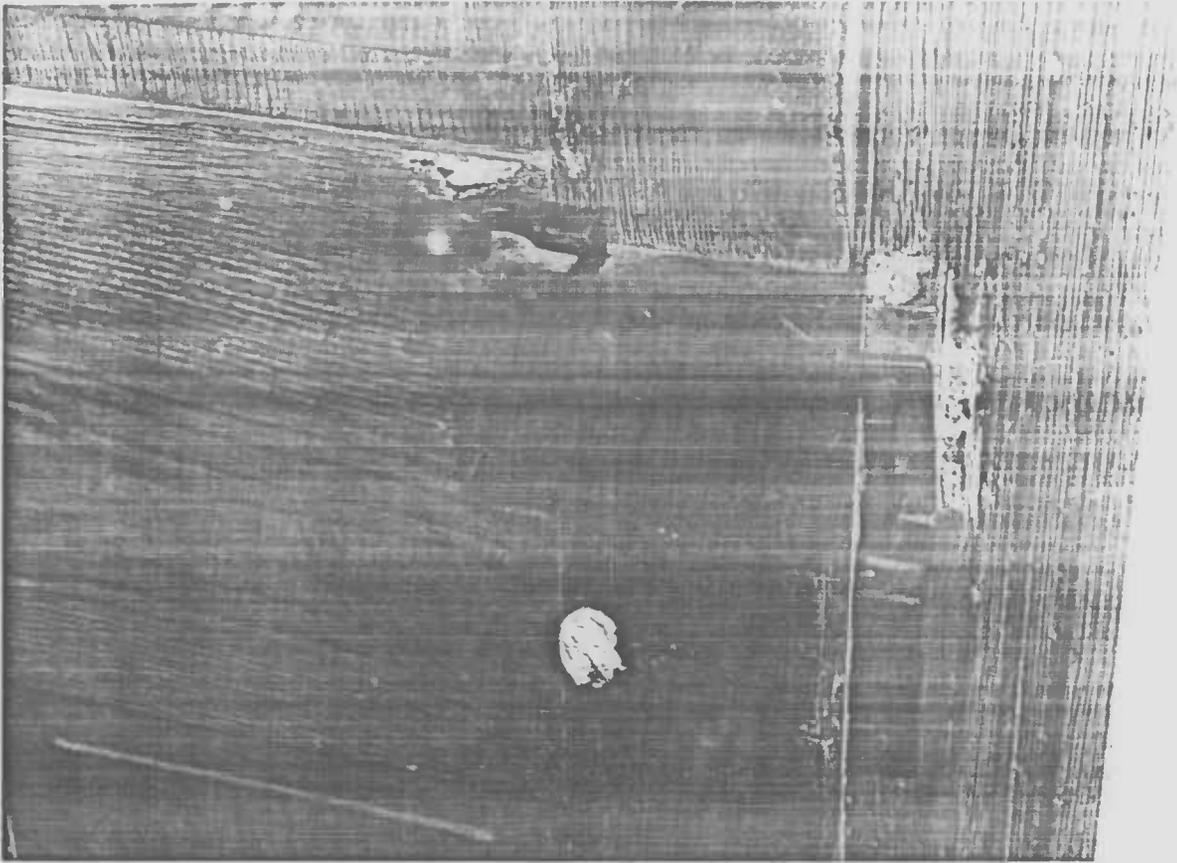
1. CARR-824 Arter-Davidson House
2. Carroll County, Maryland
3. Joe Getty
4. January, 1985
5. Md. Historical Trust, Annapolis, MD
6. Original boxloc;grained door 1st storyhall
7. 8/19

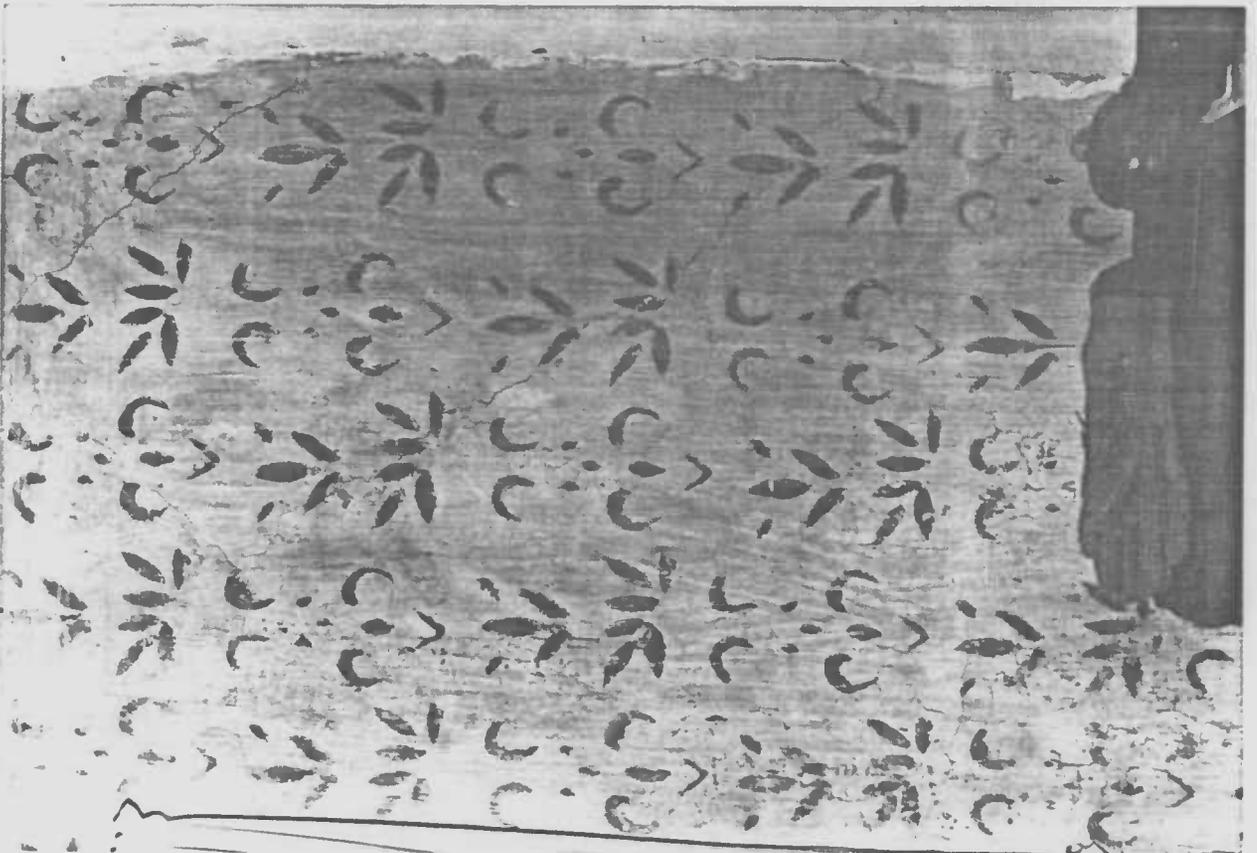
The walls of the northeast bedroom retain two sections of original stenciling. One section runs floor-to-ceiling and the other runs part of the way up the wall before it is painted over. The stenciling pattern of both sections is identical consisting of two large motifs, a red tulip rising from a heart and a green abstract leaf. The motifs run alternately in both a horizontal and vertical pattern. The heart and tulip motif was a popular design in Pennsylvania German decorative arts. It is possibly a reference to scripture (Matthew 7:17, 18; Matthew 12:3-25; and Luke 6:43-45) where it is stated that from the heart rose good deeds, and the tulip frequently represents good things or good fruit in the Pennsylvania German culture. This section of stenciling was revealed by the current owners in the late 1940s, when they removed a layer of wallpaper. They left these panels exposed, and while the light has probably faded the colors to some extent, the stencils and their colors are still quite vivid. The red color is deep and the green on one wall is dark, while on the other wall it is a blue-green.

1. CARR-824 Arter-Davidson House
2. Carroll County, Maryland
3. Joe Getty
4. January, 1985
5. Md. Historical Trust, Annapolis, MD
6. Stenciled wall in northeast bedroom
7. 9/19

The significance of the house lies in its retention of evidence for the original stencil decoration of the interior. This evidence is considered the best-preserved example of Pennsylvania German interior stenciling known in the region by officers of the Pennsylvania German Society. The panel of stenciling that survives in the northeast bedrooms shows the manner in which this treatment ran from the floor to the ceiling. The colors in this room and in the other samples use bright shades, relying primarily on reds, blues, and

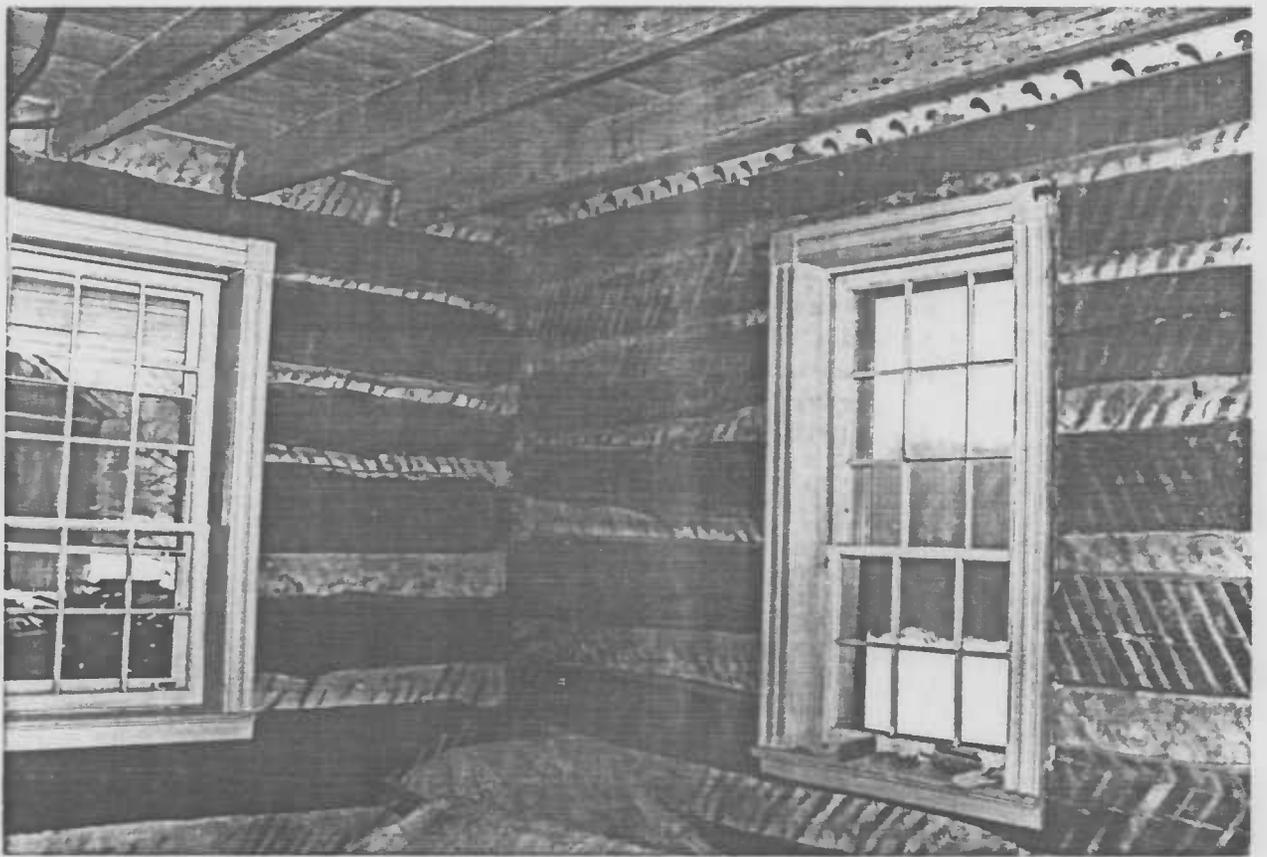
On the first story, the west interior walls were exposed during a remodeling in January 1985. With the ceiling and wall plaster dating from the early 20th century removed, the location of the former partition between the two rooms became evident. Further, the ceiling joists and underside of the second story floor boards were found to have been painted a pink color in the southwest room and whitewashed in the northwest room. Apparently, the ceilings were covered with lath and plaster in the mid 19th century and in the early 20th century the walls of both rooms were completely replastered. When this new plaster was removed during the 1985 remodeling, the only original plaster that was found was a 7 to 8 inch strip at the cornice level, which had been concealed by the earlier plastering job. This preserved strip revealed two different stencil patterns, both consisting of floral motifs. In the southwest room, the pattern had two different designs. It begins in the southeast corner of the room with a green maple leaf pattern above blue swirls, but becomes more abstract along that wall changing to a leaf pattern

1. CARR-824 Arter-Davidson House
2. Carroll County, Maryland
3. Joe Getty
4. January, 1985
5. Md. Historical Trust, Annapolis, MD
6. Remnants of southwest room stenciling, 1st story
7. 11/19

with three petals (instead of maple leaf five petals). The colors are quite bright in this room and the way the pattern is interrupted makes it appear that it continued in some manner from floor to ceiling. In the first story stairhall, evidence suggests that the blue floral and yellow pattern from the upstairs would have continued. There is no current evidence of stenciling in the rooms on the east side of the stairhall.

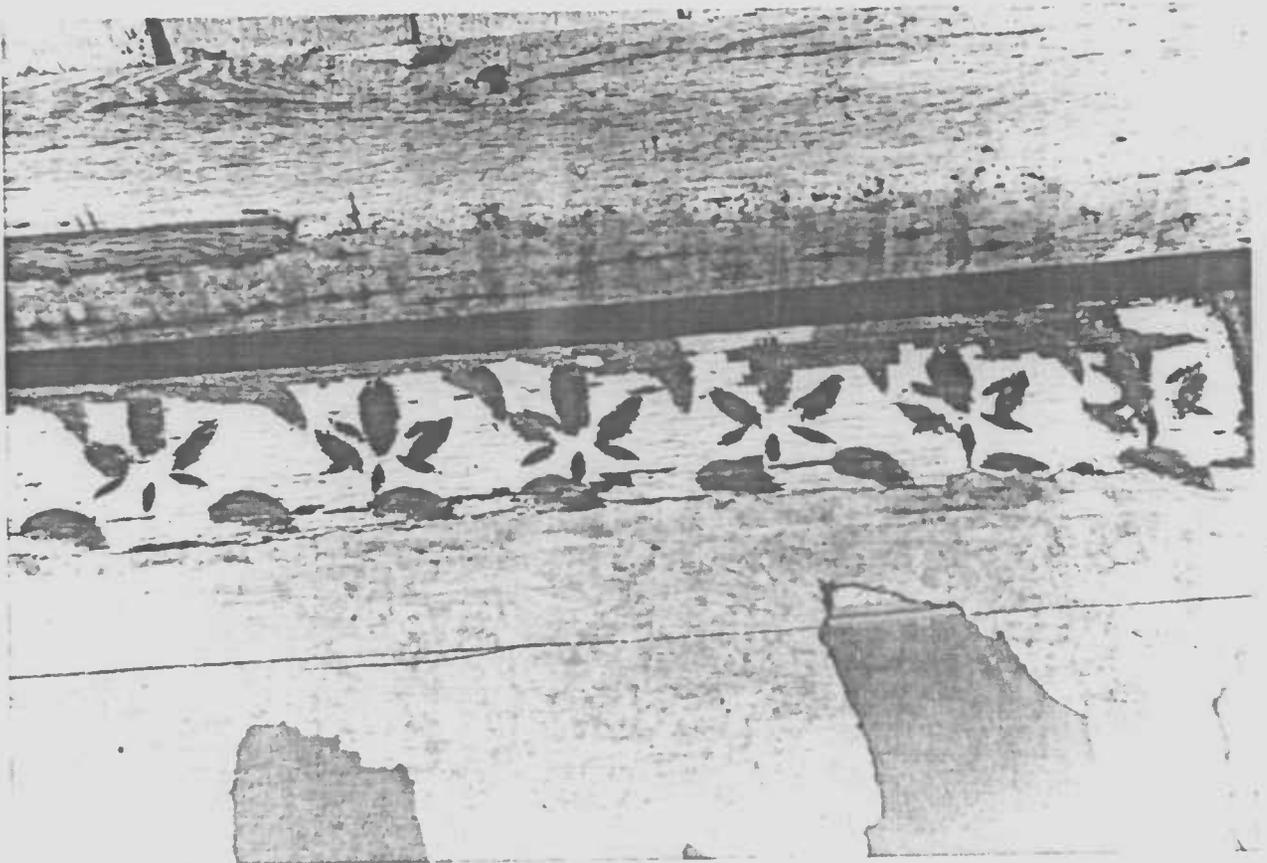
1. CARR-824 Arter-Davidson House
2. Carroll County, Maryland
3. Joe Getty
4. January, 1985
5. Md. Historical Trust, Annapolis, MD
6. 1st story, detail of southwest room  
stenciling
7. 13/19

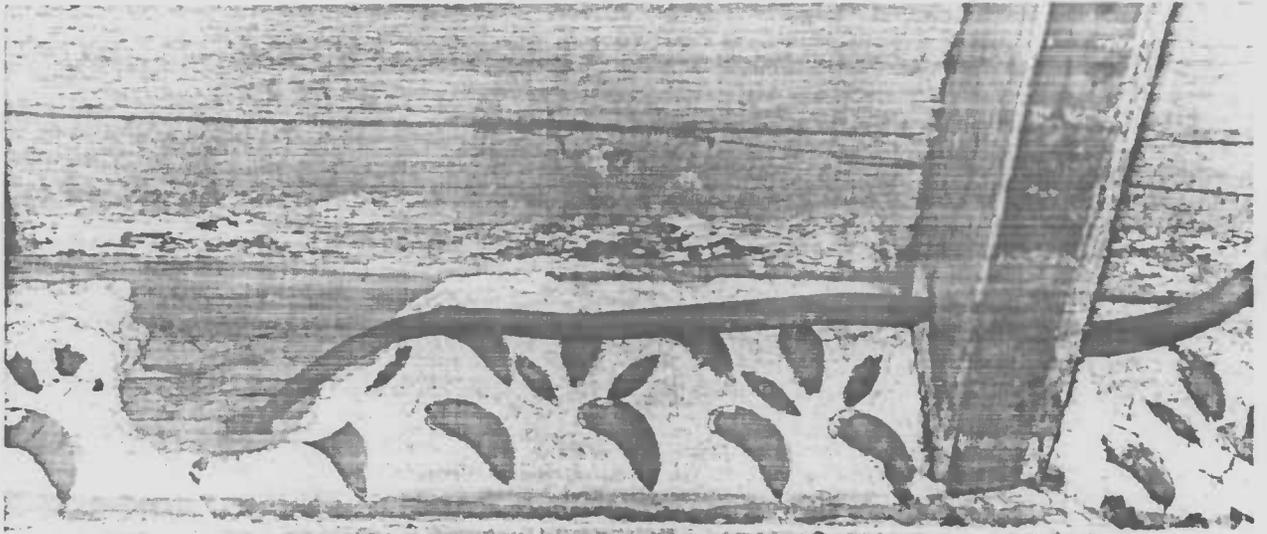
1. CARR-824 Arter-Davidson House
2. Carroll County, Maryland
3. Joe Getty
4. January, 1985
5. Md. Historical Trust, Annapolis, MD
6. 1st story, detail of southwest room  
stenciling (northeast corner)
7. 14/19 <

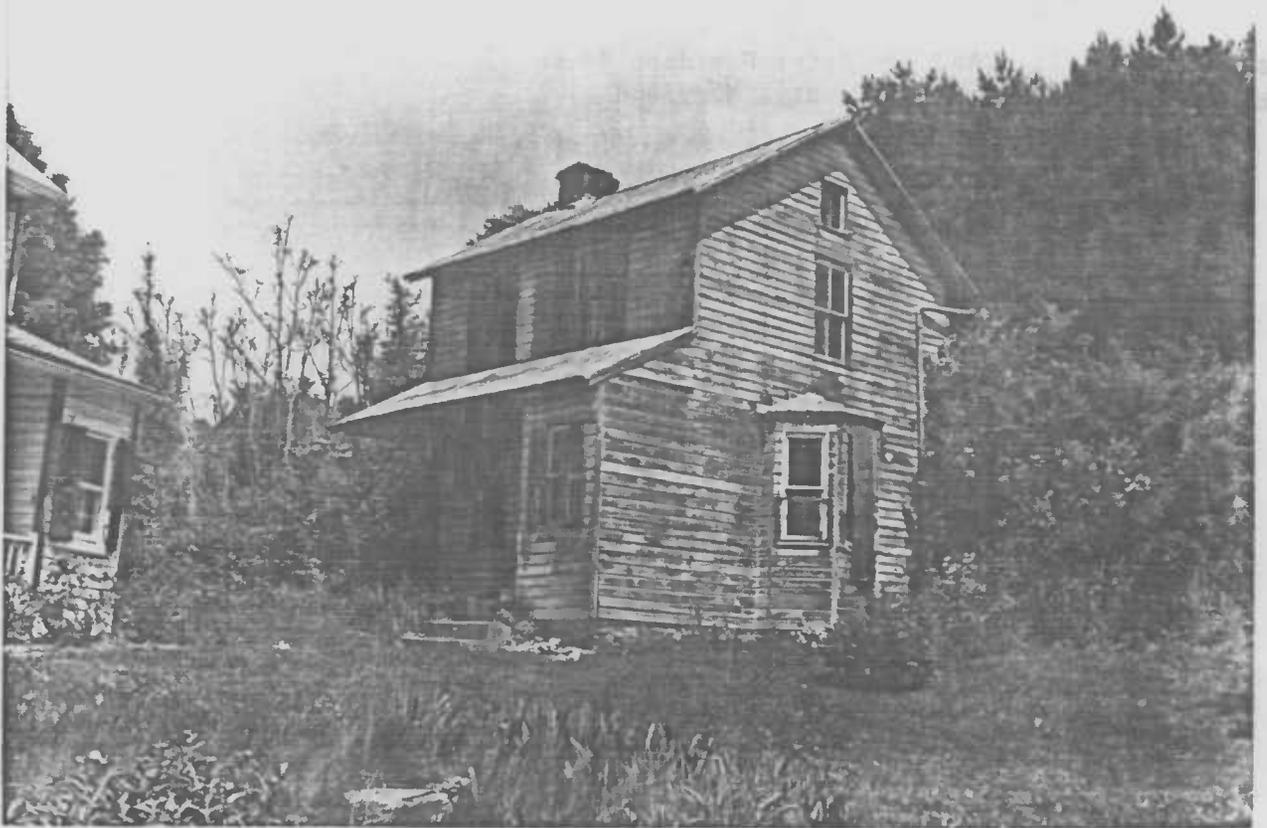
1. CARR-824 Arter-Davidson House
2. Carroll County, Maryland
3. Joe Getty
4. May, 1985
5. Md. Historical Trust, Annapolis, MD
6. Late 19th c. house, South and West elev.
7. 15/19

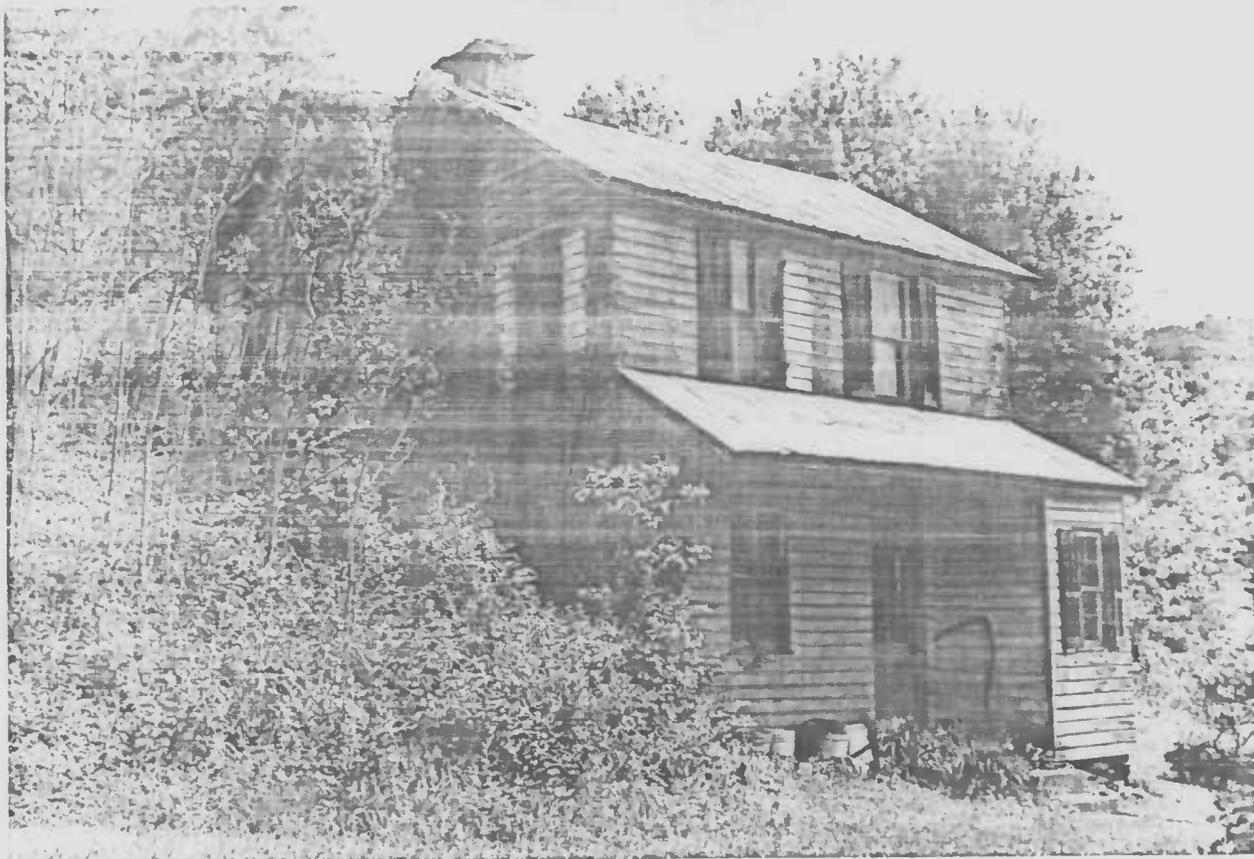
1. CARR-824 Arter-Davidson House
2. Carroll County, Maryland
3. Joe Getty
4. May, 1985
5. Md. Historical Trust, Annapolis, MD
6. Late 19th c. house, north and west elev.
7. 16/19
