National Register of Historic Places  
Inventory—Nomination Form

historic Arter, Solomon, House (preferred)

and or common Arter-Davidson House

Arter, Solomon, House  
Carroll County, Maryland

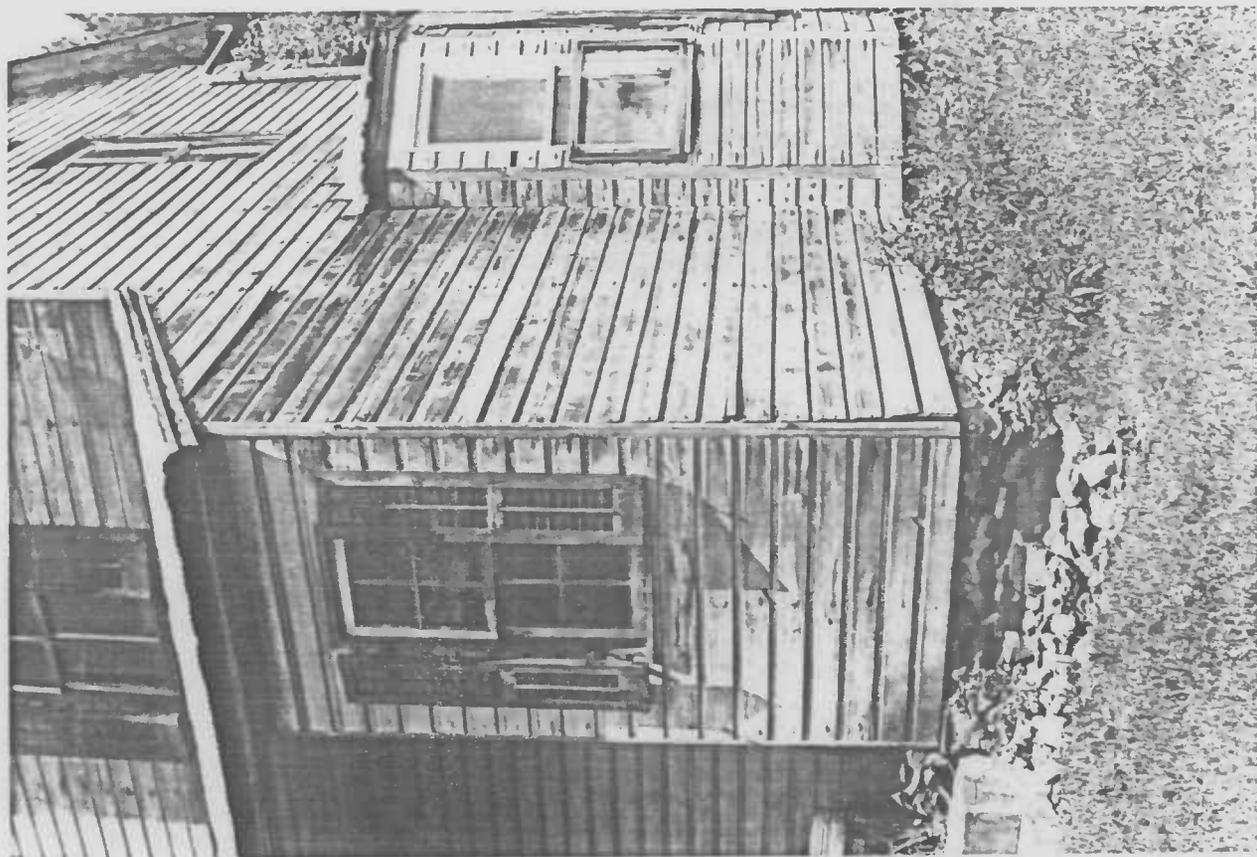
1. CARR-824 Arter-Davidson House
2. Carroll County, Maryland
3. Joe Getty
4. May, 1985
5. Md. Historical Trust, Annapolis, MD
6. Late 19th c. house, detail of porch  
feature
7. 17/19

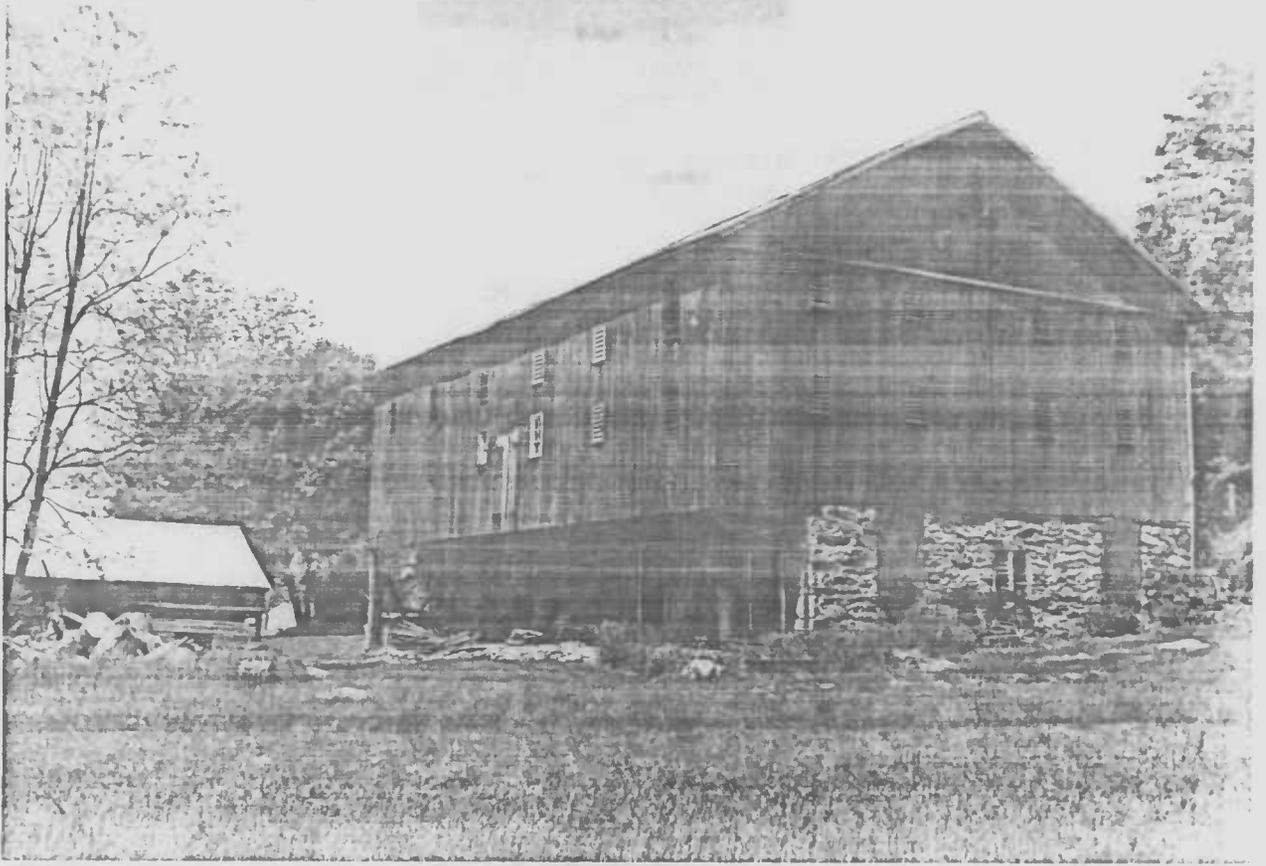
The frame bank barn was constructed in 1872. It is a large structure constructed in the regional style with a stone foundation built into a slope so that the east side has ground level entrance to the threshing floor. The west side has a projecting forebay with doors leading into the stalls. The foundation is constructed of uncoursed fieldstone. The frame section is covered in vertical boards and has louvered openings in two rows (four in each row on the gable ends). In the gables are a pattern of round-arched central-louvered windows flanked on each side by a square louvered window. The west facade forebay section has a row of six louvered windows on the

1. CARR-824 Arter-Davidson House
2. Carroll County, Maryland
3. Joe Getty
4. May, 1985
5. Md. Historical Trust, Annapolis, MD
6. Bank barn, South and West elev.
7. 18/19

second level and four (in the outer two bays on each side) on the first level with the center bay containing two four-over-two sash windows in a central doorway of double doors. The east elevation (bank side) contains two large double doors in the center of the elevation, four louvered openings on the top level and two four-over-two sash windows on the first level on the northern side of the elevation. A man-door within the large wagon doors contains Pennsylvania German style hardware with a strap hinge that is connected to a double-flange patterned pintle.

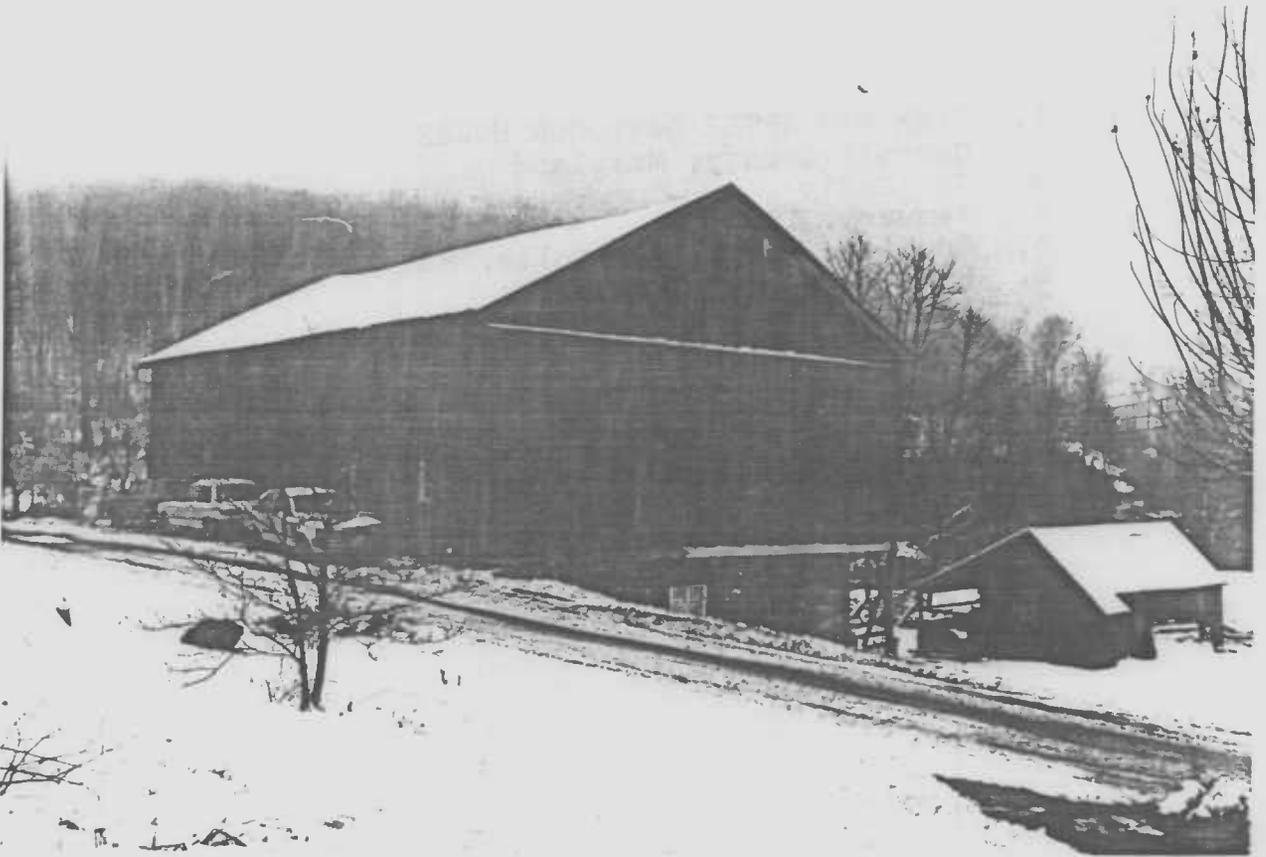
1. CARR-824 ARTER-DAVIDSON HOUSE
2. Carroll County, Maryland
3. Joe Getty
4. January, 1985
5. Md Hist. Trust, Annapolis, Md
6. Bank barn, N & E elev.
7. 19/19
