# Maryland Historical Trust State Historic Sites Inventory Form

Survey No. CARR-956

historic Locust Grove Farm

street & number Green Valley Road (Route 75)  not for publication

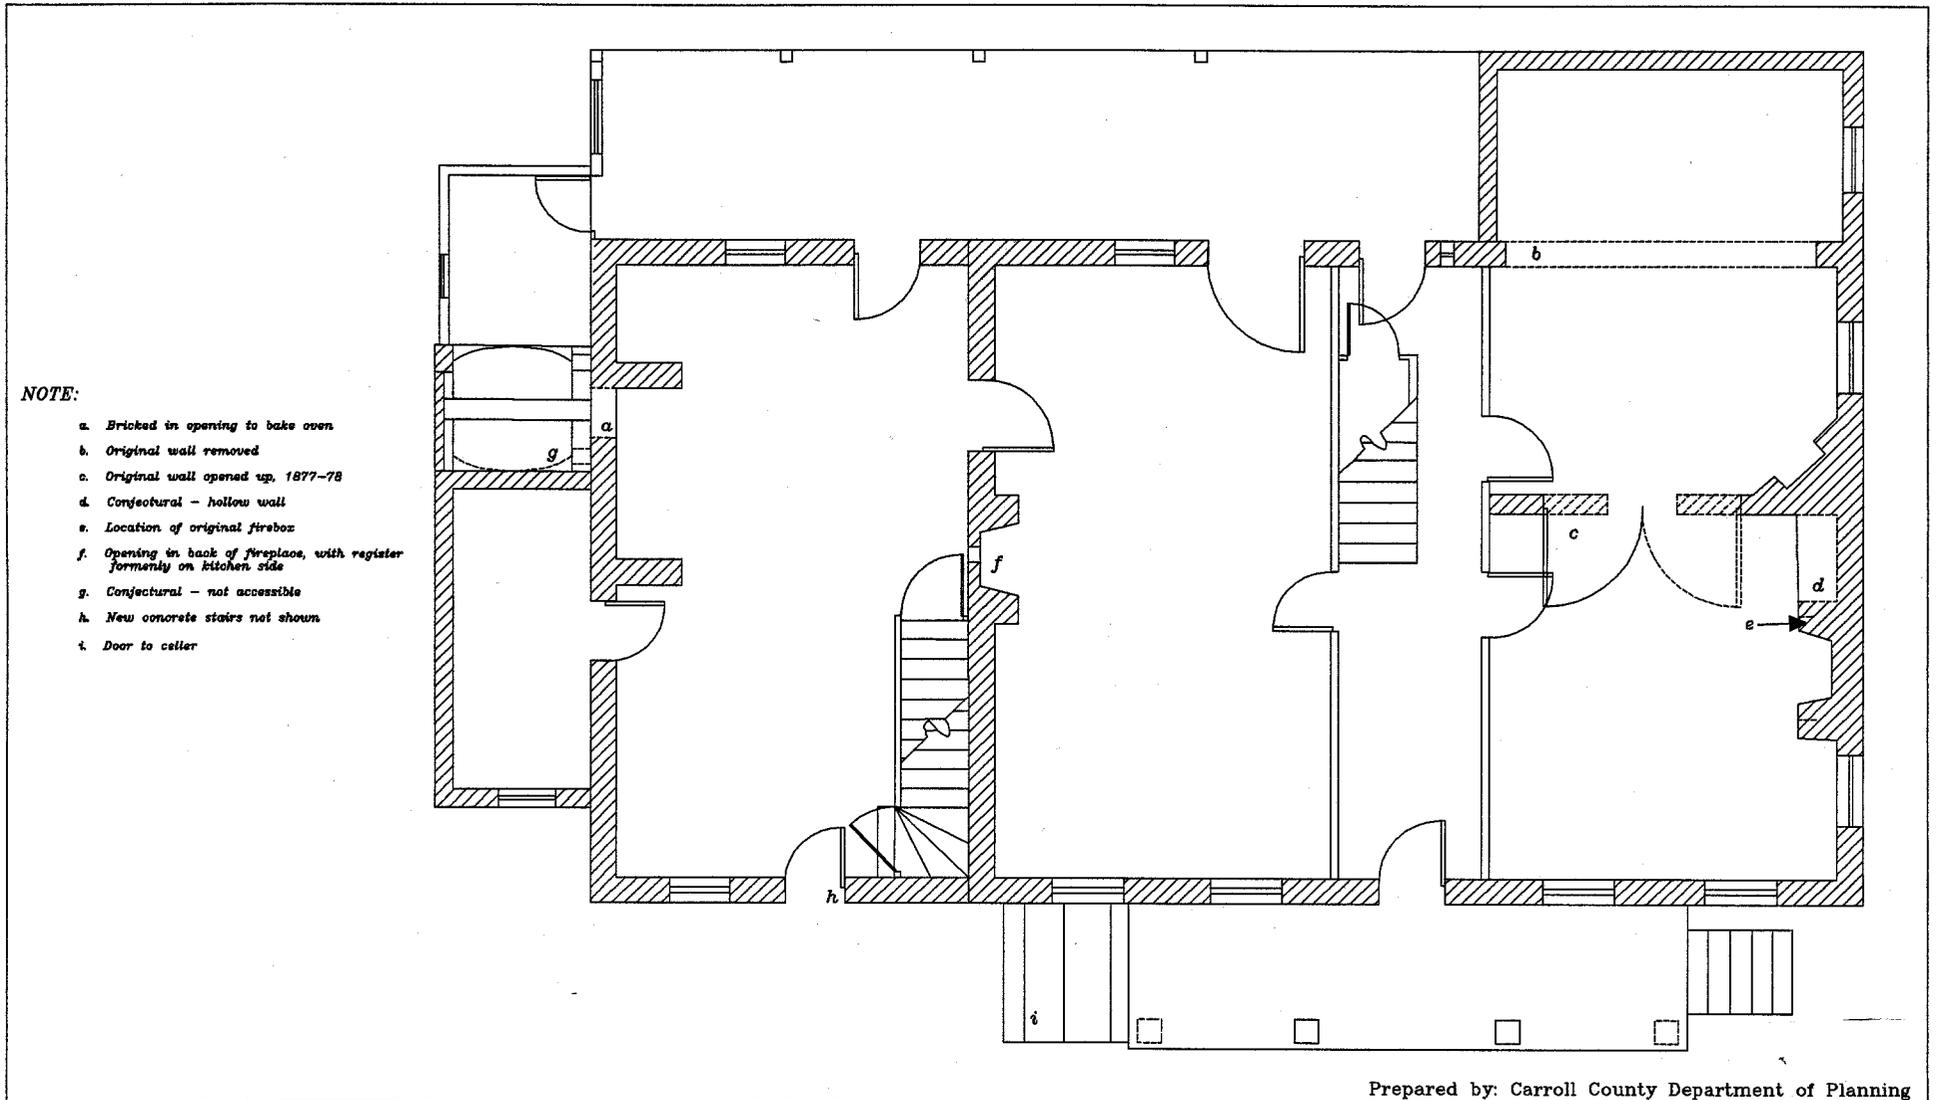
- a. Bricked in opening to bake oven
- b. Original wall removed
- c. Original wall opened up, 1877-78
- d. Conjectural - hollow wall
- e. Location of original firebox
- f. Opening in back of fireplace, with register formerly on kitchen side
- g. Conjectural - not accessible
- h. New concrete stairs not shown
- i. Door to celler

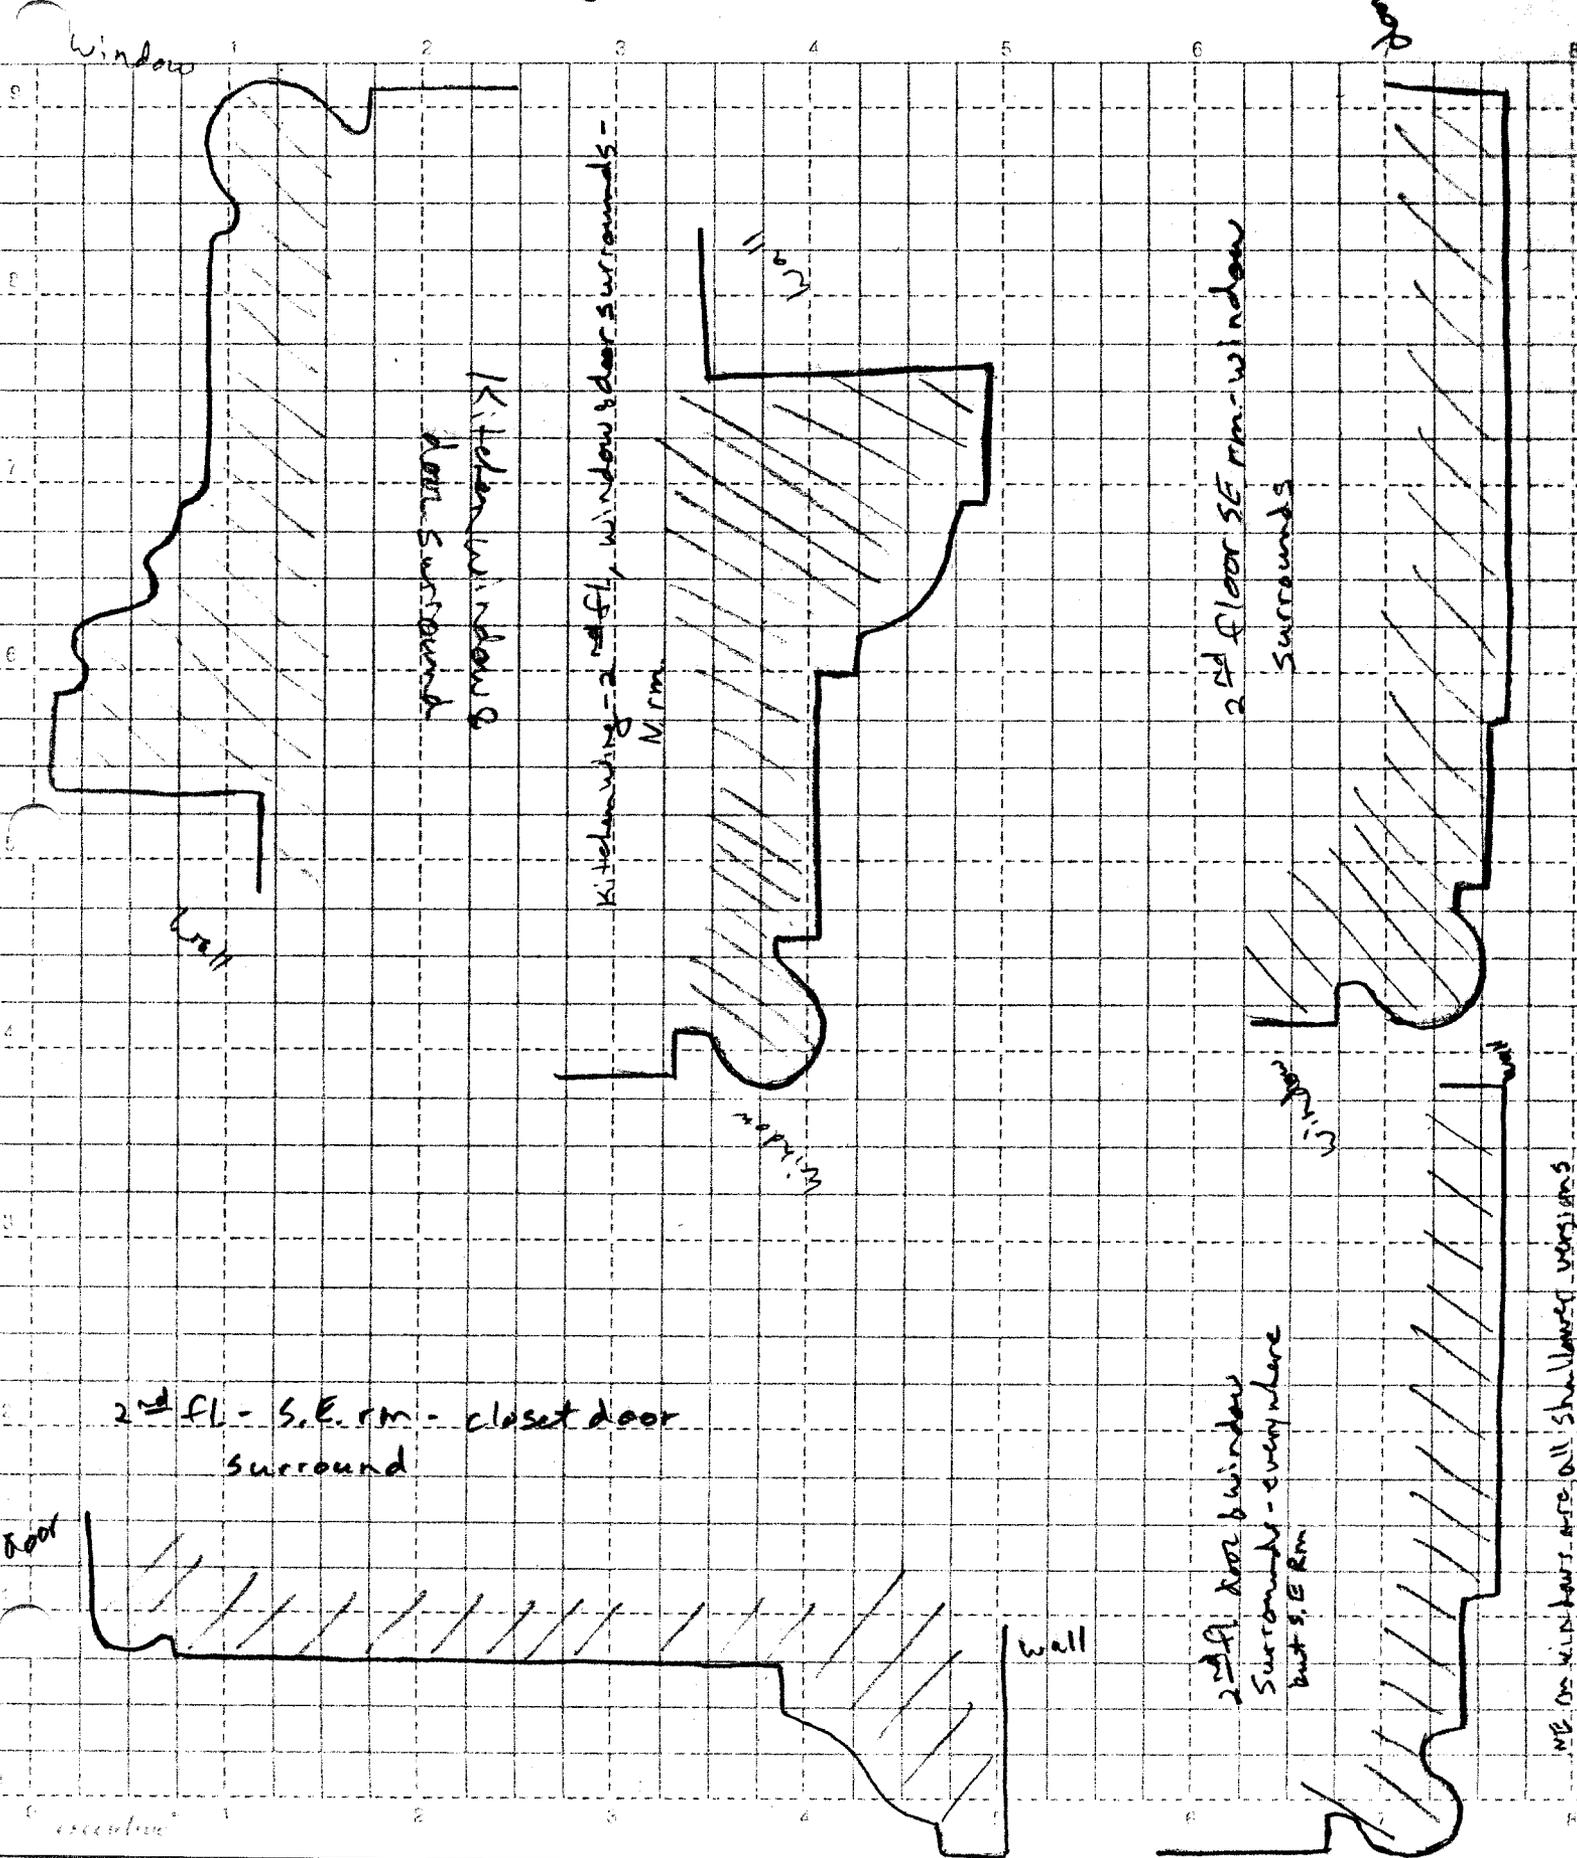
Locust Grove. Rte. 75  
Moulding Profiles

ME. OR. KITCHENS ARE ALL SHALLOWER VERSIONS

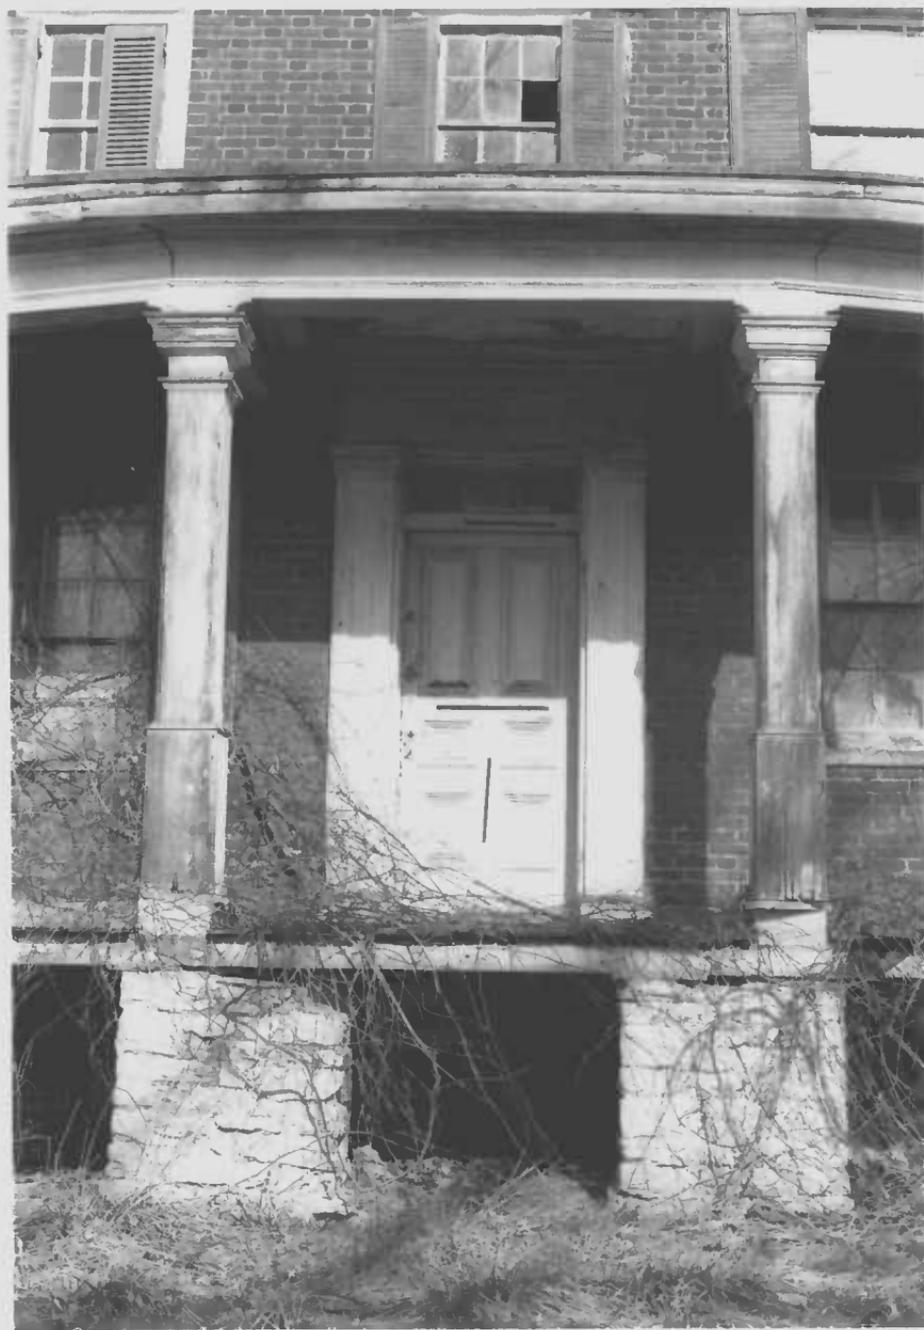
1/11

South: east elevations

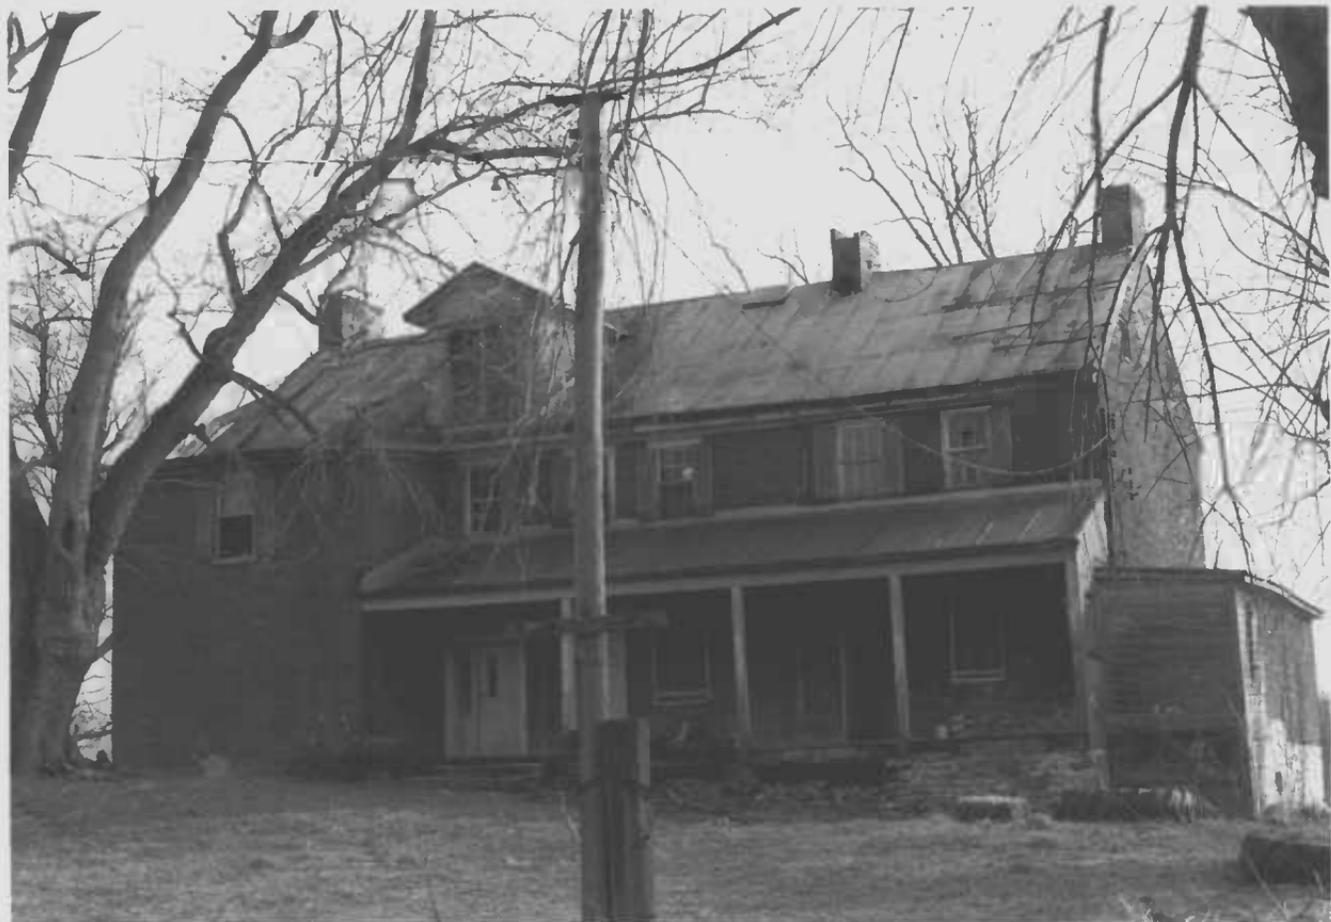
2/11

The south elevation has a central entrance, and the surround has panelled wood Doric pilasters, a plain wood frieze and a full Greek cornice. The door frame has panelled jambs and soffit. The door has six panels, with tall panels on the top and square panels in the center. Above is a three-light transom with diamond-pattern frosted glass. The two east bays each have 6/6 sash in a bullnose frame, with a wood sill, a splayed brick jack arch, and blinds. The two west bays have a 9/6 sash in bullnose frames with narrow wood sills that appear to have been replaced, splayed brick jack arches, and blinds. The second story has five 6/6 sash with wood sills and blinds. The two eastern bays have bullnose frames, but the three western bays appear to have wide, mortise and tenon, pegged frames, with an ogee moulding on the outer edge of the face of the frame. There is a single stretcher course above the wood frames, and a wood box cornice with bed mould. Centered on the first story is a three-bay porch with a half-hip roof of standing-seam metal. The porch appears to have been built in two stages. There are two central rubble stone piers that are "L"-shaped in plan and flank the door. The west pier is rectangular in plan, of different stone and construction than the center piers, and butts against the edge of a cellar window frame. This window has six lights and is set between the two west bays. The east pier of the porch has collapsed, but appears to have been the same as the west. The east cellar window is boarded over. The porch was originally supported by four boxed square columns, but the two on the ends have collapsed. Evidence suggests they matched the surviving center columns, which are set on a granite plinth, have chamfered shafts, and Doric capitals. The porch entablature has a complex cornice that is mitered at the outer edge of both inner columns, suggesting that both end bays were added later. The cellar of the far west bay has deteriorated hurricane doors with beaded-edge, tongue-and-groove boards. There are stone steps and stone cheek walls below ground, with brick cheek walls above. The foundation wall has a vertical board door in a hewn, pegged mortise-and-tenon frame. The frame is set back at the inside edge of the foundation wall.

South elevation - center bay

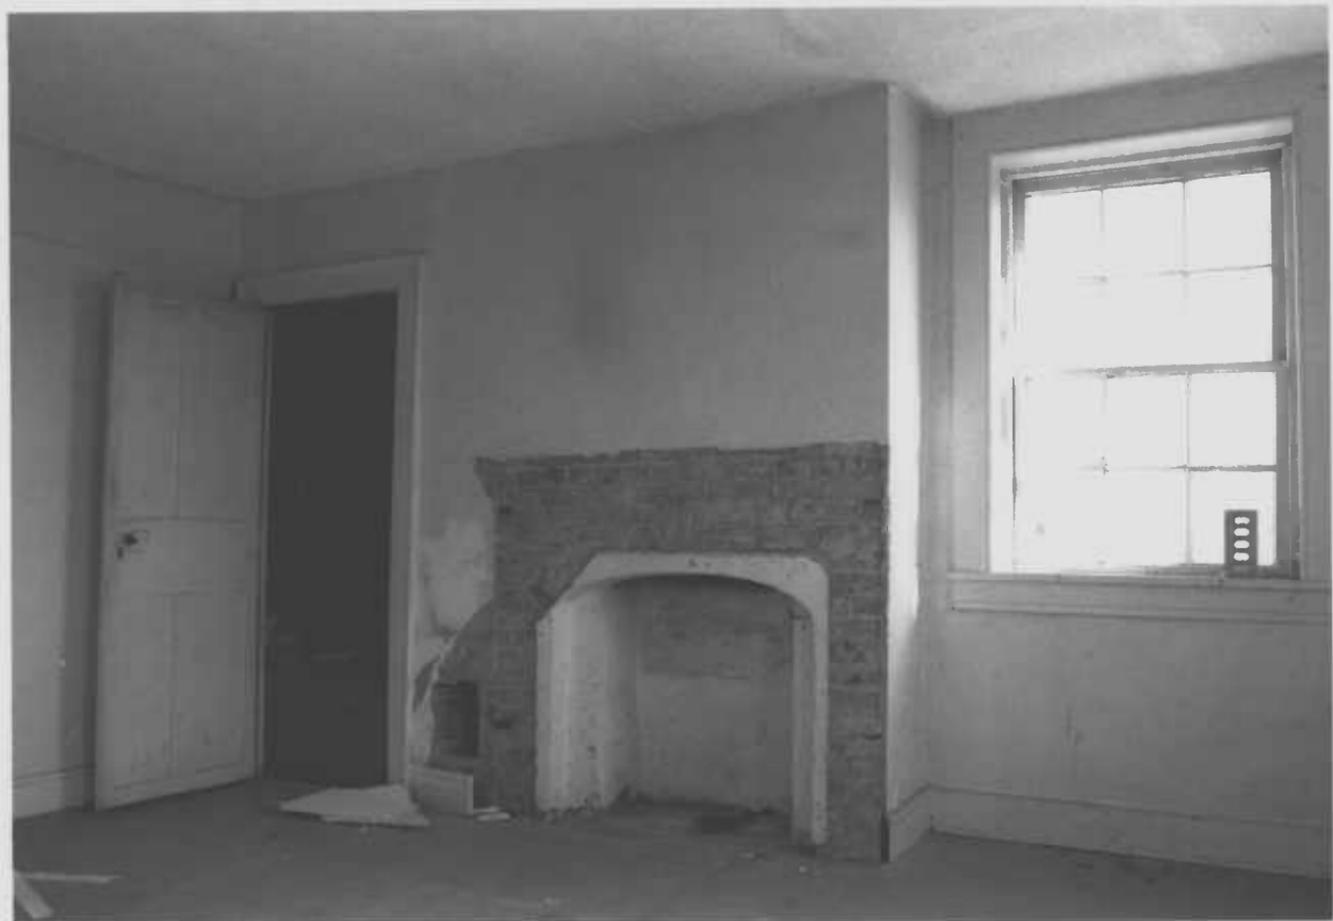
5/11

The southeast room has a fireplace centered on the east wall. The mantel is missing, but a piece of slate survives that may have been part of it. The fireplace was originally segmentally-arched, but has a steel lintel and brick infill. There is white striping on the original brick arch, and the bricks just above it, indicating it was originally exposed. Plaster around the jamb is black and marbleized, and apparently was part of the later alteration. There is a hollow space behind the wall just north of this fireplace. The floors have random-width pine boards. The window surrounds have a raised margin on either side of the field, a beaded interior edge, and corner blocks. The baseboard has a beaded top edge. The north wall was originally brick, but the narrow doorway was opened up to create a double parlor. One of the two bi-fold doors survives. Each section has four panels with wide ogee panel moulds. The doors are hung on cast iron butt hinges that have a foliate pattern. The doors have a broken field surround.

southeast room - north wall

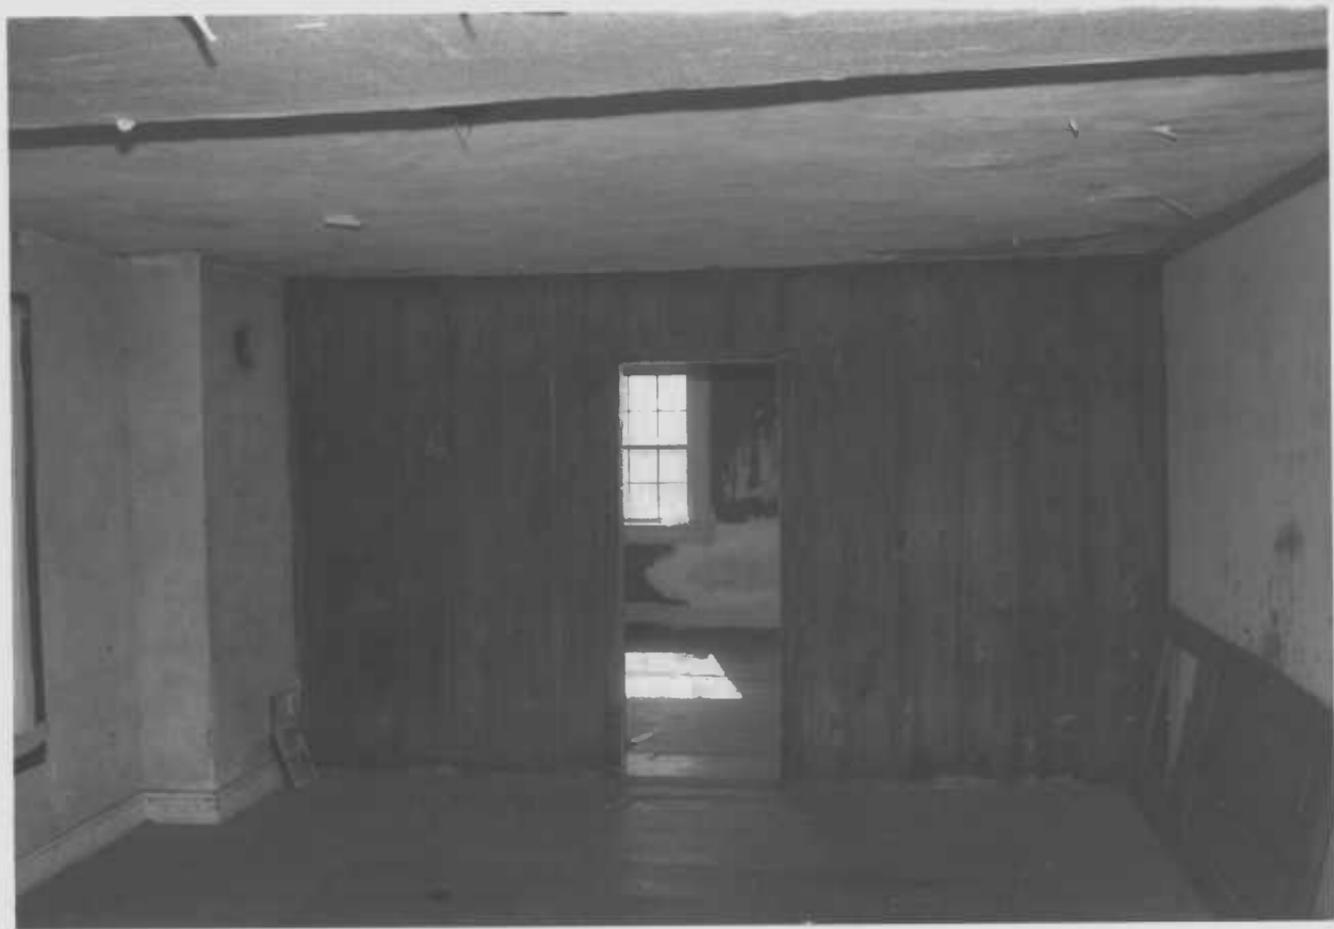
6/11

The mantel is missing from the southeast chamber. The floors are random-width pine. The remaining window and door surrounds have a broken field with a beaded interior edge, and the doors have plain corner boards. The exterior walls have plaster on brick. The north wall is of random-width vertical boards that alternate between having tongues on both sides, with panelled margins, and having grooves on both sides, with ogee-moulded edges. The south side of this wall is now covered with plaster, and the north side was as well at some point, but has now been re-exposed. There is a later door in the center of this wall, into the northeast chamber. This chamber was expanded on the north by the later wing, and the original north wall of the main block has been removed. All of the window and door surrounds, and the doors, match those in the southeast chamber. The center passage trim, and other doors in the passage, also match those in the southeast chamber.

2<sup>nd</sup> story - southeast room - view east

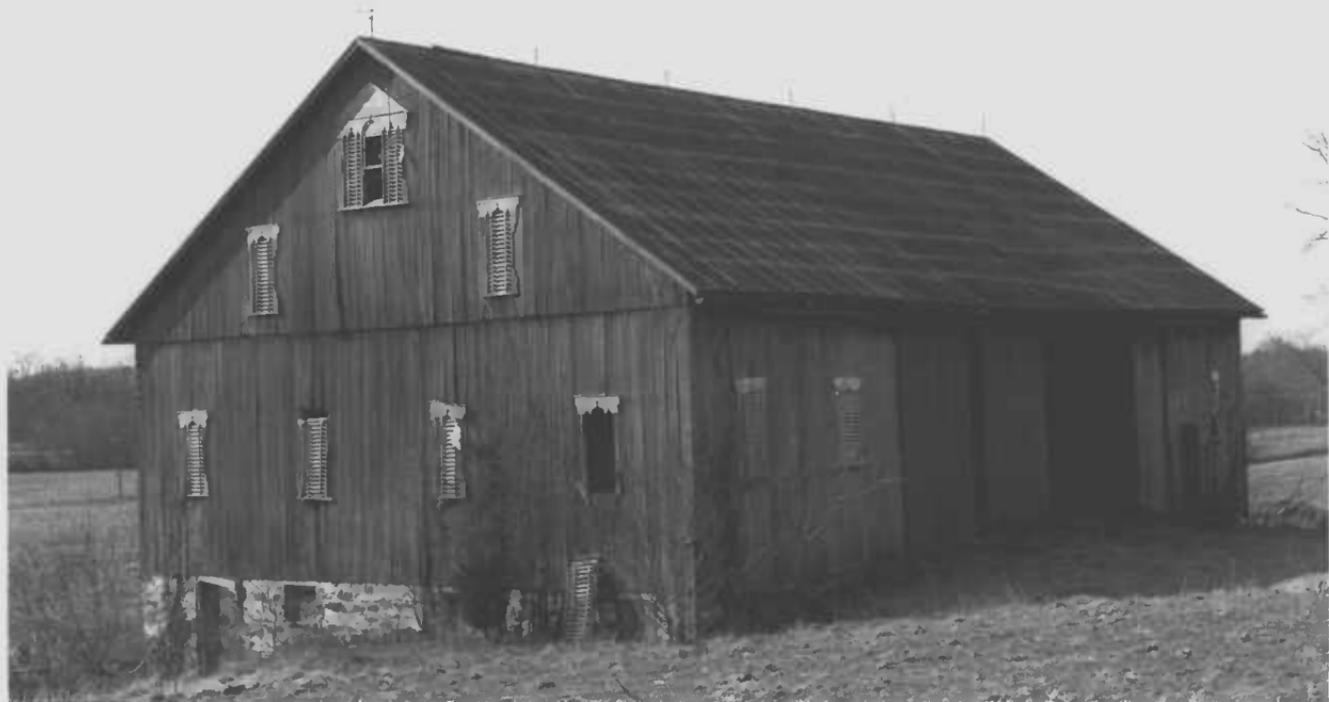
9/11

Northwest of the house is a frame bank barn with a rubble stone foundation and a CMU wall under the south-facing forebay. The upper story has vertical, beaded-edge-and-center board siding and the gable roof has standing-seam metal and an east-west ridge with six lightning rods. The upper story of the south elevation is blank in the center, with a door on rollers to each side, and three wood louvered tripartite vents. The east elevation has a stone wall under the forebay, with a wood frame opening. There are three boarded up vent openings in the foundation north of this. The upper story has four vents, with two above in the gable end, and a 1/1 sash flanked by vents, with a pedimented top, in the peak of the gable end. The north elevation has two vents to the east, two pairs of wagon doors on rollers, and two vents with sash in the bottom of them to the west. The west elevation matches the east, but in addition has a door to the granary on the north corner of the upper story. The foundation openings have been altered and connected to a one-story building of rusticated concrete block. It has two 2/2 sash on the north, one on the west, and two on the south, with a boarded-up door in the west bay of the south elevation.

barn - south : east elevations
