# Maryland Historical Trust State Historic Sites Inventory Form

Survey No. *CARR-1151*

historic *CHRISTIAN BAUER HOUSE*

street & number *1322 Bachman Valley Road (MD 496)*  not for publication

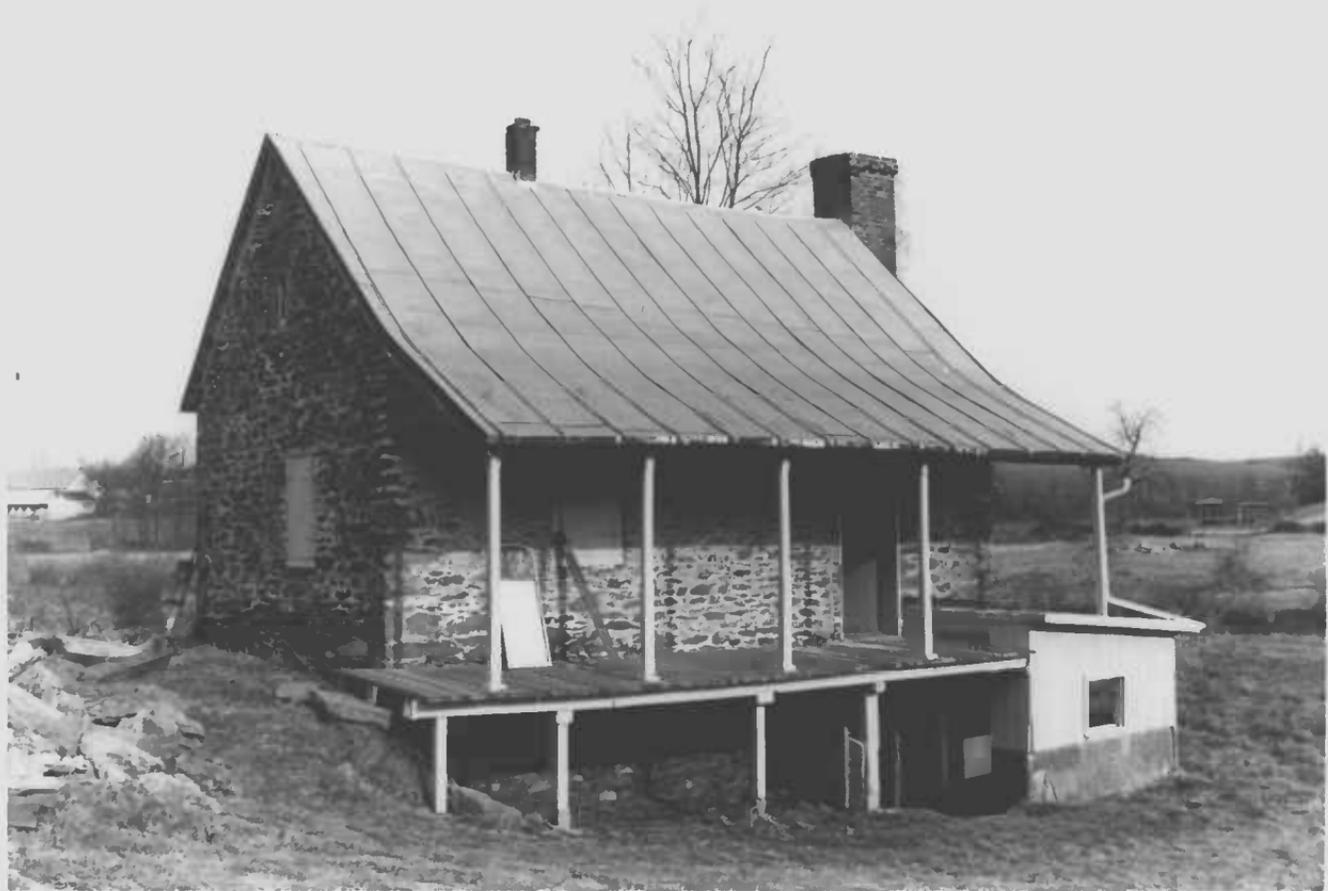
1. CARR-1151 Christian Bauer House
2. Carroll County, Maryland
3. Joe Getty
4. October 1985
5. Md. Hist. Trust, Annapolis, Md.
6. South & west elev. (camera facing ne)
7. 1/16

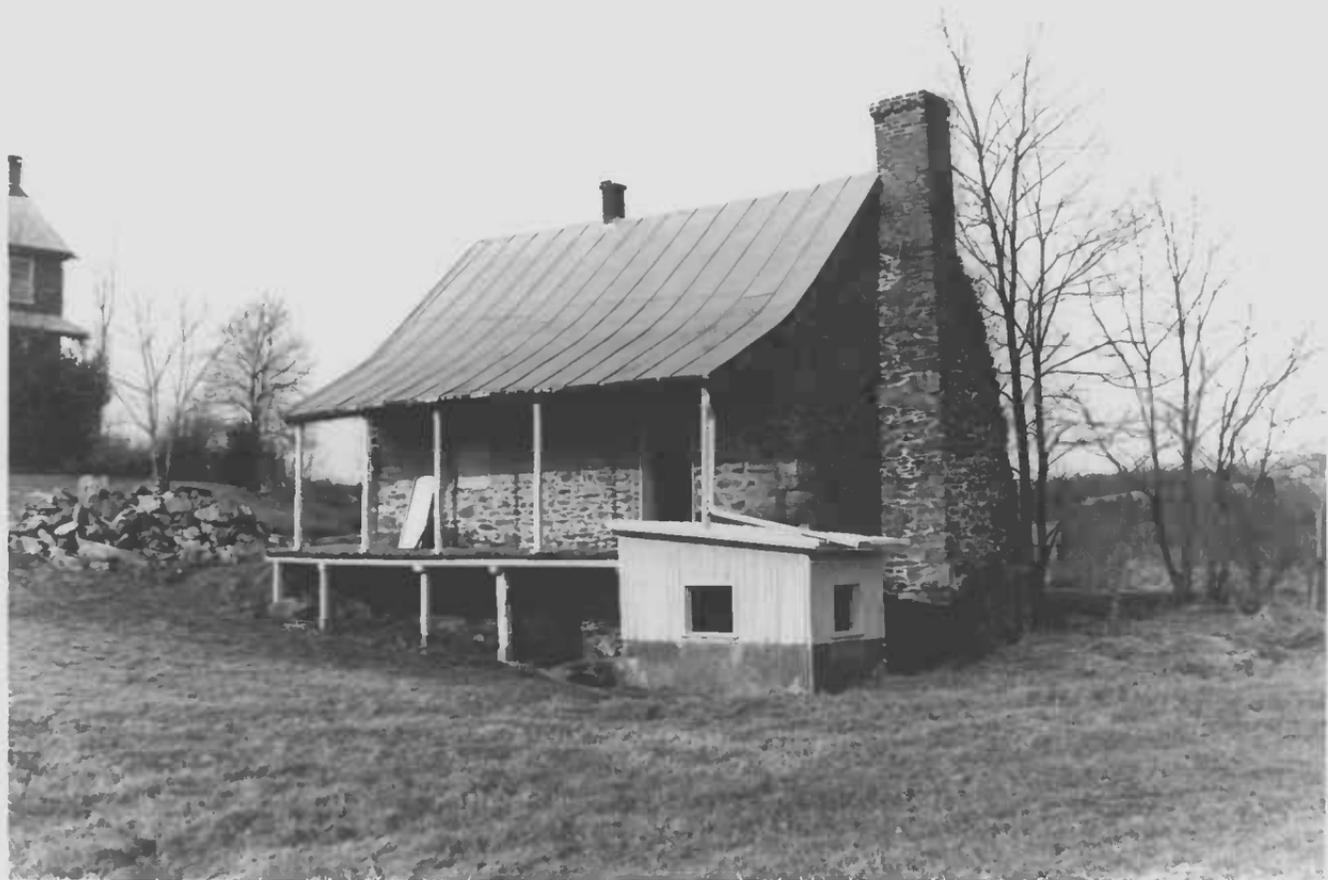
1. CARR-1151 Christian Bauer House
2. Carroll County, Maryland
3. Joe Getty
4. October 1985
5. Md. Hist. Trust, Annapolis, Md.
6. South & East elev. (camera facing nw)
7. 2/16

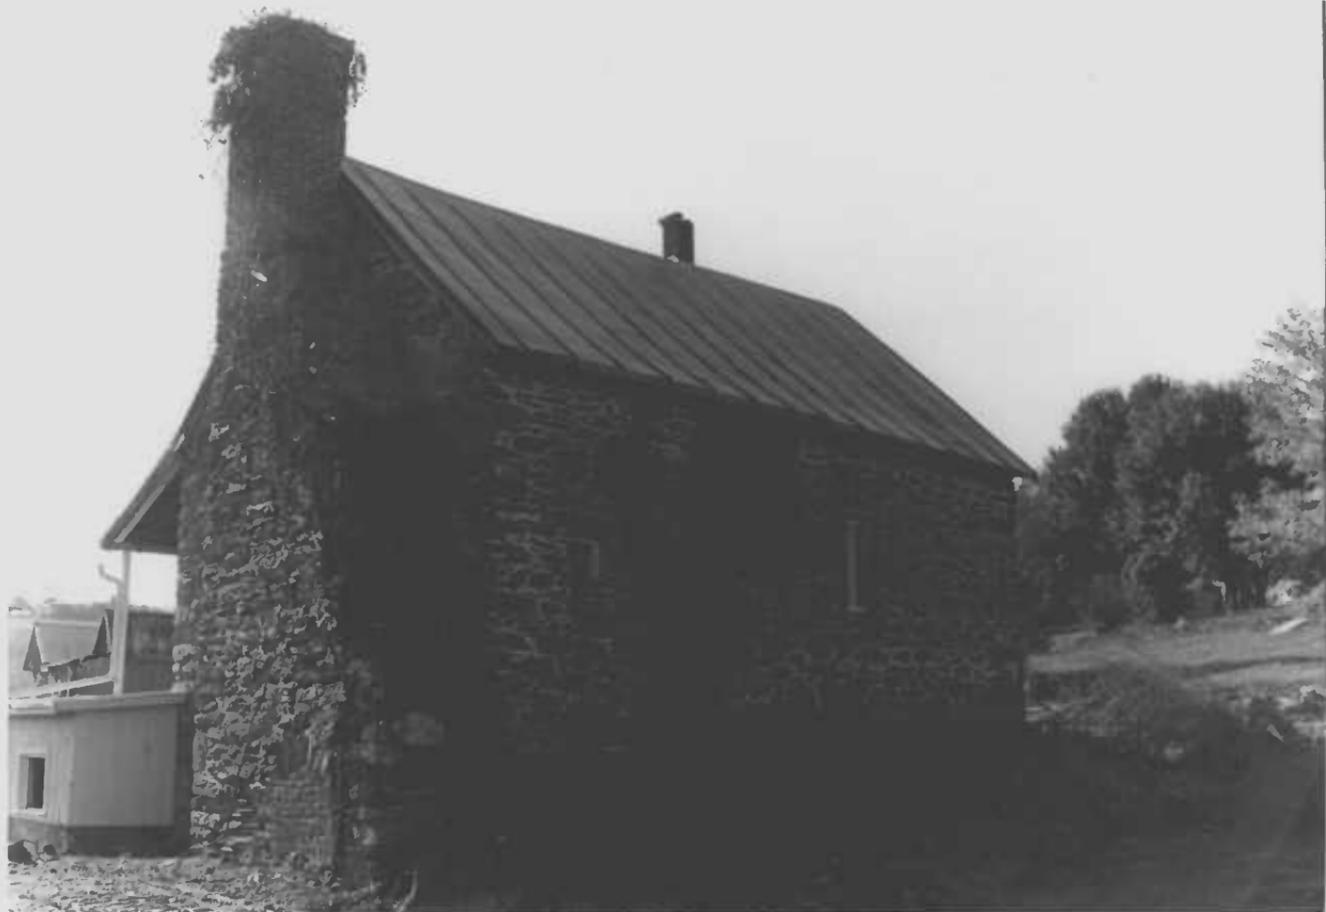
1. CARR-1151 Christian Bauer House
2. Carroll County, Maryland
3. Joe Getty
4. October 1985
5. Md. Hist. Trust, Annapolis, Md.
6. East & North elev. (camera facing sw)
7. 3/16

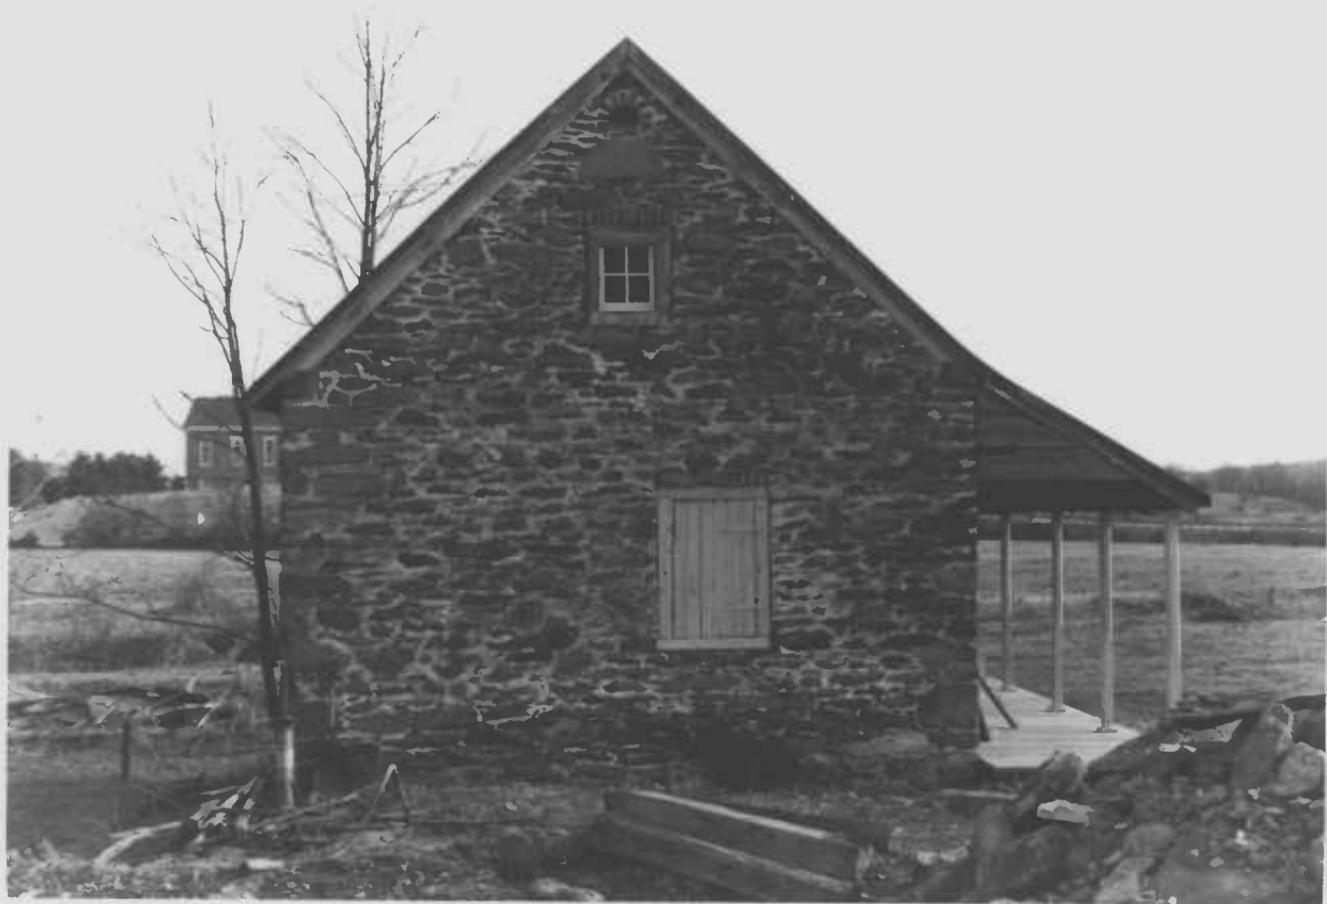
The west gable end contains a recent masonry patch which may have contained a small window into the basement level. There is also a window on the main story with a brick header lintel and batten shutter, a four-pane window to the attic, a half-round datestone, and a small arched ventilation opening to the attic.

1. CARR-1151 Christian Bauer House
2. Carroll County, Maryland
3. Joe Getty
4. October 1985
5. Md. Hist. Trust, Annapolis, Md.
6. West elev. (camera facing e)
7. 4/16

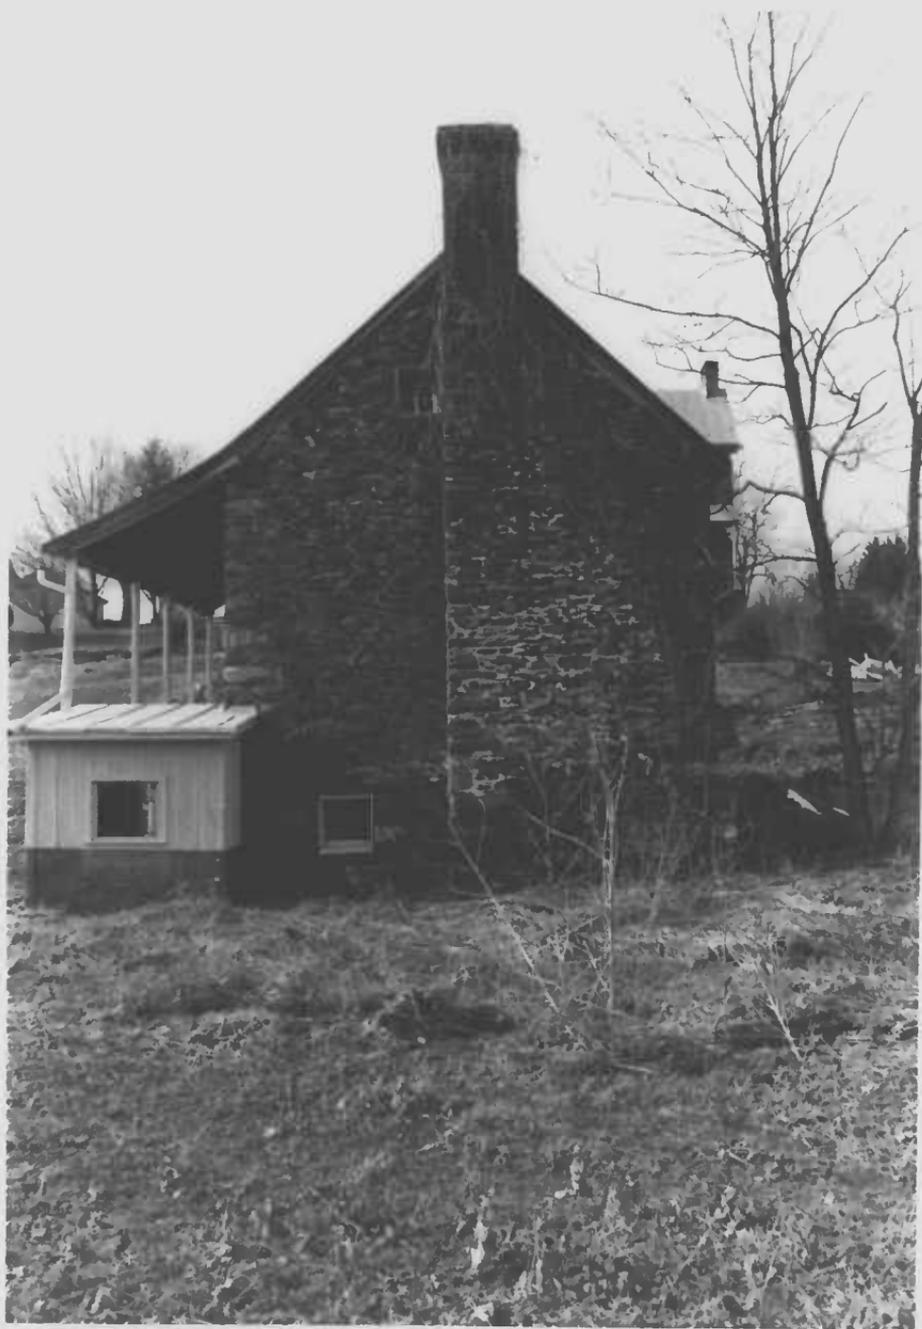
The east facade contains primarily an exterior-end chimney to the structure. There is a small basement window that appears to be reduced in size from a larger original window. There is also a four-pane window in the gable. Primarily, however, this facade contains the exterior-end chimney which is constructed of stone up to the peak of the roof where it is capped by a brick stack. The southernmost side of the chimney runs straight up to its top while the western side is stepped down to ground level. At the basement level is a bricked-in area with a stone arch lintel which provides evidence that there was exterior bake oven which served the basement fireplace.

1. CARR-1151 Christian Bauer House
2. Carroll County, Maryland
3. Joe Getty
4. October 1985
5. Md. Hist. Trust, Annapolis, Md.
6. East elev. (camera facing w)
7. 5/16

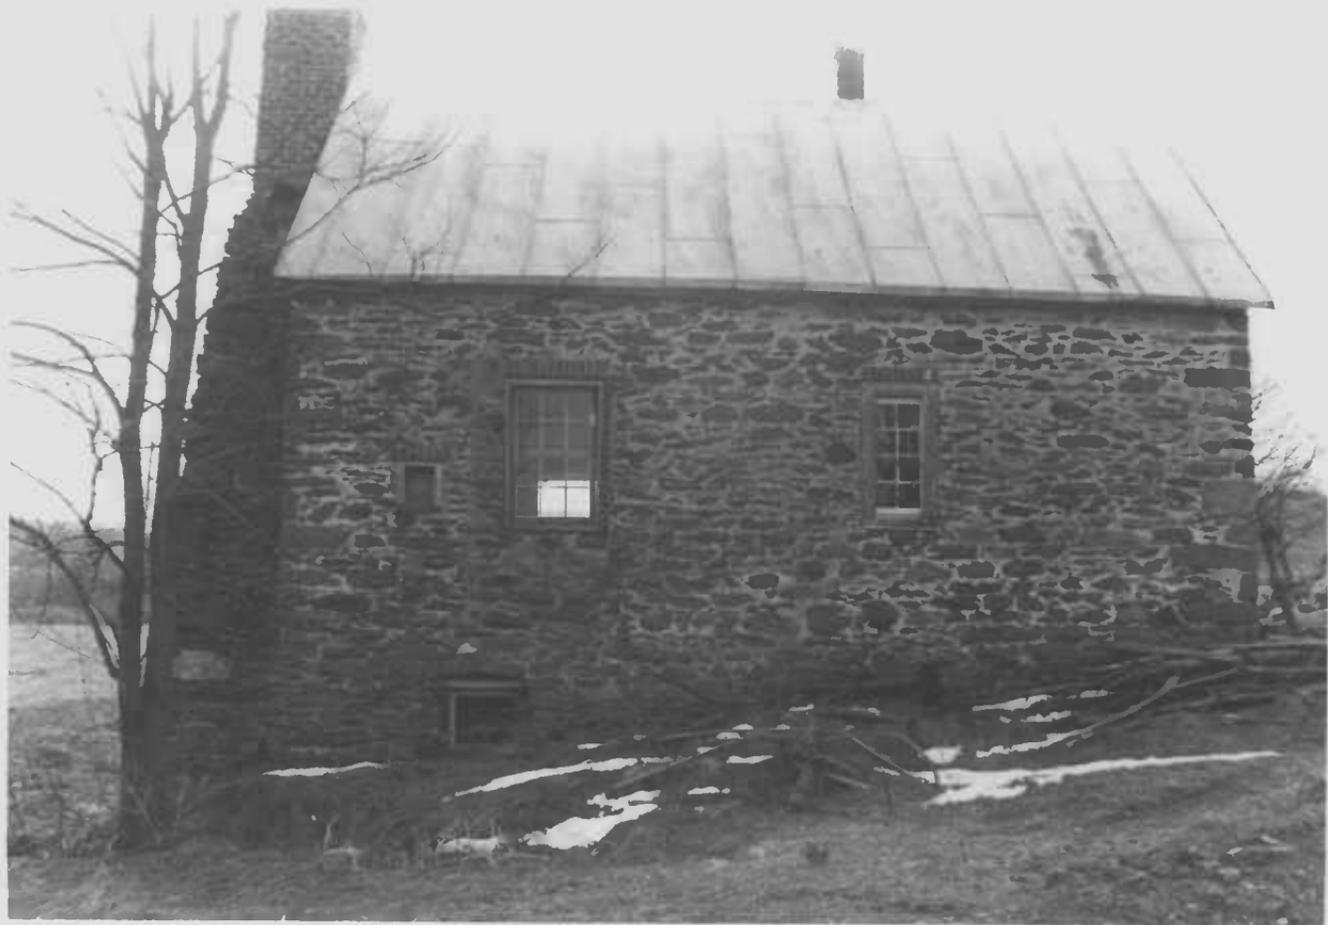
The Bauer House is constructed on a large rock over a spring and on the north side the large stone outcropping can be viewed. The north side presently contains two bays with windows. The easternmost window has filled-in stonework indicating that at one time this opening was a door, which may or may not have been the original opening. On the east side of this door opening is a small 10" x 15" window with a header brick lintel (as do the other windows on this facade). Below this window is a concrete plug for an opening that was approximately 4" in diameter. The window in the door opening is a six-over-six sash window. The westernmost bay contains an eight-pane (four rows of two panes each) casement window. At the basement level, there is a window to the easternmost room and a small narrow slit window to the westernmost room.

1. CARR-1151 Christian Bauer House
2. Carroll County, Maryland
3. Joe Getty
4. October 1985
5. Md. Hist. Trust, Annapolis, Md.
6. North elev. (camera facing s)
7. 6/16

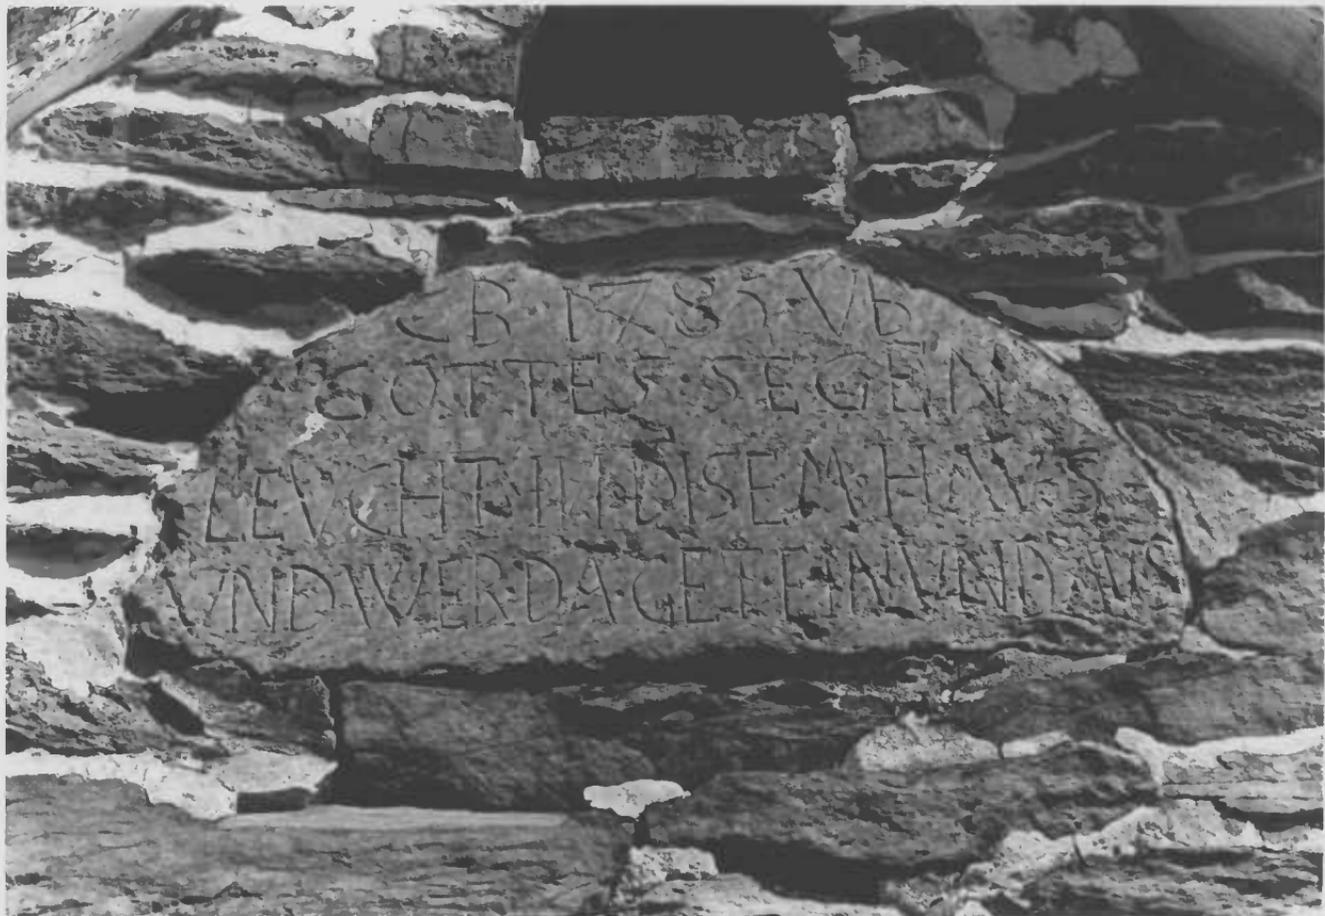
The architecture of the Bauer House presents a number of the characteristic architectural features found in Pennsylvania German houses in this region. The structure underwent some remodeling in the mid-19th century but still retains significant original features. The house can be dated to 1785 by a datestone in the gable of the west elevation. The stone is inscribed as follows: "C B 1785 V B GOTTES SEGEN LEVCHT IN DISEM HAUS VND WER DA GET IN VND AUS." The initials are for Christian Bauer and Veronica Bauer, his wife. The inscription has a house blessing using the "gehen ein und aus" theme that was so popular among the Pennsylvania Germans, not only for datestones but also on handwritten and printed Haus Segen forms. Here, it can be translated as "May God's Blessing enlighten this house and on those who go in and out."

1. CARR-1151 Christian Bauer House
2. Carroll County, Maryland
3. Joe Getty
4. October 1985
5. Md. Hist. Trust, Annapolis, Md.
6. Datestone detail (west elev.)
7. 7/16

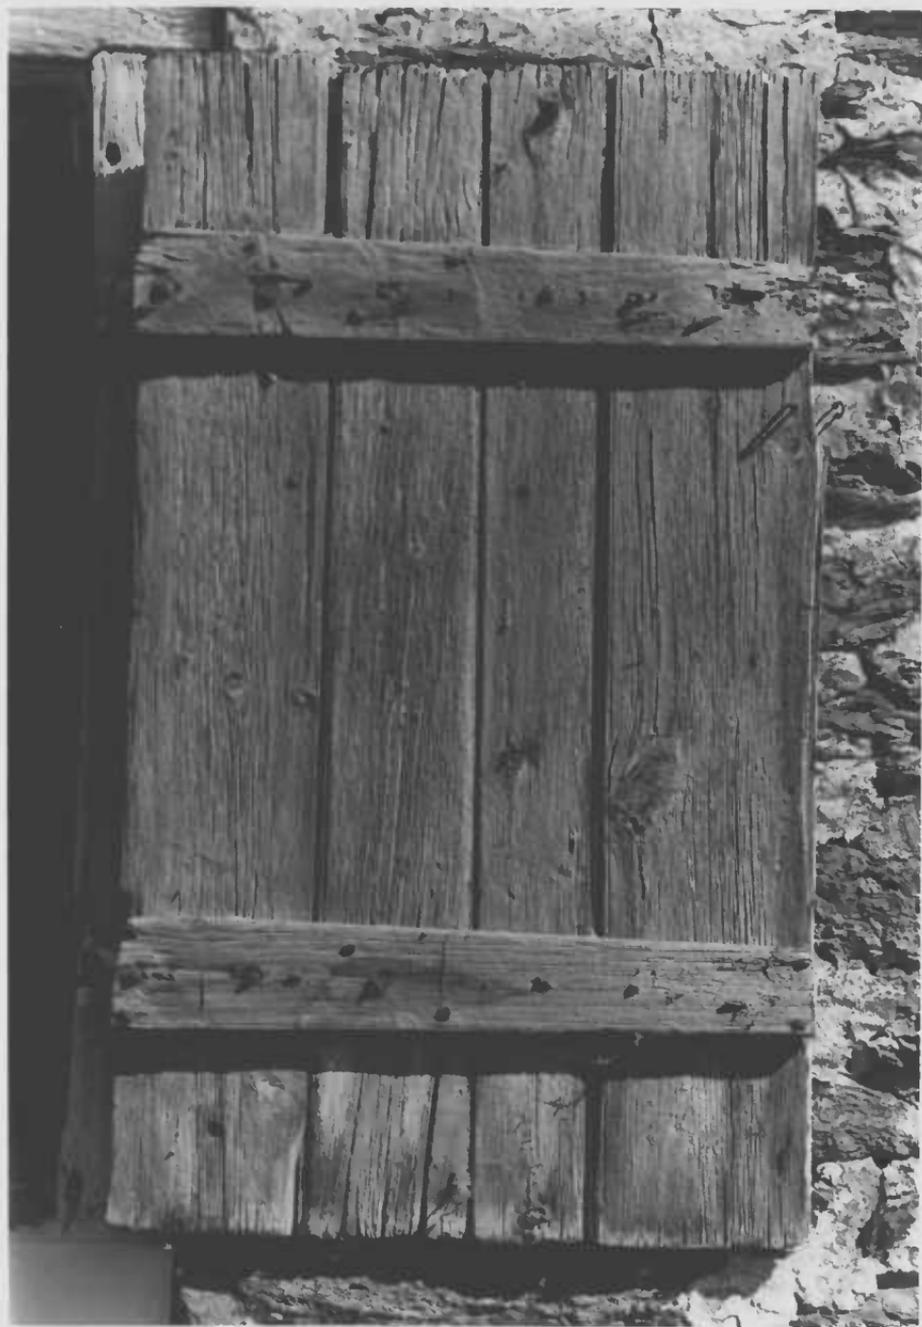
sash to these windows is gone. The batten shutters have tapered battens (going from 4" to 3¼" with bead edges). They are fastened to the shutter boards with rosehead nails. They are attached on the outside with 12" long wrought iron hinges with round ends. One might suspect that this room was originally partitioned into a front and back room with a board partition running along the summer beam to form a Pennsylvania German three-room plan. However, there is no visible evidence of that. At some locations one can view the floor joists for the attic floor. While these are chapered with run out stops, they do not appear to be painted, but they still were probably exposed in the original room configuration.

1. CARR-1151 Christian Bauer House
2. Carroll County, Maryland
3. Joe Getty
4. October 1983
5. Md. Hist. Trust, Annapolis, Md.
6. Batten shutter detail (west elev.)
7. 8/16

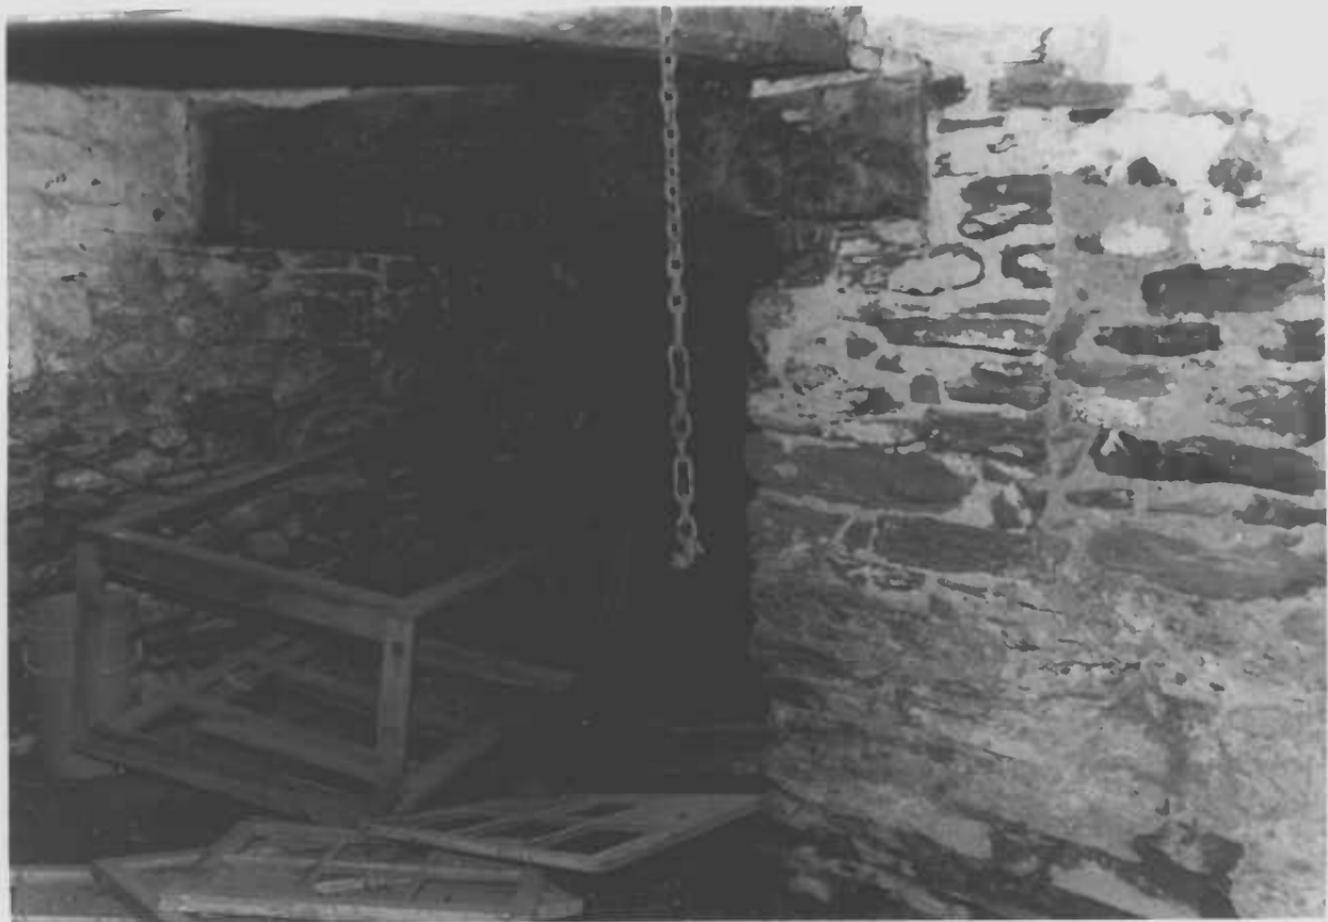
In the summer kitchen, the floor joists carrying the upper floor are exposed. There is a large kitchen hearth with log lintel. At the rear of the hearth is the opening for the bake oven that stood outside a chimney. There is also a board support system for carrying the hearth, consisting of mud and brick, to the fireplace above. There's a window on the east wall that was apparently reduced in size. On the outside of the basement there is a room that apparently was constructed in the late nineteenth century. This room had a cement trough with excess to water and may have served as a washroom or dairy.

1. CARR-1151 Christian Bauer House
2. Carroll County, Maryland
3. Joe Getty
4. October 1985
5. Md. Hist. Trust, Annapolis, Md.
6. Basement fireplace (east wall)
7. 9/16

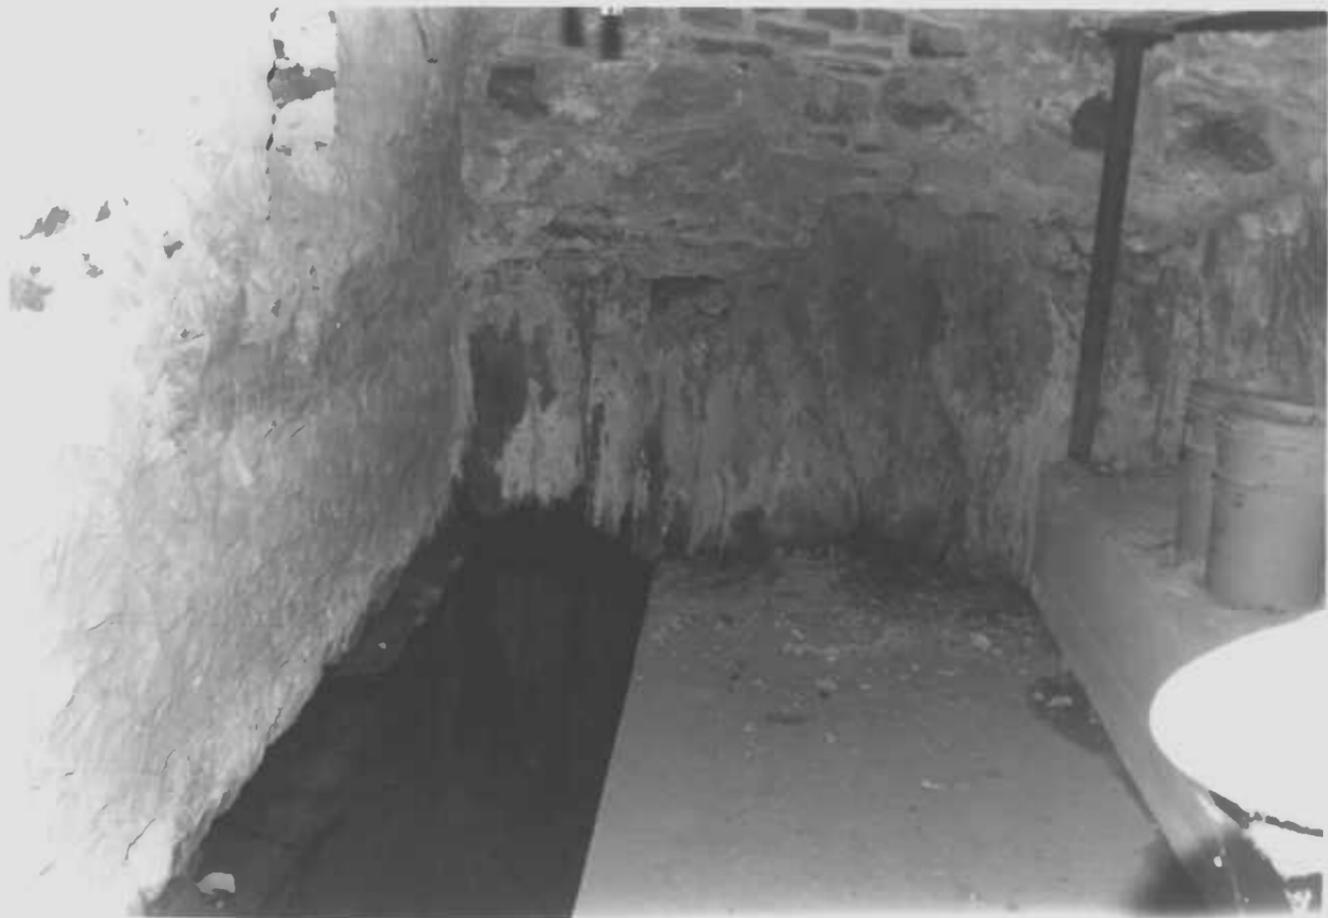
Like many early homes of the Pennsylvania Germans, this house was built directly on a spring. Apparently the early uses of these basement rooms were as a spring room in the westernmost room and a summer kitchen, perhaps the main kitchen of the house, in the easternmost room. There rooms have been altered somewhat over the years. The westernmost wall was built into a large outcropping of rock with the spring is in the southwest corner of the structure. The basement area has been given a cement floor in the twentieth century with a spring opening that served as a dairy room. This room also contains an unusual feature between the basement level and the main story. Between the joists are thick planks that are level with the bottoms of the floor joists. Where there are cracks between the planks, narrow stones are stuck into the crevices. Stones were also laid in the spaces between the floor joists, and they were covered with lime mortar to form the surface of the floor above. At a later date, the underside was covered with lathe and plaster for a basement ceiling. The walls of the summer kitchen and spring room are whitewashed. The entire basement has a large chamfered summer beam with a chamfered edge and lambs-tongue stop.

1. CARR-1151 Christian Bauer House
2. Carroll County, Maryland
3. Joe Getty
4. October 1985
5. Md. Hist. Trust, Annapolis, Md.
6. Basement - spring in sw corner
7. 10/16

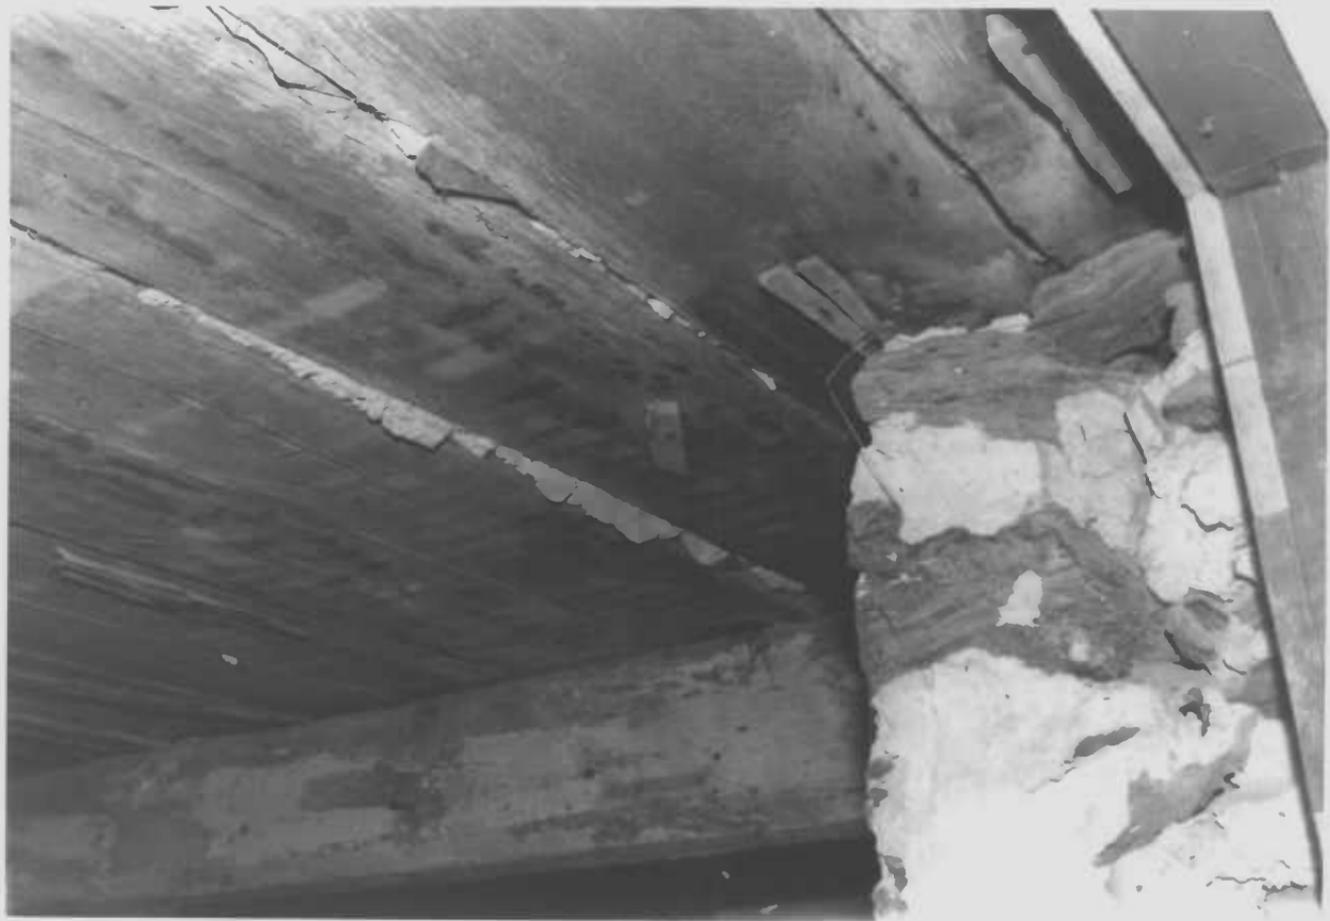
1. CARR-1151 Christian Bauer House
2. Carroll County, Maryland
3. Joe Getty
4. October 1985
5. Md. Hist. Trust, Annapolis, Md.
6. Basement - ceiling planks & mortar
7. 11/16

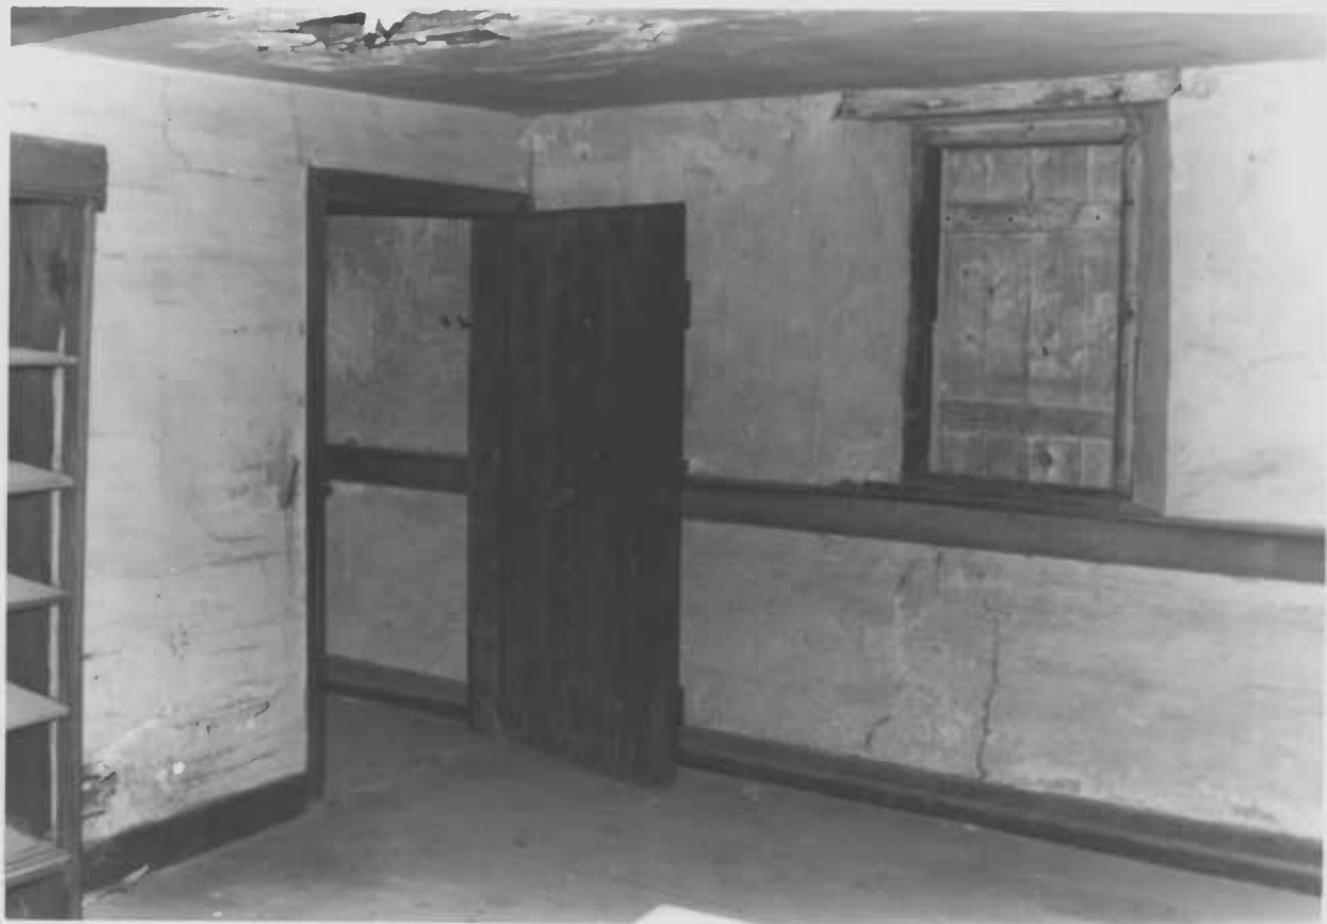
The westernmost room on the main story has plastered walls with a chairrail and baseboard. Three windows light this room and the western and southern windows contain batten shutters. However, the

1. CARR-1151 Christian Bauer House
2. Carroll County, Maryland
3. Joe Getty
4. October 1985
5. Md. Hist. Trust, Annapolis, Md.
6. Parlor - se corner
7. 12/16

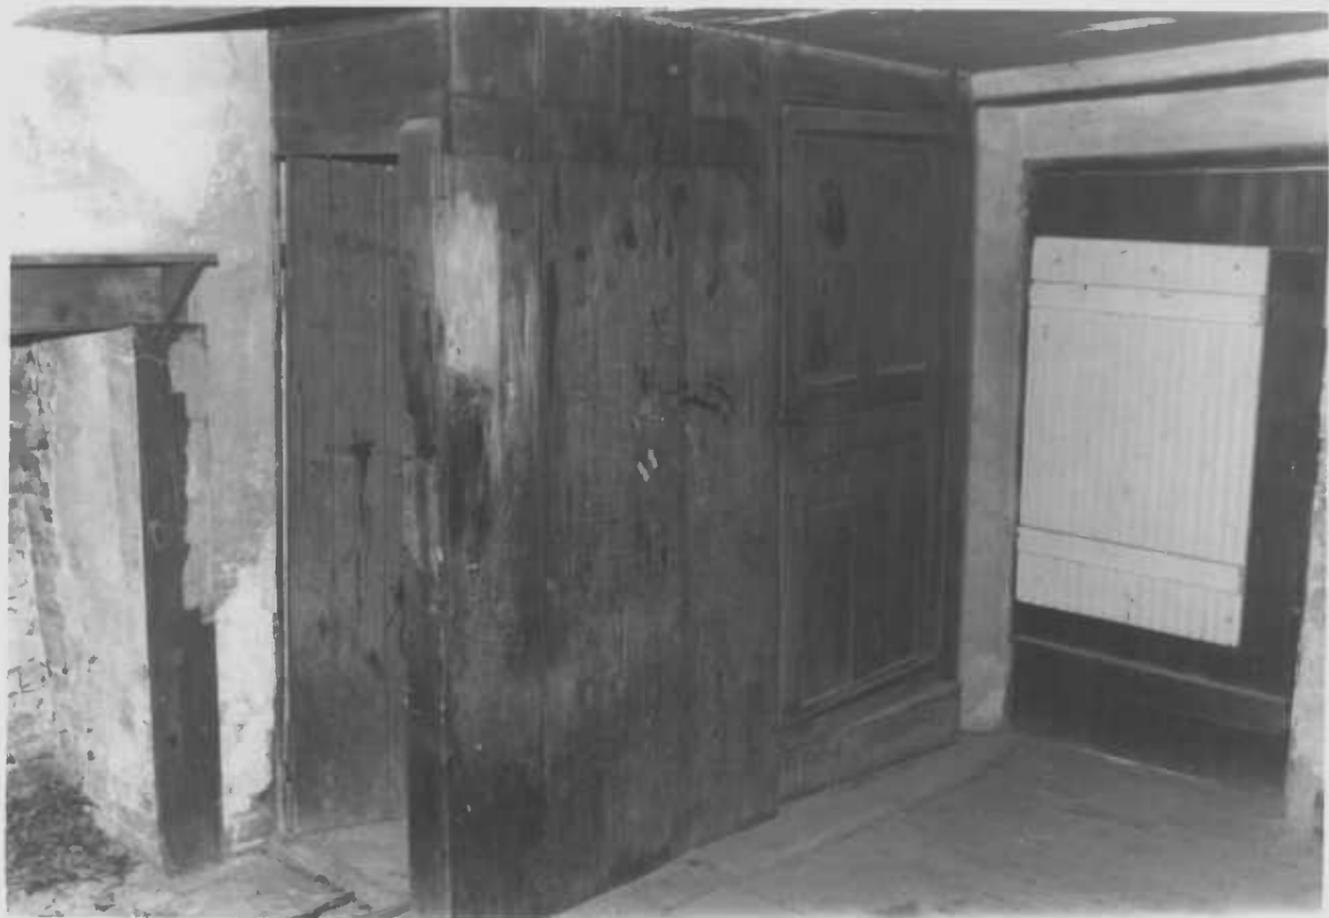
On the main floor of the structure, it is difficult to determine the original partitions. The structure now stands as a two-room plan with the frame partition running through the center of the structure. The east gable end contains a fireplace and a corner stair boxed in a board partition. However, markings on the floor of this eastern room indicate that perhaps the original partition was a board wall located just to the west side of the entrance. There is a boxed summer beam running through these two rooms.

1. CARR-1151 Christian Bauer House
2. Carroll County, Maryland
3. Joe Getty
4. October 1985
5. Md. Hist. Trust, Annapolis, Md.
6. Hall - se corner (stairway)
7. 13/16

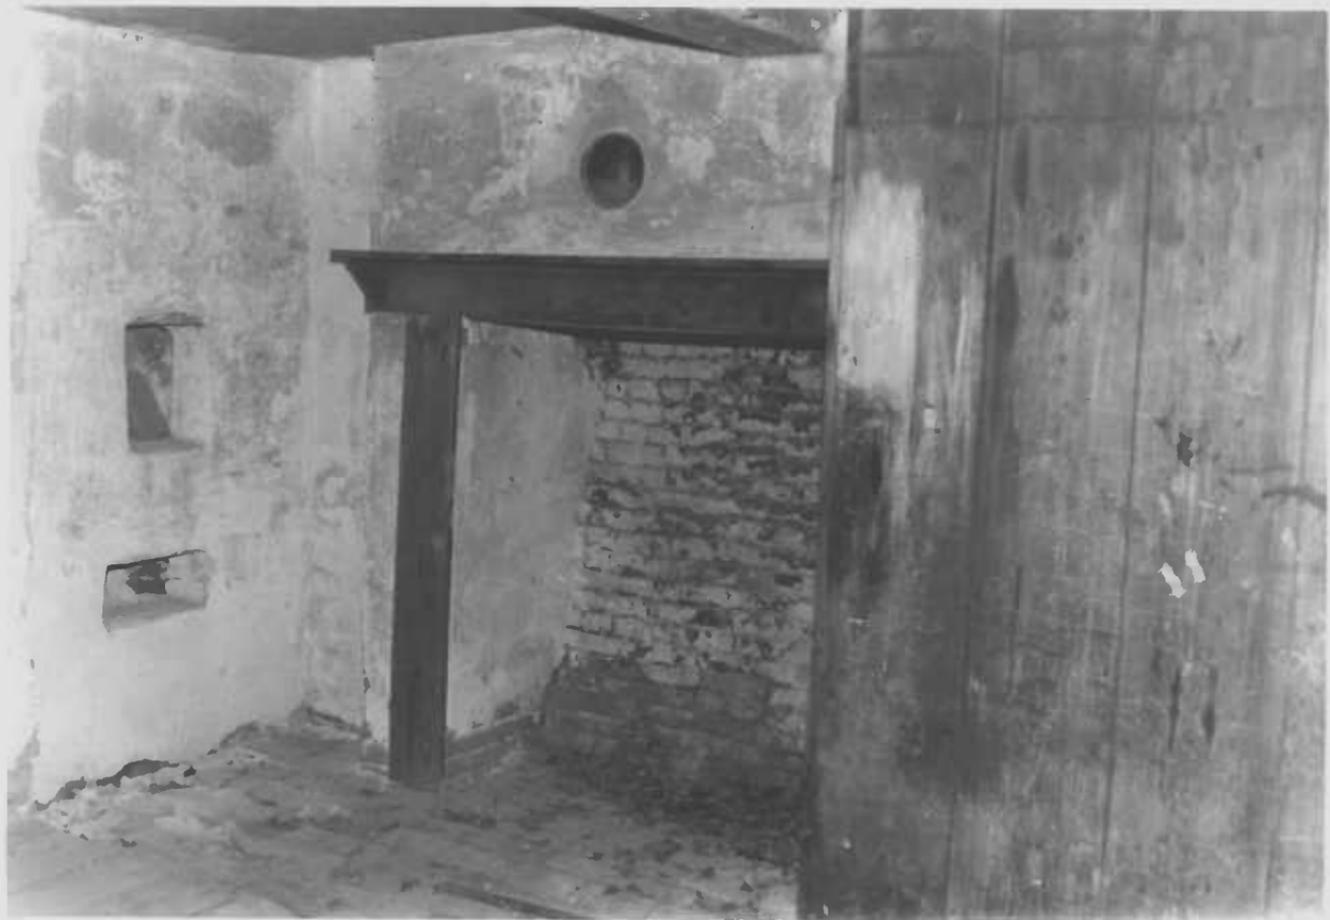
The easternmost room contains some of the most interesting features of the house. This includes the small window on the north wall that has a 15½" wide and 7" tall opening below it. The lower opening appears to be a drain for a stone sink that would have been built into this wall. The window above it was probably to light the sink and provide ventilation to the fireplace. The window on the west side of these openings is the location where there once was a door. The chairrail in this room runs out to this door opening and is notched in a way that may indicate a partitioned wall ran through the room at this location. Cuts in the floor boards in this room also indicate some changes that may have included such a partition wall. The fireplace at this location has a plain shelf with a triangular bracket but is attached with wire nails and probably replaced an earlier fireplace mantel. The stairway in the south-east corner is boxed in with a board tongue-and-groove partition wall. The stairway appears to have originally been open, and the present boards may be from the original partition wall. The door used in this stairway is an early door with a triangular-pointed door pull and a catch with a small tail. The door has strap hinges with pointed ends. However, this apparently is a reused door as the panels of the four panel section face in toward the attic. Another unusual characteristic in this room is that two of the floor boards raise up to form a trap door to the basement and an inserted floor joist in the basement has a scarf joint where this door originally appeared, but both appear to be mid-nineteenth century features.

1. CARR-1151 Christian Bauer House
2. Carroll County, Maryland
3. Joe Getty
4. October 1985
5. Md. Hist. Trust, Annapolis, Md.
6. Hall - ne corner (openings & fireplace)
7. 14/16

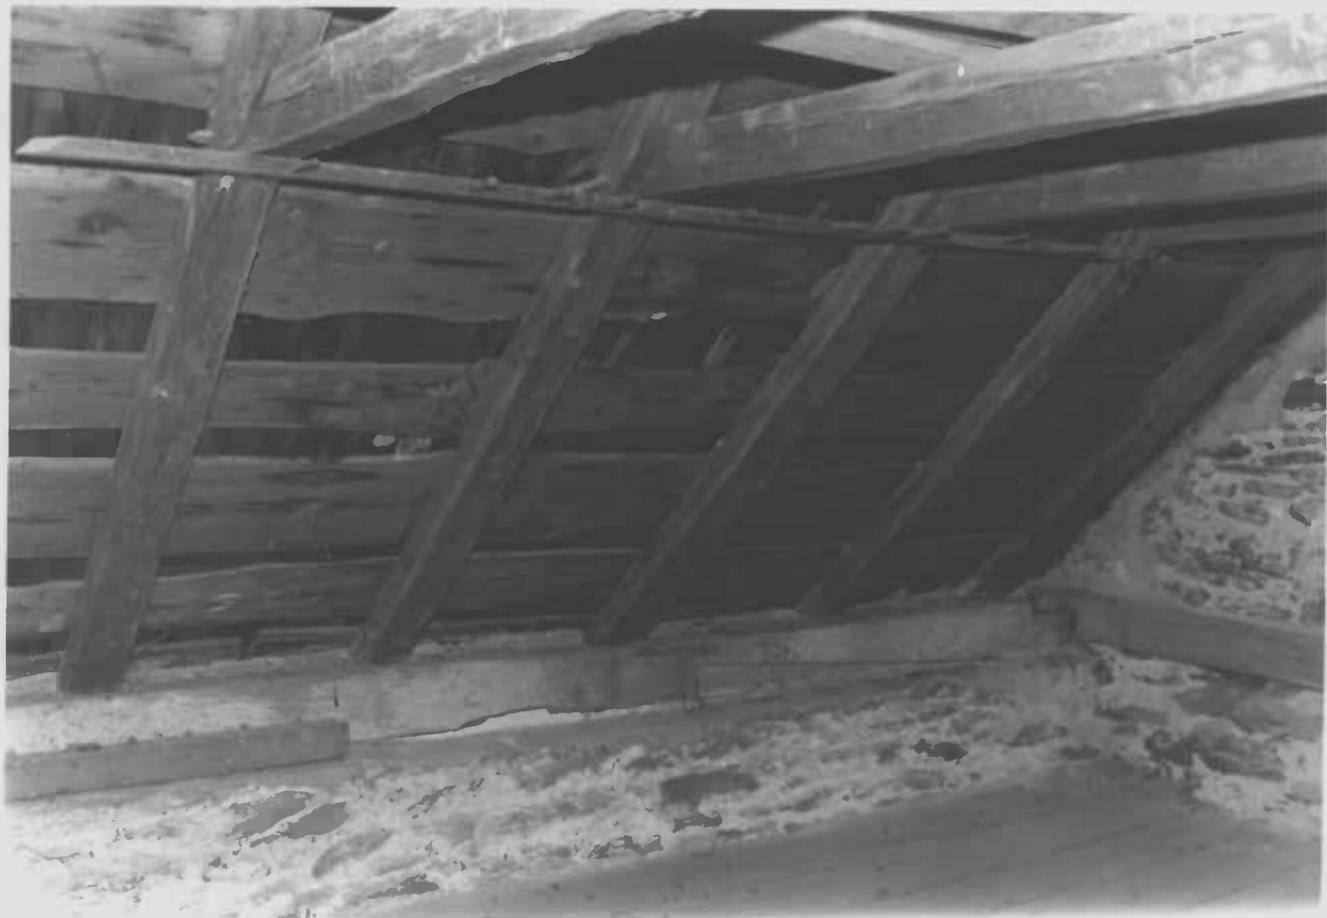
The attic contains a sleeping loft which may have originally contained partitions although there is no evidence of them at this time. As one rises the stairs to the attic, one can view one of the floor joists with its run out stop and an unusual wide notch in the framing timber of the east gable wall. The roof is constructed of common rafters pegged at the ridge and with collars to support. The rafters are notched into a hewn wood plate at the north and south sides of the structure. The plate is attached to framing timbers that run at this level in each gable end. On the north side, there are some wide boards covering the rafters which present an unusual appearance but appear not to be original. Primarily, the rafters carry 1½" x 2" per lins present and that carried a wood shingle roof. The remnants of this wood shingle roof are presently covered with sheet metal standing-seam roofing. At the west gable end is the brick opening which provided attic ventilation. A four-pane window is located in each gable end. A late nineteenth century flue is located towards the west side of the structure. This brick flue rests on a board support and received a stove pipe that came back from the room below it. Another unusual feature in the attic is a crude peg rail that appears to be contemporary to the house.

1. CARR-1151 Christian Bauer House
2. Carroll County, Maryland
3. Joe Getty
4. October 1985
5. Md. Hist. Trust, Annapolis, Md.
6. Attic - rafters & peg rail
7. 15/16

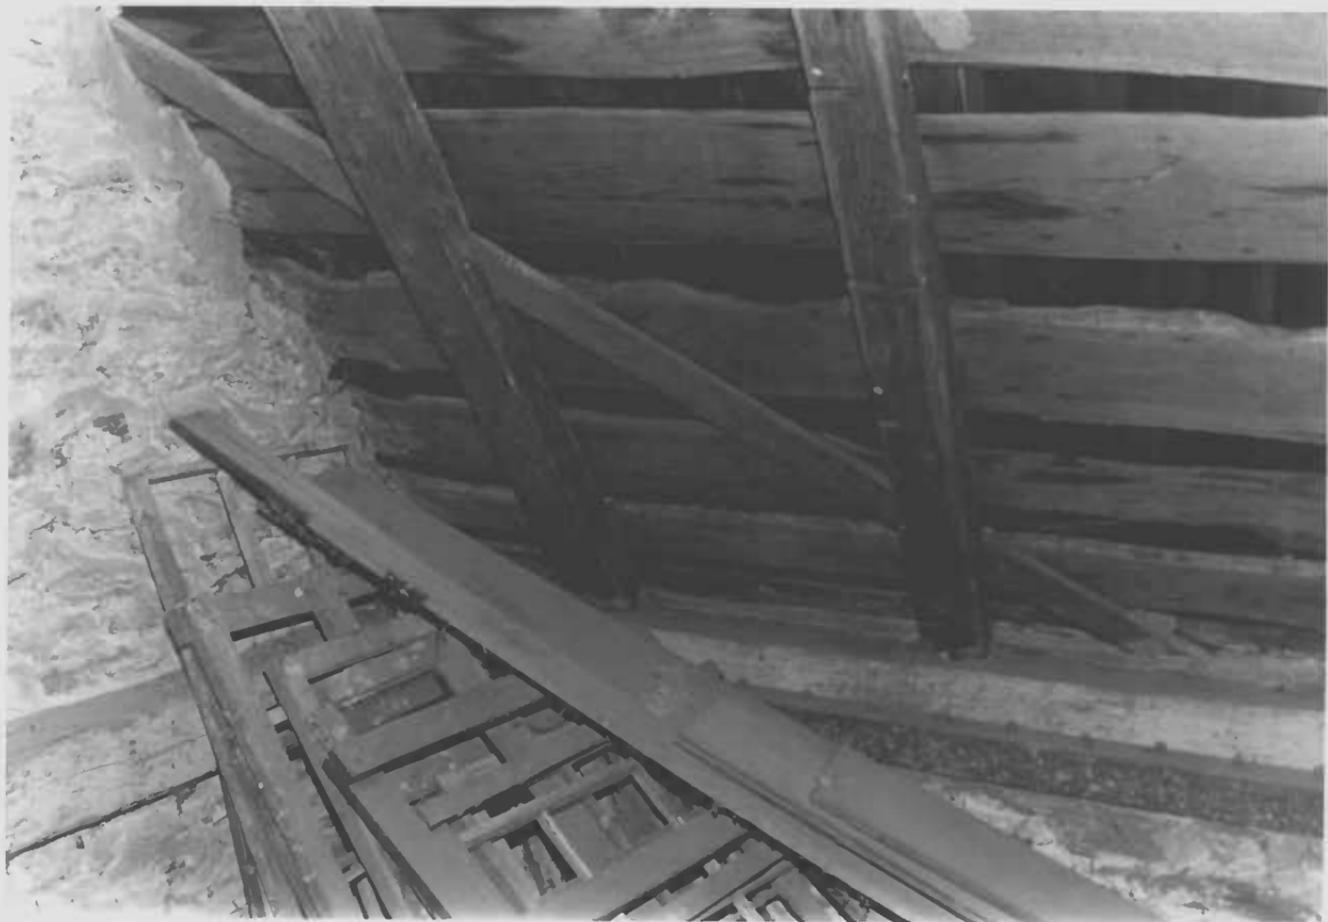
1. CARR-1151 Christian Bauer House
2. Carroll County, Maryland
3. Joe Getty
4. October 1985
5. Md. Hist. Trust, Annapolis, Md.
6. Attic - diagonal bracing
7. 16/16
