CARR - 1166

7569 MIDDLEBURG ROAD

FIELD SHEET--HISTORIC RESOURCES SURVEY

COMMON NAME: Detour Bank

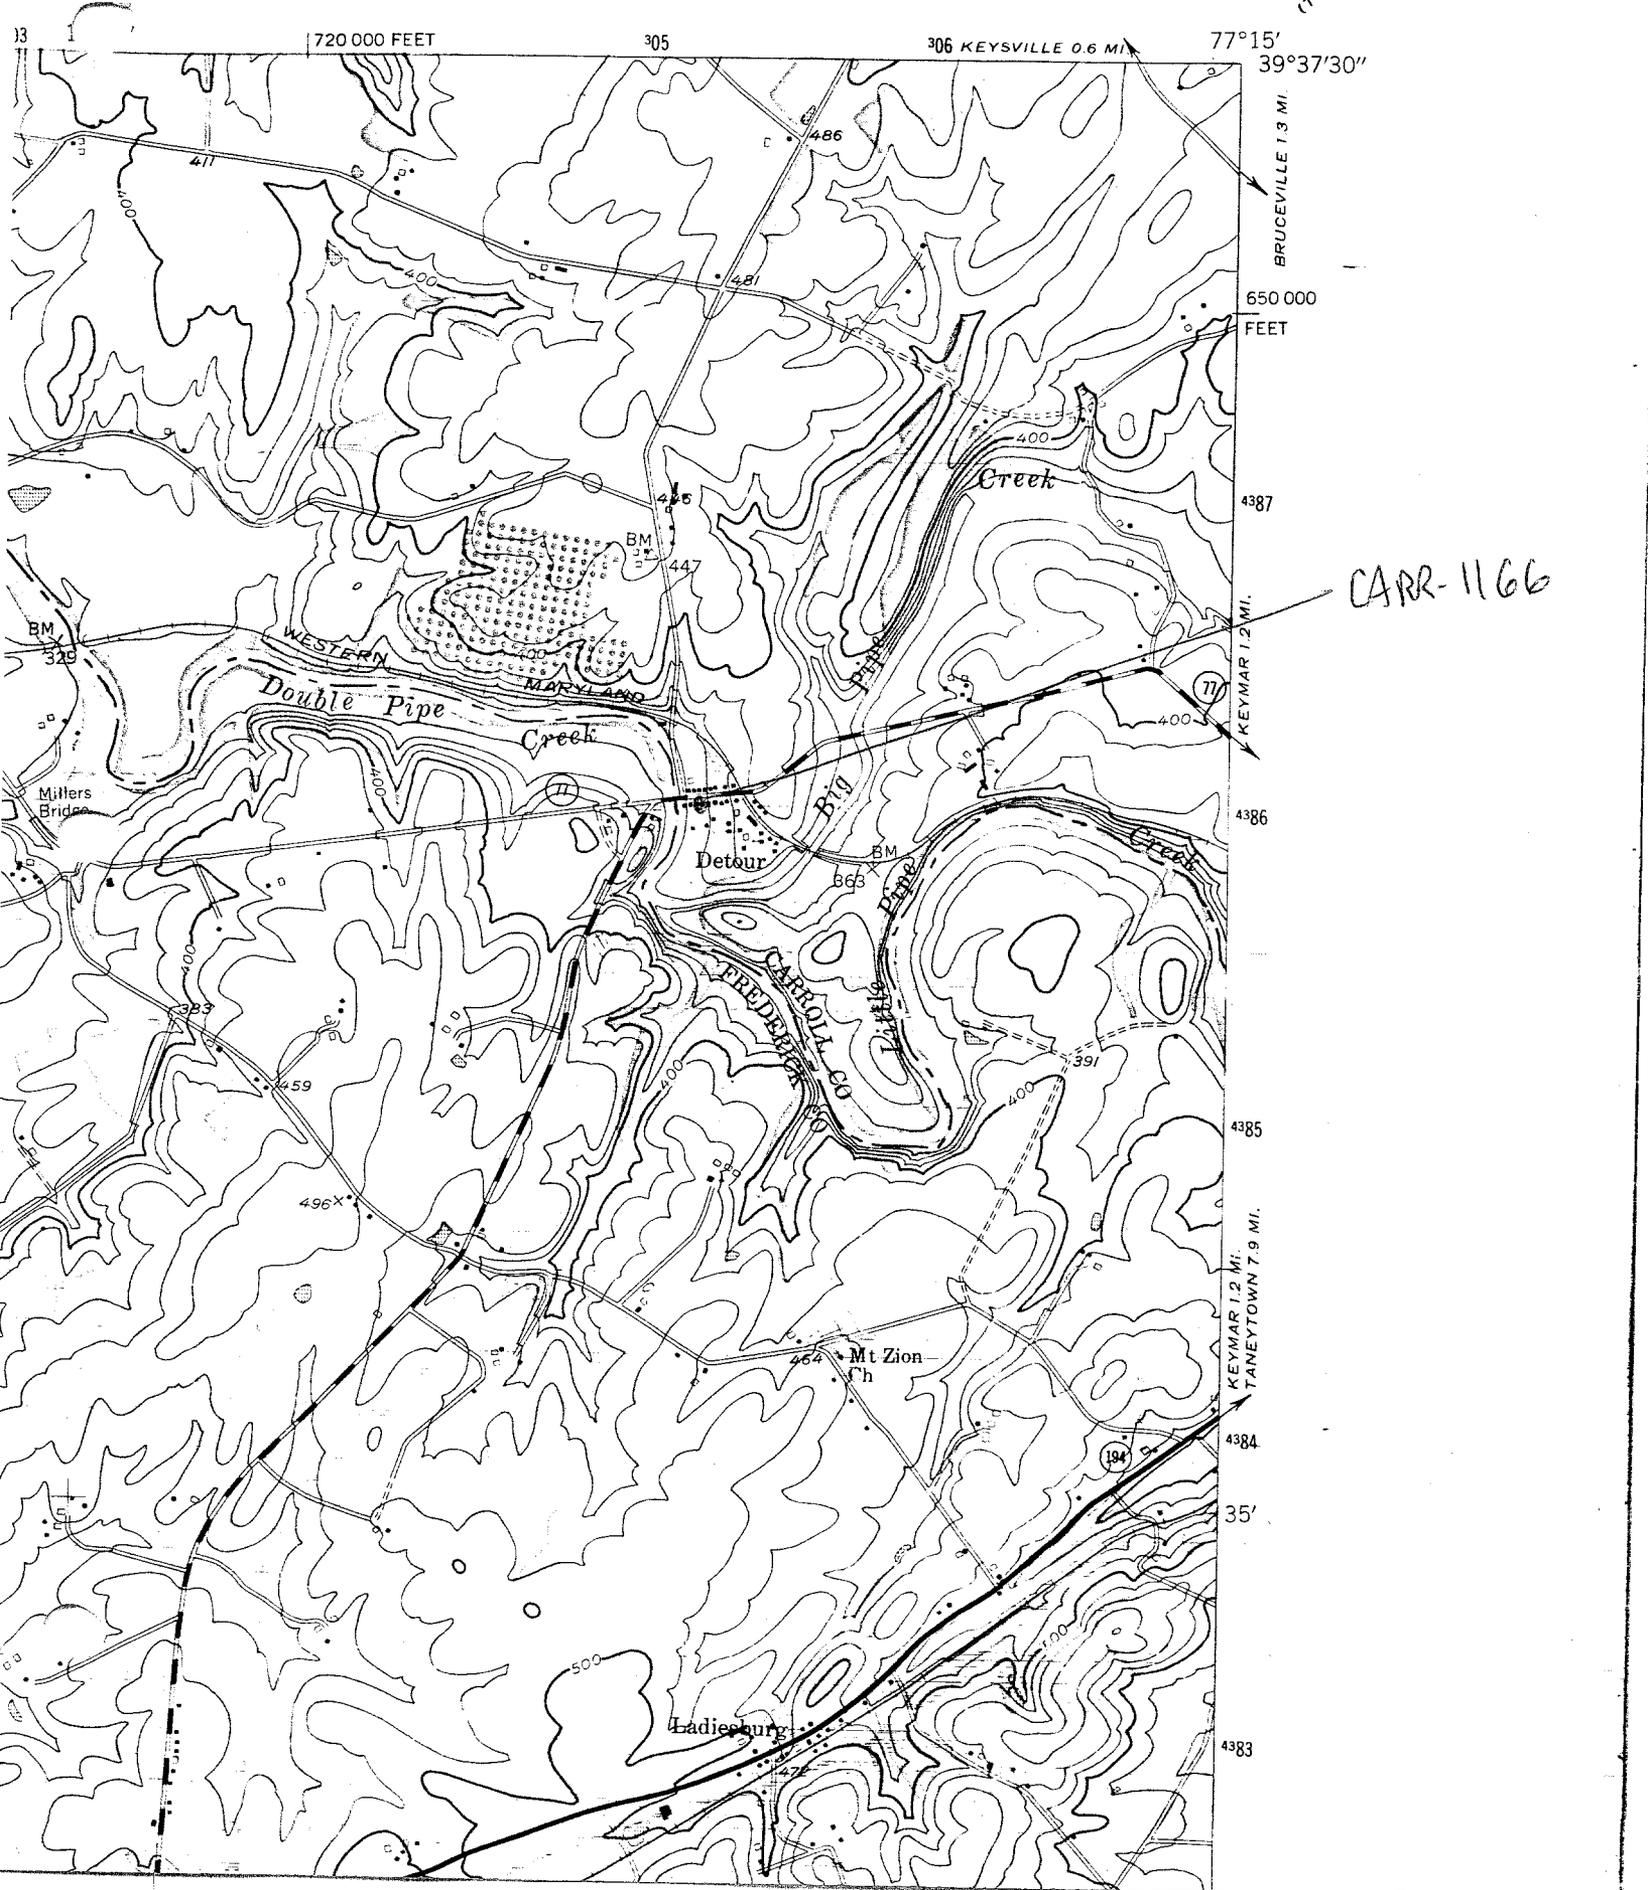
1. CARR-1166 Old Detour Bank  
7569 Middleburg Rd
2. Carroll Co, Md.
3. Joe Getty
4. April 1986
5. Md. Hist. Trust, Annapolis, Md
6. n & w elev (camera facing se)
7. 1/1

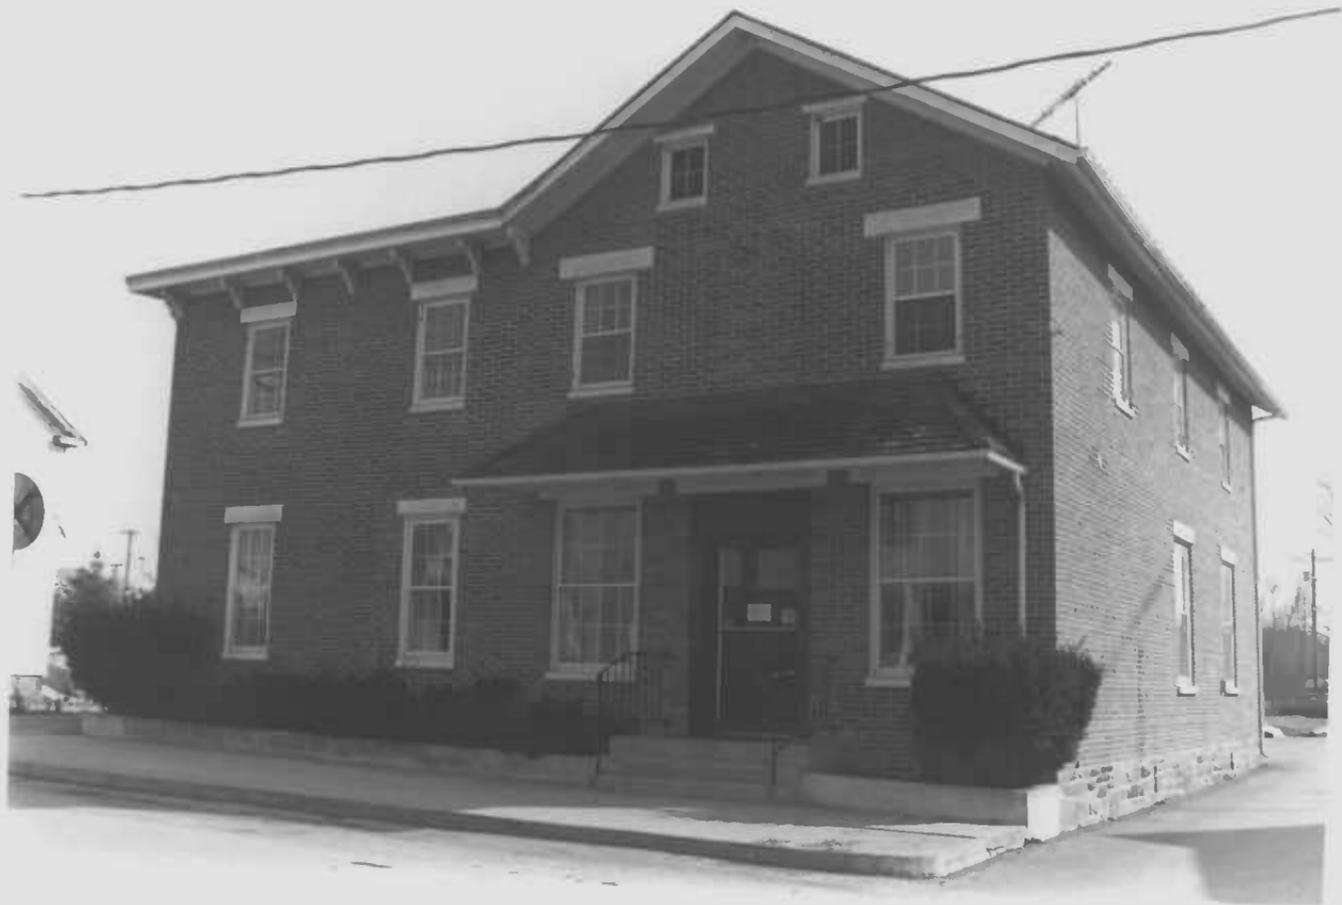
The brick structure at 7569 Middleburg Road shows an example of the combination store and house type that was popular in this region during the 19th century. There are several examples of this in Detour. This example has a gable-front store design with stretcher bond brickwork. The residence was a wing to the structure built in common bond.

Architectural changes to the building during the 20th century, when it served as a bank, have altered the original storefront design. This building is shown in the 1877 Atlas of Carroll County, Maryland as store of J. W. Weant.

Was built as a store with a wing for a residence. Store had a gable-front main facade. Alterations made during the 20<sup>th</sup> century while the structure served as a bank have altered the original storefront.
