Staffhouse #13

Springfield Hospital Center

Sykesville

State Historic Sites Inventory Form

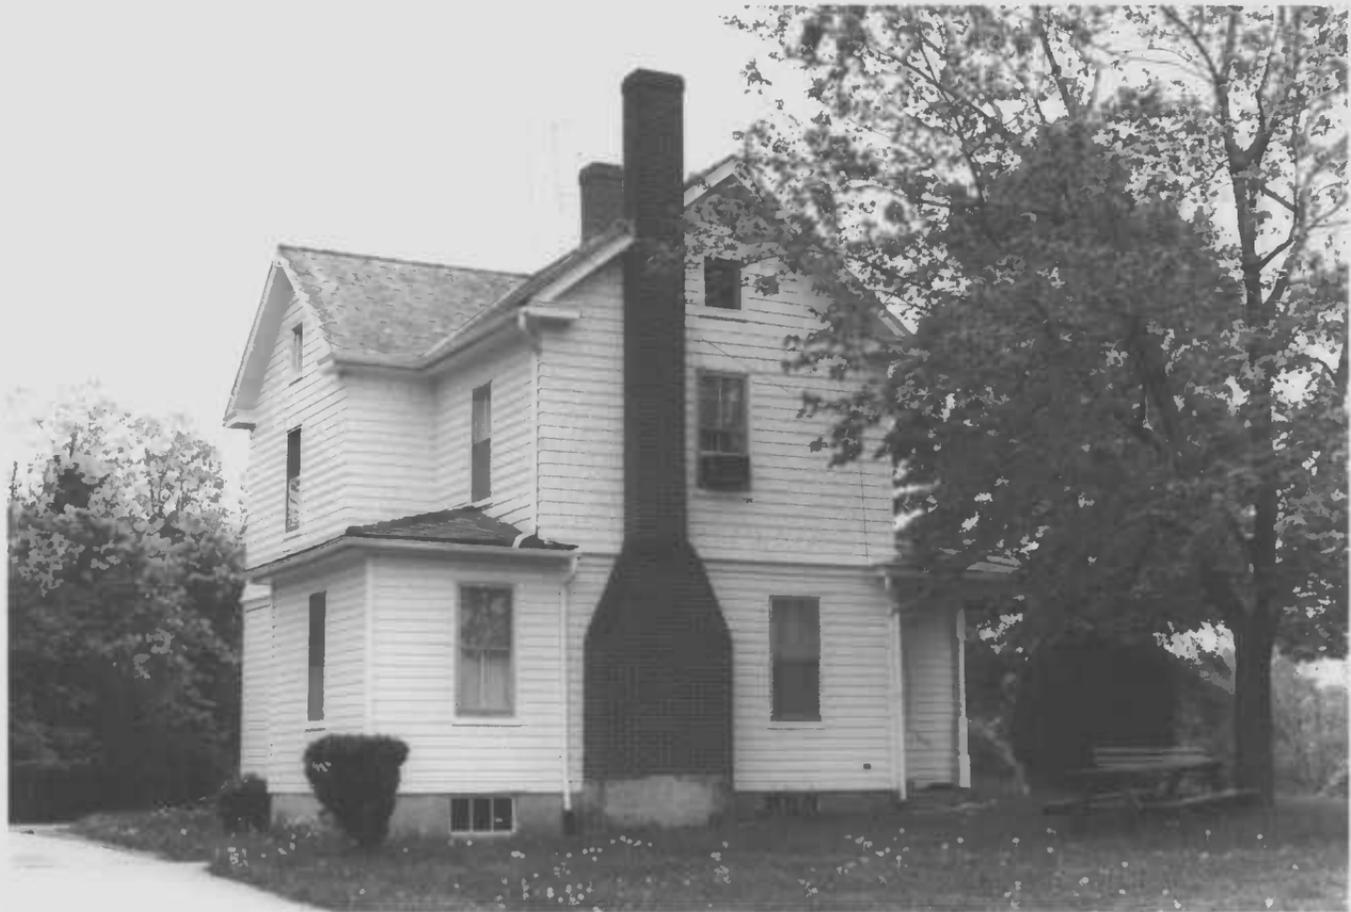
North

The fenestration remains simple. The 2/2 sash windows display wooden sills and surrounds. The windows which appear under the gable peak show a single sash window with the same treatment. The two chimneys on the building also appear plain. The north wall exhibit an exterior wall chimney constructed of stretcher bond brick. The second chimney is a central interior example.

The building does not really have a dominant facade but the north wall faces Route 32. A principle entrance appears on this wall. The western portion displays a tricorner porch supported by two pilasters and one free-standing post. All three pieces exhibit a sawn design.
