CARR-1287

Andrew Dice Farm
3252 Tracey's Mill Road
Manchester (vicinity)

Maryland Historical Trust State Historic Sites Inventory Form

CARR 1287	Andrew Dice Farm-House	First Floor Plan	March 1992	
	3252 Tracey's Mill Road		Kenneth M. Short

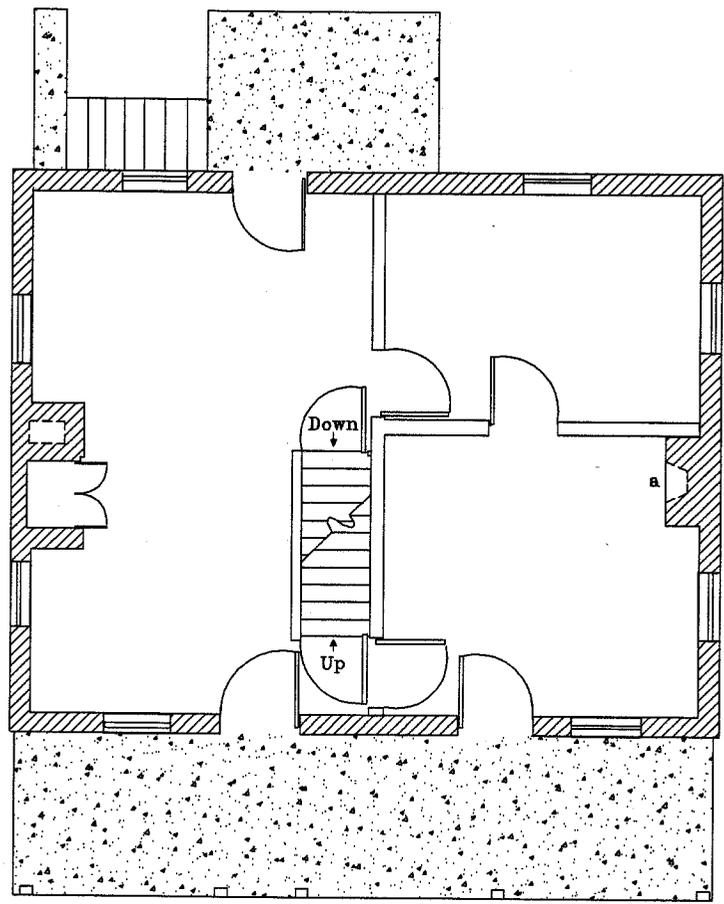
a. Bricked In

The interior of the house is laid out on a three-room plan. On the west is the kitchen, with a brick fireplace on the outside wall that contains two beaded-edge board doors on cast iron butt hinges to close off the fireplace. There are enclosed stairs on the eastern side of the room. This room once had wood rails with pegs, according to the owner. There are entrances from front and rear into this room, as well as to the two eastern rooms. The interior doors are similar to the front doors, but have three vertical panels top and bottom, with two horizontal panels in the middle. The moldings are nailed onto the panels. The southeast room was probably the parlor, and contains the most elaborate finishes, with ogee-molded low-pitch pediments above all the openings and a semi-circular fireplace (now bricked in) with a wood mantelpiece with square-section raised moldings nested within each other in the spandrels. There is a flat cartouche with elaborate jigsawed outline. There are entrances from the outside front porch and to the northeast room, which is unheated and has flat-topped architraves with ogee-moldings above all the openings. All of the windows and doors in the eastern half of the house have architrave trim with a beaded edge and an ogee in the center of the broken field. The moldings have Greek profiles. The architraves around the kitchen openings are now covered by later sheetrock. The baseboards are about 6 inches high, with a beaded edge at the top.

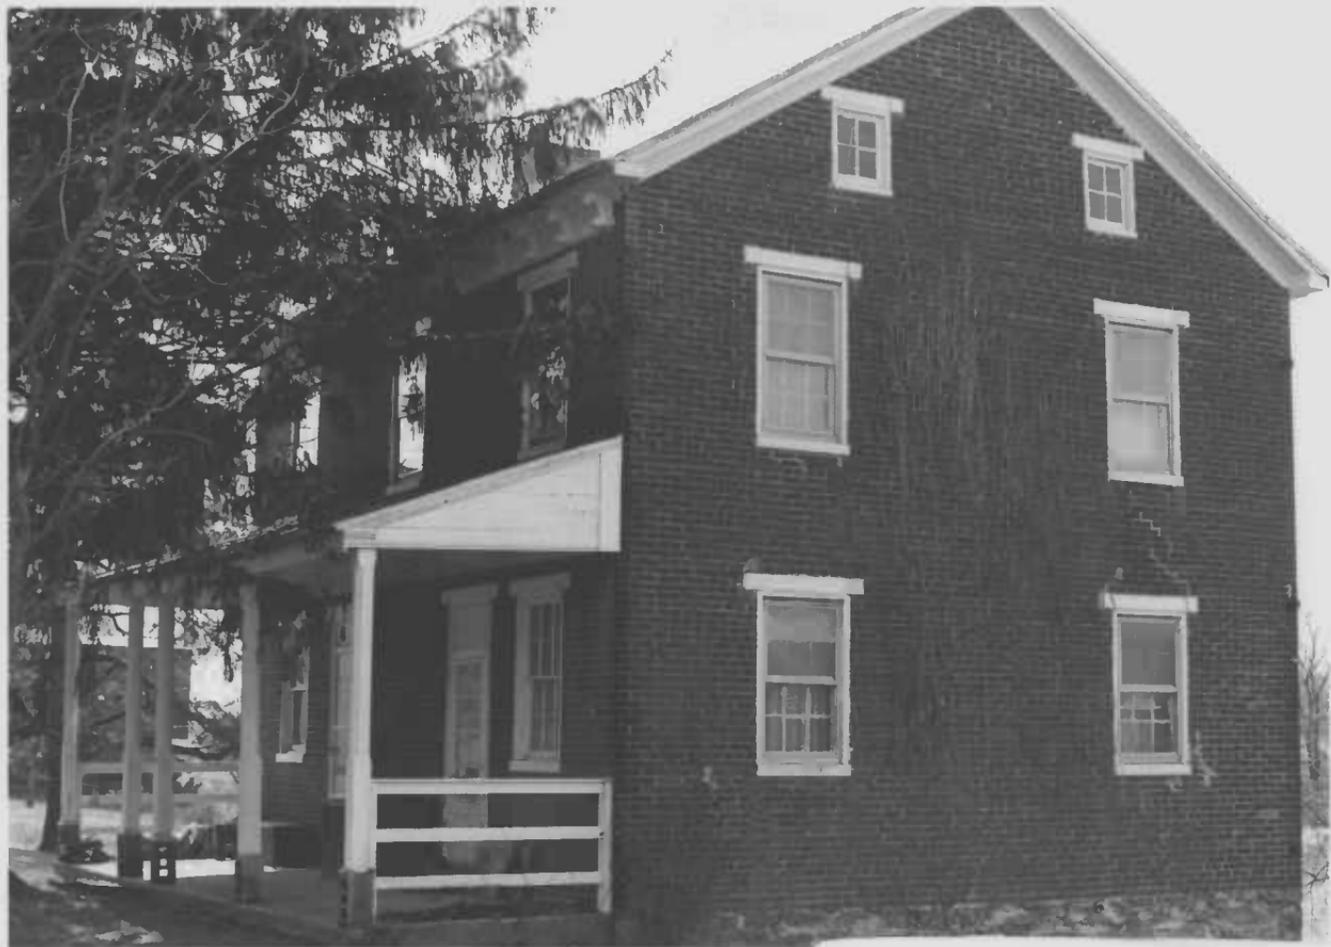
1/6

House. South - east elev.

The brick house is a banked two-story, four bay "Pennsylvania Farmhouse" plan structure with all-stretcher bond on the southern facade and 5-1 common bond on the other three elevations. The foundation wall, which is of rubble stone, is exposed on the north elevation. The southern facade faces the road and is the primary elevation. The two center bays contain doors with two horizontal panels above three vertical panels above two more horizontal panels above three more vertical panels. Above the doors are eight light casement transoms which are now covered from the outside. The remaining bays contain 6 over 6 double hung sash with wood sills and wood lintels with corner blocks. There is a one-story porch across the entire south elevation, supported by five chamfered posts. The original balustrade is gone, but had a top rail that was octagonal in

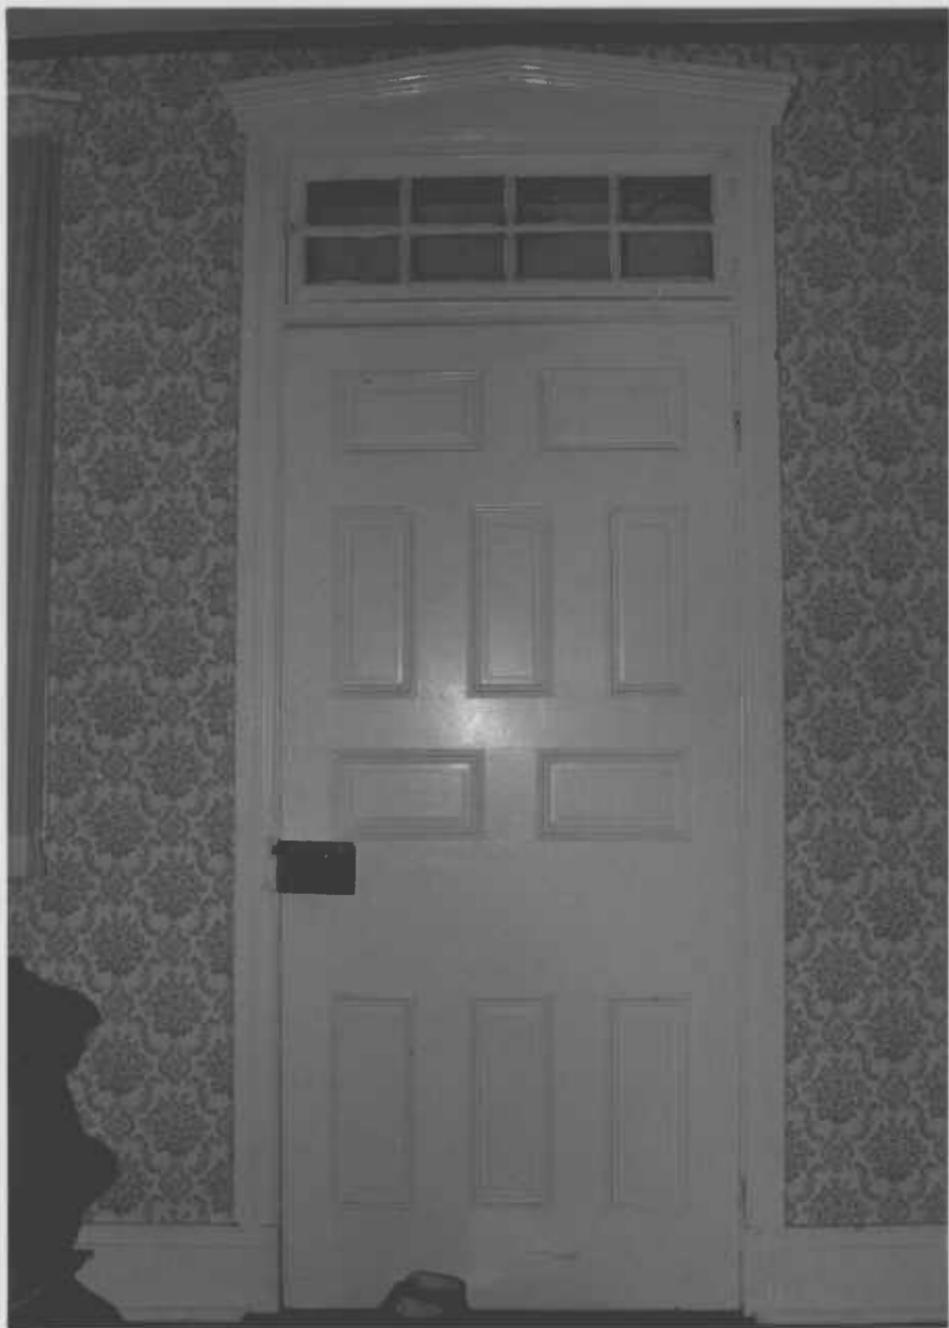
3/6

House - parlor door, interior north door

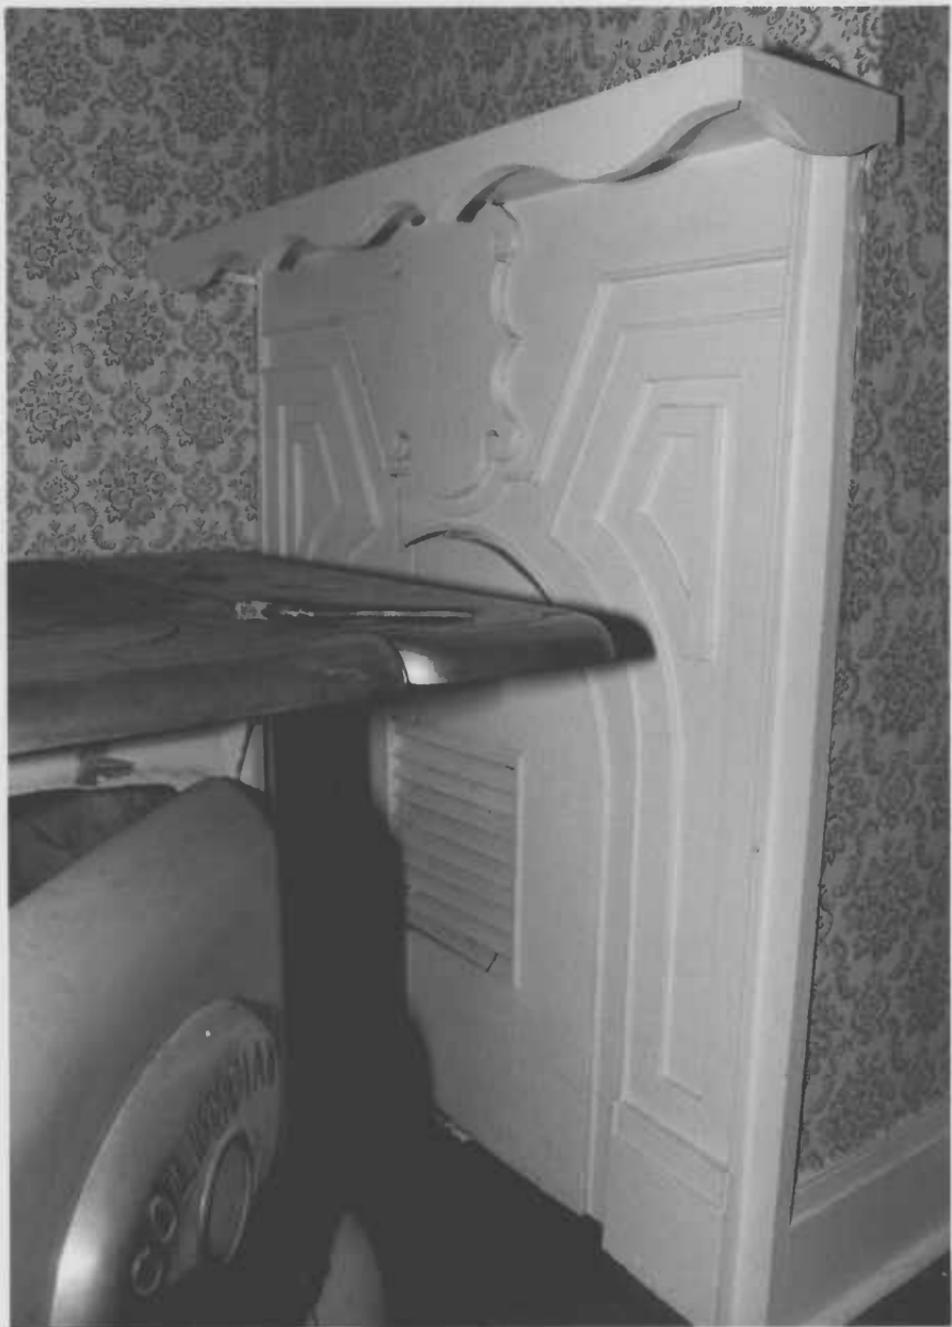
3/6

House - parlor mantel

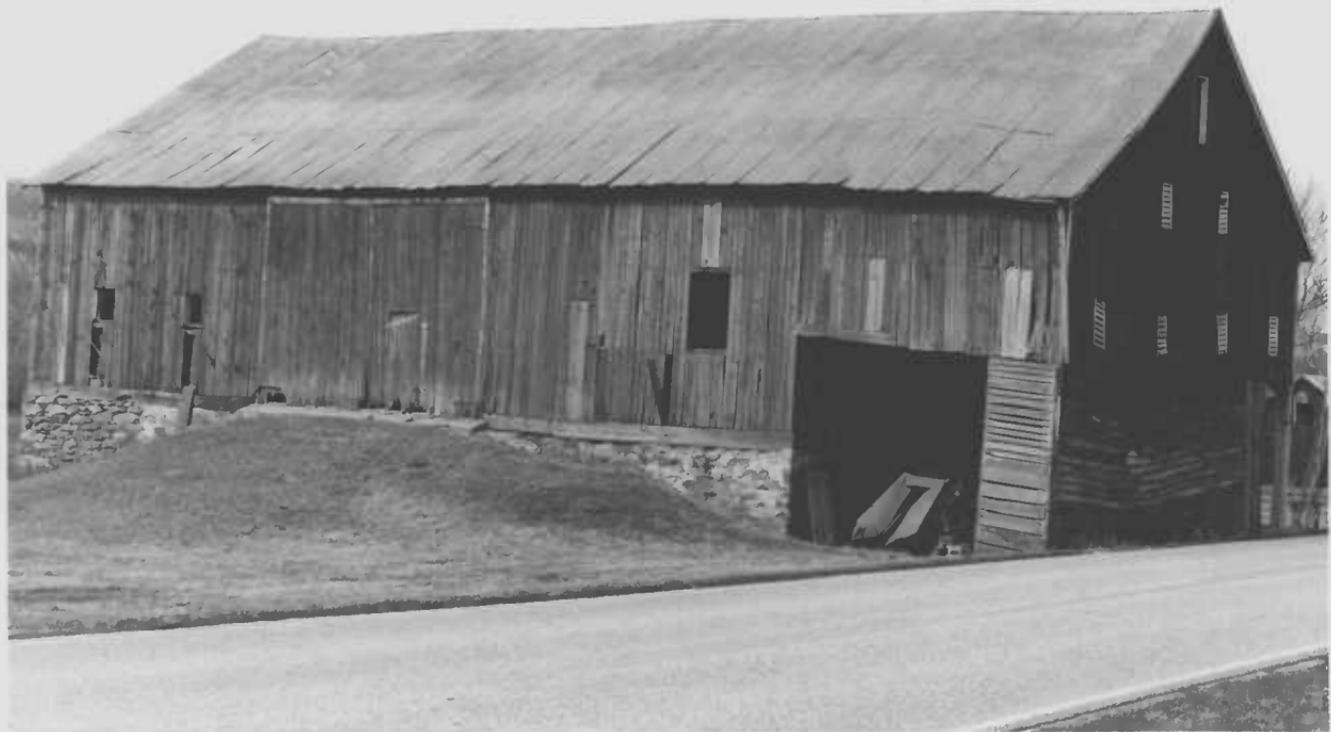
5/6

Barn - west & south elevs.

The frame barn with vertical board siding faces east and is not actually banked, so an earthen ramp has been built up on the west side to reach the upper story. The lower story is rubble stone on three sides and horizontal boards on the east elevation under the forebay. This wall is seven bays, with five vertical tongue and grooved board dutch doors on strap hinges below horizontal wood slat vents. There is a three-light sash in the second bay and a four-light sash in the fifth bay. On the south end is an integral wagon shed with openings on the east and west and corn crib with horizontal slat siding on the southern end. The stables have been altered, but the interior arrangement was probably three pens divided by two aisles. There is a hoist for butchering under the forebay. The upper story of the forebay is also seven bays, with two wood louvered vents at each end, then a 6 over 3 sash, and double doors in the center.

The north elevation has two round section wood vents in the lower story, now covered by horizontal boards, and two rows of four louvered wood vents in the upper story, below one row of two vents in the gable end. The south elevation has one row of four vents and one row of two above the horizontal slats of the corn crib. The west elevation originally had two windows to the north, but the sash is now gone. There are large double doors, with a smaller door inset in the south door, in the center, and a large opening to the south of this. The wagon shed opening is at the very southern end of the west elevation. The barn has a gable roof of corrugated metal.

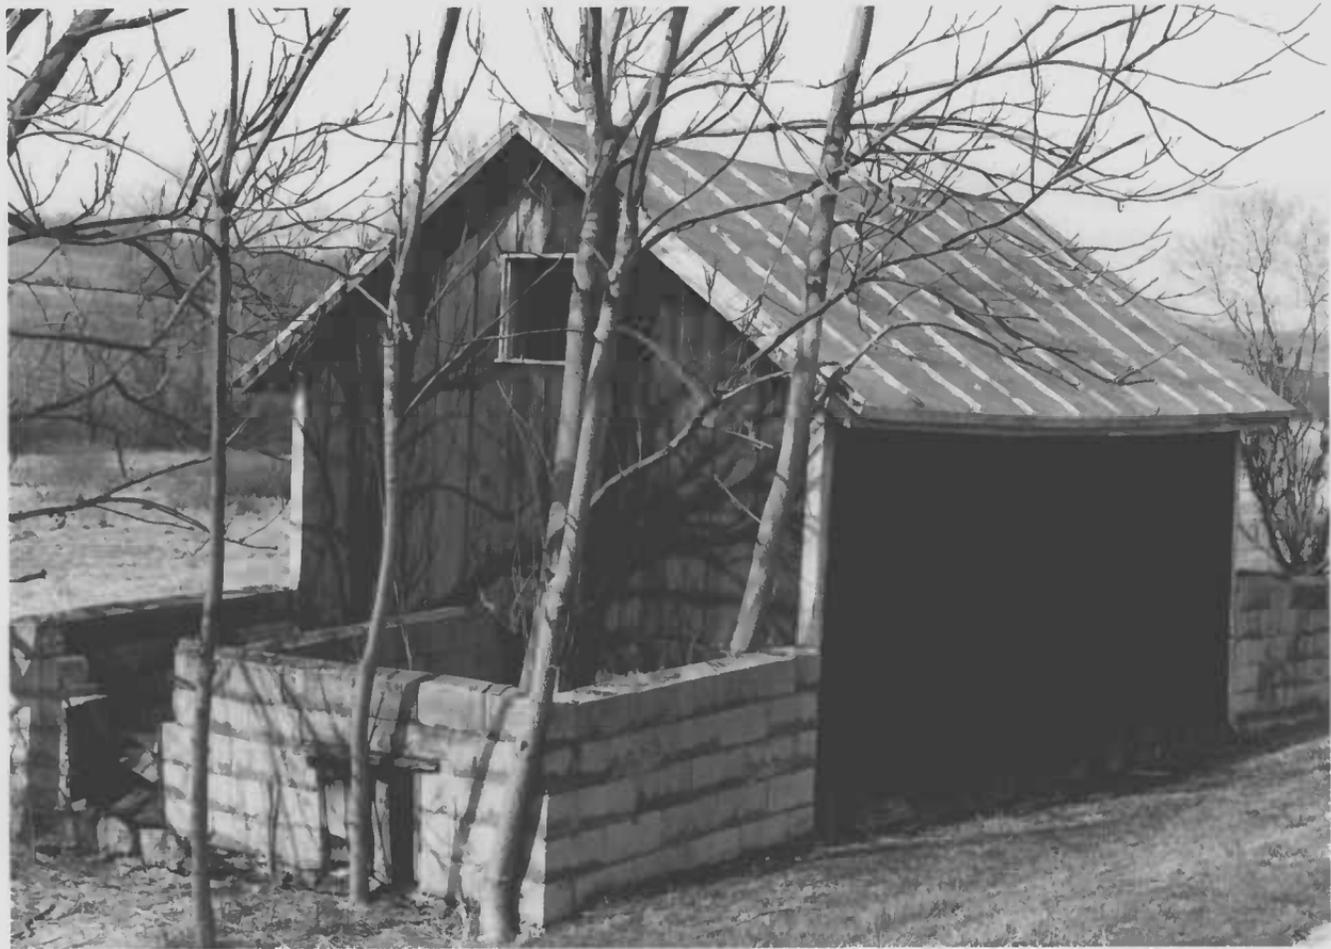
6/6

Obj. perm - west & south elevs.

The hog pen has a rubble stone foundation with vertical board siding and a standing seam gable roof. The south elevation has a central vertical board door flanked by an opening into the attic on each side. On each end, there is an opening into the attic, and two low openings into the pens. Attached to each end are CMU walls that create

two exterior pens each with an opening in each to outside. The frame of the building is hewn and mortised and tenoned, but the floor is concrete and the pens, which still survive but are not original to the structure, are of horizontal boards. The plan has a central aisle with two pens to each side.
