CONTRIBUTING RESOURCE
MARYLAND HISTORICAL TRUST
INTERNAL NR-ELIGIBILITY REVIEW FORM

Property Name: 3068 Westminster Street, Manchester, Maryland, Carroll County Survey Number: --- CARR-1295

historic William Ross Shower House

#7. Description

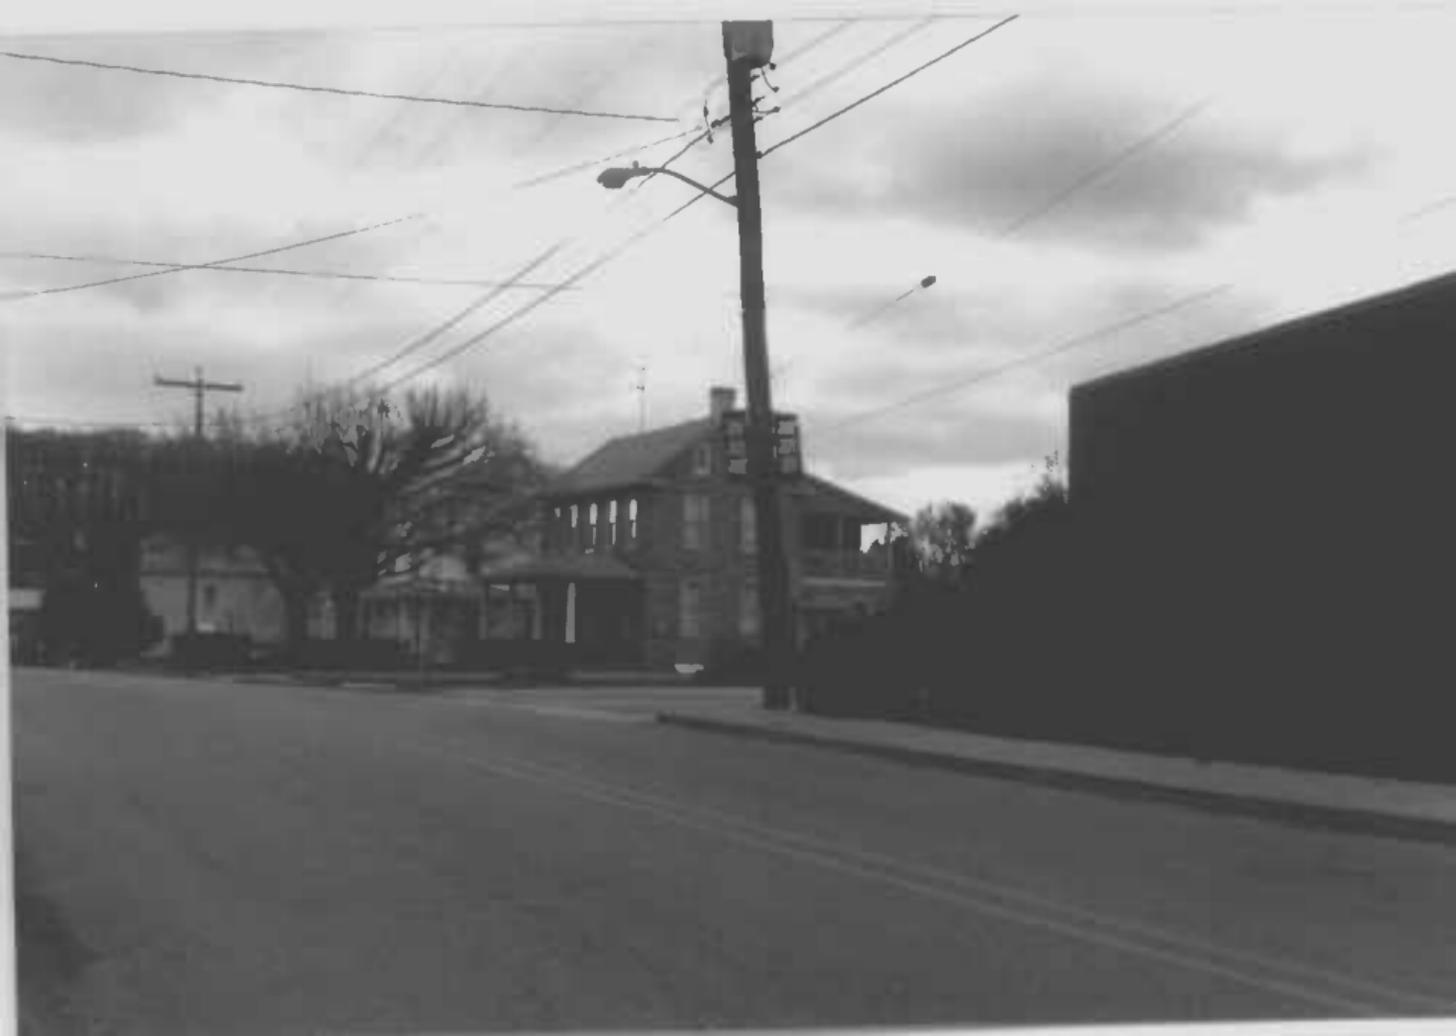
1/51

The William Ross Shower House is a vernacular structure built in the 1920s on a lot on Westminster Street in Manchester. The house is slightly set back from the street. The main facade faces southeast towards the street frontage of Westminster Street. In the early 20th century, this street was known as Foundry Avenue. The site has two medium-sized trees in the front yard and a concrete-paved driveway on the northeast side of the house. There is a small ornamental tree at the rear of the house and a hedge along the southwest property line. The northeast property line has a sharp change in elevation where a commercial parking lot and access road exists (Photo 1).

view w on Westminster St

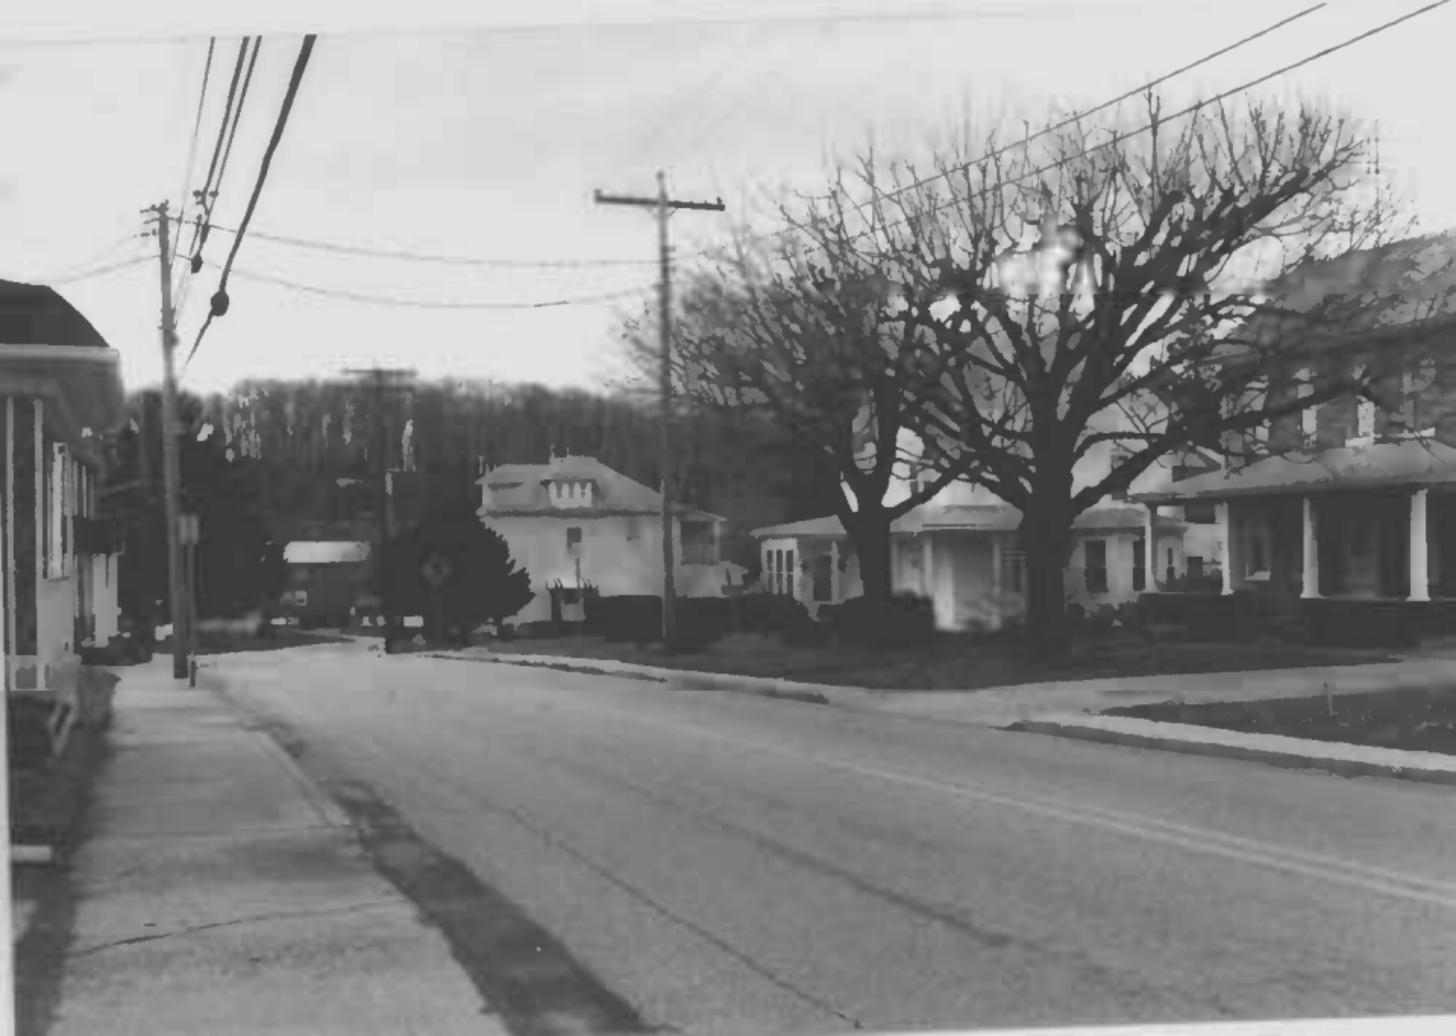
2/51

To the southwest are late 19th and early 20th century houses on individual lots (Photo 2). To the northeast, the lot is bounded by a driveway and parking lot to modern commercial development. A mid-1970s brick commercial building containing the Manchester Pharmacy (Photo 1 & 3) is located on the lot to the northeast and brick U. S. Post Office built in 1985 is located on a lot to the north (background of Photo 8).

view on W. Westminster St.

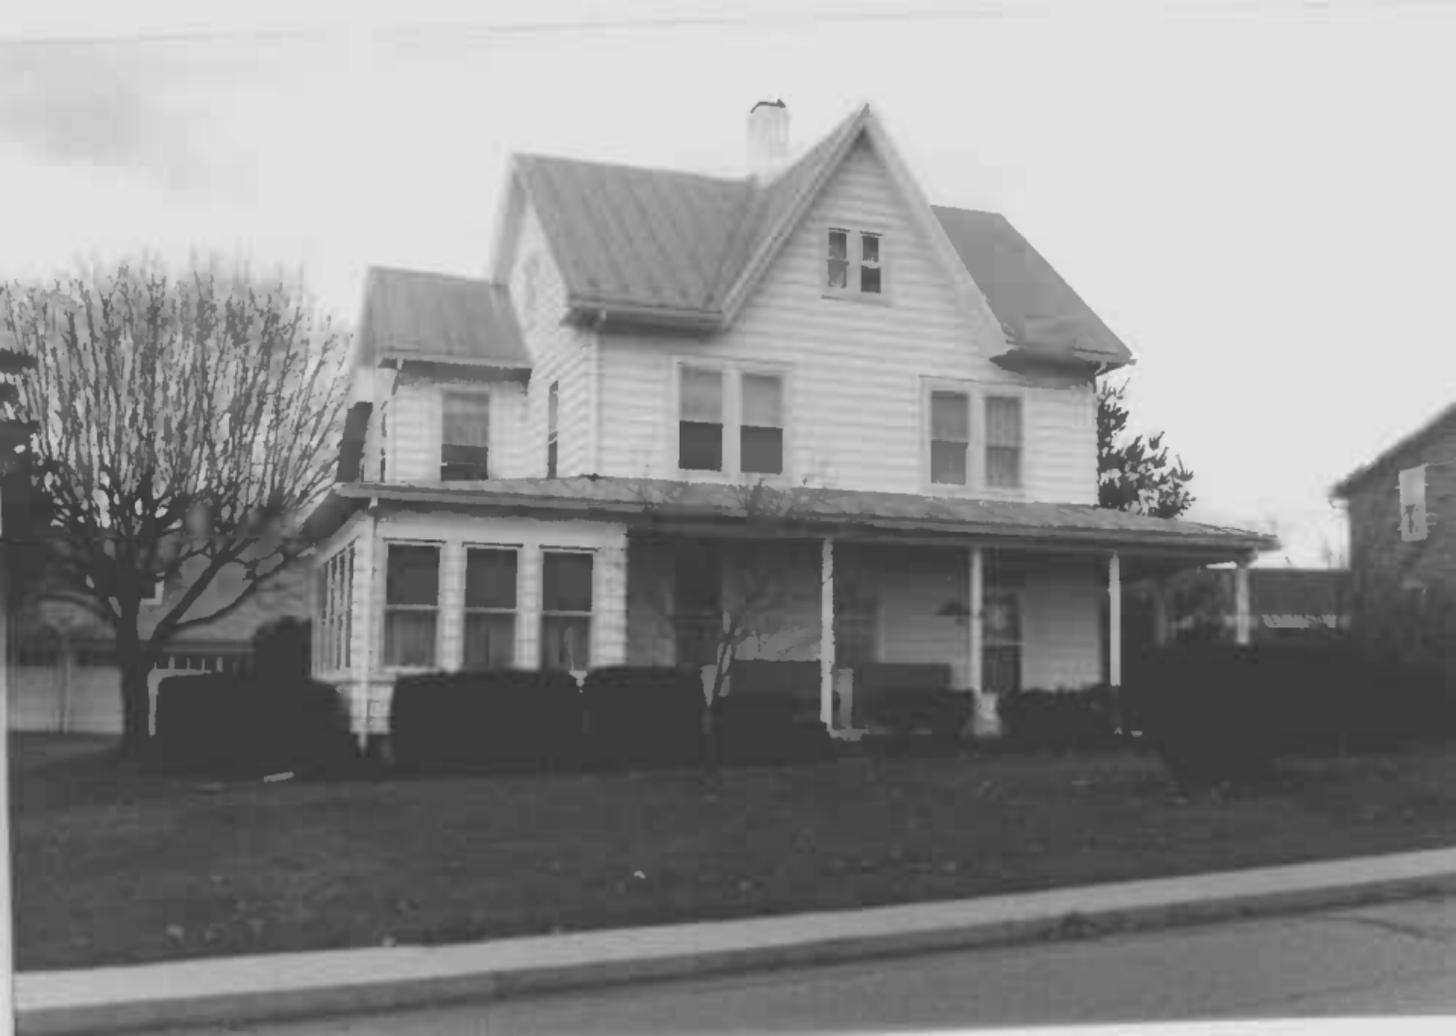
4/51

The lot to the southwest is the property known as 3064 Westminster Street (Photo 4). The house on this property was constructed circa 1893 by William H. Shower, father of William Ross Shower. This house was extensively remodeled in 1925 by the Blocher family who purchased the property from Mrs. William H. Shower.

ss elevation

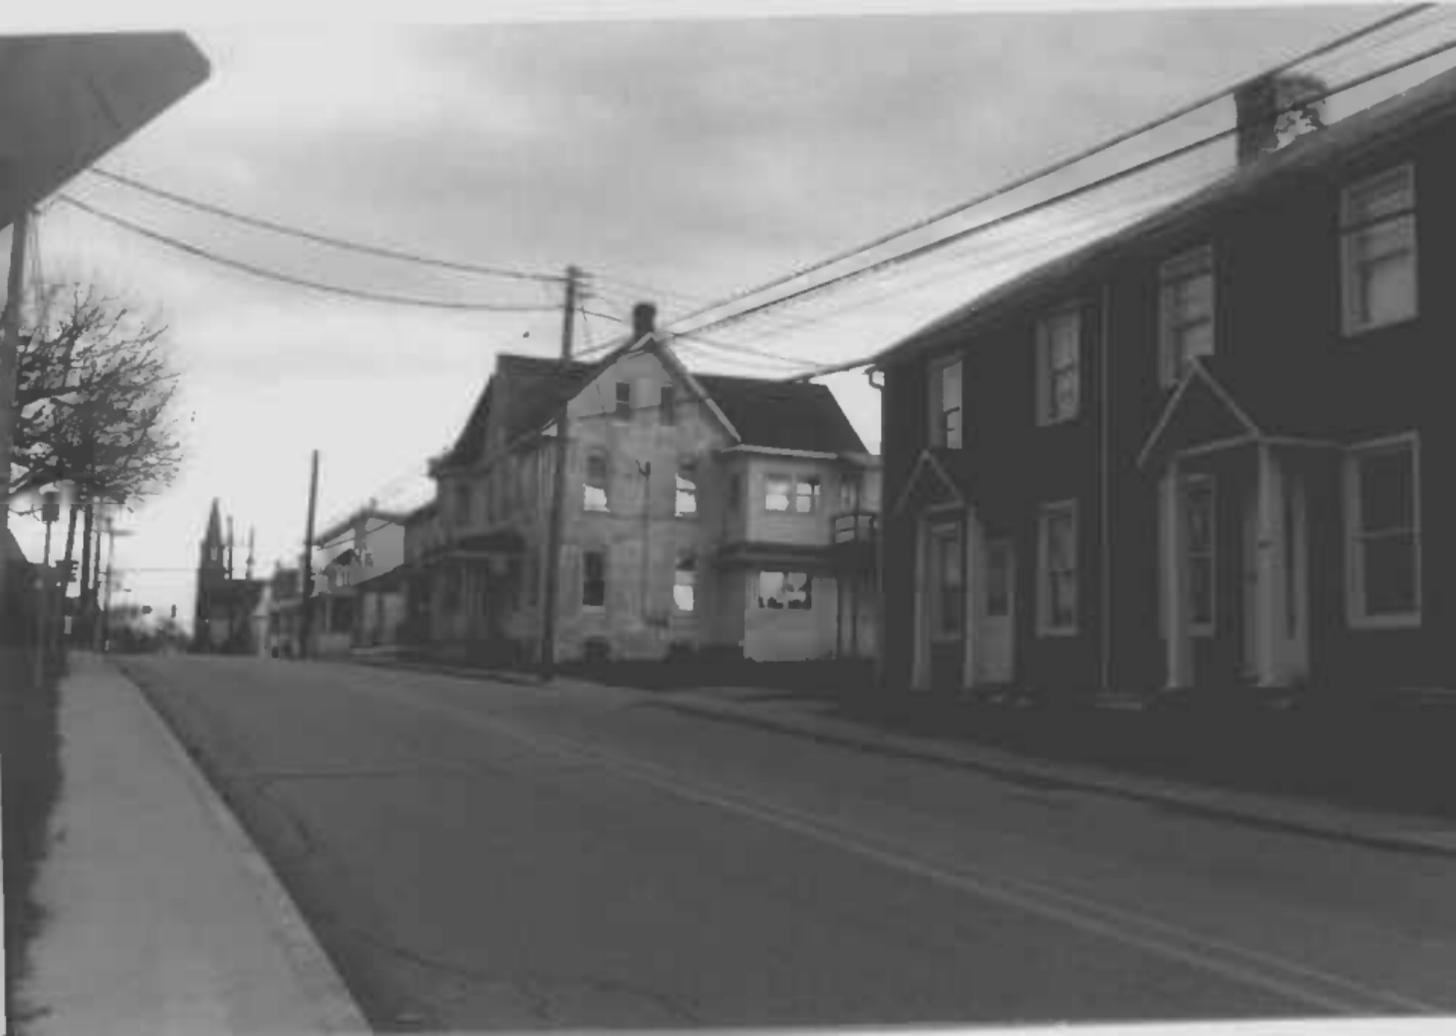
5/51

Across the street from the property is a vernacular duplex built right up to the sidewalk (Photo 5). It is a late 19th century structure covered in a shingles.

View of house across Westman Forest

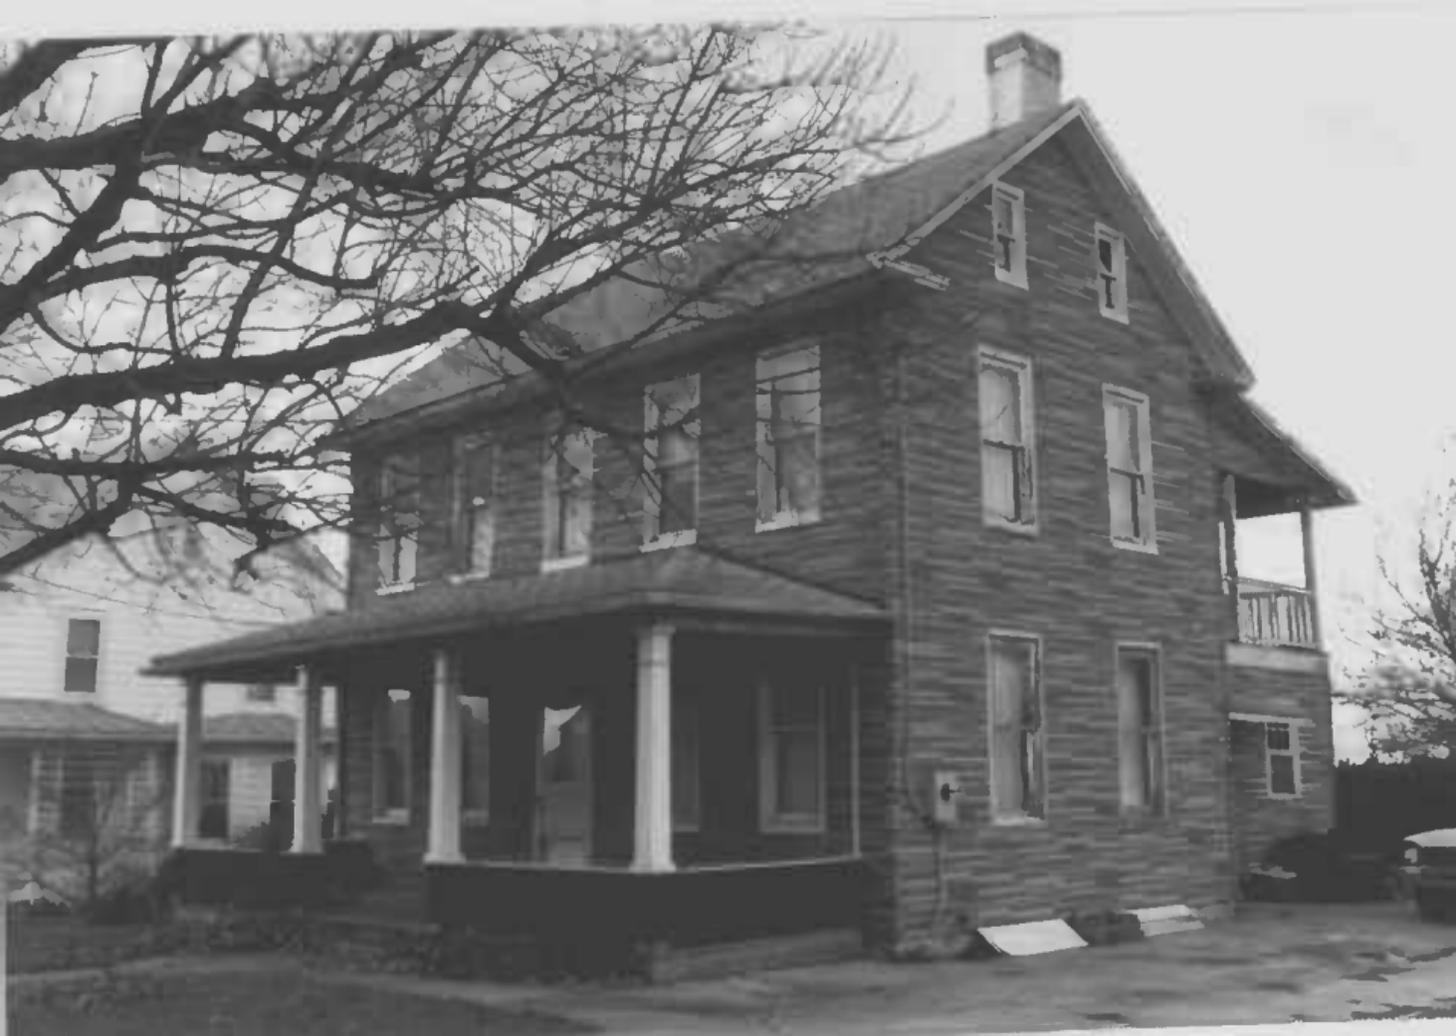
6/51

The William Ross Shower House is a vernacular style frame structure that was built in the 1920s. It is two-story building that contains an L-shaped plan (Photos 6 & 7). The L-shaped plan was a popular feature in this region from the late 18th century through the early

see $\frac{1}{2}$ no elevations

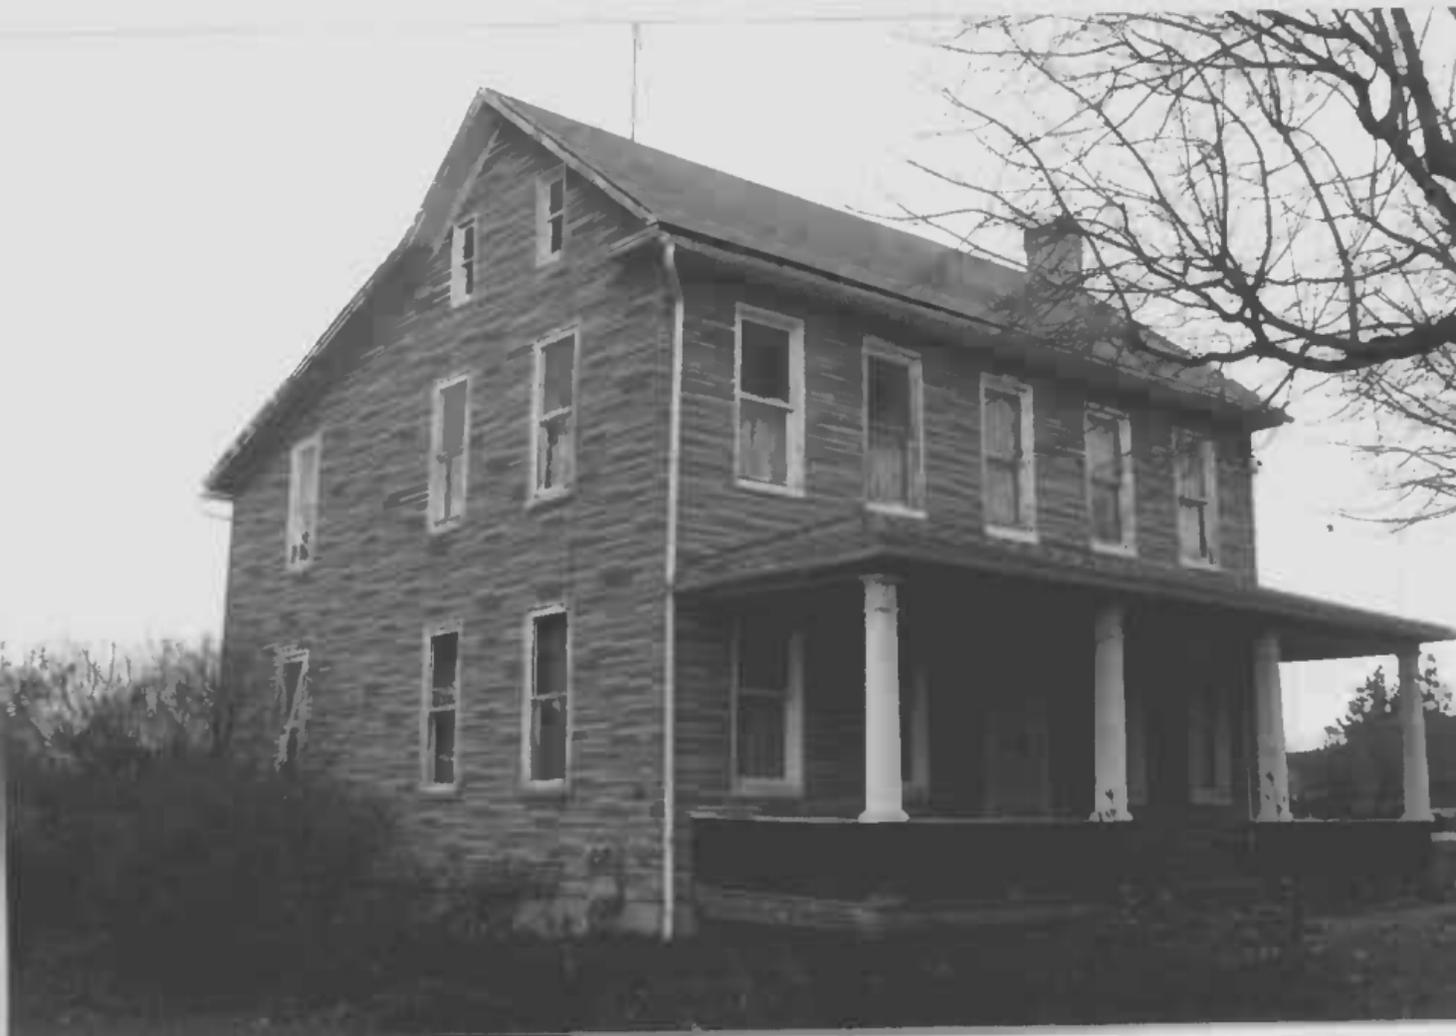
7/51

The southwest gable end of the main block has two one-over-one windows on each floor (Photo 7). In the gable are two smaller one-over-one sash windows. This elevation shows the angle of the roof in projecting out to cover the ell wing. The southwest elevation of the ell has a single one-over-one sash window on each story.

se & sw elevations

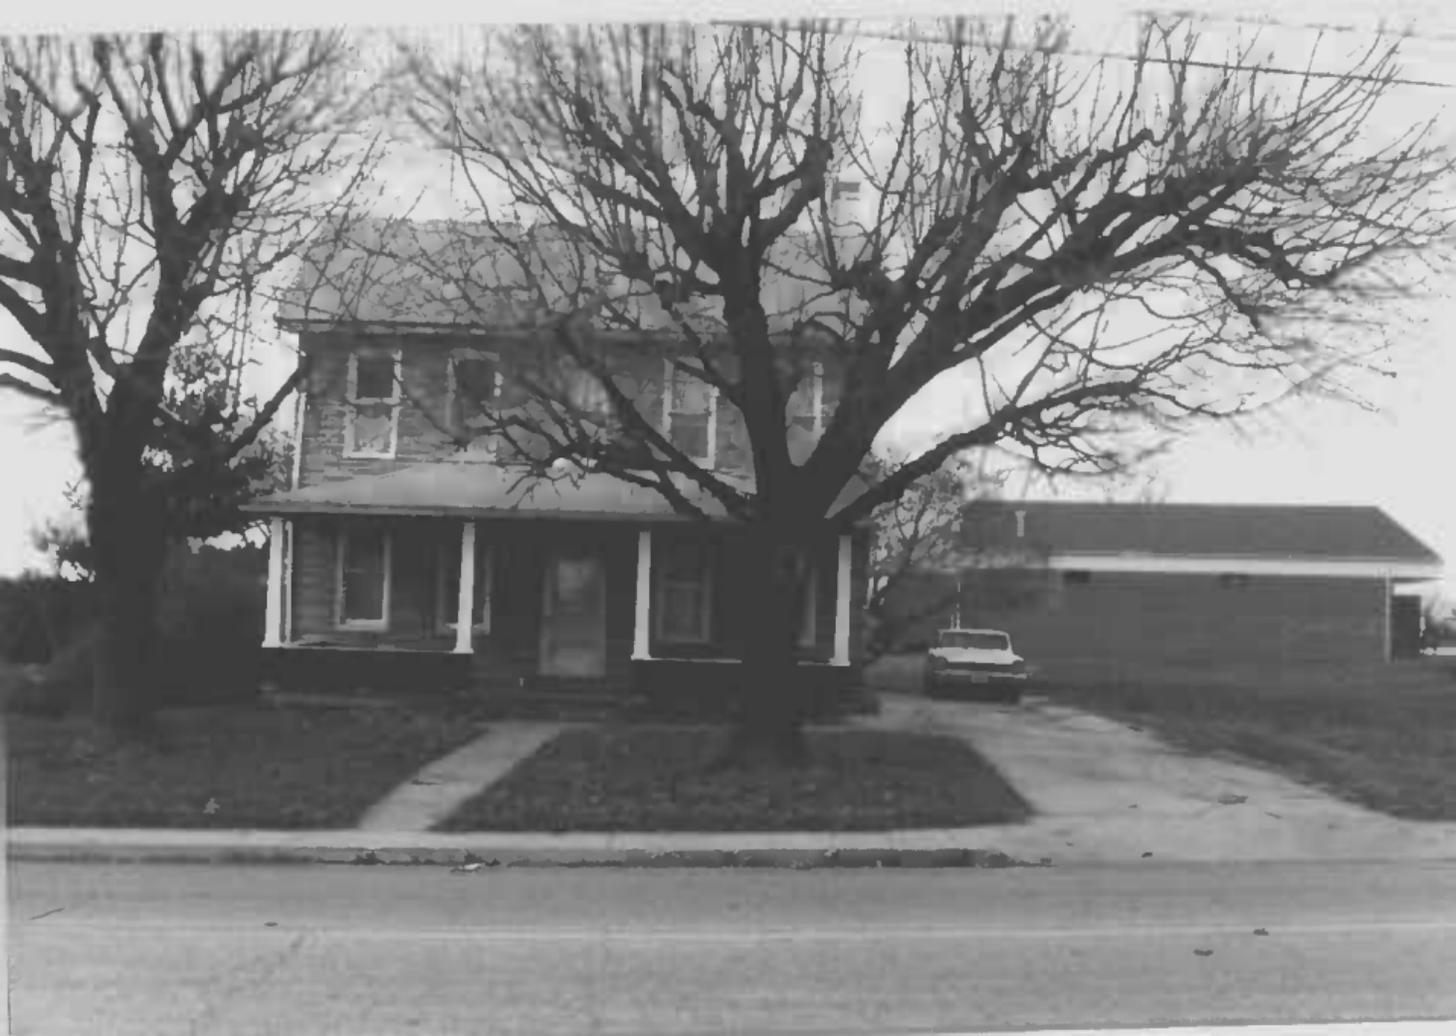
8 | 51

The main facade is symmetrically arranged with a central entrance on the first floor (Photo 8). The other bays on the first and second stories have one-over-one sash windows (Photos 8 & 9). There is a full-length, one-story porch with a hipped roof covered in asphalt shingles (Photo 10). The ceiling of the porch is a thin tongue-and-groove board painted white. The porch roof is supported by square posts with molded ornamentation (Photo 11). The porch posts sit on a railing covered in shingles. The porch has a tongue-and-groove board wooden deck.

se elevation

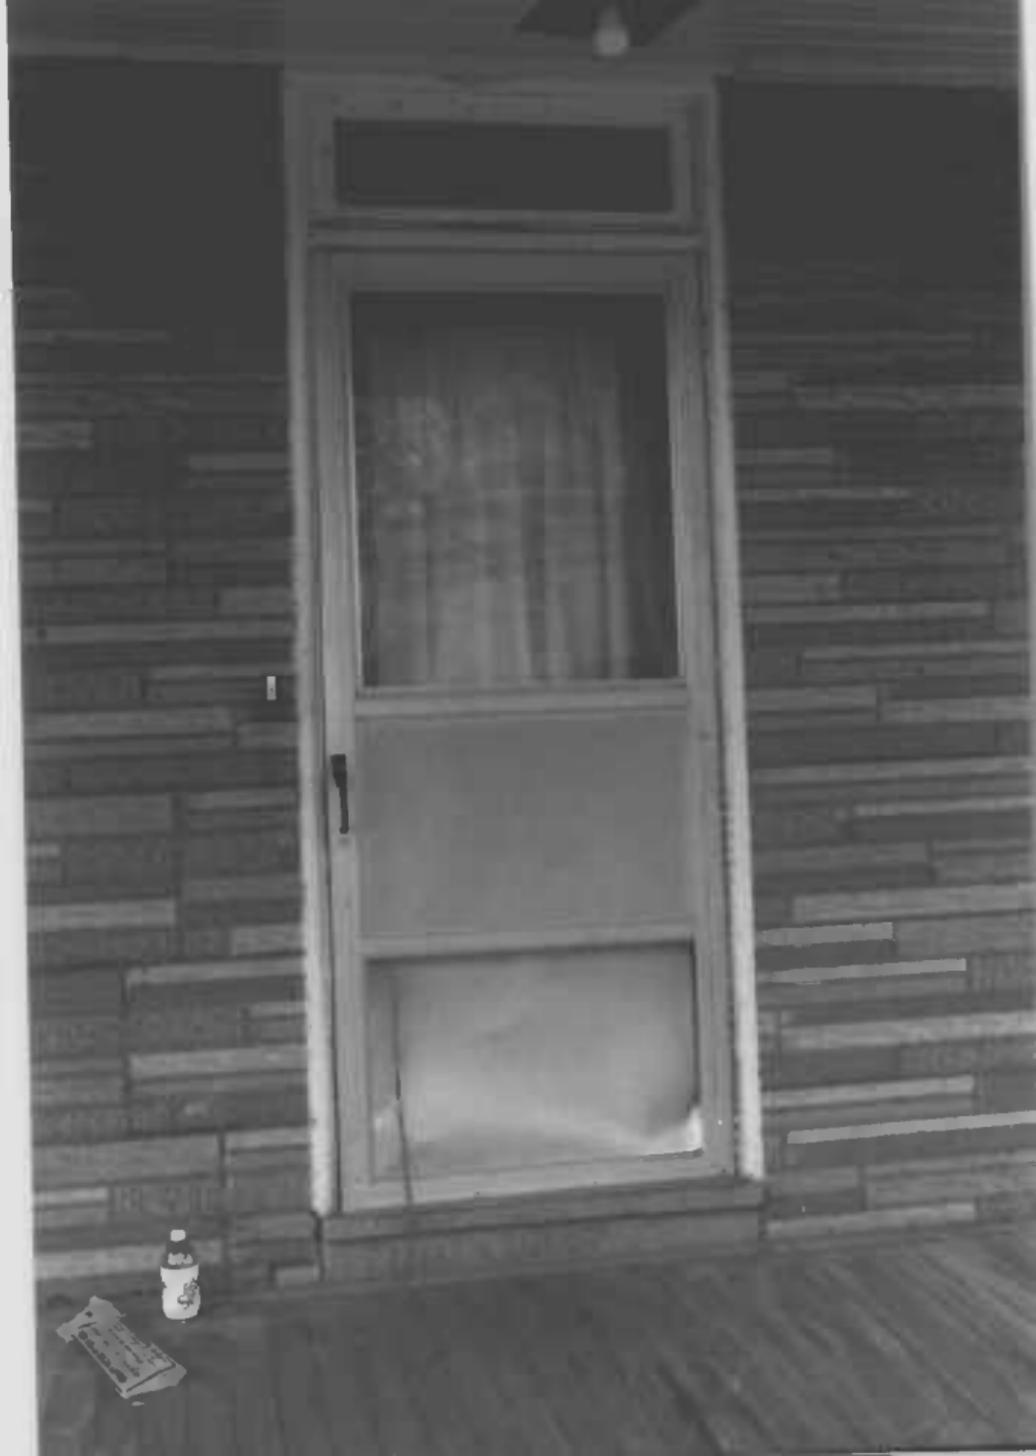
12/51

The central entrance contains a single door with a two-pane, horizontal transom above the door (Photo 12). The door has a single pane of window glass in the upper section and a single panel below. The door framing is a convex molding painted white. The exterior of the entrance has a single-pane wooden storm window over the transom and an aluminum storm door over the entrance. The window frames throughout the house have an exterior framing of a plain convex molding (Photo 13). The roofline has a plain boxed cornice that returns at the front gable ends (Photo 14).

se elevation: front door

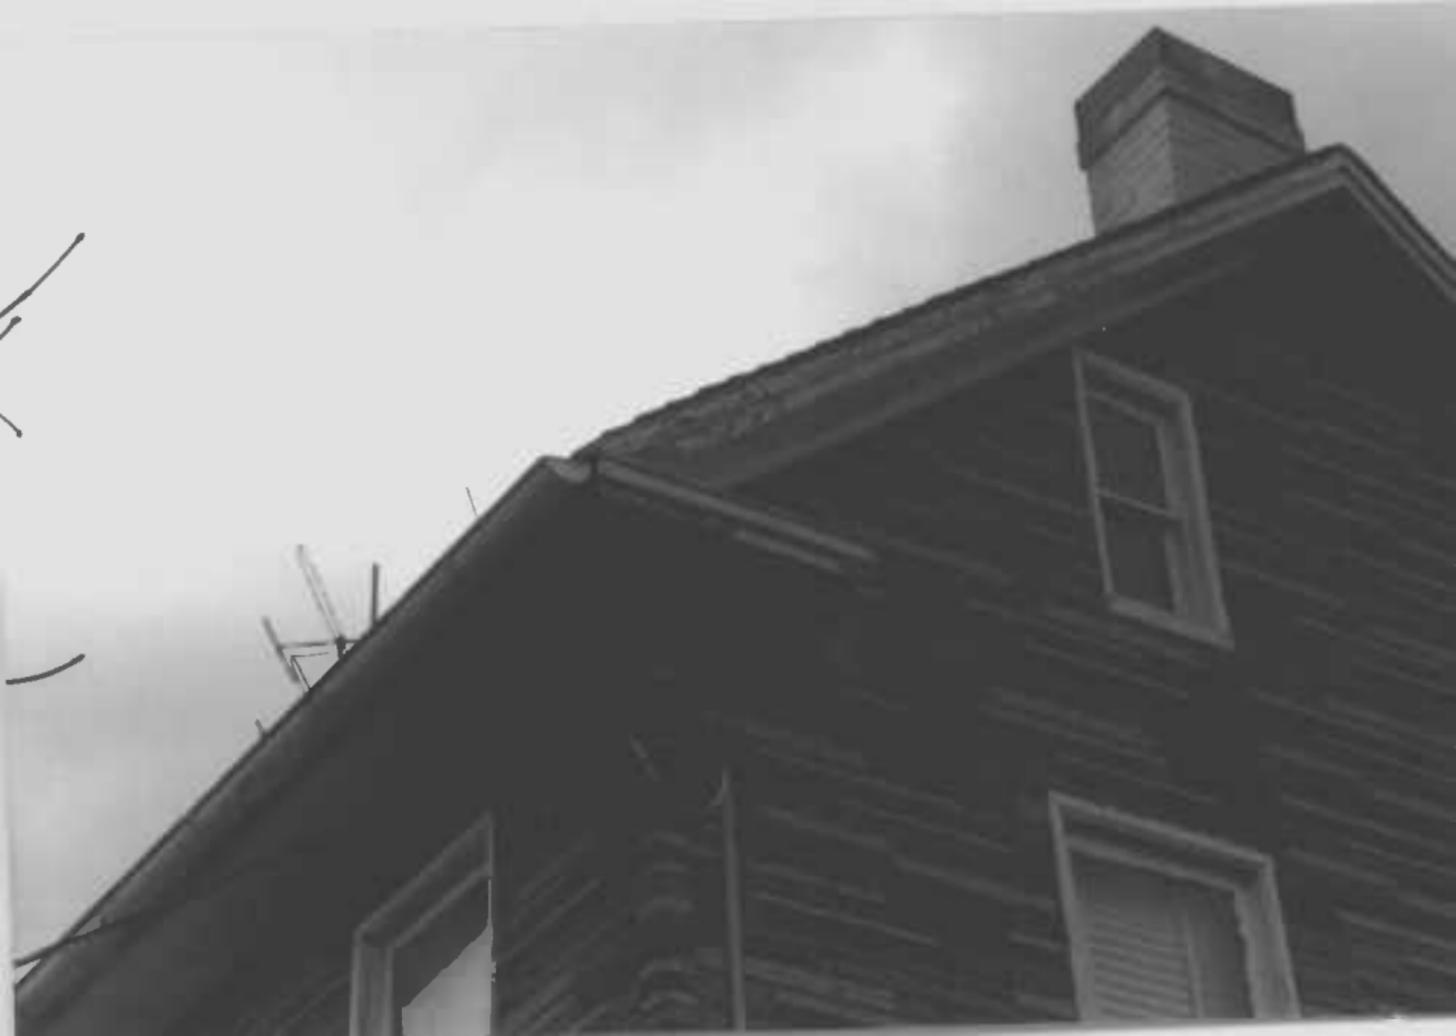
14/51

see elevation - cornice

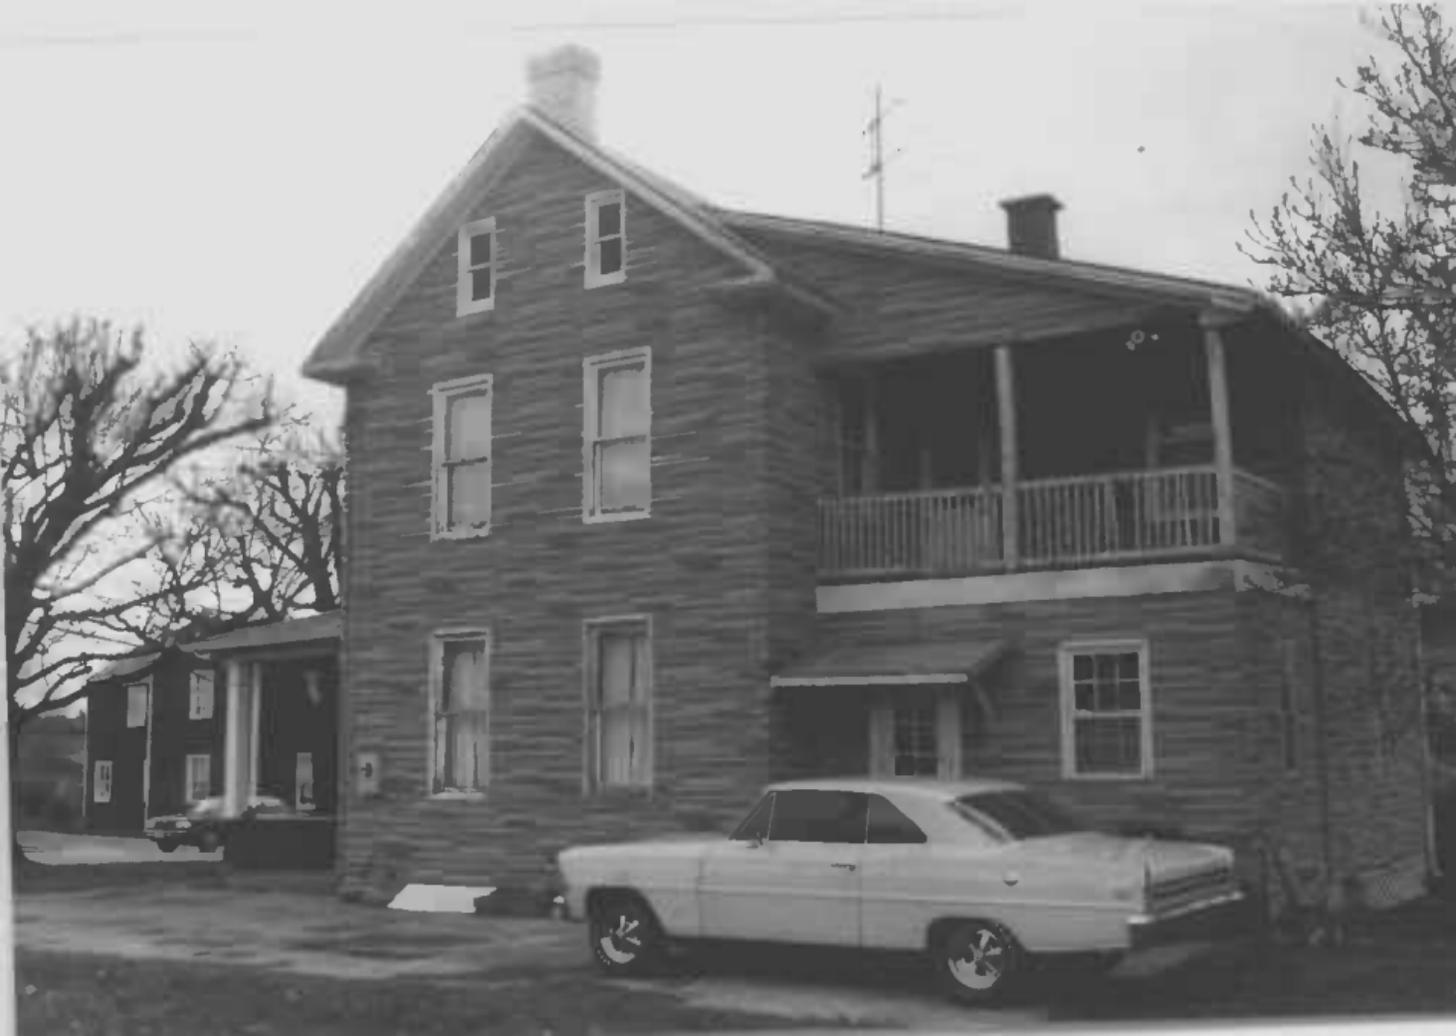
16/51

The northeast gable end of the main block has two one-over-one windows on each floor (Photos 15 & 16). In the gable are two smaller one-over-one sash windows. The brick chimney with the upper two courses projecting out as a cap is located at this gable end. On the inner side of the ell was a double-tiered porch. The lower portion of the porch has been enclosed for use as a laundry room (Photos 16 & 17). The northwest elevation of the ell wing has a single one-over-one sash window centrally located on the first floor.

ne elevation

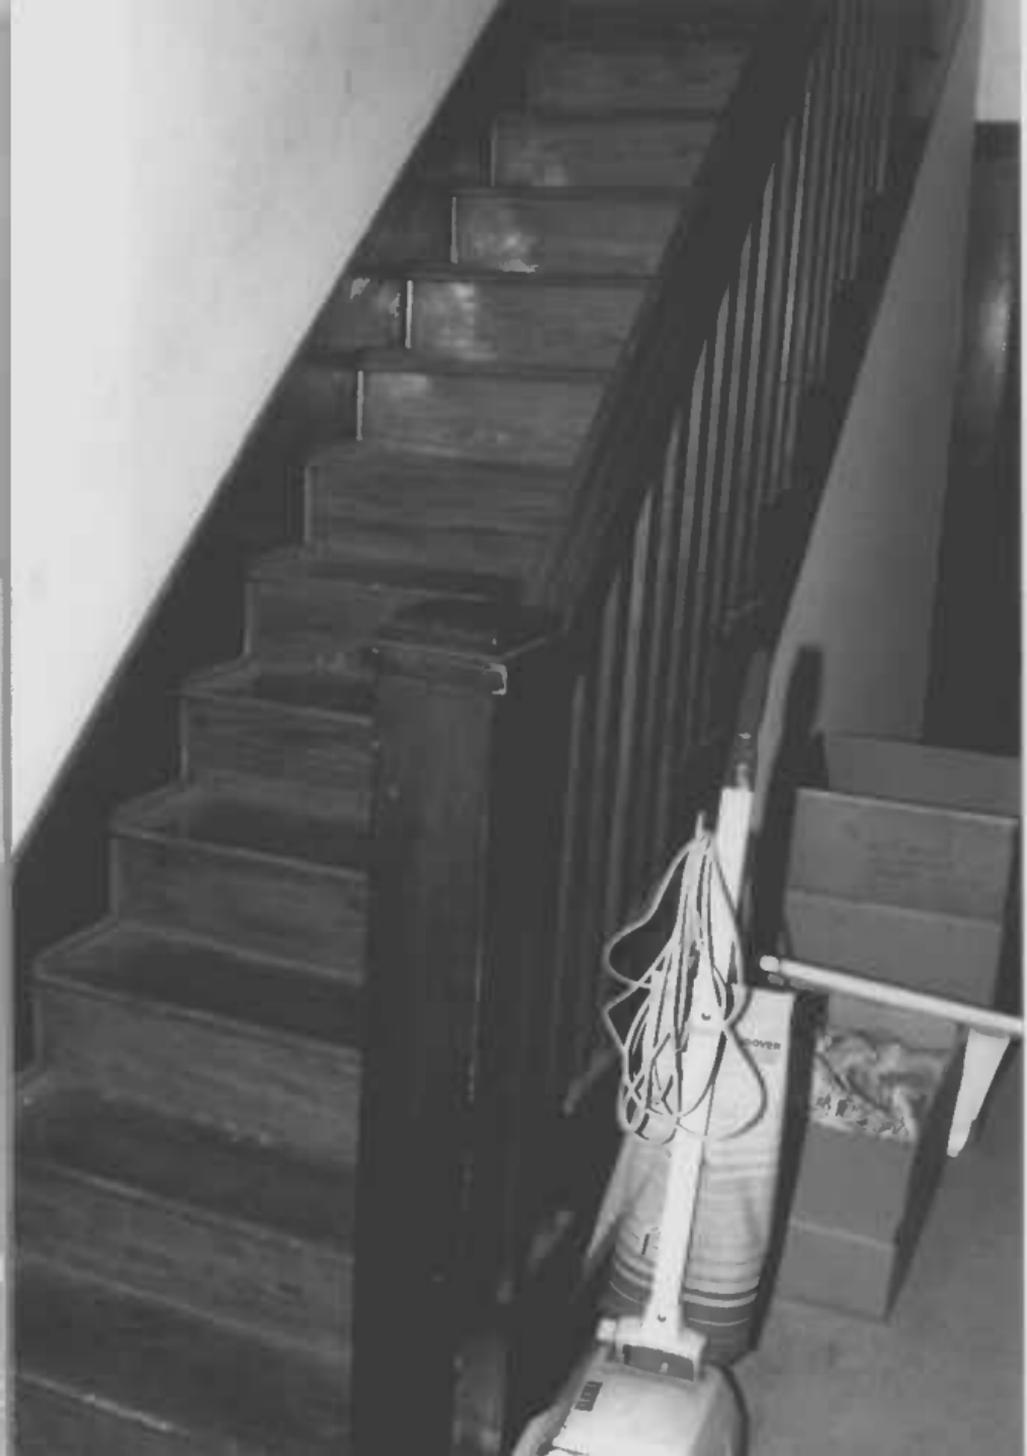
22/51

The staircase has a plain design with a square newel post and square bannisters supporting a shaped handrail (Photo 22). The stair ends are plain and the walls below the staircase as well as throughout the hallway are plastered. The exterior door has a two-pane, horizontal transom and the door has a single pane of window glass in the upper section and a single panel below (Photo 23). The interior doors are four-paneled with tall vertical panels on the upper section of the doors (Photo 24). The doorframes in the hallway consist of plain pine boards without ornamentation joined at the corners with butt-end joints (Photo 25). The woodwork of the doorframes, doors, stair risers, railing and bannisters has a natural finish and some of the interior doors have original hardware (Photo 26).

Hall - driveway

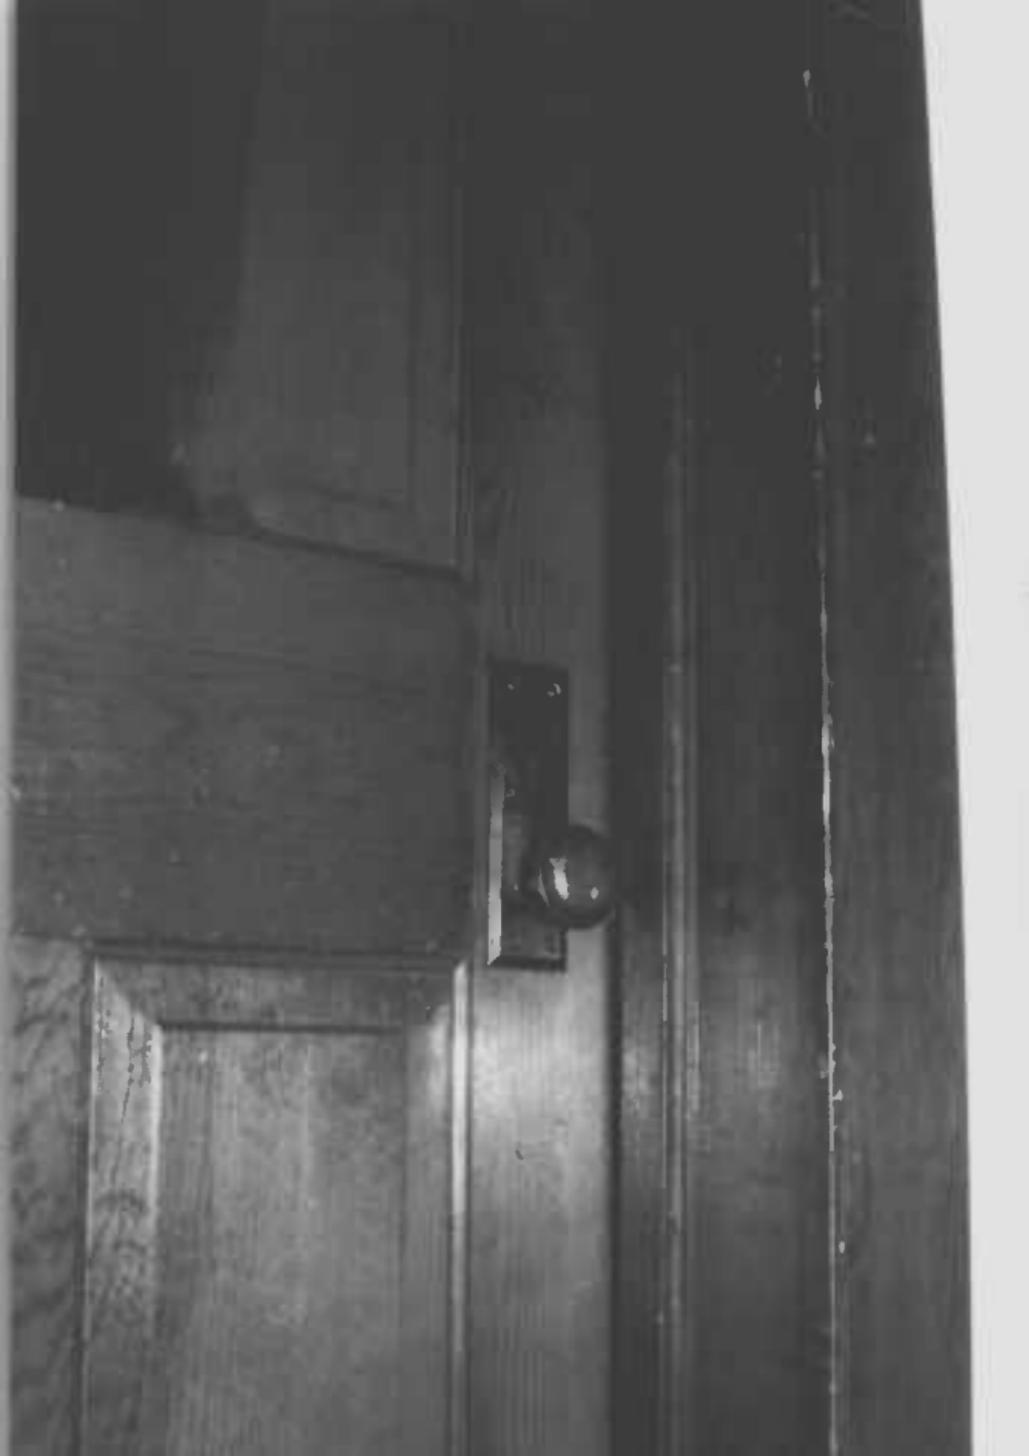
26/51

Hall - interior doors - hardware

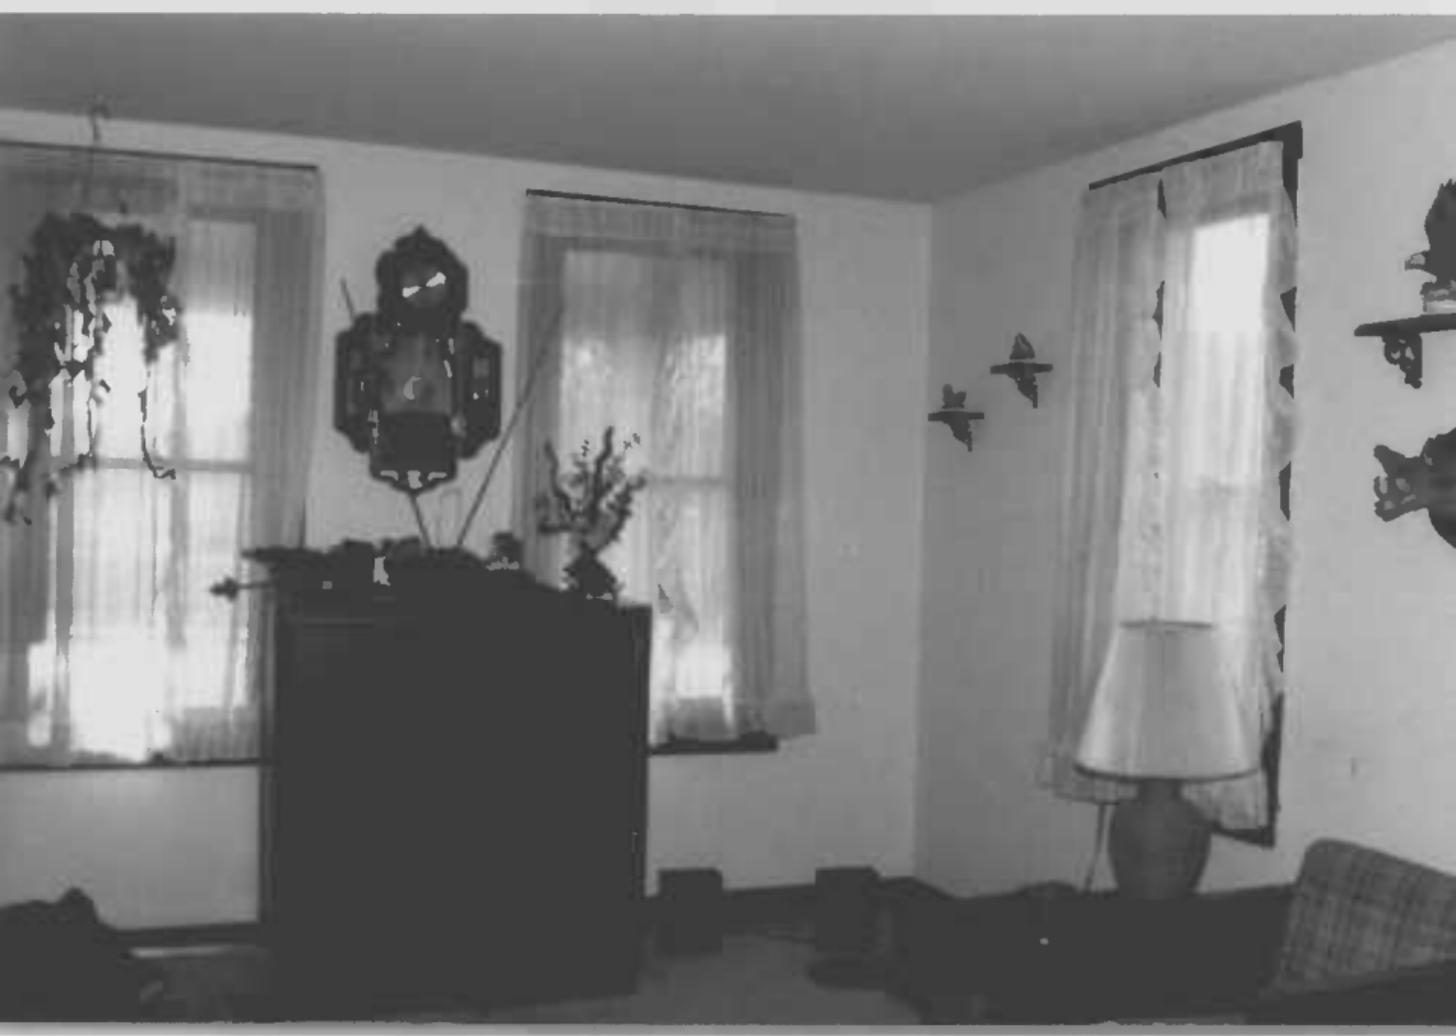
28/51

The living room is on the southwest side of the house and has two windows on the southeast wall and two windows on the southwest wall (Photo 28). On the northwest wall is an entrance to the kitchen. There is no stove flue in this room. The walls are plastered and the wood trim on the windows is a natural finish similar to that found on the hallway doorframes (Photo 29). The floor have a modern carpeting.

South side - view facing Southeast

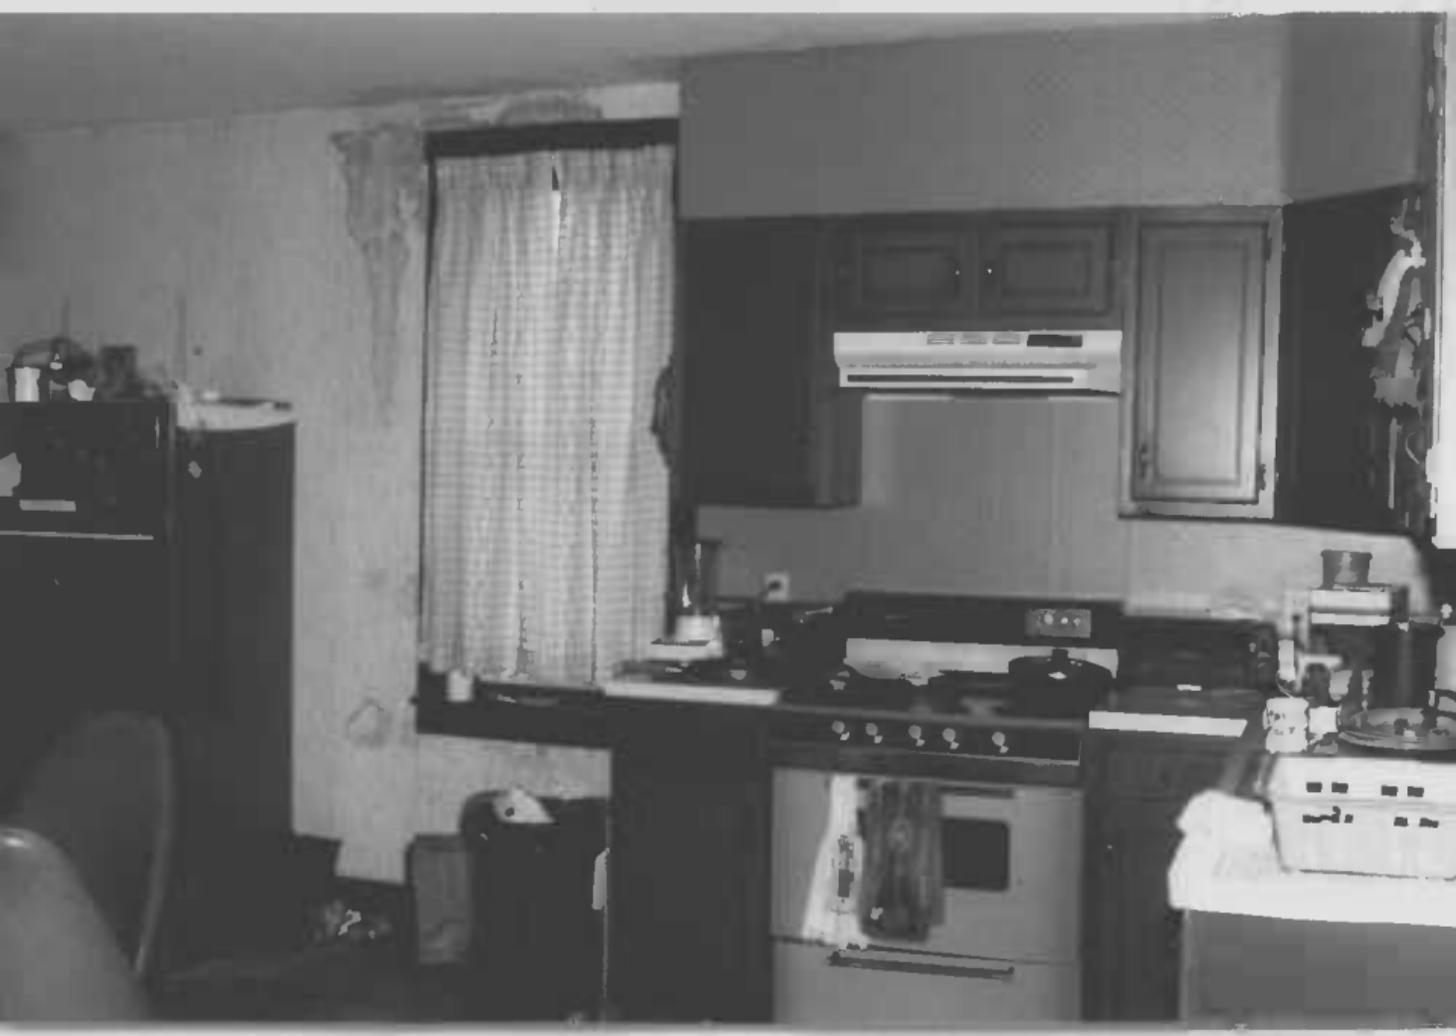
30/51

The kitchen has single windows on the southwest and northwest walls. In the north corner of the room is a modern kitchen arrangement of cabinets and equipment (Photo 30). The southeast wall has a row of three doors leading to the hallway, basement, and living room (Photo 31). The northeast wall contains a door leading to the enclosed porch on the inner

West room - kitchen - view facing W
