CONTRIBUTING RESOURCE
MARYLAND HISTORICAL TRUST
INTERNAL NR-ELIGIBILITY REVIEW FORM

Property Name: 3068 Westminster Street, Manchester, Maryland, Carroll County Survey Number: --- CARR-1295

historic William Ross Shower House

#7. Description

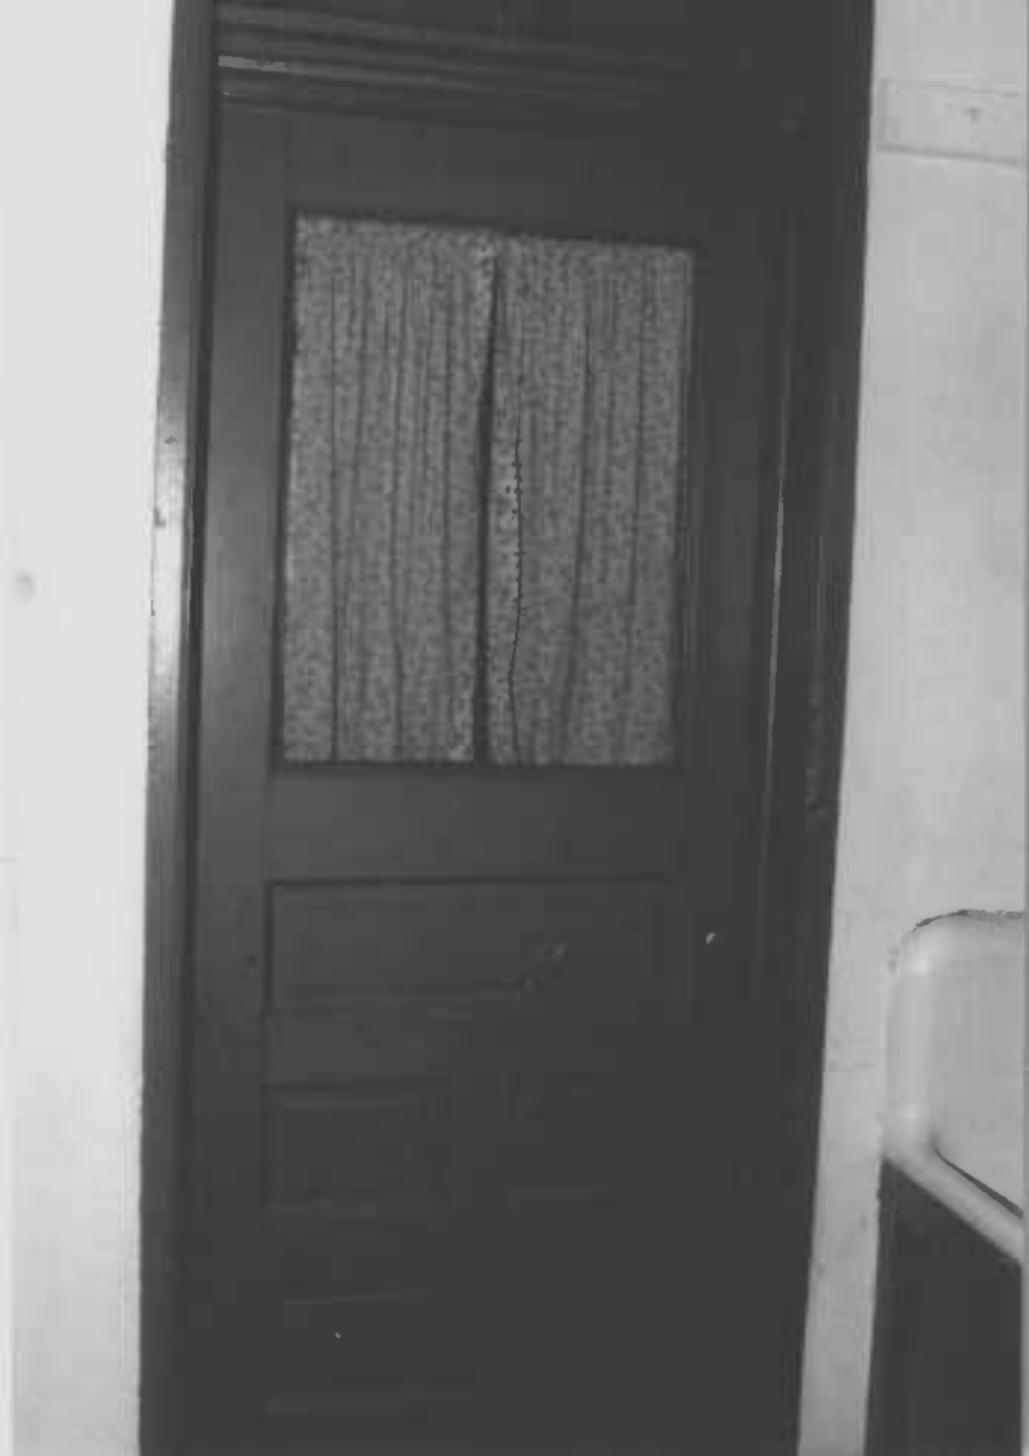
32/51

The enclosed porch contains a laundry room. The entrance has a two-pane transom and single door with a single pane upper section and four-paneled lowered section (Photo 32). It has a mid-20th century sink and wooden cupboard (Photo 33). The walls are covered in a modern wallboard and painted.

North room - rear door

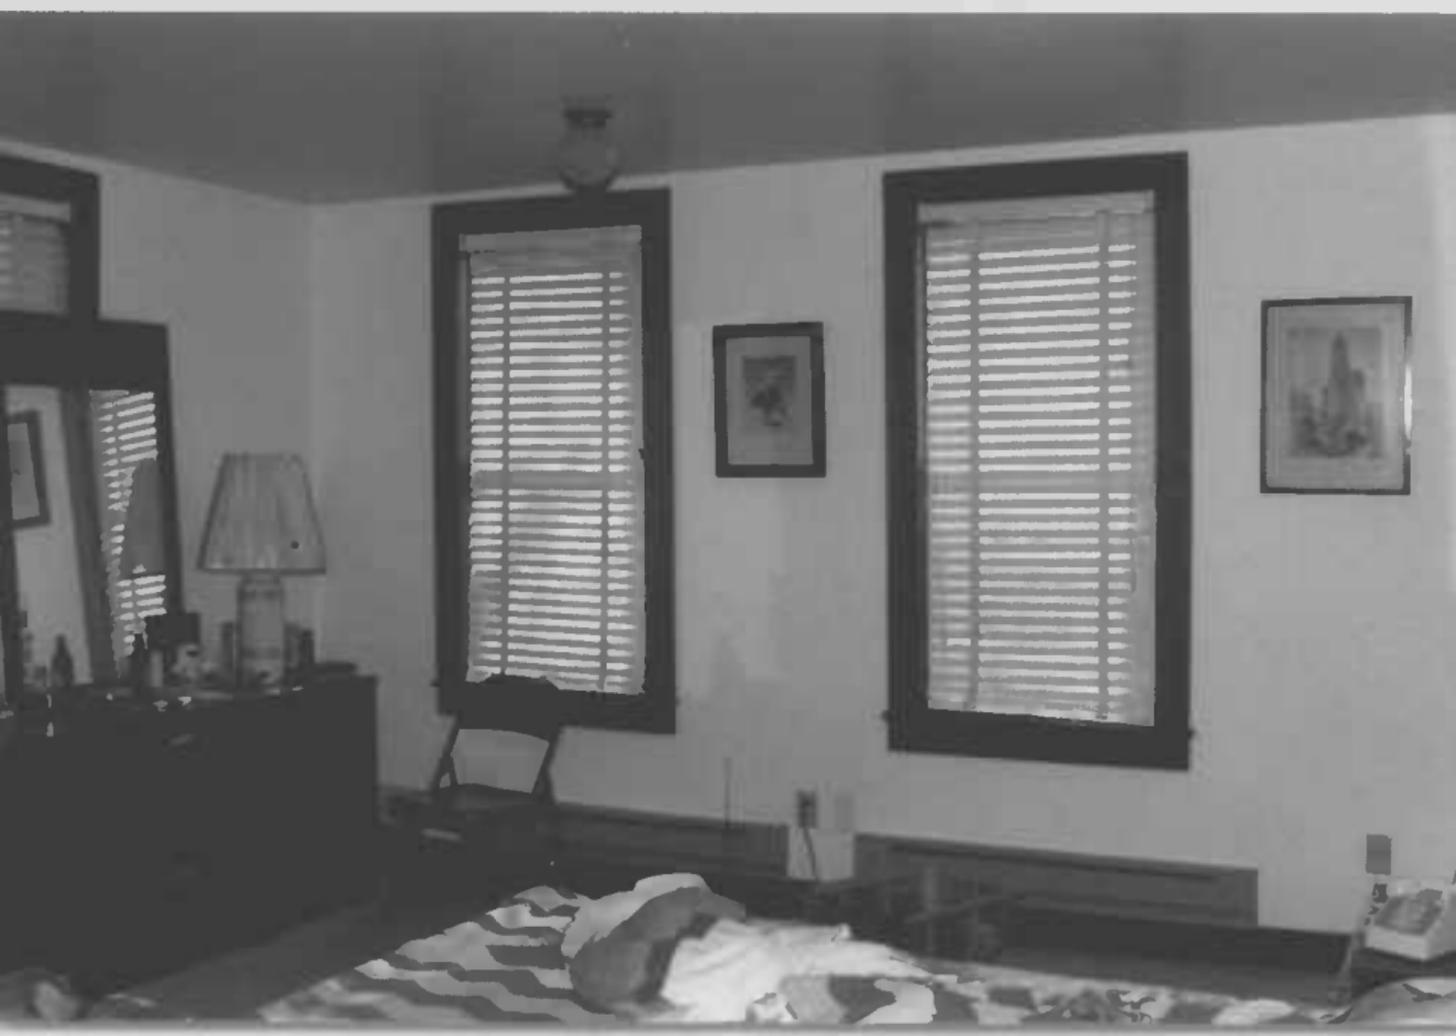
37/51

The northeastern bedroom has been remodeled with wall board on the walls and the woodwork painted (Photo 37). Two closets were built that project out into the room and flank the window on the northwest wall (Photo 38). It has two windows on the southeast wall, two windows on the northeast wall and a single window and door to the hallway on the northwest wall with the closets. On the southwest wall is an alcove formed by the entrance to the attic stairway which is enclosed (Photo 39). The floors are covered in a wall-to-wall carpet.

East bedroom - facing e

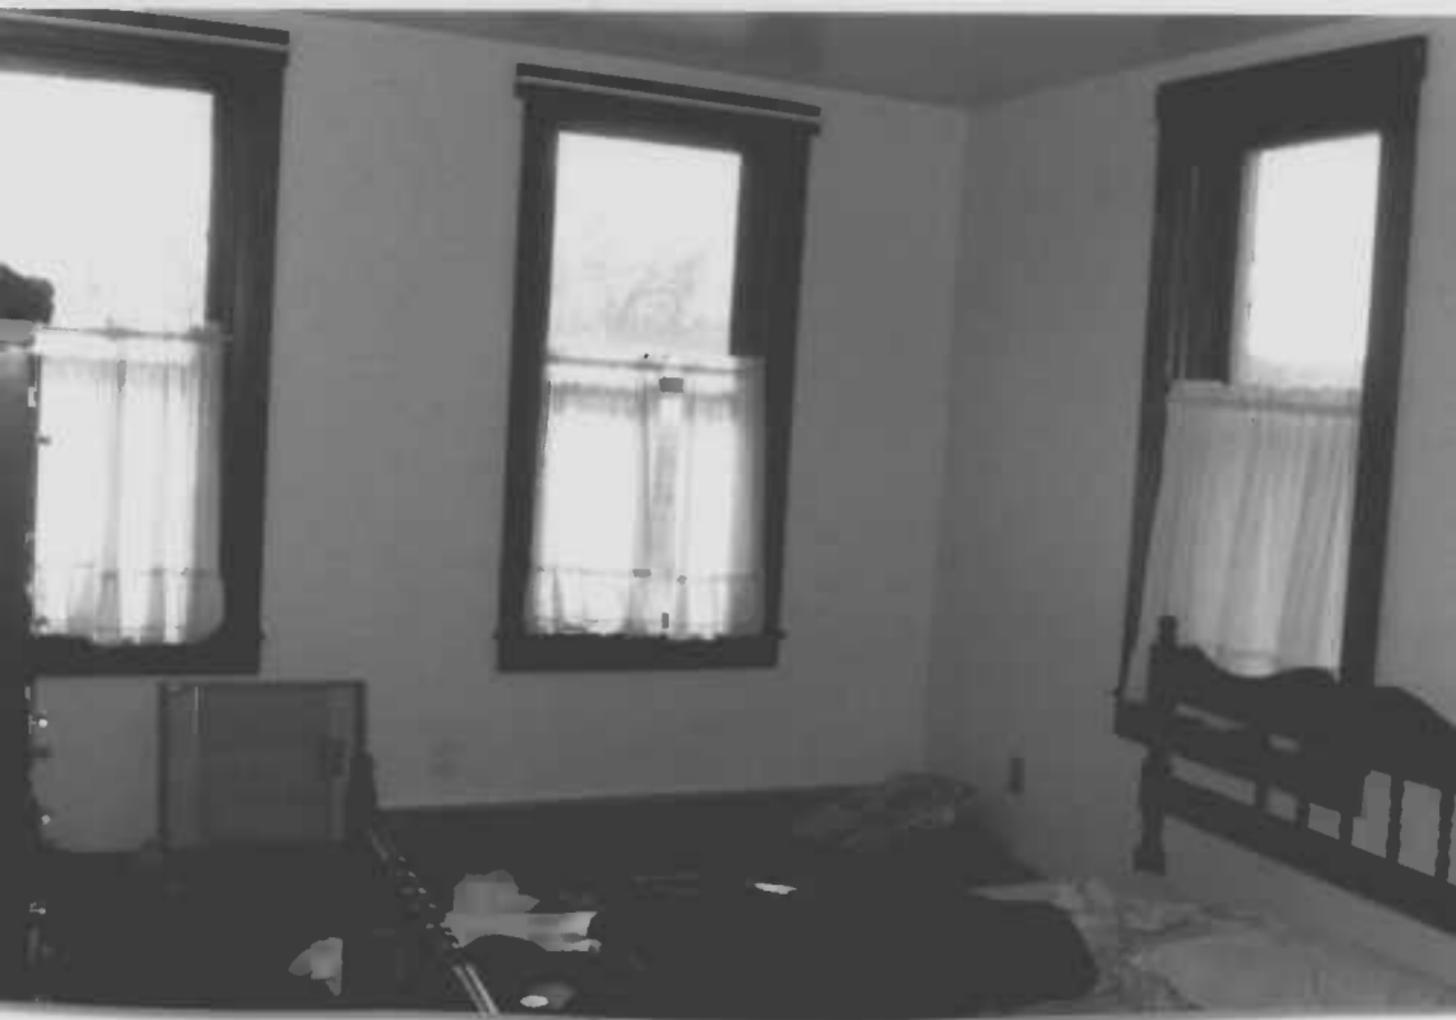
40/51

The southwest bedroom has two windows on the southeast wall and two windows on the southwest wall (Photo 40). On the northwest wall is the entrance to the hallway. The

South Bedroom - facing SE

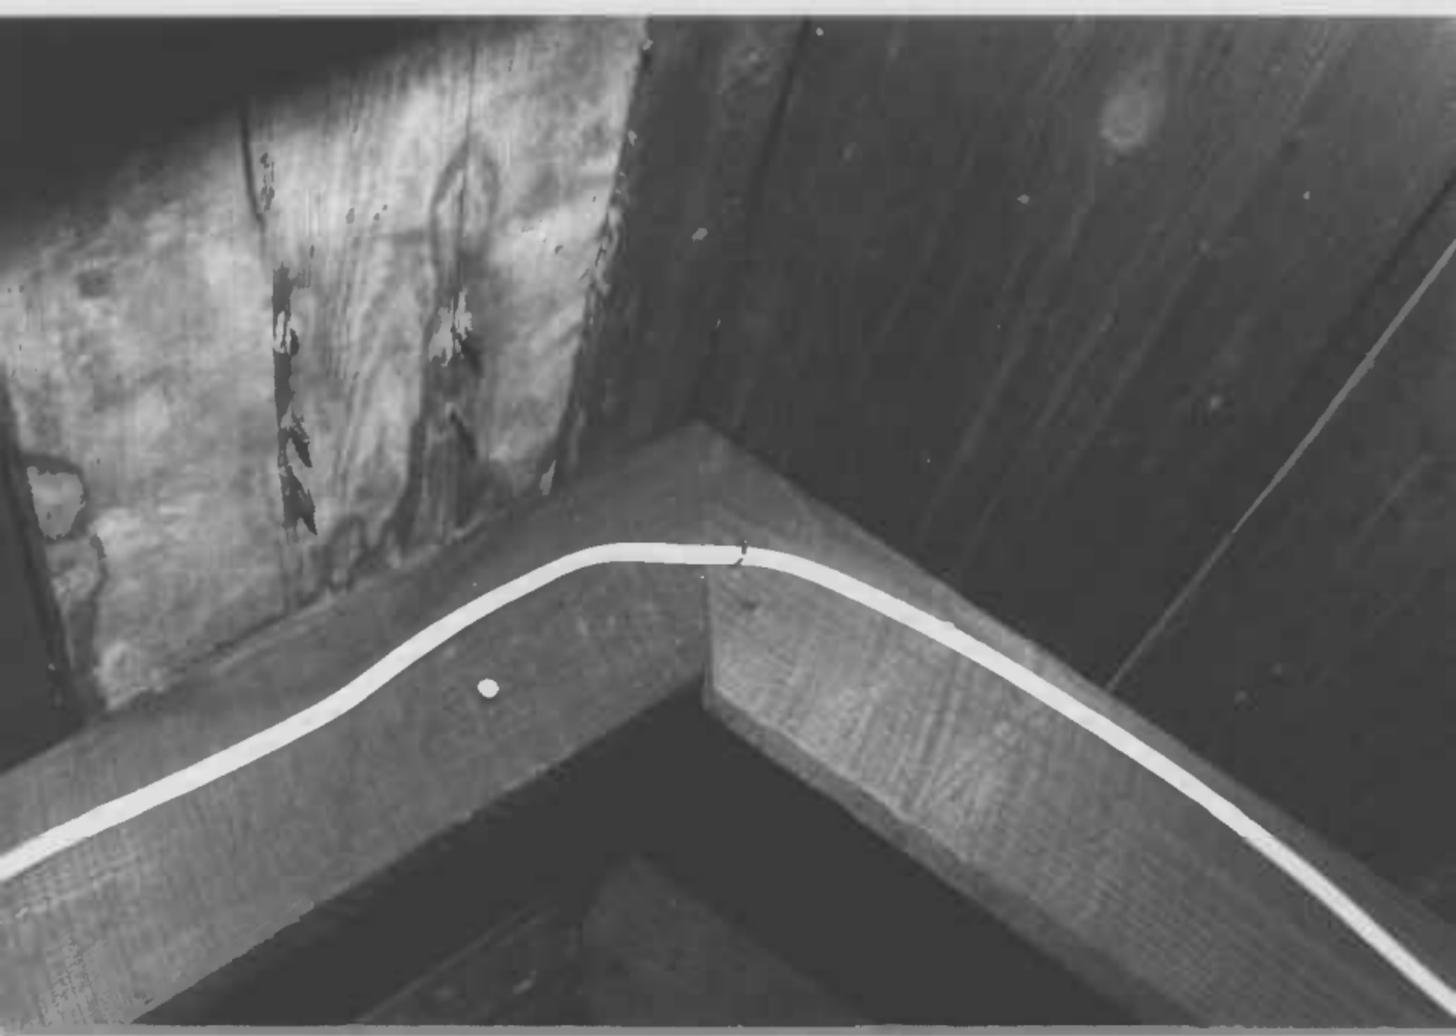
44/51

Attic - rafters

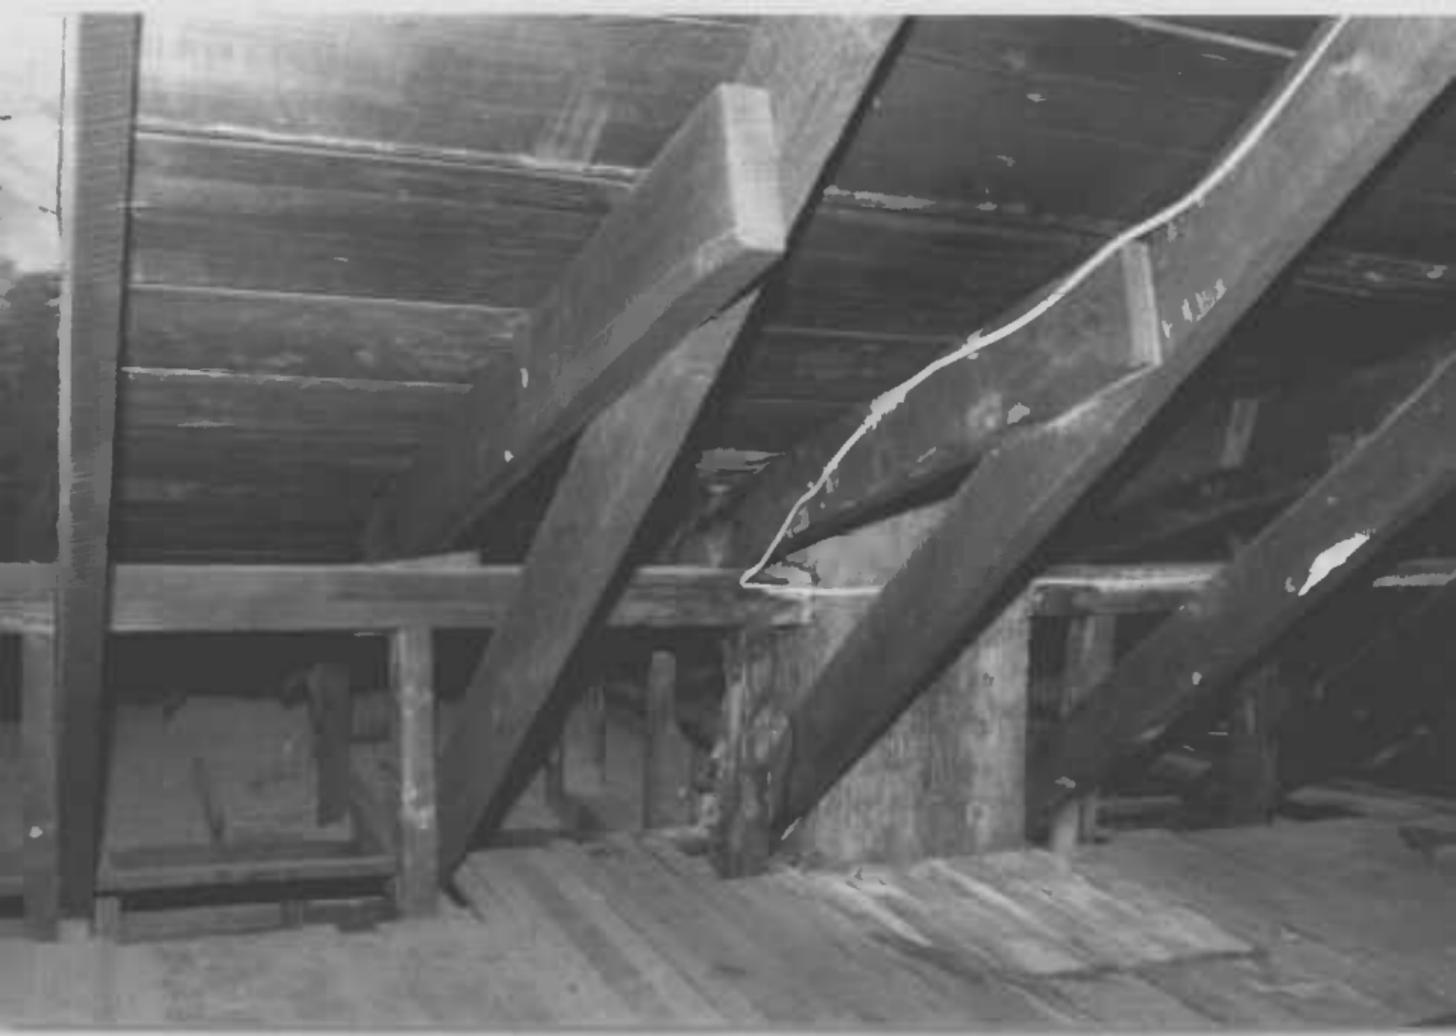
45/51

Attic - rafters at rear extension of roof

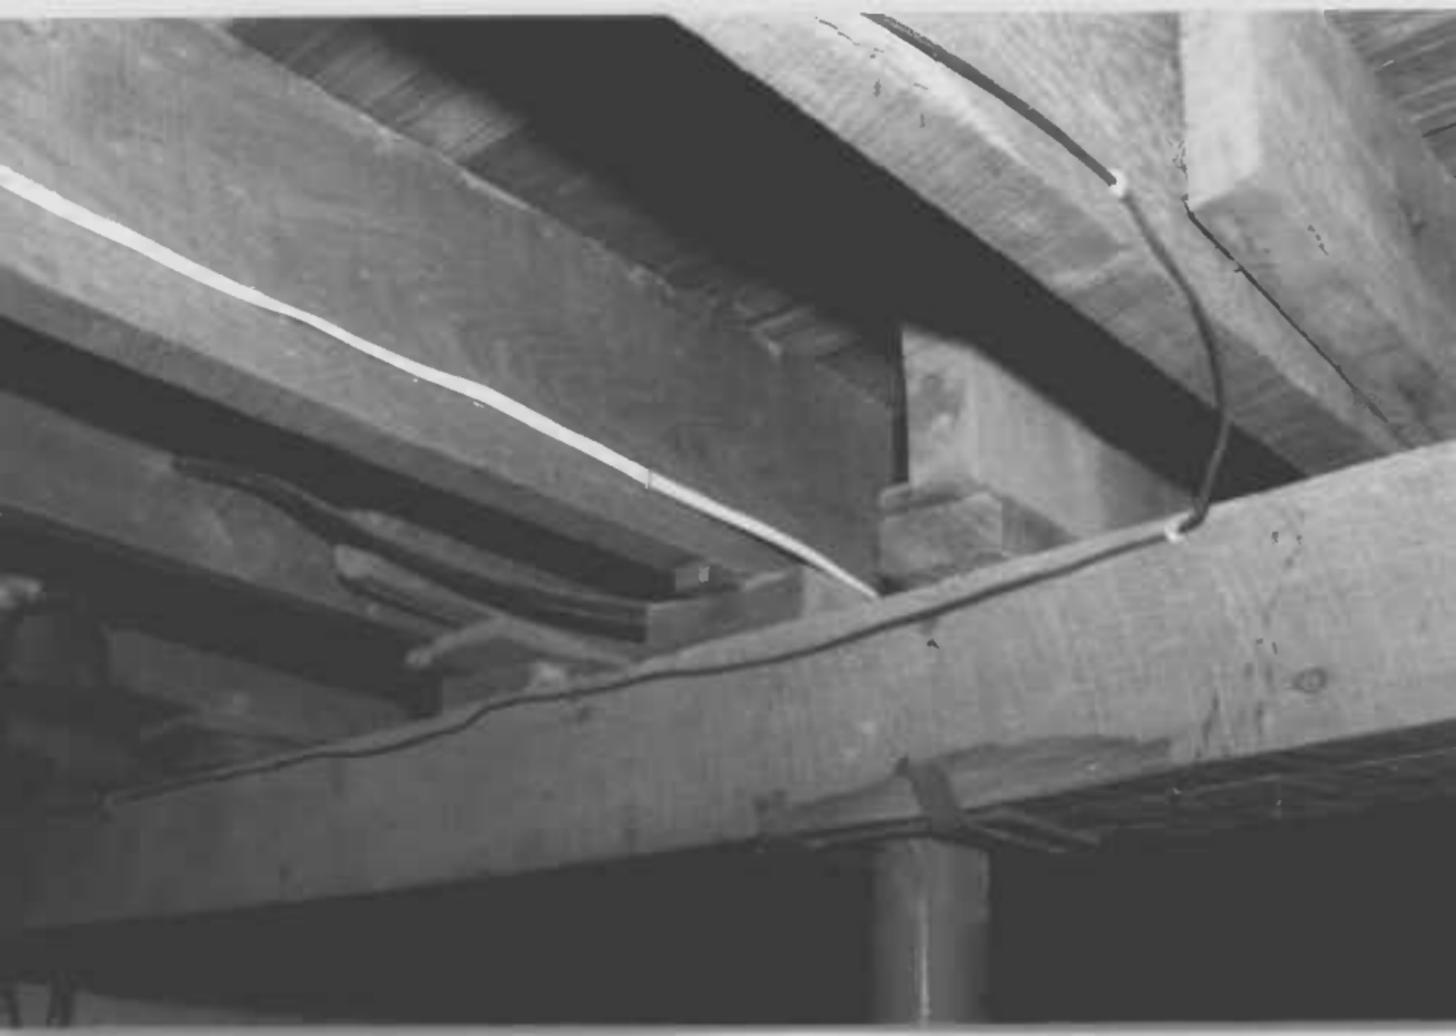
50/51

Basement - floor joint detail
