CARR-1313

Jesse B. Hare Farm
4415 Millers Station Road
Millers (vicinity)

Maryland Historical Trust State Historic Sites Inventory Form

MARYLAND INVENTORY OF
HISTORIC PROPERTIES

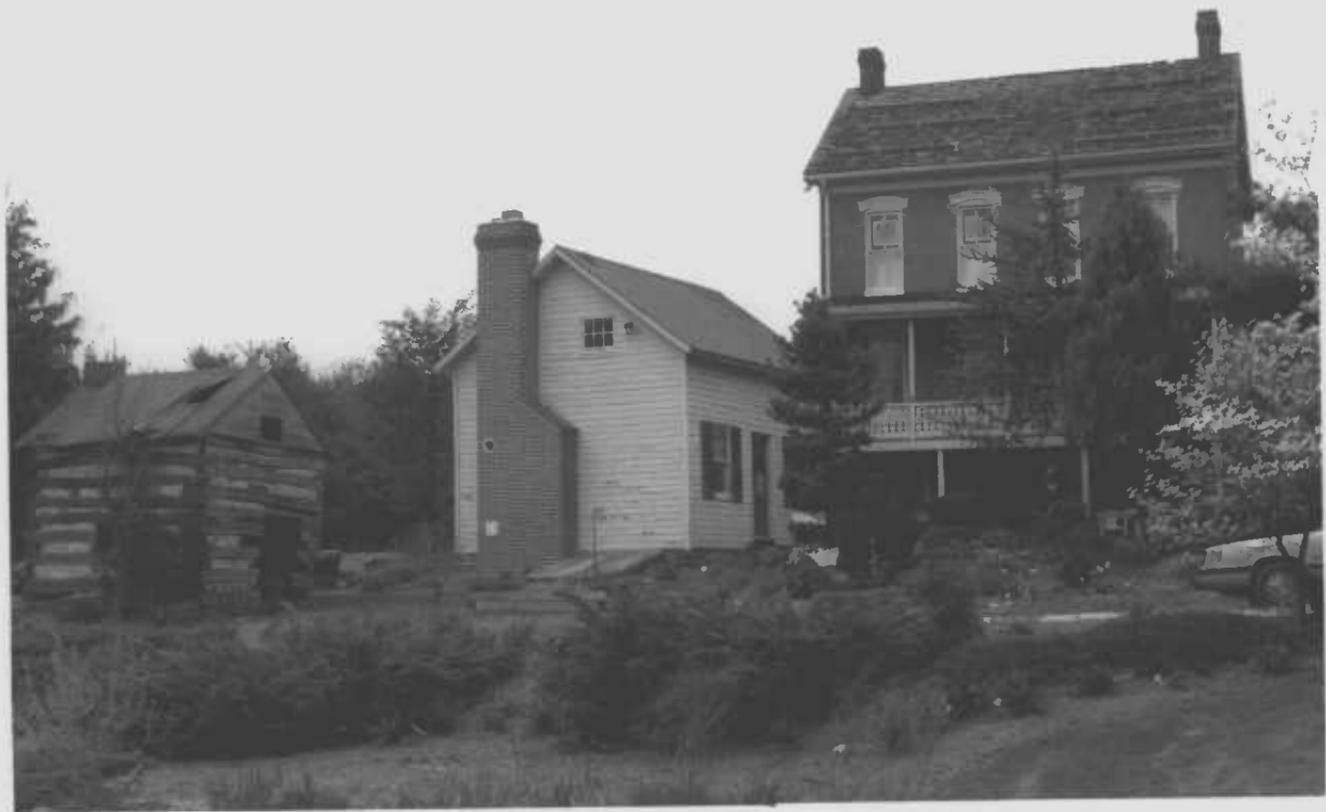
17

log: frame summer kitchens, House. vw. from
SE

Just south of the house is a one-and-one-half story frame summer kitchen with German siding. It has a rubble stone foundation topped by a layer of concrete and brick. This new introduction was either to jack up the building or to replace rotted sills. The attic is raised by half walls that create a half-story there. The northeast is three bays, with a central six-panel metal door flanked by 6/6 sash with applied muntins. The southeast elevation has a new brick chimney to the south, a cellar bulkhead to the east, and a six-light sash in the gable end, east of center. The southwest elevation is only two bays, with a pair of new 6/6 sash in the west bay and a six-light over three lying-panel wood door in the south bay. There is an identical door in the center of the northwest gable end, with a six-light sash in the gable. The gable roof has corrugated metal.

South of the frame summer kitchen is a log summer kitchen with V-notch cornering on a stone foundation that appears to have been dry-laid. The structure has diagonally-laid stone chinking set in mortar. The gable roof has corrugated metal. The northeast gable end has an opening north of center that retains only the top door jamb. The gable has horizontal board siding and an unfilled opening. The southeast and northwest elevations each have one opening that retains the jambs. There is a large brick kitchen fireplace on the southwest interior end, with a wood mantle tree and two trammel cranes. There are remains of some plaster inside the fireplace. The brick chimney is centered on the gable of the southwest end, outside. The structure has the remains of a board floor on joists that may be sleepers, although deterioration and possible sediment fill under the floor make it difficult to be sure without some excavation. There are joists, but no attic flooring, set between the side logs, three rows below the top plate. The three-quarter, round log rafters are mitered at the ridge and support wood laths. The foundation on the northwest elevation has begun to collapse and cause the lower wall on this side to collapse inward. The roof has several holes contributing to the deterioration of the building, which needs attention soon if it is to be preserved.

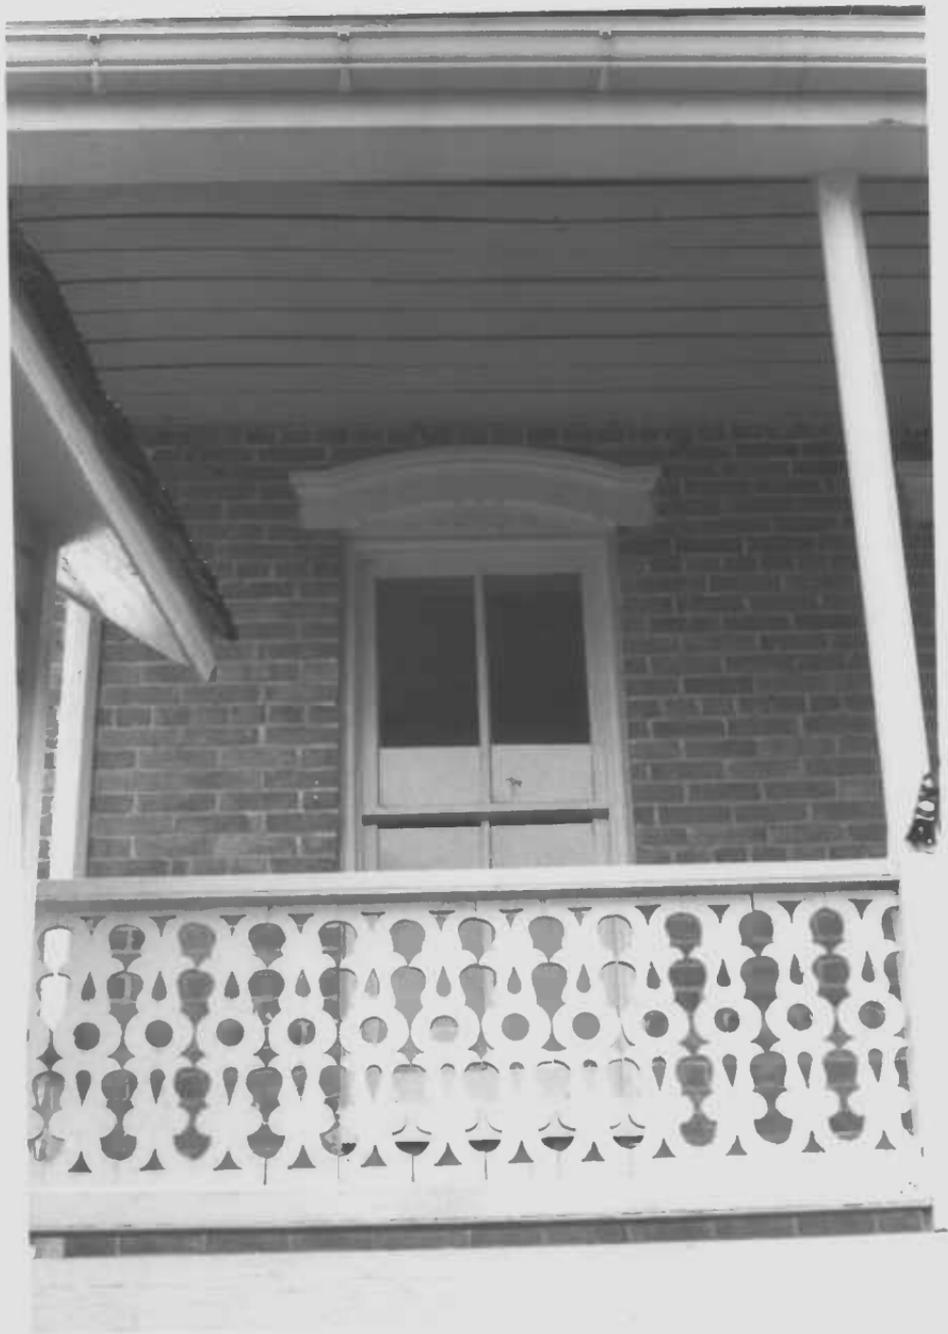
3/7

House - SE elev. - 1st Story bay

The house is a two-story, four-bay by two-bay, banked, "Pennsylvania Farmhouse" plan brick structure. It has a rubble stone foundation and a wood-shingled gable roof that has been renewed on the southeast side. The house is banked on the northwest and faces southeast. It has 2/2 double-hung sash in bullnose casings, with wood sills and cast-iron, segmentally-arched window lintels. These lintels have an ogee moulding at the top and are chamfered on the intrados edge. On the tympanum beneath the lintels are applied, jigsaw scroll trim. The house once had shutters. The southeast elevation is built of 6-1 common bond brick. The exposed cellar of the southeast elevation is brick and has only three bays, with a four-panel wood door in the center flanked by a 6/6 sash with flat wood lintels and sills, and flat casings. The first story has two center doors that have been boarded over. There is a raised, one-story porch with shed roof. It is supported at the cellar level by four chamfered wood posts. At the first story, the porch has five chamfered posts with flat, jigsaw balusters. There is a boxed cornice with plain fascia board, and an internal brick chimney with corbelled chimney cap at each end. There is evidence on the southeast that the house was once striped.

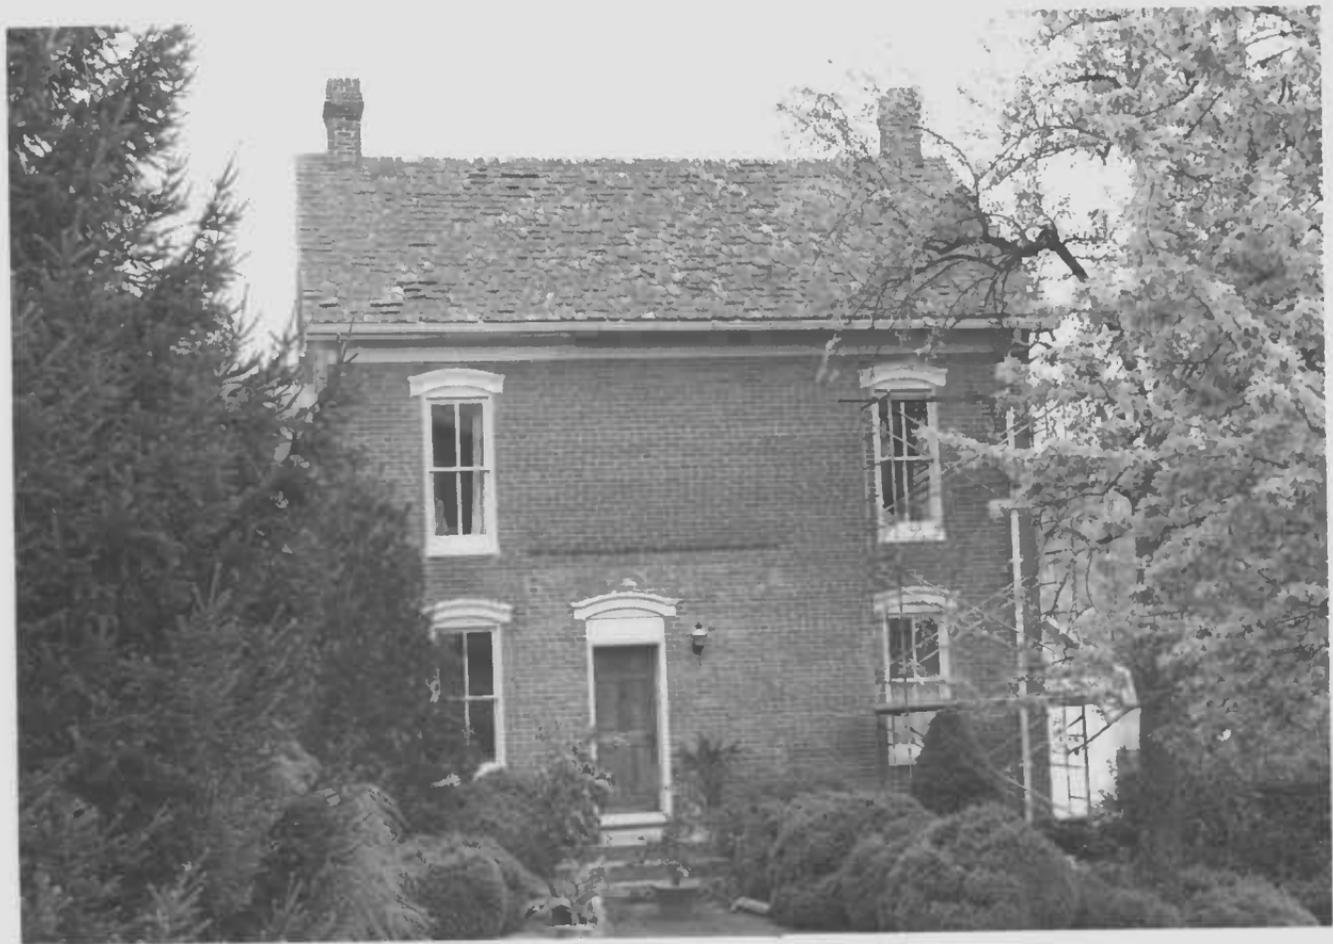
3/7

House - NW elev.

The southwest elevation has 5-, 6-, and 7-1 common bond brick, and has two 2/2 sash in the gable end with segmental lintels, but with no jigsaw trim. The northeast elevation has matching windows in the gable end, and a single 6/6 sash in the east bay of the cellar. It is built of 6-, 7-, 8-, and 9-1 common bond brick. The northwest elevation has a window in the end bays of both stories. The two center bays of the second story and the west-center bay of the first story are blank. The north-center bay has a new six-panel wood door in a new frame. There is evidence of a one-story porch that once existed over the door.

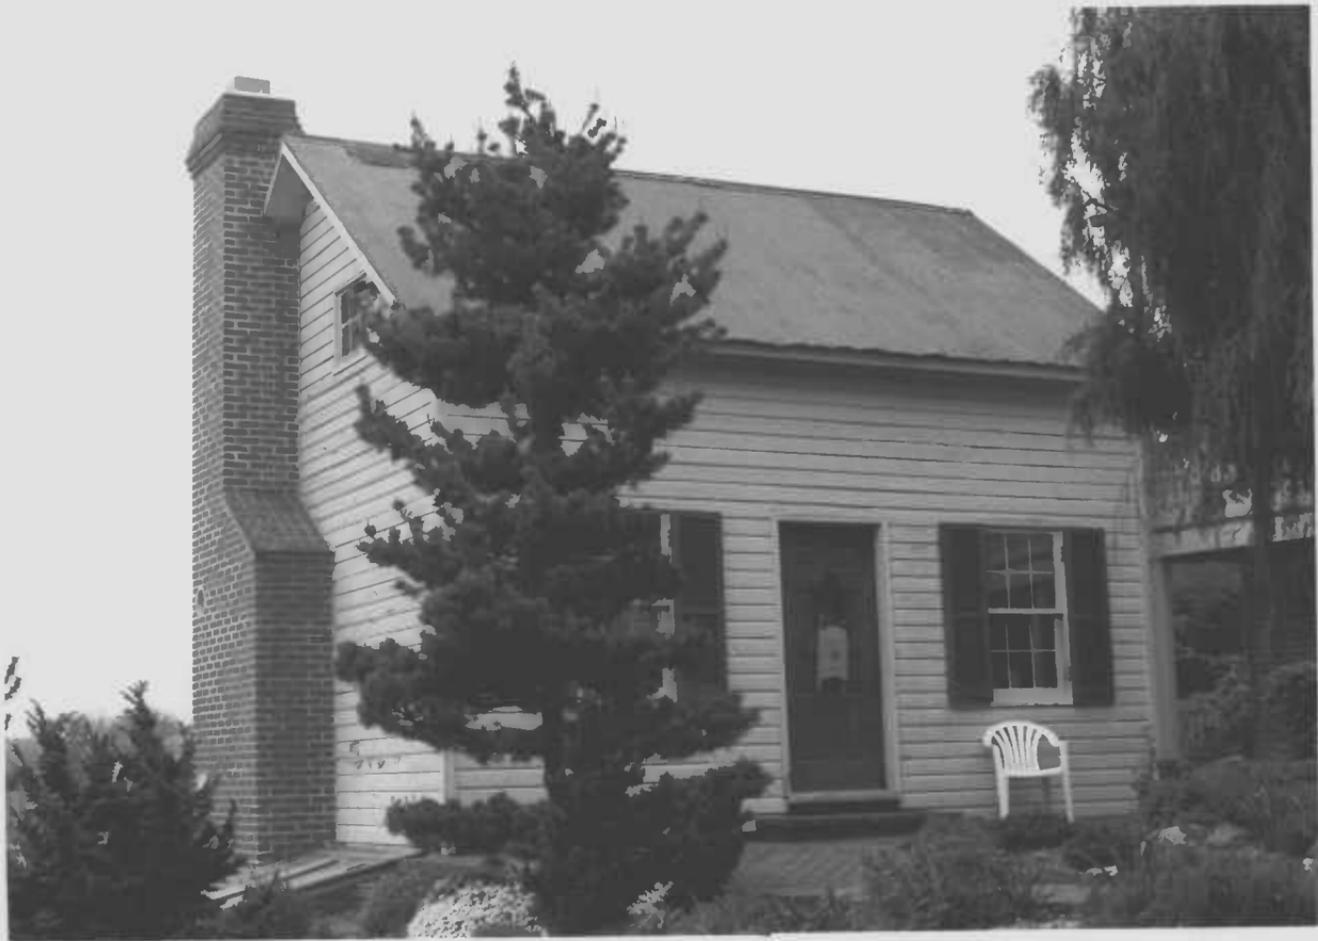
4/7

Frank Summer Kitchen - SE + NE elevs.

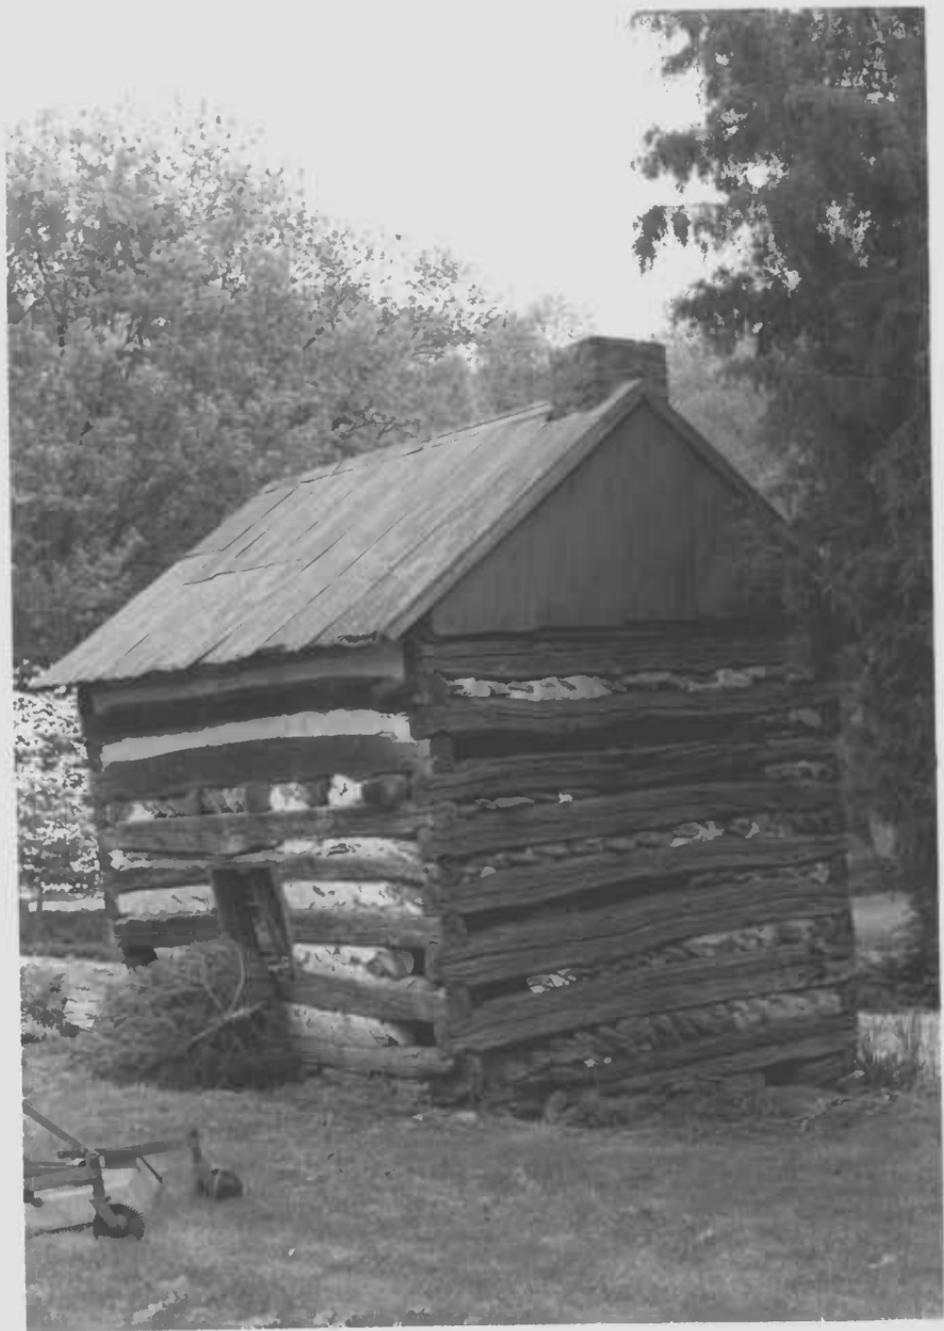
5/7

log summer kitchen - NW & SW elevs.

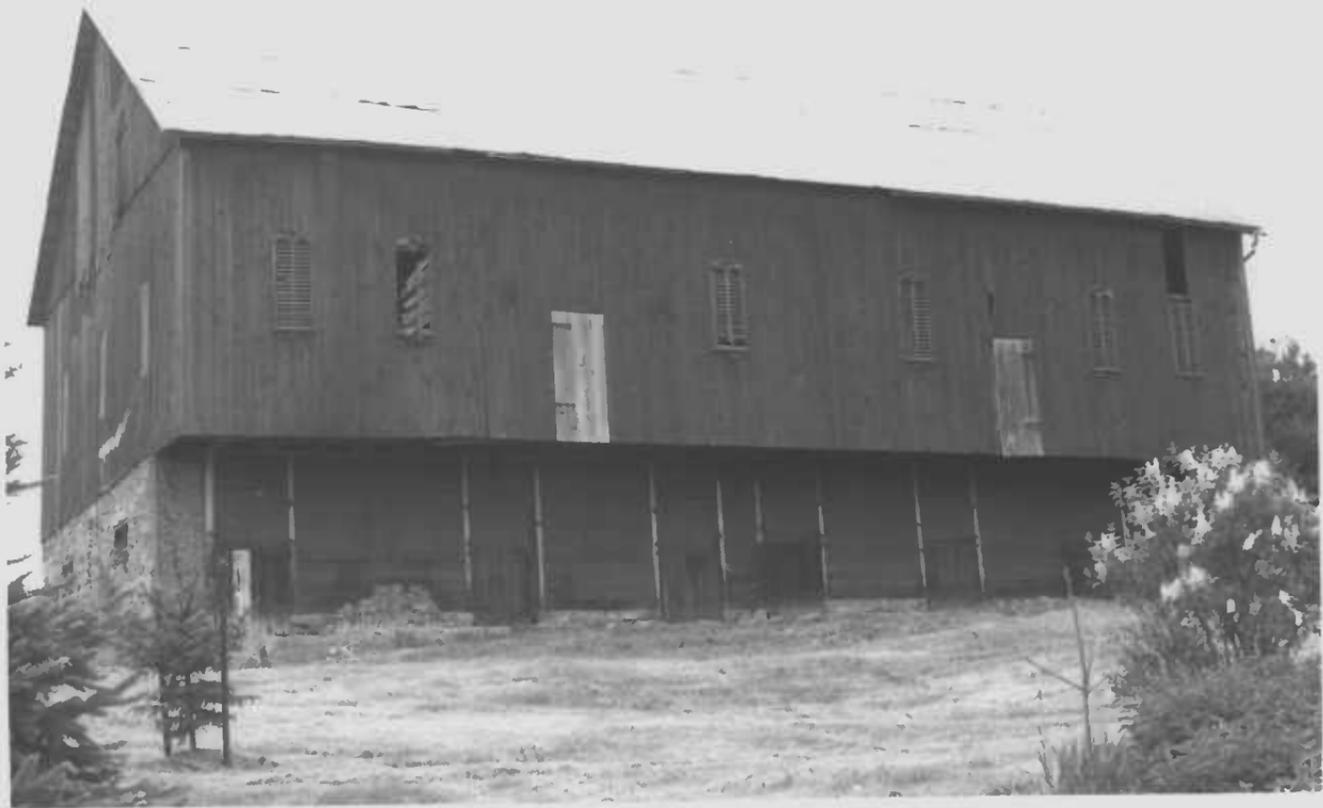
6/7

Barn-sw: SE elevs.

Northwest of the house, far up the ridge and set very close to the road, is the frame bank barn. The forebay faces southeast. The lower story is of rubble stone, with

brick ends on the southeast and brick between at ground level, with horizontal boards above. This southeast elevation has six vertical-board dutch doors on strap hinges. The upper story has vertical board siding. On the southeast elevation, there are two wood-louvered vents at either end, a vertical-board dutch door on strap hinges inside on each side, and two more vents in the center. The northeast and southwest elevations are identical, with two pairs of openings in the basement, a row of three boarded vents, a row of two boarded vents above, and a boarded vent in the gable end. One vent does survive on the southwest. The northwest elevation has a ramp. The upper story has a vent on the north bay, a pair of beaded-edge-and-center vertical board doors on strap hinges, two two-light sash in the center, matching doors with a smaller inset door in the north door, and several new boards where a vent probably originally existed in the west bay. The gable roof has corrugated metal.

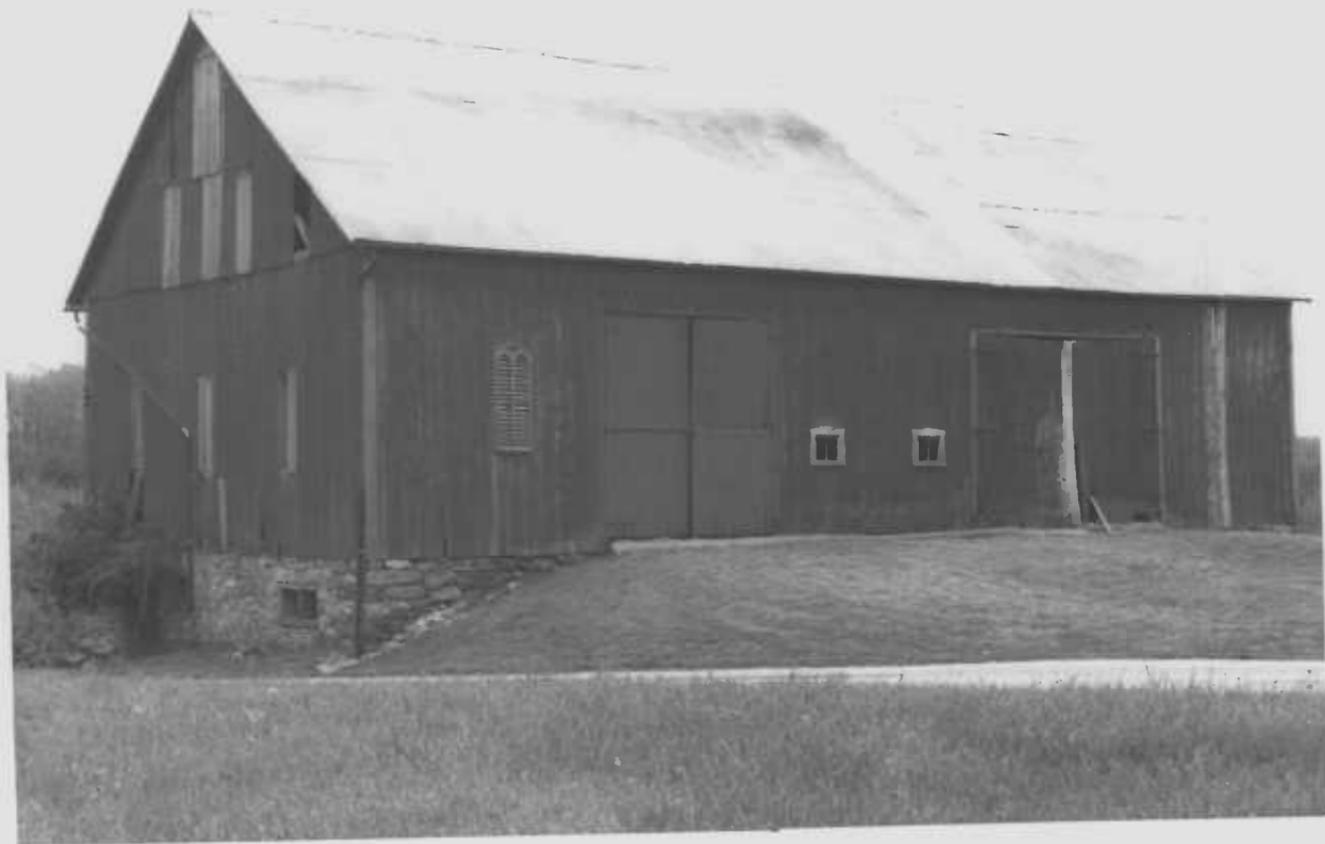
7/7

Barn - NE & NW elevs.

The lower story is remarkably intact. It has a pen on the southwest, with a trough and hay rack on the northeast side of the pen. Northeast of that is an aisle, then another trough with hay rack, a large center pen with two outside doors to it, another trough with hay rack, a second aisle, a fourth trough with hay rack, and a pen on the northeast. This pen is divided into four stalls on the southwest half. All of the pens are open from front to back. The joists are hewn top and bottom and are supported by two circular-sawn summer beams with half-lap scarfs. Each summer beam is supported by five circular-sawn posts. Four posts for each summer are set in line with the hay racks and troughs, and the fifth set of posts is in the middle of the large center pen. The southeast girt and one corner post are also circular-sawn. The remaining posts in the southeast wall are hewn and appear to be reused. The interior of the northeast wall has a long wood beam set into the stone above the windows and acts as both a lintel and for hanging tack on the pegs in it. The east corner has a wood box set into the stone wall. The upper story has two threshing floors, with a hay mow at each end and one in the center. The granary is in the center mow, on the northwest side. The barn has six queen-post-truss bents constructed of circular-sawn timbers that are mortised, tenoned and pegged. The rafters are primarily 3/4 round logs that appear to be mitered at the ridge. They support laths. In the southwest end of the ridge is the metal track for a hay fork.
