CARR-1328

Joseph Harnish Tenant Farm
Taneytown (vicinity)

Maryland Historical Trust State Historic Sites Inventory Form

historic Joseph Harnish Tenant Farm

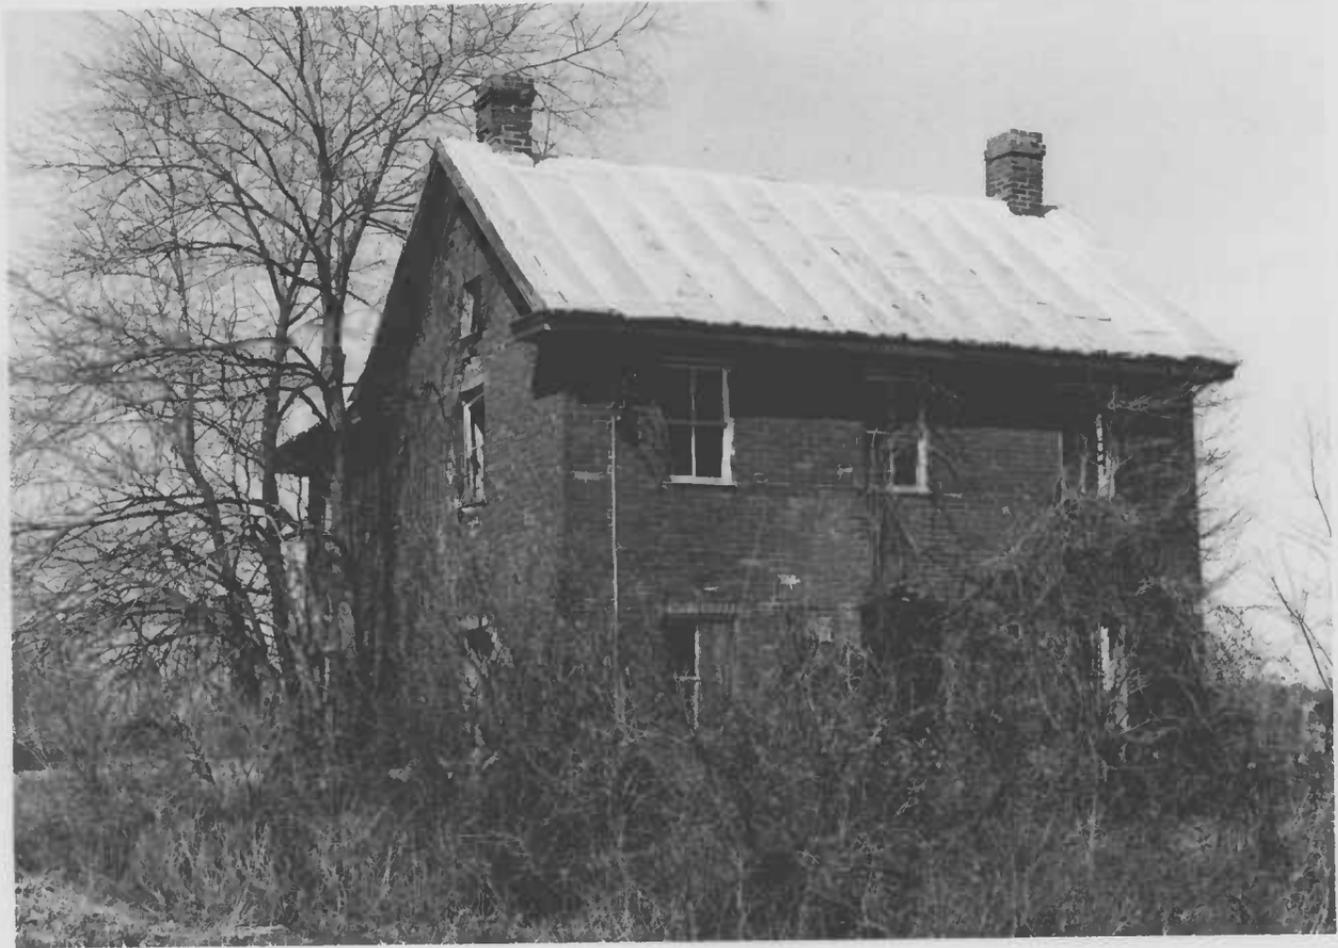
The house is a two-story, three-bay, stretcher bond, brick-cased frame, "T" plan building with a rubble stone foundation and a standing-seam metal gable roof. The box cornice has returns. The south elevation has a central entrance, but the door is missing. There is a charred, long, panelled shutter or door lying on the ground in front of the building. On either side of the entrance is a single 2/2 sash. The second story has three 2/2 sash. All the windows on this elevation have narrow wood board sills and the first story windows have rebuilt splayed brick jack arches and formerly had exterior shutters or blinds. The foundation had a vent with diamond-section wood louvers in the east and west bays. Only the east one survives. There was formerly a one-story porch across the front. The house also has an interior brick chimney with corbelled cap at each end.

Neg. Loc.: Maryland Historical Trust
west: south elevations

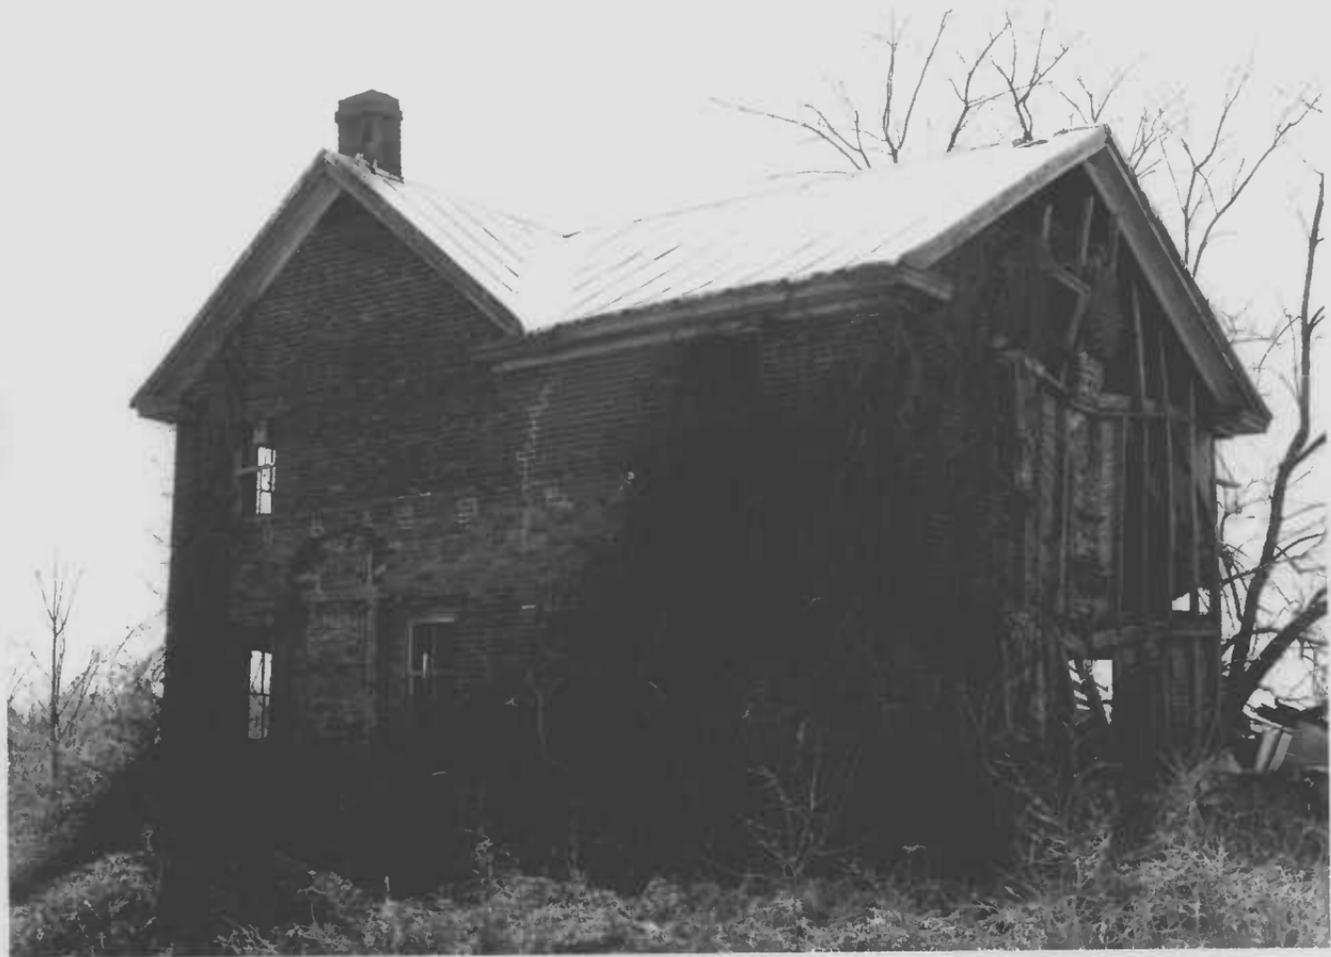
The west elevation of the main block has a single 2/2 sash centered on each story, with a small opening in the gable end. The chimney is set north of the windows, and is corbelled southward in the attic, being centered on the east-west ridge where it passes through the roof. The west elevation of the back building has one 4/4 sash on each story. The back building is the same width as the main block of the house, has a north-south ridge, and was cased in brick at the same time as the front section. The north elevation has one 2/2 sash in the east bay on each story. The windows have large wood

Neg. Loc.: Maryland Historical Trust
east: north elevations

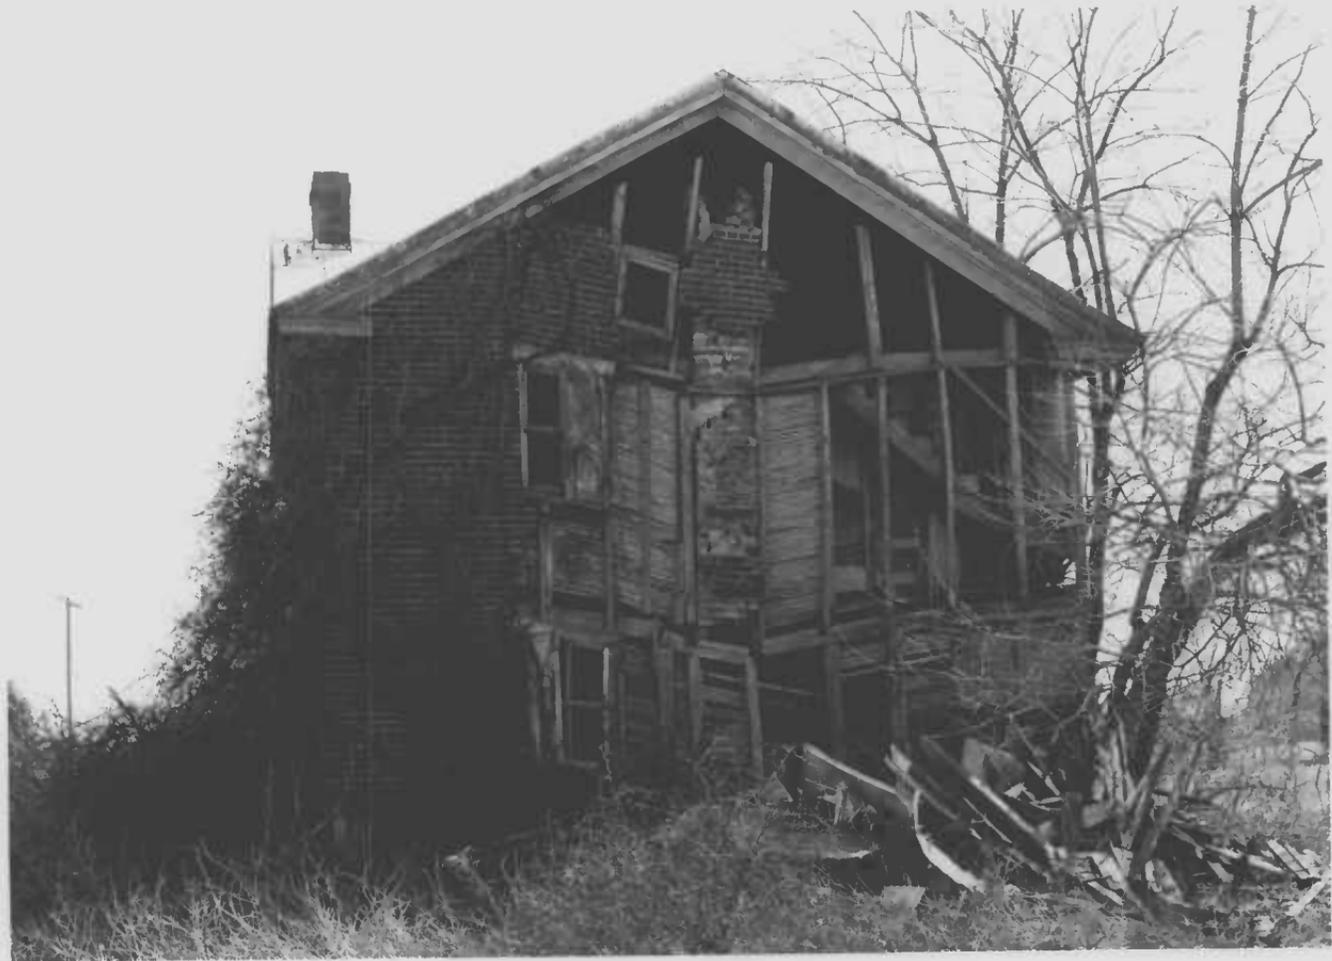
lintels and portions of paired, two panel shutters on both stories. There was formerly an interior brick chimney centered on the ridge, but it, and much of the brick veneer, have collapsed. There is a window opening just east of the chimney in the gable end. It formerly had a large wood lintel. The first story of the east elevation of the main block has a door opening in the south bay. Beneath it is a diamond-section wood louver vent. There is a 2/2 sash in the north bay of the main block, with a cellar entrance below this window. The south bay of the back building also has a door opening. The second story has a 6/2 sash in the south bay of the main block and a window covered by blinds in the north bay of the back building. There was apparently a one-story porch across the whole south elevation, but it was later removed and the holes for the rafter ends filled with brick. The lintels on the windows of this elevation are also wood.

Neg. Loc.: Maryland Historical Trust
north elevation
