CARR-1335

138 E. Main Street

MARYLAND INVENTORY OF HISTORIC PROPERTIES
Maryland Historical Trust
State Historic Sites Inventory Form

Survey No. Carr-1335

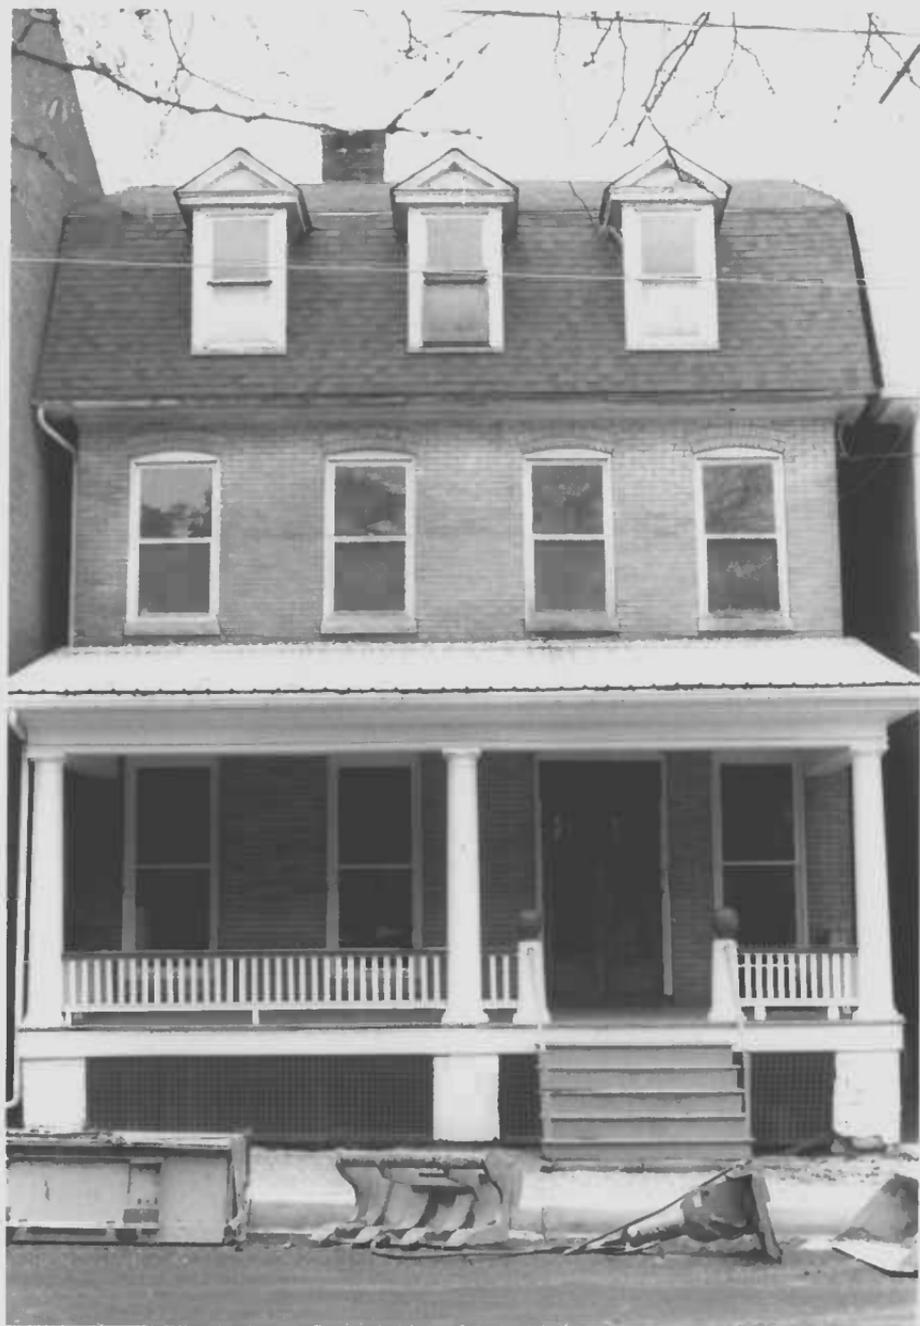
1/4

northeast elevation

The northeast elevation has two 1/1 sash to the east, another to the north, and a doorway in the north-central bay. The double doors each have one-light over one panel with a deep bolection moulding. There is a one-light transom and double wood storm doors each with four lights over a lying panel. The door has a brownstone sill and is segmentally-arched. There is a door bell on the jamb with a cast (bronze?) plate that has an acanthus leaf on the top and bottom. The windows have rock-faced granite sills, segmental arches, and flat frames with chamfered interior edges. The second story has four matching 1/1 sash. The roof has three pedimented, gable roof dormers with 1/1 sash and asphalt shingles. There is a wood box cornice with a Greek ovolo bed mould. The interior brick chimneys are located over the east-center and north-center bays.

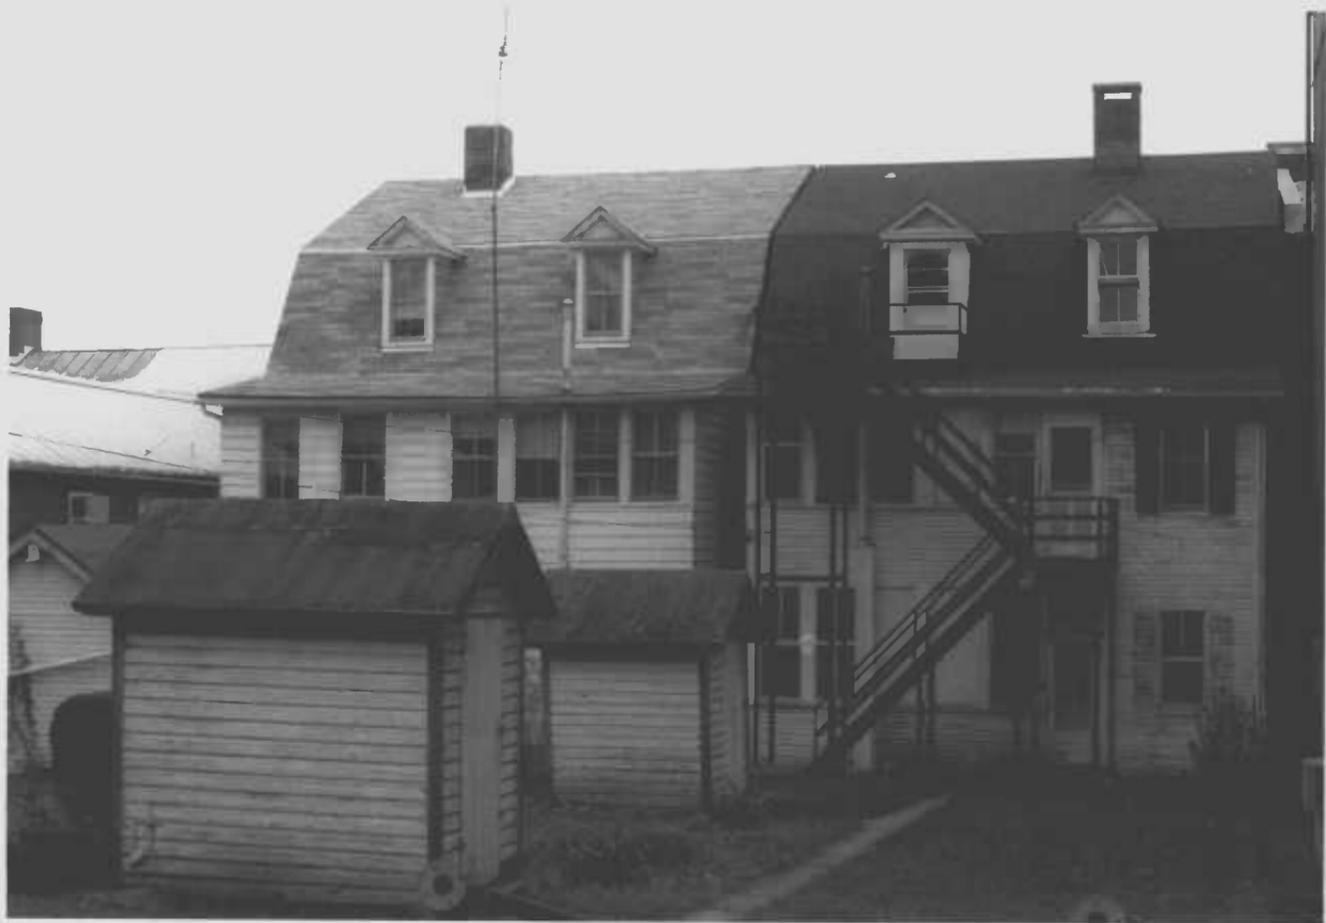
2/4

Southwest elevation, w/ outbuildings

The southwest elevation of the first story has, from west to south, two 2/2 sash, two boarded-up windows, a 2/2 sash, a four-light over two-panel door with a six-light sash above it, and a 2/2 sash. The second story has three 2/2 sash, a boarded opening, a 2/2 sash, a four-light over two-panel door, and a 2/2 sash with blinds. All of these openings have beaded-interior-edge frames. There is a steel fire escape attached to the rear. The attic story has two pedimented dormers, with a door with three lights over three lying panels to the west and a 2/2 sash to the south.

Behind the house are two small sheds with German siding, a gable roof running northwest-southeast, and a door on the southeast elevation.

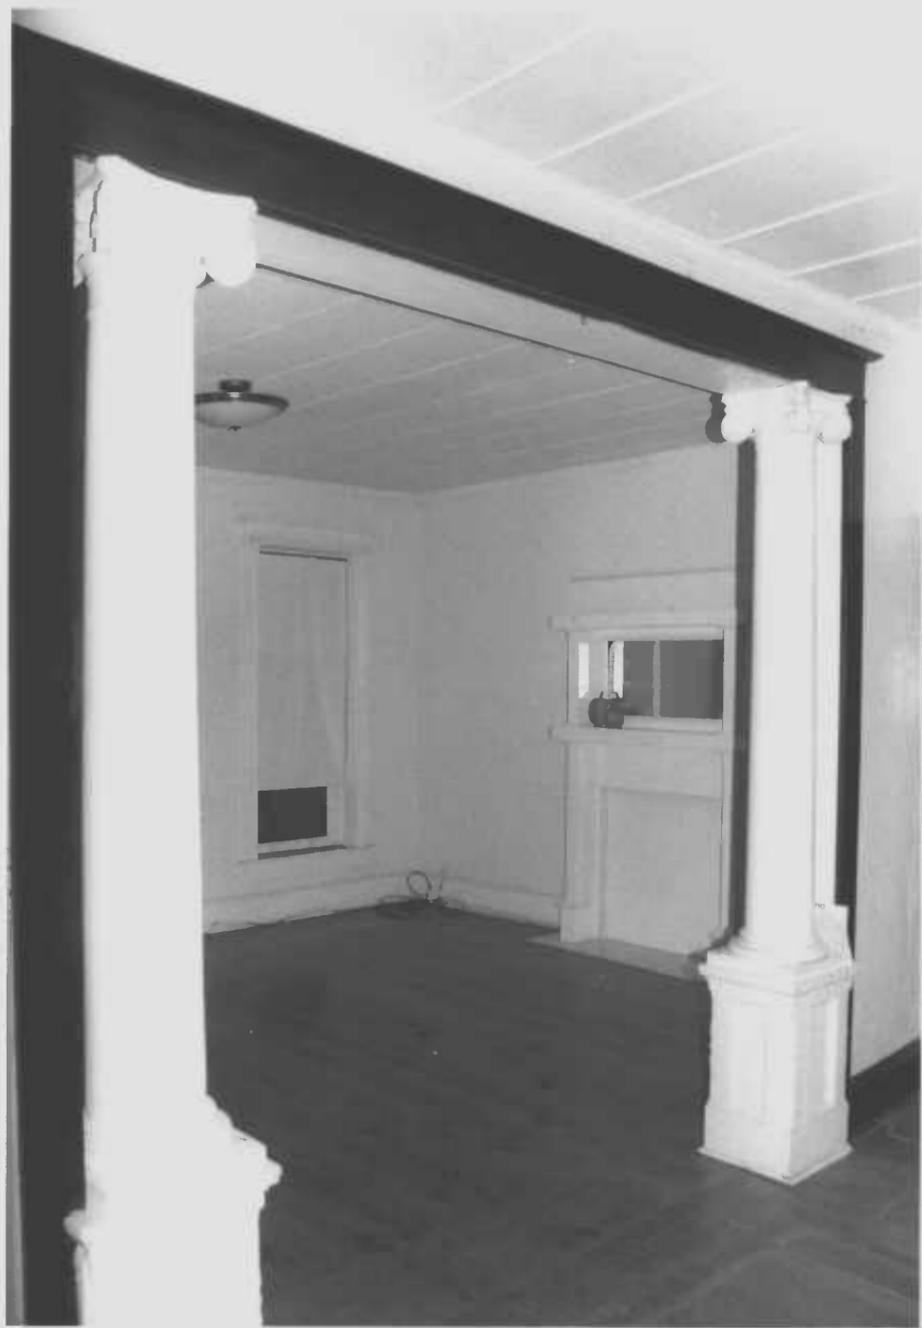
3/4

Neg. Loc.: Maryland Historical Trust
Foyer & northwest room, view south

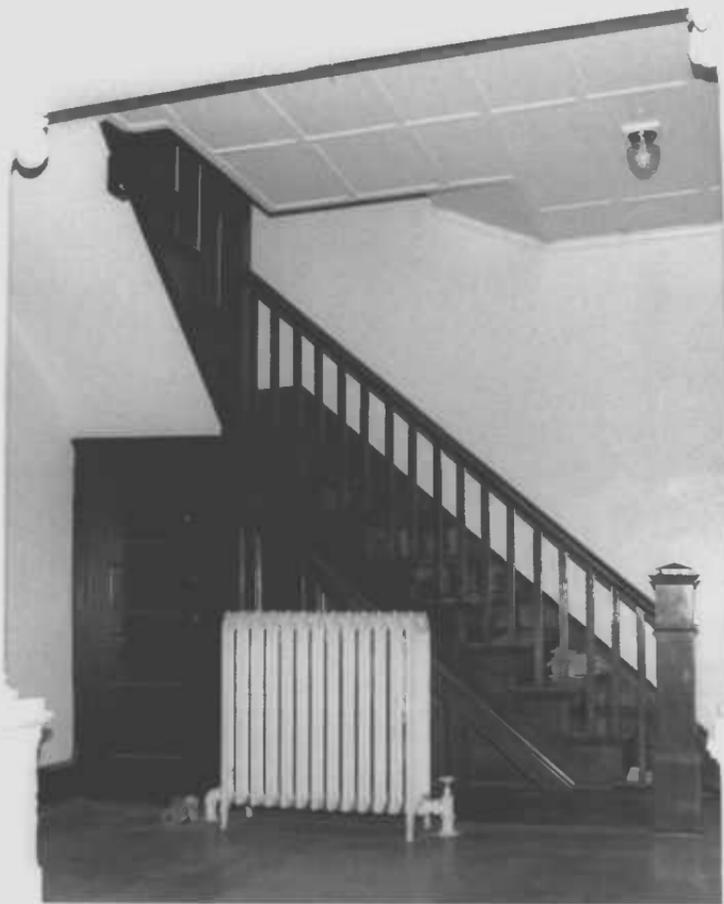
7/4

Neg. loc.: Maryland Historical Trust
stairway in foyer

opening. The radiators have a foliate design on the top and a cypher with the initials "NYR". The foyer has a two-run staircase on the northwest and southwest walls. It has a large square newel, square balusters, and a moulded handrail. There are four panels under the stairs with ogee panel moulds, and a closet door with four flat, sunk panels and moulds that have an ovolo inside of a cavetto. The southeast wall has a wide opening into the east room, with two Ionic columns on panelled pedestals that have turned cushion balusters at the corners. The panels are flat and sunk, with ogee moulds. The east room has a fireplace on the southwest wall that is now closed off. The hearth and jambs have narrow white tiles. The mantel is wood, with two free-standing square columns, and an overmantel with the same and a bevelled glass mirror. There is a drop ceiling in this room.
