CARR-1380

Samuel Weant Farm
Taneytown (vicinity)

Maryland Historical Trust State Historic Sites Inventory Form

MARYLAND INVENTORY OF
HISTORIC PROPERTIES

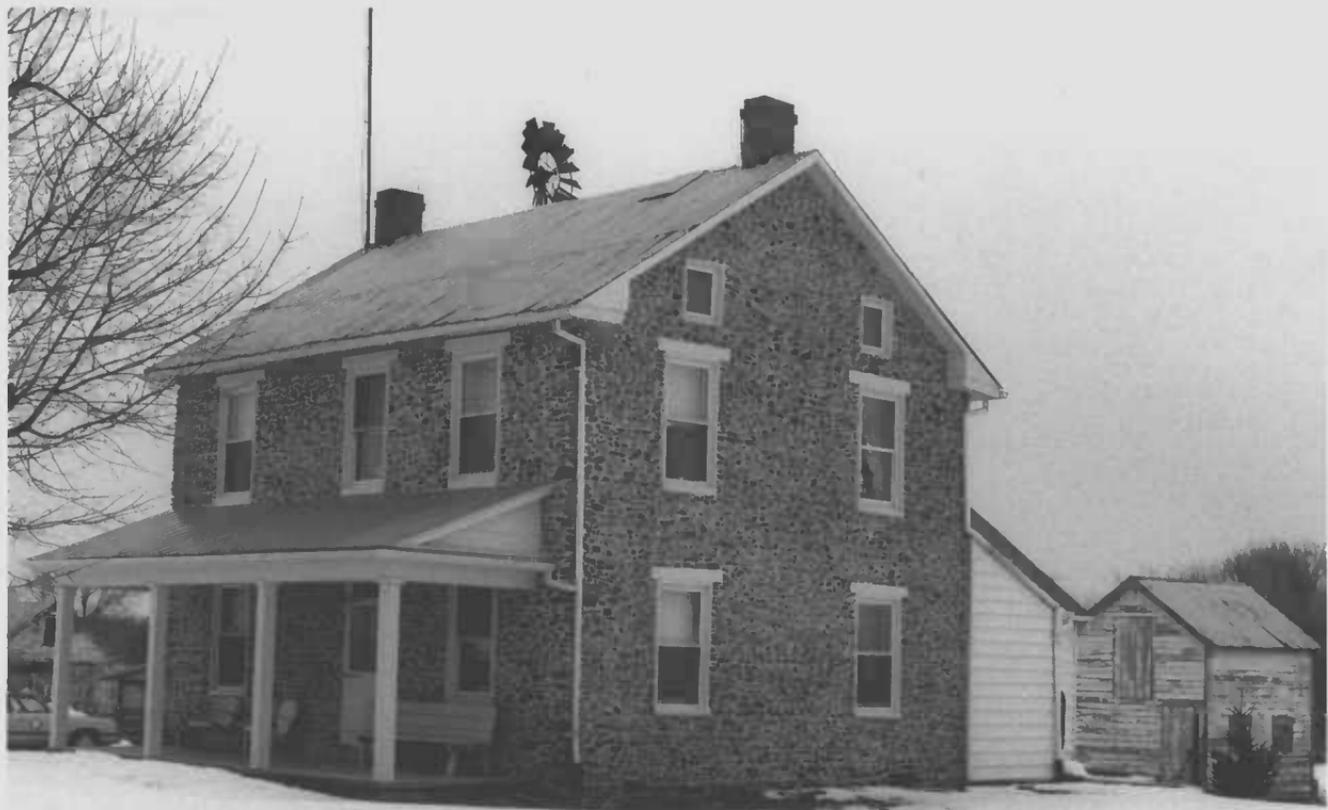
1/2

The house is a two-story, three-bay by two-bay structure of small rubble fieldstone that was formerly stuccoed, but this covering has recently been removed. The house faces northwest, toward the road. It has a gable roof of inverted-V-seam metal and a northeast-southwest ridge. The northwest elevation has an entrance set west of center, with a four-panel door that has quirked ogee panel moulds. The frame has a beaded-interior edge, the sill is wood, and there is a three-light transom. On each side is a new 1/1 sash set in square, mitered frames with a wood sill. The lintels are hidden by the

About 12 feet southeast of the summer kitchen is a shop building with a concrete foundation, German siding with corner boards of German siding, and a corrugated metal gable roof with a northwest-southeast ridge. It is a two-story, one-bay by two-bay structure. The northwest elevation has a random-width, beaded-edge vertical-board door on the first story at the west corner, and a similar door in the center of the second story. The southwest elevation has two six-light sash with pedimented surrounds on the first story. The southeast elevation has one such sash on the first story and a window opening with pedimented surround in the gable end. The northeast elevation is identical to the southwest. The shop is built with hewn corner and center posts that are about 4

Neg. Loc.: Maryland Historical Trust
House & Shop - NW & SW elevations

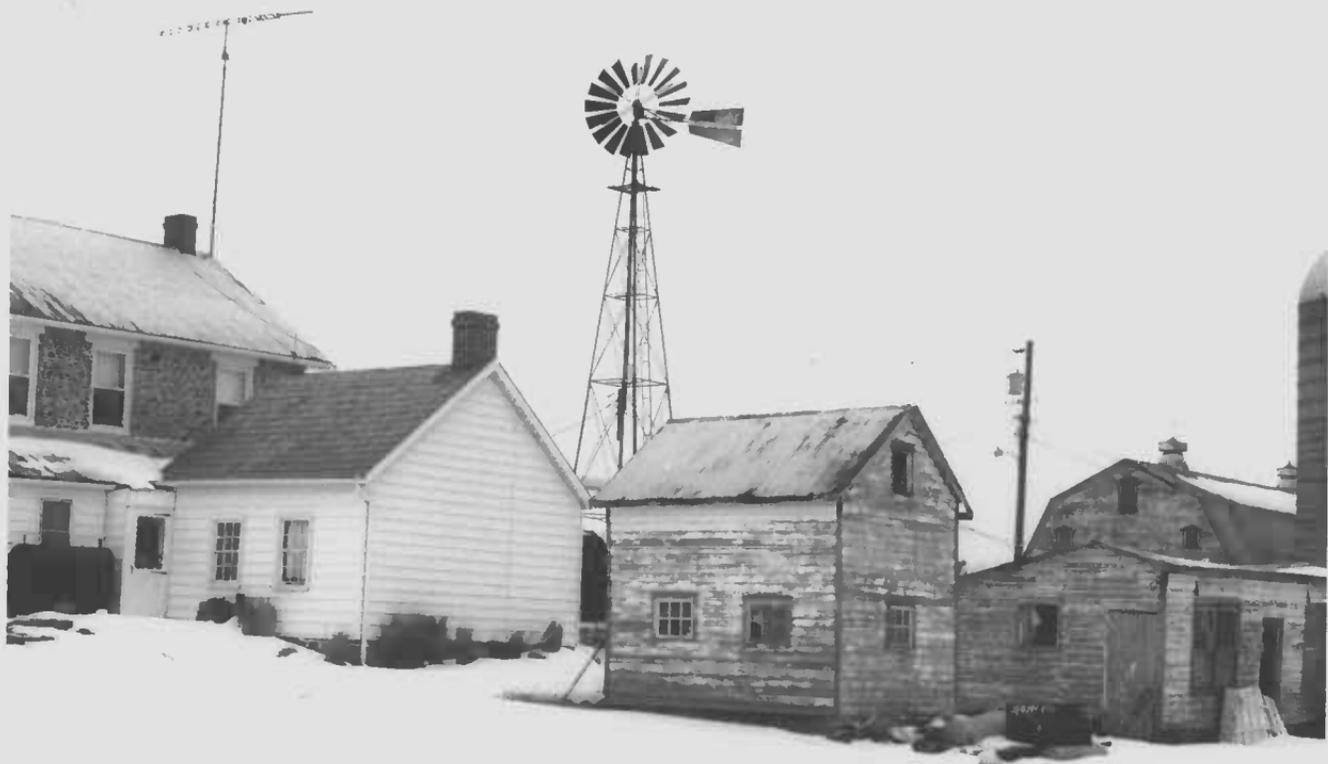
2/2

There is a summer kitchen set about 1¹/₂ feet from the rear porch. It is one story, with a rubble stone foundation, aluminum siding over German siding, and a gable roof with slate and a northwest-southeast ridge. The northwest elevation is now enclosed in the rear porch. It is two bays, with two four-panel doors that have narrow ogee panel moulds and cast iron box locks. The gable end has a door which is the only access to the attic. The northeast elevation has a later shed-roof addition on the north half. It has a concrete foundation, aluminum siding, and a metal roof. There is one 6/6 sash on the northeast elevation of the addition. There is a central 6/6 sash on the same elevation of the kitchen, two 6/6 on the southwest elevation, and an interior brick chimney centered on the gable of the southeast end. The kitchen has two rooms that are not interconnected. The southwest room has horizontal tongue-and-groove siding and a brick fireplace on the southeast wall, set to the east. The attic joists are exposed, are approximately 2 by 6 inches, are circular sawn, and run northeast-southwest. There is a random-width floor above. The northeast room has horizontal beaded-edge boards on the walls and ceiling and a 4¹/₂-inch wide pine floor that runs northwest-southeast.

There is a small poultry house about 40 feet southwest of the summer kitchen. The foundation is not visible. There is German siding with corner boards of German siding, and a shed roof of inverted-V-seam metal that slopes down to the northwest. The southeast elevation is three bays, with a 6/6 sash in the south and center bays and a beaded-edge vertical-board door to the east. The northeast elevation has a hatch door of German siding at the floor level. The southwest elevation has no openings. It is built of circular-sawn 2 by 4 construction and has a tongue-and-groove wood floor that runs northeast-southwest.

About 10 feet northeast of the summer kitchen is a steel-framed windmill with a rubble stone wellhead underneath it.

House, summer kitchen, shop, poultry house,
windmill - SW & SE elevations
