CARR-1388
Reindollar-Mehring Farm
Taneytown (vicinity)

Maryland Historical Trust State Historic Sites Inventory Form

historic Reindollar-Mehring Farm

street & number 5055 Francis Scott Key Highway (MD 194) not for publication

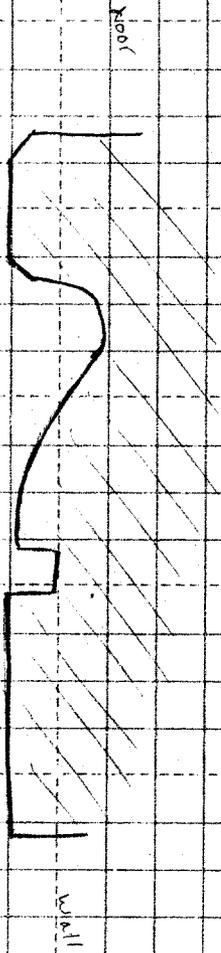
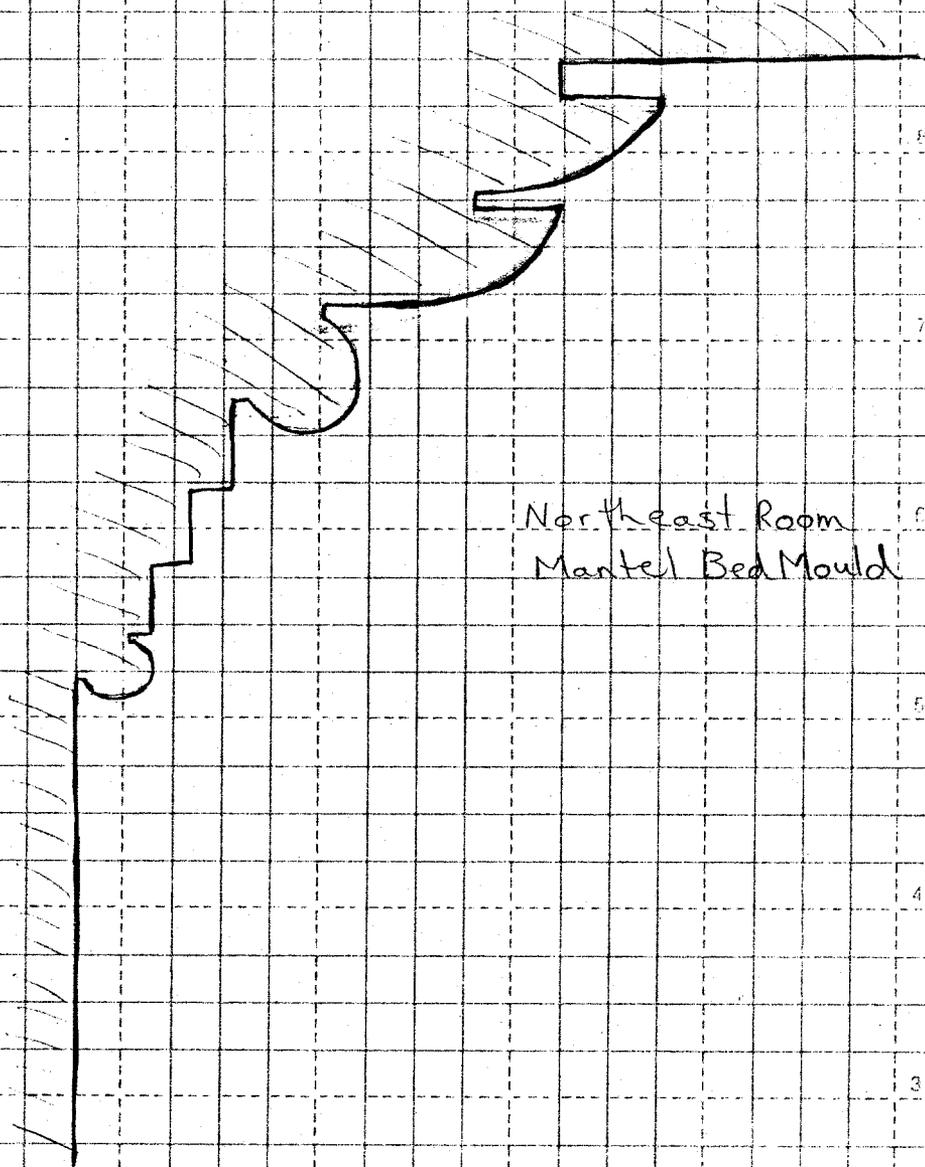
Second (ry Door Surrounds

5055 Francis Scott Key Highway
Moulding Profiles

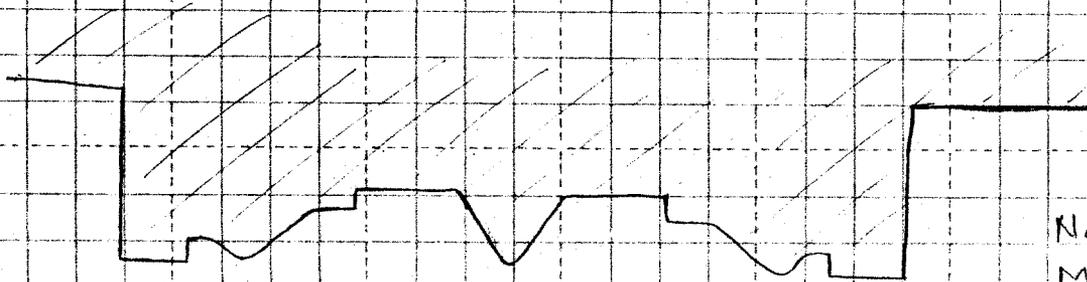
Northeast Room
Mantel Bed Mould

The northeast room has a fireplace on the east wall, to the south, that has splayed, plastered jambs. The wood mantel architrave is a symmetrical moulding with a Greek ovolo on either edge and a lancet profile in the center. The bulls-eye corner blocks have the same pattern, run circular. The frieze has sunk, flat panels with Greek ogee moulds. The bed mould has two Greek ovolos at the top, then an astragal, three fillets, and an astragal at the bottom. The southwest corner of the room is canted. This appears to be a later alteration when the stairs were moved to the east about three feet. The southeast room has now been converted to a bathroom. The door architrave trim has a broken field with a cavetto at the break, and a beaded interior edge. The southwest room has a large fireplace on the west wall, to the north. It has brick with straight jambs, and is parged. The mantel has a plain wood surround and shelf. The bed mould has a chamfer along the bottom corner, with a bead below it. The rear, center bay door is now gone, but the architrave and transom survive and match those on the front. On the east wall is a door to the cellar that is identical to the front door. On

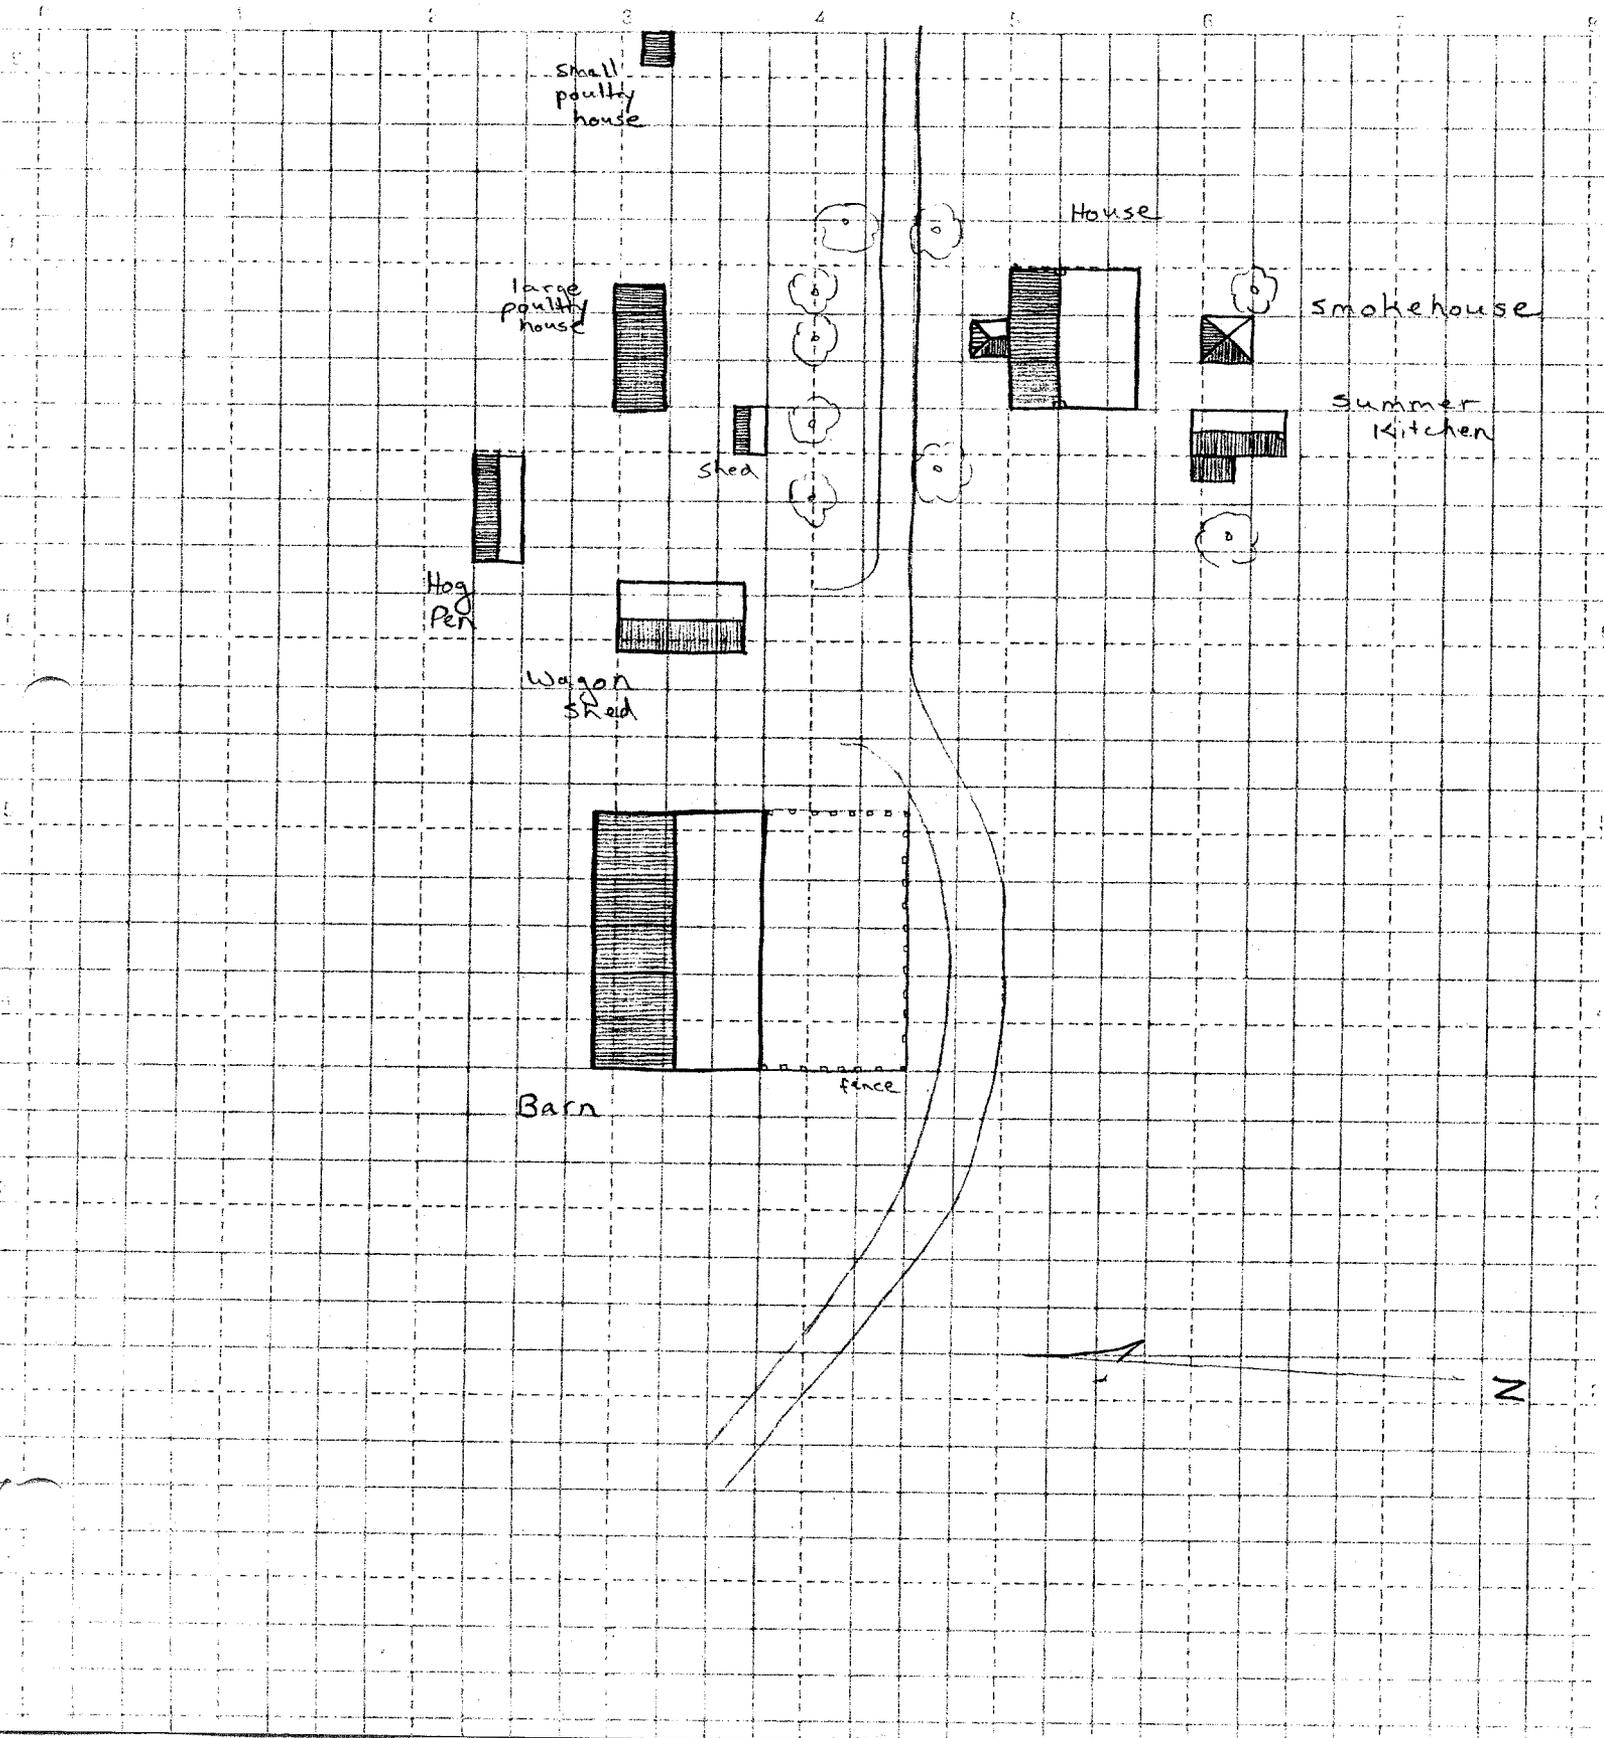
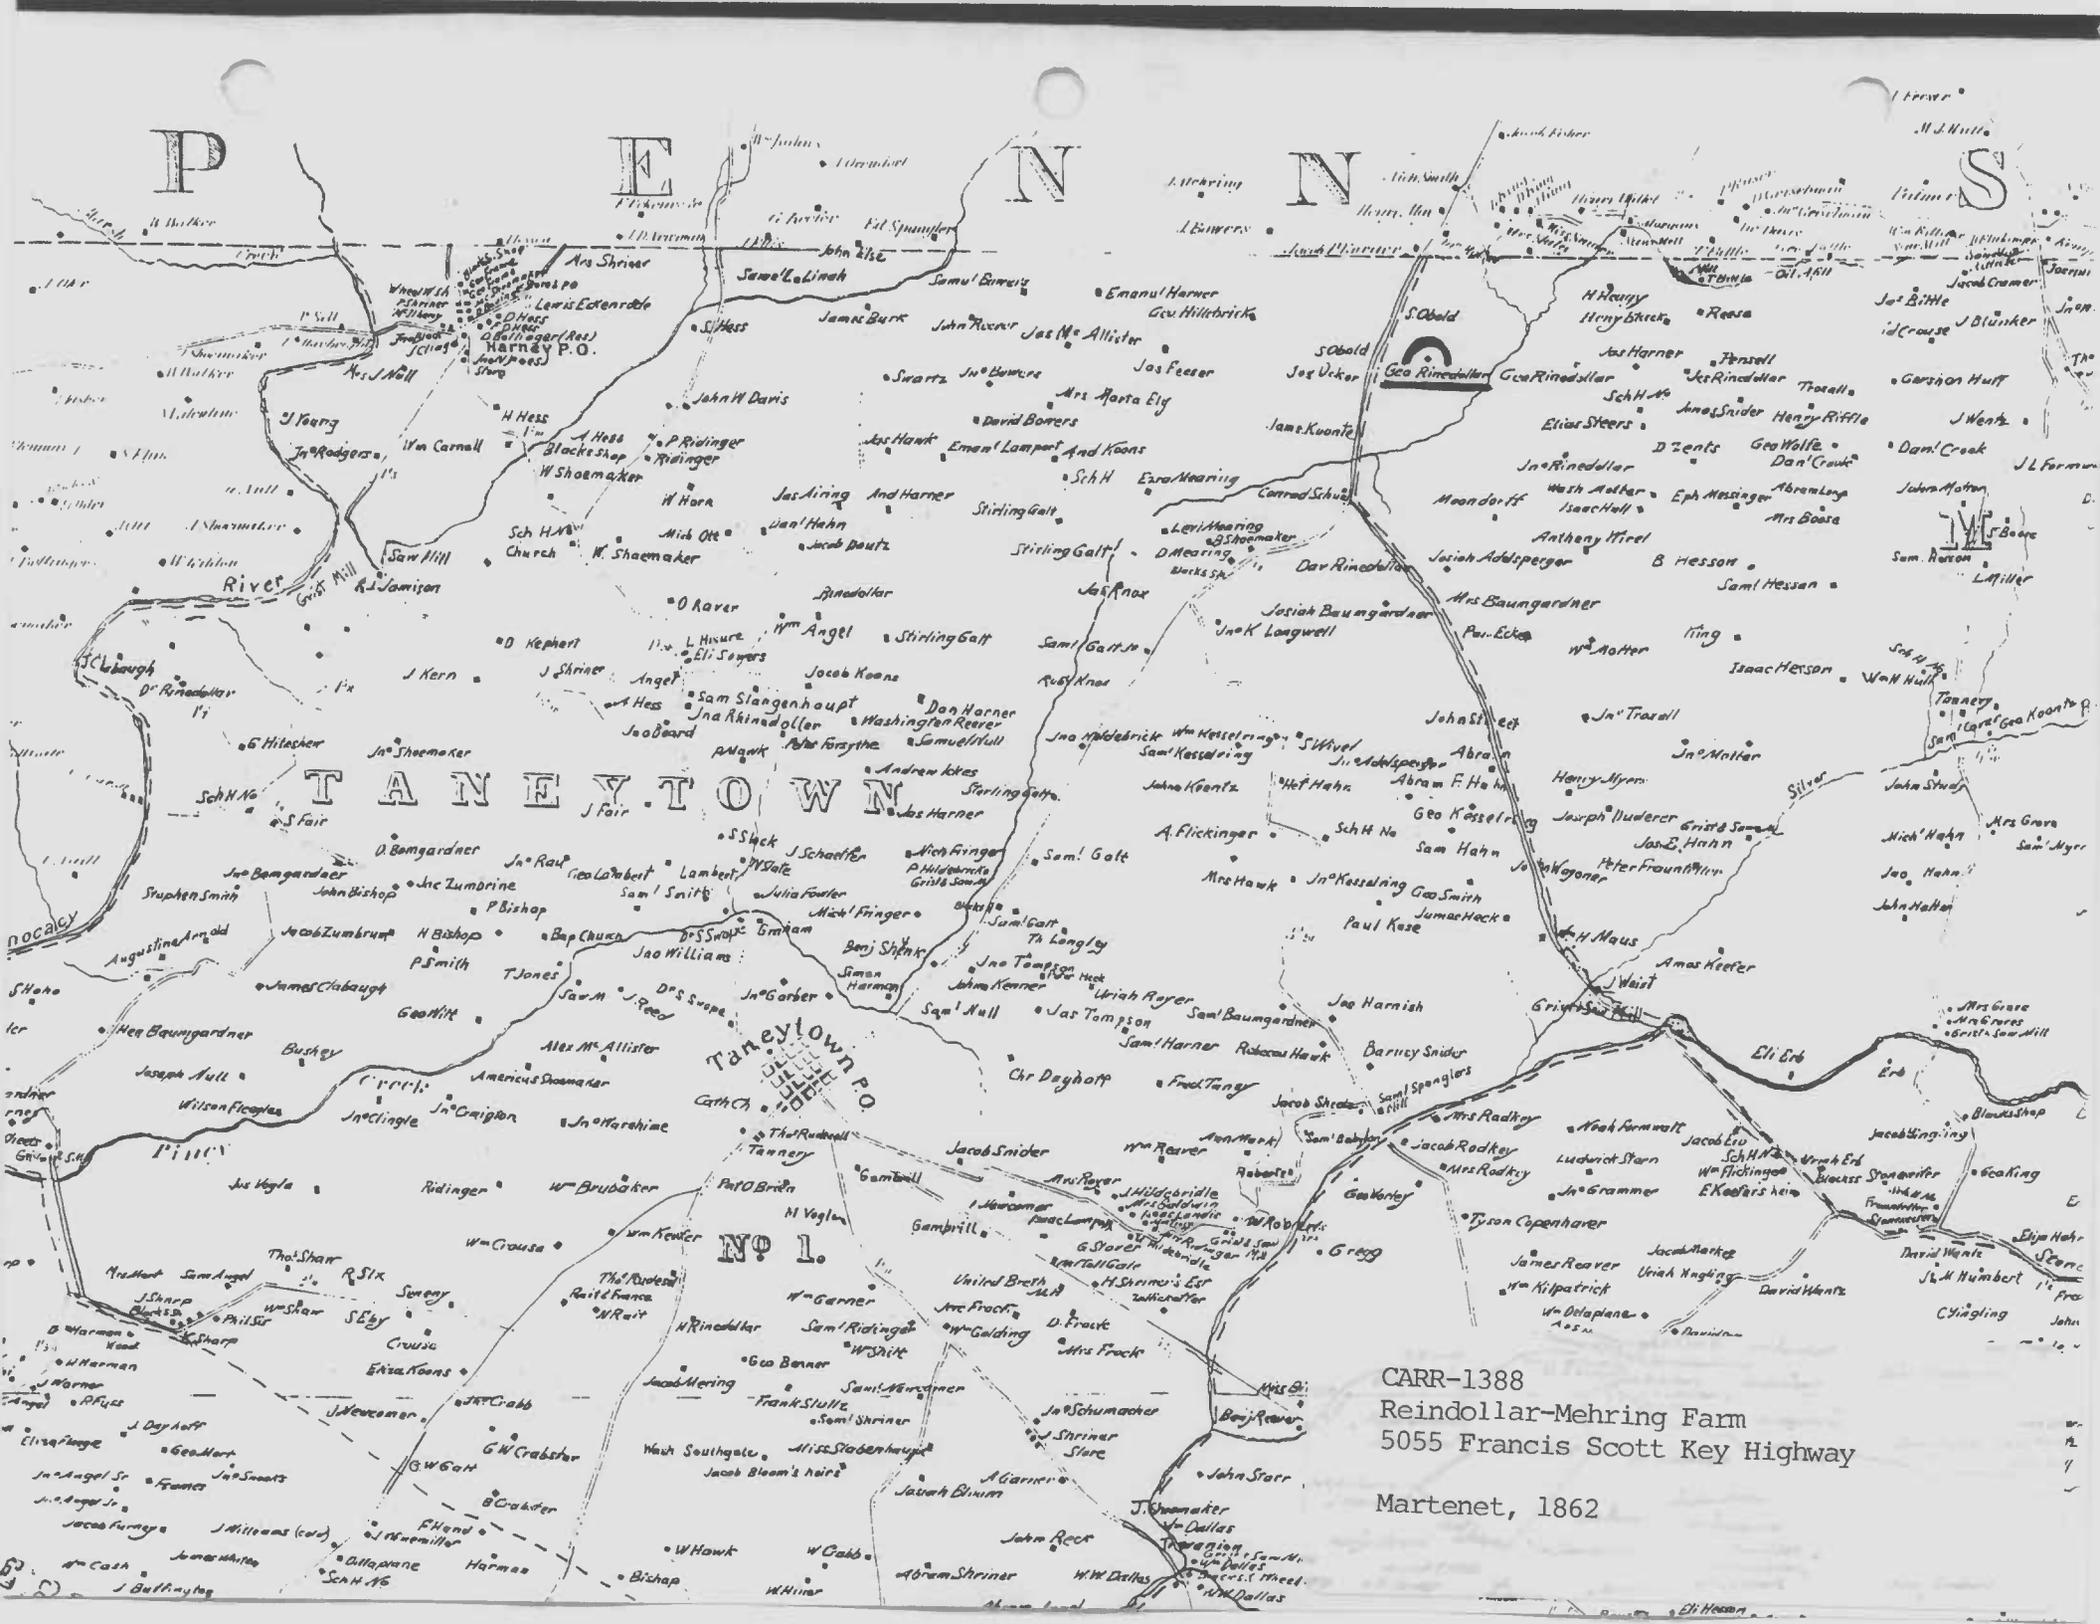
5055 Francis Scott Key Hwy
Site Plan

The Reindollar-Mehring Farm is located at 5055 Francis Scott Key Highway, about 4½ miles northeast of Taneytown in northwest Carroll County, Maryland. The farm is located well east of the road on a generally flat site, and consists of a brick house, a frame barn, a stone smoke house, a brick summer kitchen, a wagon shed, a hog pen, a shed and two poultry houses. The buildings are vacant and beginning to deteriorate.

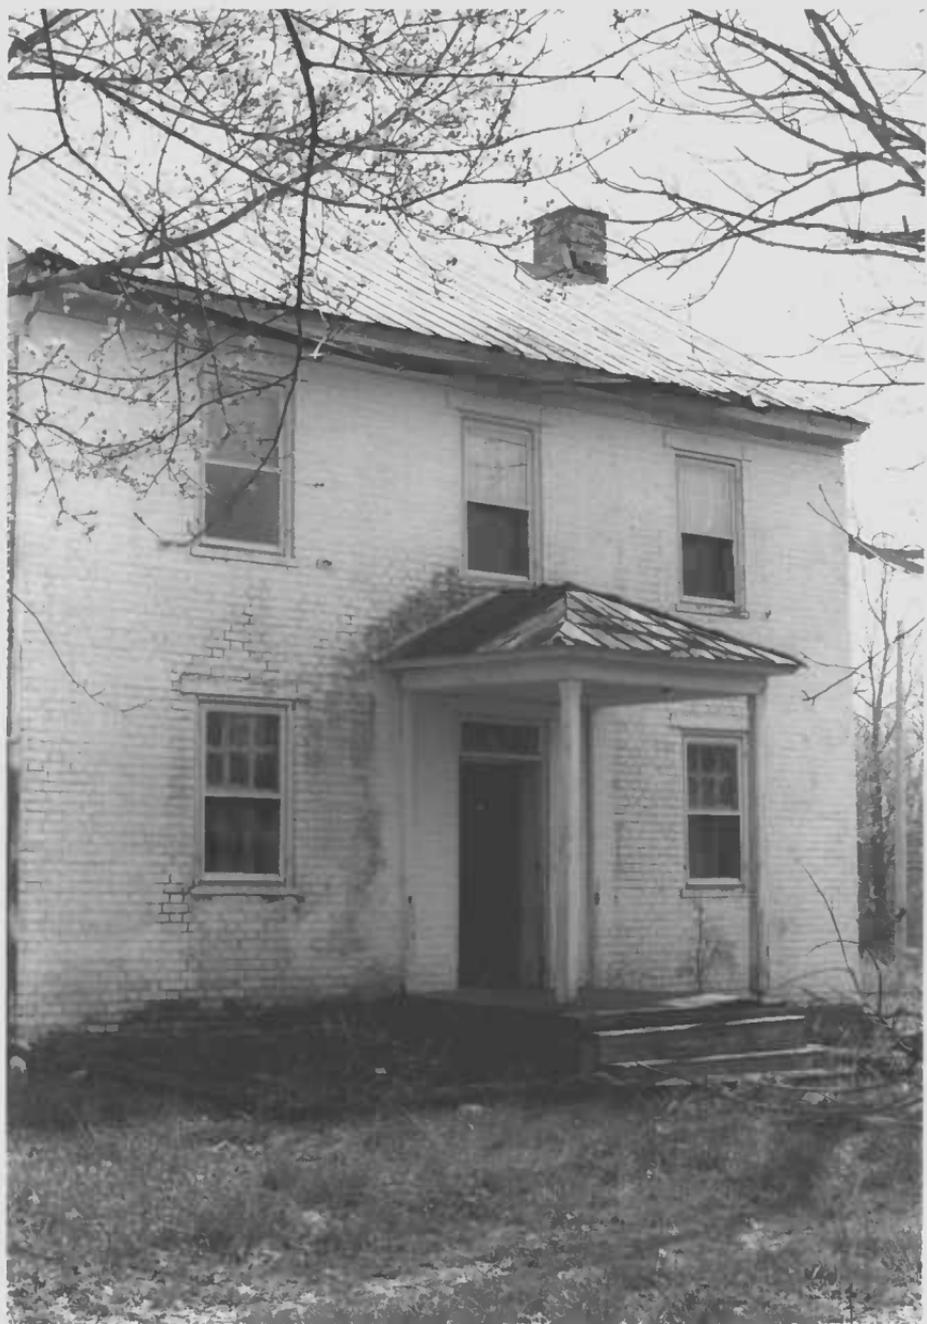
1/7

The house faces north and is a three-bay by two-bay, two-story structure with a rubble stone foundation, Flemish bond brick on the north elevation, 5-1 common bond brick on the other elevations, and a gable roof of inverted V-seam metal with an east-west ridge. The north elevation has a center entrance with an eight-panel door. The top six panels are square and the bottom two rectangular. They all have sunk fields with

Neg. Loc.: Maryland Historical Trust
house-north elevation

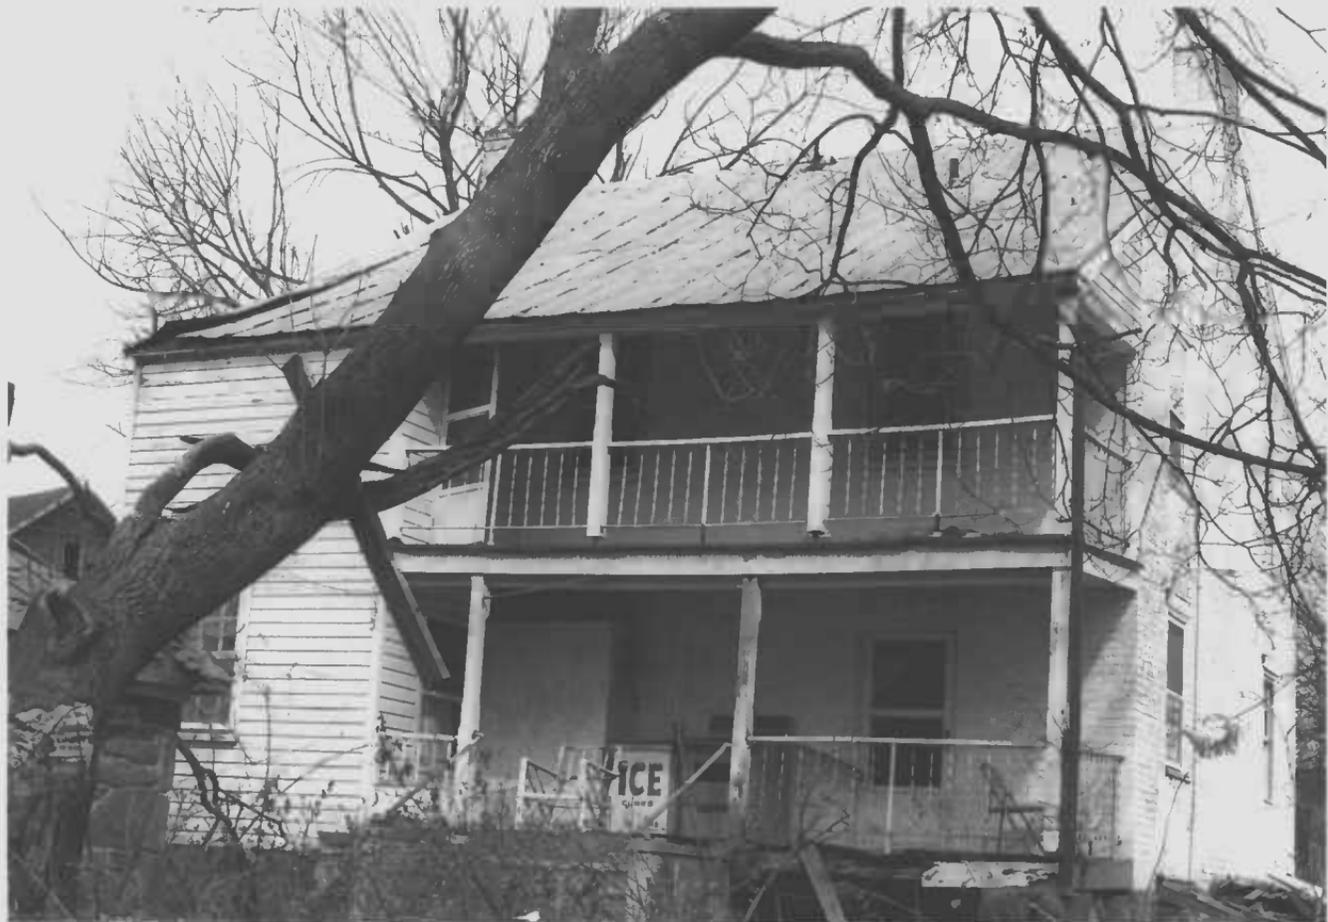
2/7

The south elevation foundation, in the east bay, has a wood vent like that on the east elevation, with a four-light sash behind it. There is a stone pier in the middle of the porch and a stone wall in the west bay, under the enclosed portion of the porch. This wall continues under the east elevation of the enclosed portion, and has a beaded-edge vertical-board door in it with a beaded-interior-edge frame and a cast-iron box lock. The first story has a four-panel door with sunk fields and ogee moulds in a beaded-interior-edge frame. The door in the center bay is now covered by a later enclosure, but the bullnose frame and transom are visible. The east bay had a window that has been converted to a door. It has a beaded-interior-edge frame and a four-panel door with sunk, fielded panels and ogee moulds. The second story has German siding in the west bay. The east elevation of the enclosed portion has a doorway; the door is now missing. The center and east bays have the typical 6/6 sash. The two-story porch has a shed roof that continues the slope of the house roof. The porch has a new deck and railings, though a piece of the old rail survives. It had a horizontal-board bottom rail with semi-circular cut outs on both ends, and small, square-in-plan vertical balusters. The square, chamfered porch posts appear to have been moved on the first story.

Neg. Loc.: Maryland Historical Trust
house - south elevation

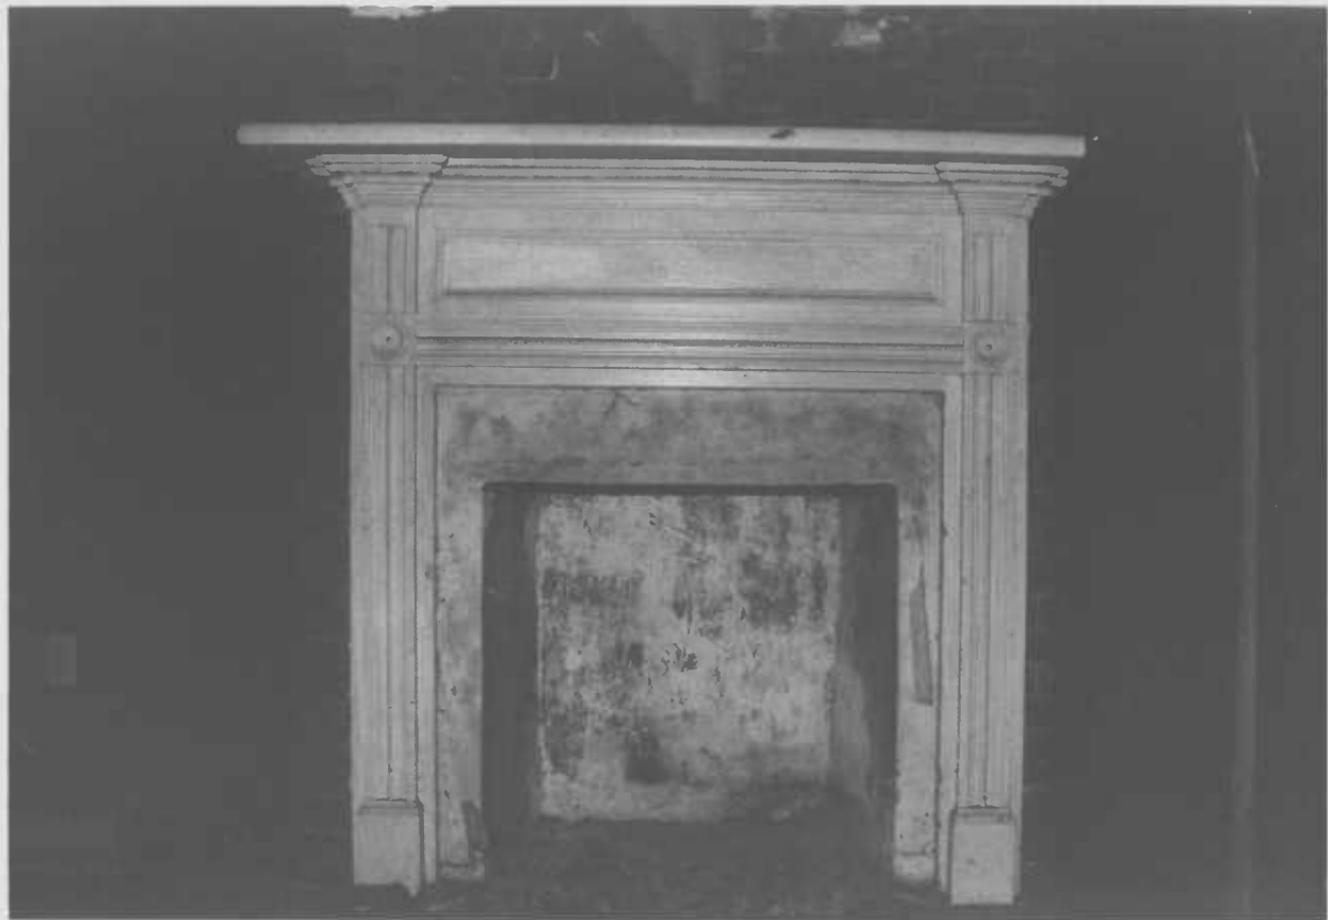
3/7

Neg. Loc.: Maryland Historical Trust
house - northeast room mantel

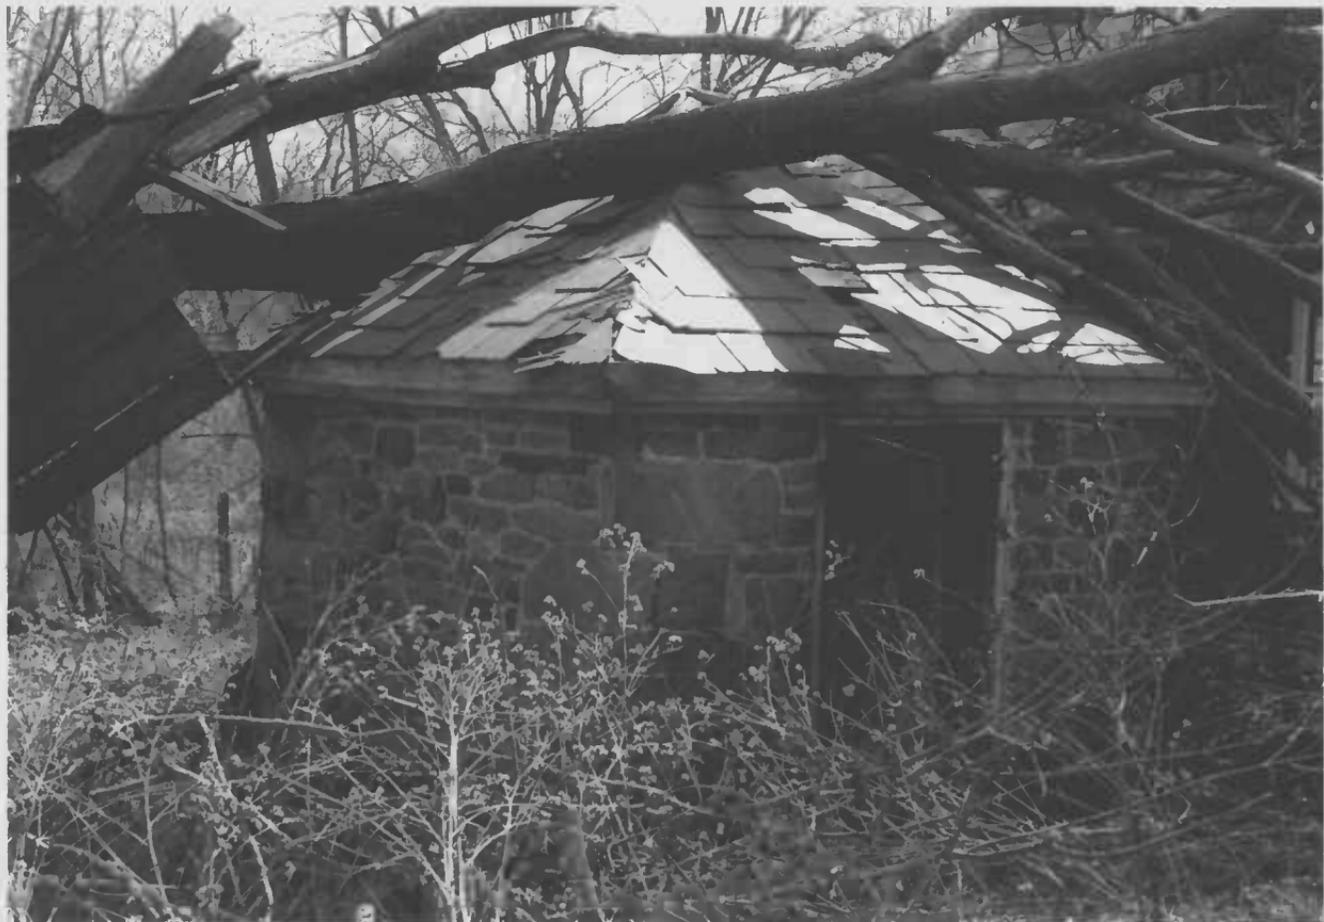
4/7

There is a rubble stone smokehouse about 15 feet south of the house that has some quoining at the corners. The hipped roof is covered with slate that has been badly damaged by a large fallen tree limb that still rests on the roof. The north elevation has a beaded-edge vertical-board door, and the door jambs are circular-sawn. The interior walls are plastered. There are many joists running north-south that appear to be mill-sawn and were used to hang meat on. The rafters are circular-sawn.

Smokehouse - east & north elevations

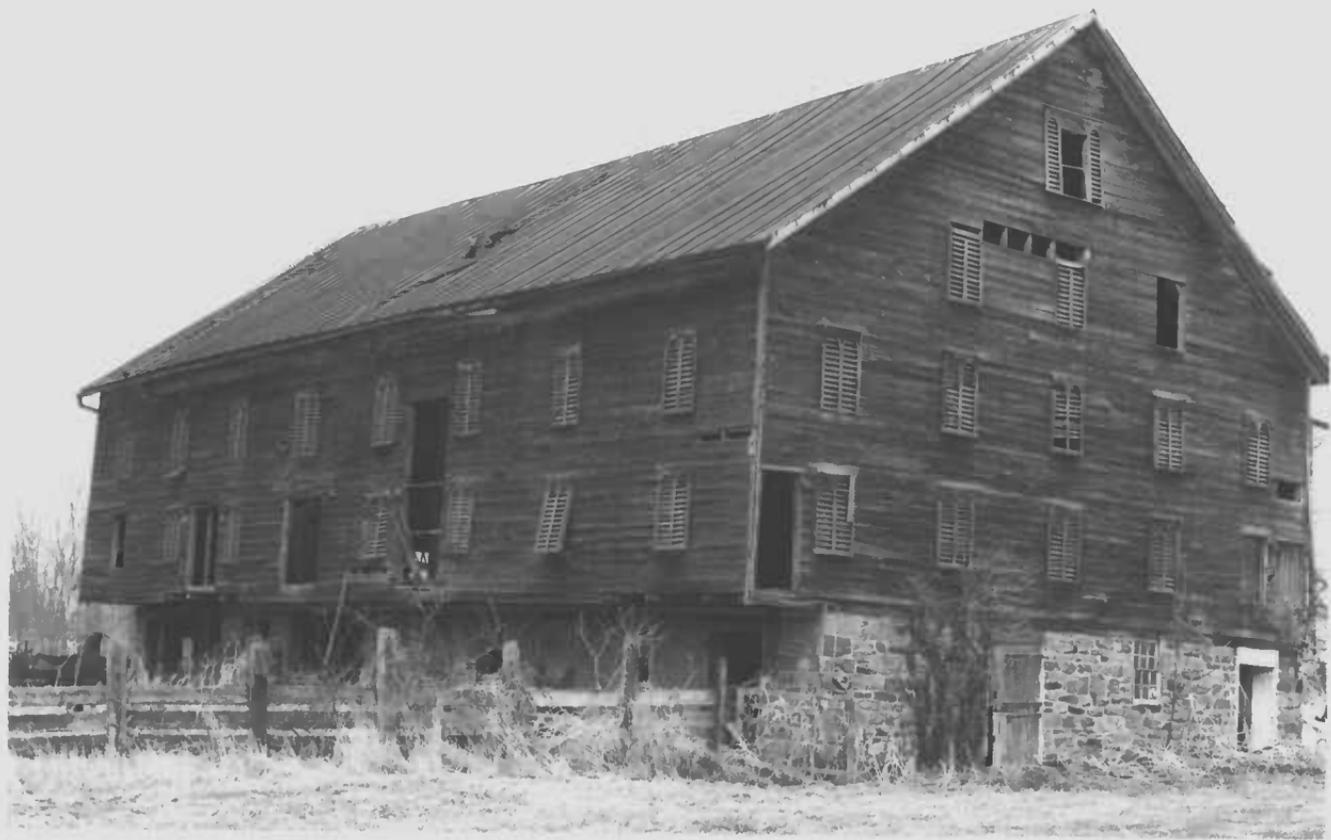
6/7

There is a bank barn with a south-facing forebay about 75 feet northwest of the house. The lower story has rubble field stone, with 7-1 common bond brick on the south elevation. The upper story is clapboard. The gable roof has an east-west ridge with inverted V-seam metal on the south and slate on the north. The south elevation, on the lower story, has from west to east, a widened opening that was probably a door and a window, a vertical-board dutch door on strap hinges, a wide opening that was probably a window and door, a matching door, a vent opening with round holes in the jambs, another matching door, a vent converted to a 4/2 sash, and a matching door. Some of the strap hinges are tapered to a point and others have a rounded end. The upper story has two wood louvered vents above two vents, a door opening, a vent above a vent, a door opening above a door opening, and three vents above three vents. The east elevation, on the lower story, has a vertical-board dutch door on strap hinges to the south, a 6/6 sash, and a door opening to the north. The upper story has a door opening in the forebay at the south corner, five vents to the north, and a vertical-board door at the north corner. Above the five vents are five more vents, with three vents above them. Centered in the gable end is a window opening flanked by a vent on each side.

The upper story has two center threshing floors with a hay mow on each end and a granary in the northeast and southeast corners. There are five bents of mostly circular-sawn timber, with some hewn members that are probably re-used. There are pegged mortise-and-tenon joints and the horizontal members are inset into the verticals slightly, with a splayed face to the end of the horizontals. The bents each have five posts, but the center post does not extend above the top girt. A queen post truss supports the roof, which has 2 x 4 rafters and a ridge beam. There is a hay track hanging in the ridge. The roof has holes and the barn is deteriorated, with the floor falling through in places.

barn - south & east elevations
