CARR-1391

**Poulson-Englar Farm
New Windsor (vicinity)**

**Maryland Historical Trust
State Historic Sites Inventory Form****1. Name** (indicate preferred name)

historic Poulson-Englar Farm

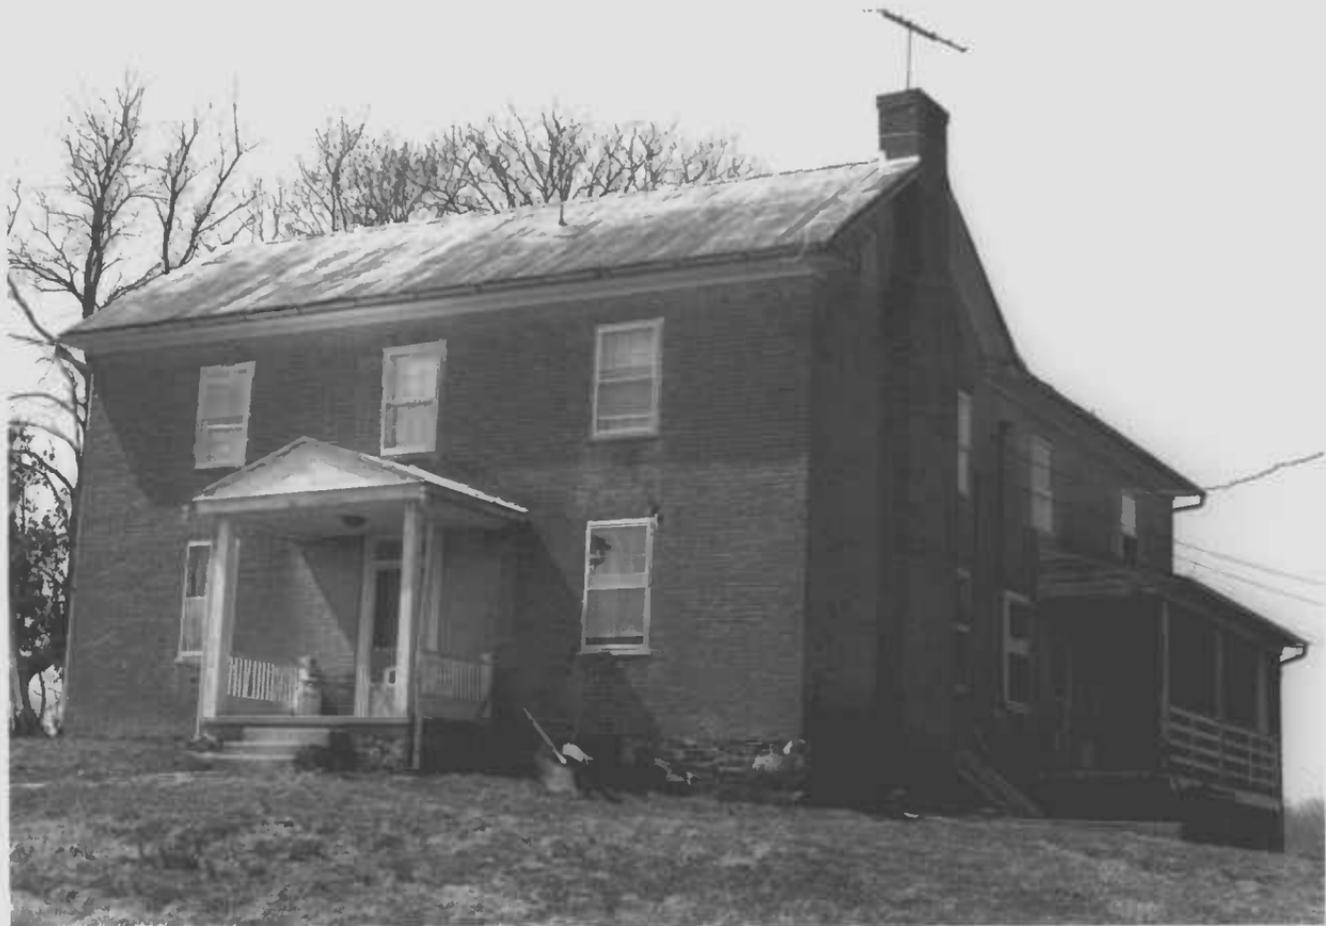
1/6

house - SE & NE elevations

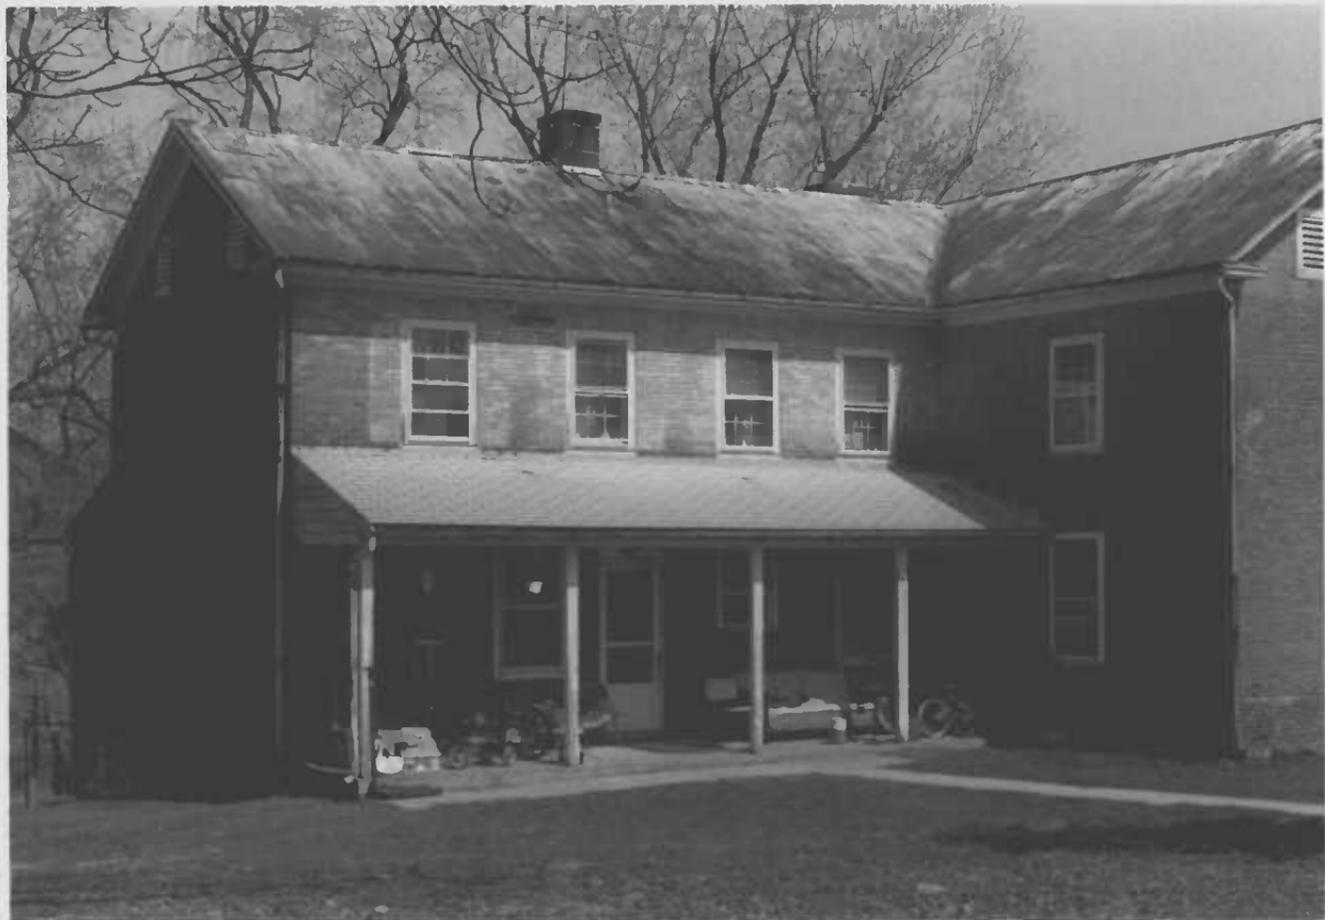
2/6

Neg. Loc.: Maryland Historical Trust
house - NW & SW elevations

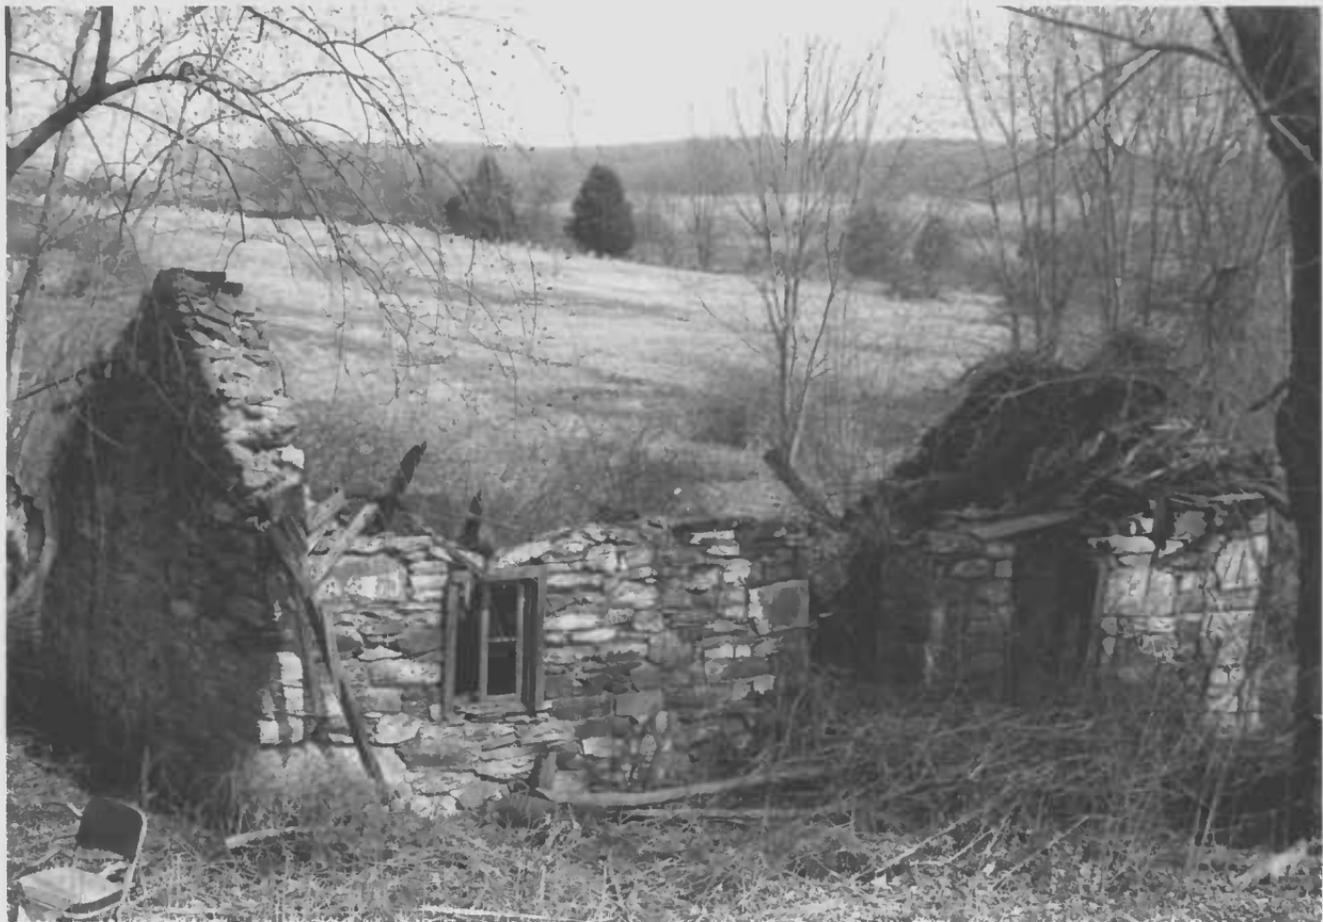
3/6

summer kitchen - NW & SW elevations

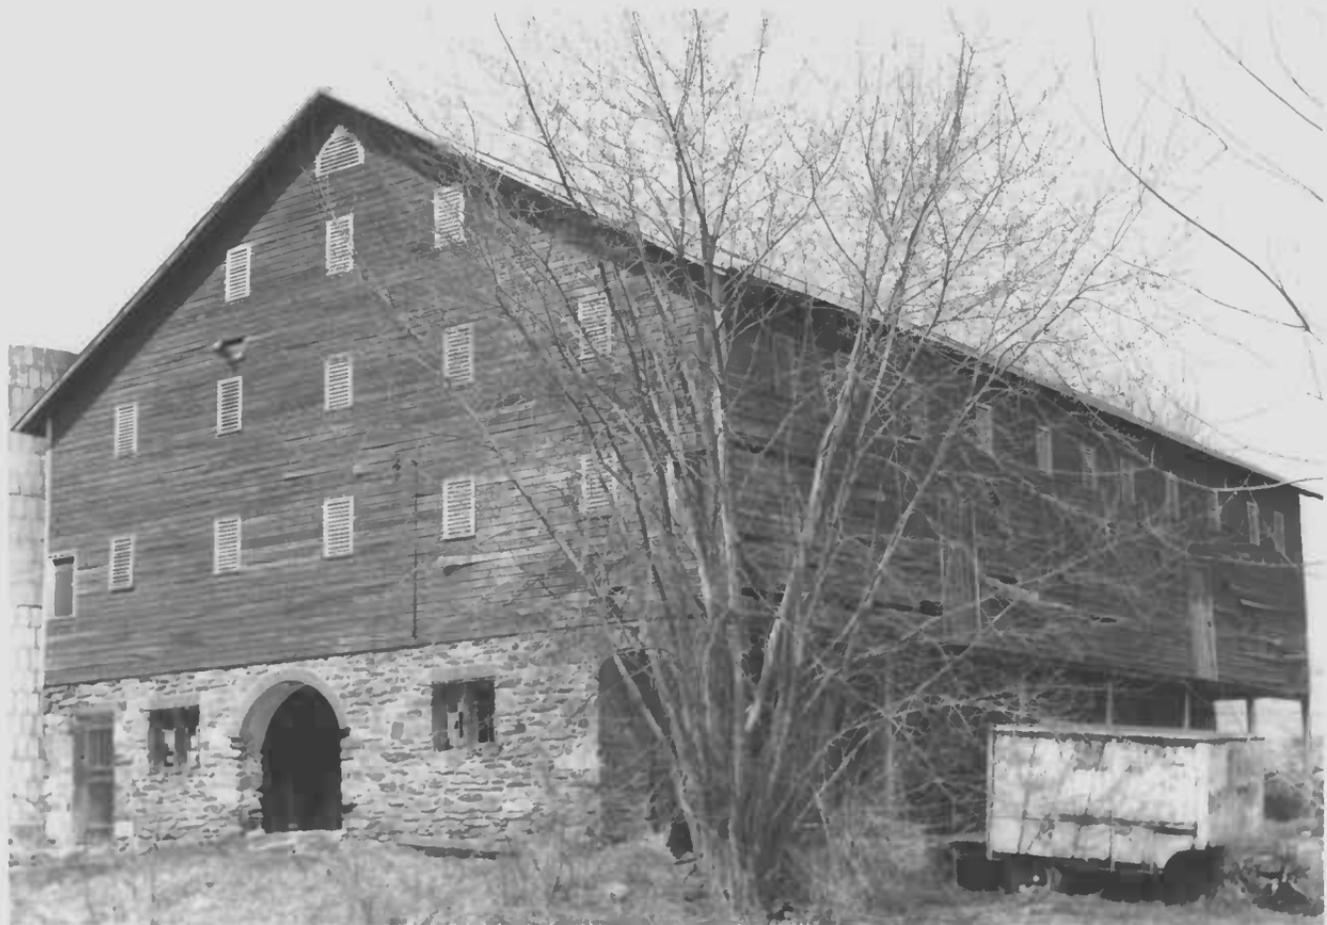
4/6

There is a banked barn about 150 feet northeast of the house. It has a southeast facing forebay. The lower story is rubble stone. The upper story is German siding with corner boards. The gabled roof has a northeast to southwest ridge and is covered with corrugated metal. On the southeast elevation the lower story has stone on either end with 5-to-1 common bond brick in between. From southwest to northeast there is a door, a vent, a door, a vent, a door, a vent, and a door. The doors are vertical-board dutch doors on strap hinges that are tapered and have round ends. There is a vent above each door that has five wood louvers that are diamond in section. The vents between the doors either have or had nineteen diamond-in-section horizontal louvers. The vent frames appear to have a center tenon into the sill. There is a trim board nailed to the face of the frame and to the forebay sill. There are reused sash placed behind the vents. The joists under the forebay are, for the most part, hewn on all four sides. There is a new sill placed under the joist ends and six posts to support the sill. The upper story has five wood louver vents in the center and three wood louver vents on either end with a pair of vertical-board double doors on "T" hinges between each set of vents.

constructed of 2 x 4 studs. The forebay has suffered some deterioration and has been altered. It has wide posts that are tenoned and pegged into the sills, but the bottoms have been cut off of some of these posts with 2 x 4's scarfed to the sides of them to connect them to the sill.

barn - SW & SE elevations

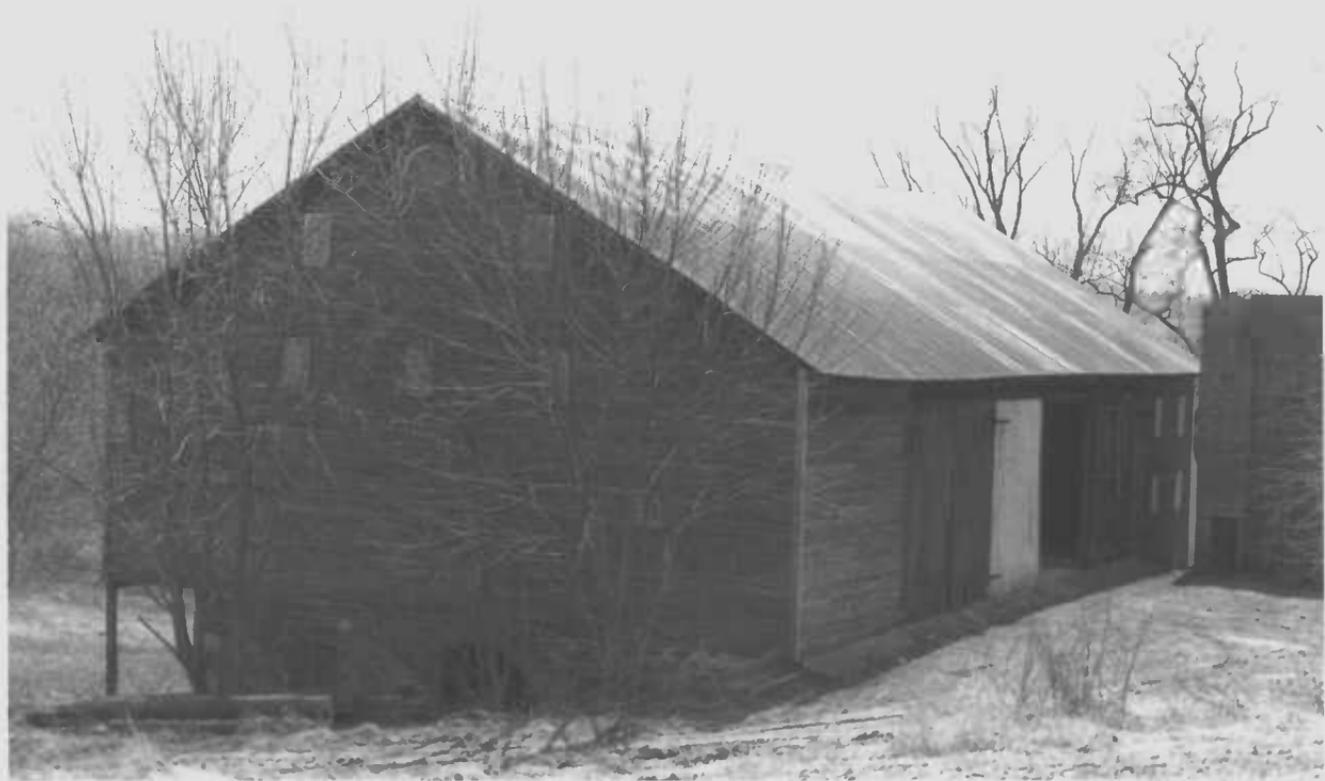
5/6

On the northeast elevation there is a semi-circular-arched opening with brick voussoirs in the center bay. The intrados is parged. It appears to be an original opening. On either side of this opening are paired vents with eleven diamond-in-section horizontal louvers on each half. The northwest end of this wall has stone infill that makes it appear that there was an opening between the back wall of the barn and the retaining wall for the ramp. This area is covered overhead by the northwest end of the barn. The upper story on the elevation has three vents set very high, with two more vents above them over the end vents, and a semi-circular vent or lunette in the gabled end. The northwest elevation has three pair of wagon doors on strap hinges. They are made of beaded-edge-and-center vertical boards. To the west are two vents set above two other vents. Over each vent is decorative jig-sawn

barn - NE & NW elevations

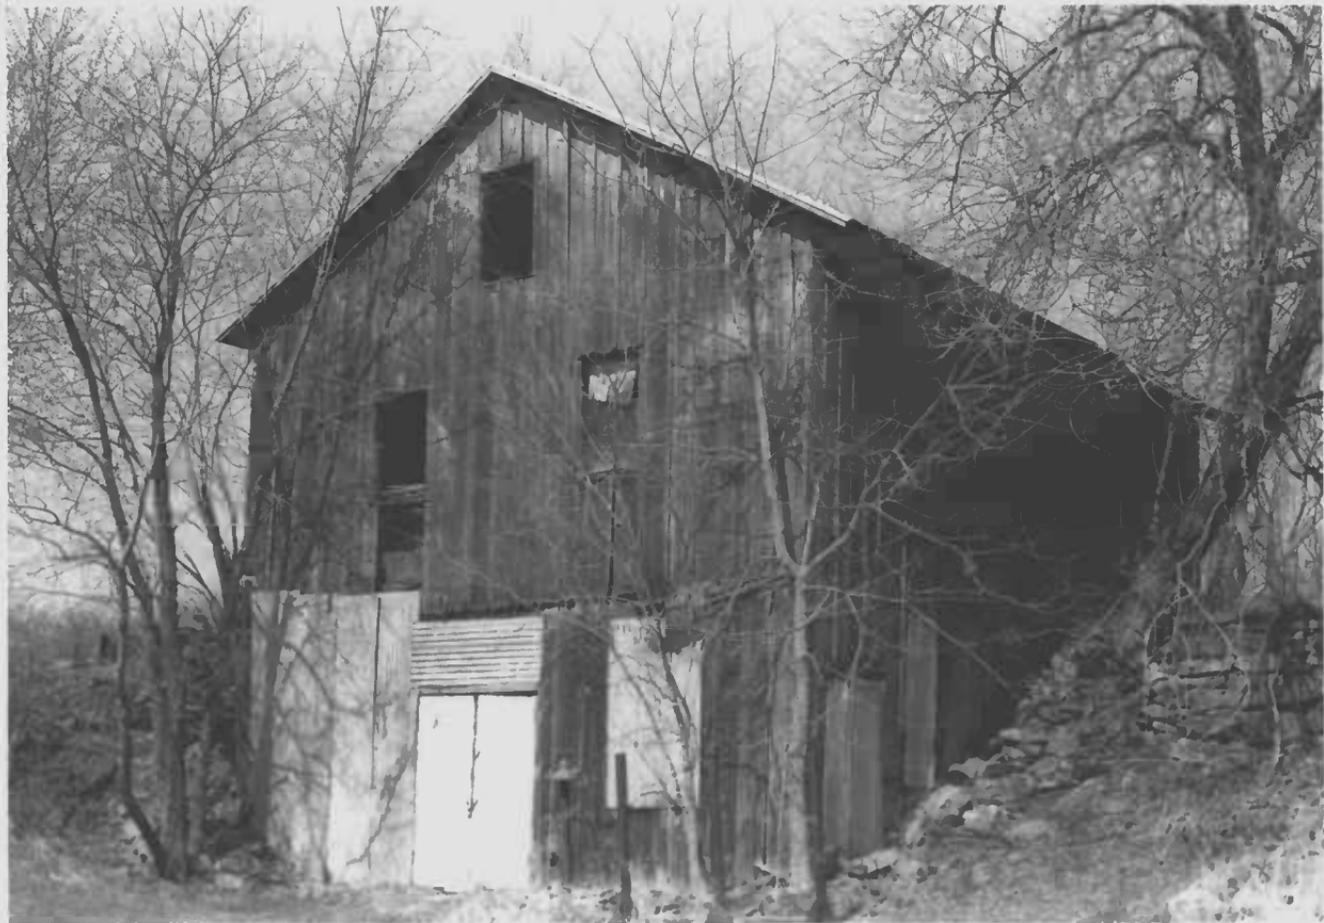
6/6

About 30 feet northwest of the barn is a shed that is banked on the northeast. It has board-and-batten siding, a rubble stone foundation, and a gabled roof with corrugated metal and a northeast to southwest running ridge. It appears to have been added on to on the southwest end. The northeast end is open. It is built with a circular-sawn, heavy timber, mortised-and-tenoned-and-pegged frame. The rafters are approximately 2 x 4, with a ridge pole.

Shed - SW & SE elevations
