Maryland Historical Trust State Historic Sites Inventory Form

Survey No. CARR-1401

historic Heiner-Haugh Farm

street & number 1302 Otterdale Mill Road ___ not for publication

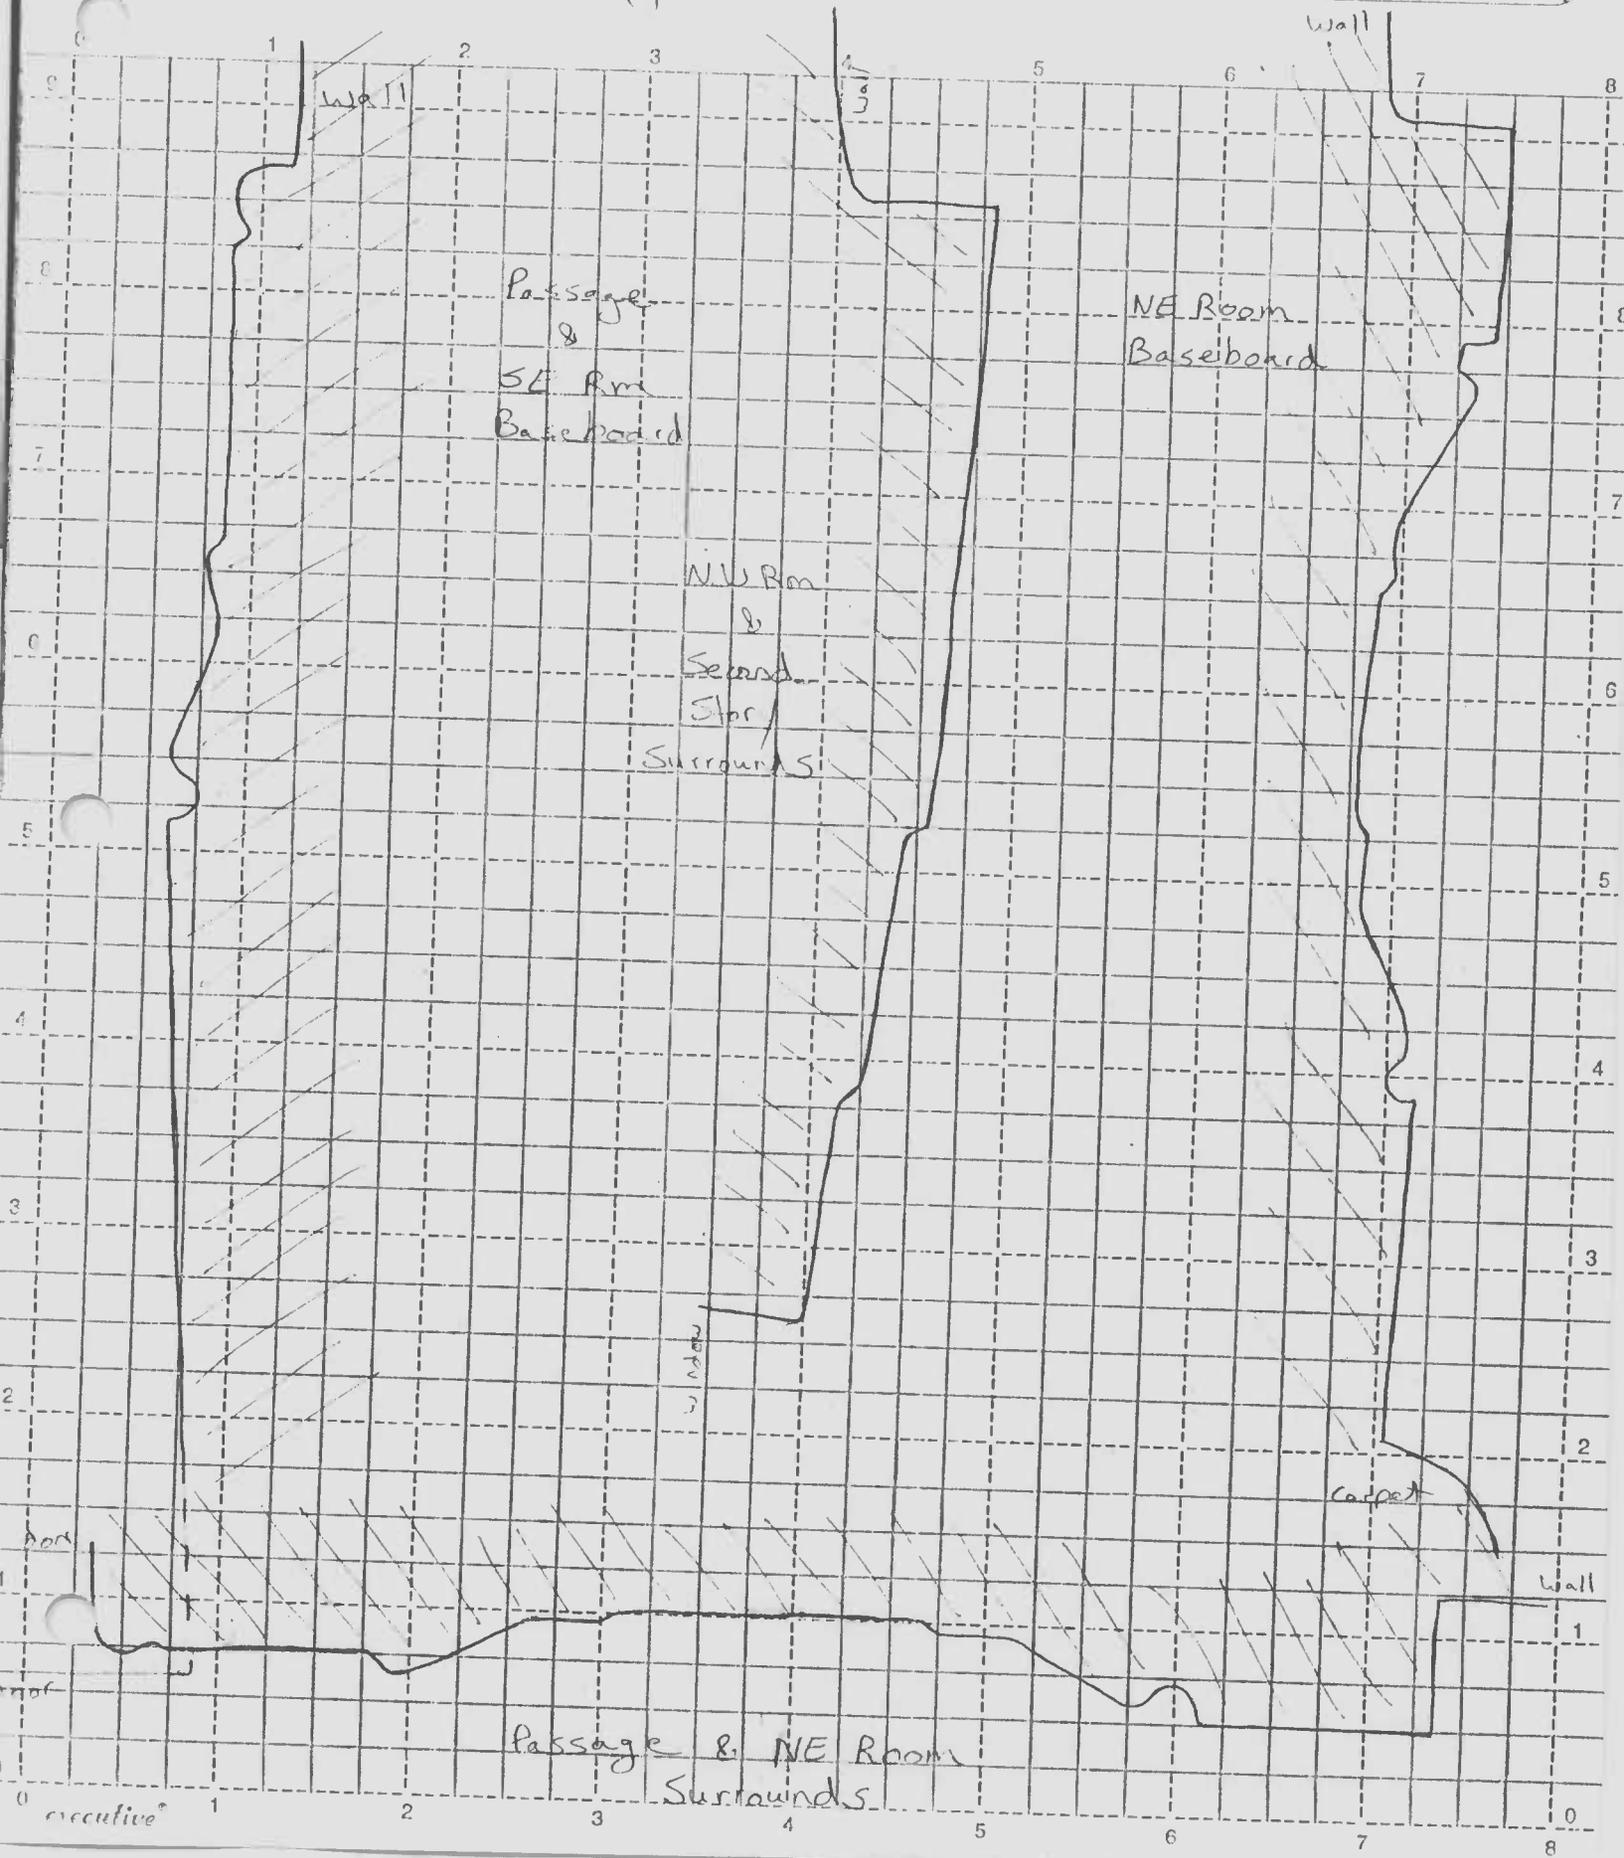
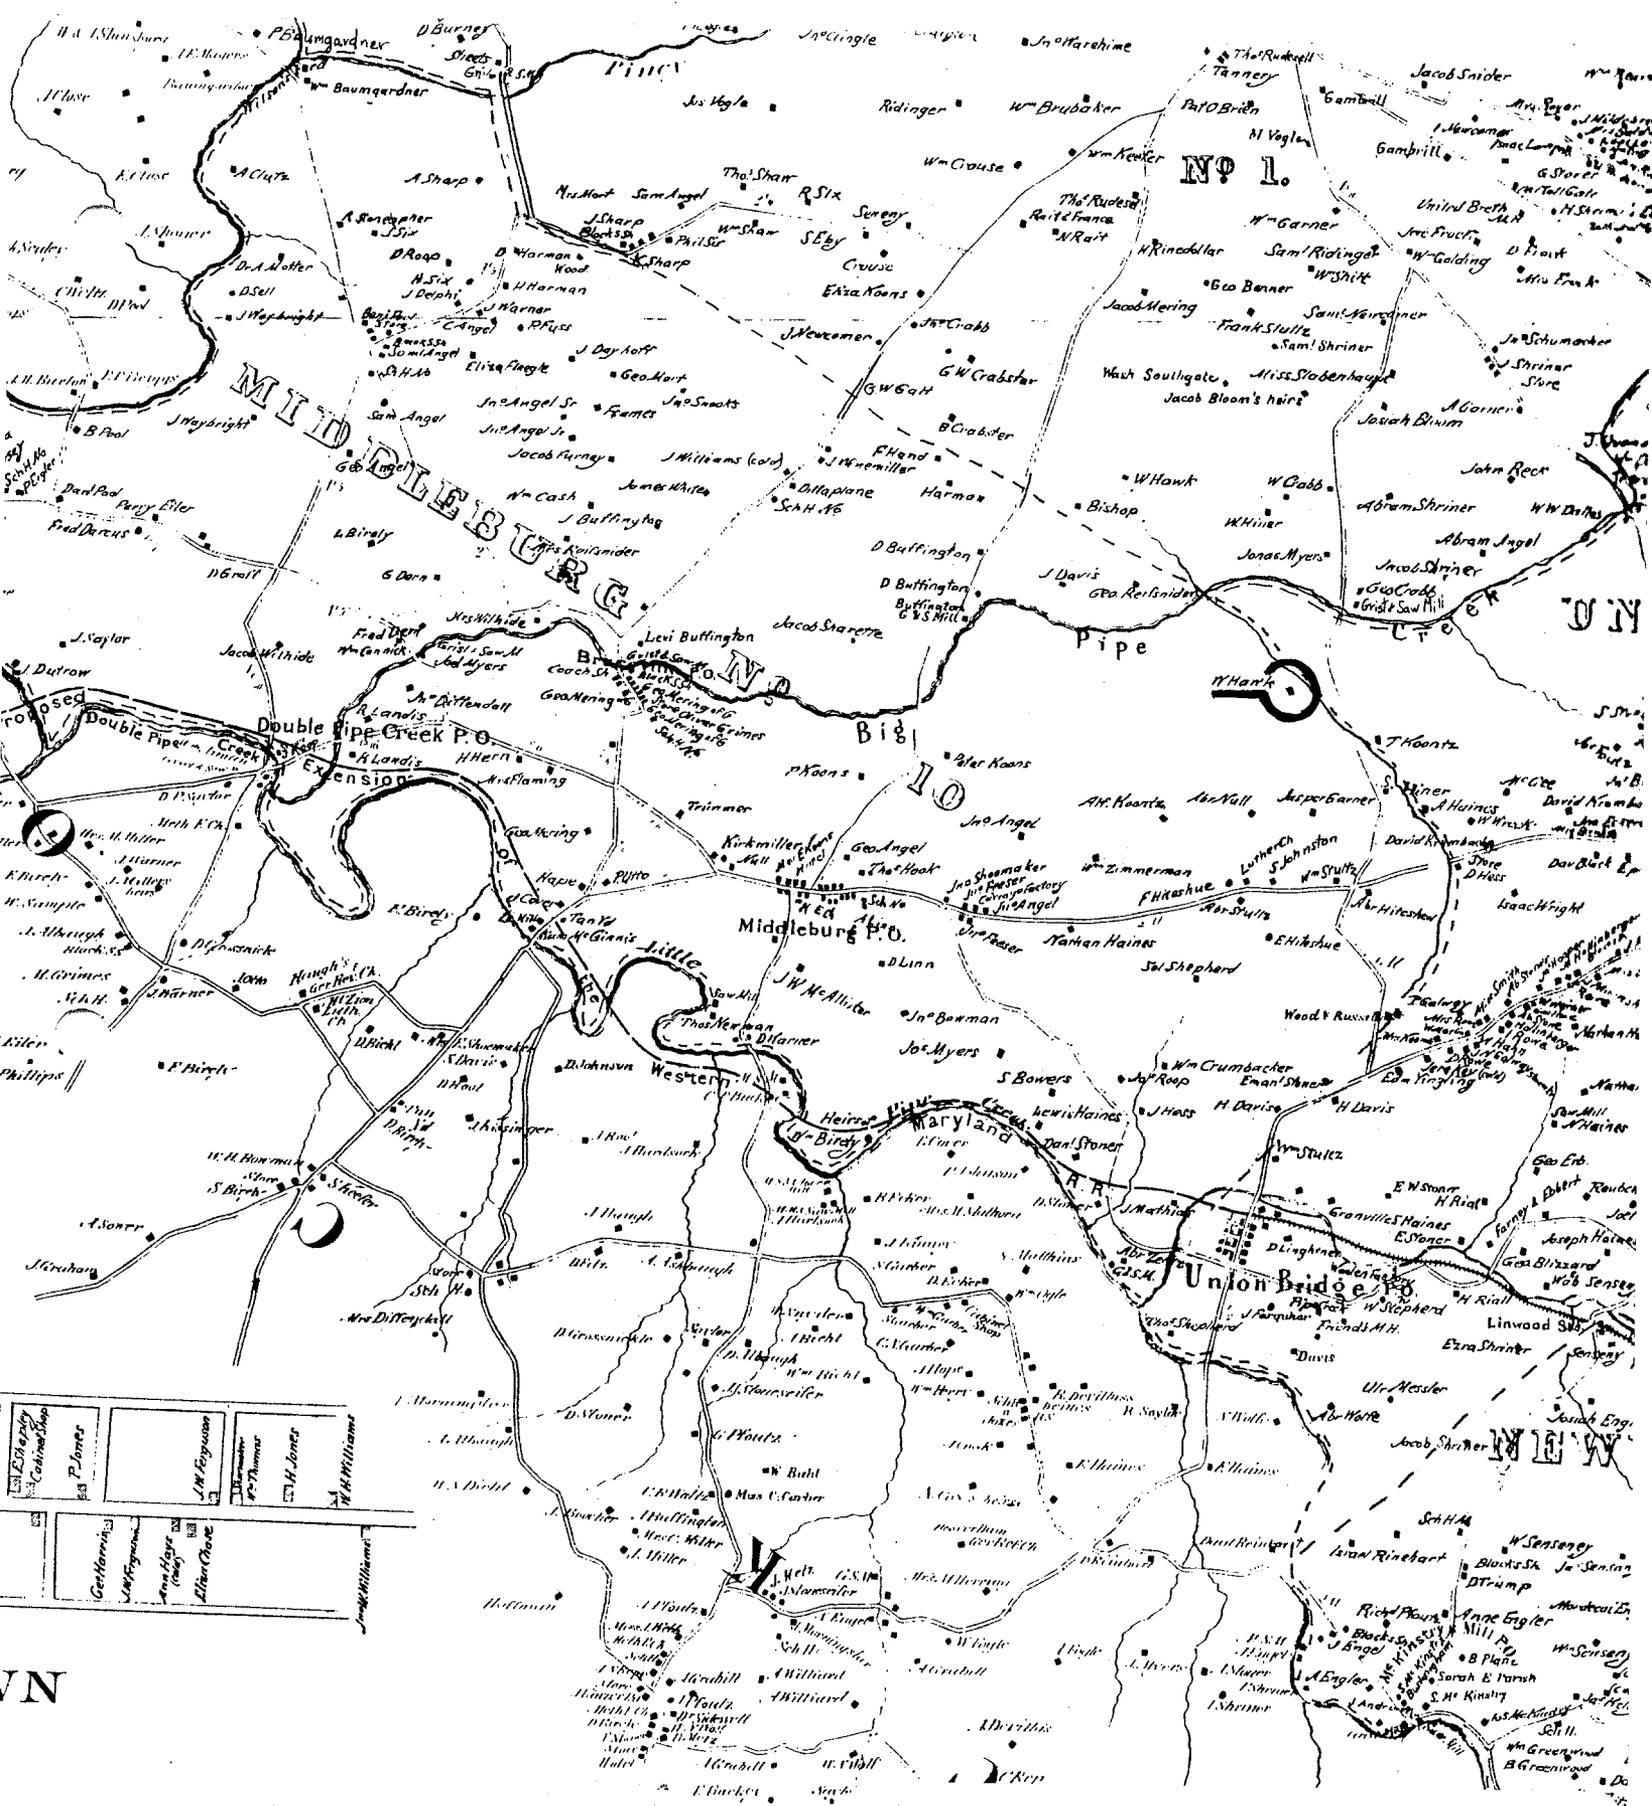
1302 Otterdale Mill Rd Moulding Profiles

bead on the bottom edge. The balusters are rectangular-in-plan and there is a $\frac{3}{4}$ -round hand rail. The turned newel is painted black with gold bands on the turnings. This appears to be an original treatment. There is a brown paint underneath of the black that may be a red lead primer. The stringer on the wall is also painted black. It has a quirked Greek ogee and bead on the top edge and gold paint on the quirk and bead. The balusters are painted black over white over tan. This shade of black is different than what is found on the newel. The floors run north-south, are $5\frac{1}{4}$ inches wide, and are of a wood with a tighter grain than pine. The architraves are symmetrical and have two Greek ogees. The outer ogee is quirked. There is also a bead on the inner edge. The baseboards have a quirked Greek ogee on the top edge.

The northeast room has the same floors and architraves as are found in the passage. The baseboards are identical to the architrave with a quirked Greek ogee on the top and bottom, and one on the sides at the corners and at the door frames. There are no beads on the baseboards. This same moulding is used underneath the windows and high on the east wall, between the two windows. There is a fireplace on the north wall, set to the west. It is brick with a plastered surround and retains some plaster on the splayed jambs of the firebox. It has a wood mantel with plain wood pilaster strips and a segmentally-arched frieze. There is a Greek ogee bed mould and a Greek ogee cymatium. There is a door on the west wall to the northwest room. The northwest wall has circular sawn lath and cut nails. The studs in this wall are approximately 2 inches by $3\frac{3}{4}$ inches and are spaced 16 inches on centers. No tool marks are visible. The wood trim was nailed to the studs and then the lath and plaster added.

The southeast room has the same floor as the passage and the same baseboards as the passage. The trim underneath the windows is identical to that found in the northeast room. The architraves have a quirked Greek ogee in the center and a bead on the inner edge. They have no back band and there is no evidence that there ever was one. Between the two east windows is a moulding like that on the northeast room, but the ogees are on the top and bottom only and not on the sides. The south wall, to the west, has a wood mantel on a brick chimney. There was never a fireplace here. The mantel has plain pilaster strips and a segmentally-arched frieze. It is identical to the northeast room mantel, but is much narrower.

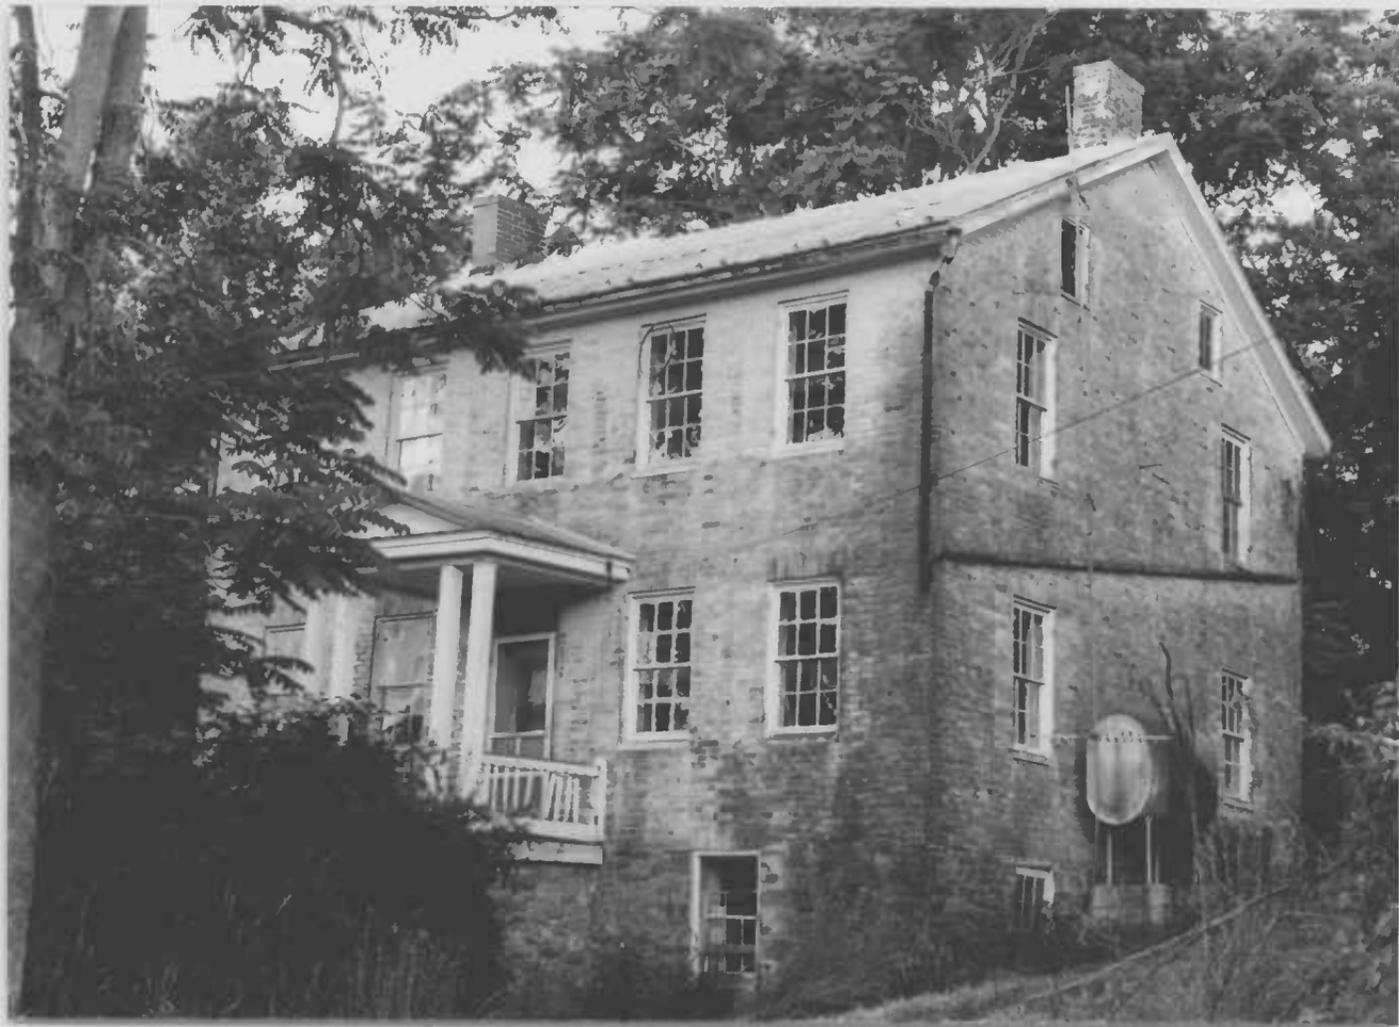
Neg. Loc.: Maryland Historical Trust
house - east & north elevs.

The house is a five-bay by two-bay, two-story banked structure with a rubble stone foundation, all-stretcher bond brick, and a gable roof with inverted-V-seam metal and a north-south ridge. There is an interior brick chimney on each end. The house is banked on the west with an exposed cellar wall on the east elevation. The east elevation in the cellar is only three bays. The center bay has a projecting stone porch foundation that does not appear to be tied into the house foundation. There is a 6/6 double-hung sash set between the south and south-center bays. It has a wood sill, a splayed brick jack arch, and a bullnose frame.

There is a similar 6/6 sash set between the north and north-center bays. There is some quoining at the corners of the foundation. The first story has a center entrance. The door has one light over two panels, and a four-light transom. The soffit has one panel and the jambs two panels each, one panel set at transom level, and one at the door level. These panels are sunk and flat, with quirked Greek ogee panel moulds. On either side are two 6/6 sash like those found on the cellar story. They also have shutter hardware. There is a one story, one-bay porch with four boxed posts that have Greek-ogee-moulded caps. The sides of the porch have rectangular-in-plan vertical balusters that are set into mortises in the top and bottom rails. The bottom rails are horizontal boards, the ends of the boards are set in mortises in the posts, but are not pegged. The end posts are set very close to the inside post, and there were originally balustrades between each pair of closely-set end posts. The second story has five typical 6/6 sash with blind hardware. The wood box cornice has a fascia board underneath of it. There are a series of T-shaped metal spikes in the brick wall to tie it to the structure behind, which is apparently log. They are set in the same rows and in alternating columns to create a distinct pattern on each elevation of the building. On the east elevation there are five rows, one beneath the first story windows, one in the middle of the first story windows, one just above the first story windows, one below the second story windows, and one in the middle of the second story windows.

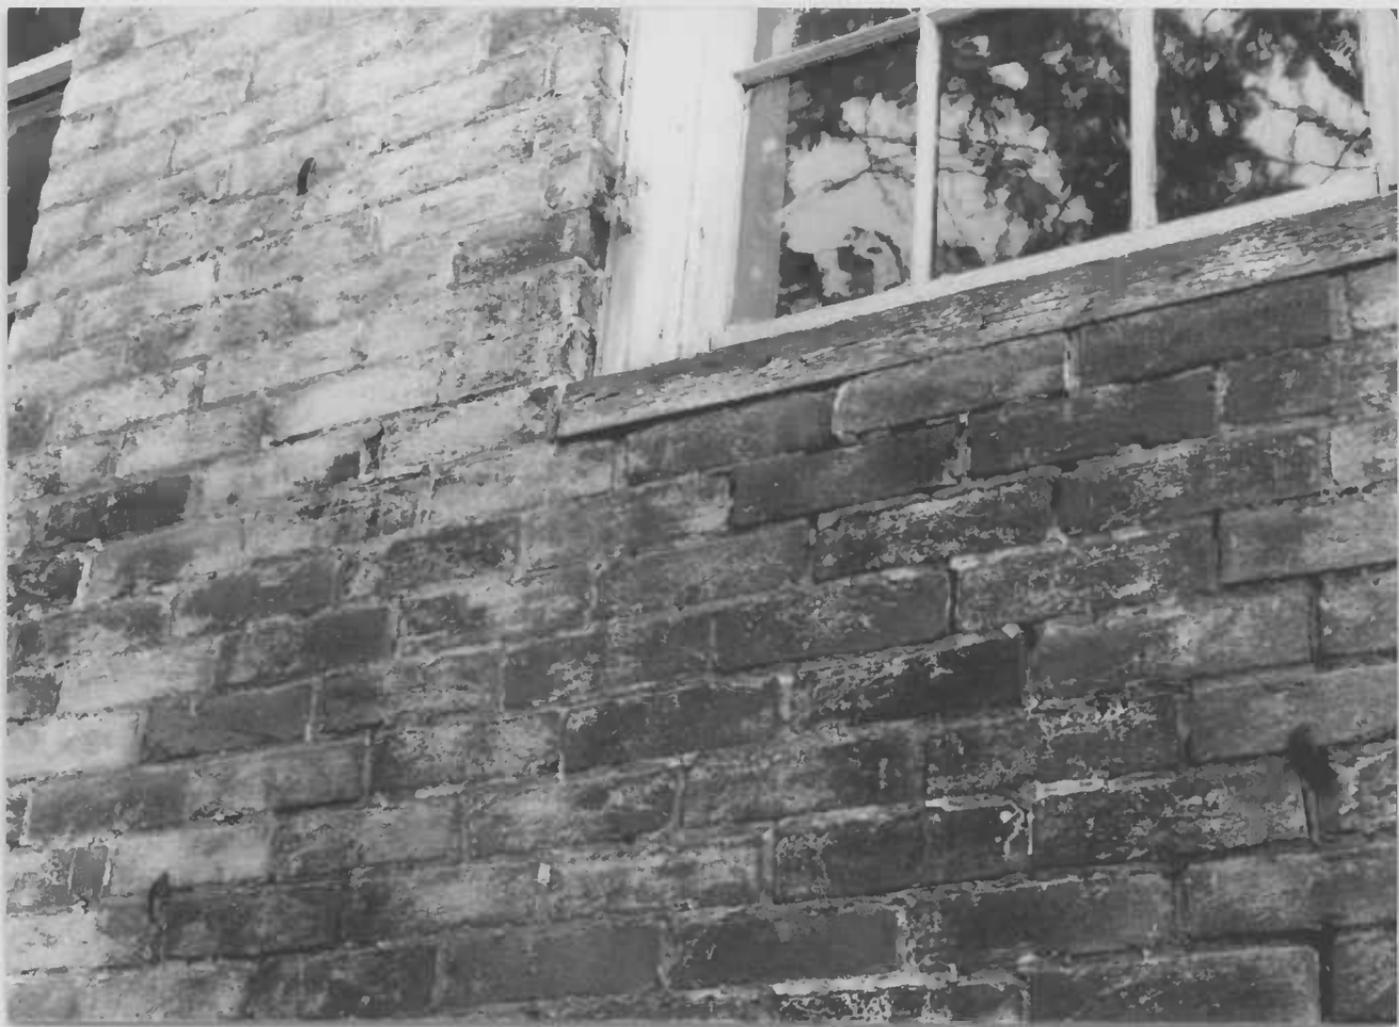
house - east elev. detail - clamps

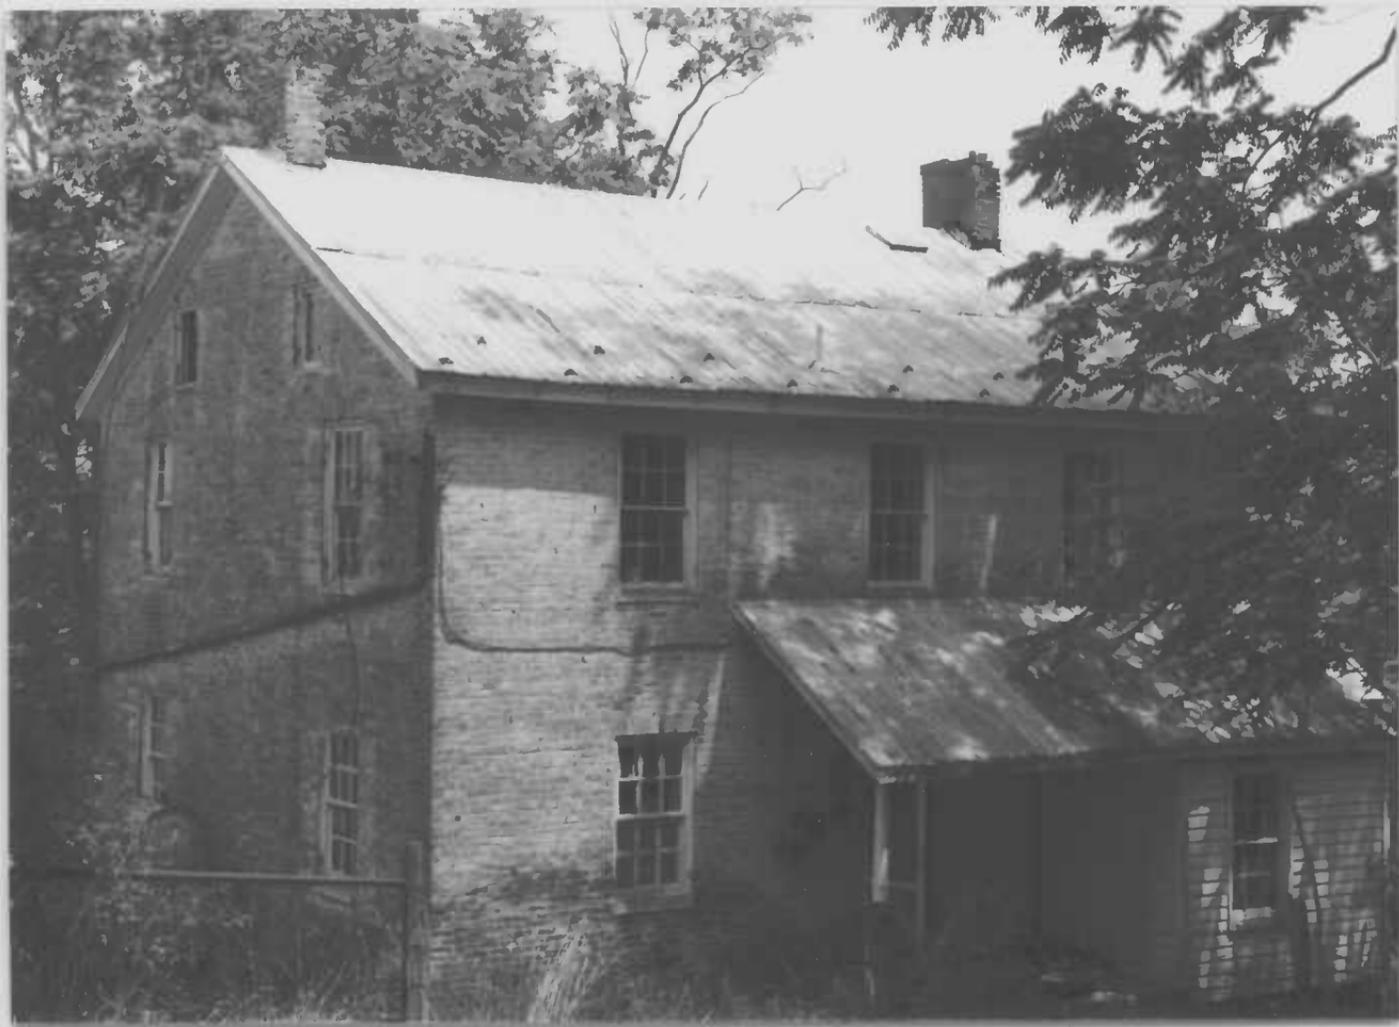
house - north and west elev's.

The north elevation foundation has a typical 6/6 sash in the east bay. The west bay has a diamond-in-section wood louver vent with a splayed brick jack arch. The frame of the vent is notched on the top rail to hold three stiles, one of which is in the center. The frame is not mortised and tenoned and pegged. The first story has two typical 6/6 sash with blind hardware. The second story is identical. The gable end has two four-light sash with wood sills, straight brick jack arches, bullnose frames, and shutter hardware on both sides of the frame. There are eight rows of spikes on this elevation, the bottom five being identical in placement to those in the east elevation. In addition there was one row just above the second story windows, one just above the gable end windows, and one spike in the gable peak.

The west elevation is three bays. The first story has a center entrance. The door has now been altered and is one light over two small panels, with two tall panels at the bottom. These panels have sunk fields with Greek ogee panel moulds. The door has a bullnose frame and a four-light transom above it. The soffit and jambs are plain and there is a splayed-brick jack arch. The north bay has a typical 6/6 sash. The south bay is a porch that has been enclosed with German siding and cornerboards of German siding. There is a 6/6 sash with surrounds made of cut-down German siding. The sash has shutter hardware. The porch was originally one bay and one story in the center bay and this enclosure in the south bay was added later. It covers a small part of the porch and the roof is not integral. Both the porch and the addition have a shed roof with corrugated metal. The second story has three typical 6/6 sash. There are five rows of metal spikes, or clamps, on the west elevation and they are identical in placement to the east elevation.

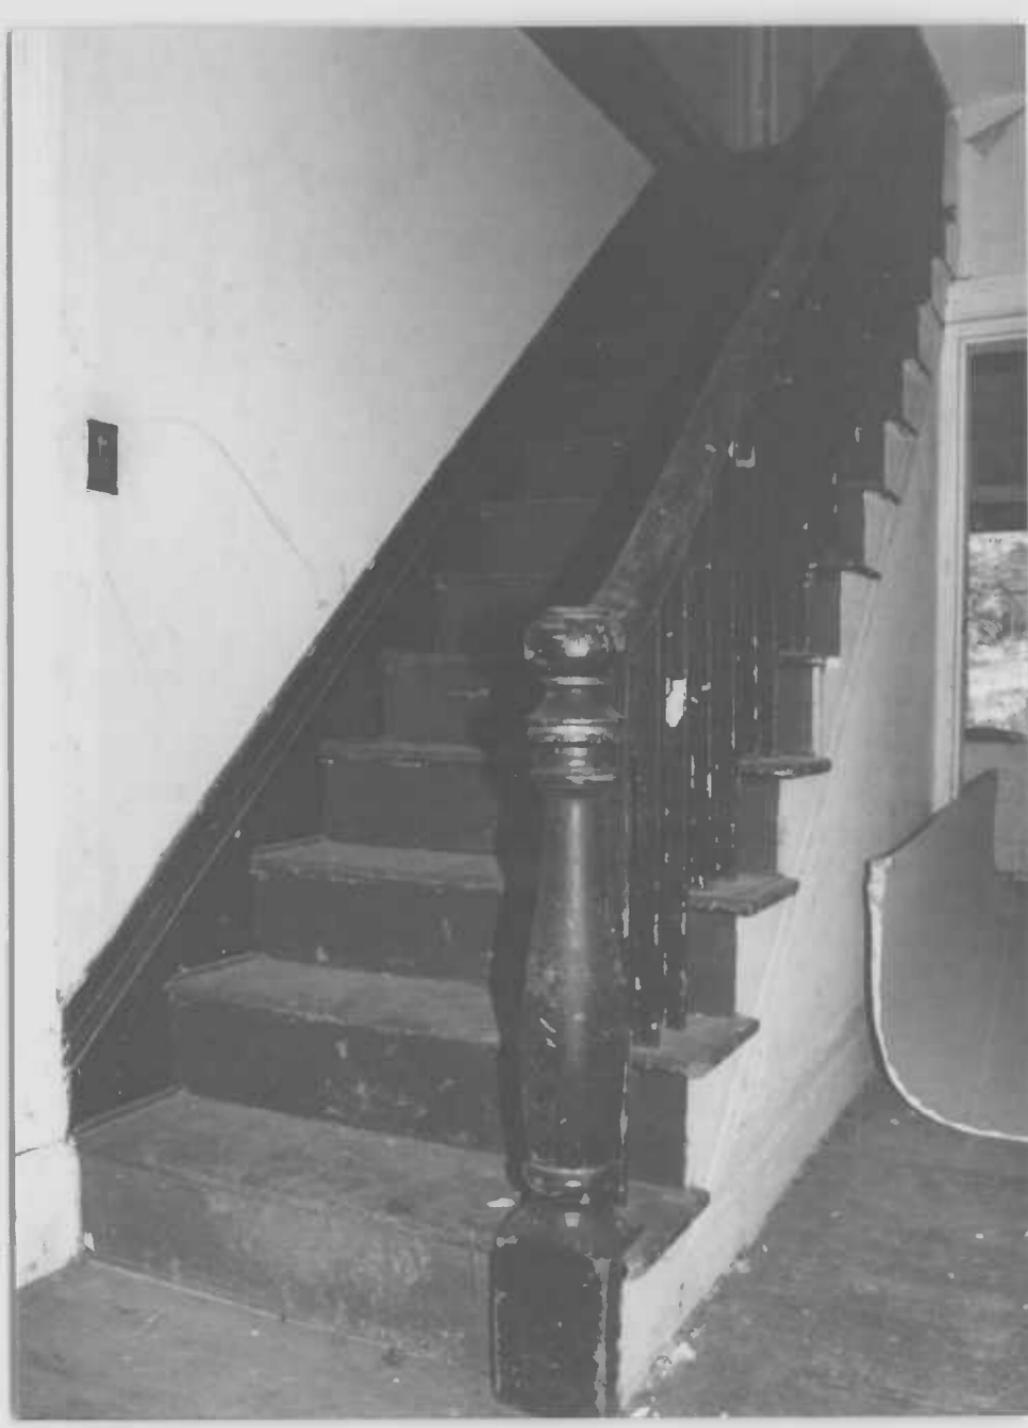
house - stairway

The first story has a center-passage double-pile plan. The center passage has a straight run of stairs along the south wall. This has an open stringer with a Greek ogee and

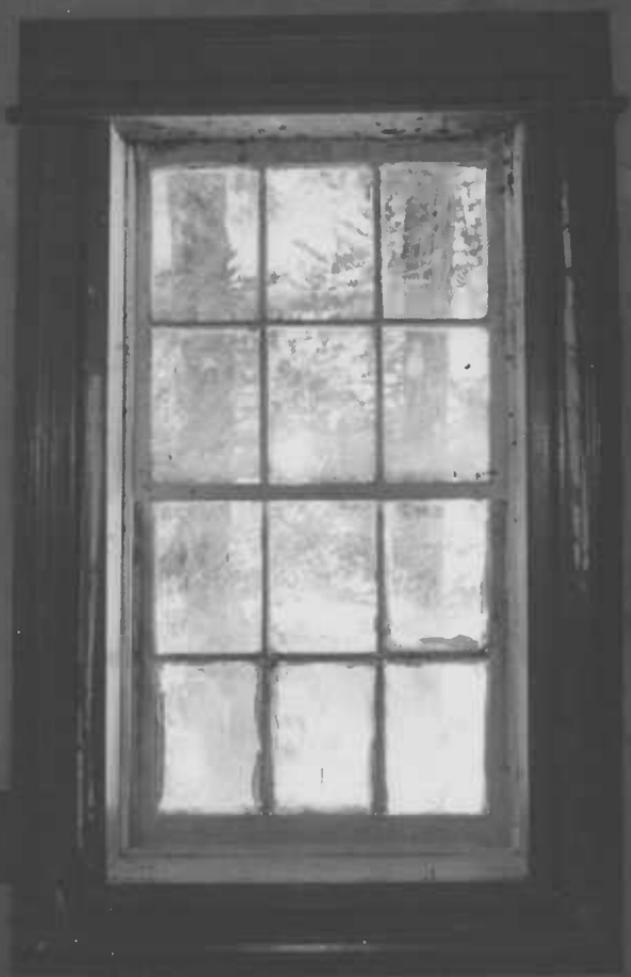
Neg. Loc.: Maryland Historical Trust
house - northeast room, window detail

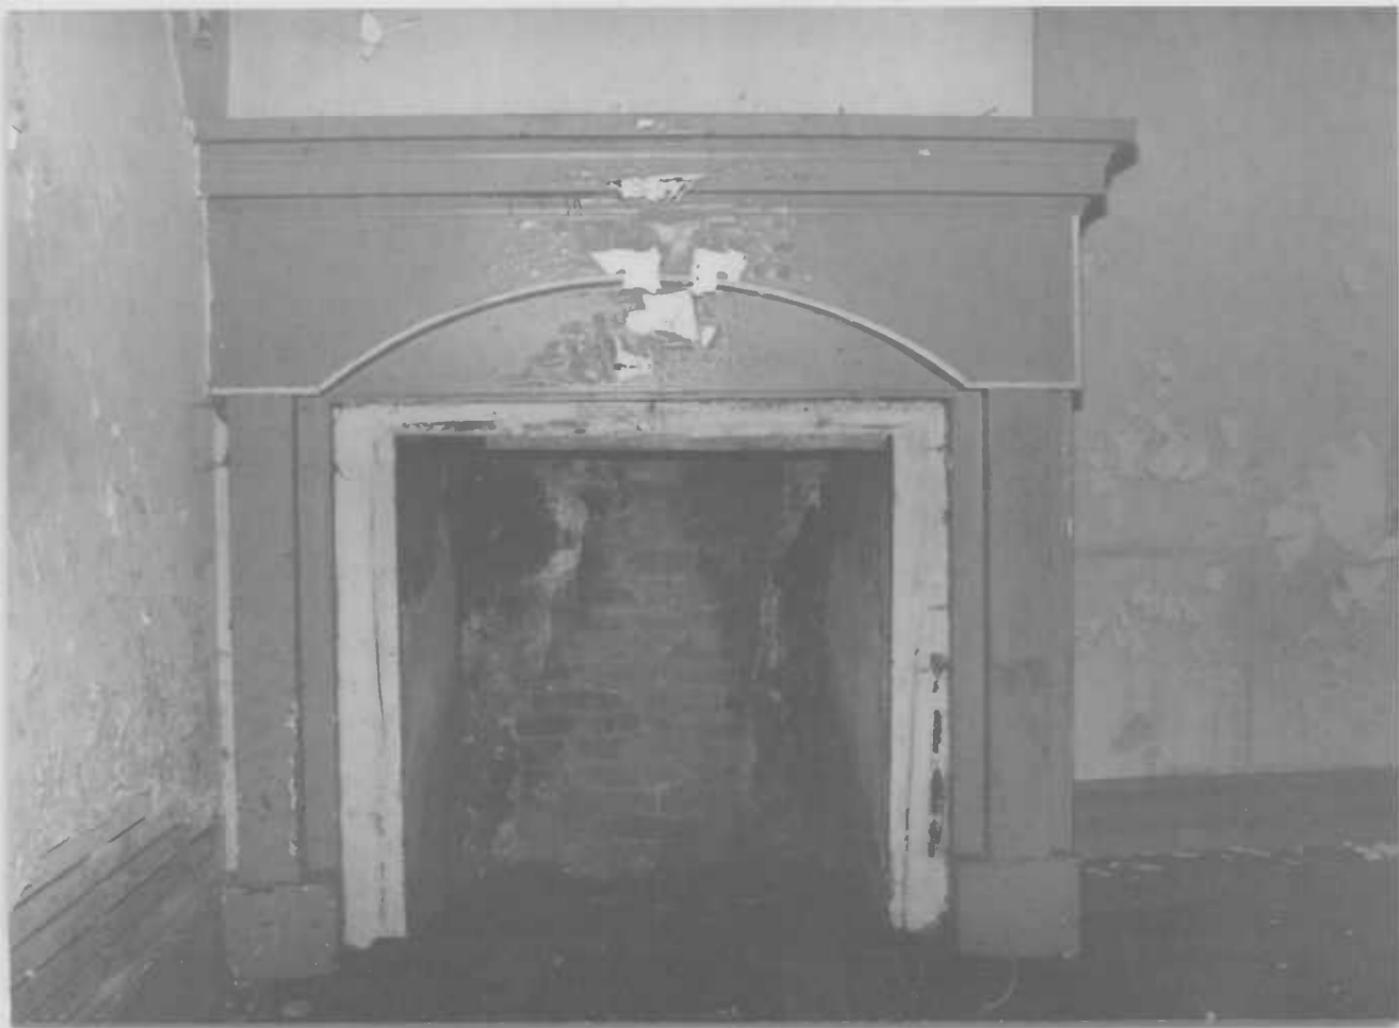
Neg. LOC.: Maryland Historical Trust
house - northeast room mantle

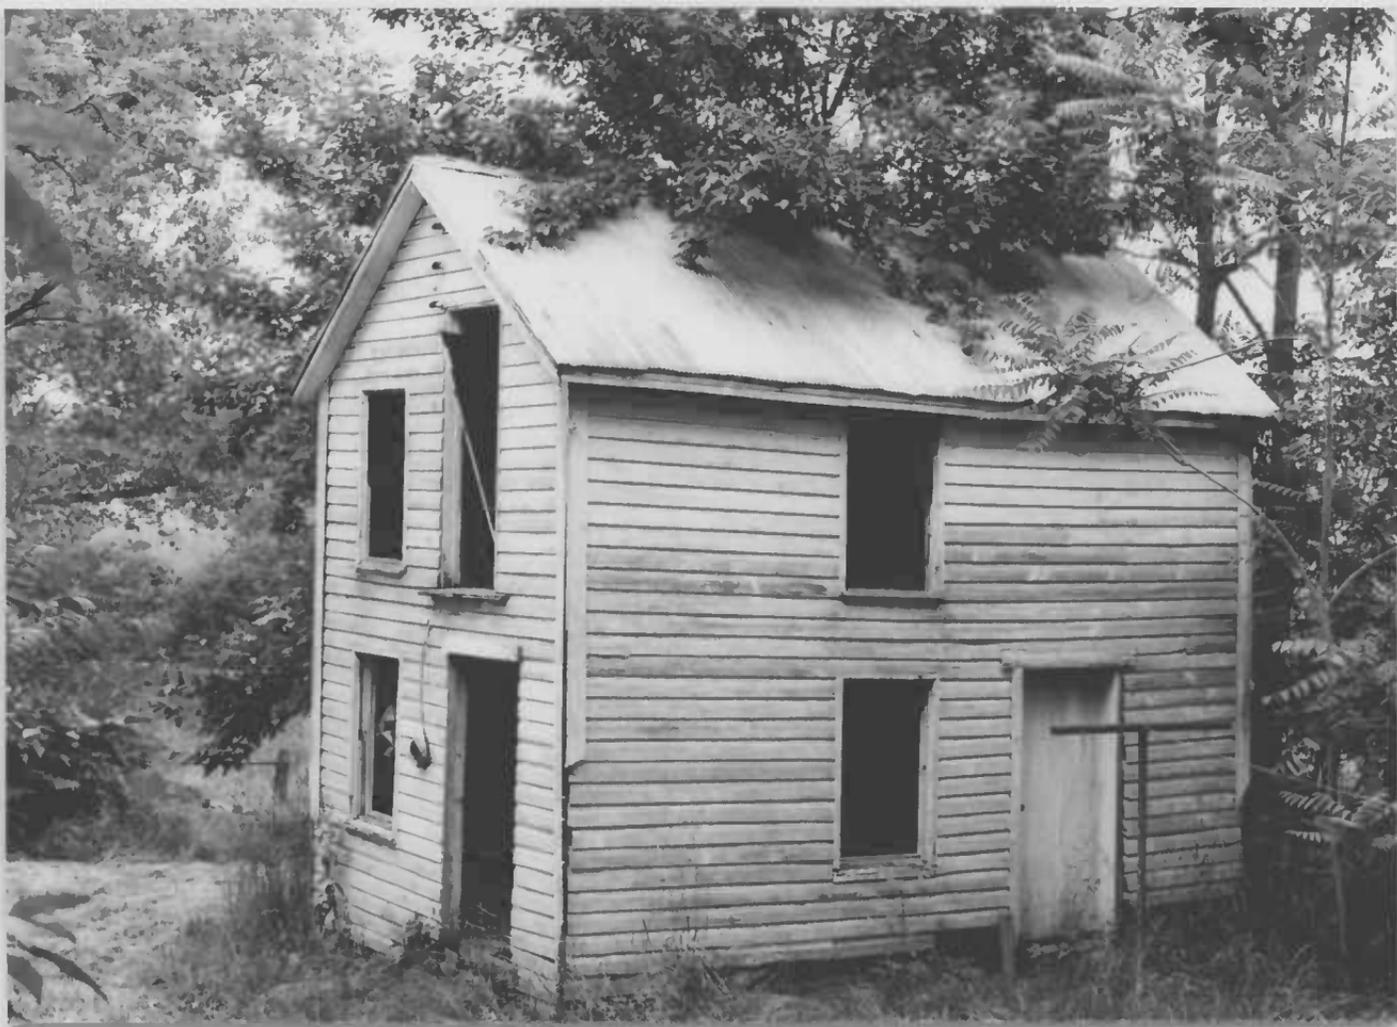
Summer house - north & west elevs.

About 20 feet south of the house is a summer kitchen. It is two bays by two bays and two stories tall. It has a rubble stone foundation, German siding with corner boards of German siding, and a corrugated metal gable roof with a north-south ridge. The north elevation in the first story has a window opening to the east and a vertical-board door to the west. The second story is identical to the first story. The east elevation has one window opening centered on the first and second stories. The west elevation on the first story has a window opening to the north and a vertical-board door to the south. The second story has a window opening to the north. The south elevation has no openings.

The first story of this structure has a large brick fireplace centered on the south elevation. It has a wood mantel tree and formerly had a crane, but only the two pivots for the crane survive in the brick masonry. The structure is built of 2 x 4 circular-sawn lumber. There is a winder stair in the southwest corner. The rafters are also circular-sawn 2 x 4's and are mitered at the ridge. Part of a six-light sash survives on the second story east elevation.

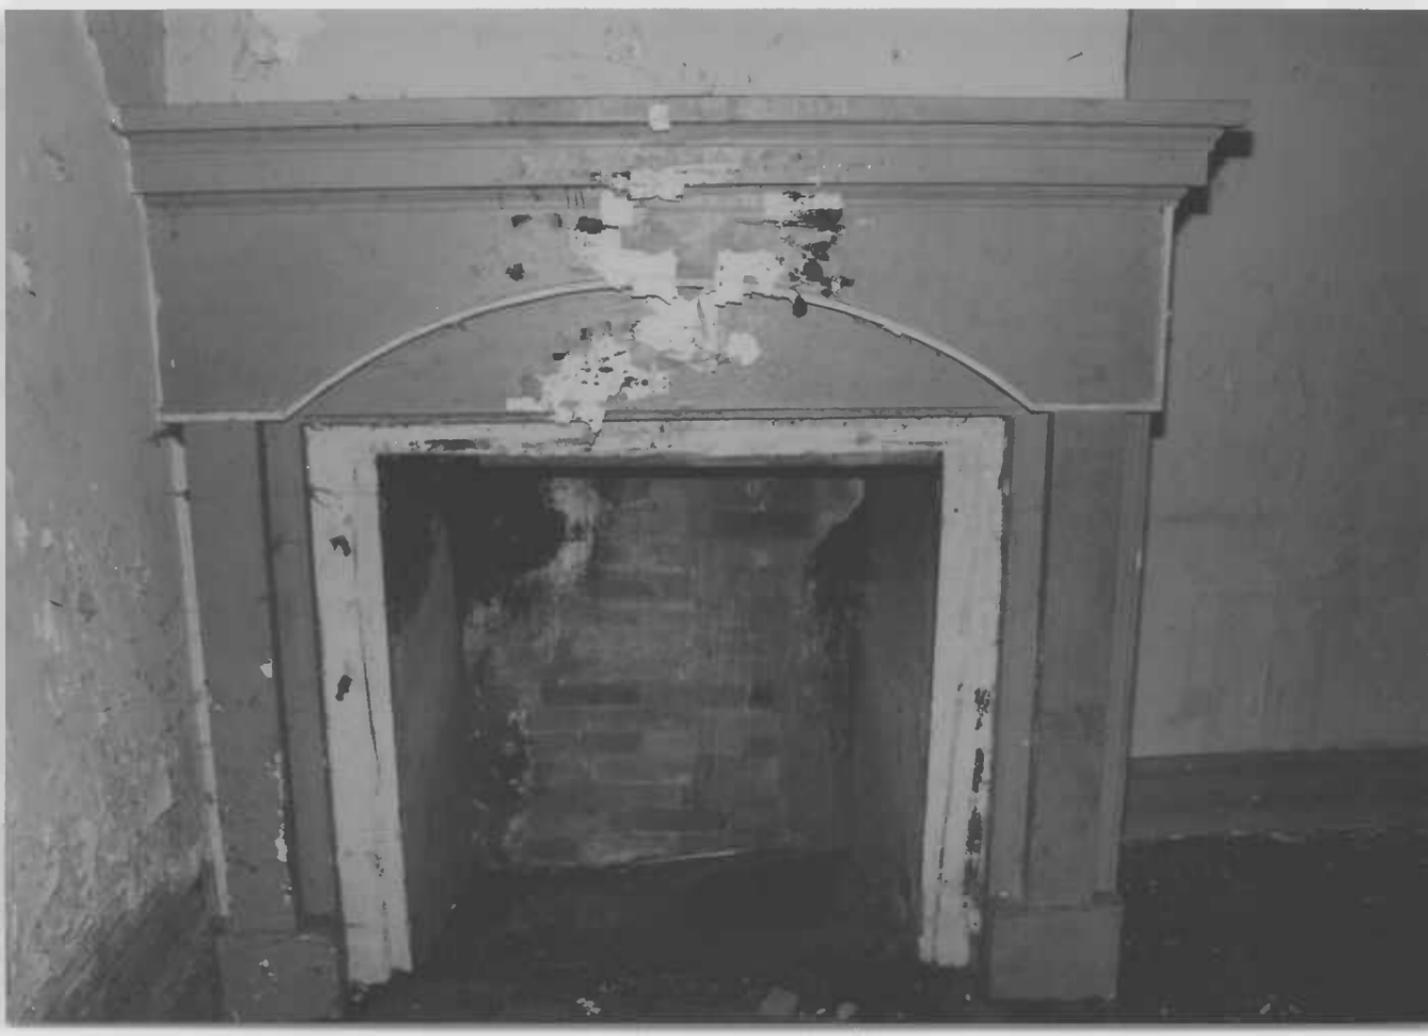
Neg Loc, Maryland Historical Trust
NE RM. Mantel

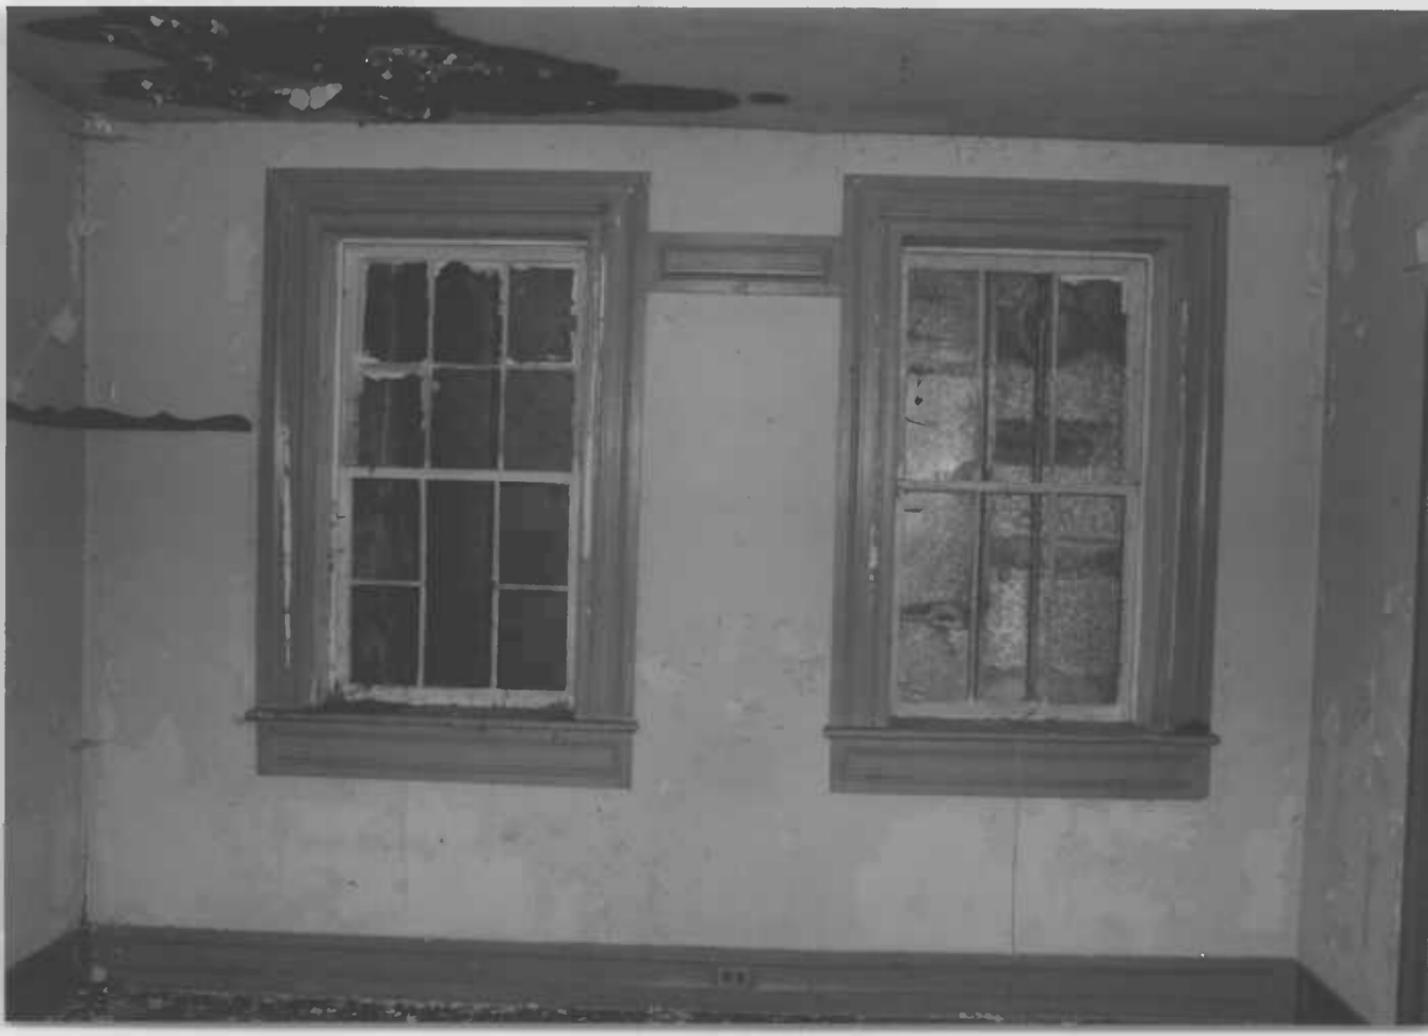
NE RM - 6 - Elev.

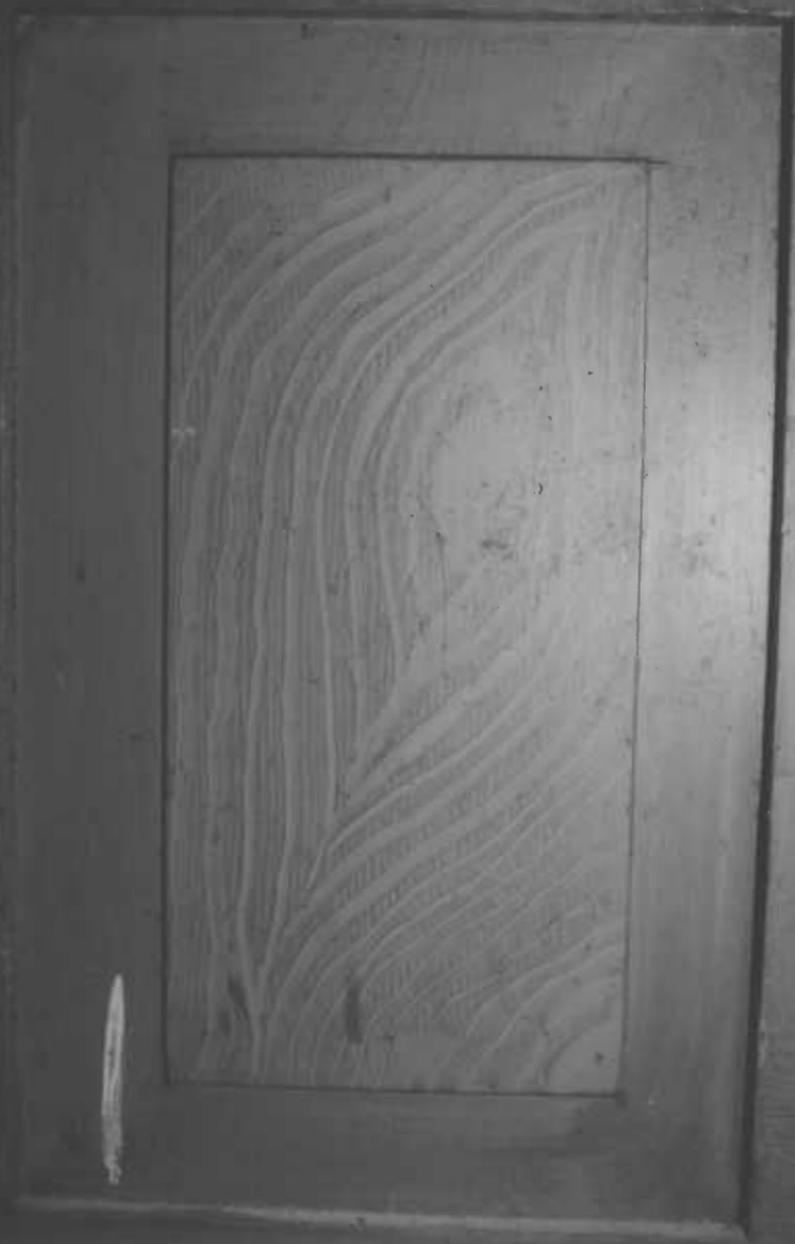
Heiner-Haugh Farm
1302 Otterdale Mill Rd
SW Chamber Deer Shaving

The southeast chamber has the same trim, baseboard, doors, and floor as found in the northeast chamber. The southwest chamber also has the same finishes. The door has a cast iron rim lock with "D.M. & Co. NEW HAVEN". The chamber side of the door is grained dark, like walnut. The west chamber also has the same finishes, but the door is painted. The northwest chamber has the same finishes and flooring and the same box lock as is found in the southwest chamber. The east wall has mill-sawn studs and a combination of mill-sawn and circular-sawn lath.
