Maryland Historical Trust State Historic Sites Inventory Form

Survey No. CARR-1401

historic Heiner-Haugh Farm

street & number 1302 Otterdale Mill Road ___ not for publication

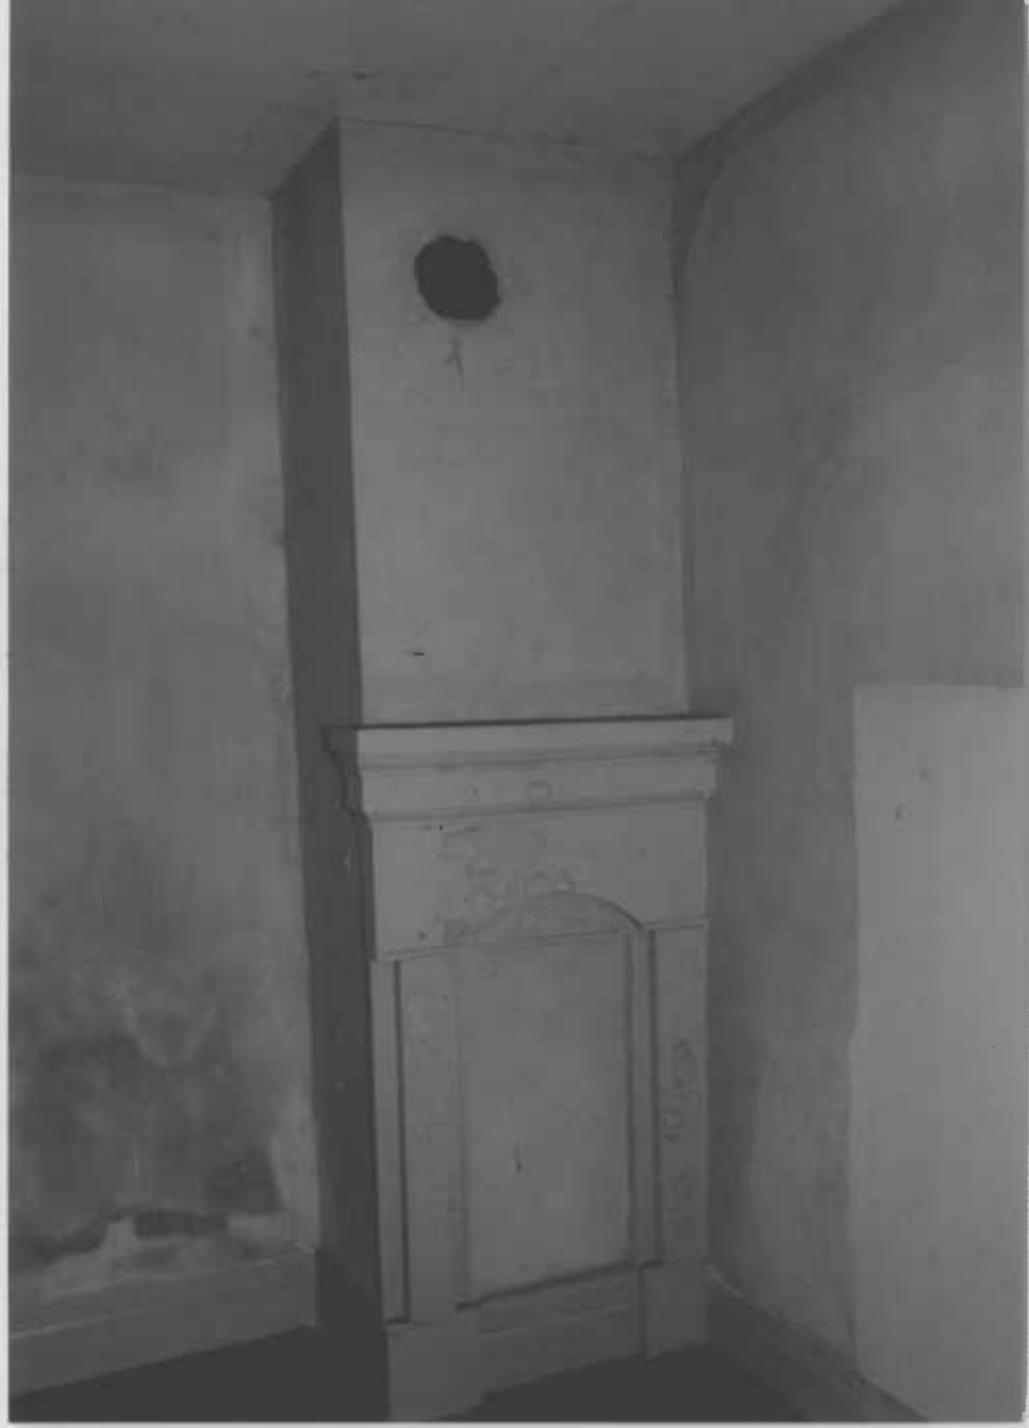
SE. RM Fireplace

The southeast room has the same floor as the passage and the same baseboards as the passage. The trim underneath the windows is identical to that found in the northeast room. The architraves have a quirked Greek ogee in the center and a bead on the inner edge. They have no back band and there is no evidence that there ever was one. Between the two east windows is a moulding like that on the northeast room, but the ogees are on the top and bottom only and not on the sides. The south wall, to the west, has a wood mantel on a brick chimney. There was never a fireplace here. The mantel has plain pilaster strips and a segmentally-arched frieze. It is identical to the northeast room mantel, but is much narrower.
