CARR-1459

Taneytown Bank and Trust Company Building
Taneytown

Maryland Historical Trust State Historic Sites Inventory Form

CARR-1459
Taneytown Bank and Trust Company Building
24 East Baltimore Street

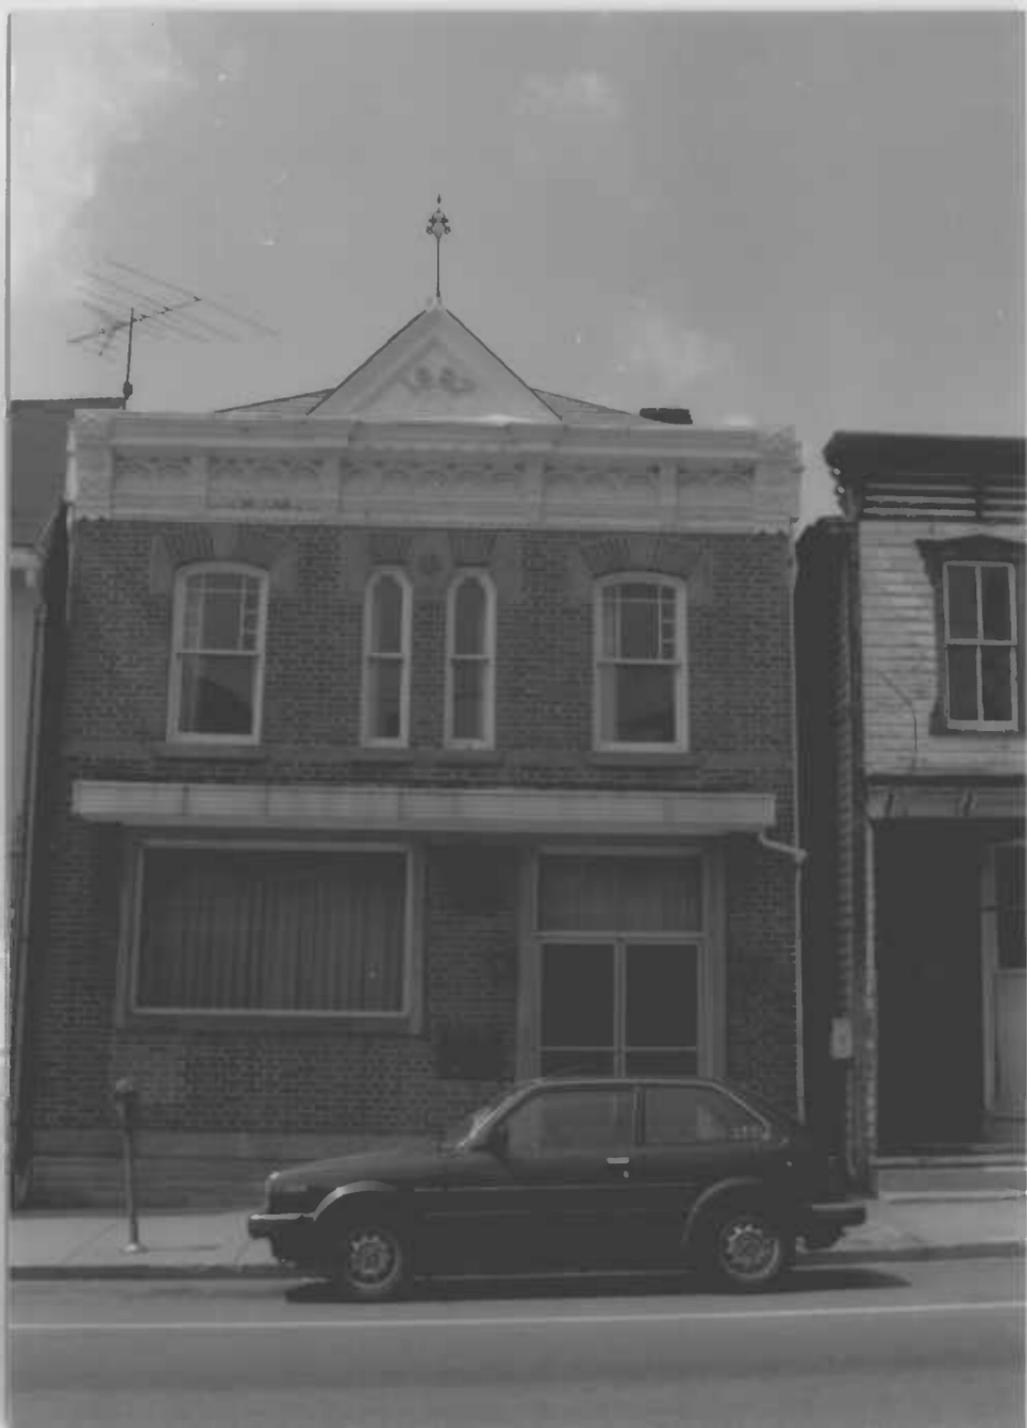
1/3

The Taneytown Bank and Trust Company Building is located at 24 East Baltimore Street in Taneytown, in northwestern Carroll County, Maryland. The building is located on the west side of the street and faces east. It is a two-story, three-bay brick building, with a hip roof of slate and a pediment on the east elevation. The east elevation foundation is rubble stone covered by formstone. Above it is a water table that appears to be granite. The east elevation has Flemish bond brick work. The first story has a new window opening to the south with an architrave that appears to be granite. To the north is a new door opening with the same stone trim. There is a small new metal pent roof between the first and second stories and a granite belt course. The second-story, center bay has two 1/1 sash with shouldered depressed arches. The arch has a stone voissior on each end and one in the center. They appear to be granite. The center voissior is carved with a four-lobed leafy design. There are brick voissoirs between the stone voissoirs. The end bays have segmentally-arched Queen Anne sash above a single-light sash. There is a pressed-metal cornice with brackets, and segmental arches in the frieze between the brackets. There are large end brackets that have fleur de lis, and there is a pediment in the center with "1887". There is also cast iron roof cresting with a finial.

east elev.

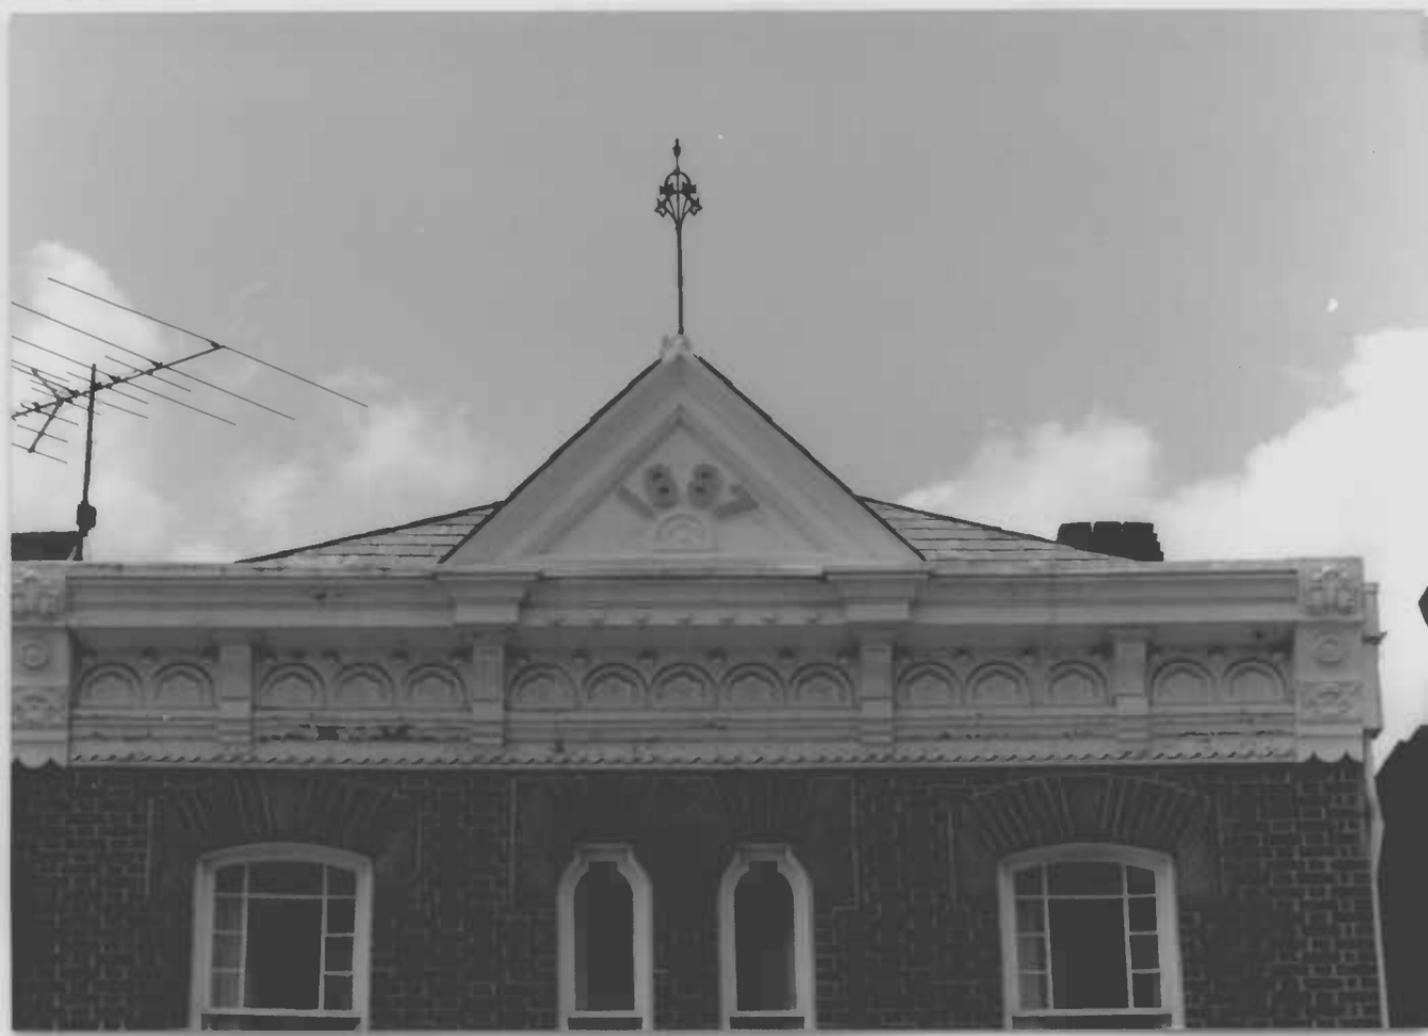
2/3

Neg. Loc.: Maryland Historical Trust
east elev. - pediment

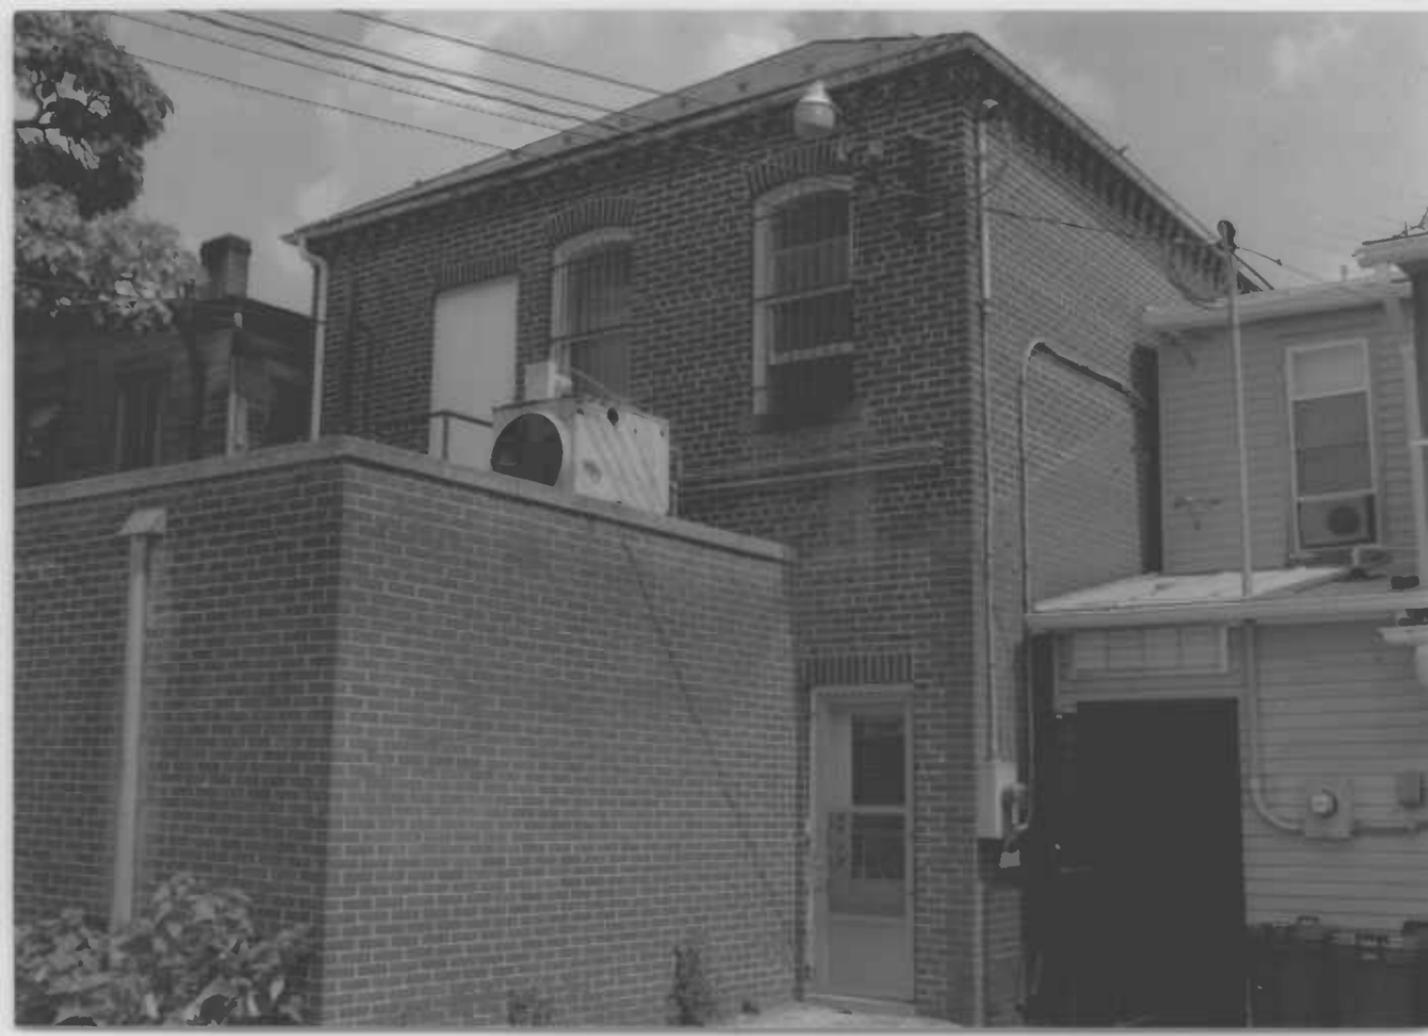
3/3

On the west elevation, the north bay of the first story has a segmentally-arched 1/1 sash with steel bars. There is a hurricane door to the cellar beneath this window. A new brick vault has been added to the center of this elevation. The south bay has a door with one light over one panel. The second story has new brick and mortar and a new door in the north bay. The center and south bay windows match the first story. The cornice is identical to the north elevation. The roof is hipped on the west. The south elevation is basically inaccessible, but has the same cornice as the north elevation.

w. S. elevs.
