CARR-1489

Pickett Mill Property  
Winfield (vicinity)

**Maryland Historical Trust**  
**State Historic Sites Inventory Form**

Survey No. CARR-1489

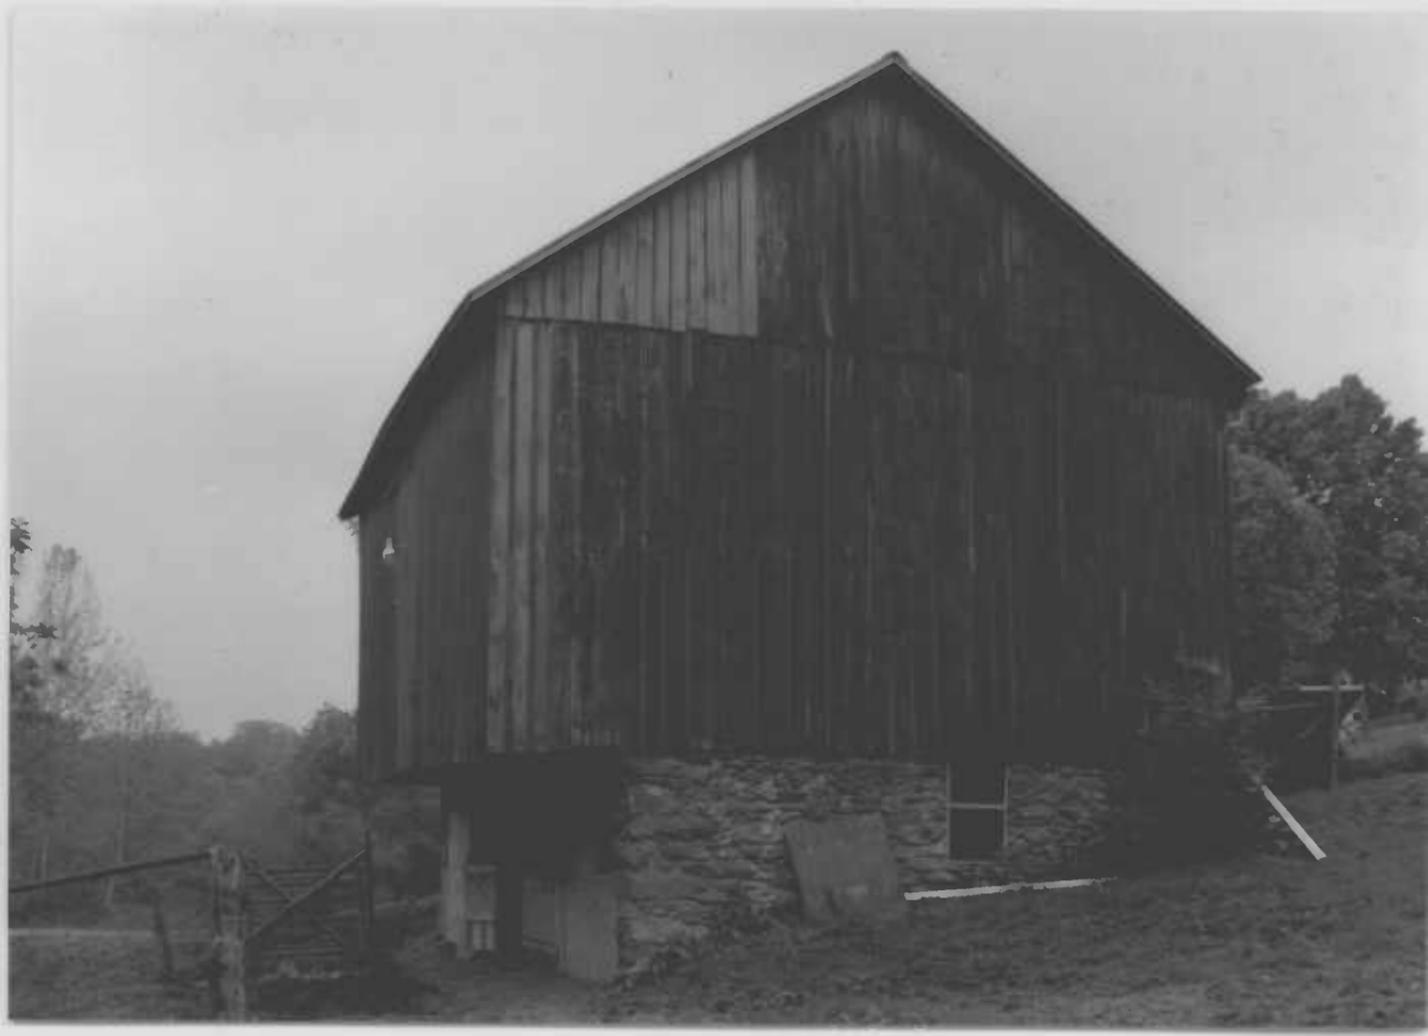
1/2

Also on the property is a bank barn with a forebay that faces northeast. The northeast elevation on the lower story has some horizontal board-and-batten siding with a center dutch door on strap hinges that have round ends. There is a large opening on either side that had a door on rollers, but now has plywood infill. The upper story has beaded-edge-and-center vertical boards and had a center door on rollers, but is now infilled. The southeast elevation lower story has board-and-batten siding with two window openings. The upper story has board-and-batten siding with no openings. The northwest elevation has a new window in an original opening in the lower story, and board-and-batten siding in the upper story with no openings. The southwest elevation has center wagon doors on rollers with board-and-batten siding. The barn has new inverted V-seam-metal roofing, with a northwest-to-southeast running ridge. It has a gable roof.

The lower story has a circular-sawn summer beam that runs northwest to southeast. It has a beveled half-lap scarf and had two posts, one of which has been removed. The southeast end of the summer beam has a post underneath of it. This appears to be an original configuration. The joists run northeast to southwest, and are circular sawn on top and bottom. They span the whole width of the barn. The forebay wall is frame and has a concrete foundation. The stall arrangement has been altered. The upper story has four circular-sawn, mortised and tenoned and pegged bents. Each bent has three posts. The end posts are braced, with a single girt at the top. The roof is supported by a Queen post truss, however, the vertical posts of the truss are not located above posts in the bottom half of the barn bent. The barn has a center threshing floor with a hay mow on each side. There are  $\frac{3}{4}$ -round log rafters that are mitered at the ridge and that support new lath.

Neg. Loc.: Maryland Historical Trust  
barn - NW elev.

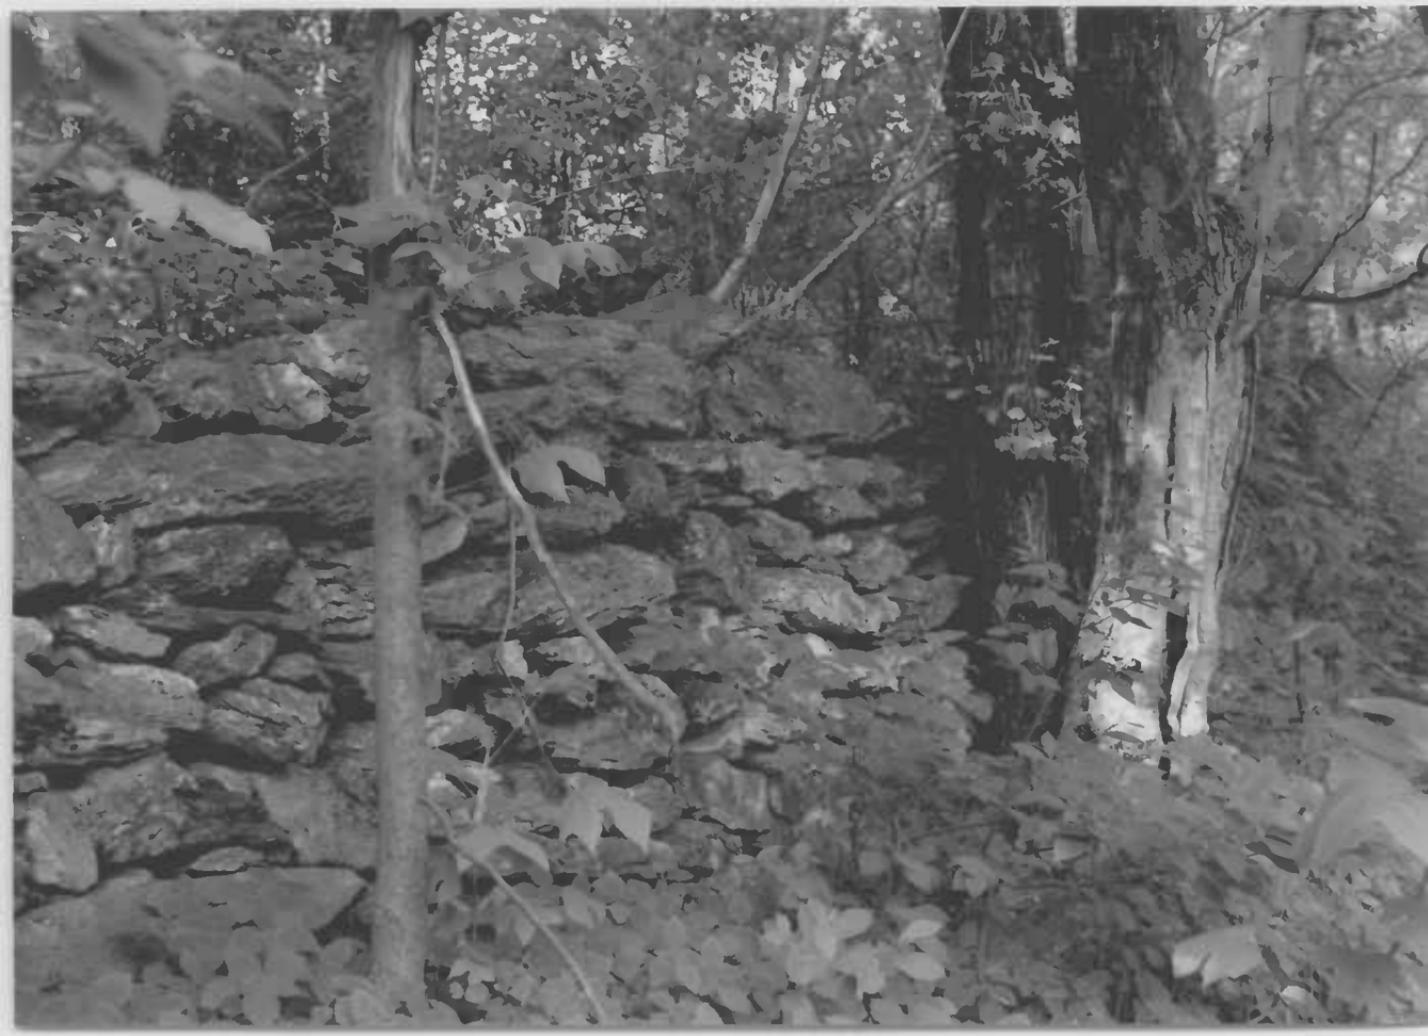
2/2

The Pickett Mill property is located on the west side of Skidmore Road, near the intersection of Braddock Road, about 1 mile southwest of Winfield in southwest Carroll County, Maryland. The property contains a house that was built in 1948, according to the tenant, and was added onto in 1960-61. There is a mill dam of dry laid stone on the property. According to the tenant, it measures about 560 feet long, and the dam was pretty much intact until a few years ago when tropical storm Hugo caused flooding that damaged it.

Neg. Loc.: Maryland Historical Trust  
near Braddock Rd., dam - partial view
