T-385
Chenar Farm
9284 Chenar Farm Road
Easton Vicinity
Ca. 1922-1923
Private

Maryland Historical Trust Maryland Inventory of Historic Properties Form

Inventory No. T-385

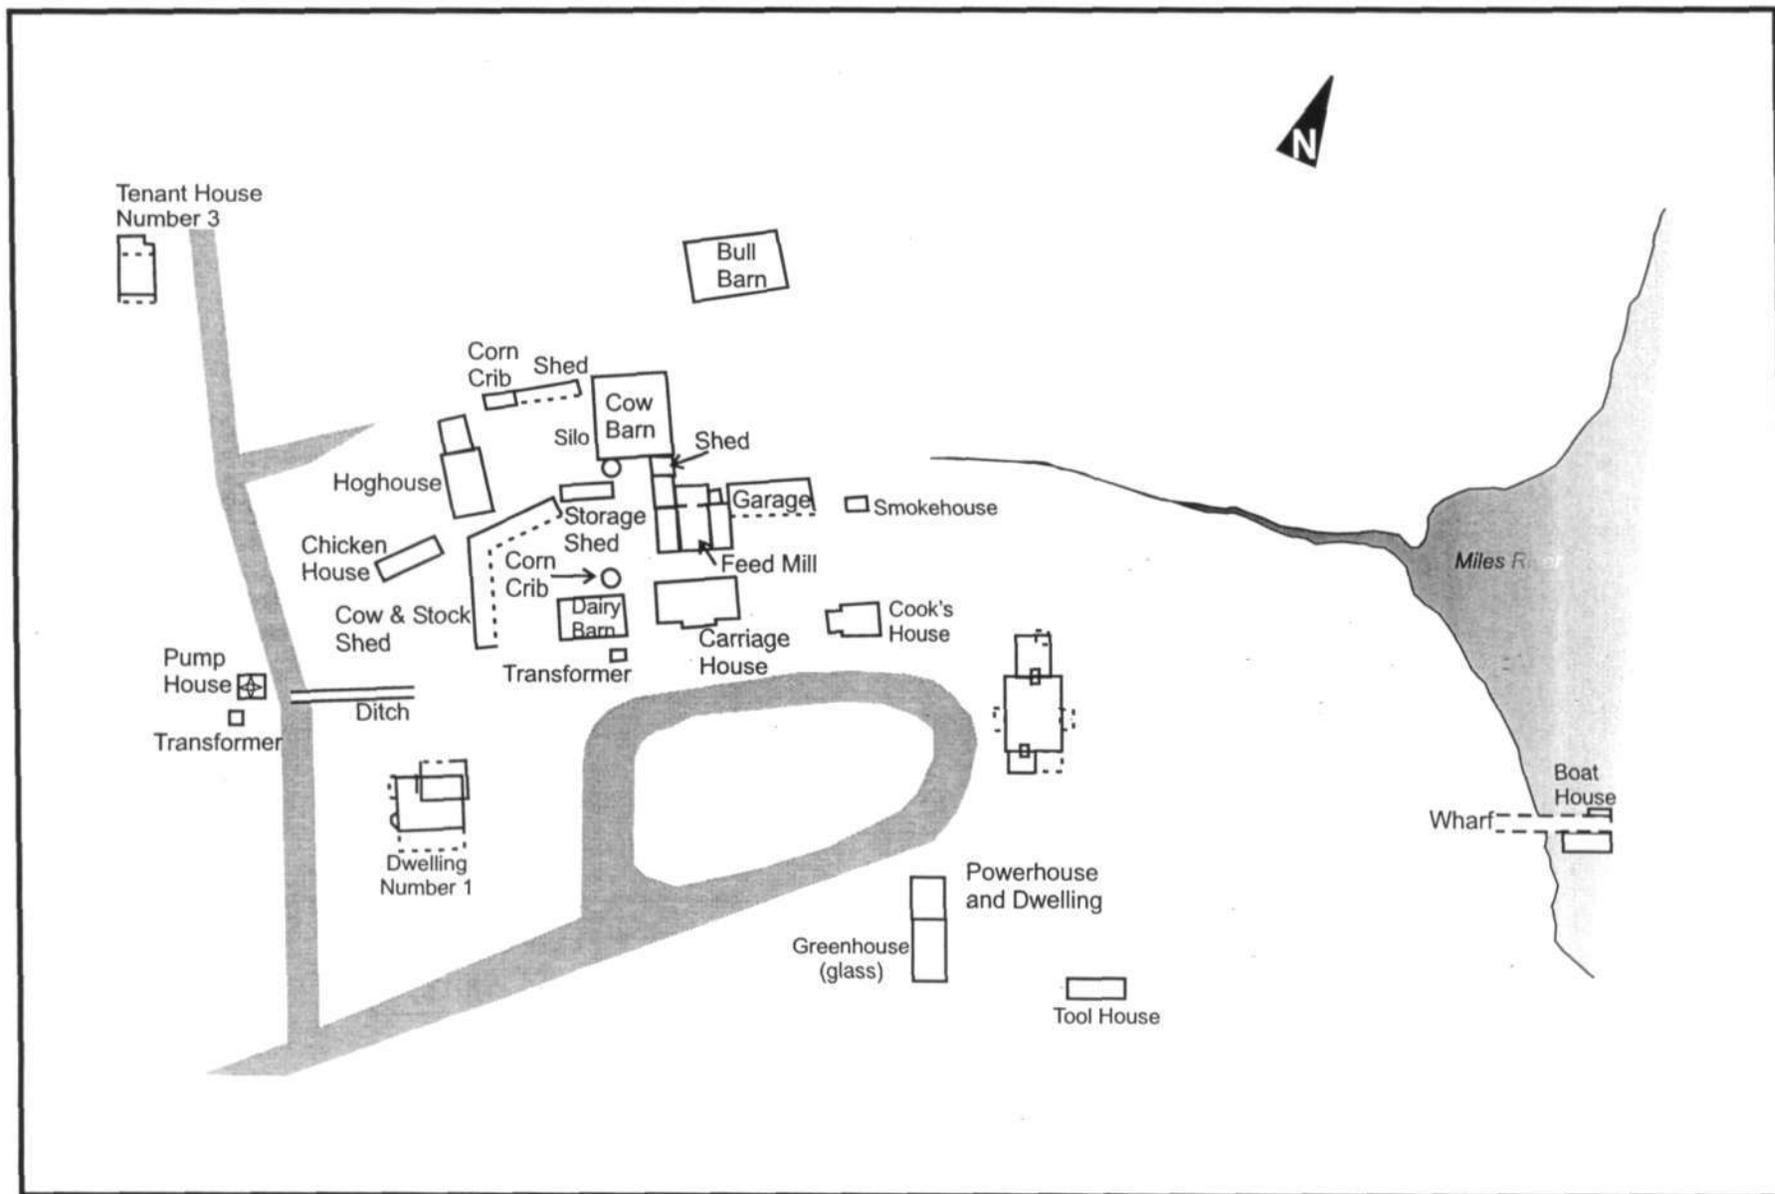
T-385
Chenar Farm
9284 Chenar Farm Road
Talbot County
Site Plan - 1923

The landscaping was designed by J. Franklin Meehan & Son, a landscape architecture firm with offices located in Mt. Airy, Maryland and Philadelphia, Pennsylvania. The plan called for the property to be approached down a long road lined with sycamores, and with the main house at the end of the drive with a circular driveway and grassy circle in the front. Between the main house and the Miles River, the land gently slopes with specimen plantings. Gardens were to be located to the south of the house. The original plans also called for a formal flower garden, arbors for roses and vines, a berry garden, a vegetable garden, and grape vines. The landscape plan was followed closely, with the exception of the garden area. The formal garden was developed in its intended location, but there are no traces of the planned arbors, berry garden, vegetable garden, or grape vines. In the intended vegetable garden location a second formal garden was planted. The areas away from the main house were left as grassy fields, with deciduous trees planted as windbreaks and view screens. The house, tool house, powerhouse, and tenant house #1 are located amongst dense overgrowth.

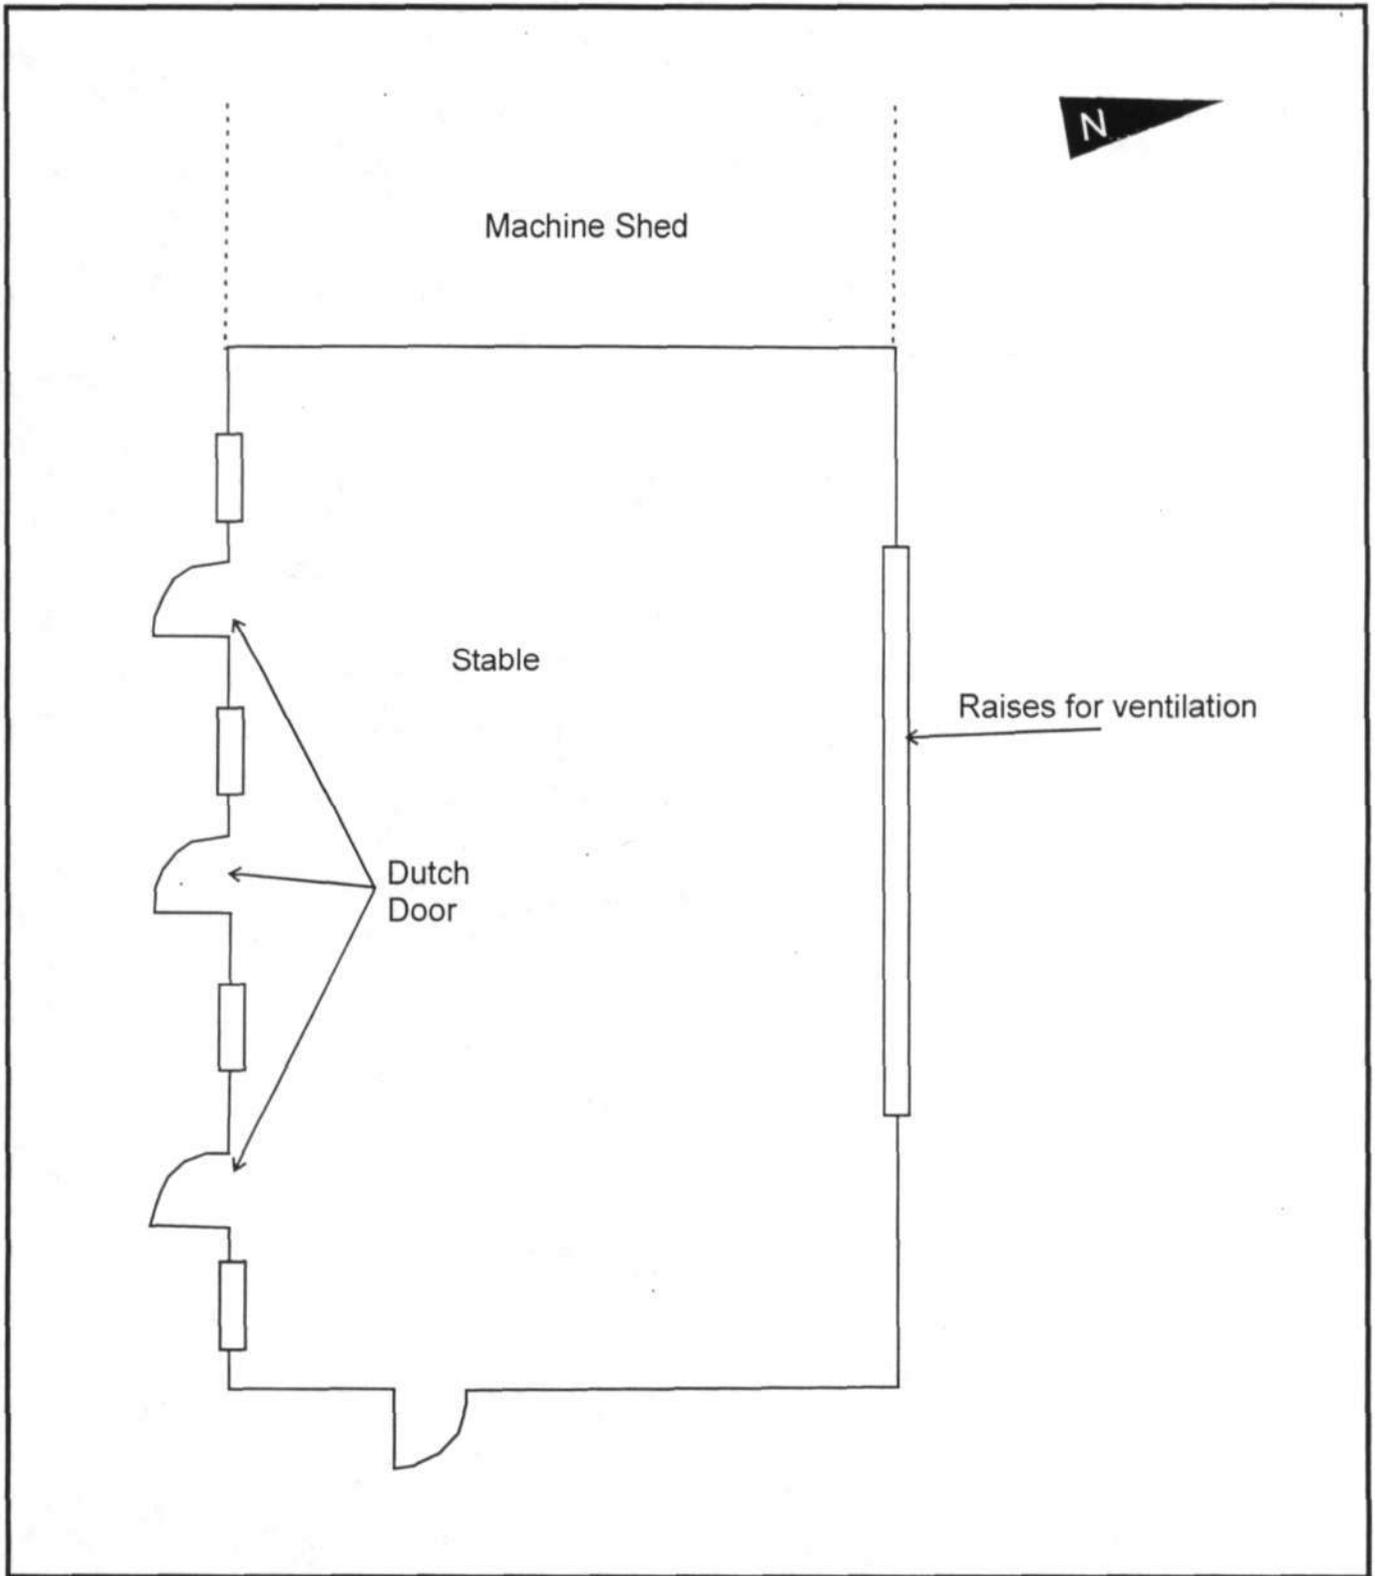
T-385
Chenar Farm
9284 Chenar Farm Road
Talbot County
Machine Shed - 2003

A machinery shed is located to the east of tenant house #2 and faces southwest. It is three bays wide and is of timber frame construction with an open southwest façade. The shed rests on a combination pier and continuous poured concrete foundation. The walls are clad with vertical wood planks. The offset side gable roof is clad with standing-seam metal. There are no doors or windows. The interior of the building is unfinished with an earthen floor.

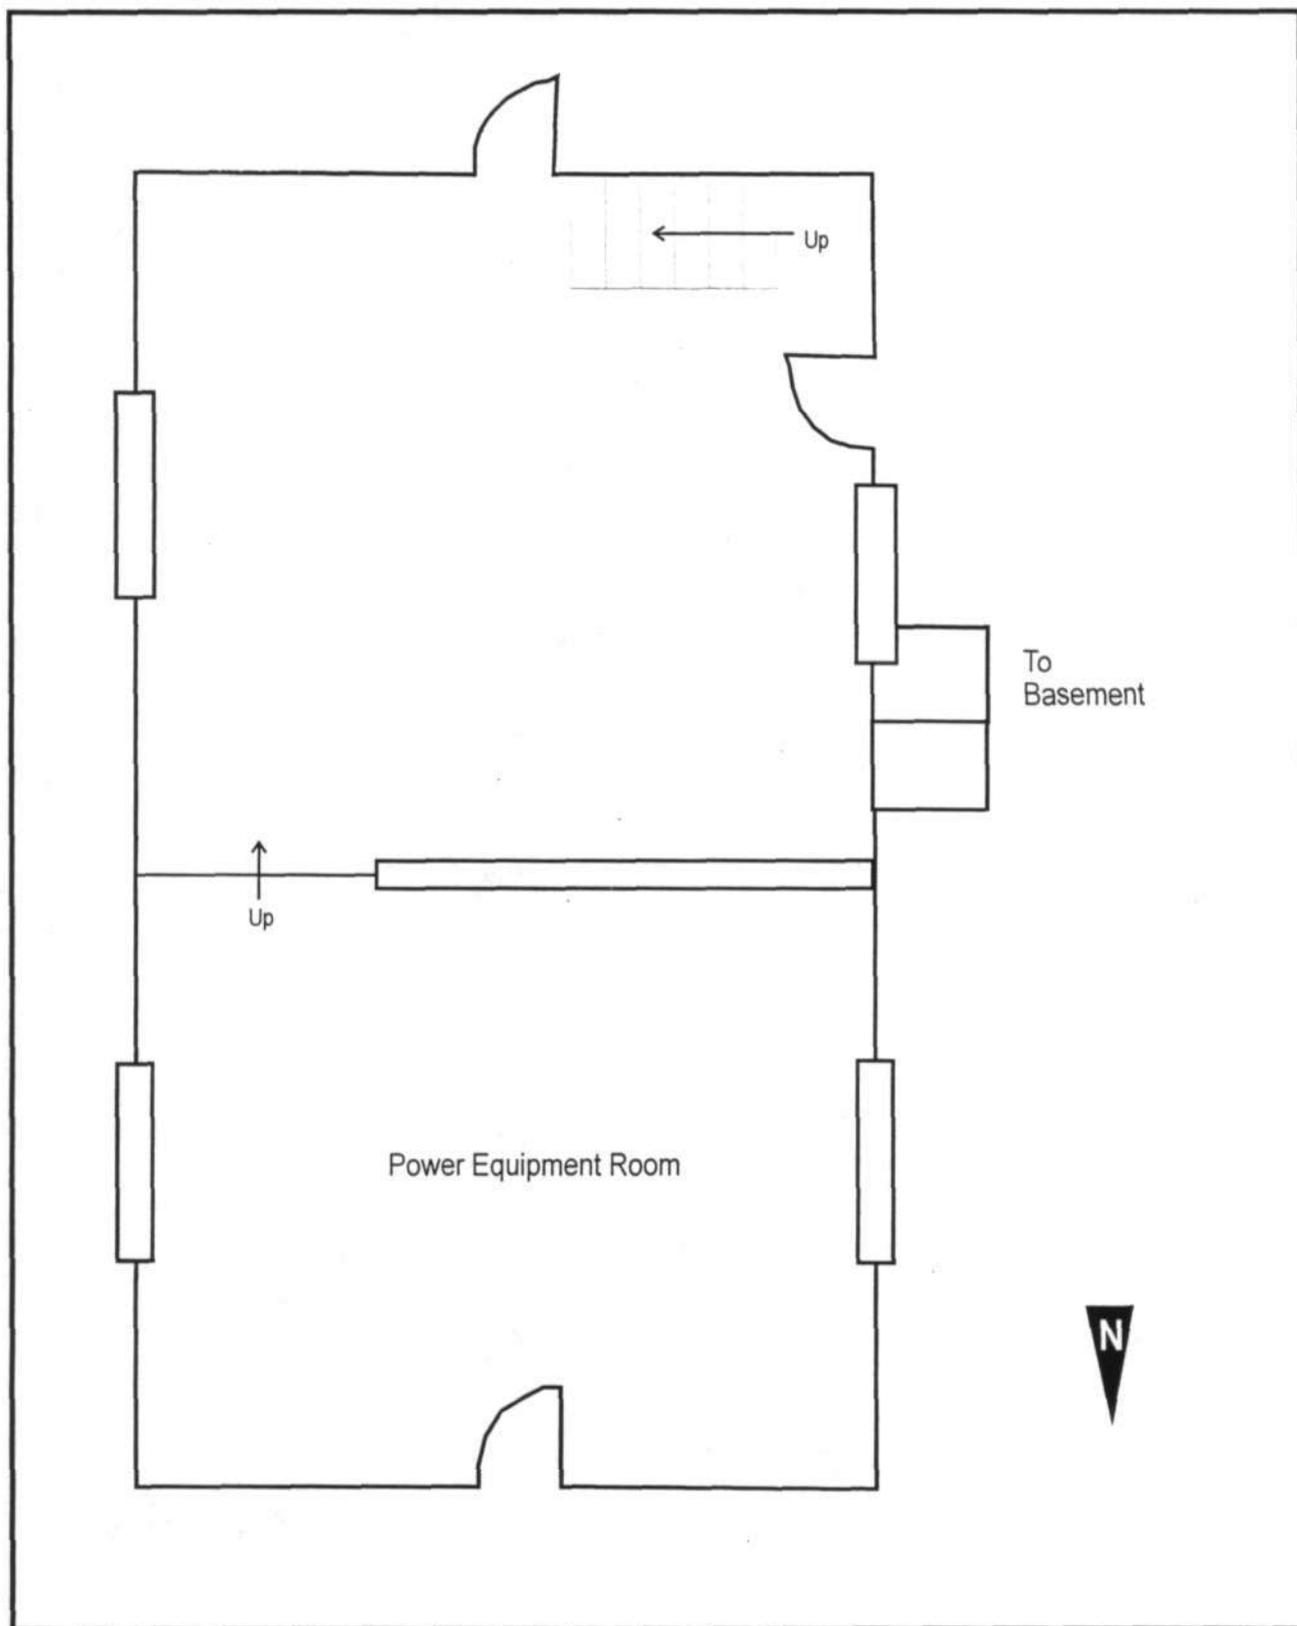
T-385
Chenar Farm
9284 Chenar Farm Road
Talbot County
Powerhouse - 2003

The powerhouse is a two-story wood frame structure with a double pen plan. The building rests on a continuous brick foundation. The walls are clad with wood shingles. The clipped gable roof with is clad with asphalt shingles. The front and side entries have hinged two panel one-light wood doors on the north and west façades. The basement entry has a pair of hinged wood plank cellar doors. The windows are six-over-six wood sashes, with an arched six-over-six wood sash on the gable ends. The interior walls and ceiling are clad with beadboard. The interior has a wood plank floor and open wood stair to the second level. A wood frame greenhouse was originally attached to the rear of the building, but was removed due to deterioration ca. 1980.

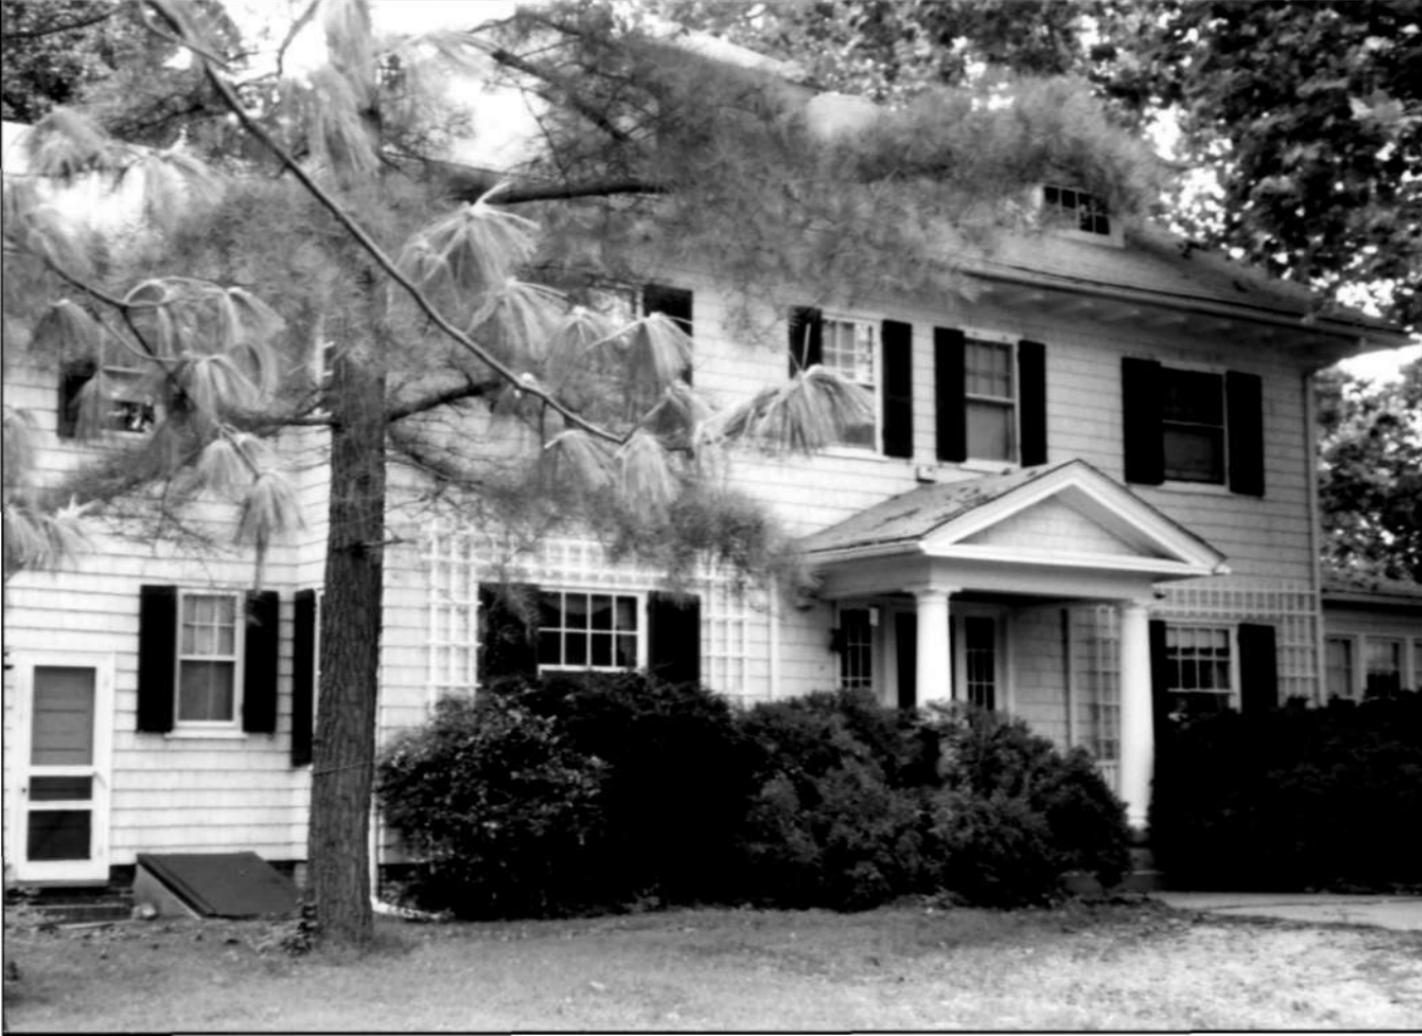
1/52

The west façade is the principle building entry and faces the entry drive. The walls are clad with wood shingles. The building is entered through a central hinged four panel wood front door with fifteen-light sidelights. The side entry doors are hinged five panel wood doors. The windows are a combination of six-over-one and eight-over-one wood sashes. The front entry porch has a poured concrete floor, two fluted wood Doric columns, and a front-gable roof clad with asphalt shingles.

HOUSE (FRONT) SW

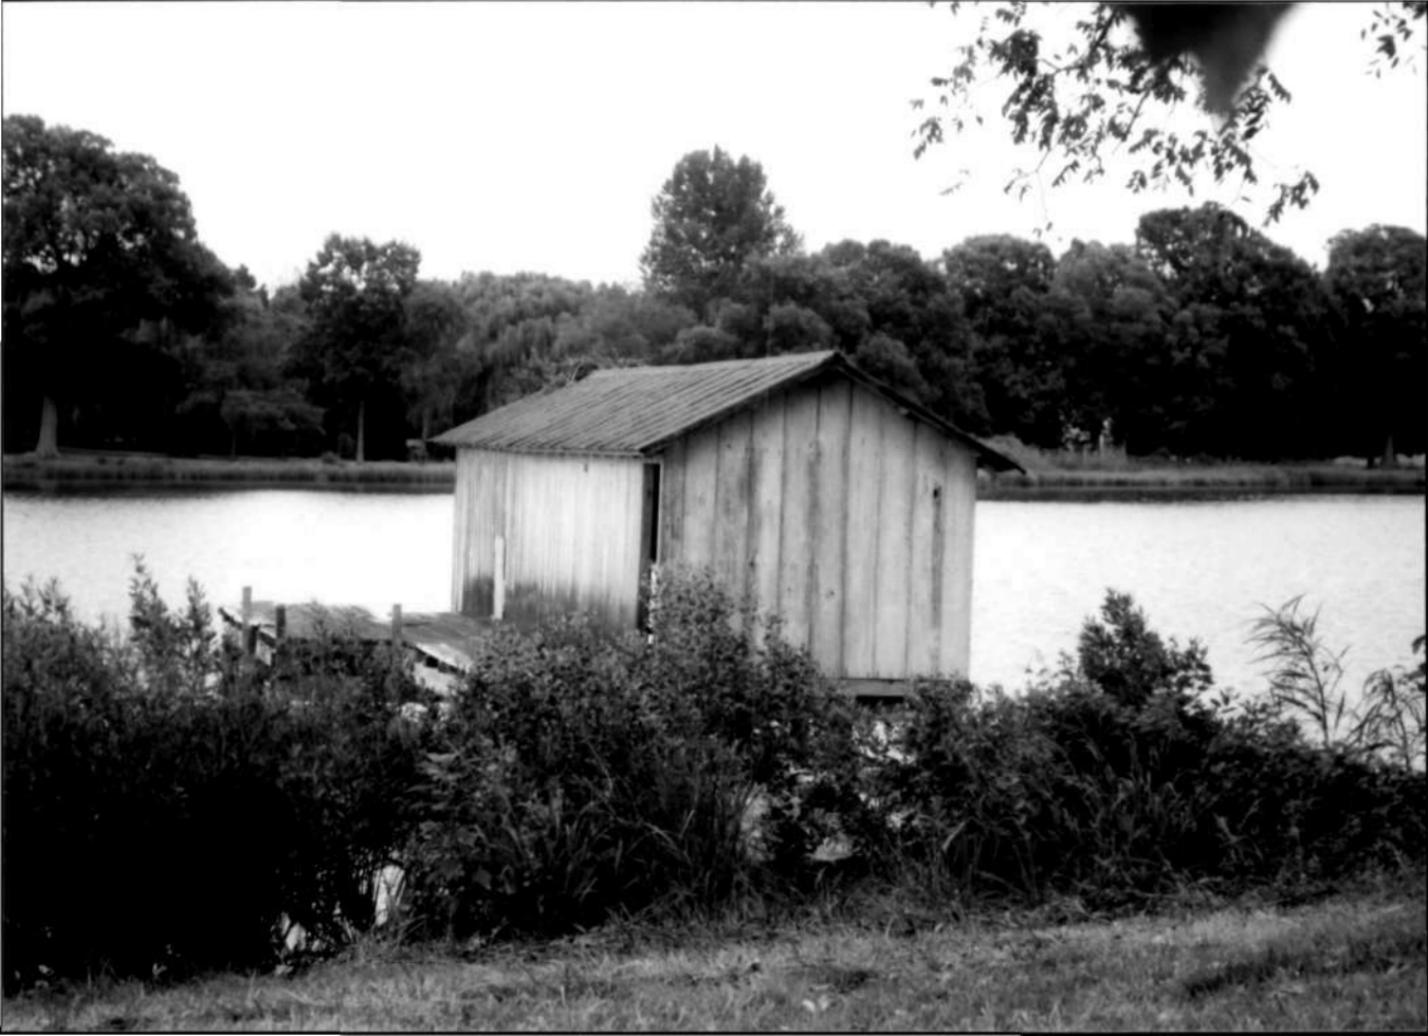
8/52

The boathouse is located at the end of a wood dock and is a one-story wood frame structure with an undivided interior space. The building rests on wood piers sunk into the river bottom. The walls are clad with six inch vertical wood planks. The side gable roof is clad with standing-seam metal. The building is accessed through a hinged wood plank door on the north façade. There are no windows. The interior of the building is unfinished with a wood plank floor.

Boat house looking E

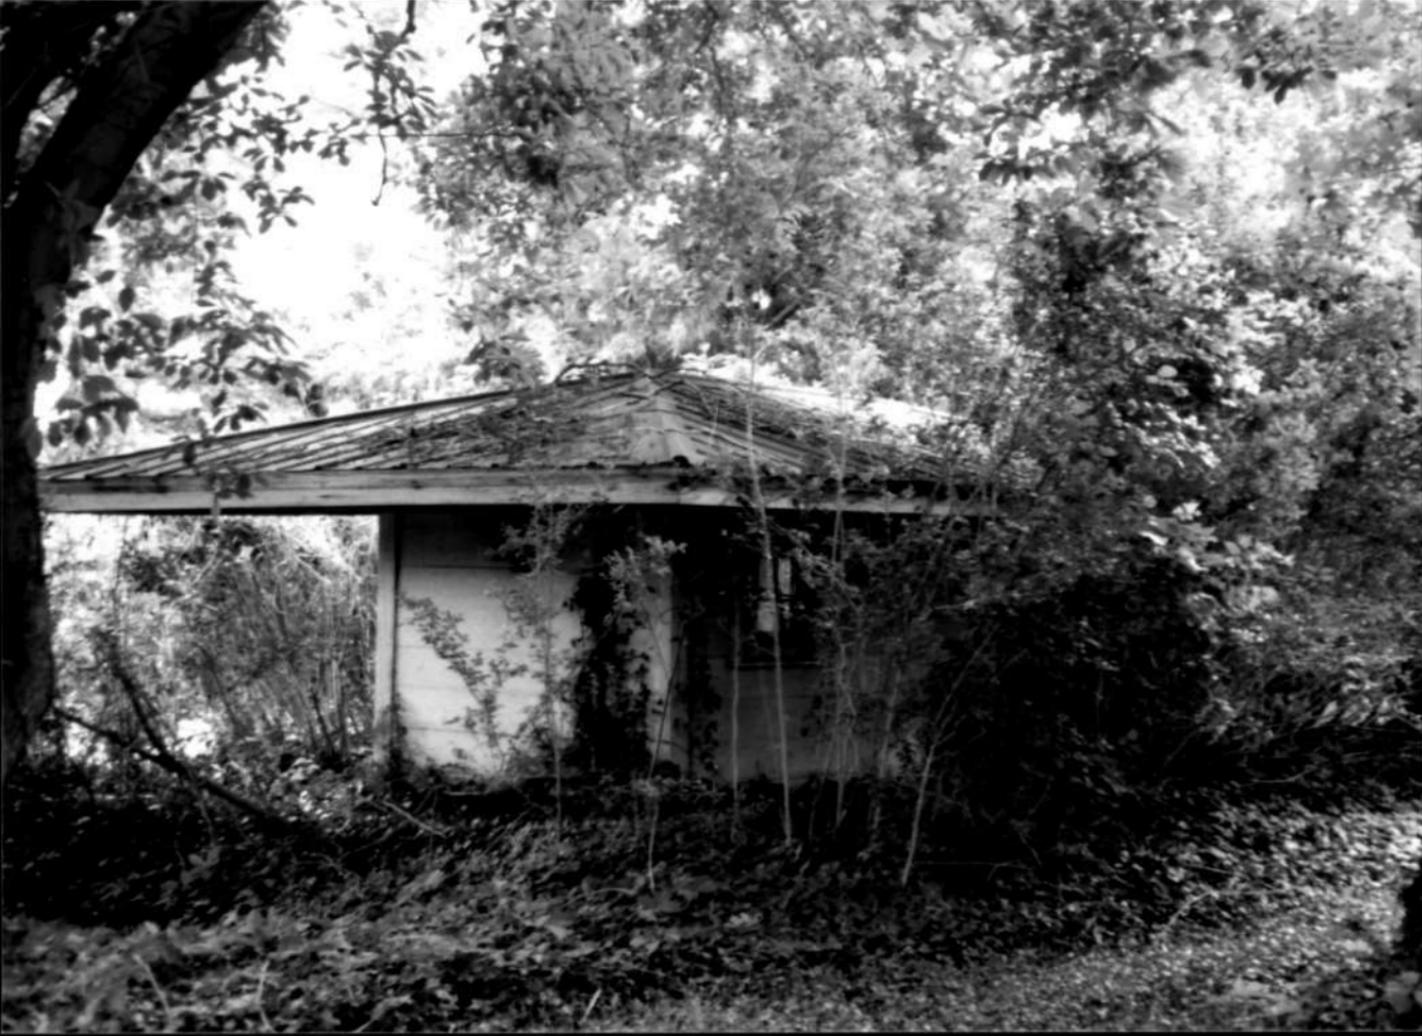
9/52

The tool house is a one-story wood frame structure with an undivided interior space. The building rests on a continuous brick foundation. The walls are clad with horizontal wood planks. The low-pitched hipped roof with large overhanging eaves is clad with standing-seam metal. The building is accessed through a hinged wood plank door on the east façade. The windows are six-pane wood hopper sashes. The interior of the building is unfinished with a wood plank floor.

Tool shed looking S

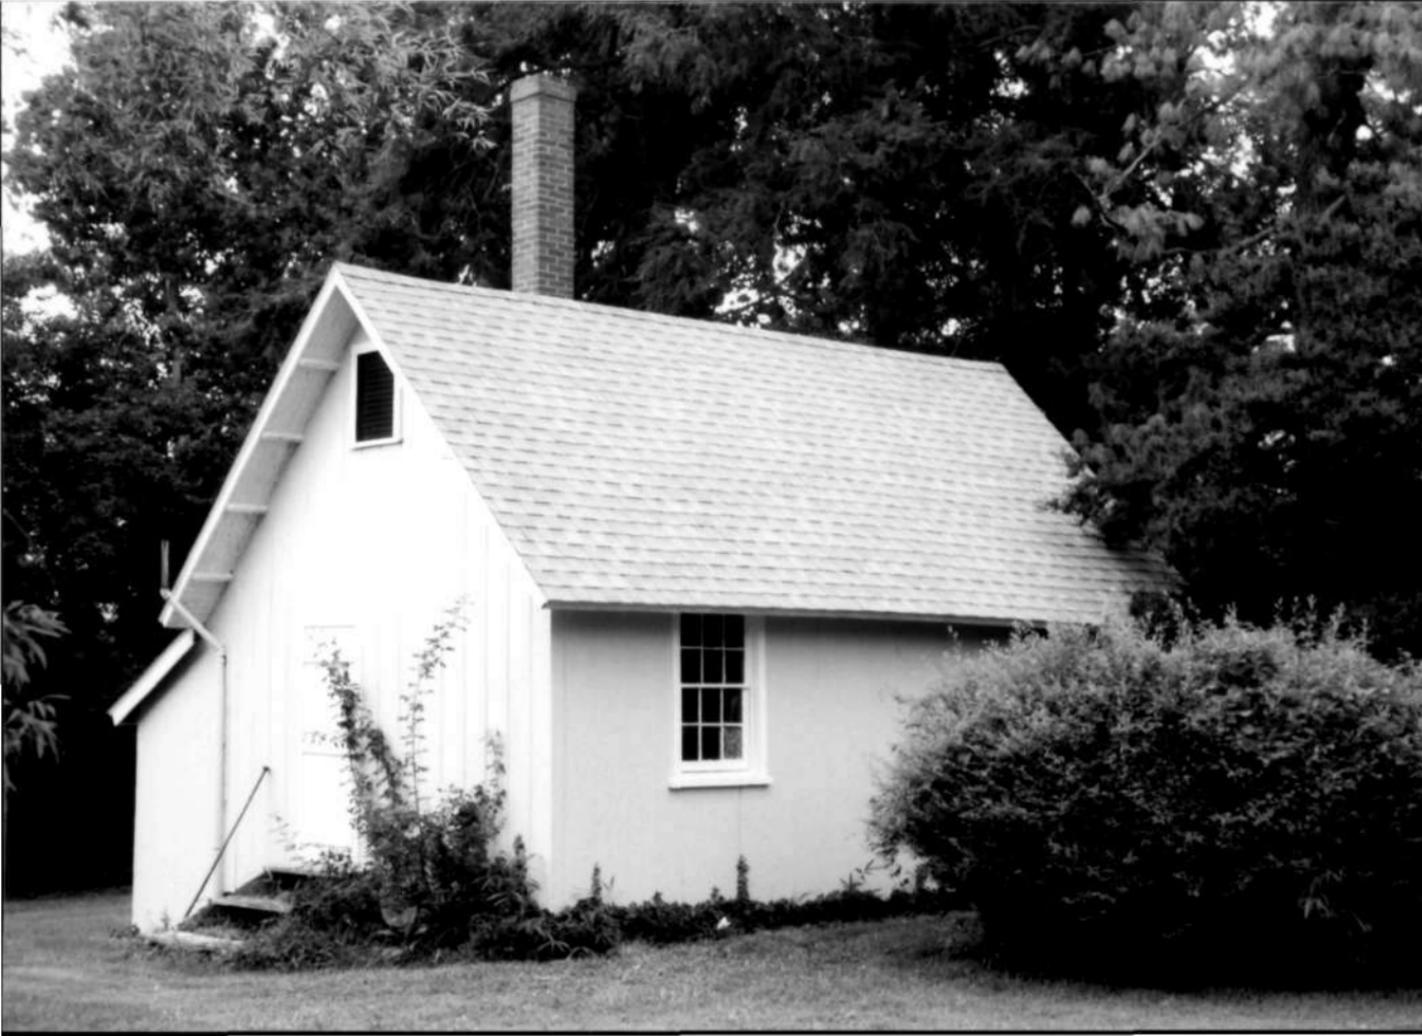
14/52

The building known as the Cook's House, or the Help's Quarters, is a two-story wood frame structure with an undivided interior space, originally used as a residence for the domestic help. The building rests on a continuous brick foundation. The walls are clad with board and batten. The front-gable roof is clad with asphalt shingles. The building is accessed through a hinged wood plank door on the east façade. The windows are six-over-six wood sashes and six-pane wood hopper sashes. The building has an exterior side wall brick masonry chimney. A one seat privy with a shed roof is located on the north façade. The interior walls and ceiling are clad with beadboard. A portion of the building has been removed.

COOKS HOUSE looking NE

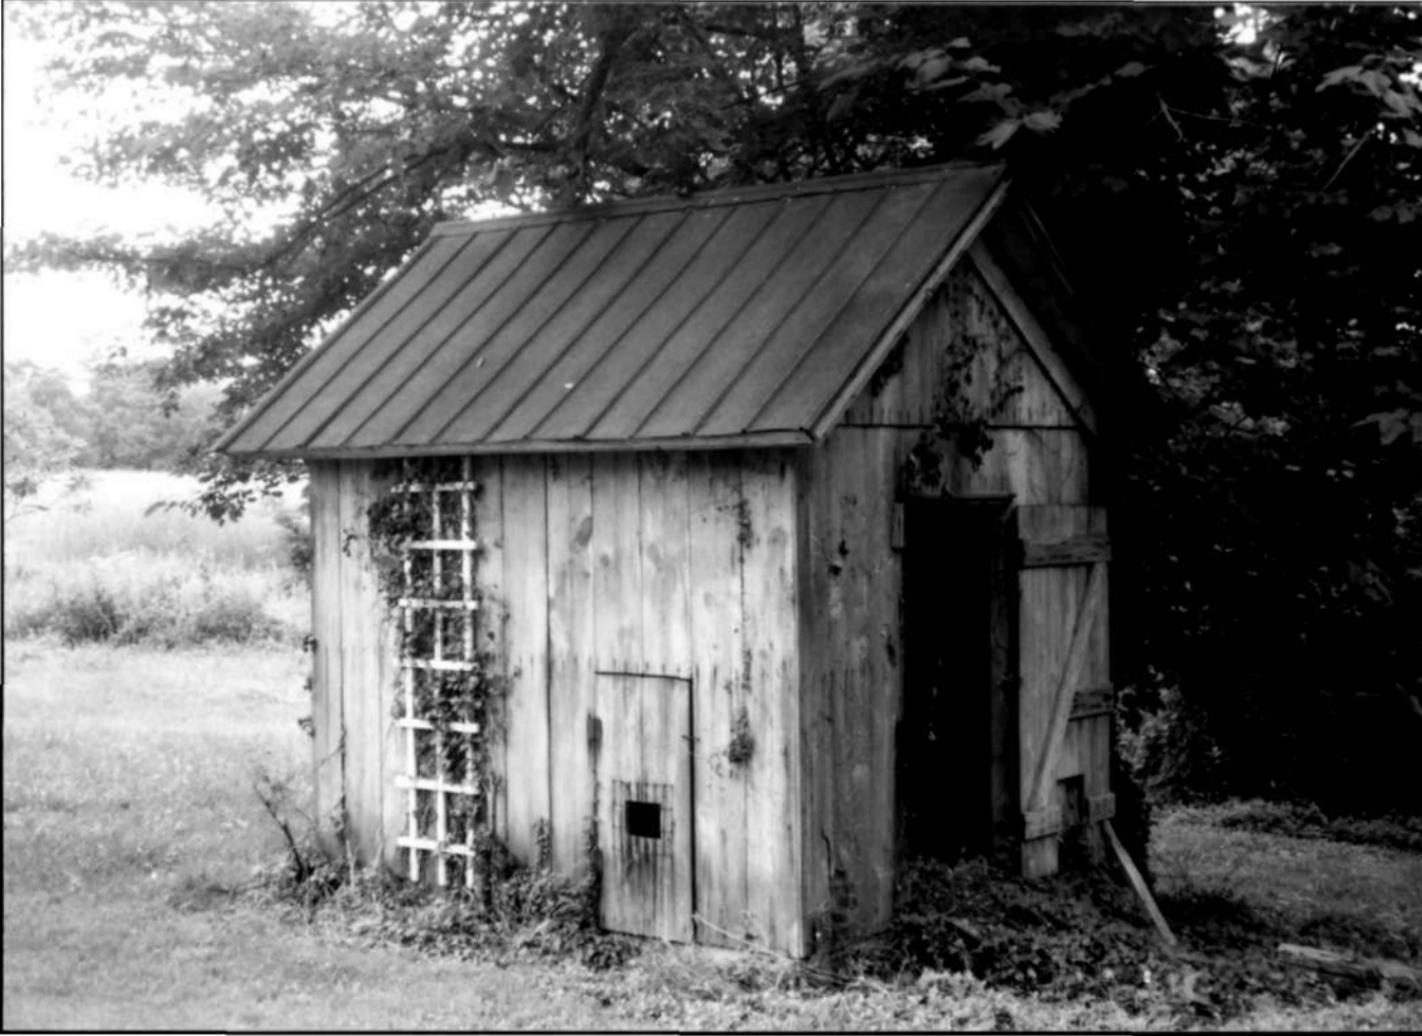
17/52

The smokehouse is a one-story timber frame structure with an undivided interior space. The building rests on a continuous poured concrete foundation. The walls are clad with six inch vertical wood planks. The front-gable roof is clad with standing-seam metal. Ventilators are located on the gable ends. The building is accessed through a hinged wood plank door on the east façade. There are no windows. The interior of the building is unfinished with an earthen floor. The building has been moved to its current location from elsewhere on the property.

Smoke House looking N

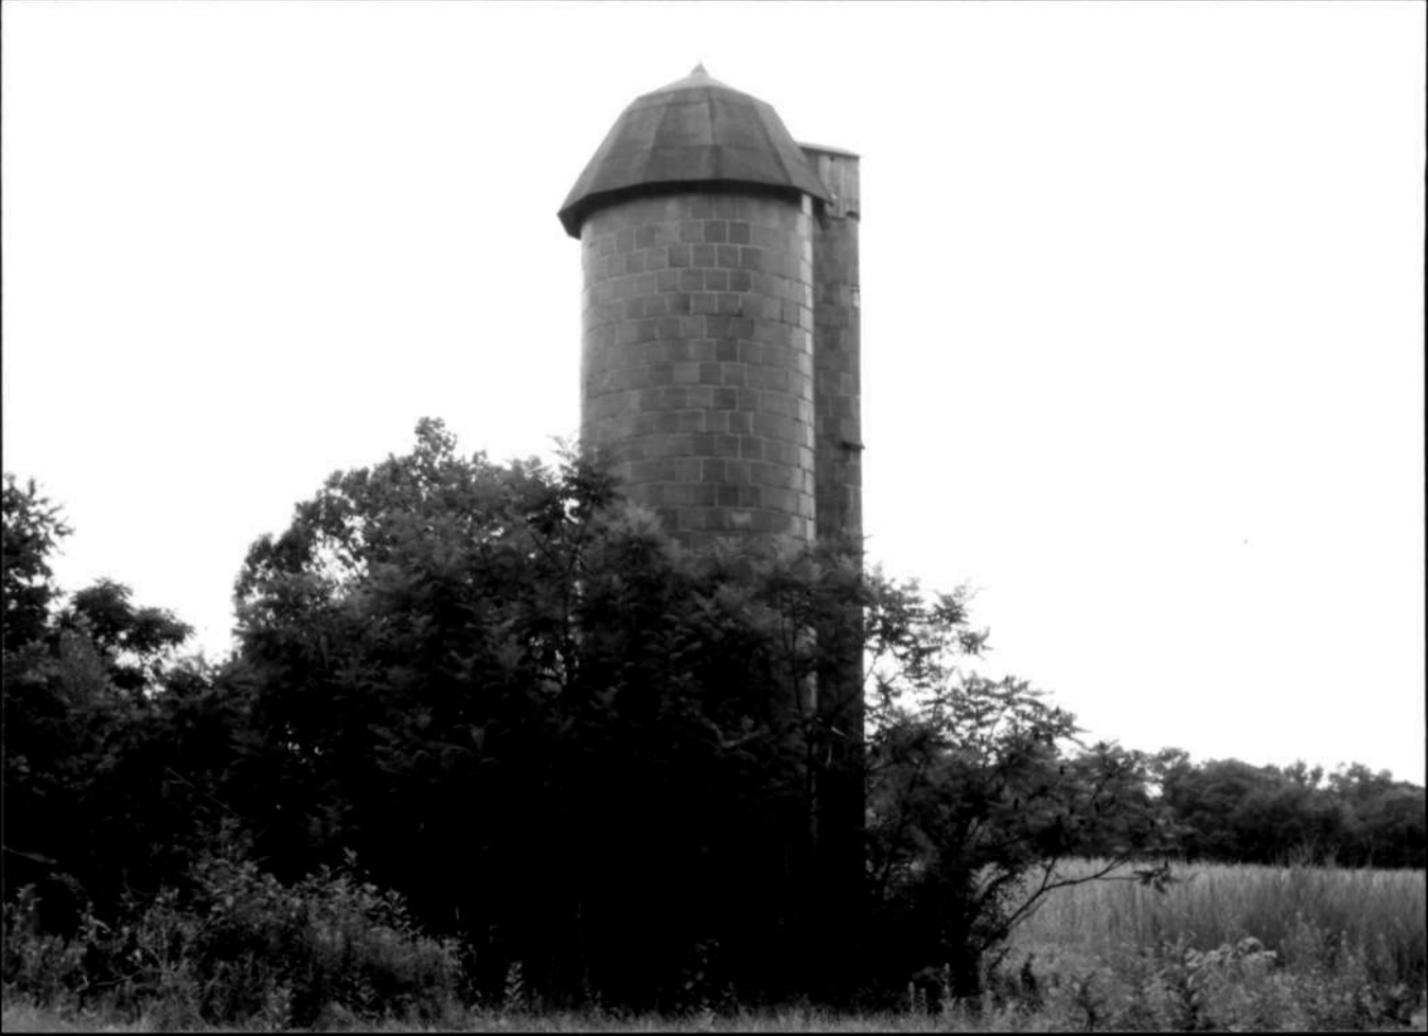
19/52

The silo, constructed ca. 1920, is of glazed hollow-tile construction and rests on a poured concrete pad. The silo has a hipped roof clad with standing-seam metal. An enclosed metal ladder is located on the north façade.

Silo Looking NW

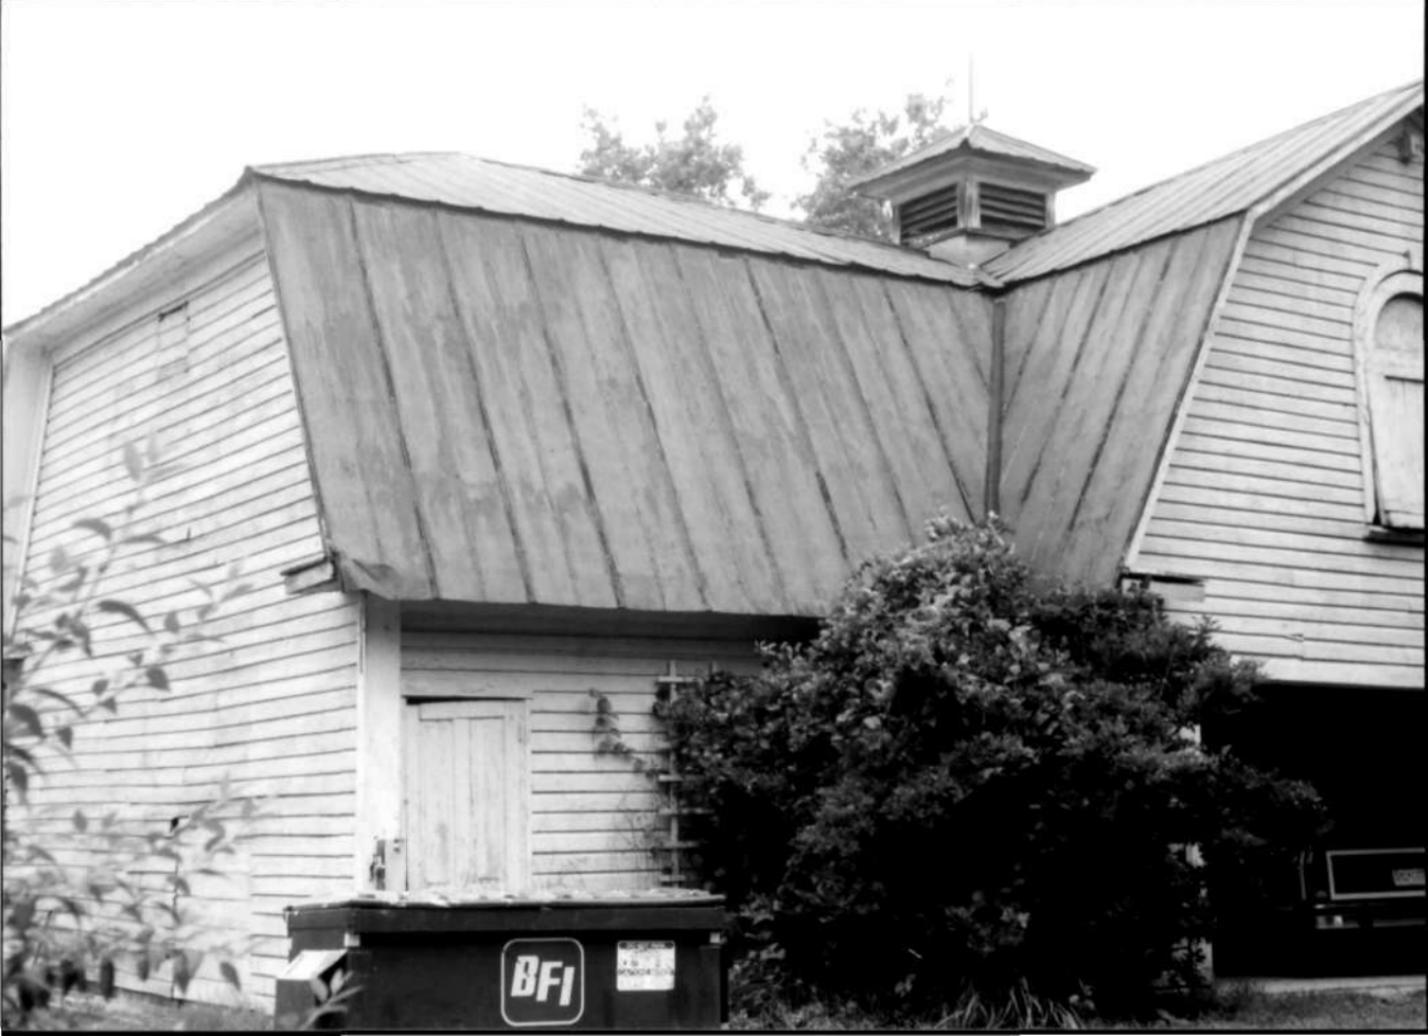
21/52

The carriage house, constructed ca. 1922, is three bays wide and is of timber frame construction with open entries on the north and south façades. The easternmost bay is a storage room. The structure rests on a continuous combination brick and poured concrete foundation. The walls are clad with beveled wood siding. The cross gambrel roof with clipped gable ends is clad with standing-seam metal and has a cupola at the intersection. The doors are hinged four panel wood doors with sliding Dutch doors on the side façades. The front hayloft door is arched. The windows are six-over-six wood sashes. The interior of the building is unfinished with an earthen floor in one bay, poured concrete in the second bay, and a wood plank floor in the third bay. The walls of the third bay are clad with wood planks.

Carriage House looking NE

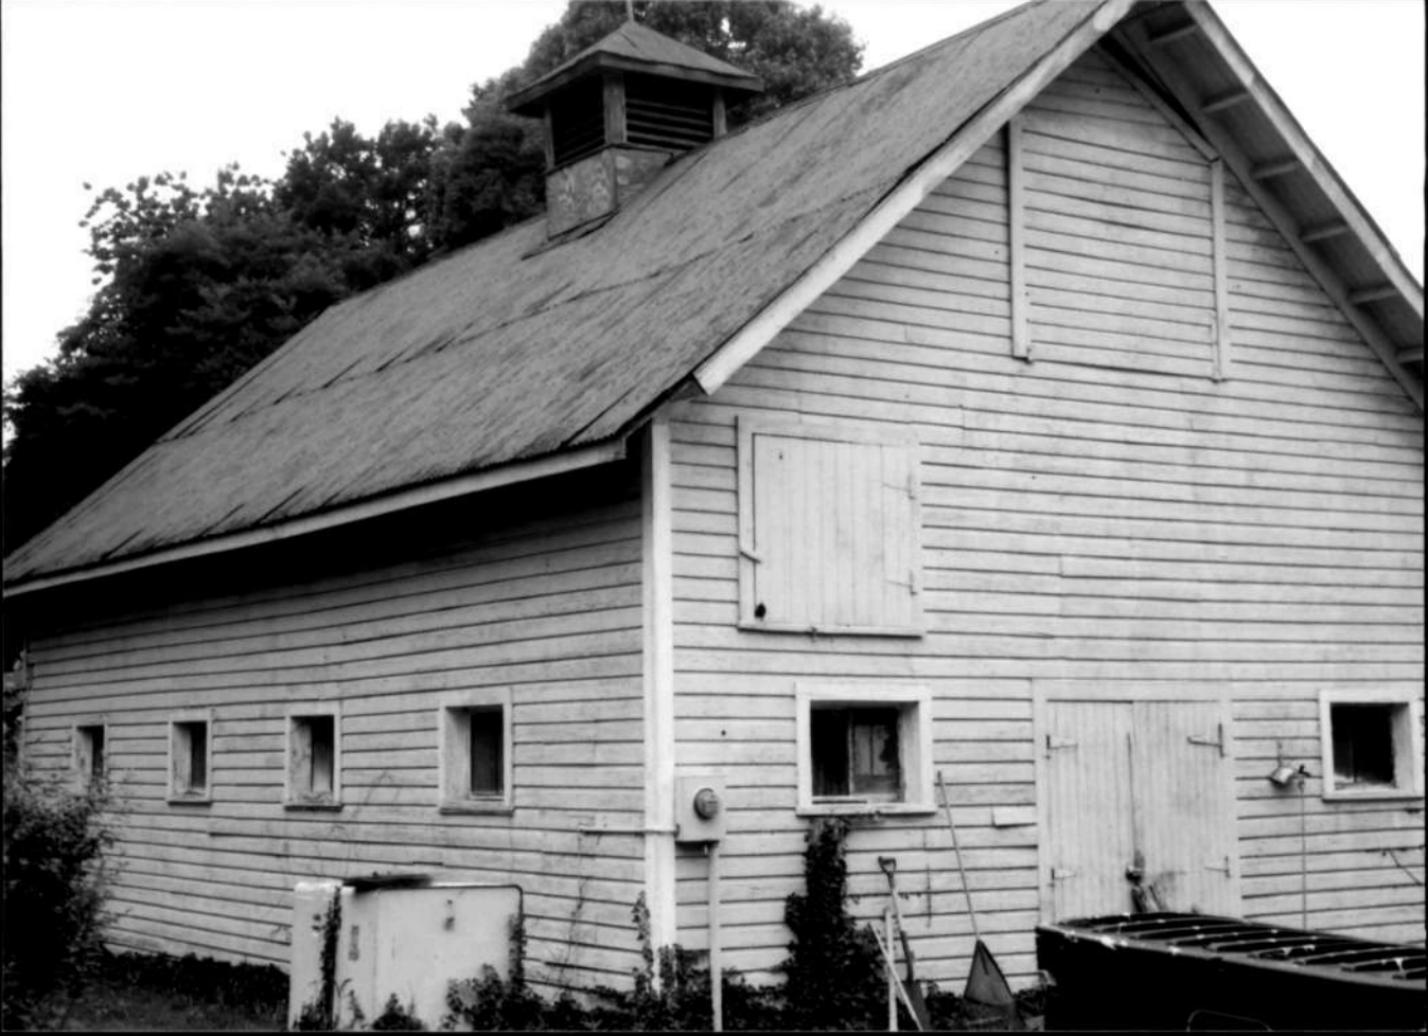
22/52

The dairy barn, constructed ca. 1922, is three bays deep and is of timber frame construction with a one-story milk house rear addition. The structure rests on a continuous poured concrete foundation. The walls are clad with beveled wood siding. The front-gable roof is clad with corrugated metal and has a cupola. The doors are hinged wood planks with diagonal bracing. The windows are two-pane steel hopper sashes. The interior of the building is unfinished with a poured concrete floor. Original plans of the barn in the possession of the current owner indicate that the barn was designed by the Extension Service, University of Maryland, Division of Agricultural Engineering, and that the design was either a free or low cost plan.

Dairy BRN look NW

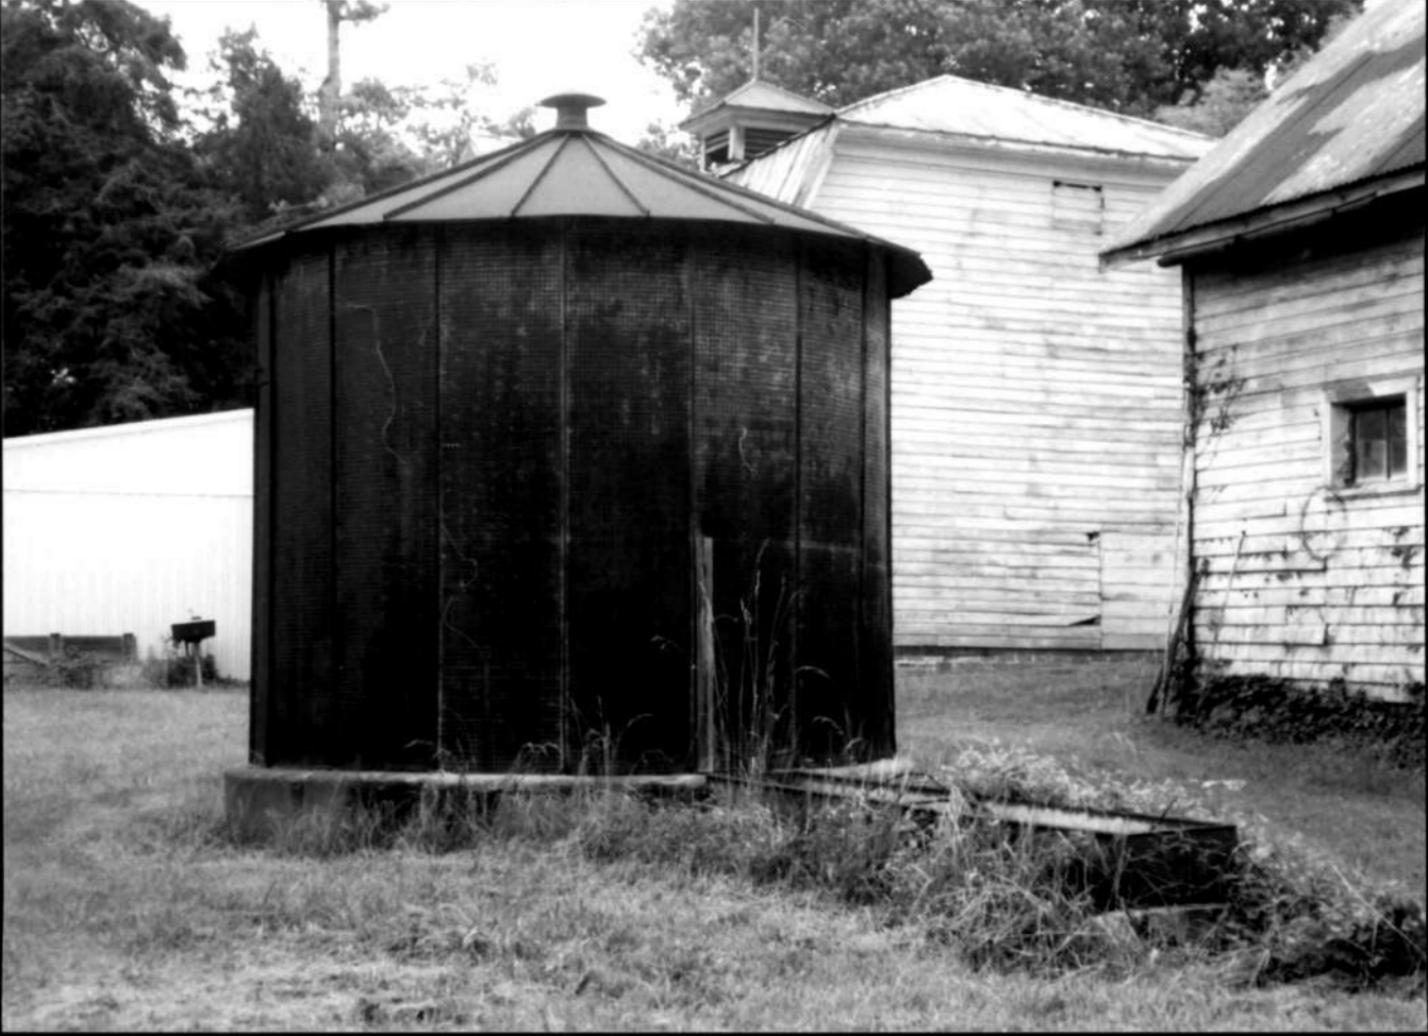
28/52

The corncrib, constructed ca. 1922, is a one-story round structure with a metal frame constructed by the Iron Crib and Bin Company of Wooster, Ohio and has a 1909 patent date. The structure rests on a continuous poured concrete foundation. The walls are clad with pierced steel panels bolted together. The conical roof is clad with standing-seam metal. The door is a pierced steel panel. There are no windows. The interior of the building is unfinished with a poured concrete floor.

Metal Corn Crib, looking S
