T-385
Chenar Farm
9284 Chenar Farm Road
Easton Vicinity
Ca. 1922-1923
Private

Maryland Historical Trust Maryland Inventory of Historic Properties Form

Inventory No. T-385

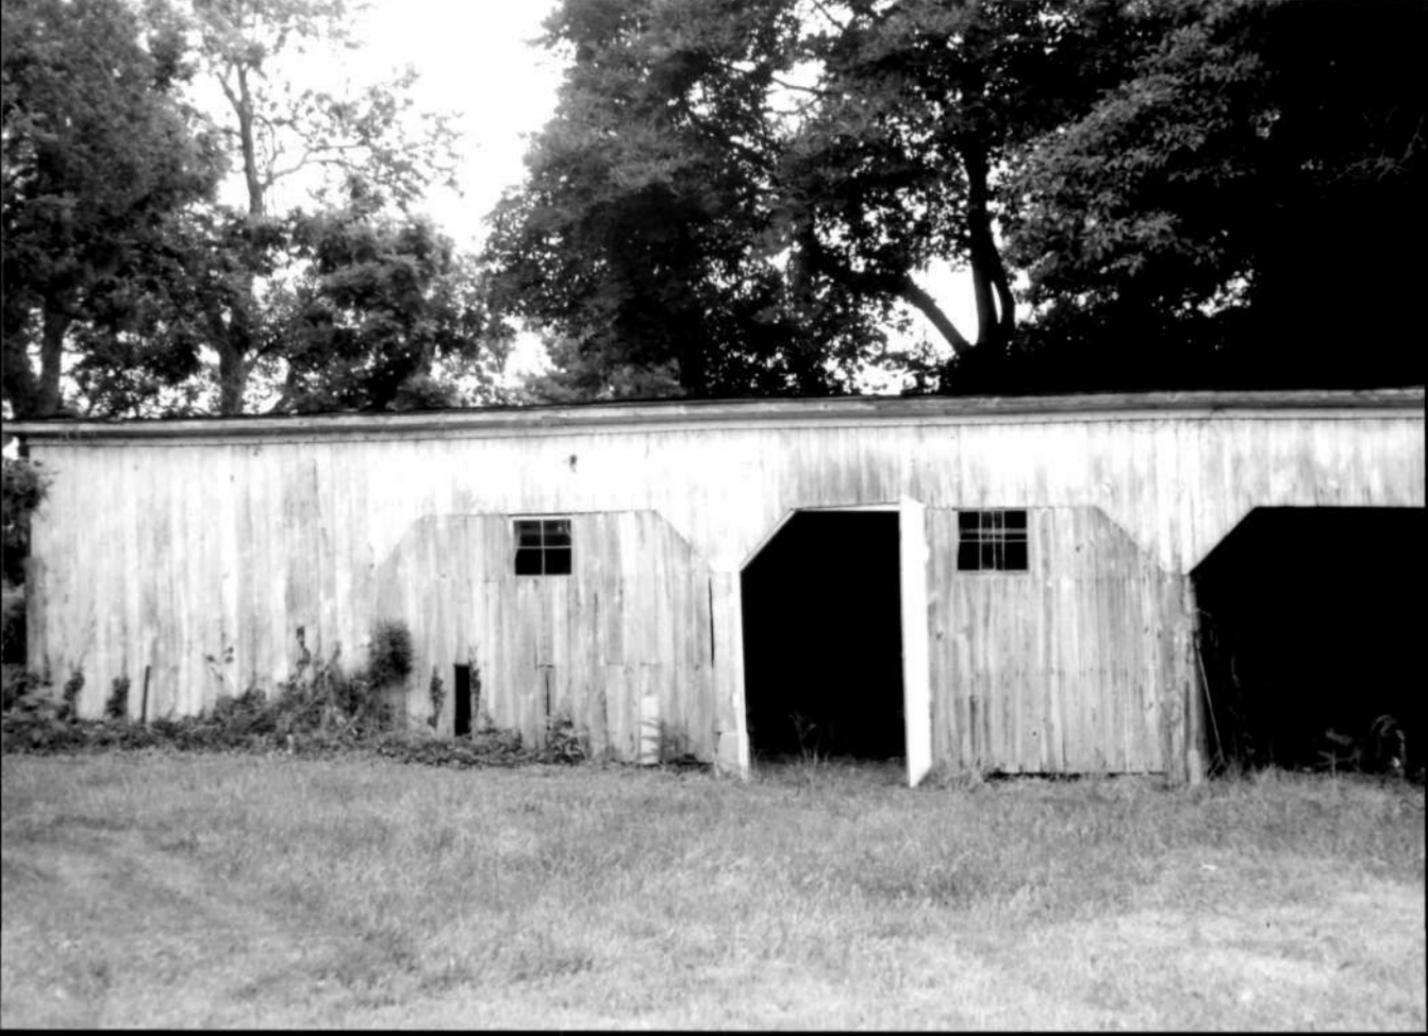
29/52

The ten-bay animal shed and stable are connected structures that form an "L" shape. The stables are located on the eastern end. A portion of the southern end of the animal shed was enclosed in the 1960s and converted into a hen house. The animal shed rests on a poured concrete pier foundation. The walls are clad with six inch vertical wood plank siding. The shed roof is clad with standing-seam metal. The doors are hinged wood planks with diagonal bracing. The windows are four-pane wood fixed sashes. The interior of the building is unfinished with an earthen floor. The stable portion rests on a poured concrete pier foundation. The walls are clad with six inch vertical wood plank siding. The shed roof is clad with standing-seam metal. The Dutch doors are hinged wood planks with diagonal bracing. The windows are six-pane wood awning sashes. The interior of the building is unfinished with an earthen floor.

ANIMAL STORAGE Bldg. Look'g W

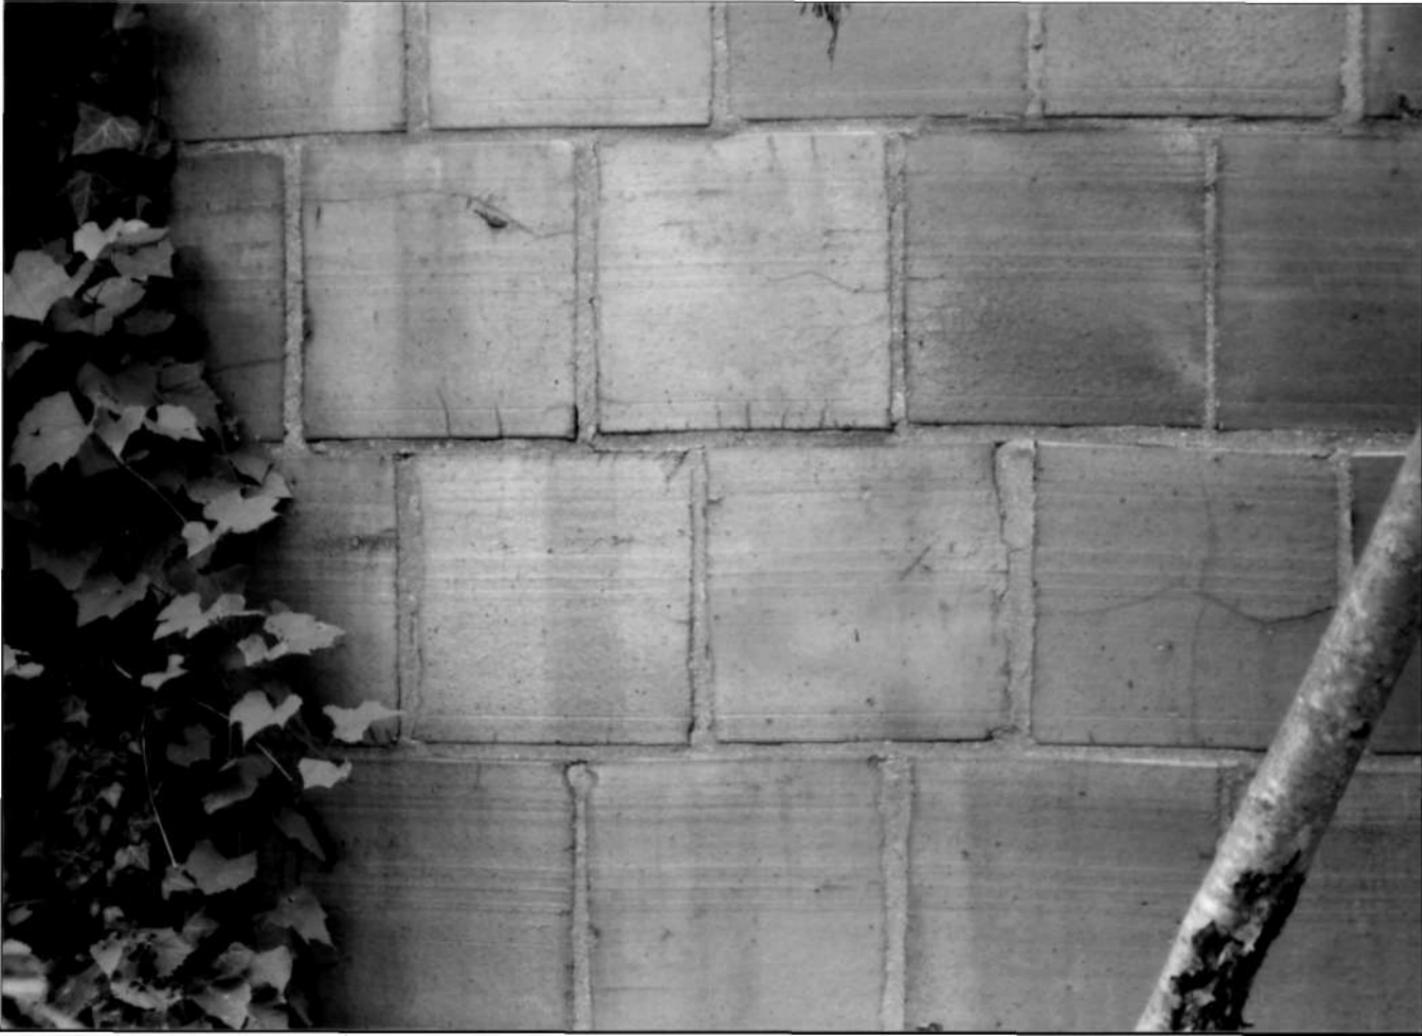
36/52

The silo, constructed ca. 1920, is of glazed hollow-tile construction and rests on a poured concrete pad. The silo has a hipped roof clad with standing-seam metal. An enclosed metal ladder is located on the north façade.

Silo (detail) look NE
tile

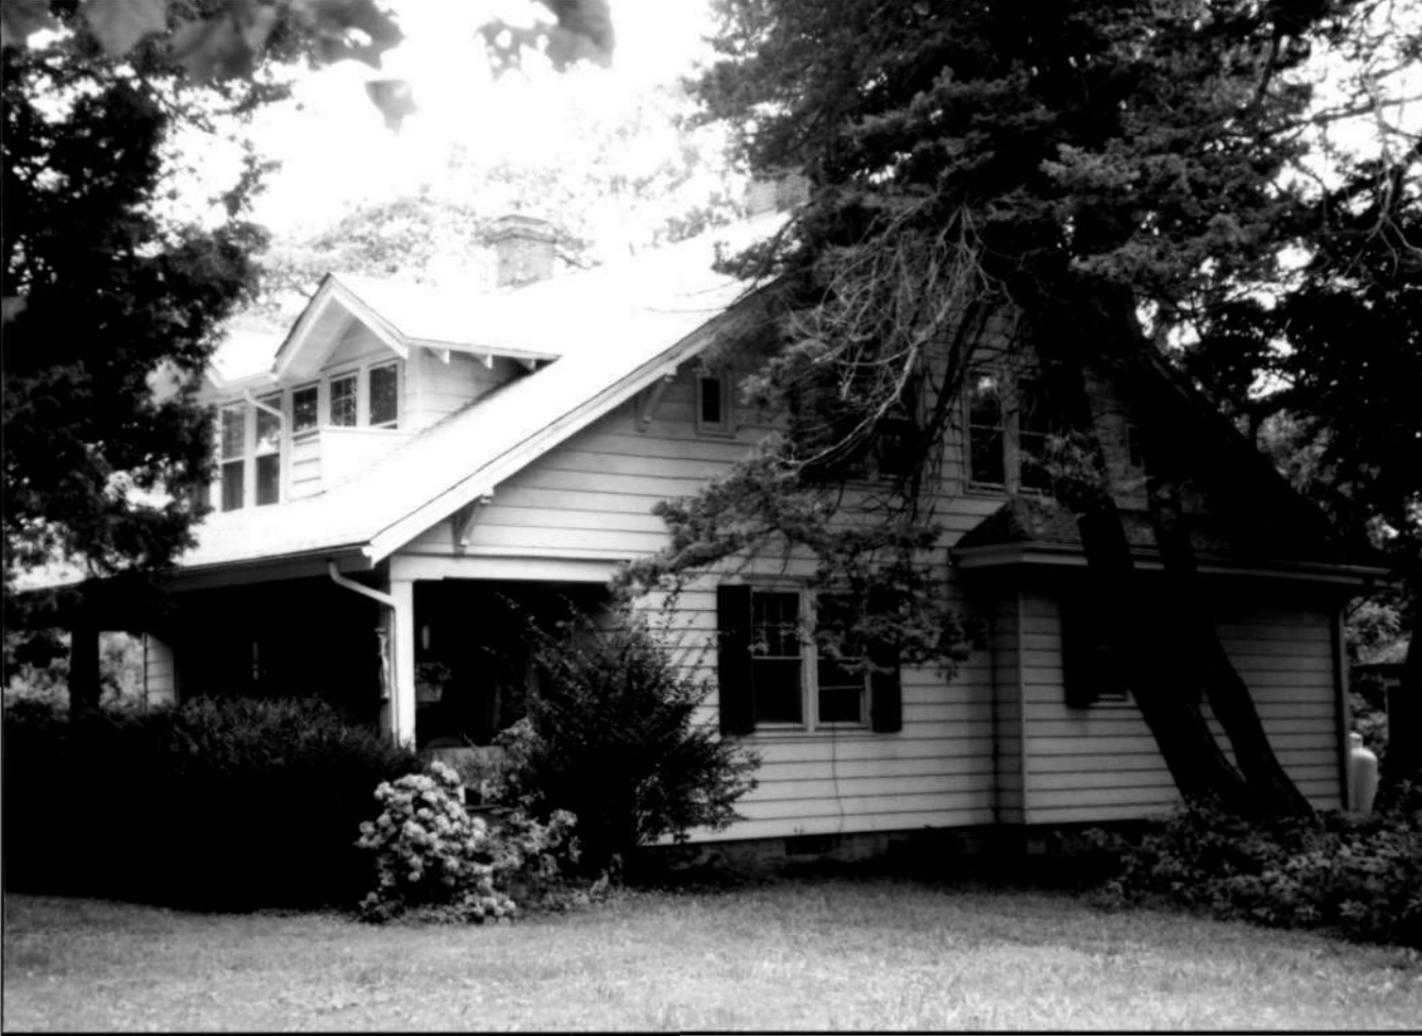
Tenant house #1, constructed ca. 1910, is a one-and-a-half story wood frame structure with a hall-parlor plan. According to a past caretaker, the building was the original main house for the property and was moved to this location ca. 1922 to make room for the construction of the current main residence. The building rests on a continuous concrete masonry unit foundation. The building is clad with aluminum siding. The side gable roof is clad with asphalt shingles and has a paired gable roof dormer on the front façade. The central entry door is flanked by paired nine-over-one wood sashes. The windows are a combination of nine-over-one, eight-over-one, and six-over-one wood sashes. A curved bay window is located on the west façade. The building has two interior brick masonry chimneys. The integral front porch has four square wood columns and a wood plank floor. The rear porch has been enclosed with screening. The interior was not accessible at the time of the survey.

Tenant House # 1 looking NW
39/52

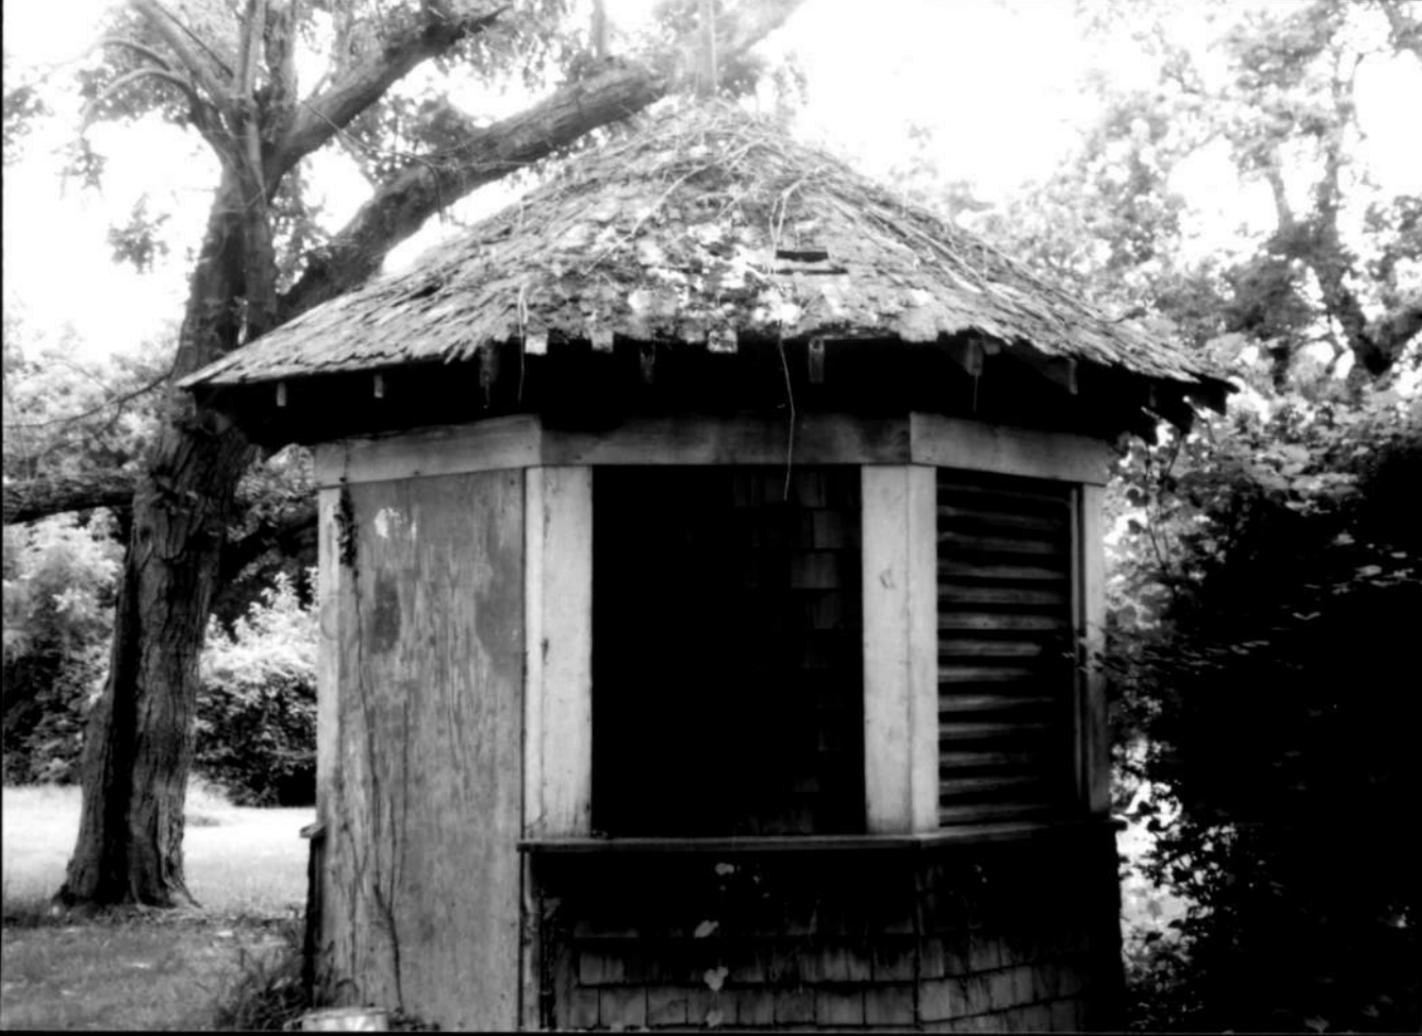
40/52

A one-story octagonal wood frame gas house, constructed ca. 1922, with an undivided interior plan is located to the rear of tenant house #1. The building encloses a brick lined pit. The exterior walls and conical roof are clad with wood shingles. The upper portions of the walls are louvered wood panels. The door is a hinged plywood panel.

Gas House looking NW

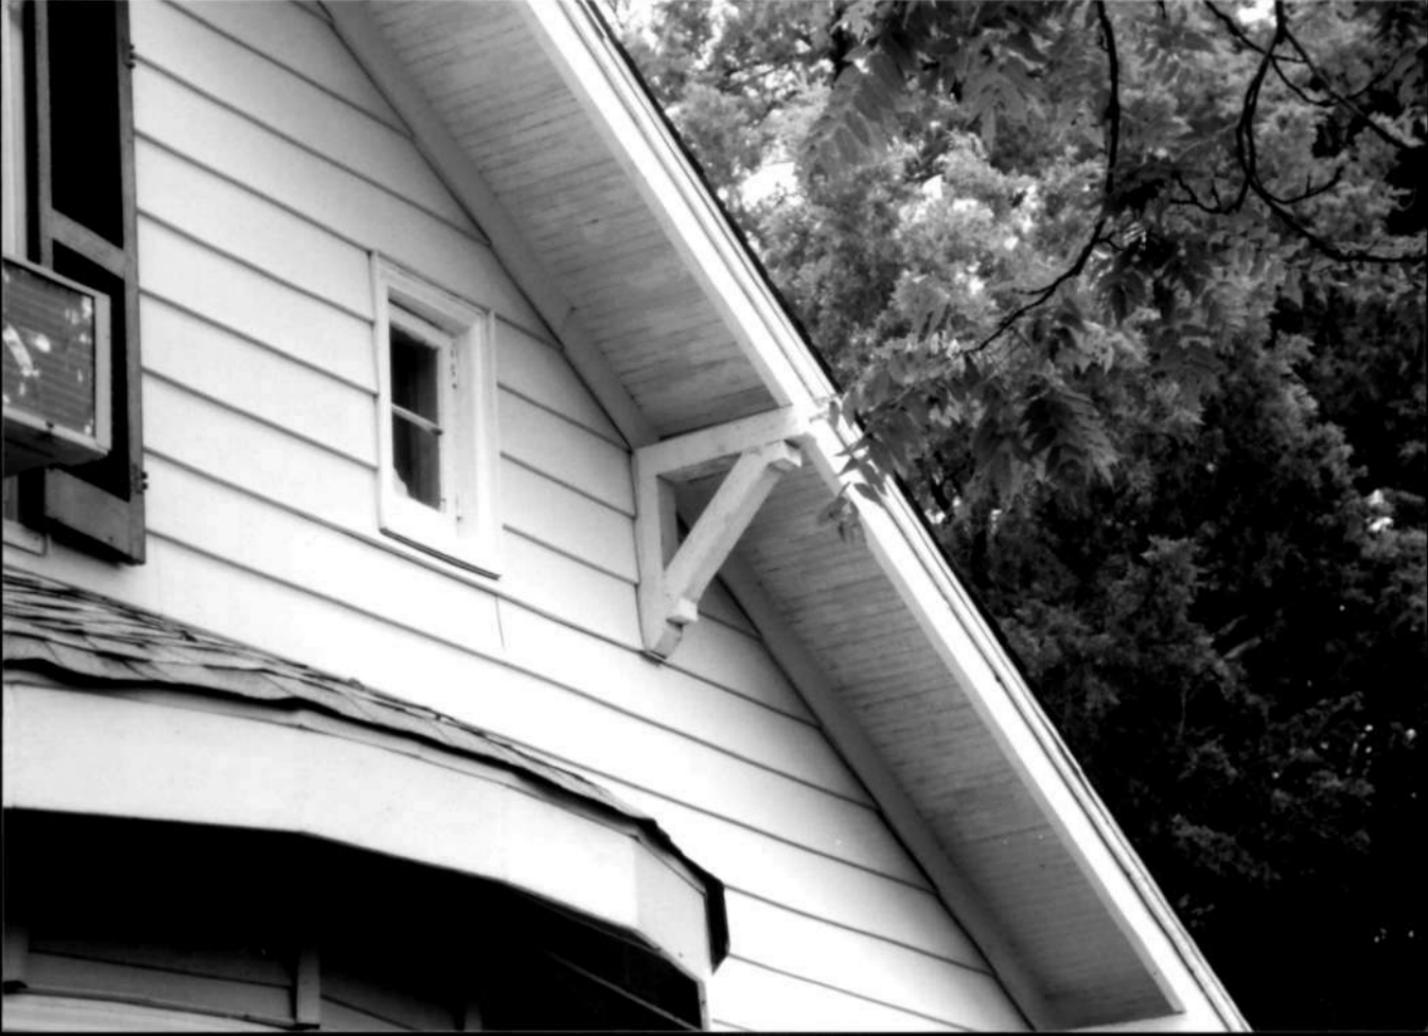
43/52

Roof BRACKET on Tenent House #1 Looking S

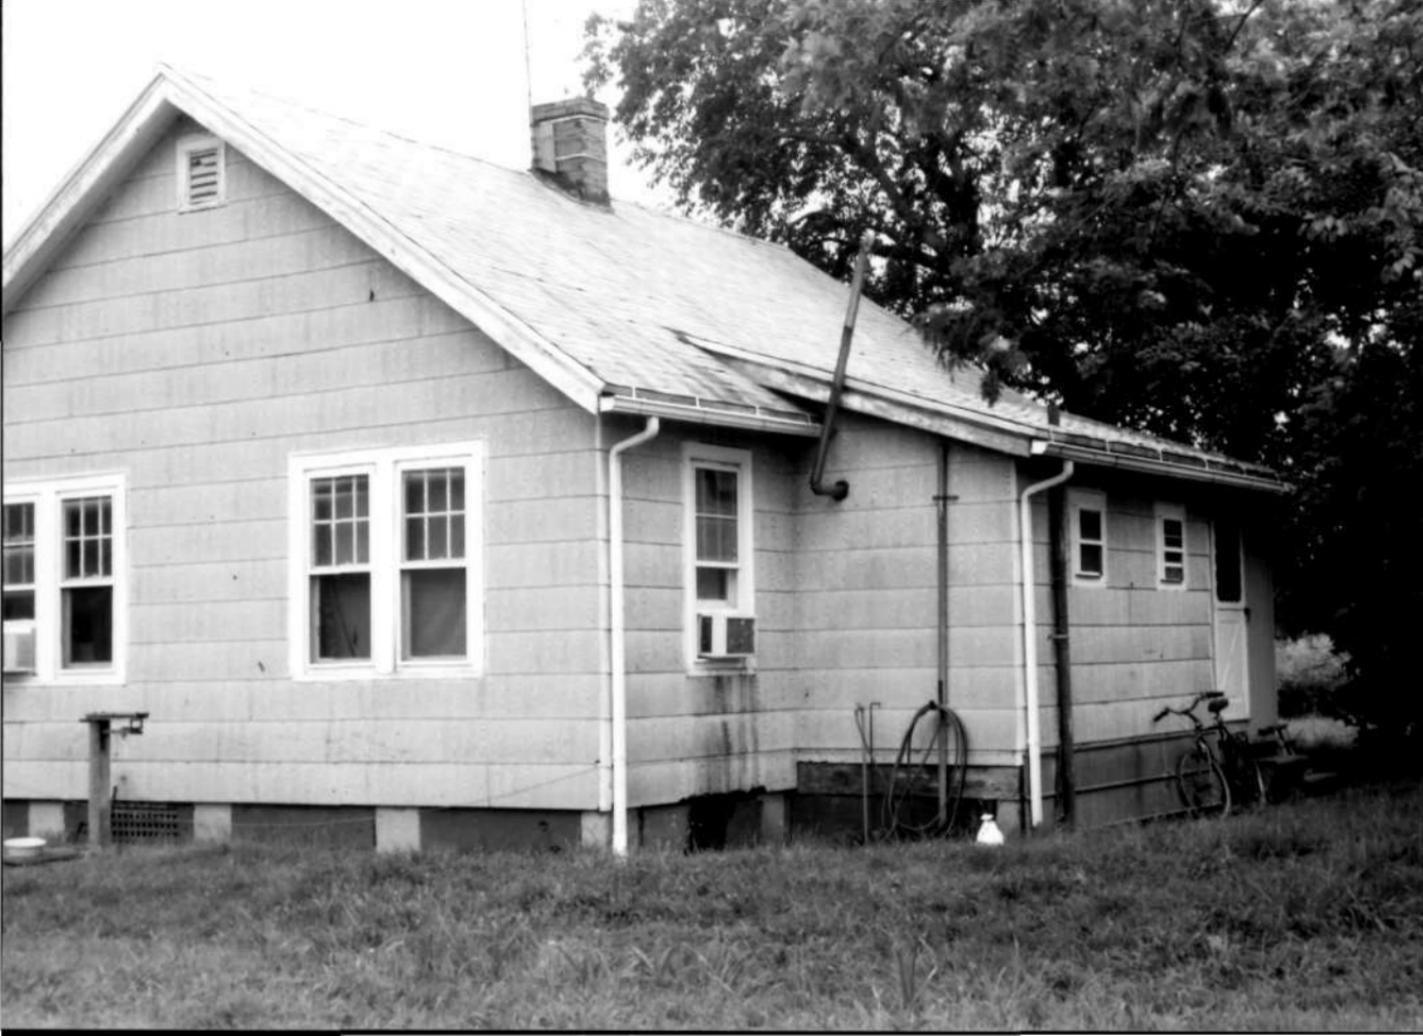
46/52

Tenant house #2, constructed ca. 1930, is a one-story wood frame structure with a hall-parlor plan. The building rests on a poured concrete pier foundation with plywood panels infilling the space between piers. The building is clad with asbestos shingles, embossed with a wood texture. The broken side gable roof is clad with asphalt shingles. The hinged two panel four-pane wood entry door is offset. The windows are paired six-over-one wood sashes. The building has a central brick masonry chimney. The integral front porch has four square wood columns and a wood plank floor. The interior was not accessible at the time of the survey.

Tenant House #2 looking S

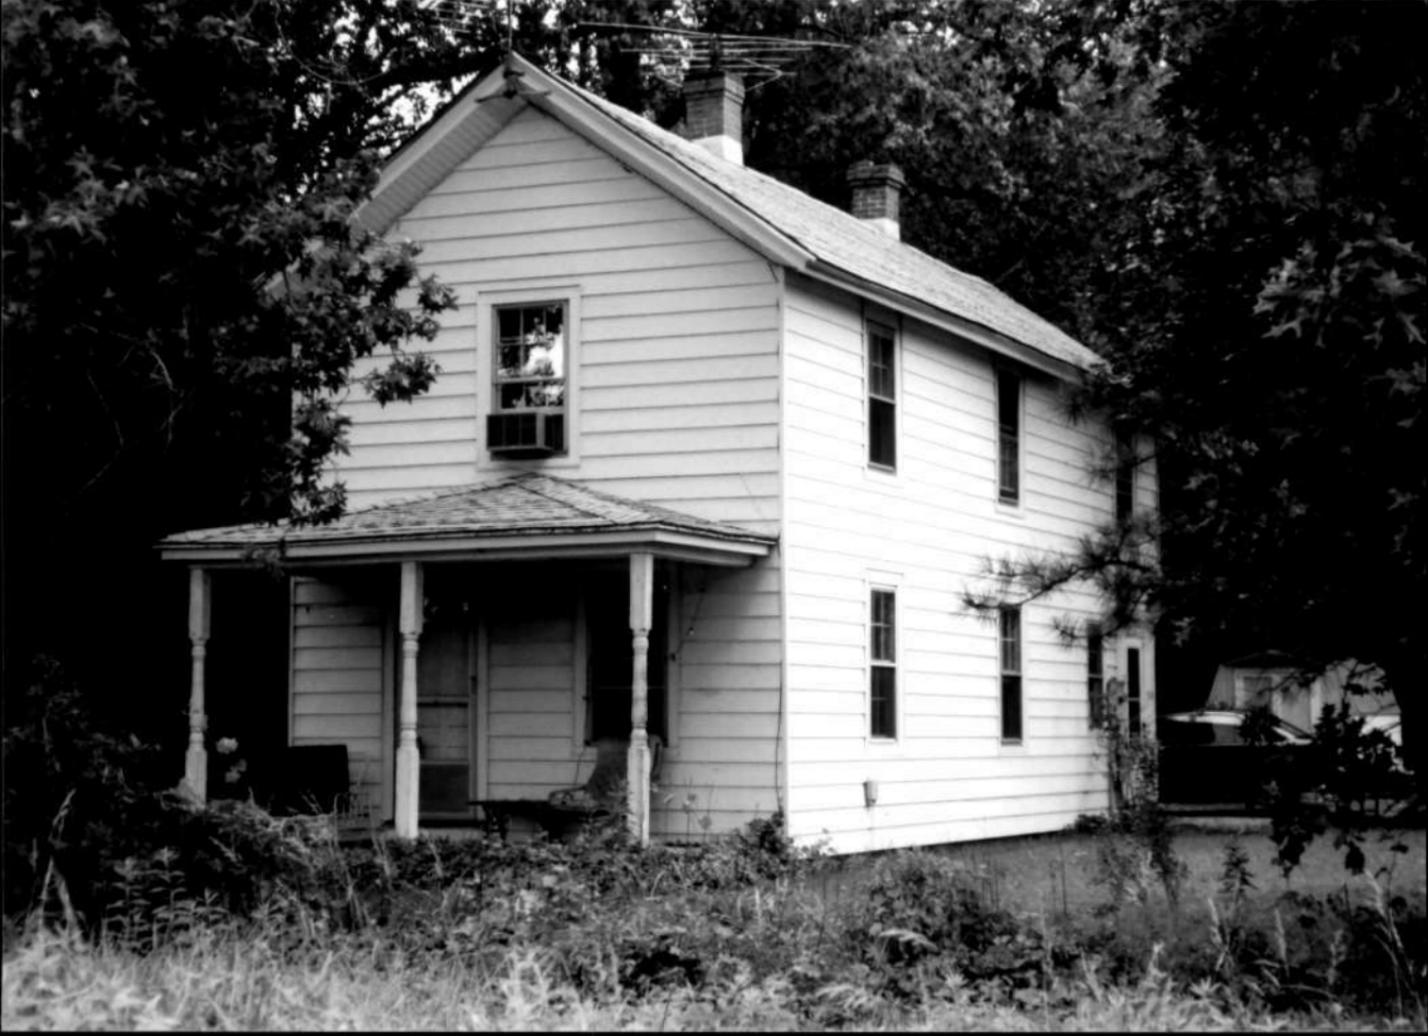
50152

Tenant house #3, constructed ca. 1890, is a two-story wood frame structure with a three room shotgun plan. The building rests on a continuous brick masonry foundation. The building is clad with aluminum siding. The front-gable roof is clad with asphalt shingles. The hinged four panel wood entry door is offset. The windows are six-over-six wood sashes. The building has two central brick masonry chimneys. The front porch has a wood plank floor, three turned wood columns and hipped roof clad with asphalt shingles. The interior was not accessible at the time of the survey.

Tenant House # 3 looking NW
