CAPSULE SUMMARY SHEET

Survey No.: T-952 (PACS 14) Construction Date: circa 1875

Name: Charles W. Ross Property

Location: 30440 North Dover Road, Easton vicinity, Talbot County

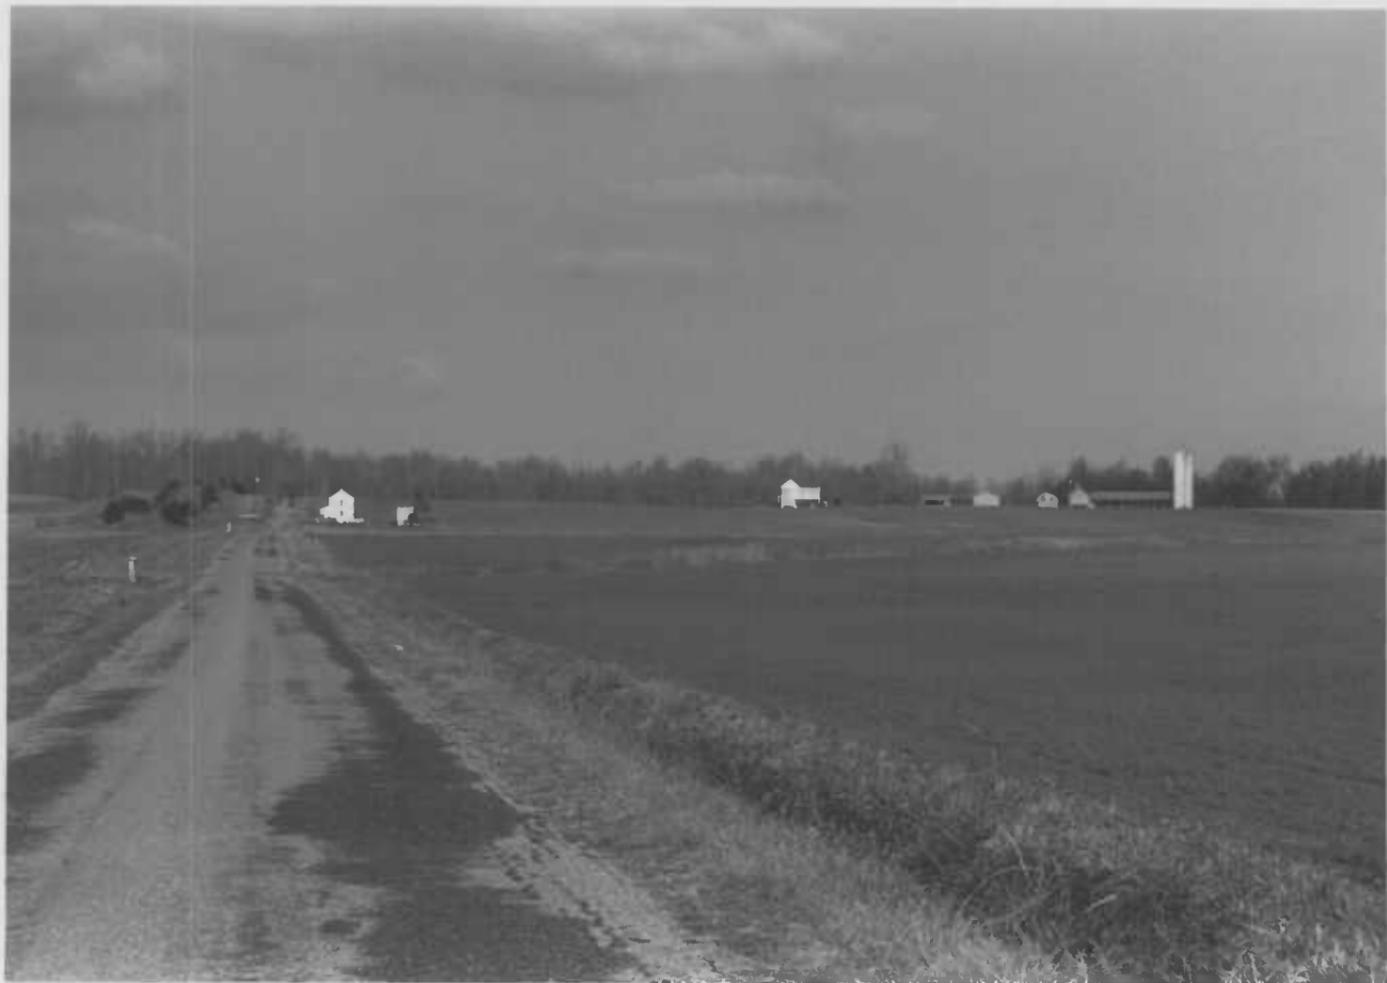
1 OF 25

FARM COMPLEX, VIEW W

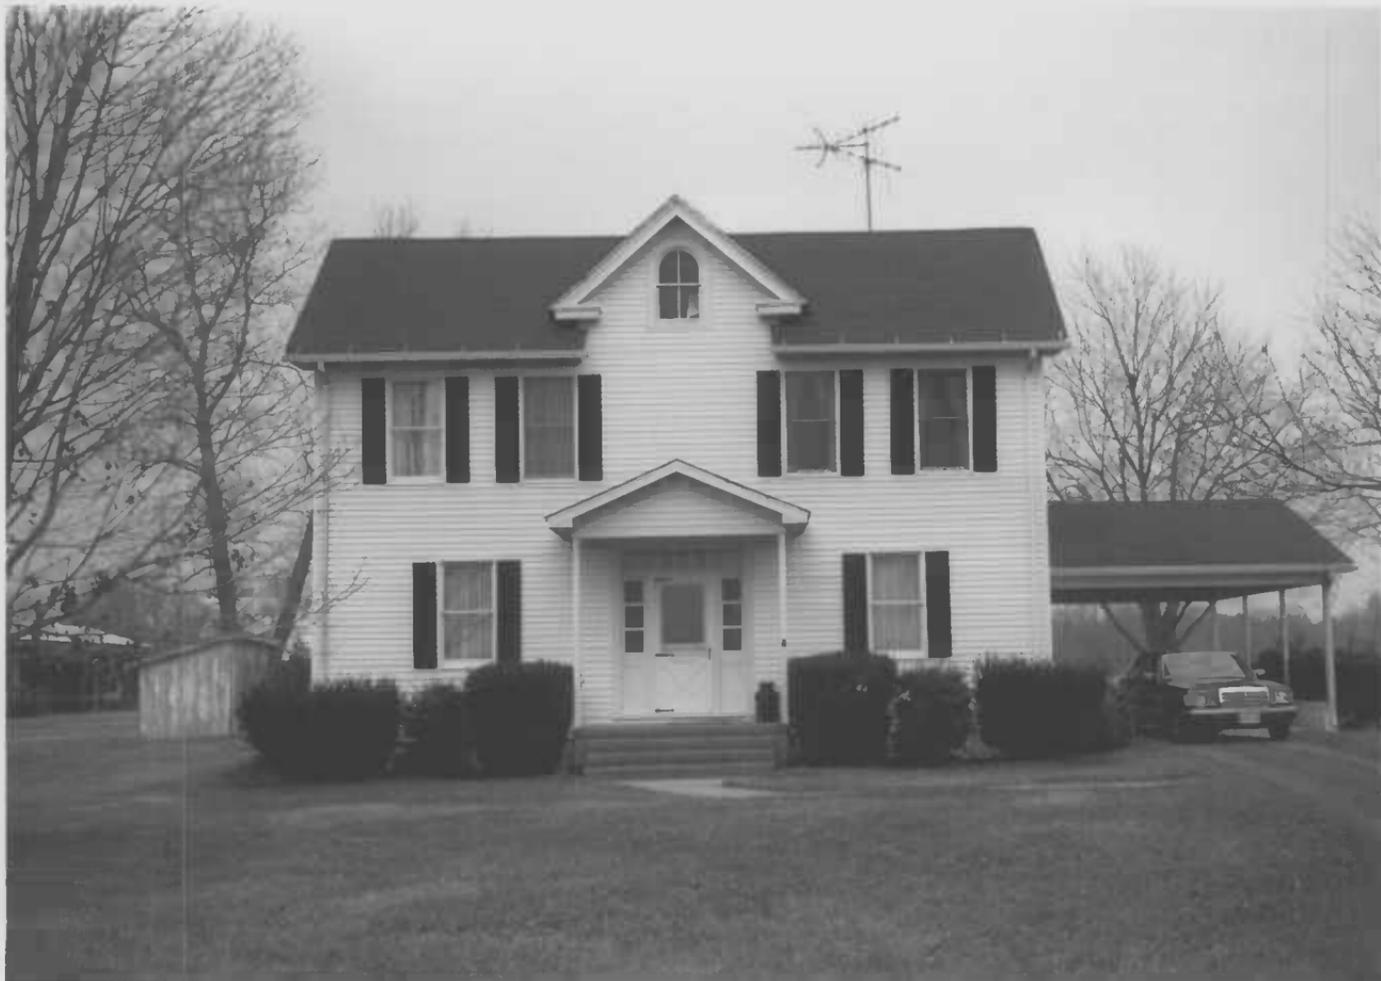
2 OF 25

The south, or front facade has a symmetrical fenestration pattern and central entrance with a front-gable entrance porch. The porch has an asphalt shingle roof supported by two wood posts on a concrete floor. The first story entrance is a wood door with a large single-light and an aluminum storm door. The doorway is flanked by 3-light sidelights and topped by a rectangular transom with seven lights. The first and third bays of the first story have double-hung windows. The second story has three double-hung windows vertically aligned over the first story openings.

SOUTH (FRONT) ELEVATION

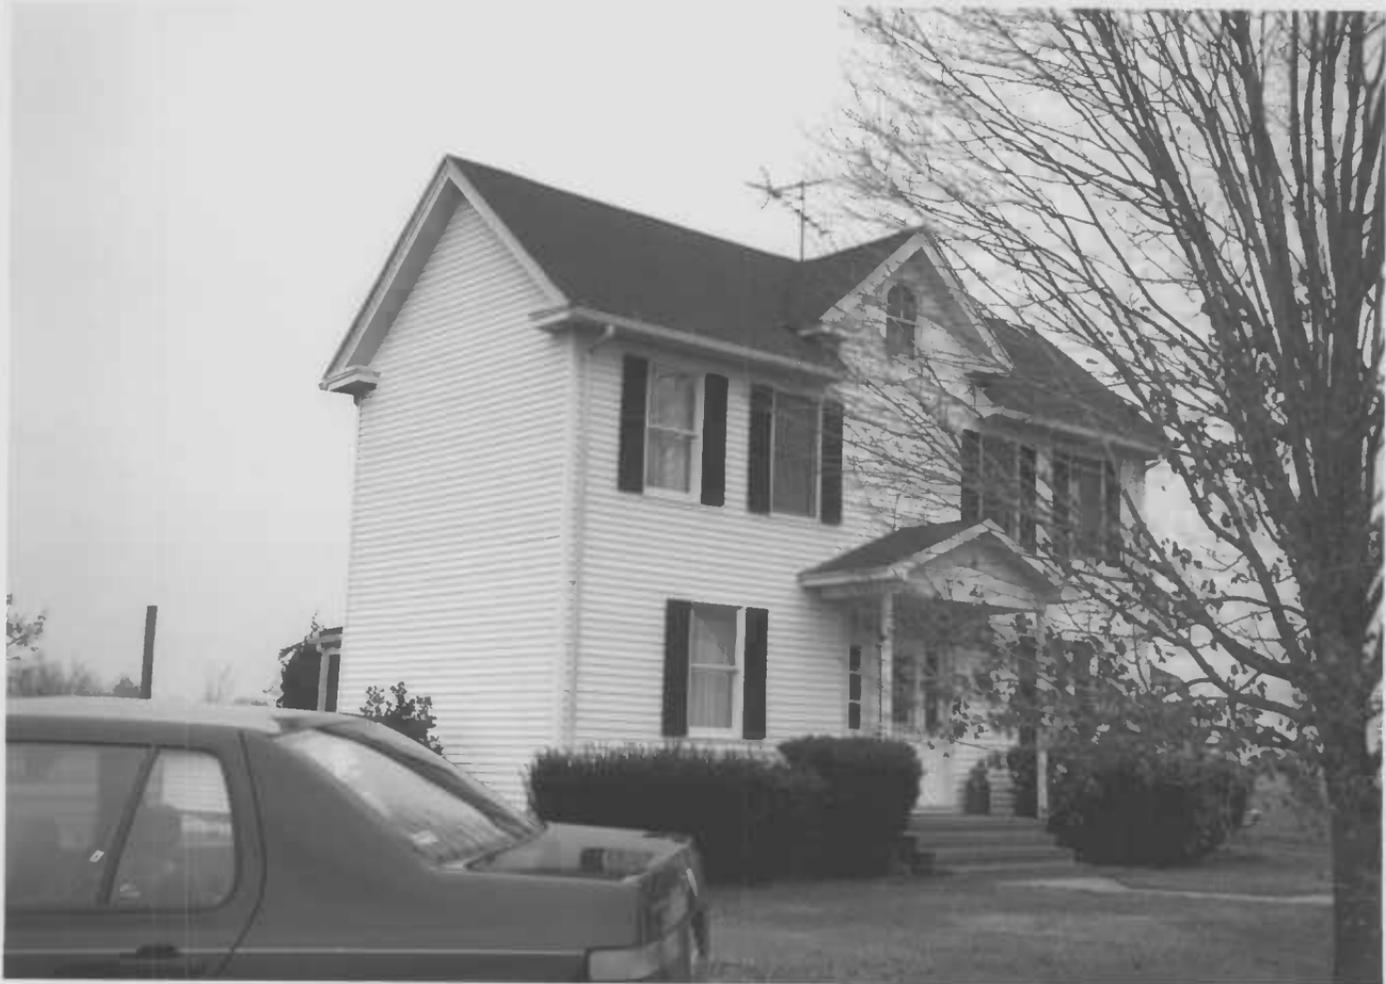
3 OF 25

The west elevation of the main block has a 3-light awning window on the basement level. The first and second stories have no fenestration. The west elevation of the rear ell has a single double-hung window on the second story. The west elevation of the enclosed rear porch has two double-hung windows.

SOUTH WEST CORNER

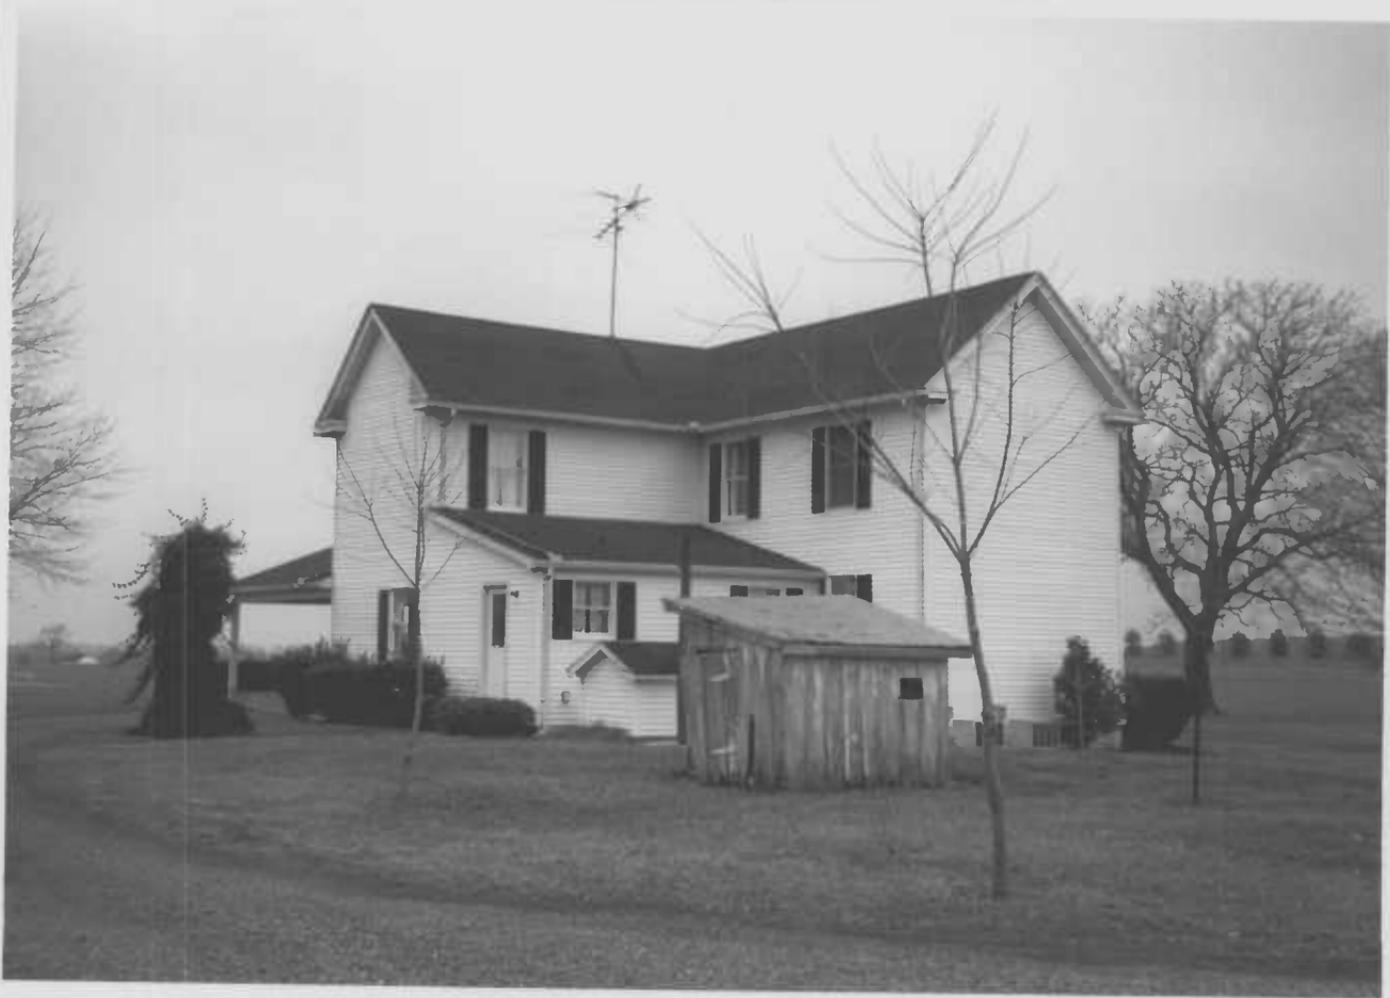
5 OF 25

The north, or rear elevation has a single double-hung window on the first story of the main block. Two double-hung windows are located on the second story. The rear ell has a double-hung window on the first story of the rear elevation. The rear elevation of the enclosed rear porch has wood door.

NORTH WEST CORNER

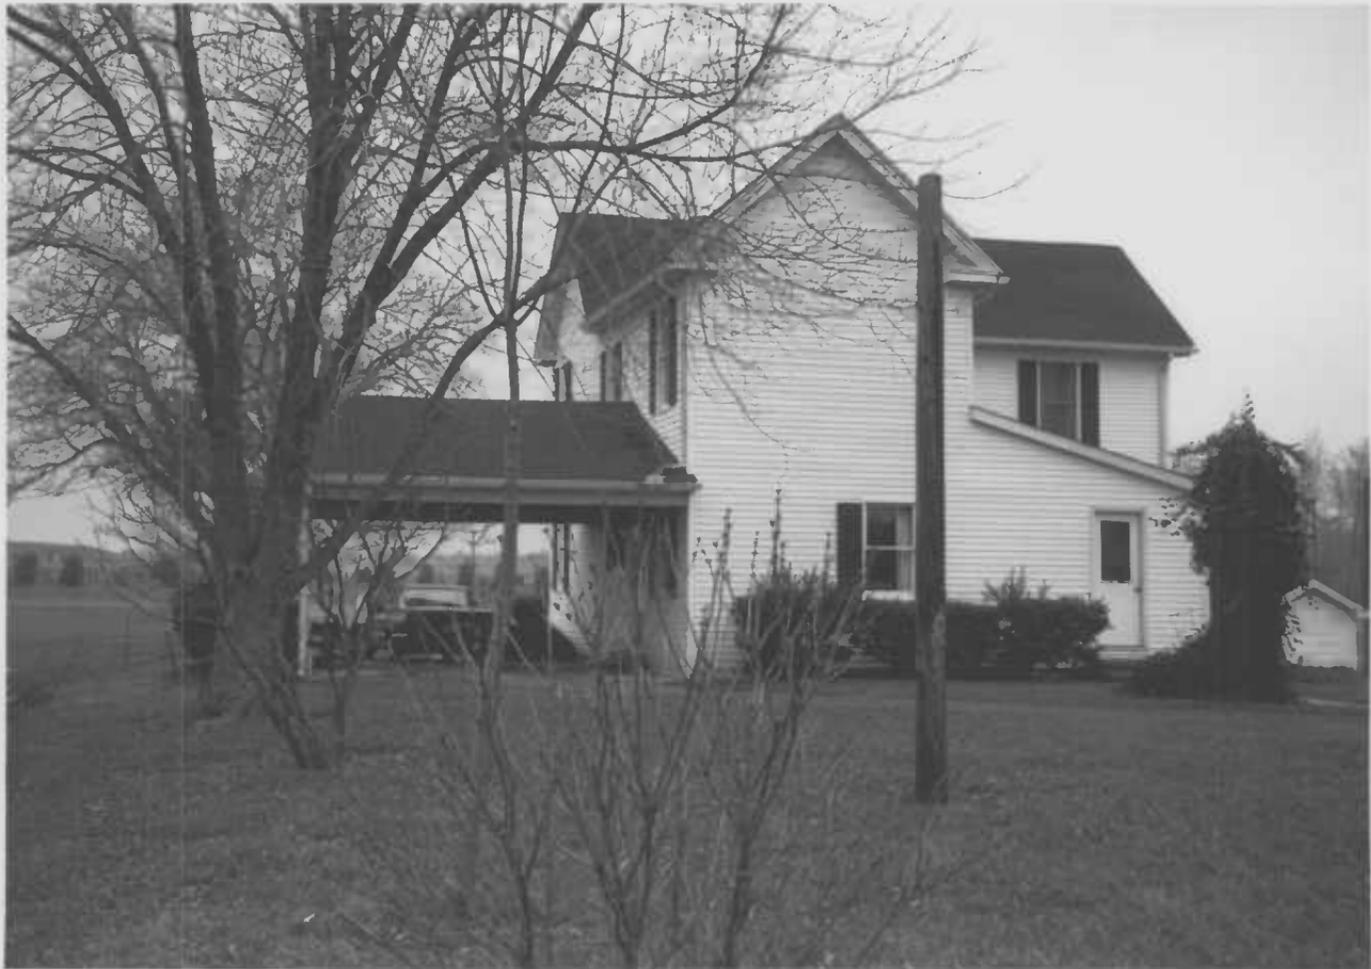
7 OF 25

NORTH EAST CORNER

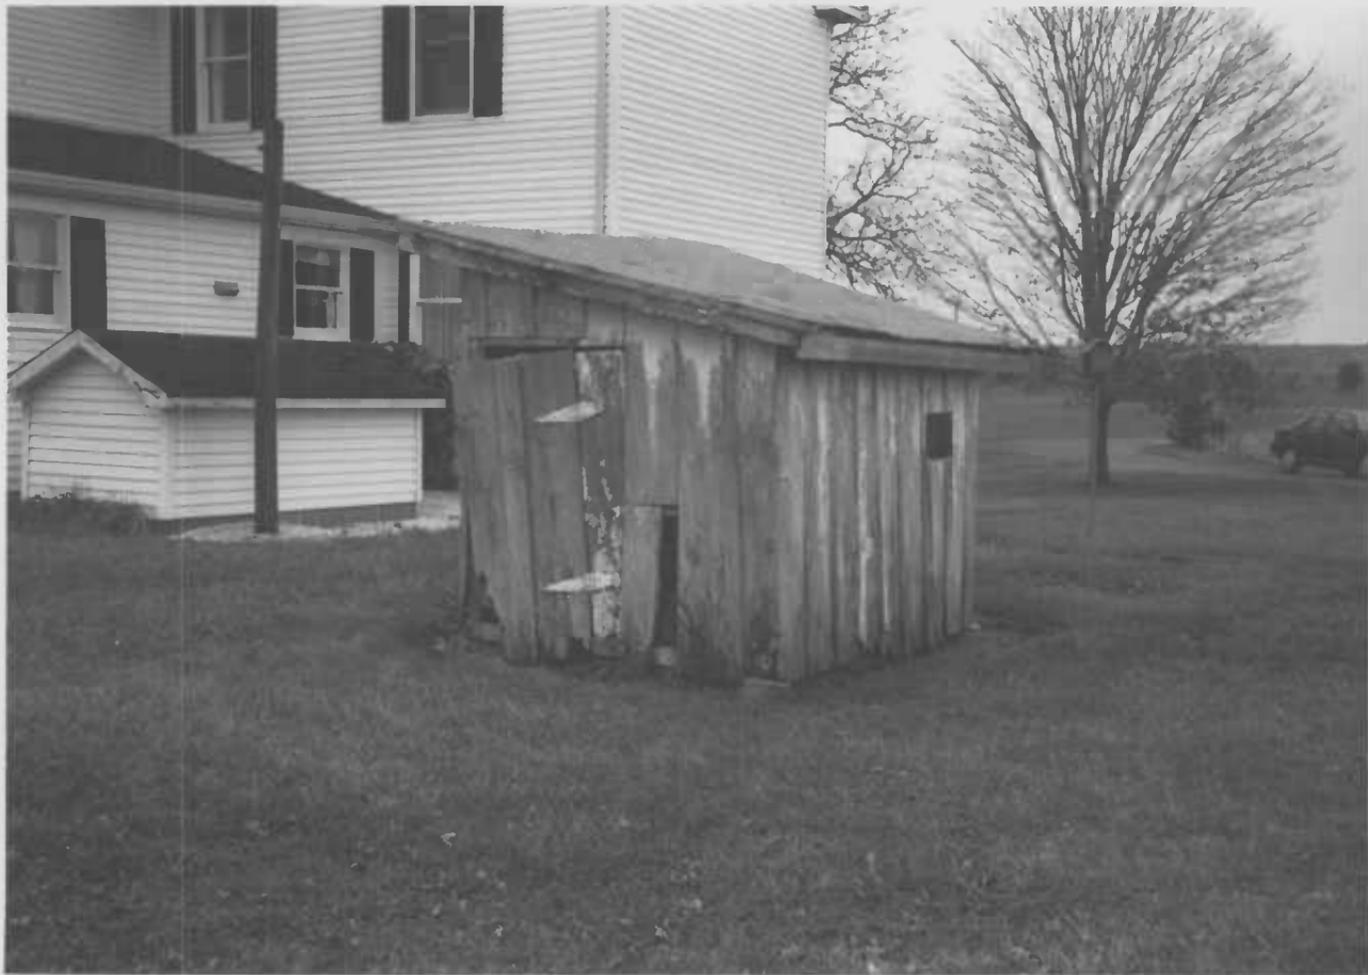
10 OF 25

has a metal shed roof, vertical wood siding and is supported by concrete piers. The building has a batten door on the north elevation and two 6-light awning windows on the east elevation.

HEN HOUSE, NORTH WEST CORNER

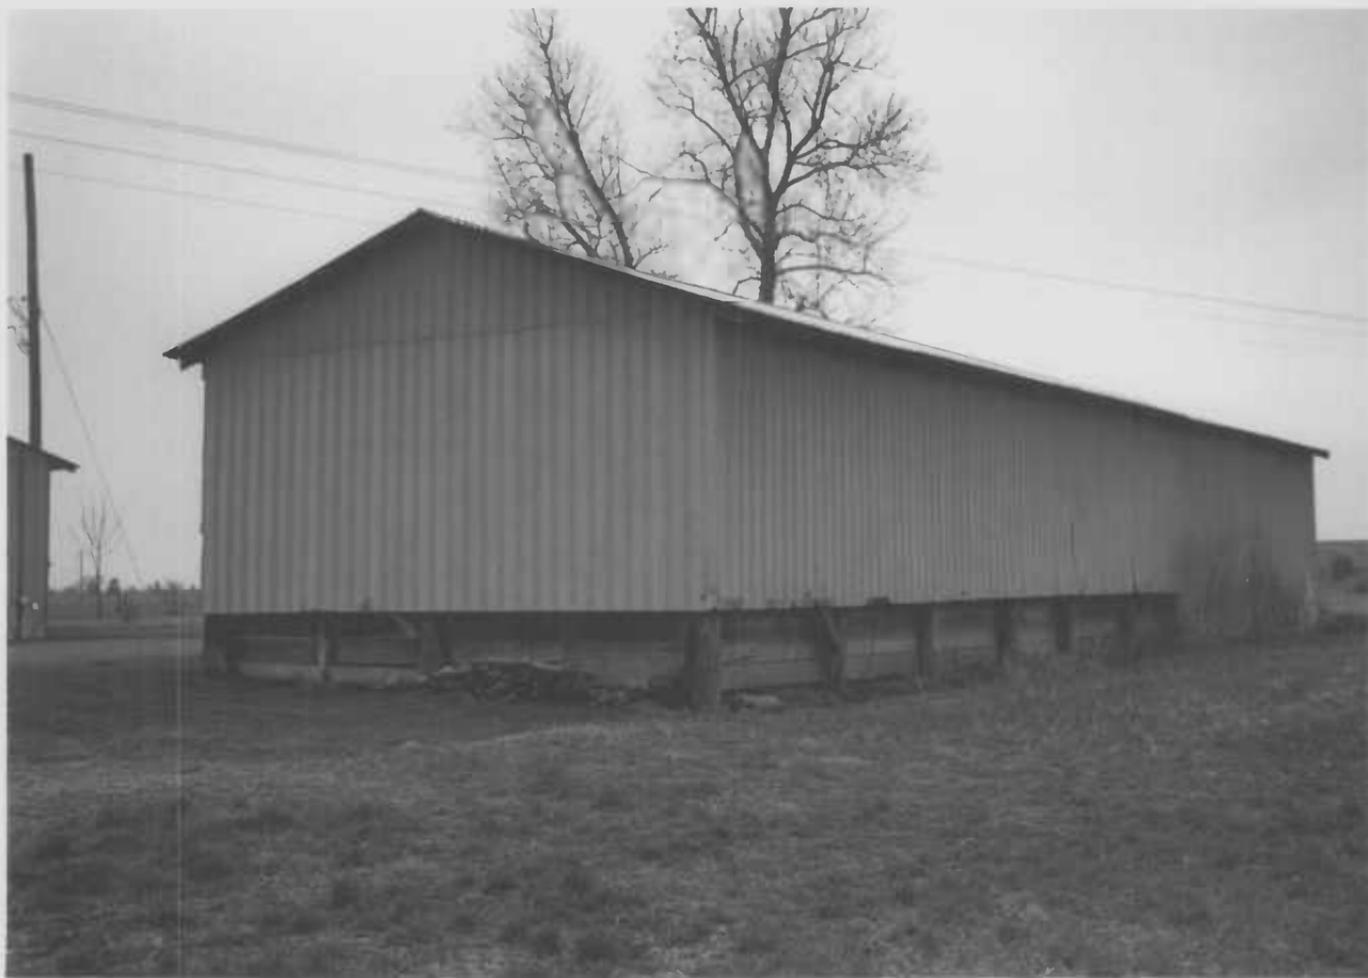
12 OF 25

To the north of the main house and hen house are two machine sheds. The first machine shed is located on the west side of the lane extending north from the house. The shed, constructed circa 1910, is of post and beam construction with metal siding and a metal side-gable roof. The metal siding was replaced circa 1980. The building has five open bays on the east elevation. The second machine shed is located on the east side of the lane extending north from the main house. Constructed circa 1910, the shed has a side-gable roof and metal sheathing. It is of post and beam construction with a wooden roof truss system replaced circa 1995. The shed has four open bays on the north elevation.

MACHINE SHED, NORTH WEST CORNER

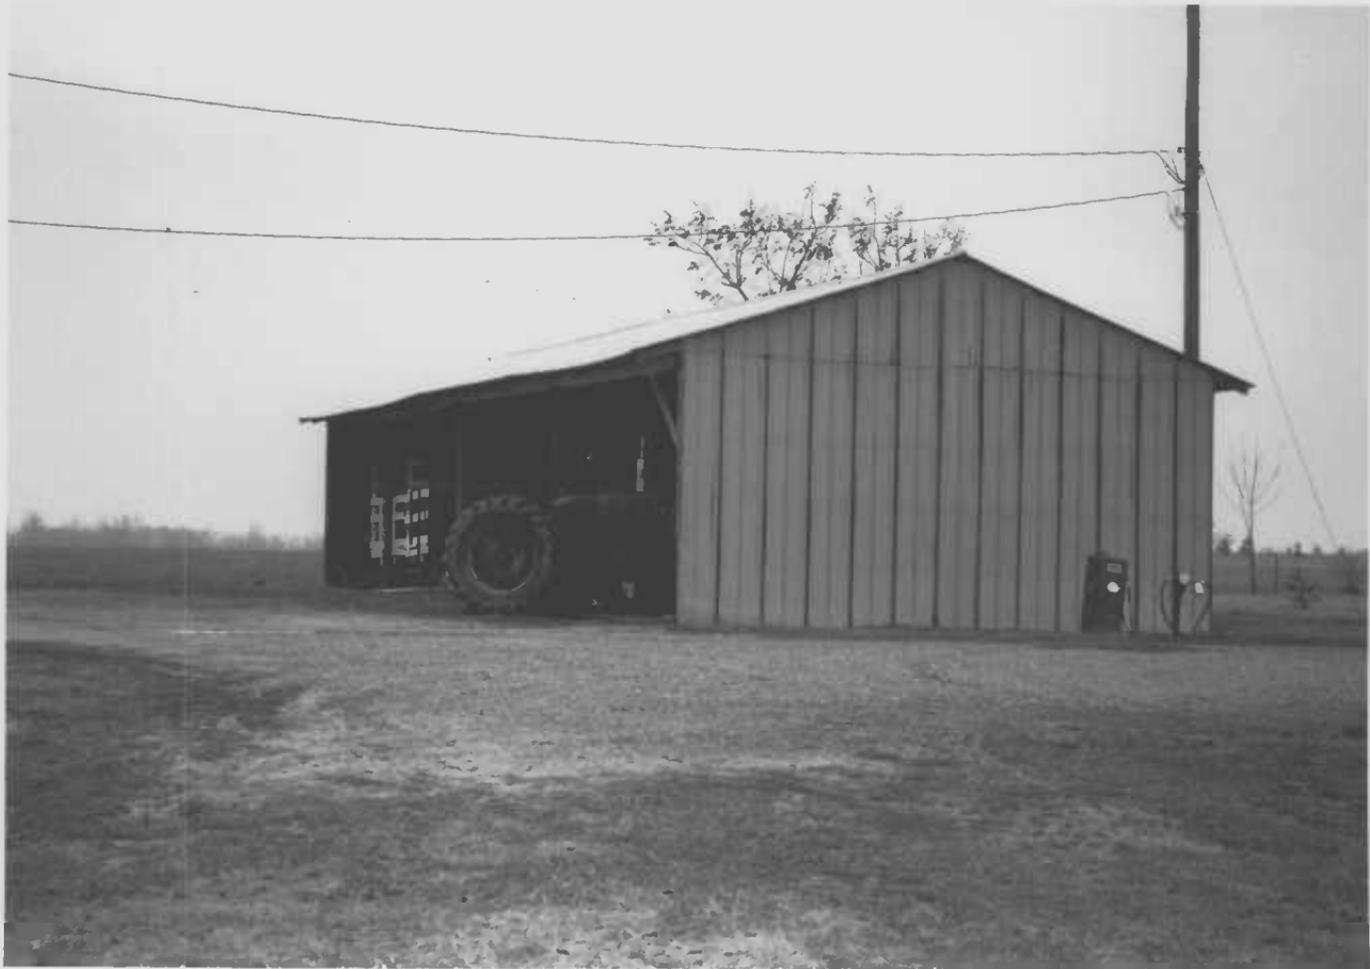
13 OF 25

MACHINE SHED 2, NORTH EAST CORNER

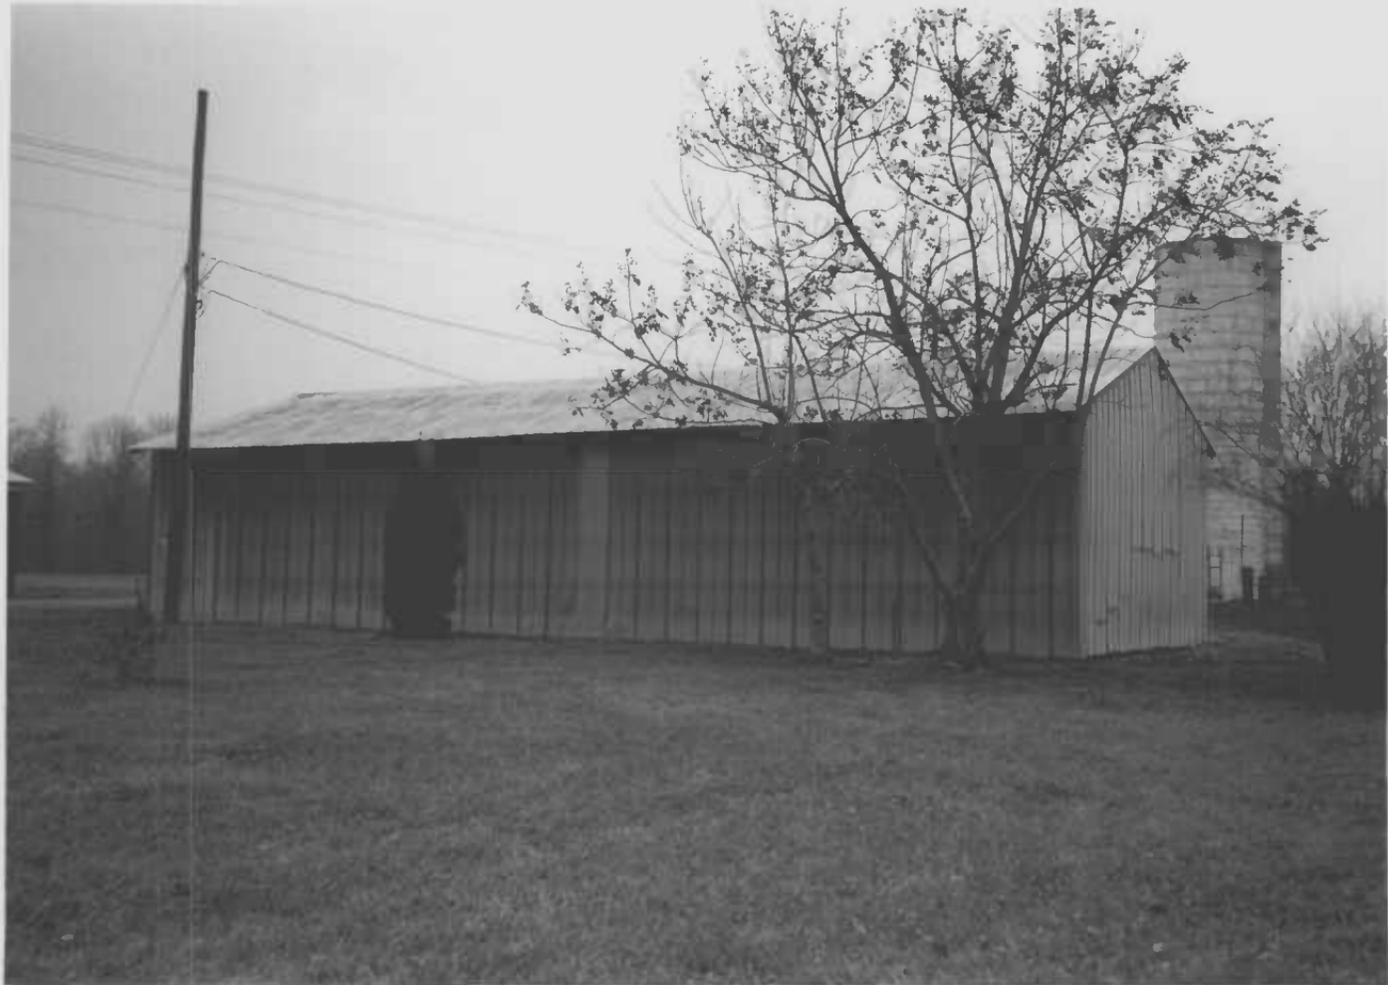
14 OF 25

MACHINE SHED 2, SE CORNER

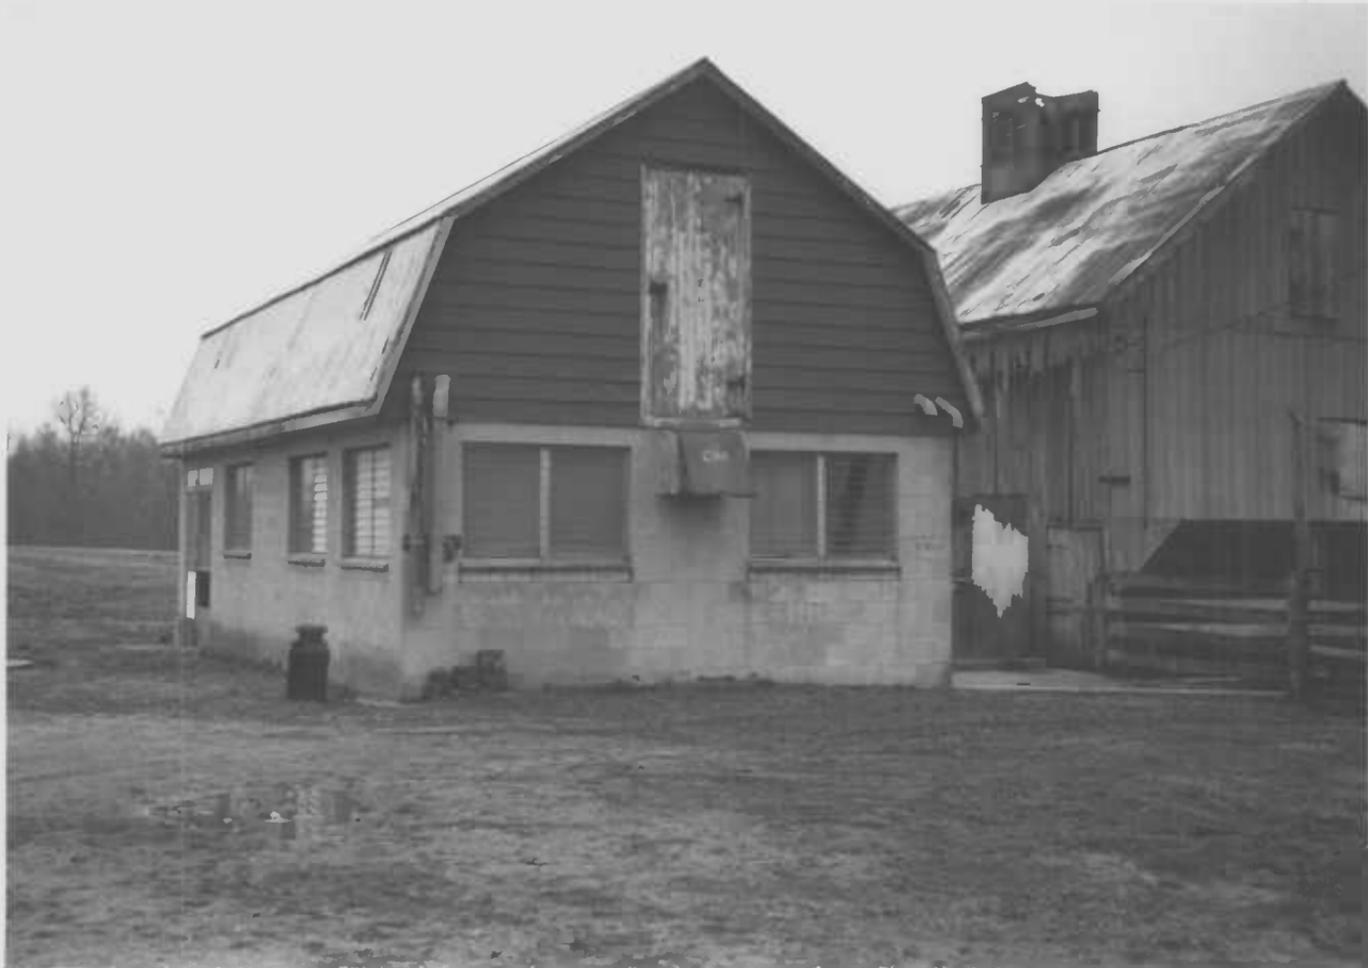
15 OF 25

MILKING PARLOR, SOUTH EAST CORNER

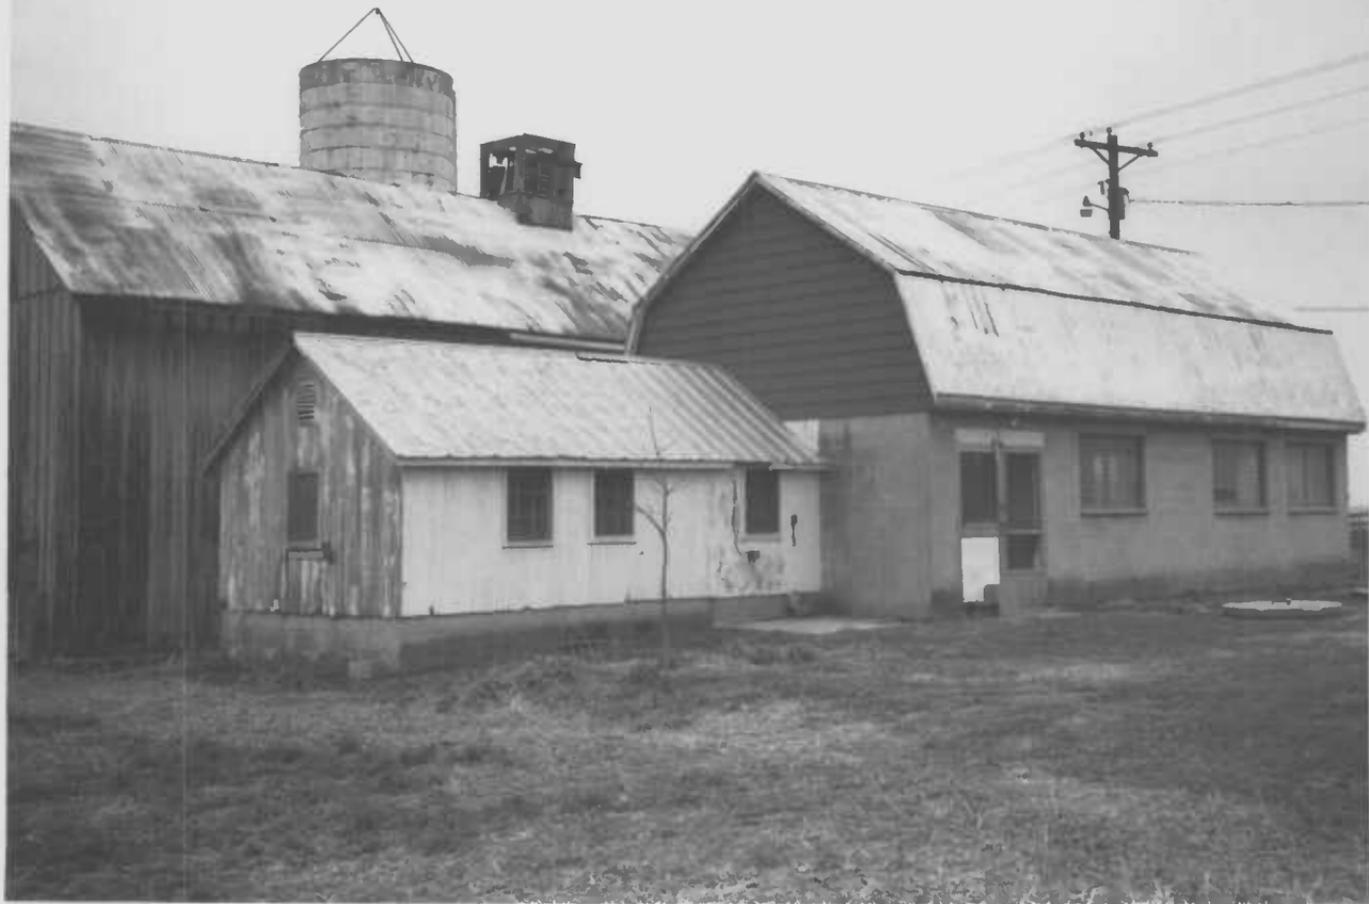
16 OF 25

MILKING PARLOR, SOUTH WEST CORNER

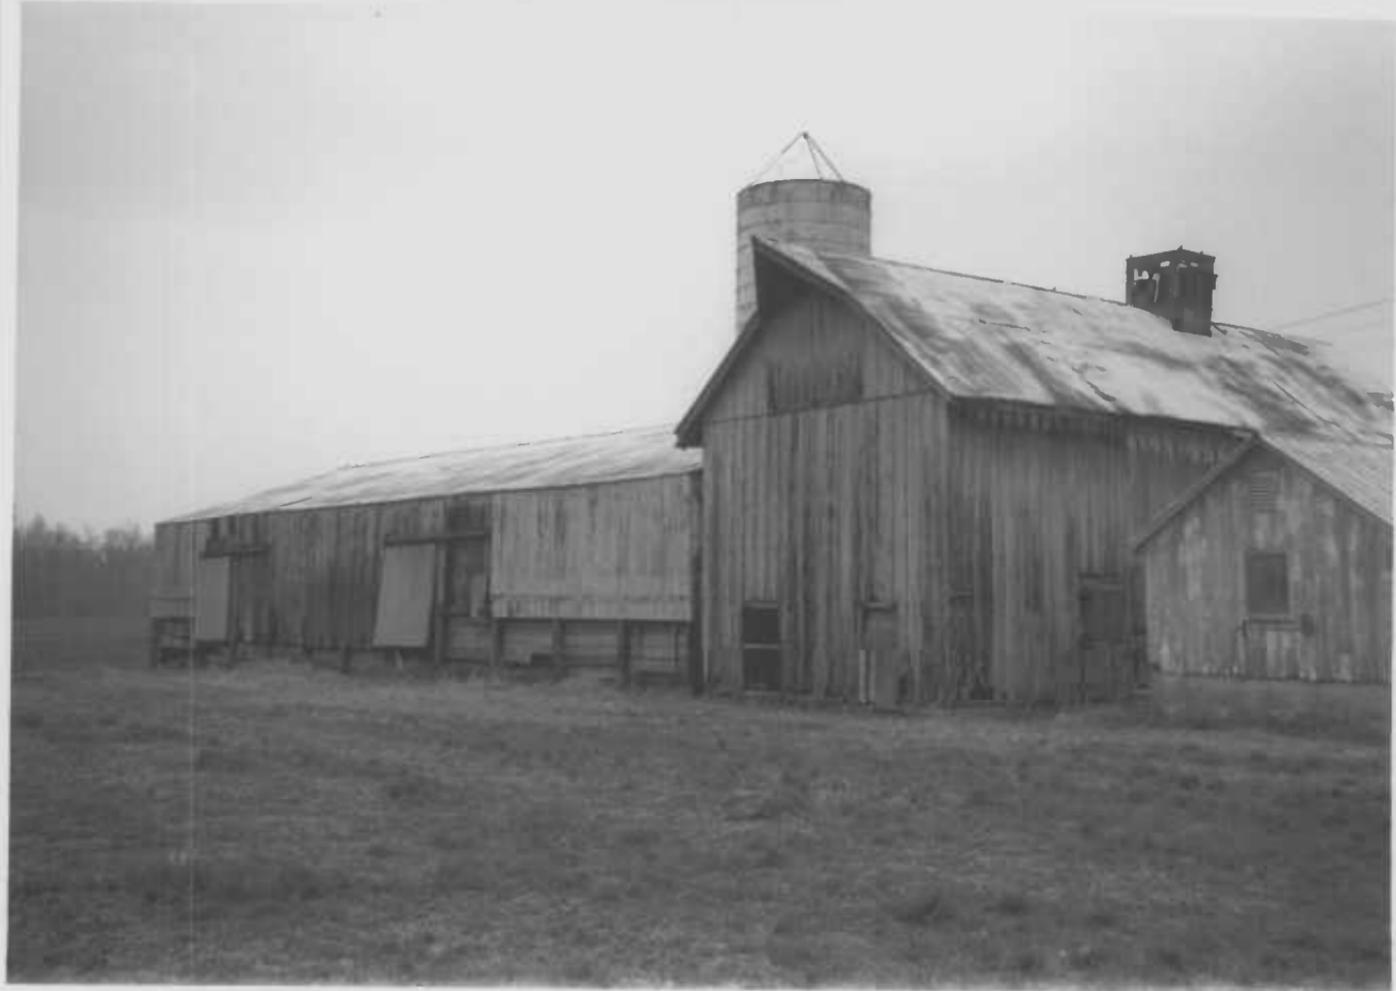
18 OF 25

North of the dairy barn is a cow barn. The structure, constructed circa 1900, is 2-stories in height with a gable roof covered with metal. The barn is of wood-frame construction with concrete block piers. The building has vertical wood siding and a wood cupola on the roof ridge. The first story of the east gable end has two open bays, with a sliding metal door on the second story and a wood batten door in the loft. The first story of the south elevation has three wood doors and three windows. The second story has one door. The west elevation has two window openings on the first story and a triangular hay hood over hinged double doors in the loft. Attached to the north elevation of the cow barn is a 1-story cow shed addition. Constructed circa 1930, it is of post and beam construction like the machine sheds. The structure has five open bays on the east elevation with no additional fenestration. The building is covered with vertical wood siding. North of the cow barn and shed is a metal silo.

BARN, SW CORNER

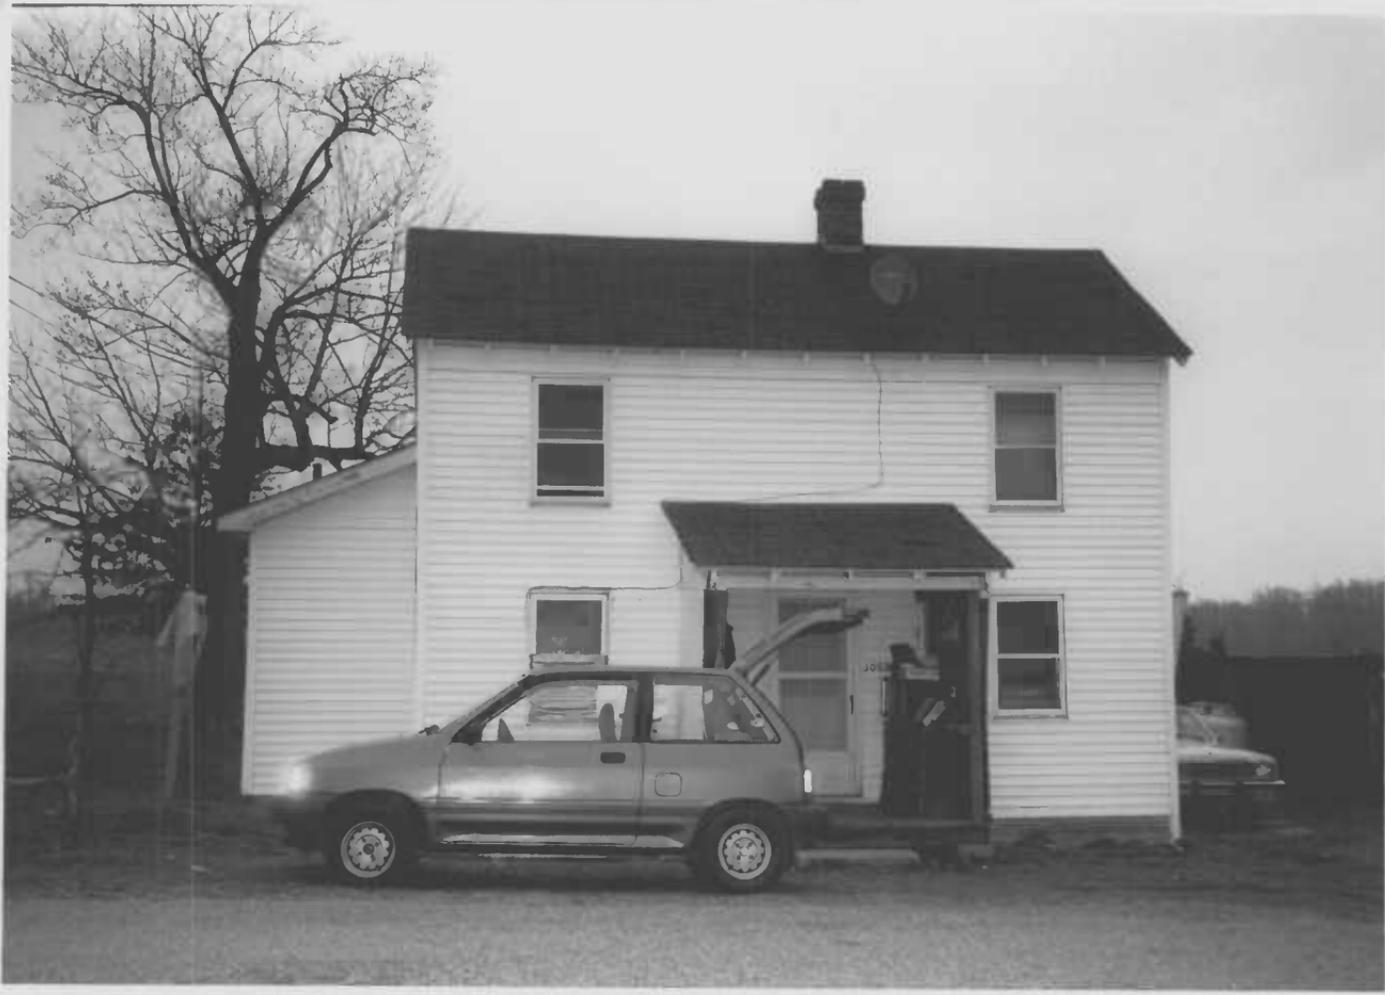
19 of 25

The east elevation has a double-hung window on both the first and second stories. A vinyl vent is located in the gable end.

TENNIS HOUSE, E. ELEVATION

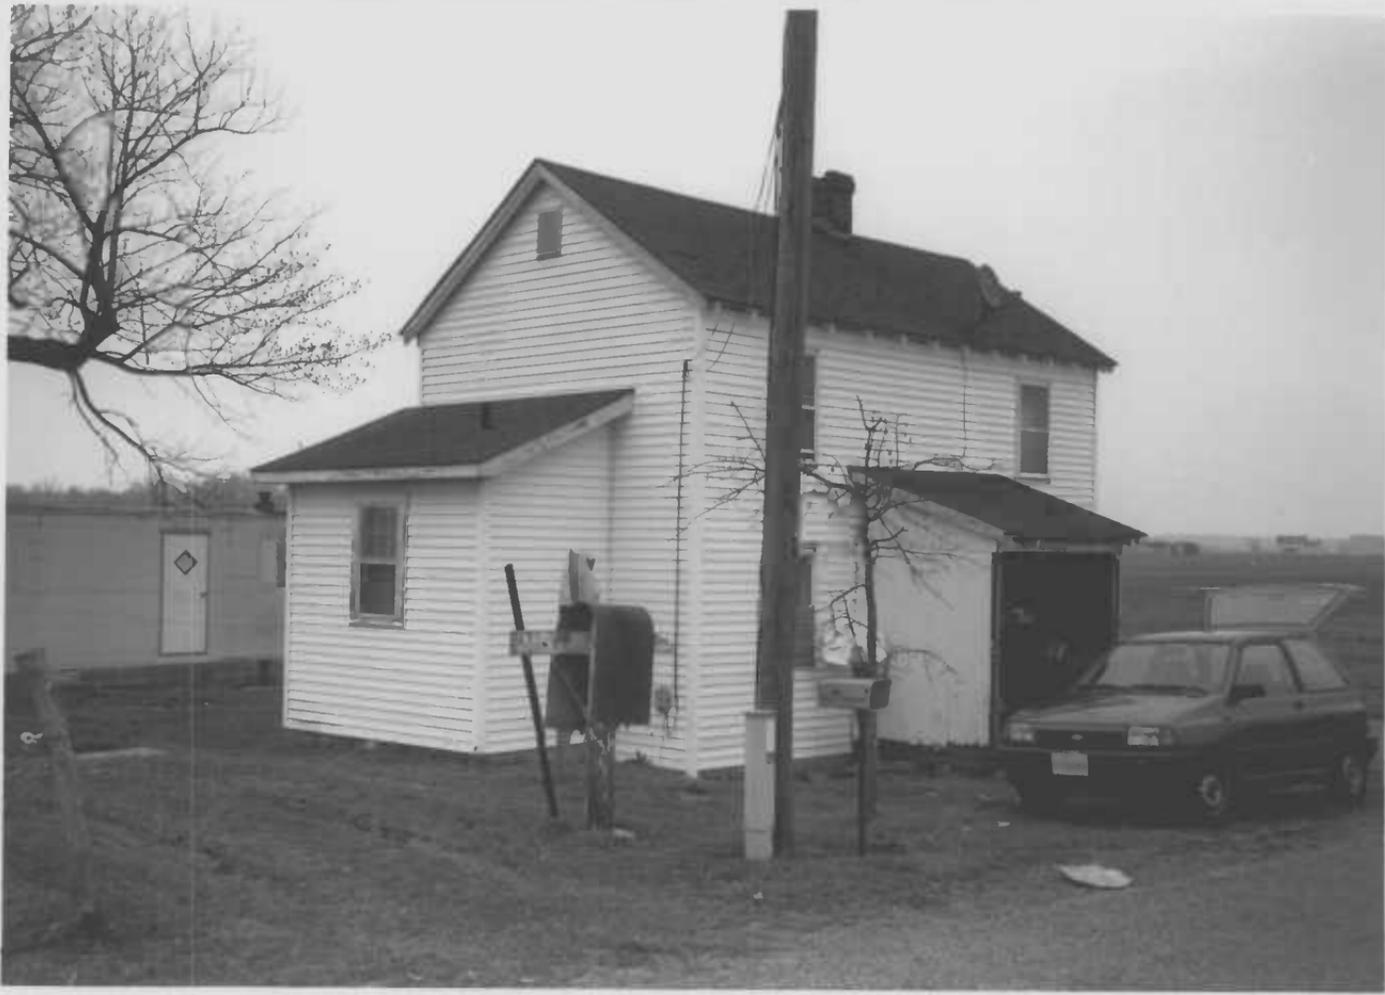
20 OF 25

The west elevation of the tenant house has one 6/1 double-hung wood window in a 1-story shed roof addition. The second story has no fenestration, and a vinyl vent is located in the gable end.

TENANT HOUSE, SW. ELEVATION

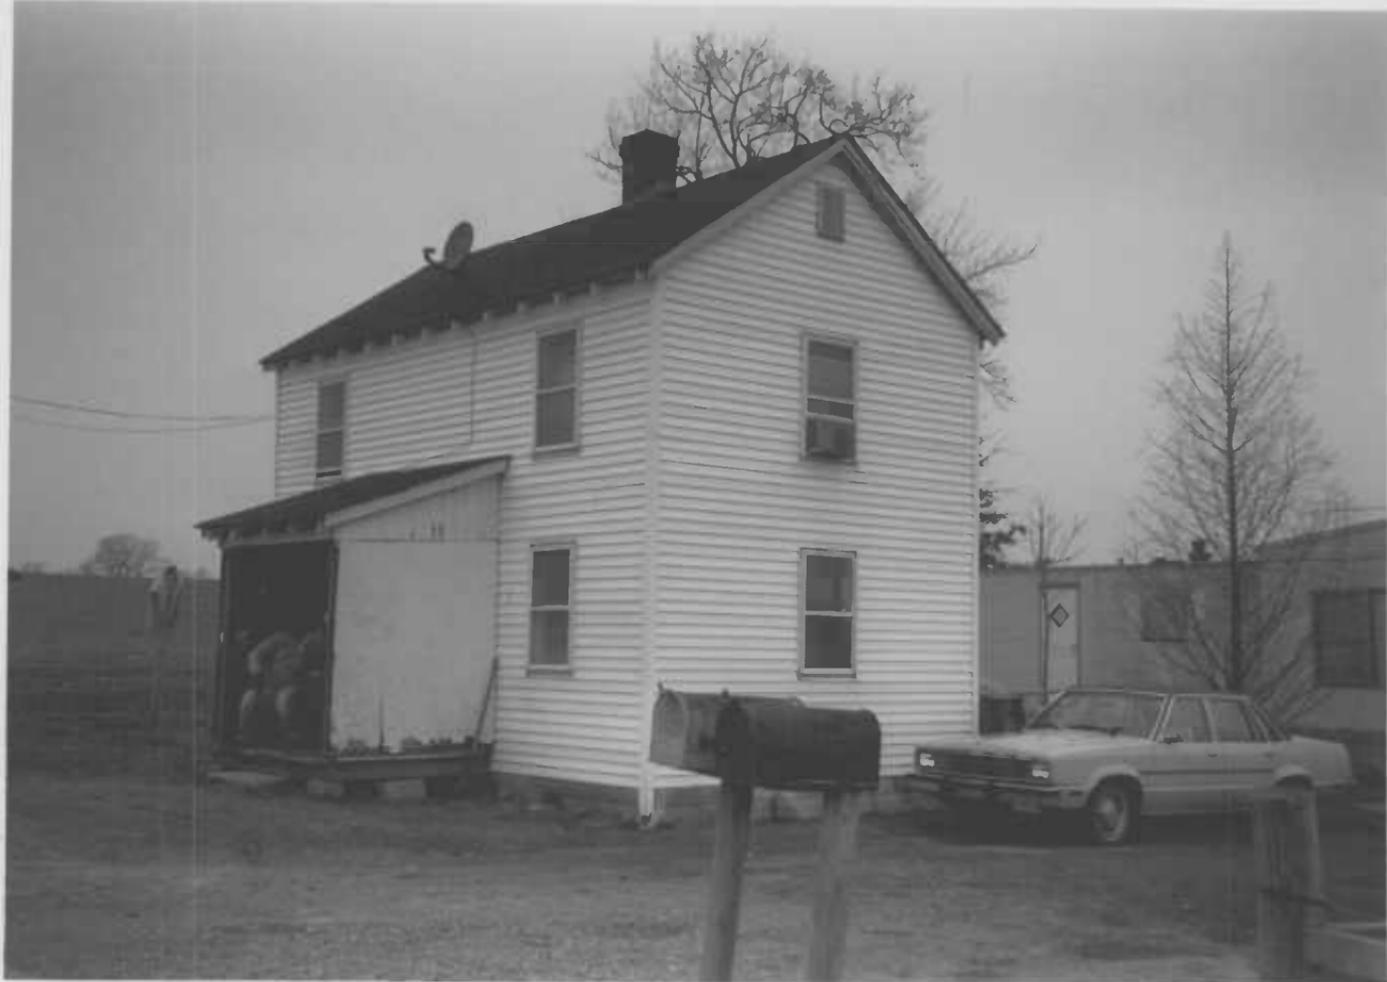
23 OF 25

TENANT HOUSE, SE CORNER

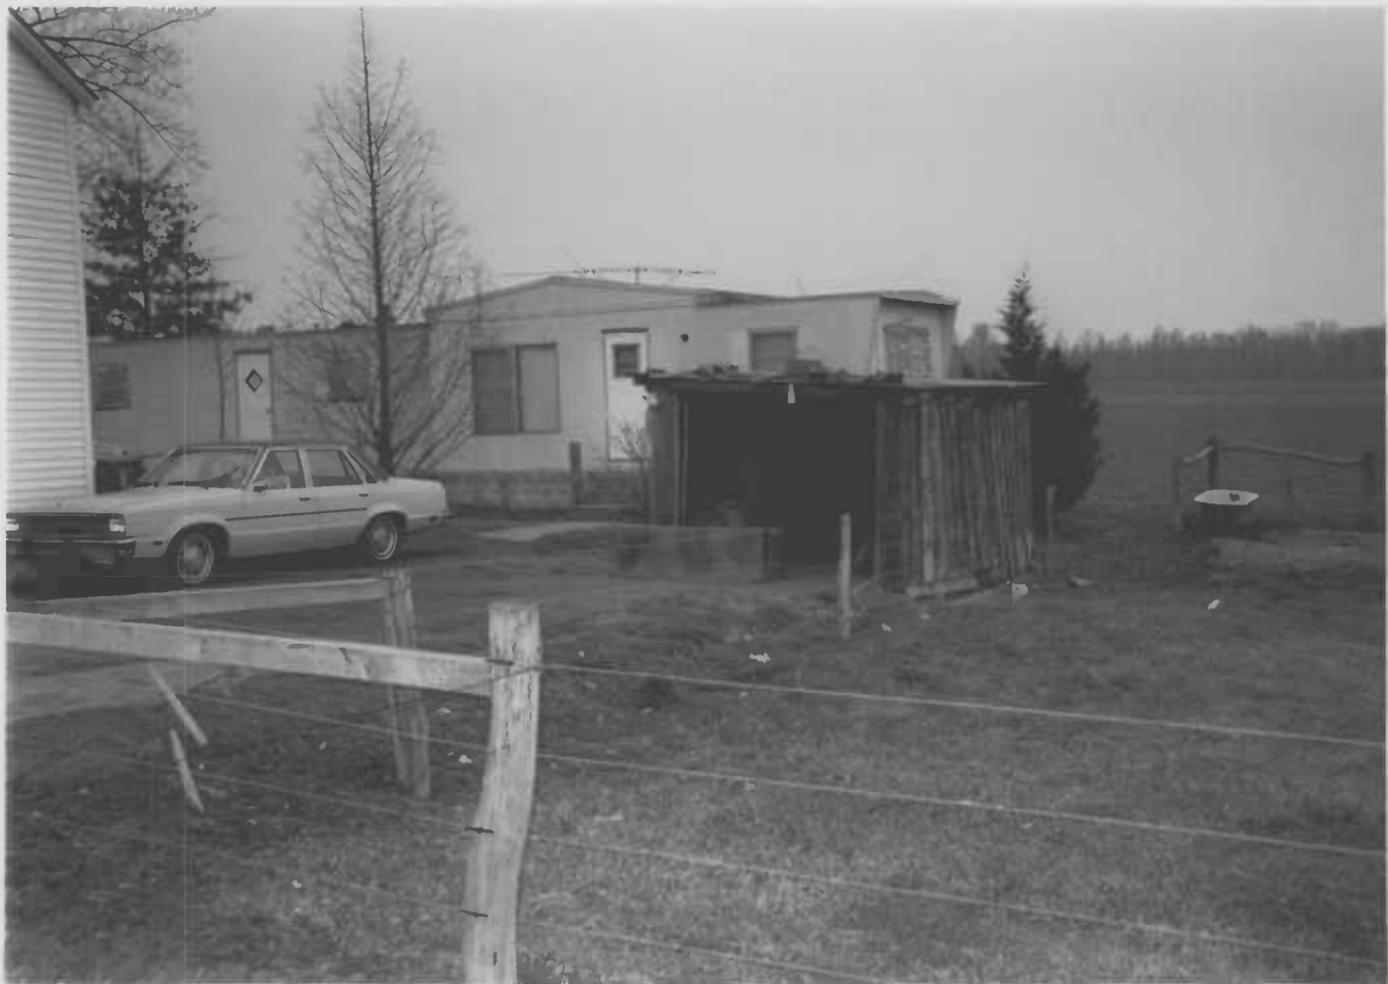
25 OF 25

Located north of the tenant house is a small garage and trailer. The garage, constructed circa 1940, is wood-frame with a shed roof and metal siding. The trailer, constructed circa 1970, has a wood exterior and aluminum sliding windows.

GARAGE, SOUTH ELEVATION
