T-393
Clarke W. Sewell Farm
5705 Old Trappe Road
Trappe Vicinity
Ca. 1900-1960
Private

Maryland Historical Trust Maryland Inventory of Historic Properties Form

Inventory No. T-393

Clarke W. Sewell Farm
Continuation Sheet

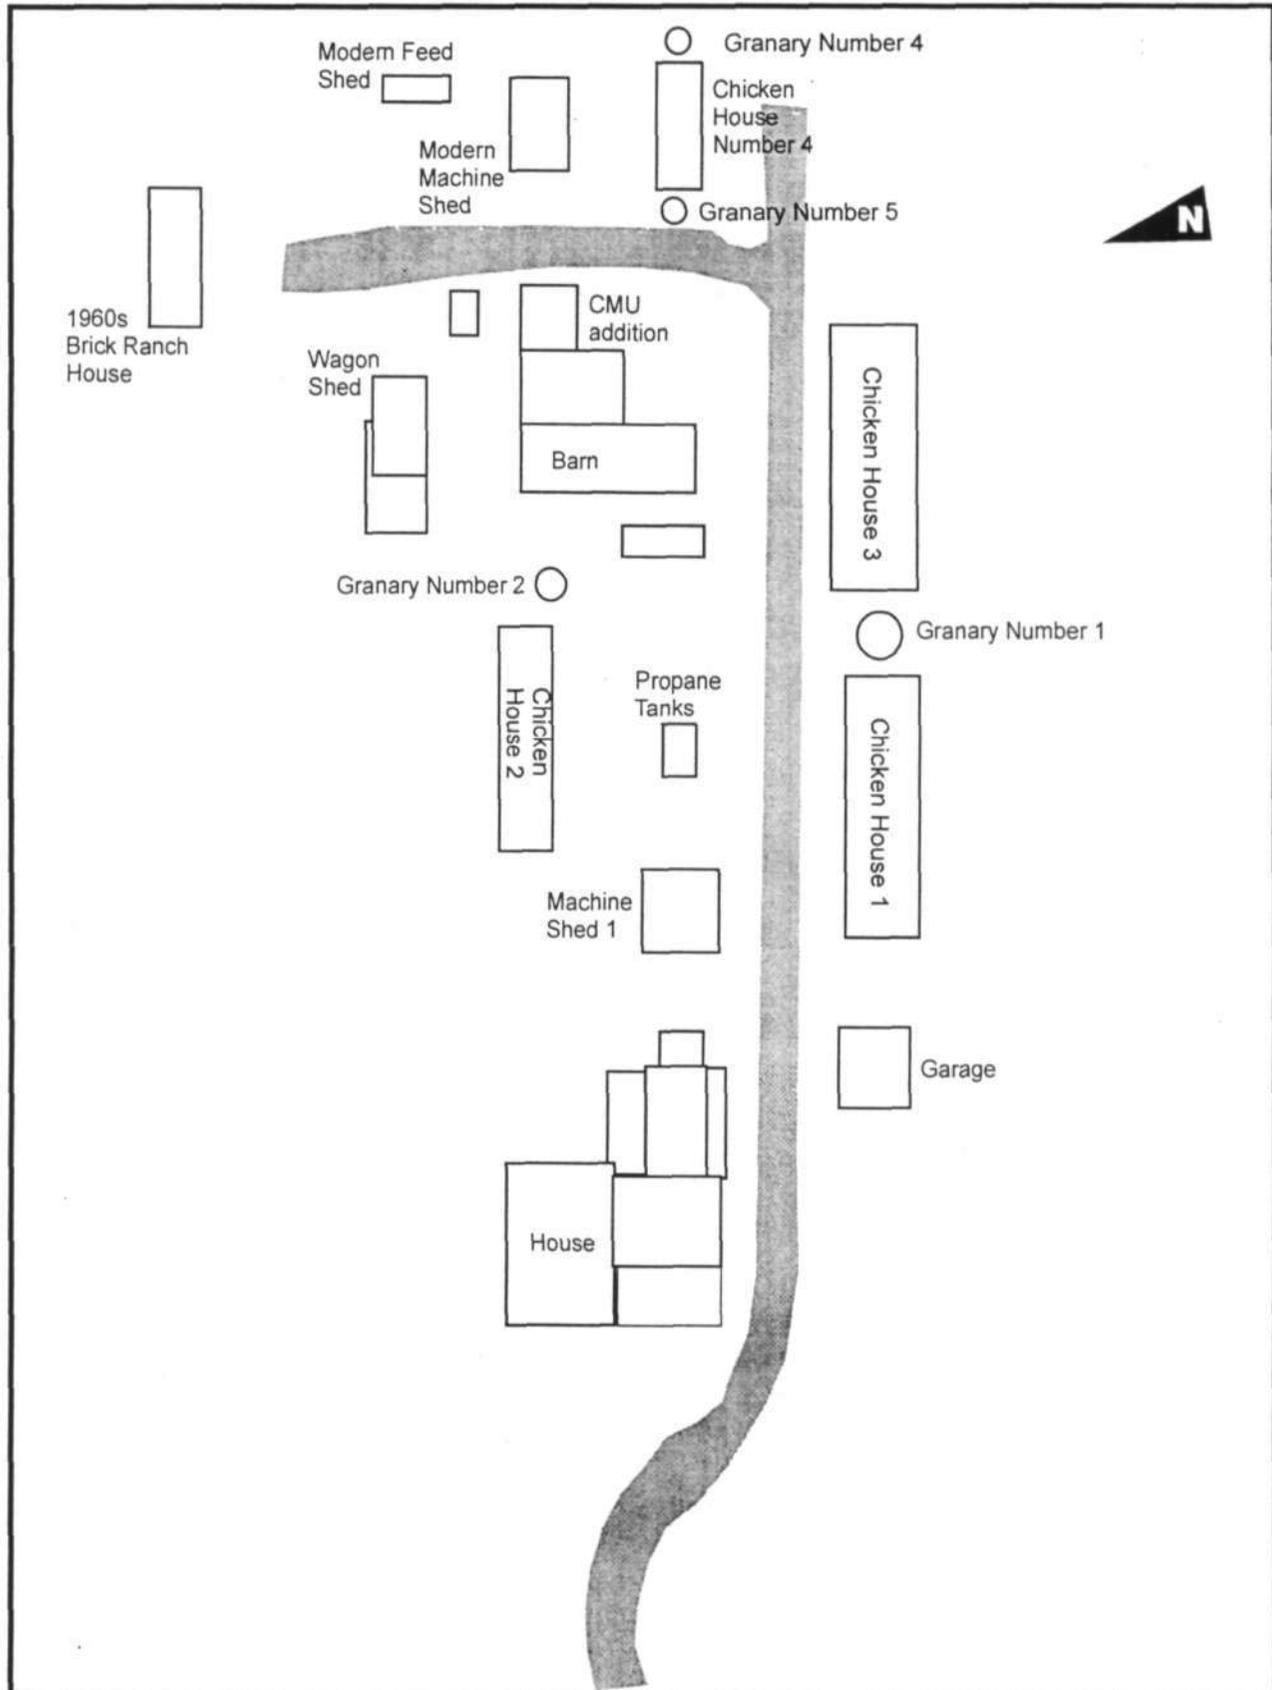
T-393
Clark W. Sewell Farm
5705 Old Trappe Road
Talbot County
Site Plan - 2003

The main residence is located approximately 500 feet down a straight gravel access road with the agricultural buildings located in a linear plan flanking the access road to the rear of the main residence. The property is surrounded by cultivated agricultural fields and is an active poultry farm.

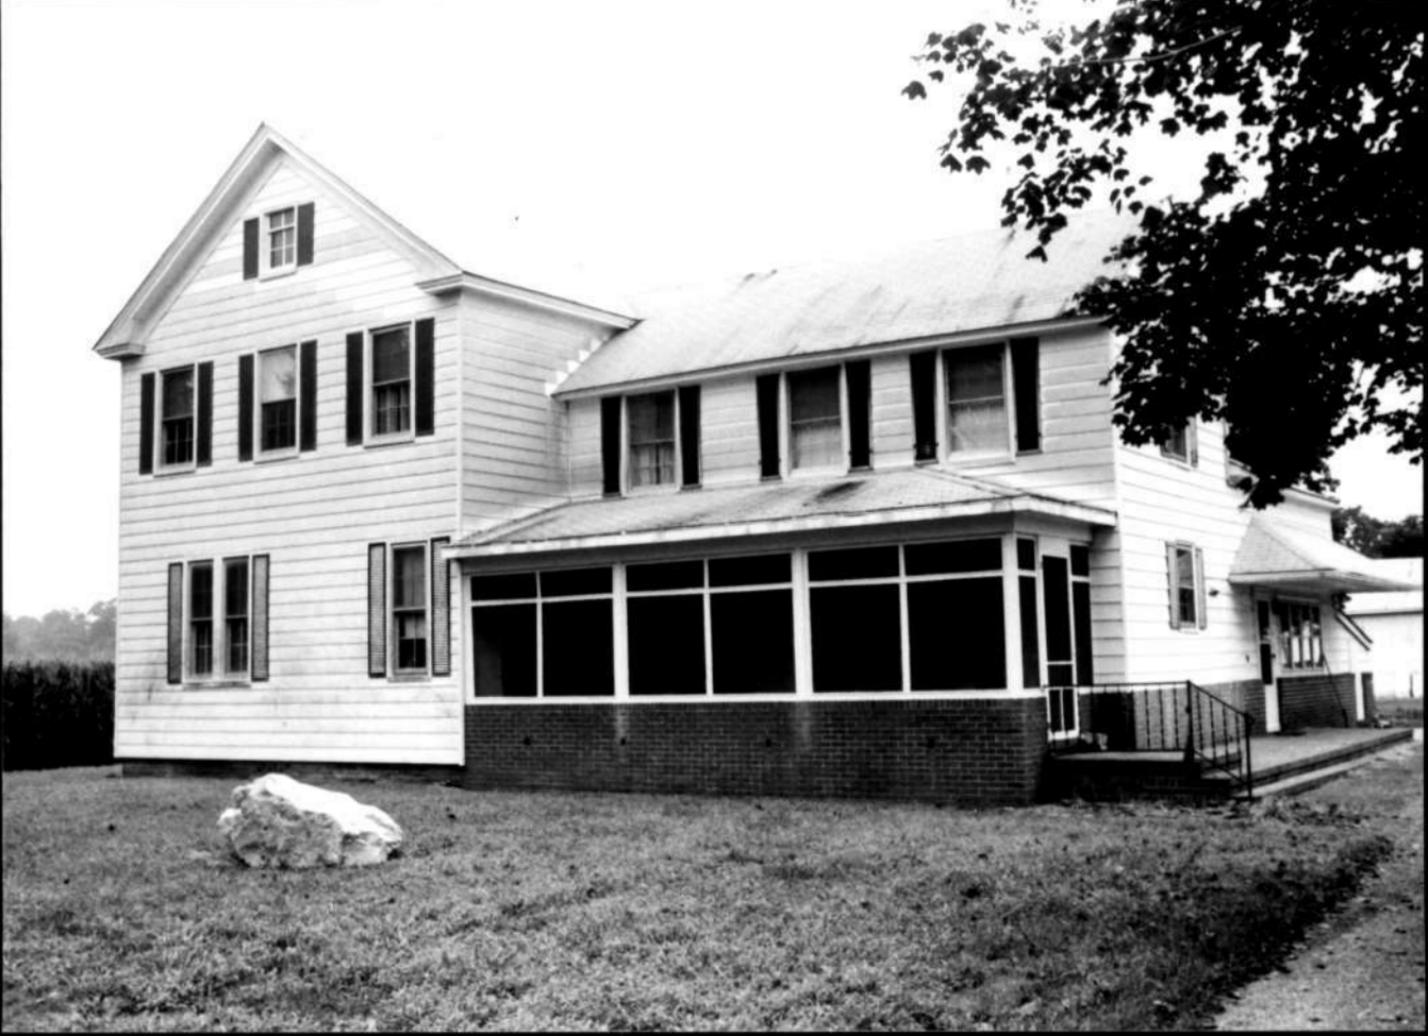
1/22

The main house is a two-and-a-half story wood frame structure, built ca. 1900, with a rear and a side wood frame addition. The building rests on a brick pier foundation with a continuous brick masonry foundation under the side addition. The rear addition has a continuous poured concrete foundation. The building has a hall-parlor plan. The cross-gable roof is clad with asphalt shingles. There is one interior brick masonry end gable chimney.

The west façade is the principle building entry. The walls are clad with aluminum siding. The building is entered through a central hinged four panel wood front door into the side addition. The windows in the oldest portion of the building are two-over-two wood sashes, with six-over-six wood sashes in the side addition. The hipped roof front porch has been enclosed.

MAIN HOUSE VIEW LOOK

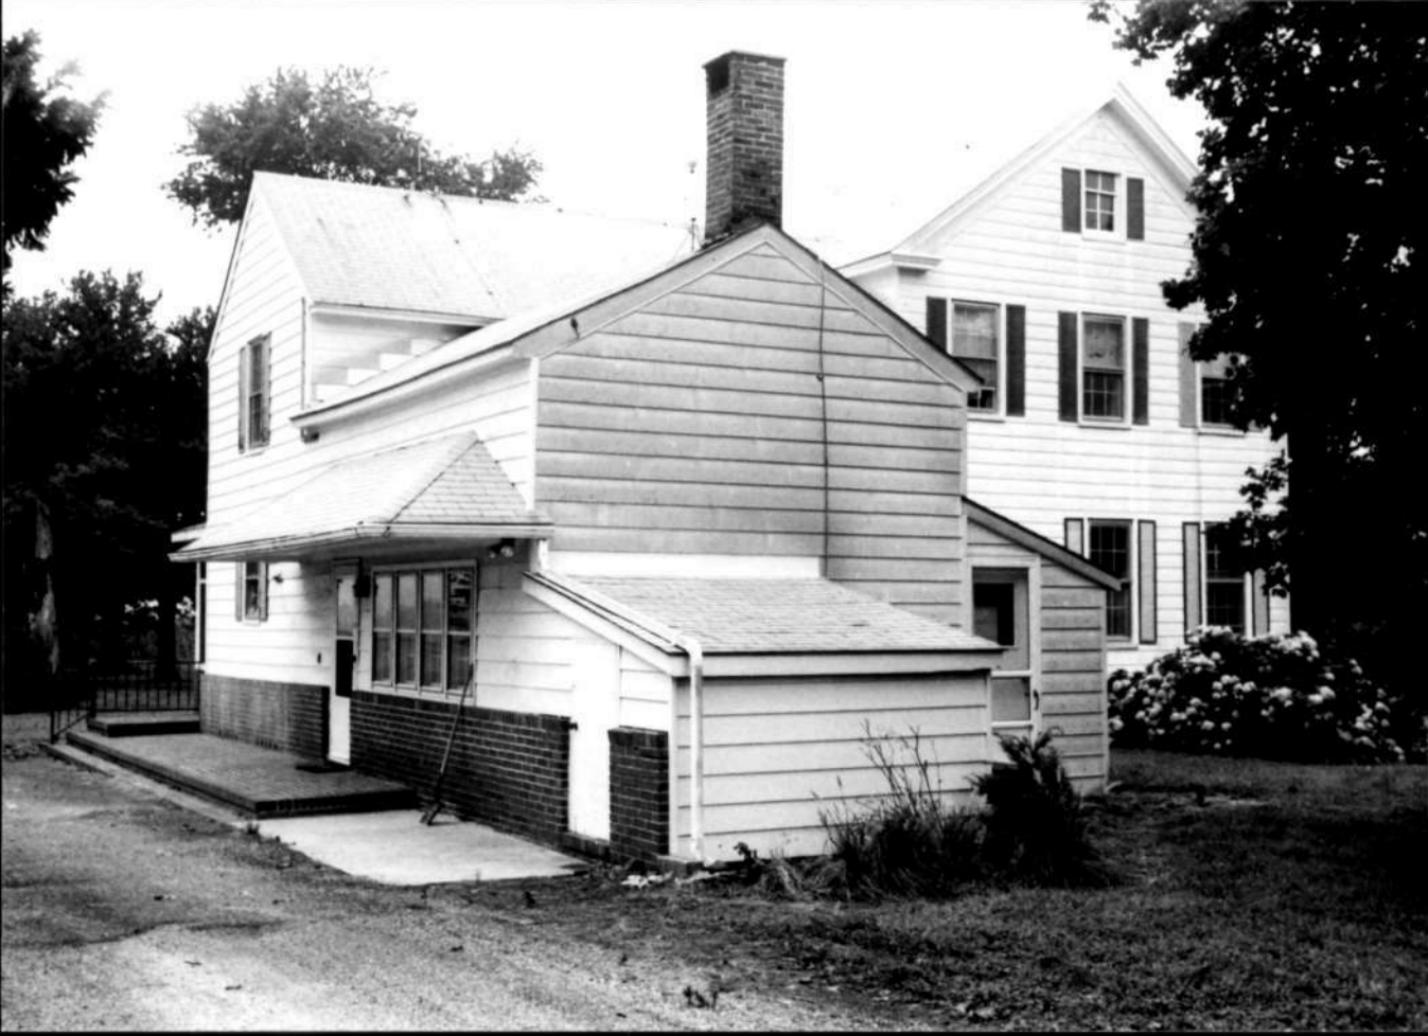
2/22

MAIN HOUSE 314 VIEW LODGE TRW

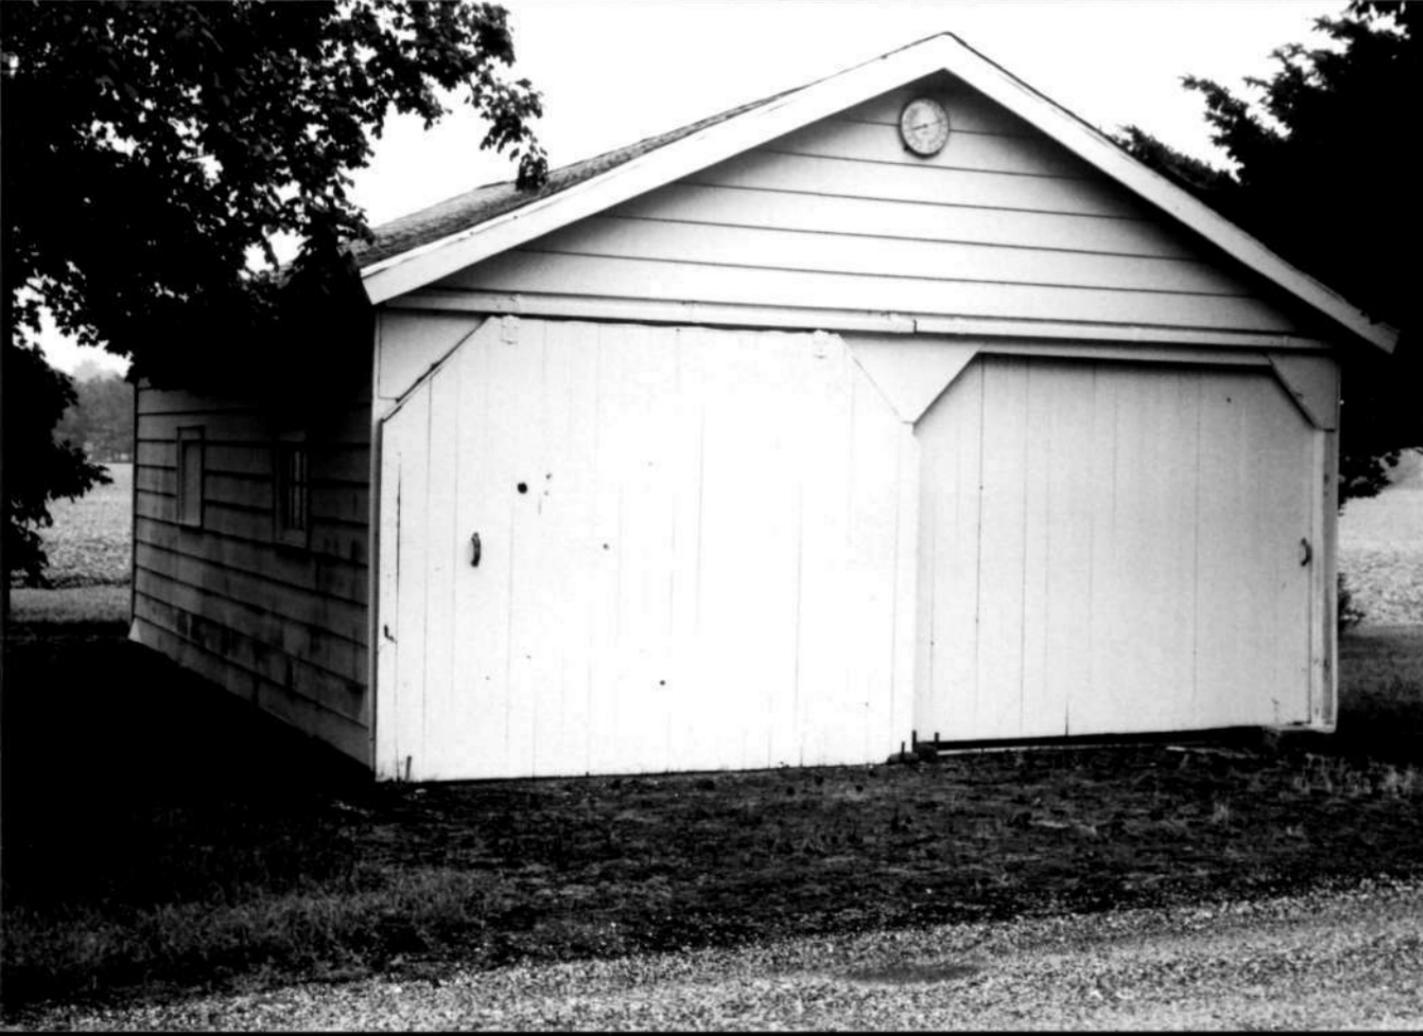
3/22

The garage is a one-story light timber frame structure with an undivided interior space. The building rests on a continuous concrete masonry unit foundation. The walls are clad with aluminum siding. The front-gable roof is clad with asphalt shingles. The building is accessed through two sliding wood plank doors. The windows are six-pane wood hopper sashes. The interior of the building is unfinished with a poured concrete floor.

Garage 3/4 New E 55 SW

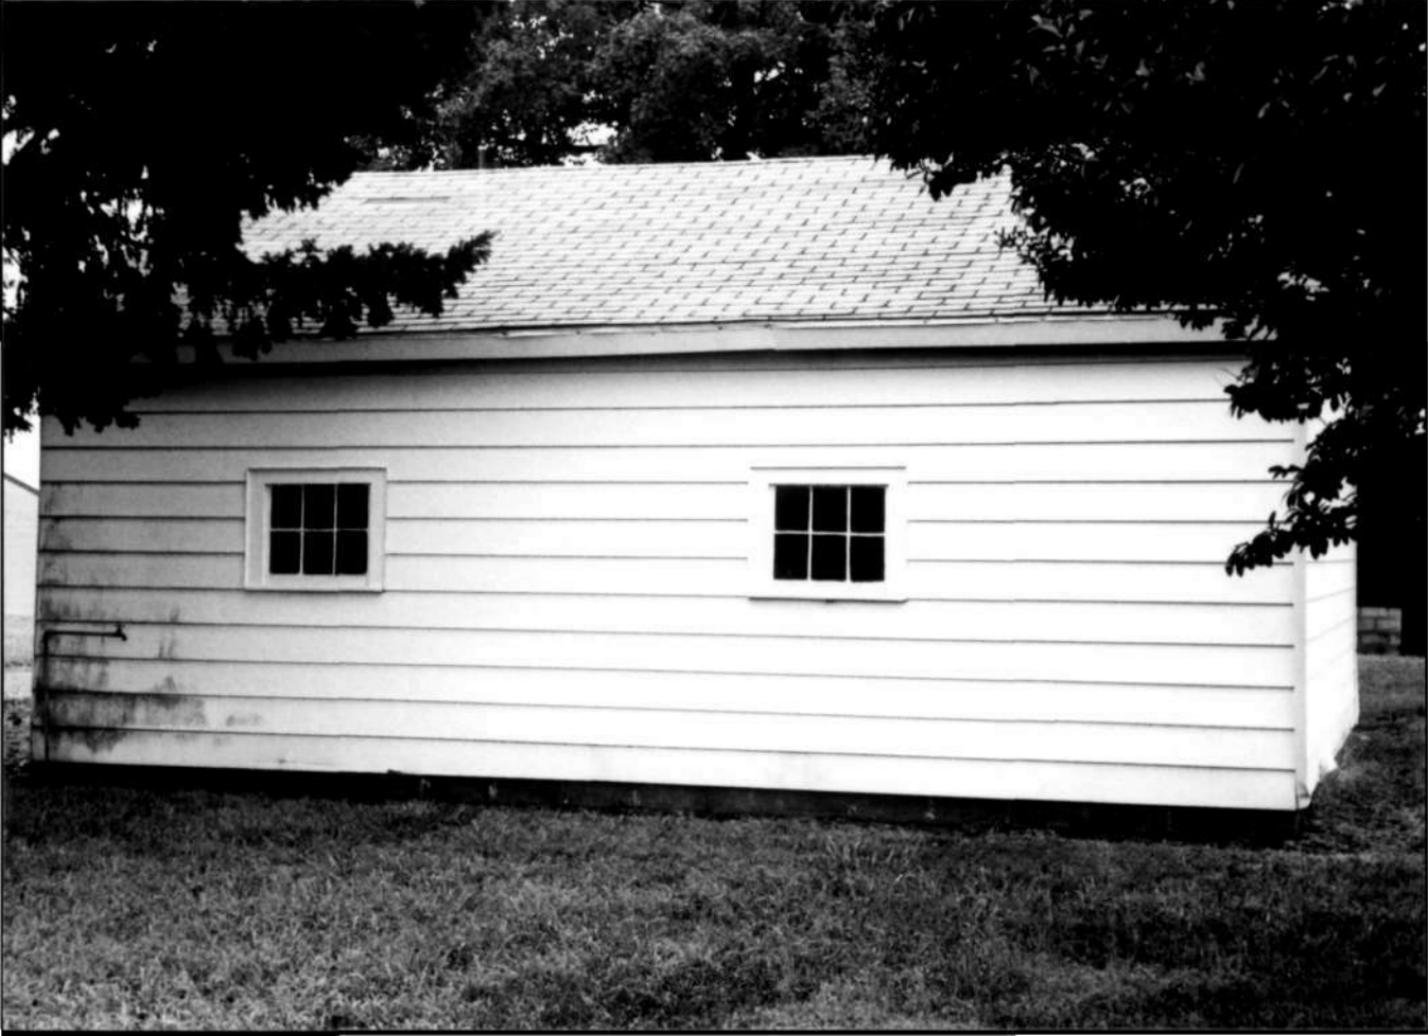
4/22

GARAGE

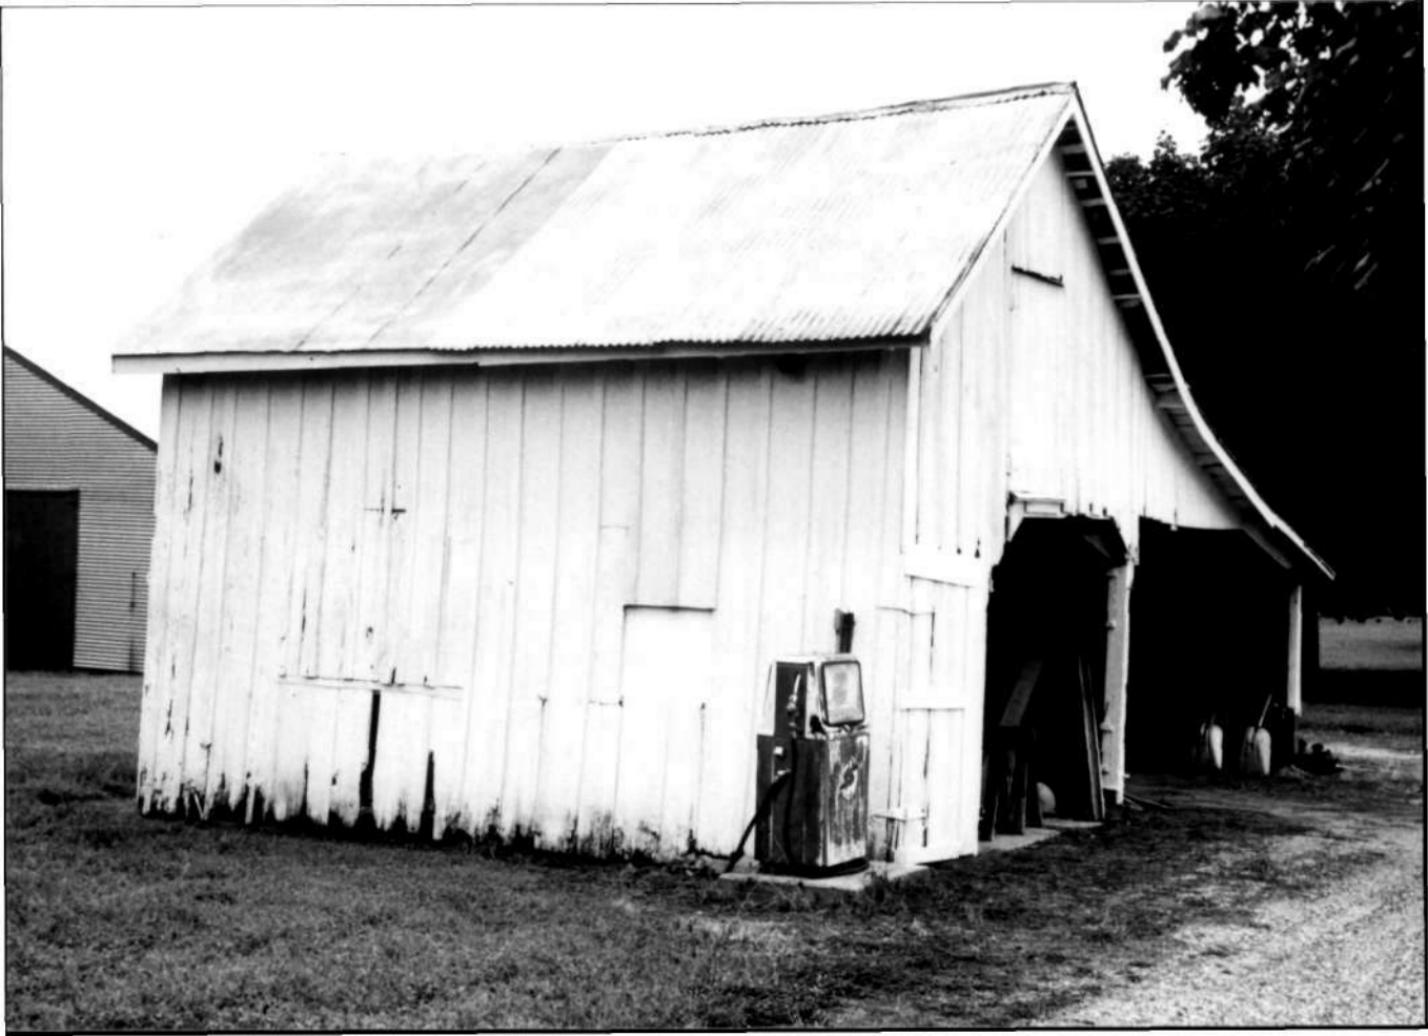
5/22

Three machinery sheds are located on the property. Shed #1 is located across from the garage and is two bays wide with an open south façade. The timber frame shed rests on a combination pier and continuous concrete masonry unit foundation. The walls are clad with vertical wood planks and board and batten siding. The broken front-gable roof is clad with corrugated metal over asphalt shingles. There is a hinged wood plank door on the west façade. The windows openings have six-pane hopper sash windows and have been boarded up. The interior of the building is unfinished with an earthen floor.

Machine shed 3/4 view look E

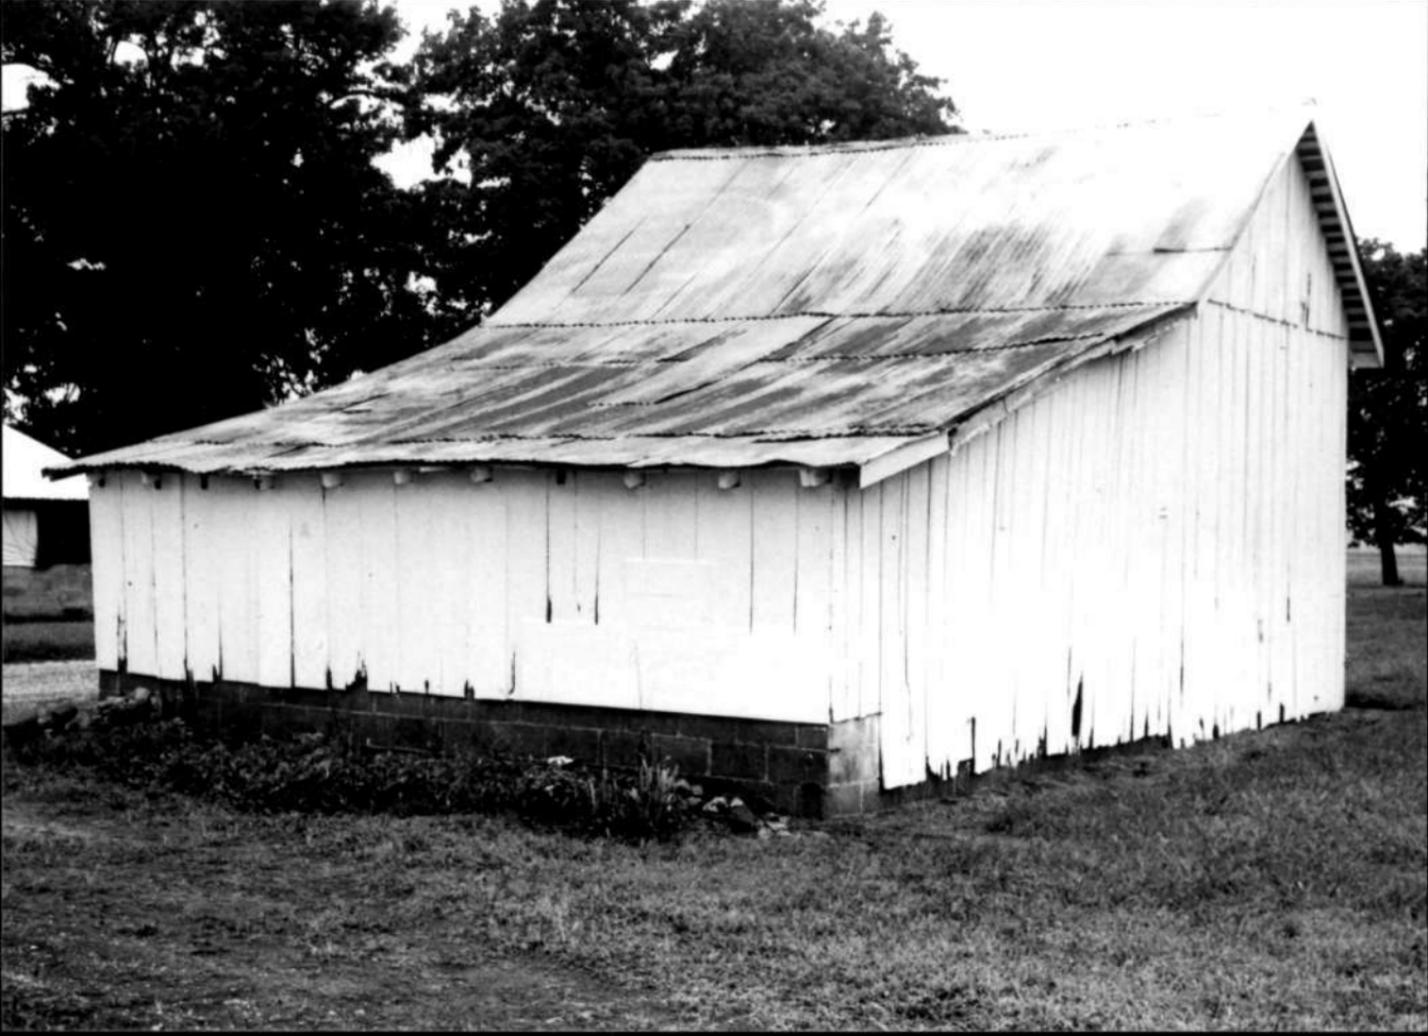
6/22

Shed #2 is located to the north of the barn and is five bays wide with an open south façade. The timber frame shed rests on a combination pier and continuous poured concrete foundation. The walls are clad with corrugated metal. The offset side gable roof is clad with corrugated metal. There are no doors or windows. The interior of the building is unfinished with an earthen floor.

MACHINE shed 3/4 new look SW

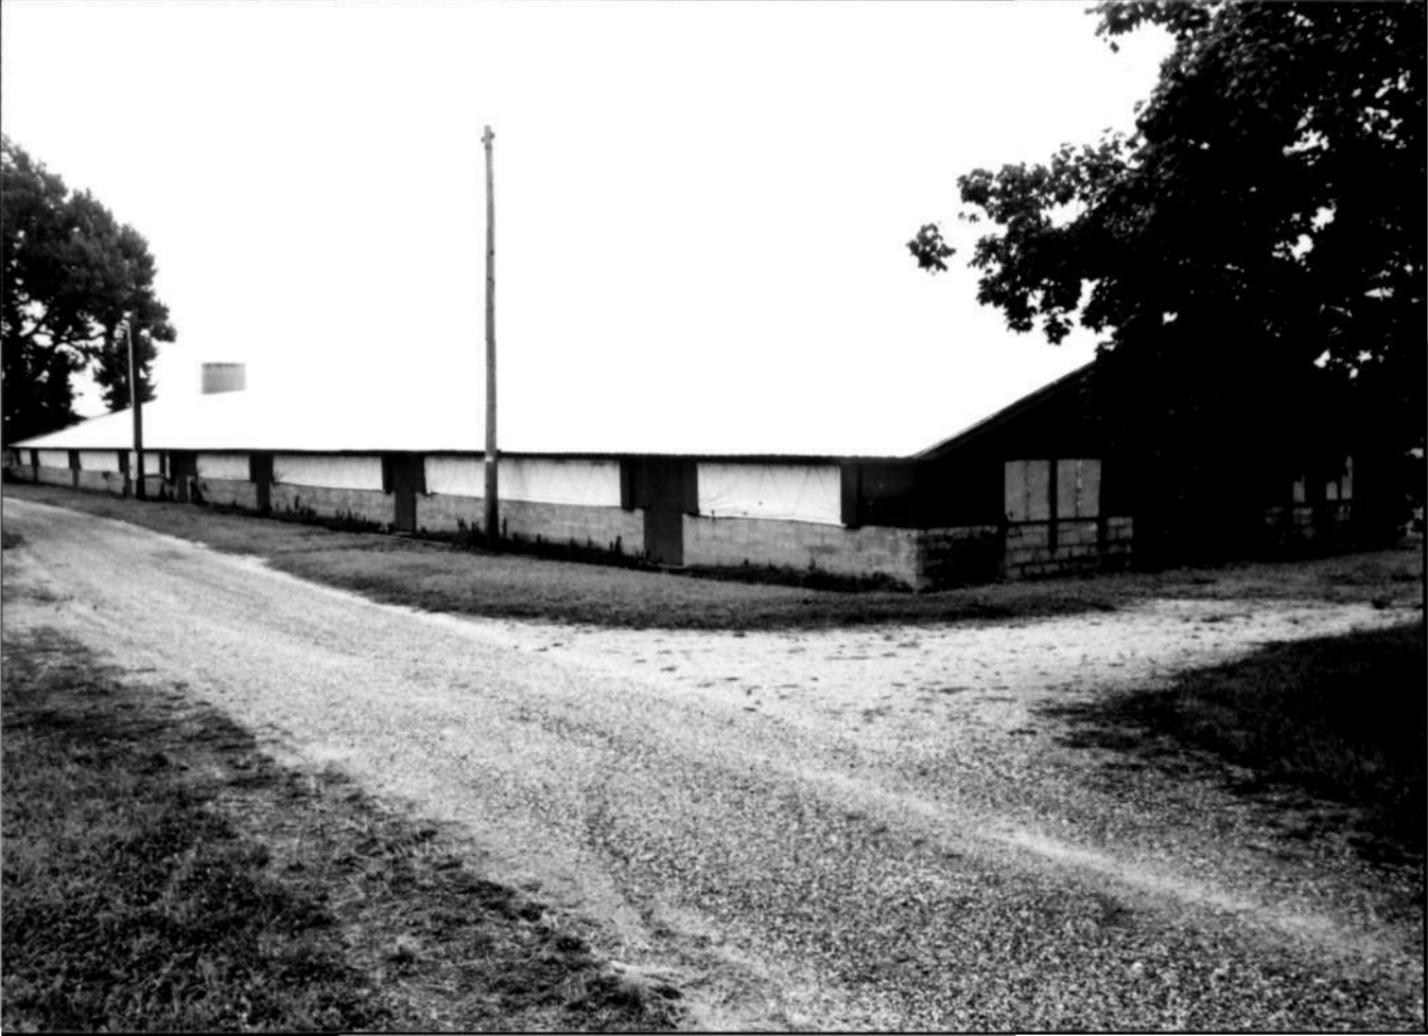
7/22

The exterior walls of broiler house #1 are clad with plywood panels. The side gable roof is clad with corrugated standing-seam metal.

Chicken House #1 $\frac{3}{4}$ view Long St

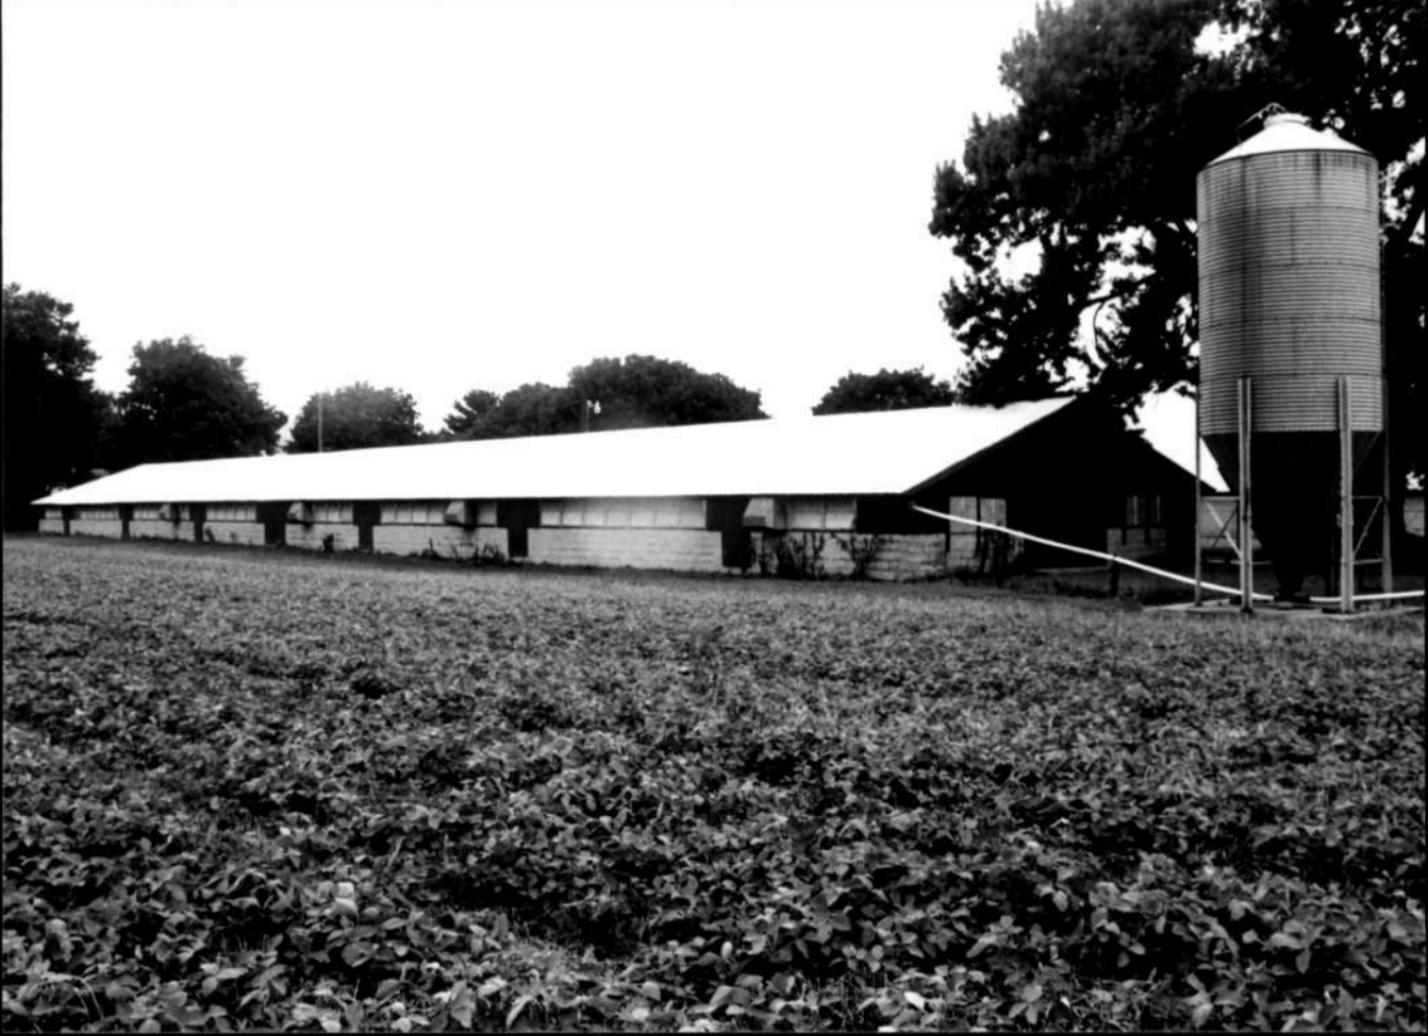
8/22

CHICKEN HOUSE # 1 3/4 VIEW WAY W

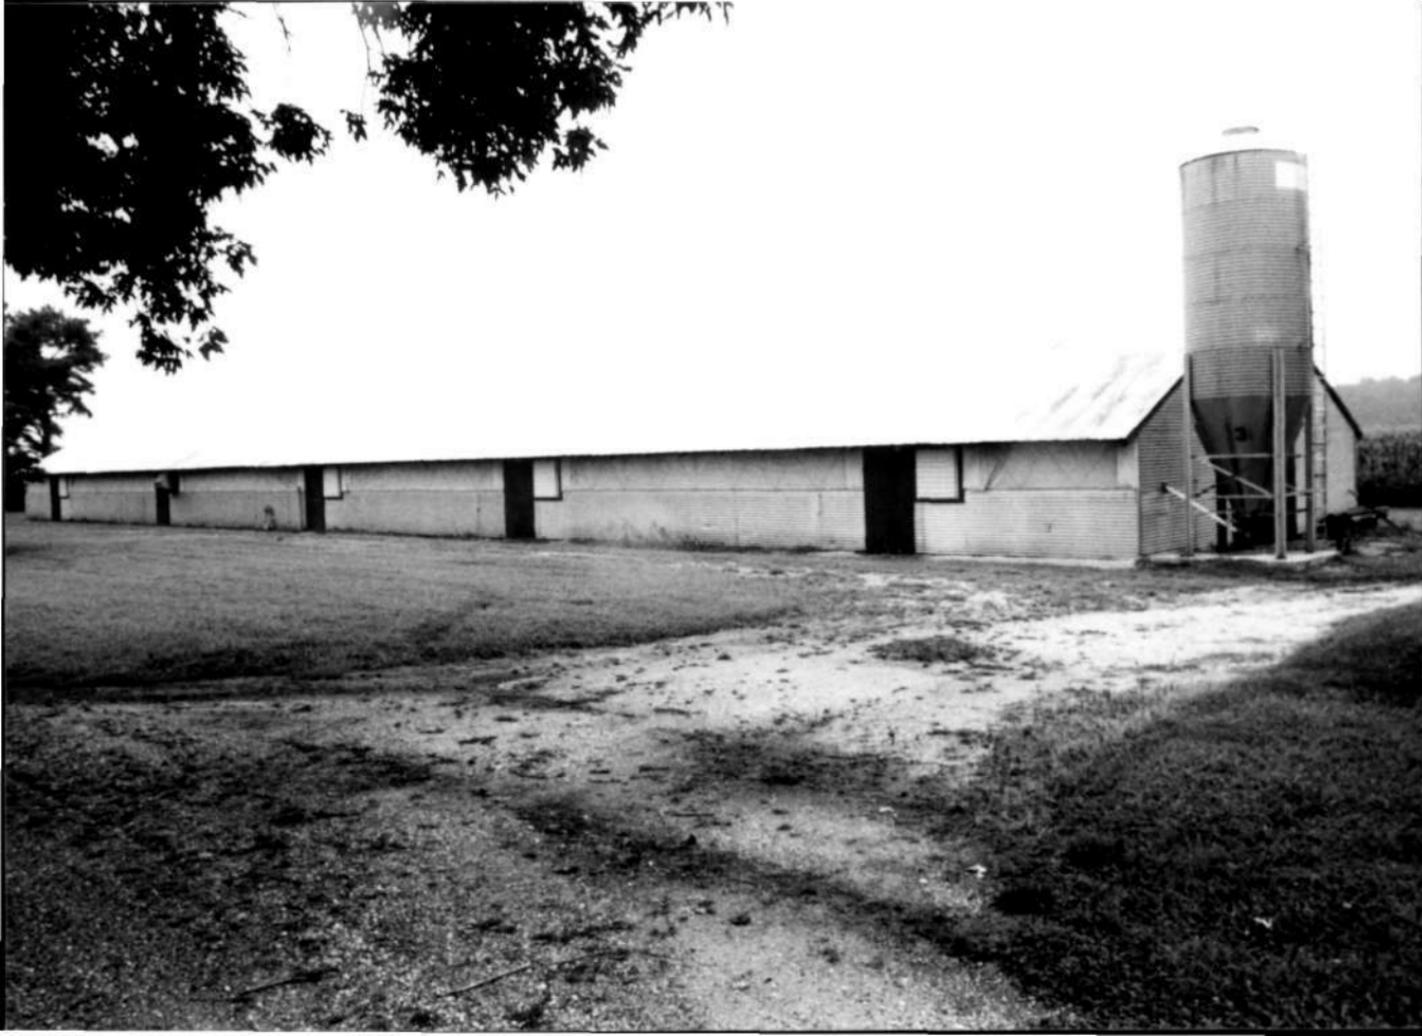
9/22

The exterior walls of broiler house #2 are clad with horizontal corrugated metal with a diamond texture. The side gable roof is clad with standing-seam metal. Fiberglass louvers are located next to each door.

Chicken house #2 $\frac{3}{4}$ view Lodge W

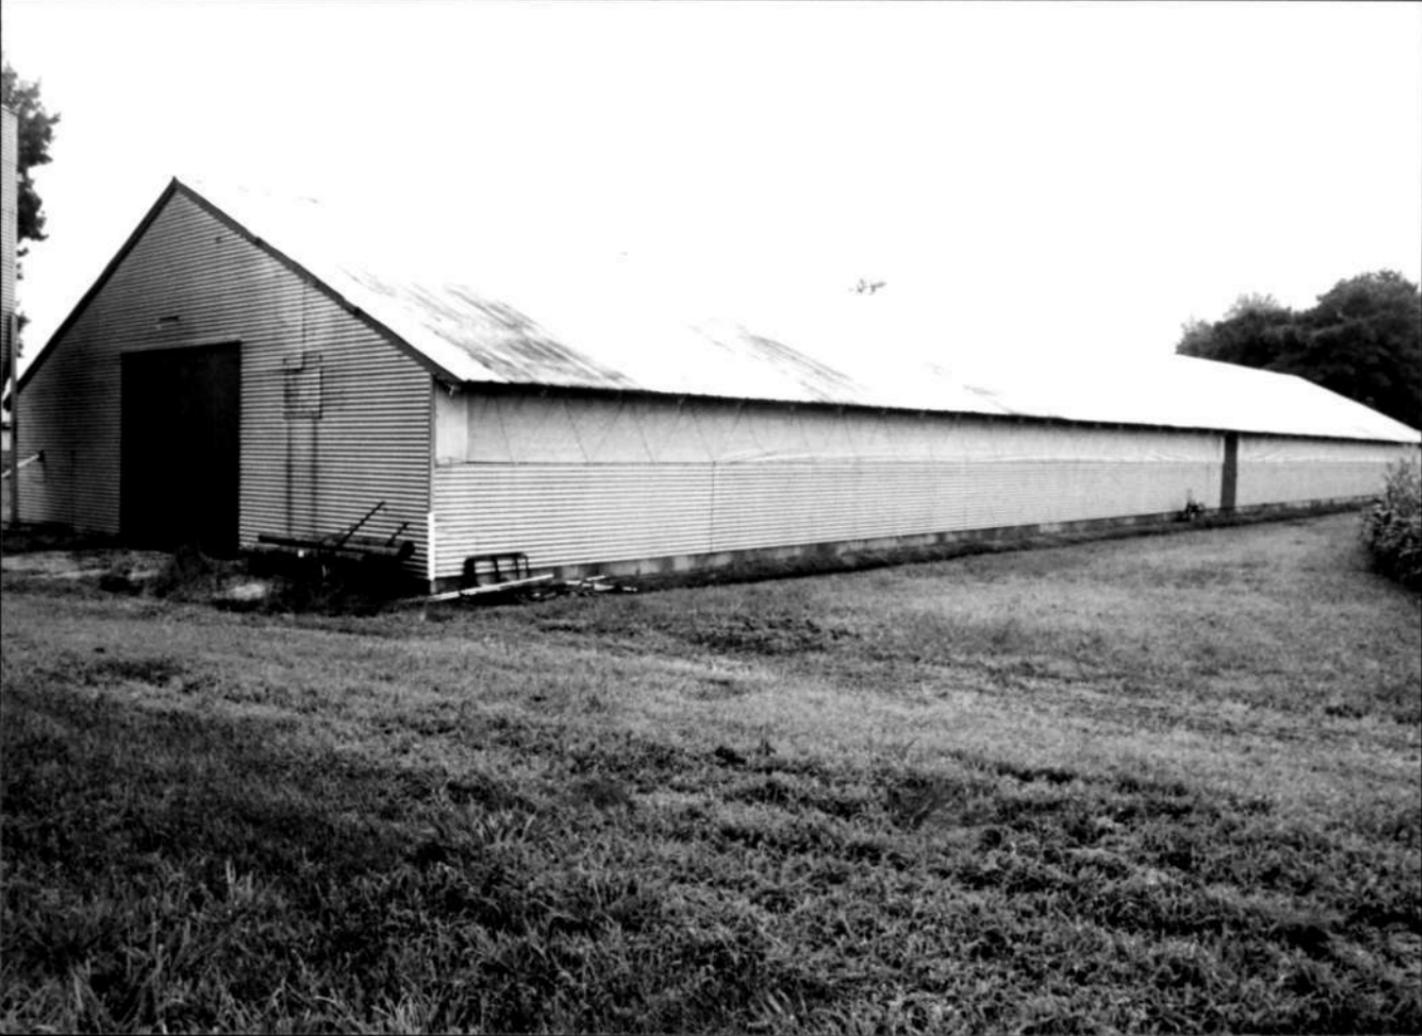
10/22

Chicken House #2 3/4 view Long SW

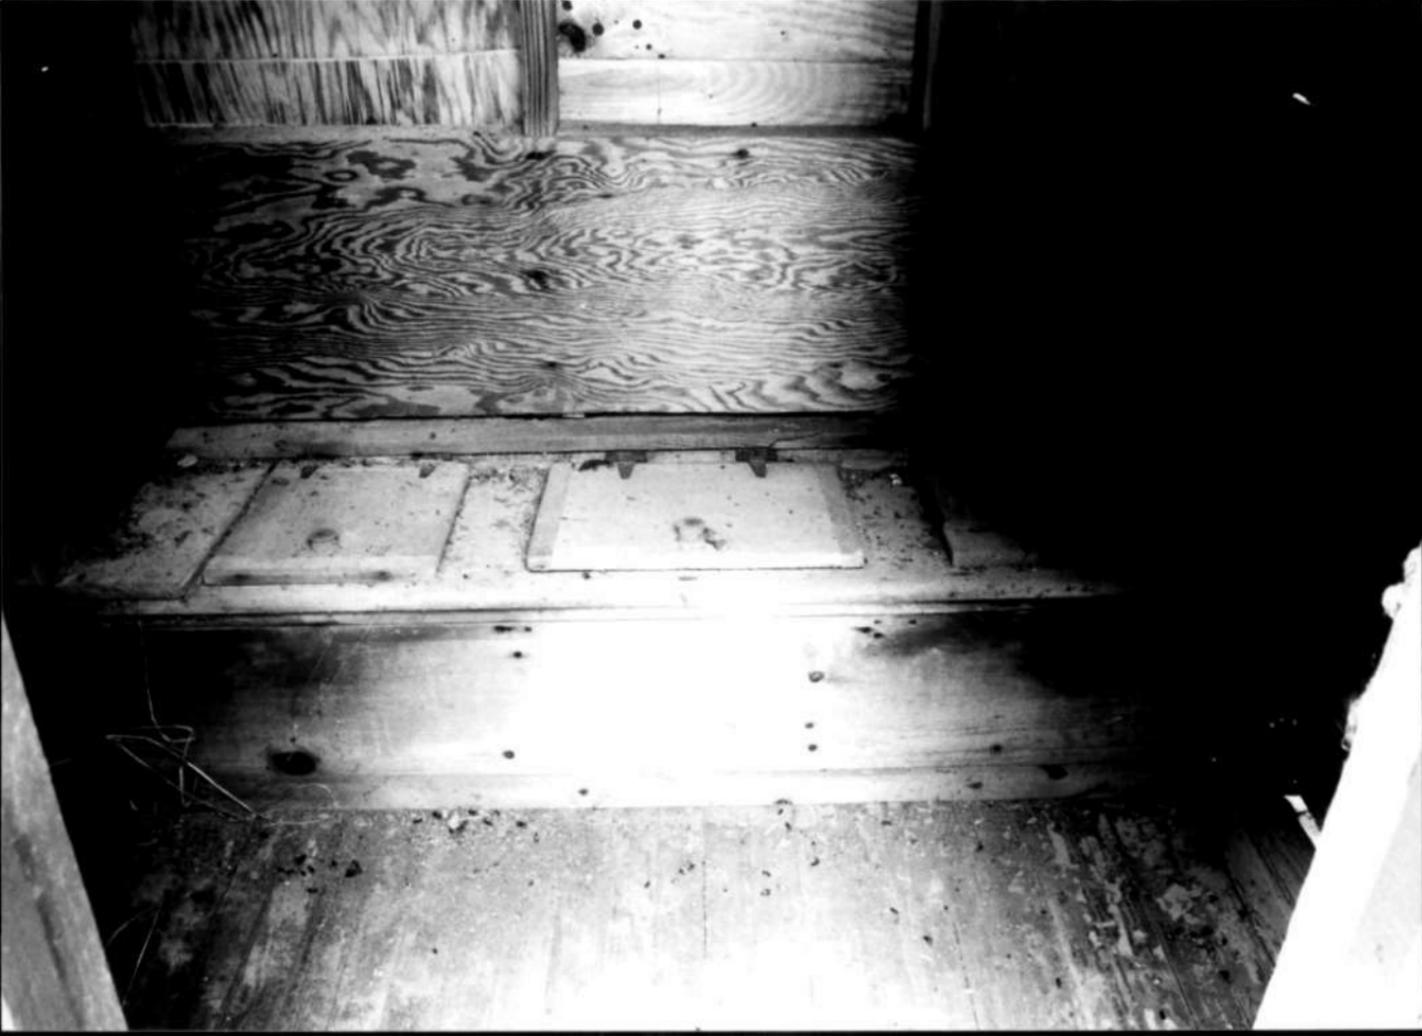
11/22

of the building is unfinished with a wood plank floor. The machine shed side addition is constructed of concrete masonry units and has a side gable roof clad with corrugated metal. The interior of the building is unfinished with an earthen floor. The privy is a one-story wood frame structure with an undivided interior space. The building rests on a concrete masonry unit pier foundation. The walls are clad with three inch vertical wood planks with beveled wood siding used on the north façade. The side gable roof is clad with slate and has metal and asphalt shingle patches. The building is accessed through a hinged wood plank door on the south façade. The windows have been boarded up. The interior of the building is unfinished with a wood plank floor. The ceiling is clad with one-inch wood boards spaced one-half-inch apart. There are three seats with lids and no interior partitions.

outhouse Interior Showy 3 Seater Loop N

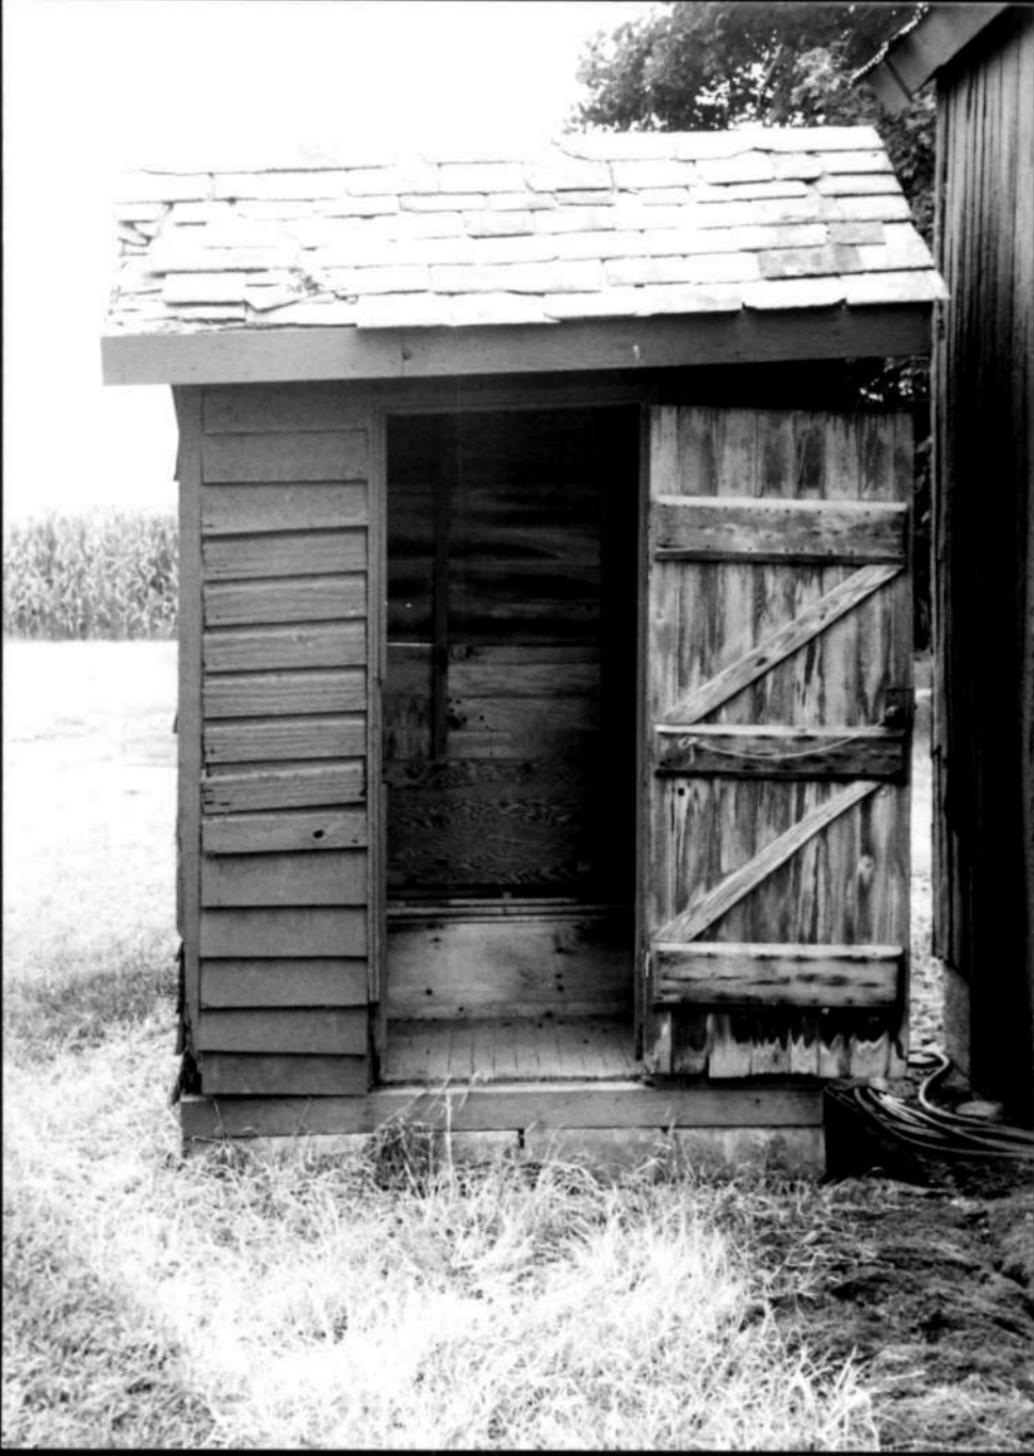
12/22

outhouse front facade look N

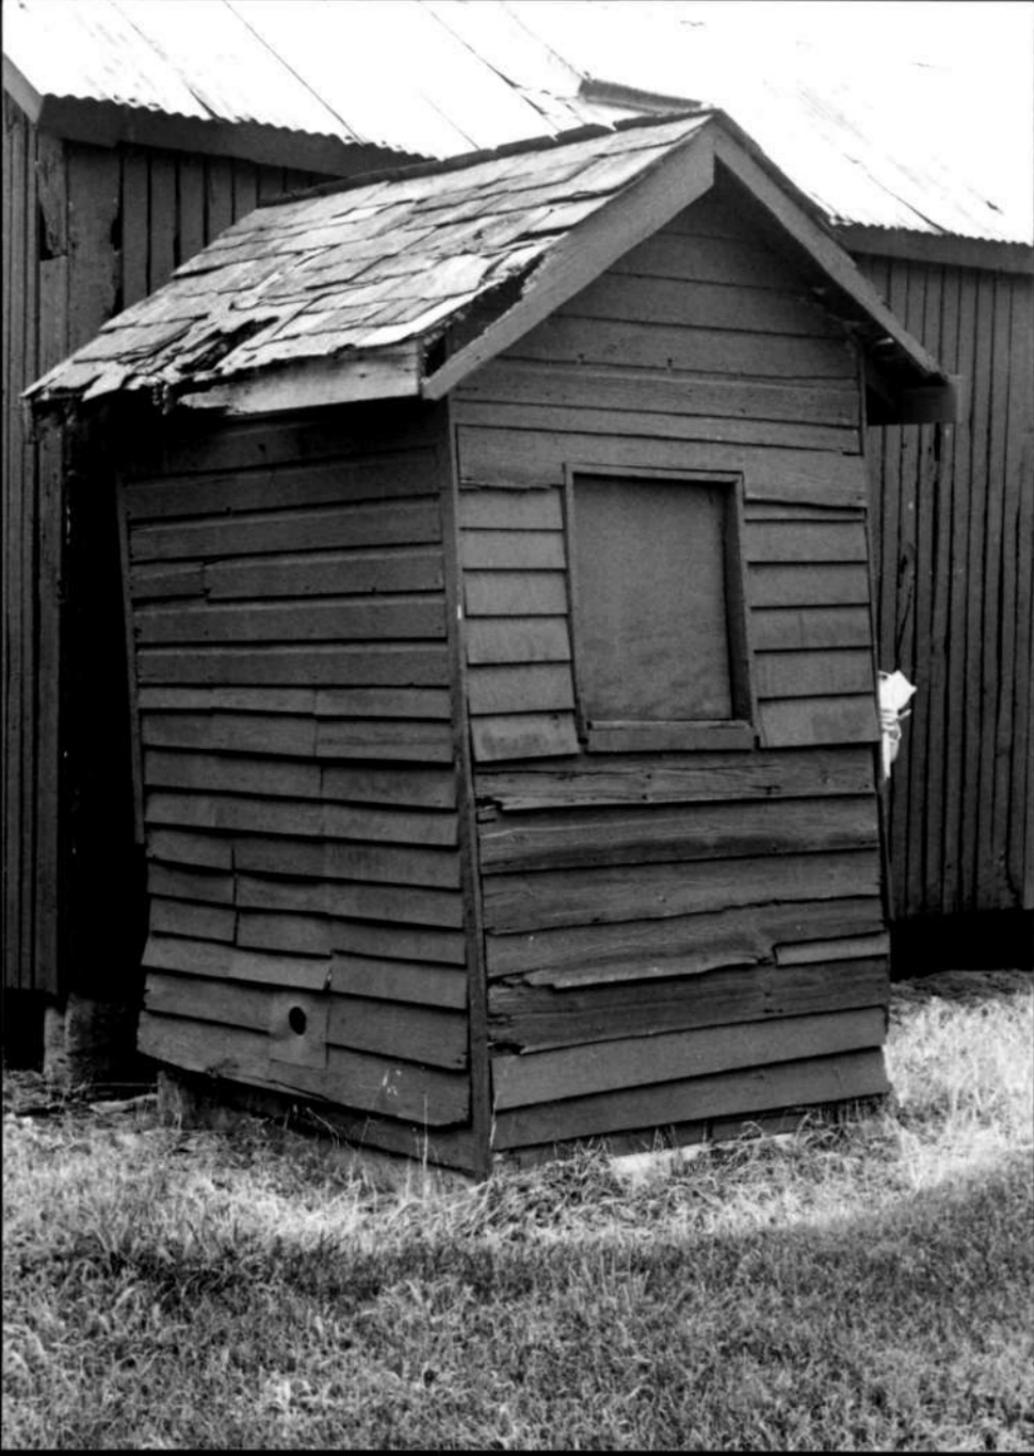
13/22

outhouse 3/4 view low E
