T-393
Clarke W. Sewell Farm
5705 Old Trappe Road
Trappe Vicinity
Ca. 1900-1960
Private

Maryland Historical Trust Maryland Inventory of Historic Properties Form

Inventory No. T-393

Clarke W. Sewell Farm
Continuation Sheet

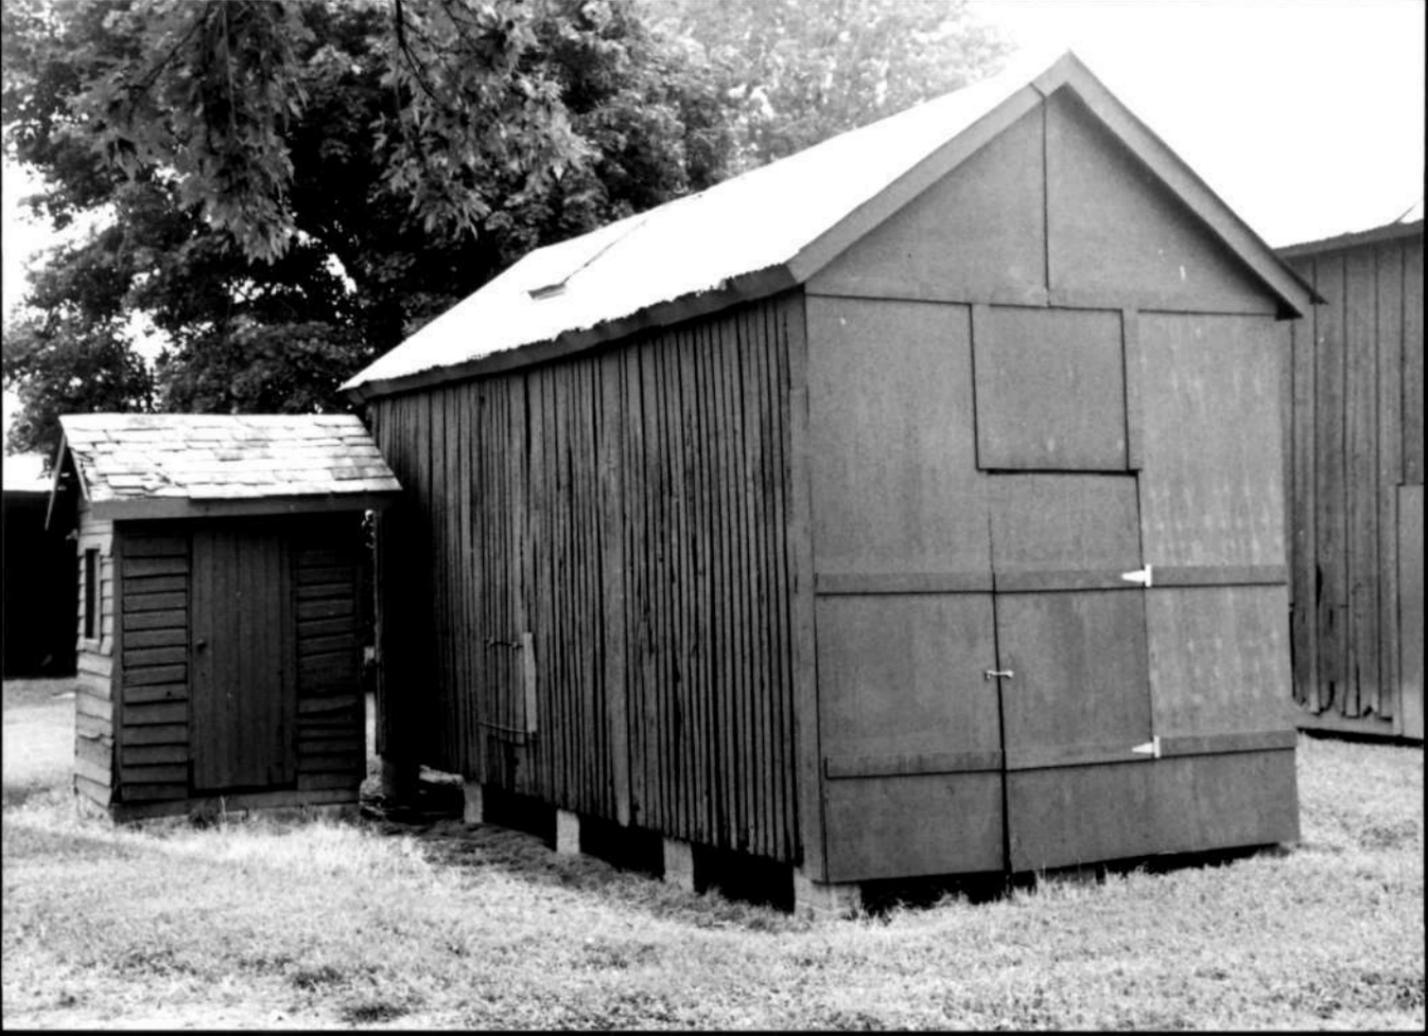
14/22

The corncrib is a one-story timber frame structure with an undivided interior space. The building rests on a brick pier foundation with a concrete protective coating. The walls are clad with three inch vertical wood planks spaced approximately 1-inch apart. The front-gable roof is clad with corrugated metal. The building is accessed through a hinged plywood panel door on the north façade and hinged wood plank feeder doors at the roofline. There are no windows. The interior of the building is unfinished with a wood plank floor.

GRANERY 3/4 VIEW LOOK N

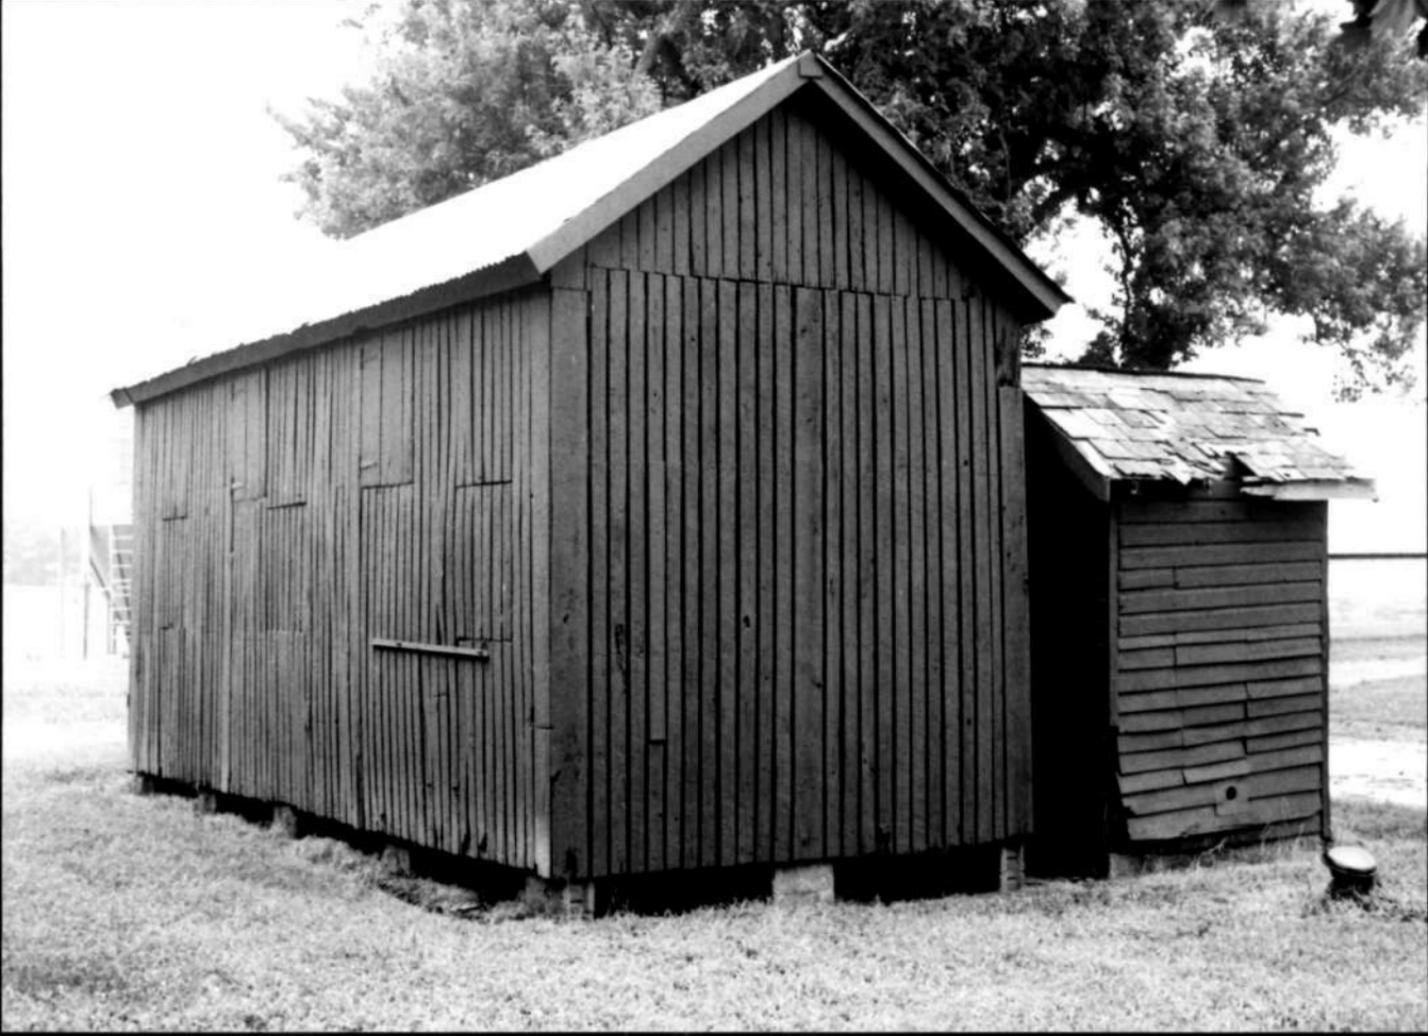
15/22

GRANEKY 3/4 NEW LOOK SW

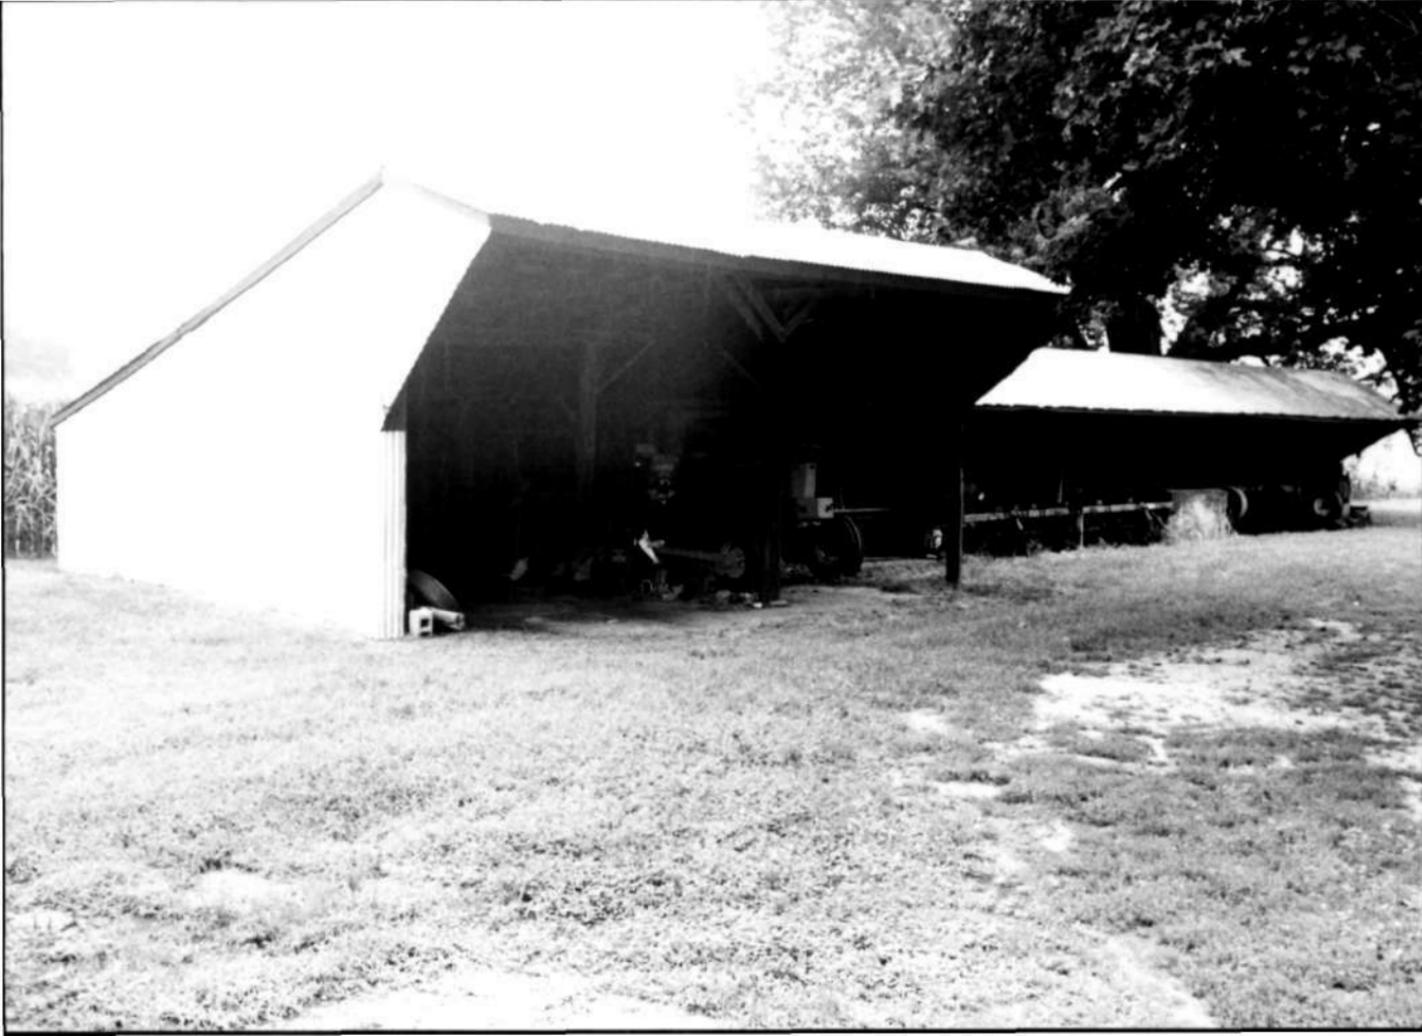
16/22

WAGON SHED LOOK NE

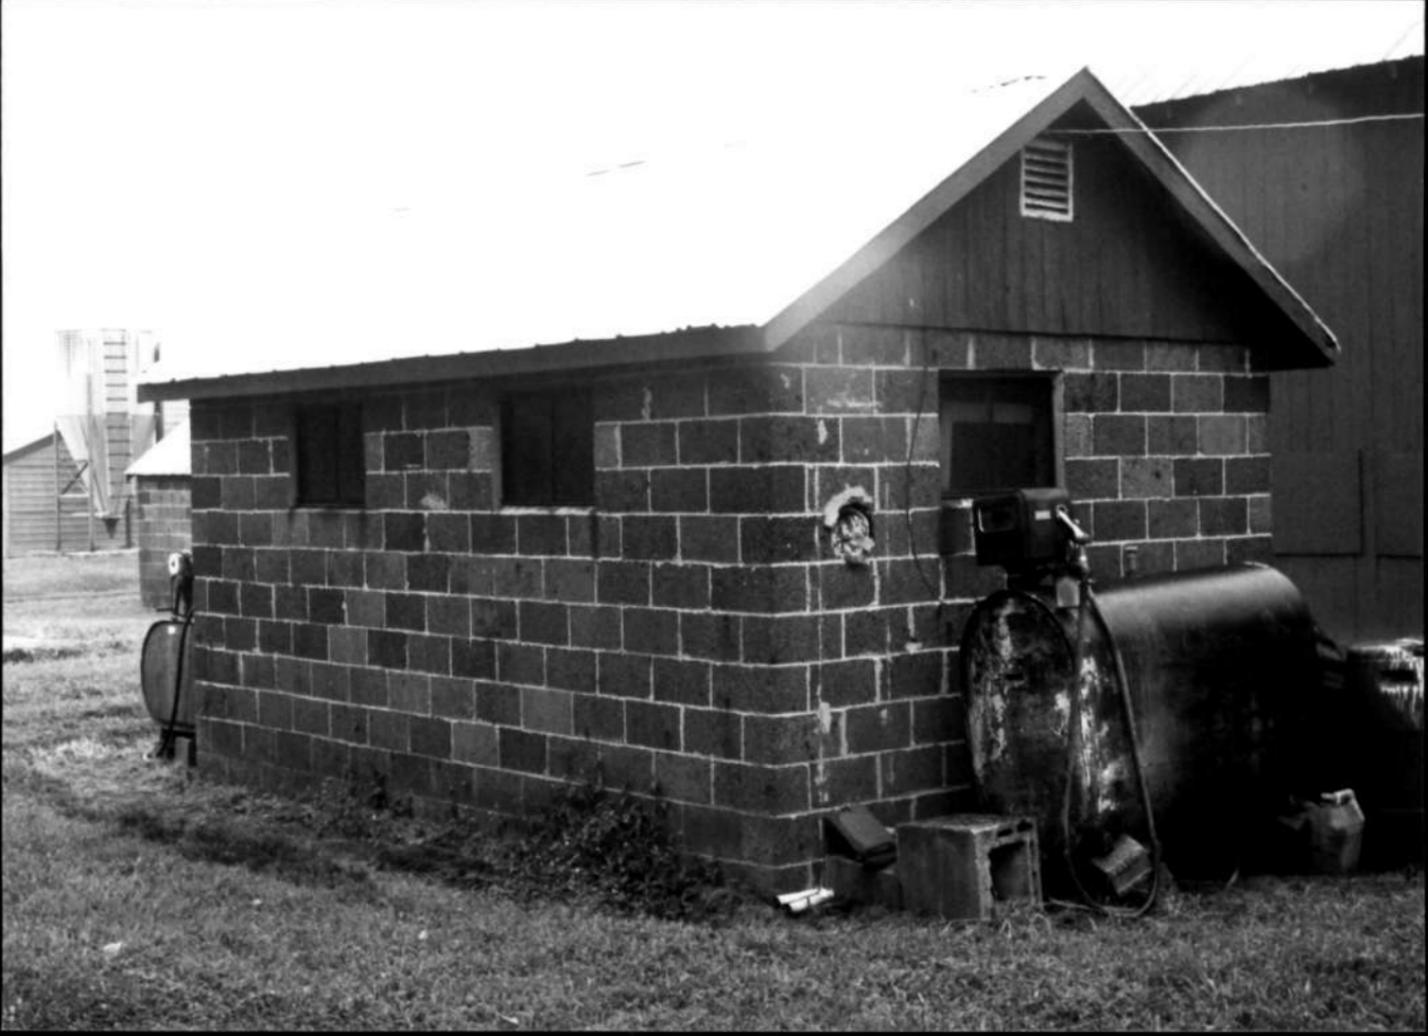
17/22

The shed is a one-story masonry structure. The building rests on a poured concrete slab and is constructed of concrete masonry units. Vertical wood boards are used to infill the gable ends. The side gable roof is clad with standing-seam metal. The building is entered through a hinged wood plank door on the south façade. A two-pane metal awning sash window is located on each façade. The interior was not accessible at the time of the survey.

Cinder block shed 3/4 view look E

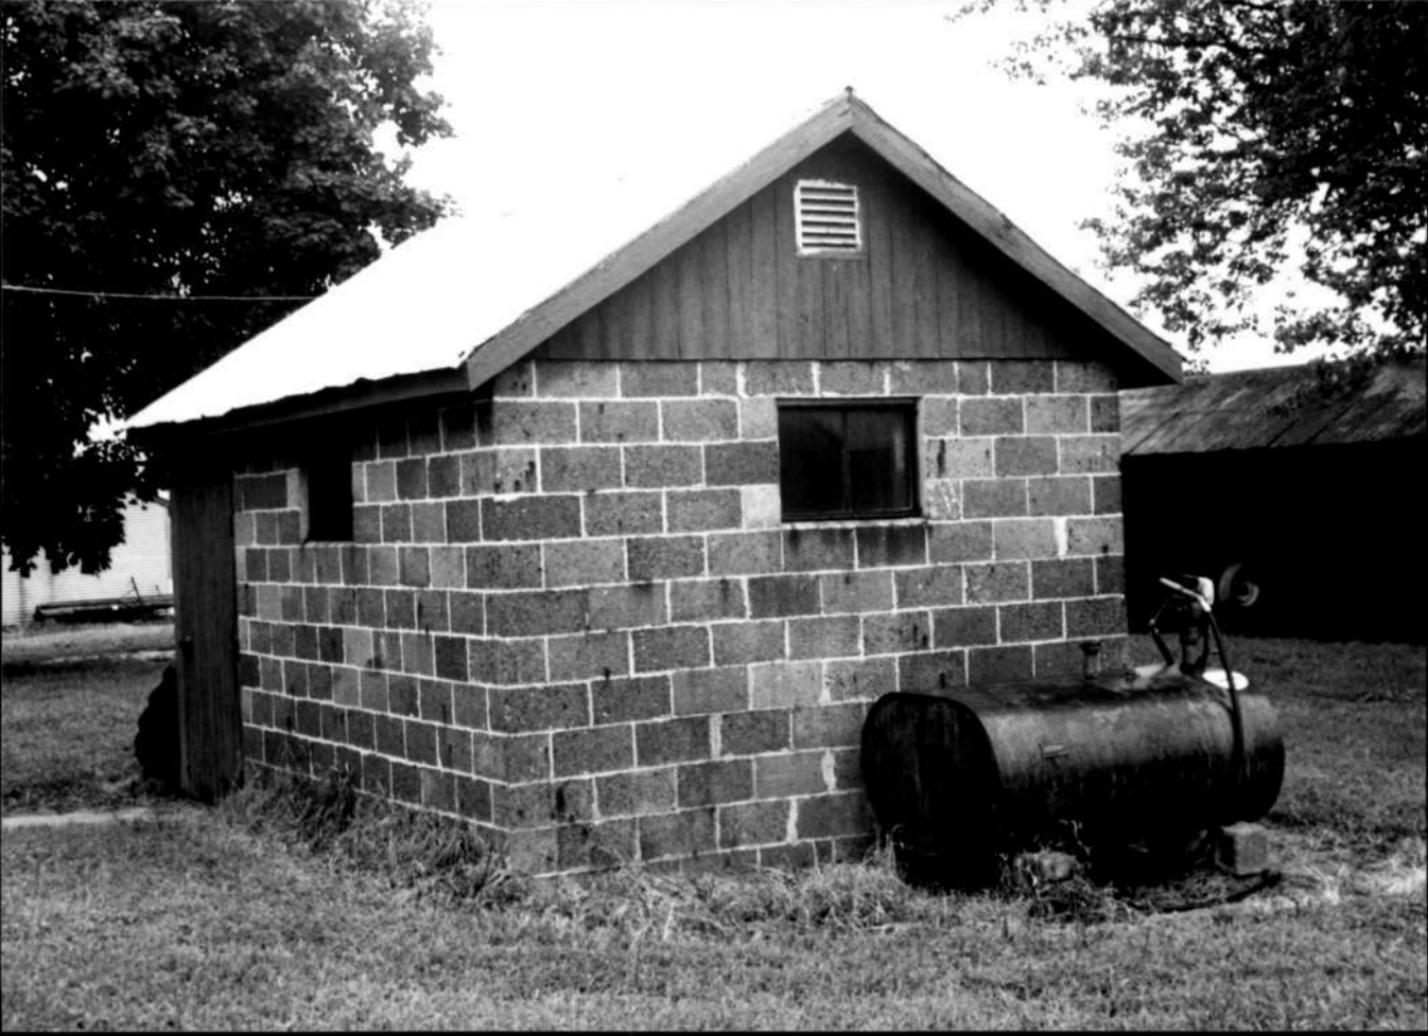
18/22

Cinderblock shed 3/4 view showing door

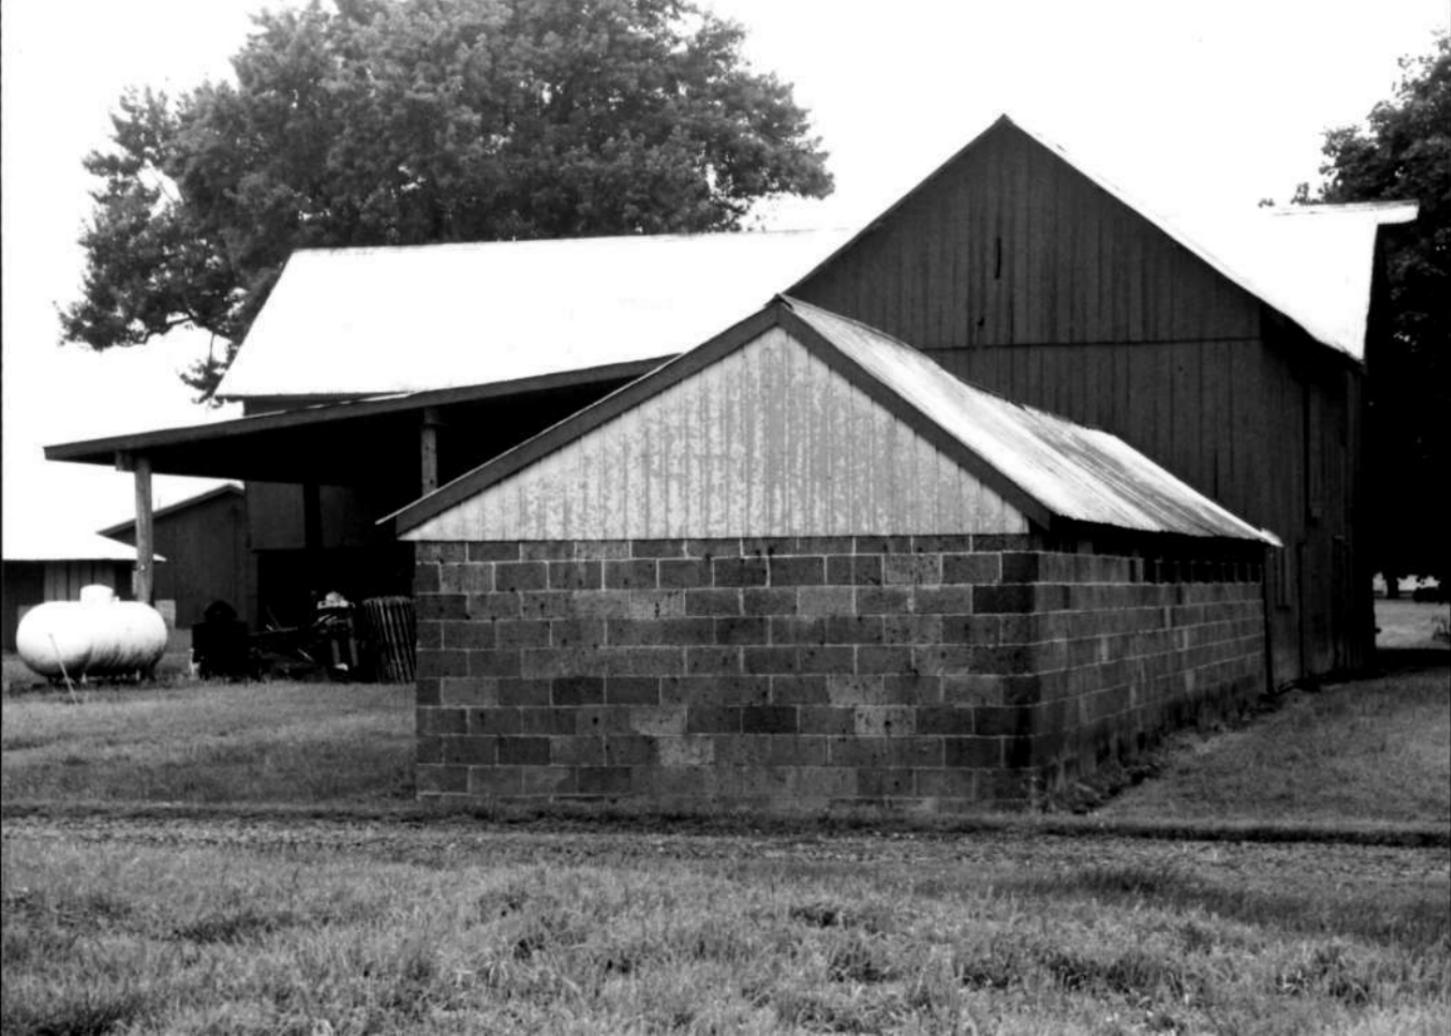
19/22

The multi-purpose barn is three bays deep with a hayloft and a two side additions, one of which is a machine shed. The structure rests on a brick masonry pier foundation. The timber frame barn is clad with board and batten siding. The side addition is clad with plywood panels. The cross-gable roof is clad with corrugated metal. The barn has a hay hood on the north and south gable ends. The doors are hinged wood planks with diagonal bracing and are clad with either plywood panels or board and batten siding. One door is a Dutch door. The windows openings have been boarded up. The interior

BARN w addition $\frac{3}{4}$ view look W

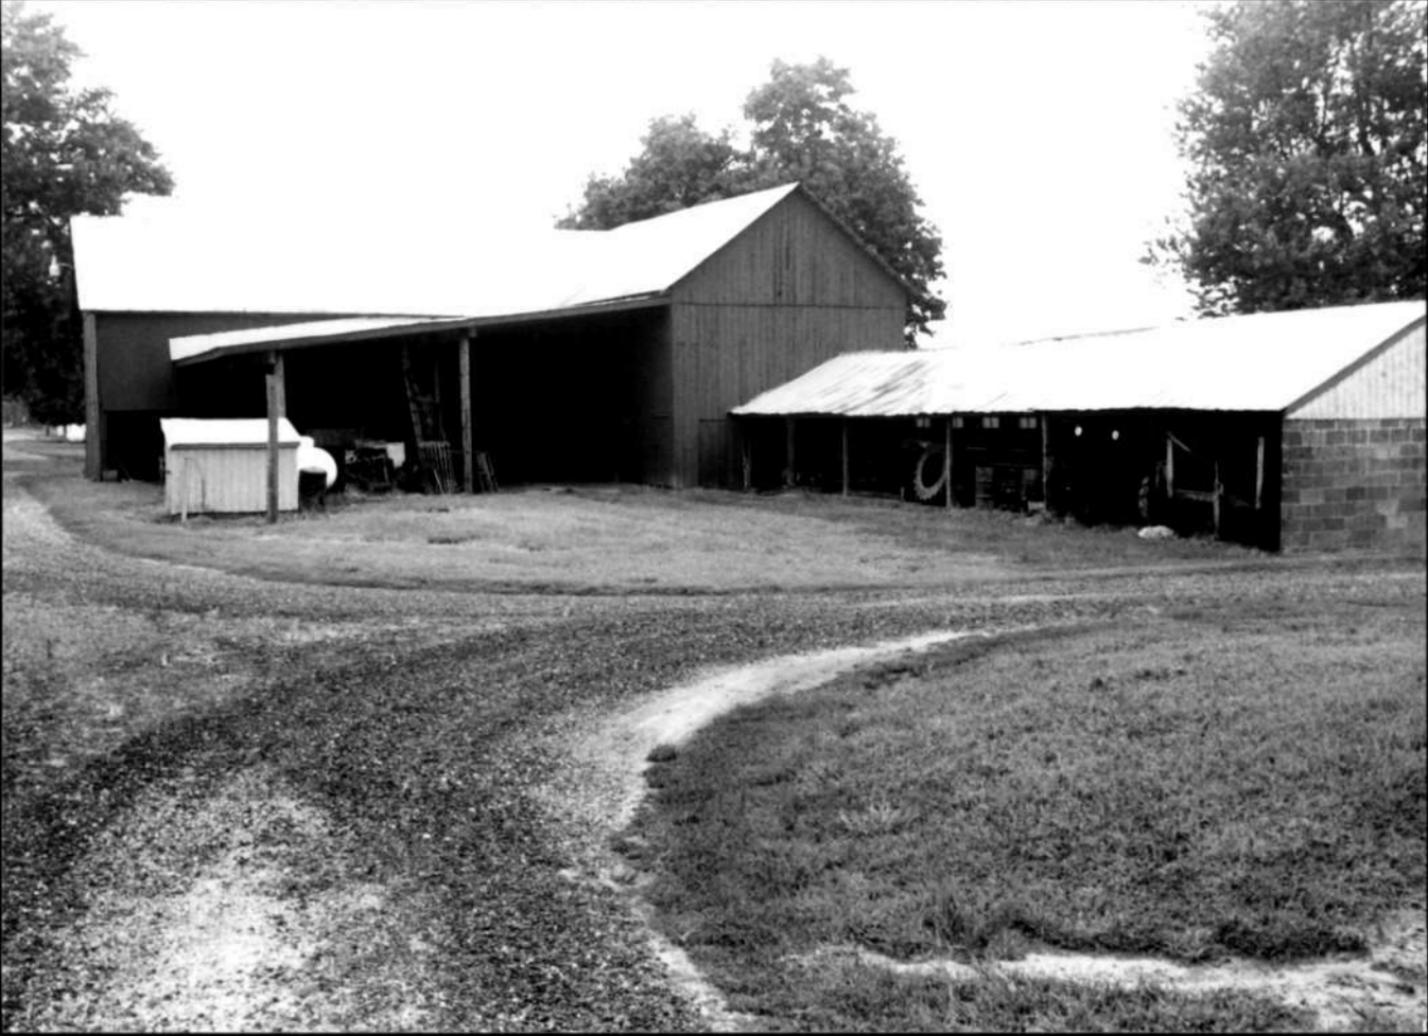
20/22

BARN w/ addition Louis W

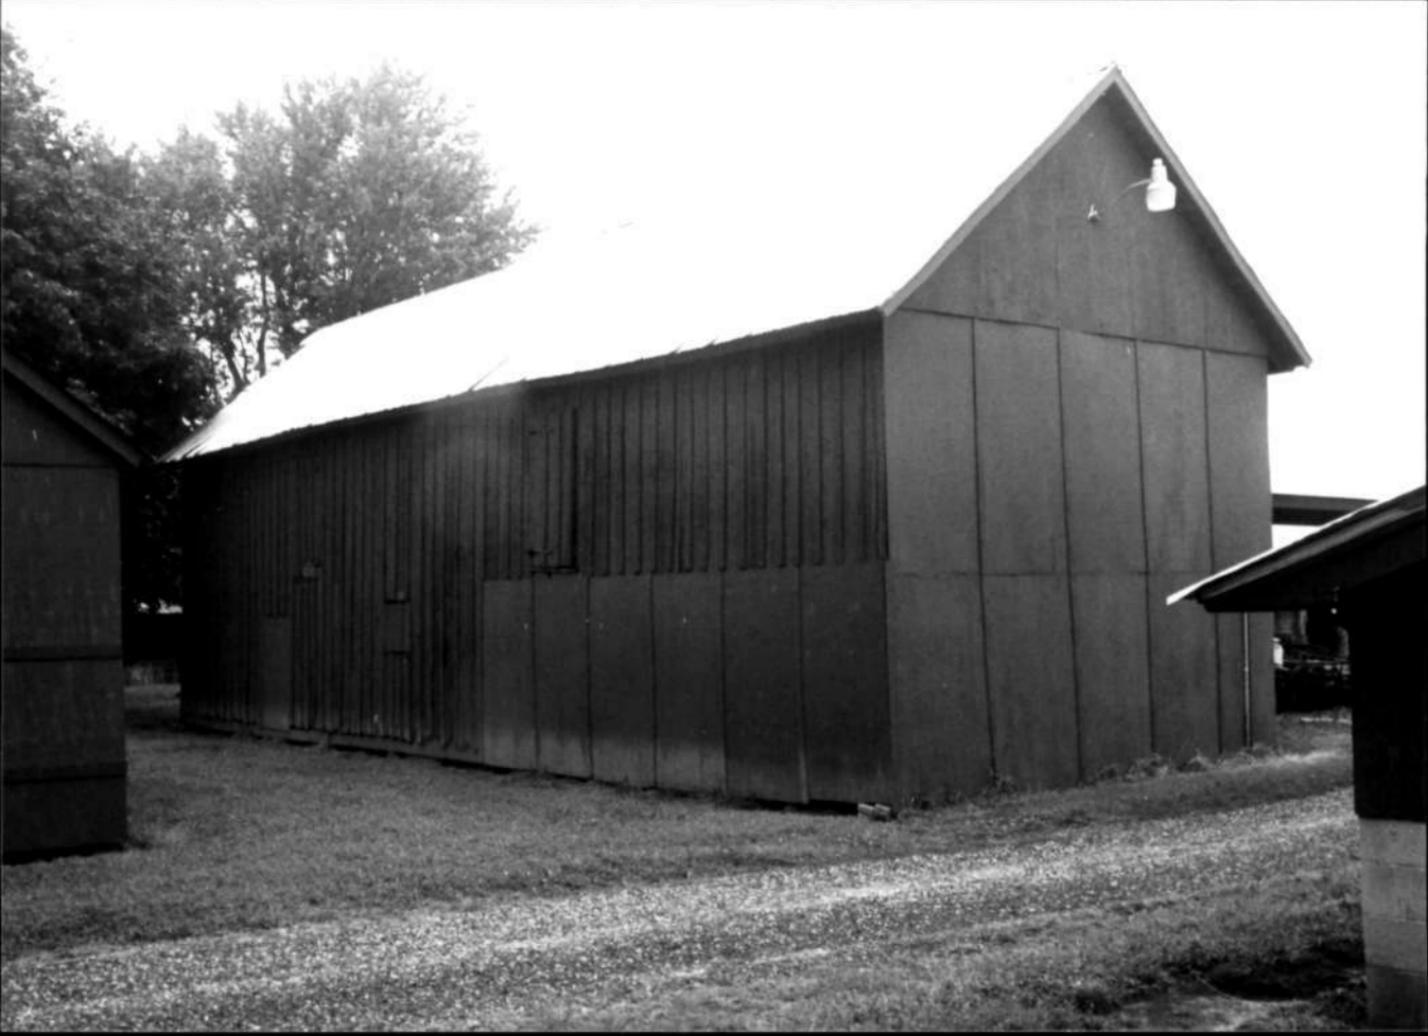
21/22

BARN front look N

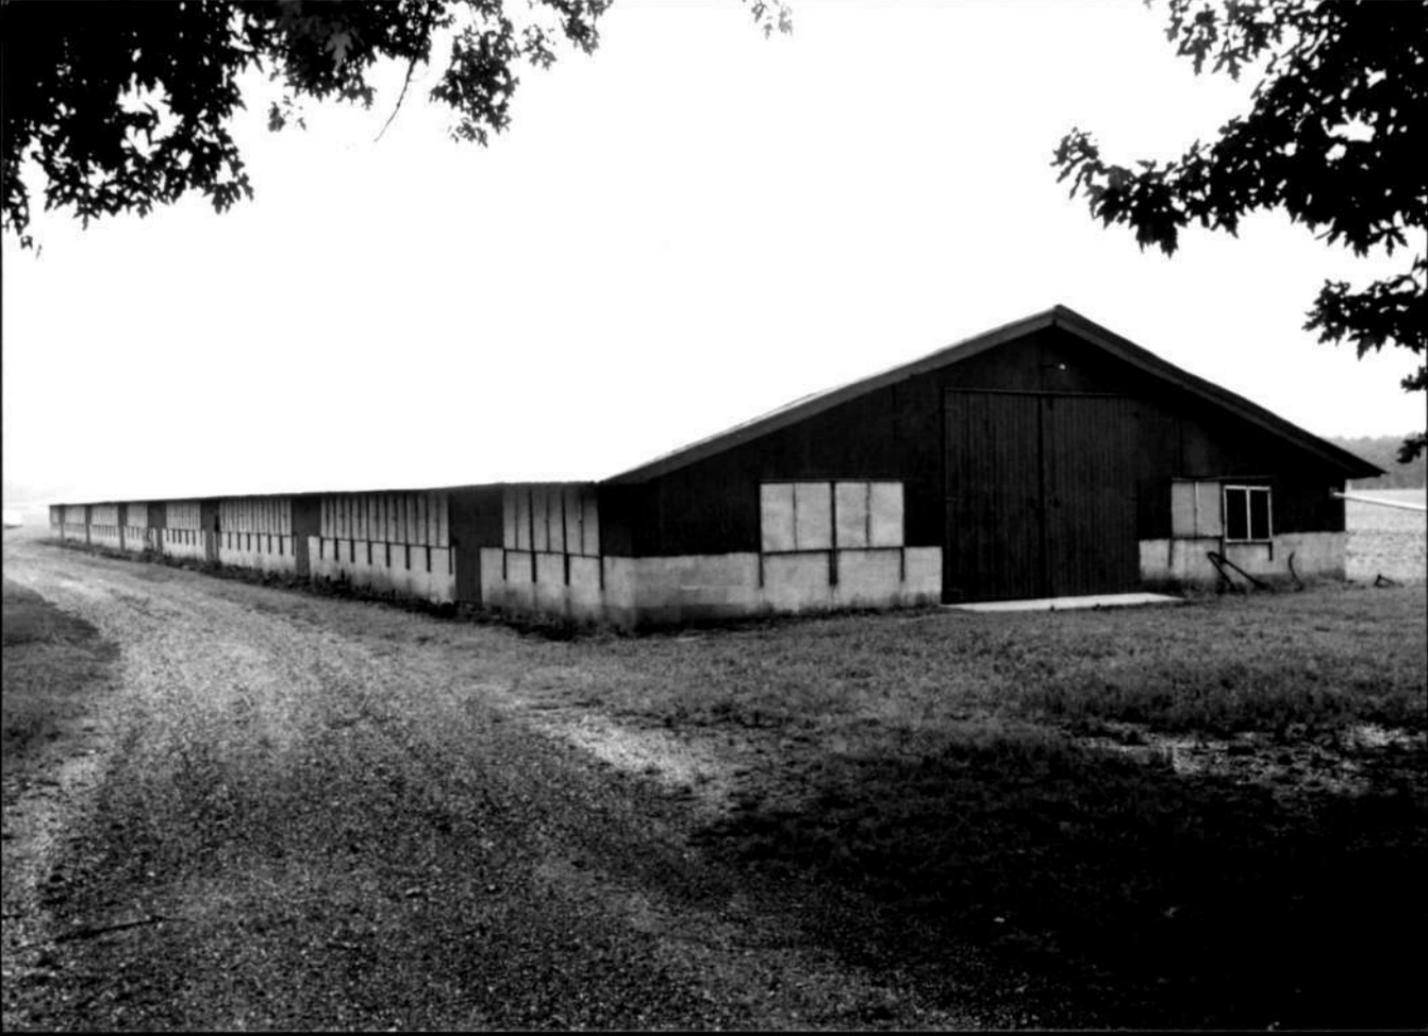
22/22

The exterior walls of broiler house #3 are clad with embossed wood panels. The side gable roof is clad with standing-seam metal.

Chicken house 3/4 view #3 look E
